# South Bog Stream Brook Trout Habitat Restoration

FISHERY INTERIM SUMMARY REPORT SERIES NO. 08-02  
SOUTH BOG STREAM BROOK TROUT HABITAT RESTORATION

SOUTH BOG STREAM BROOK TROUT HABITAT RESTORATION  
INTERIM SUMMARY REPORT NO. 3 (2003-2007)

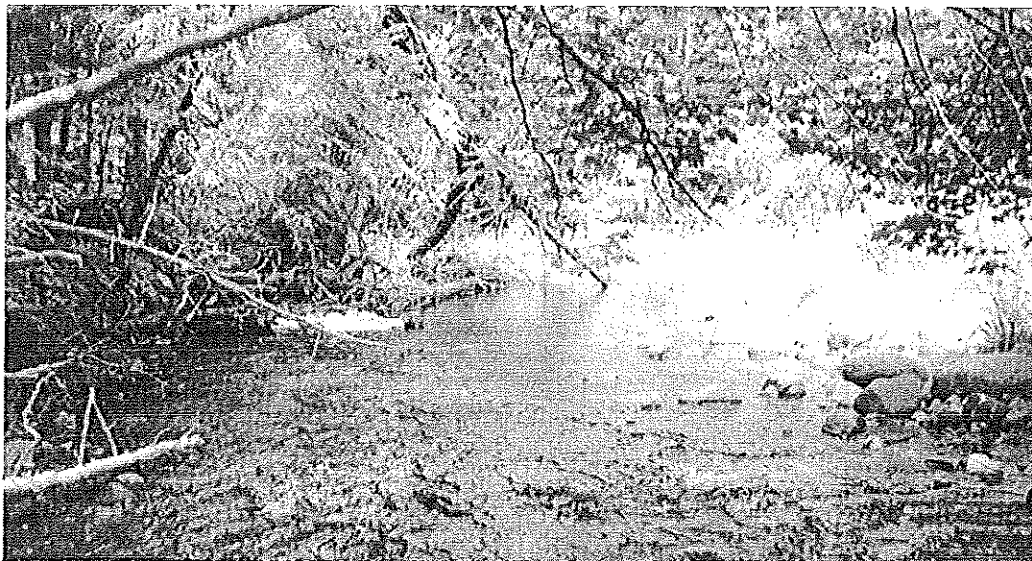
Transect 11 (control) looking upstream, August 2007. The presence of boulders and woody debris in this reach provides habitat complexity for brook trout.

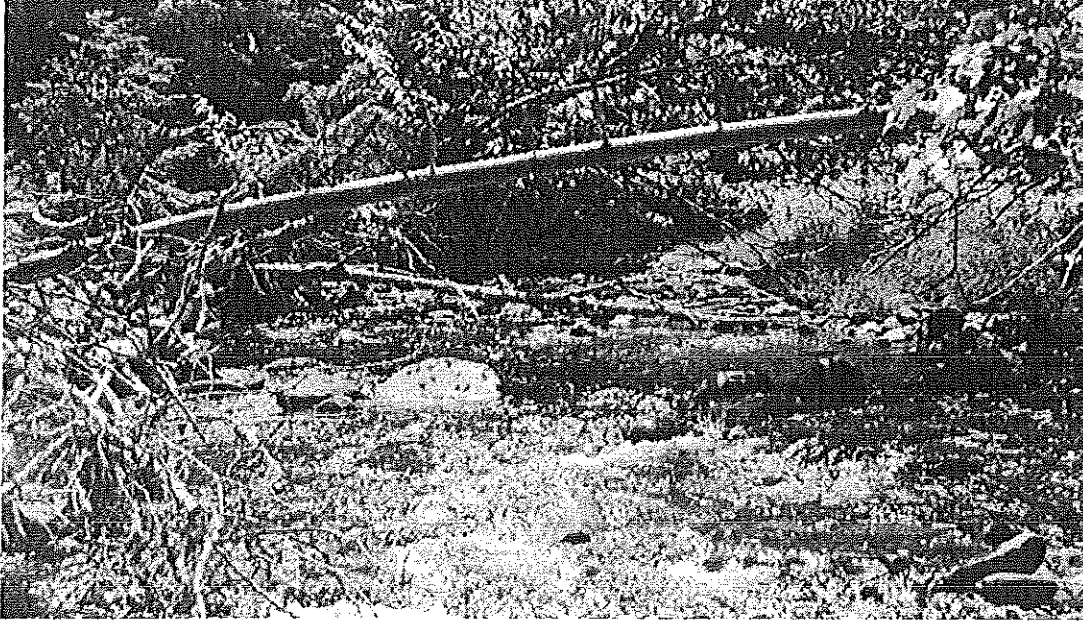
Transect 12 (control) looking downstream into lower treatment area, August 2007. Four log deflectors, highlighted by arrows, are visible.

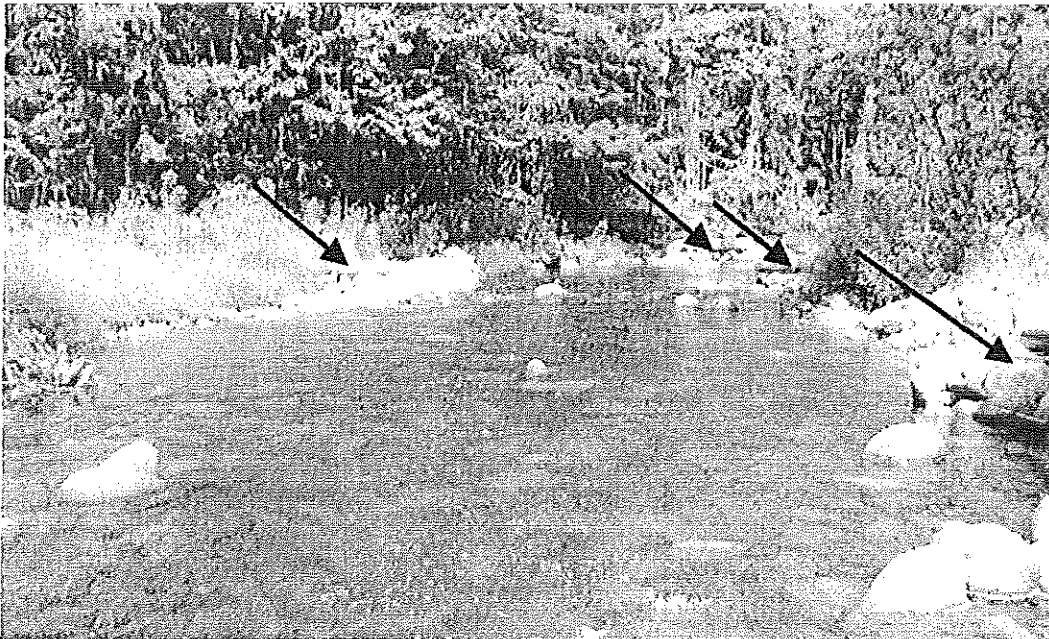
Transect 12 looking downstream after construction of rock weir no. 1, October 2007. Wing of rock weir is at left; pool and root wad visible immediately downstream of weir. Four log deflectors (highlighted by arrows) are visible downstream. The left log deflector of the second pair was removed in order to construct this weir.

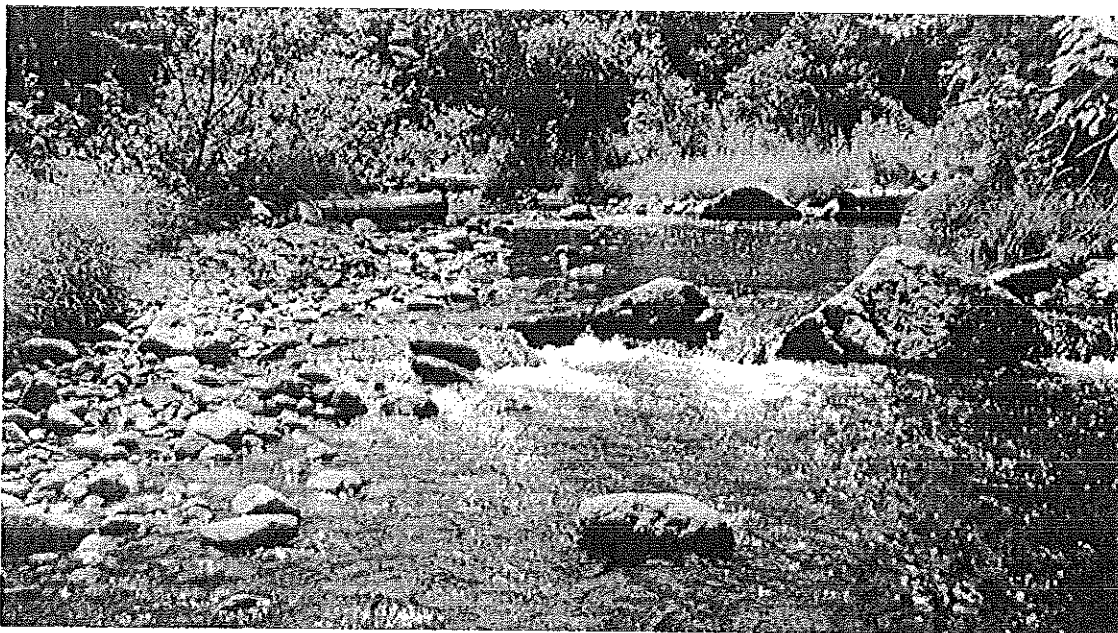
The log deflectors constructed 1,650 feet downstream of the bridge have trapped sediment along the stream edges and have maintained pools to an extent, but annual monitoring revealed that the pools were slowly filling in. As a result, two rock weirs were constructed among the log deflectors and an additional one was constructed immediately downstream in 2007 to add additional pools to the reach. Cross sectional transects were constructed to monitor these structures.

Transect 14 looking downstream, August 2007. Lowermost log deflectors showing ice damage to structure on left.

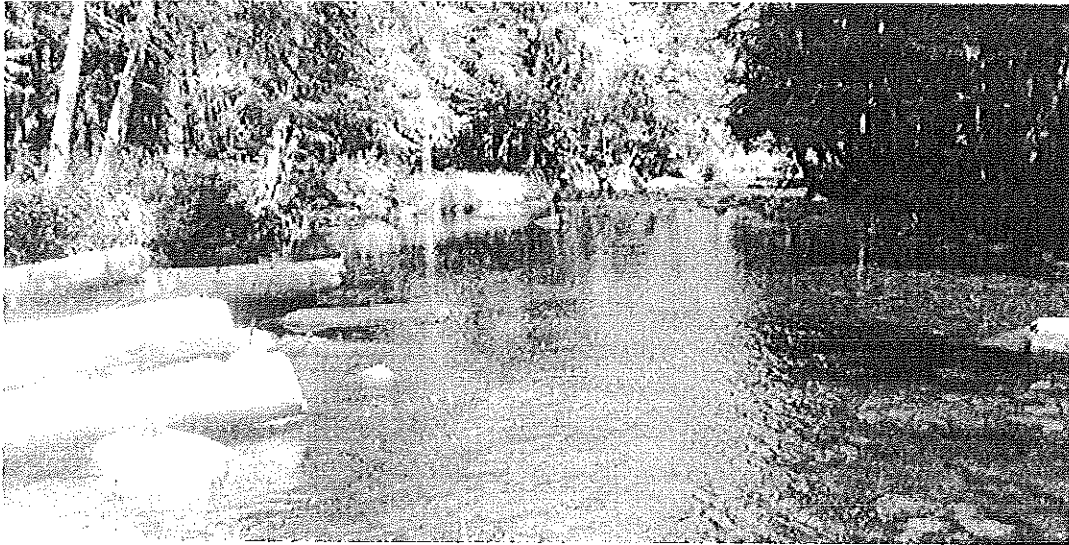
Transect 15 looking upstream, August 2007, prior to construction of Weir No. 2. Several log deflectors, including ice-damaged structure on right, are visible.

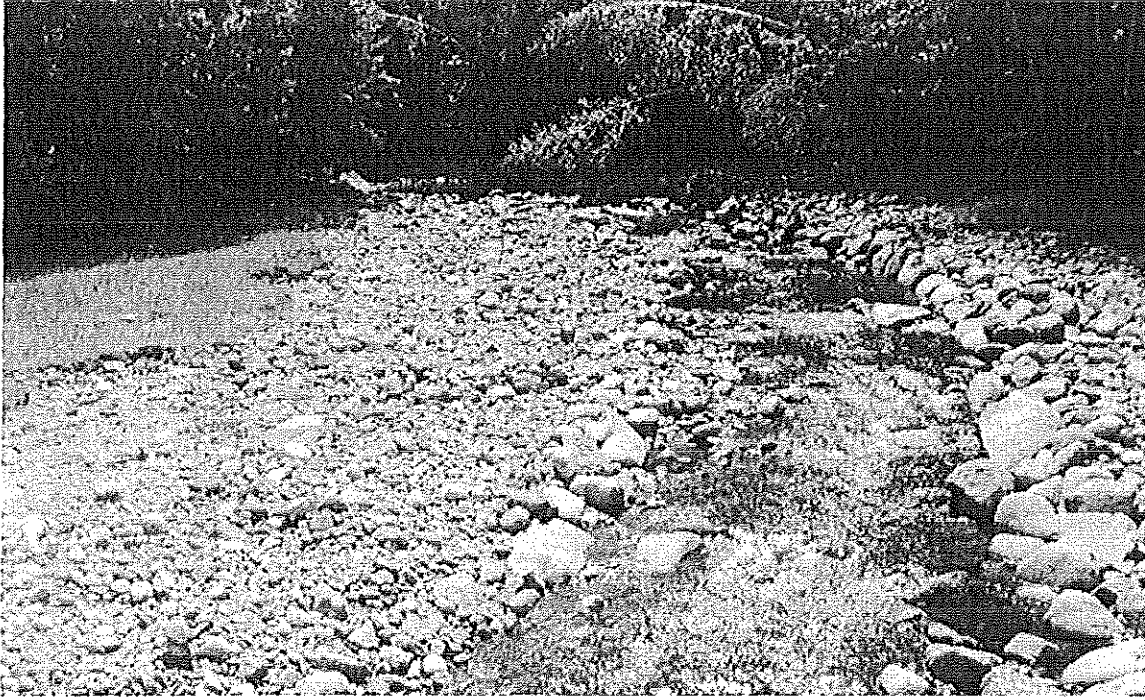
Monitoring is ongoing and only preliminary results have been determined to date. The upper (keystone) treatment has retained its formation after two years in place and has proved resistant to high flows and effective in concentrating low flows, providing an active flood plain, maintaining a favorable width-to-depth ratio, and providing shallow pools for brook trout. A layer of topsoil applied to the newly-constructed floodplain eroded substantially during storm events that occurred within weeks of placement (first photo, Appendix D). Although the loss of this soil unfortunately added sediment to the stream, the structural integrity of the keystone treatment was not compromised.

Keystone riffle/pool sequence upstream of South Shore Drive bridge (Upper Project), August 2007.

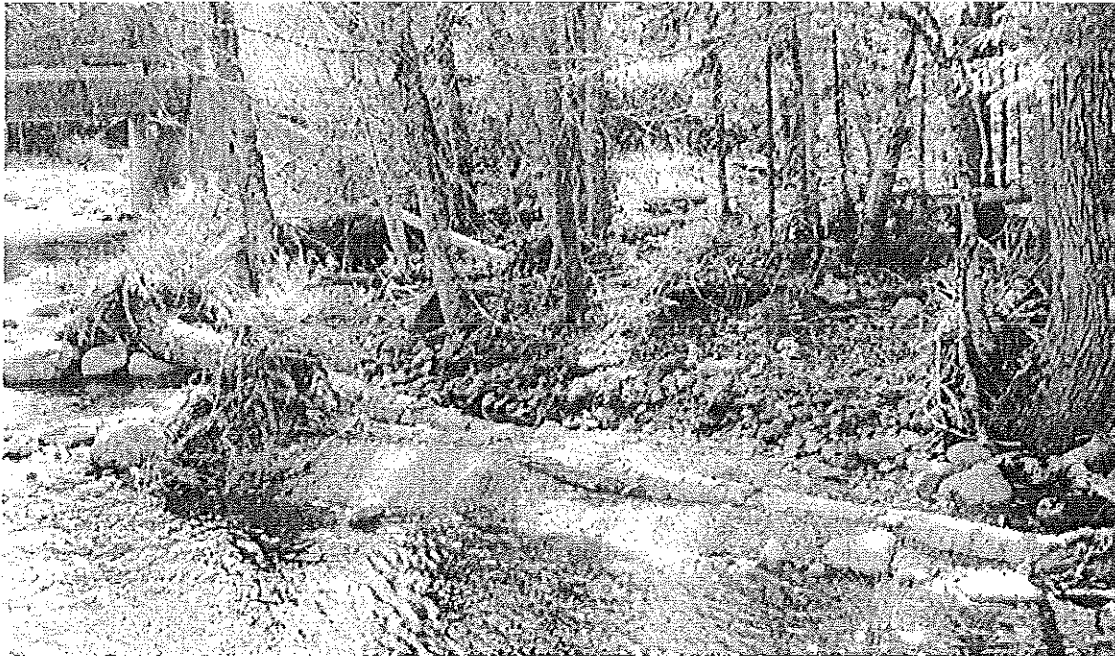
The four rock weirs immediately downstream of the bridge have been effective in maintaining pools of several feet in depth and have retained their form after one year in place. The associated root wads are effective in encouraging pool scour and provide excellent cover for brook trout. The logs positioned at the first meander bend downstream of the bridge have been effective in trapping sediment. The logs on the overwidened reach located 850 downstream of the bridge have not, to date, been effective in trapping sediment but remain anchored in place.

Logs placed downstream of bridge (Middle Project) with trapped sediment, October 2007.

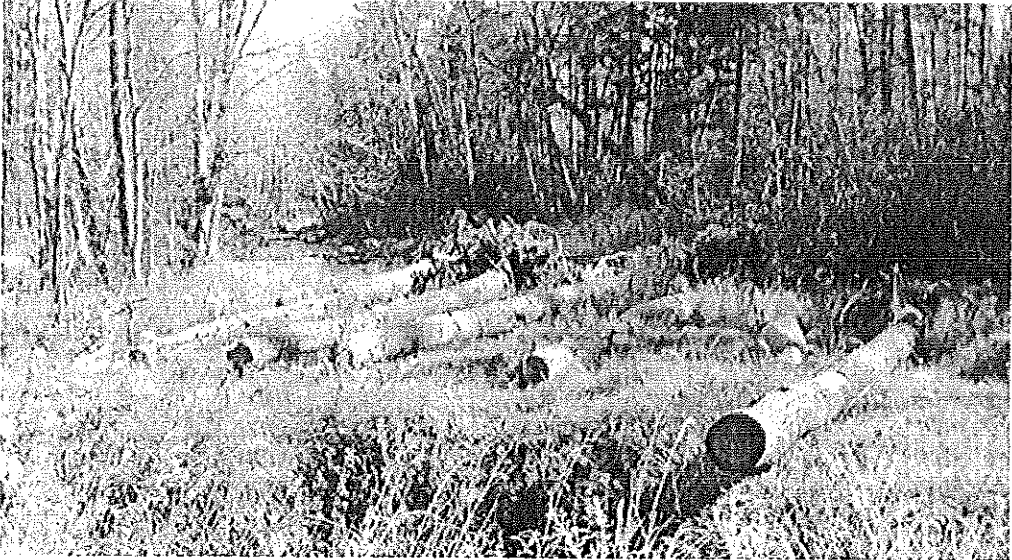
Cabled logs with attached root wads, Middle Project, east shore, October 2007, 14 months after construction. Little sediment has been trapped by these logs to date.

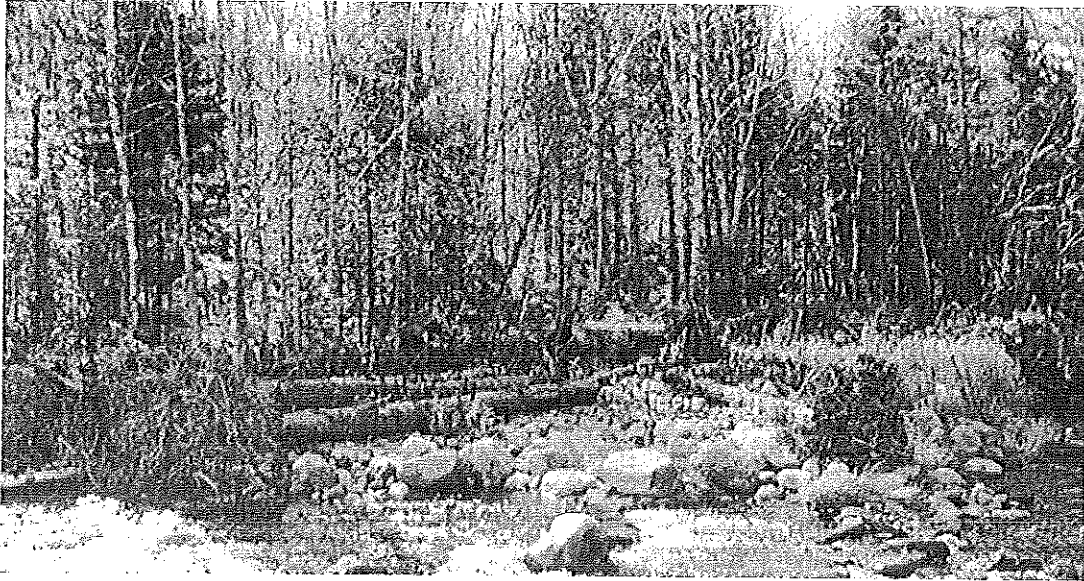
Cabled logs with attached root wads, Middle Project, west shore, October 2007, 14 months after construction (approximately across the stream from those in previous photo). Little sediment has been trapped by these logs to date.

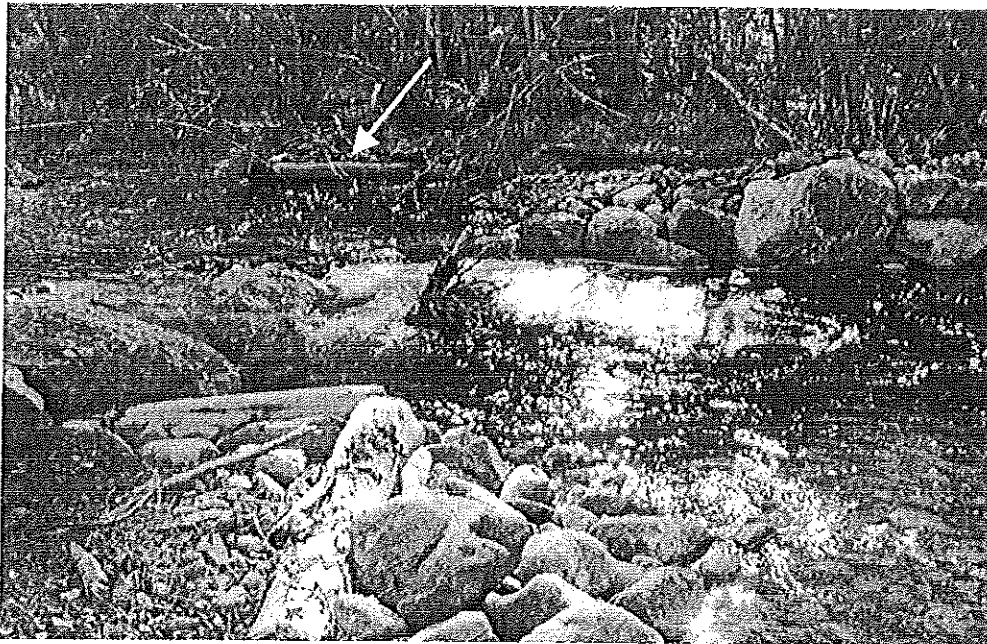
Weir No. 1, Lower Project, was constructed proximate to the second pair of log deflectors, and the river-right deflector was removed to accommodate the weir; the river-left log deflector is visible in the foreground of the photograph; river-left log deflector of first pair is highlighted by arrow.

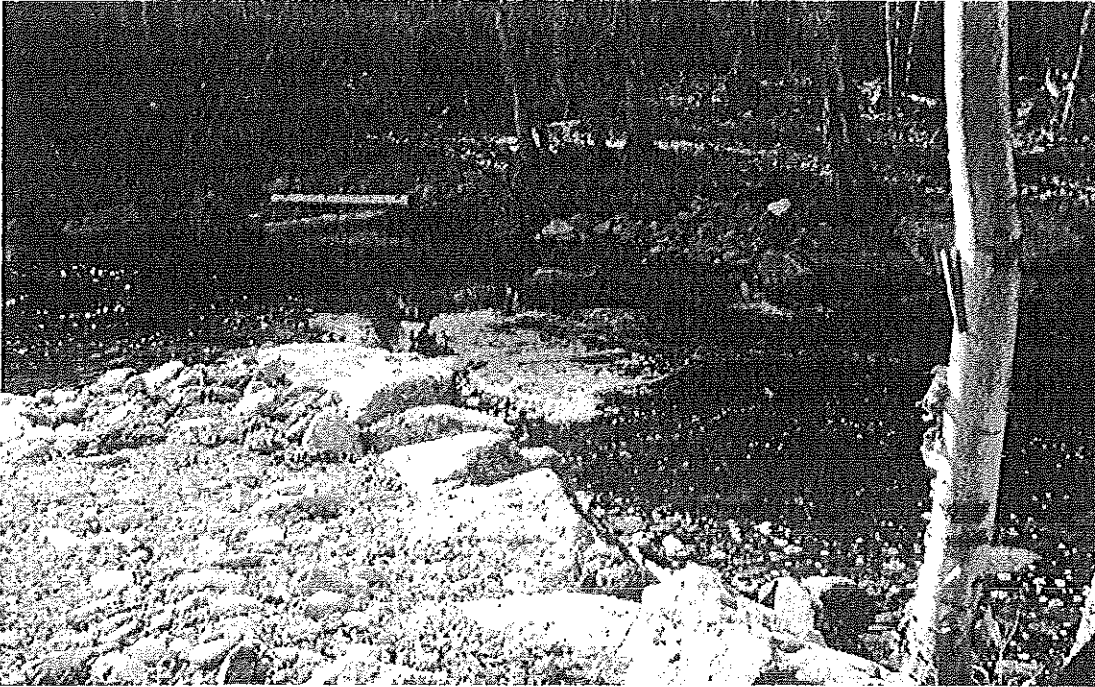
Rock weir No. 2, Lower Project, October 2007, two months after construction. The river-left log deflector of the lower-most pair (which suffered ice damage) was removed to construct this weir.
