Maine Department of Transportation

Pavement Condition Report

DEXTER REGIONAL AIRPORT (1B0)

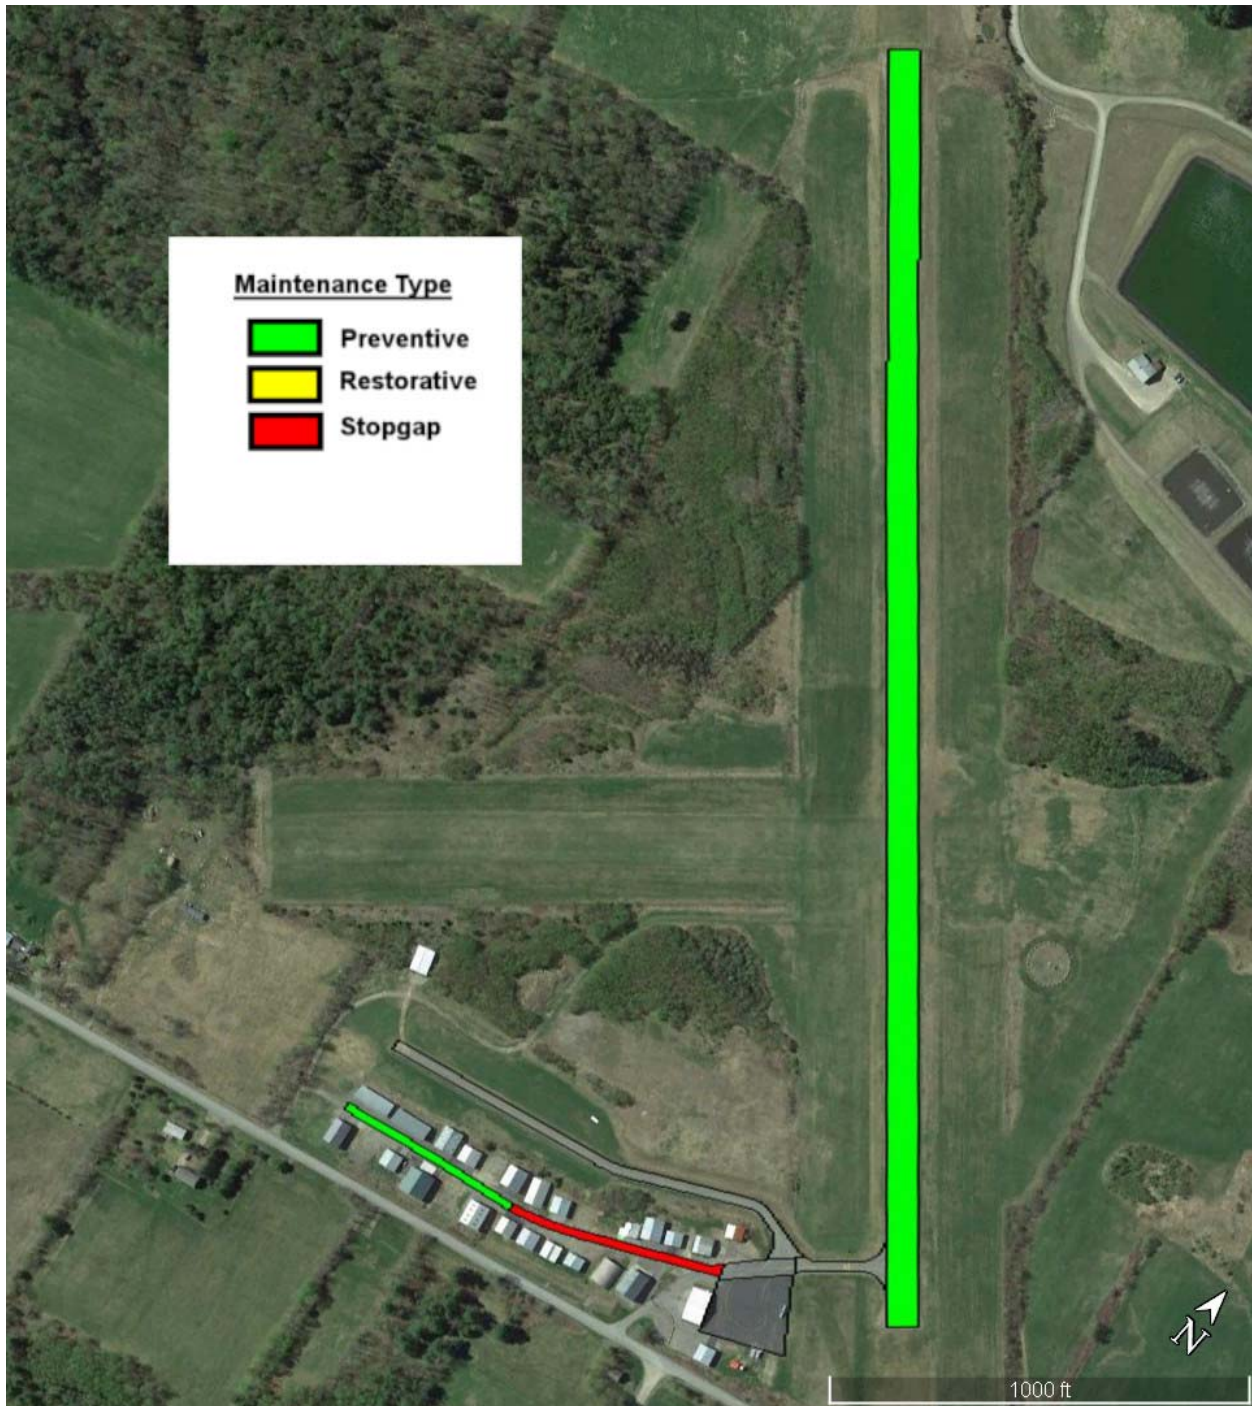
Figure 8. Maintenance type

Branch	Section	Work Type	Quantity	Unit	Cost
RY1634	001	Crack Sealing - AC	120	Ft	\$166
TLA	002	Crack Sealing - AC	167	Ft	\$231
TLA	002	Patching - AC Deep	2,925	SqFt	\$54,334
TLA	002	Patching - AC Shallow	24	SqFt	\$394
TLA	003	Crack Sealing - AC	13	Ft	\$18

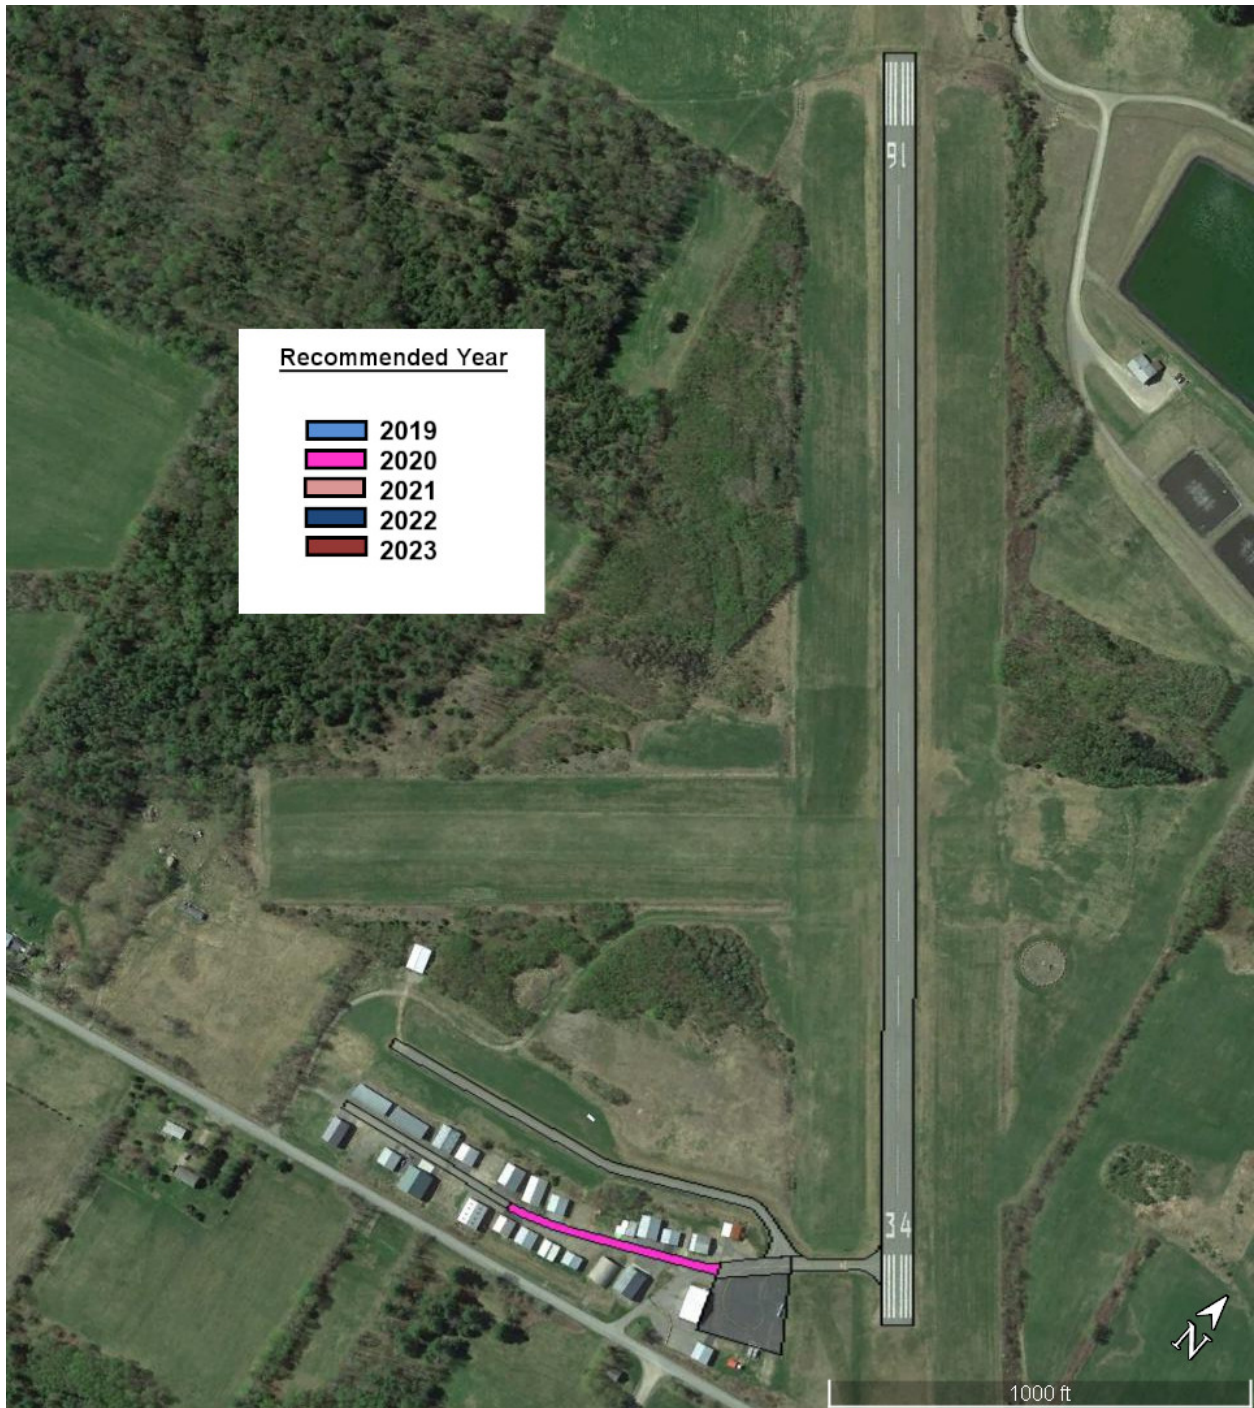
Figure 9. Major M&R

The pavement sections identified for major rehabilitation in Table 10 and shown in Figure 9 are at or are predicted to reach a condition level where major M&R should be considered. While the predicted rehabilitation timeline identifies specific sections and the general timing for the repair, more in-depth project-level studies will be needed to determine exactly how to fix each pavement (i.e. asphalt overlay, reconstruction, or some other repair alternative). Additionally, the airport may find it desirable to adjust the timing of projects to meet fiscal and operational constraints. For example, if the runway and several connector taxiways were forecast to reach the MSL in various years ranging from 2019-2023, it may be preferable to group these pavement sections into a single project.

Branch ID	Section ID	Year	Predicted PCI Before Rehab	Estimated Cost
TLA	002	2020	25	\$215,216
5-year Airport Total				\$215,216

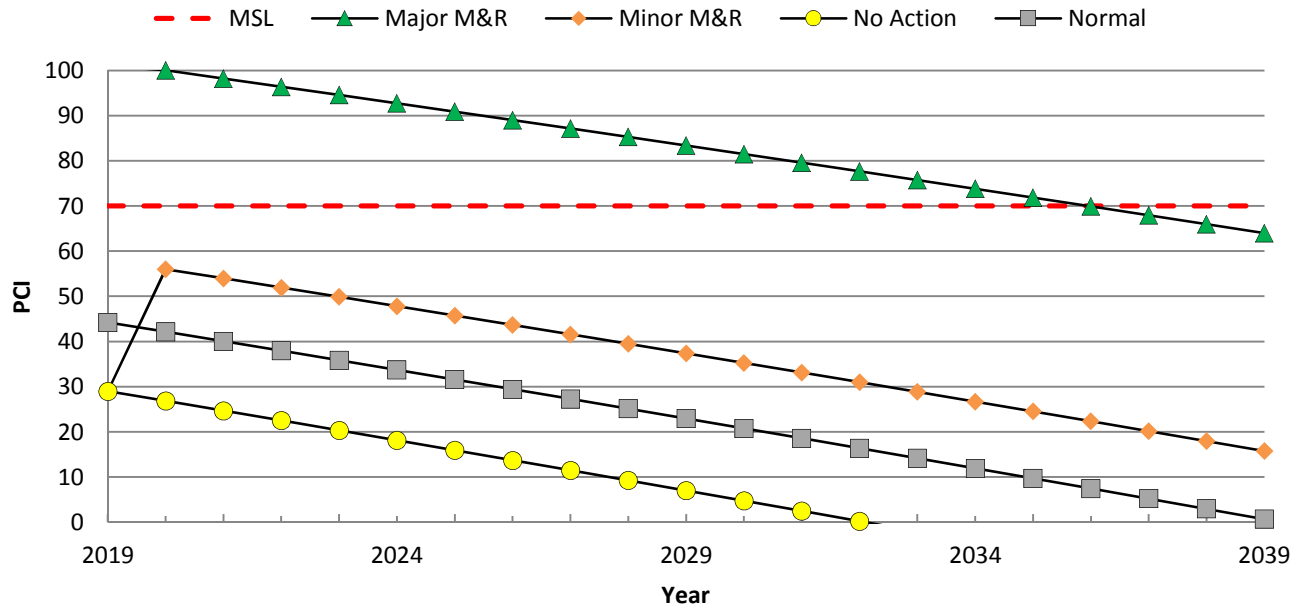
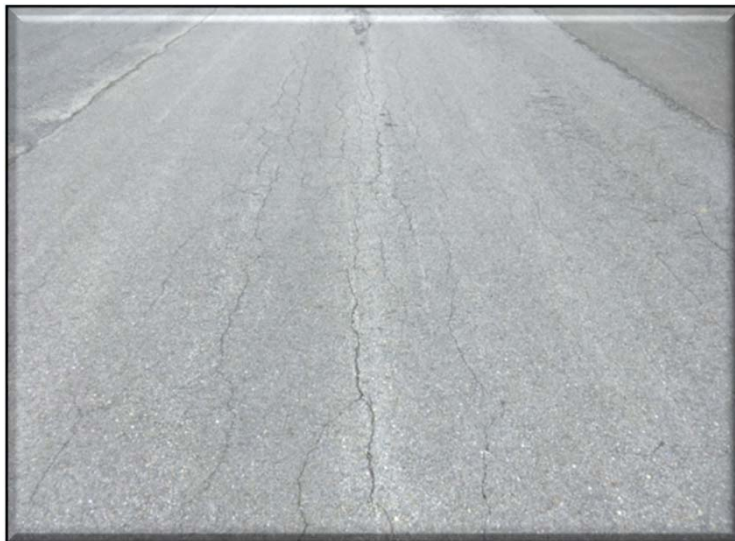
Section:	1B0::TLA::002
Description:	Taxilane A
PaveType:	AC
Area:	10,550
Built:	2/15/1990
Age:	29yr

M&R	Action	Year / Quantity	Cost (\$)	Ending PCI
Major	Major M&R	2020	215,216	100
Minor	All Minor	2020	54,959	56
1	Patching - AC Deep	2925 SqFt	54,334	-
2	Patching - AC Shallow	24 SqFt	394	-
3	Crack Sealing - AC	167 Ft	231	-
4	-	-	-	-
5	-	-	-	-
6	-	-	-	-
7	-	-	-	-
