Maine Department of Transportation

Pavement Condition Report

OXFORD COUNTY REGIONAL AIRPORT (81B)

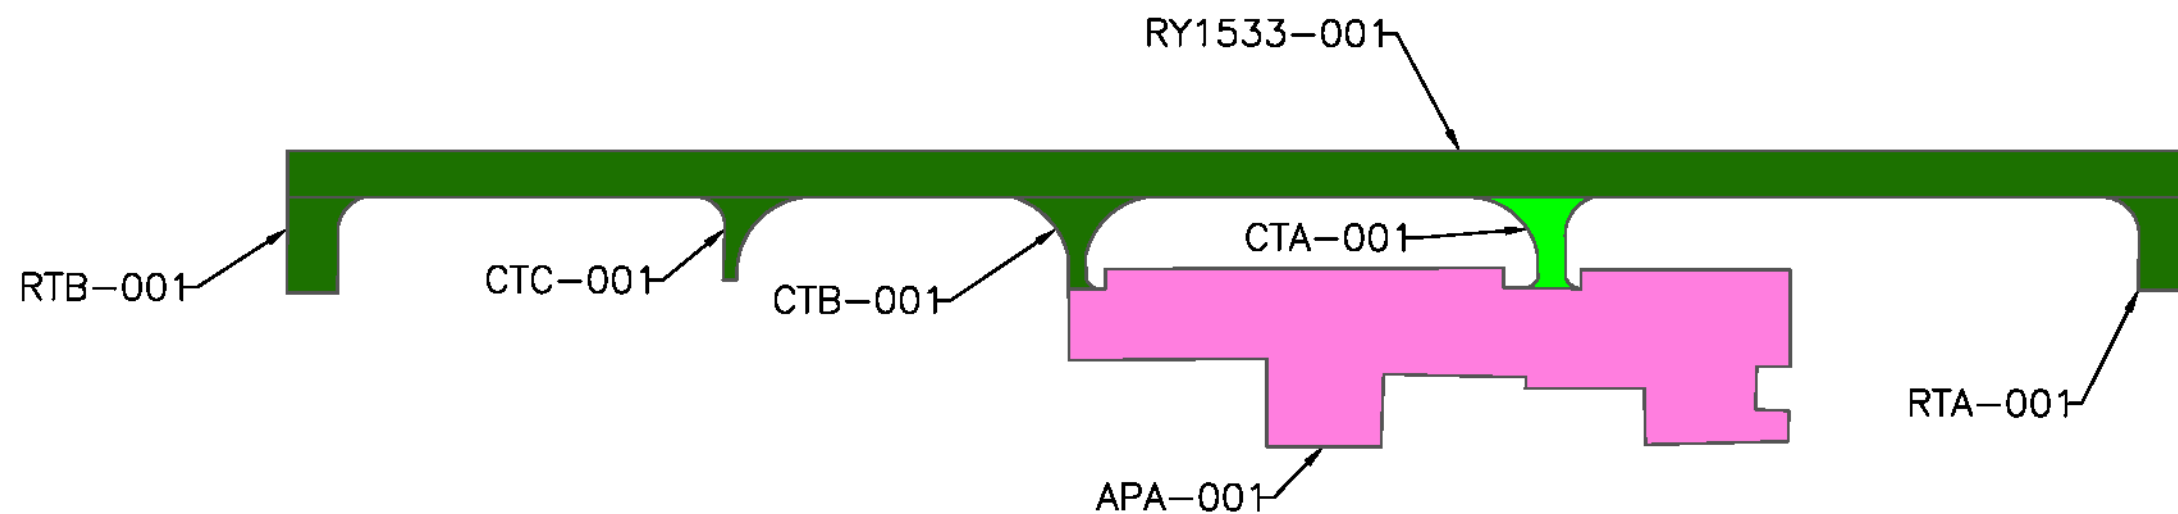
2018 Pavement Condition Map Oxford County Regional Airport (81B)			
ENGINEER:	DRAWN BY:	DATE:	CTAF
BDA	MJP	Jul 2019	122.8

The average inspected Pavement Condition Index (PCI) for all the airfield pavements at 81B was 73. Runway 15-33 had an average inspected PCI of 88, which is above the MSL of 70. Taxiways had an average inspected PCI of 91, and aprons had an average inspected PCI of 55. A comparison of the average PCI values at 81B to the statewide average PCI values, by branch use, is shown in the figure below.

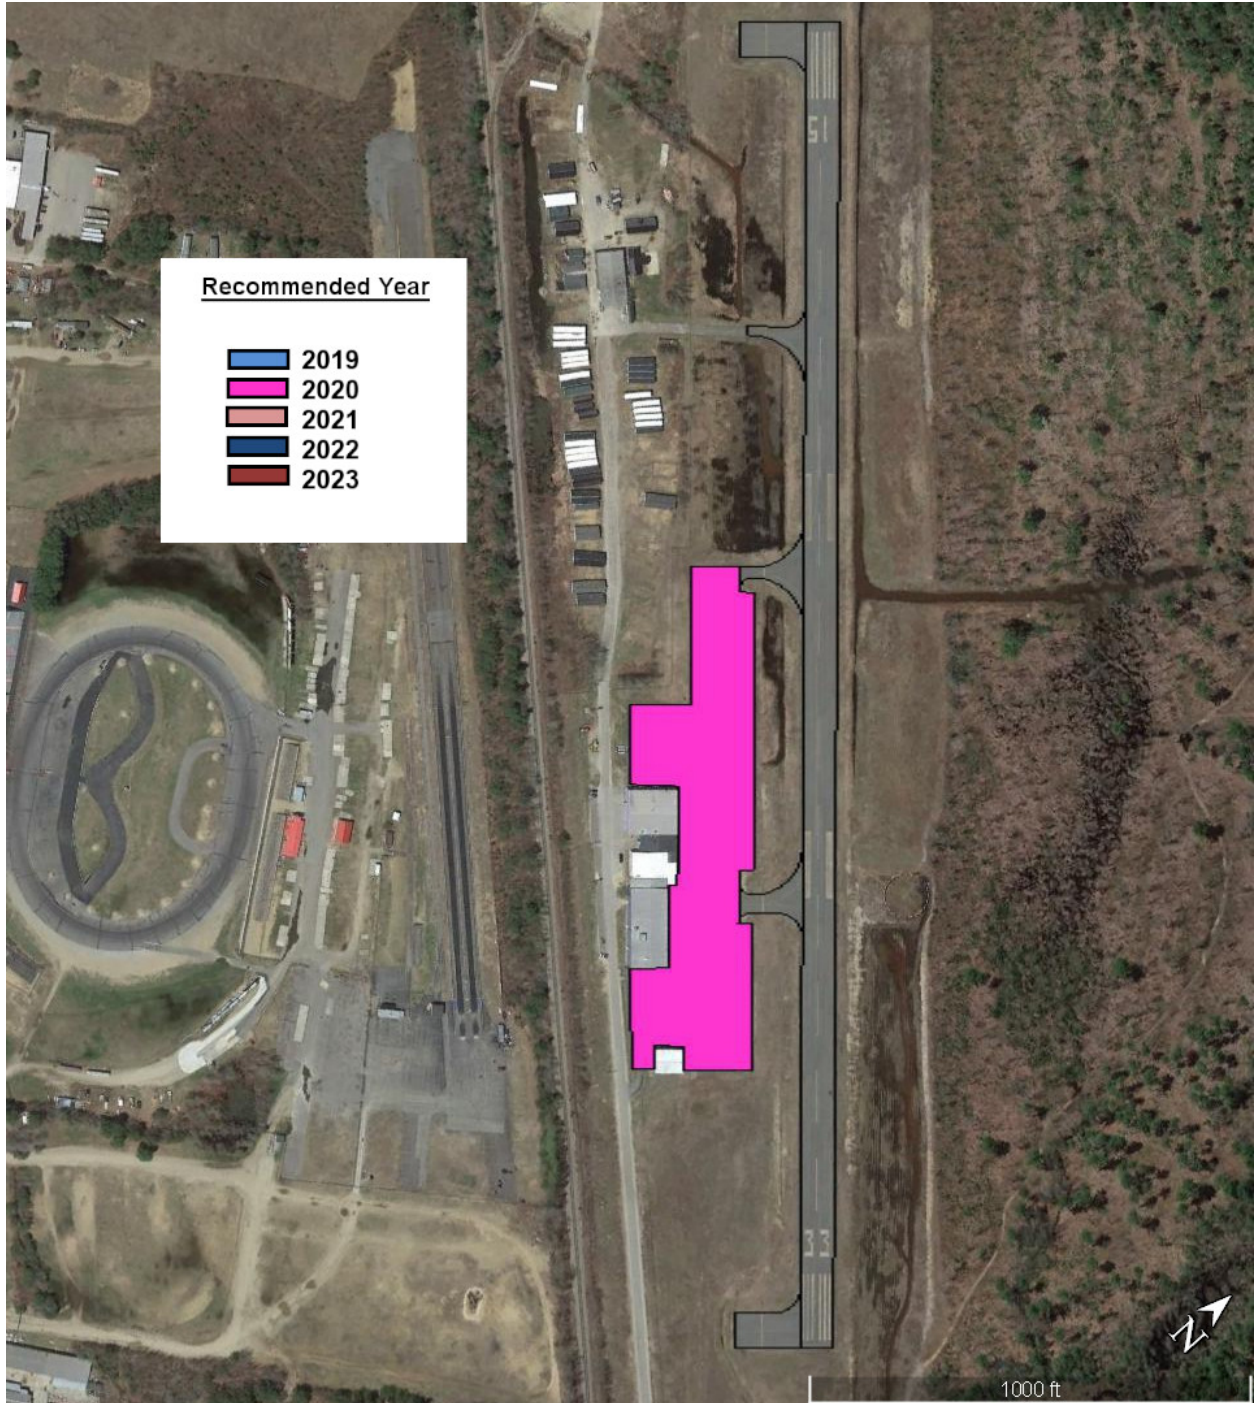
Figure 9. Major M&R

The pavement sections identified for major rehabilitation in Table 10 and shown in Figure 9 are at or are predicted to reach a condition level where major M&R should be considered. While the predicted rehabilitation timeline identifies specific sections and the general timing for the repair, more in-depth project-level studies will be needed to determine exactly how to fix each pavement (i.e. asphalt overlay, reconstruction, or some other repair alternative). Additionally, the airport may find it desirable to adjust the timing of projects to meet fiscal and operational constraints. For example, if the runway and several connector taxiways were forecast to reach the MSL in various years ranging from 2019-2023, it may be preferable to group these pavement sections into a single project.

Branch ID	Section ID	Year	Predicted PCI Before Rehab	Estimated Cost
APA	001	2020	51	\$4,545,042
5-year Airport Total				\$4,545,042
