# *Maine Department of Transportation*

Pavement Condition Report

## **SUGARLOAF REGIONAL AIRPORT (KB21)**

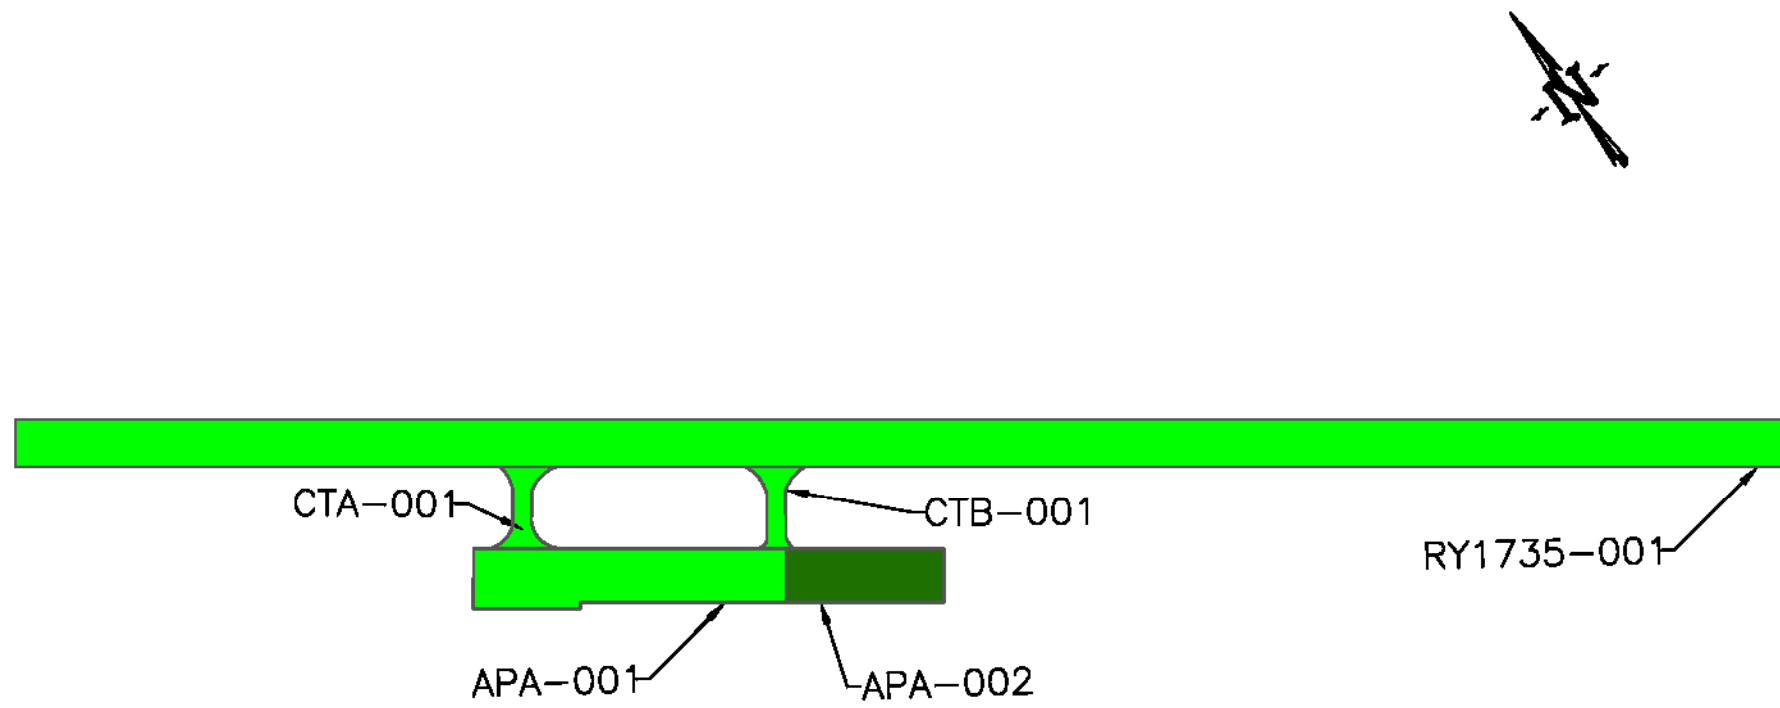
2018 Pavement Condition Map Sugarloaf Regional Airport (B21)			
ENGINEER: BDA	DRAWN BY: MJP	DATE: Jul 2019	CTAF 122.8

The average inspected Pavement Condition Index (PCI) for all the airfield pavements at B21 was 79. Runway 17-35 had an average inspected PCI of 76, which is above the MSL of 70. Taxiways had an average inspected PCI of 82, and aprons had an average inspected PCI of 87. A comparison of the average PCI values at B21 to the statewide average PCI values, by branch use, is shown in the figure below.

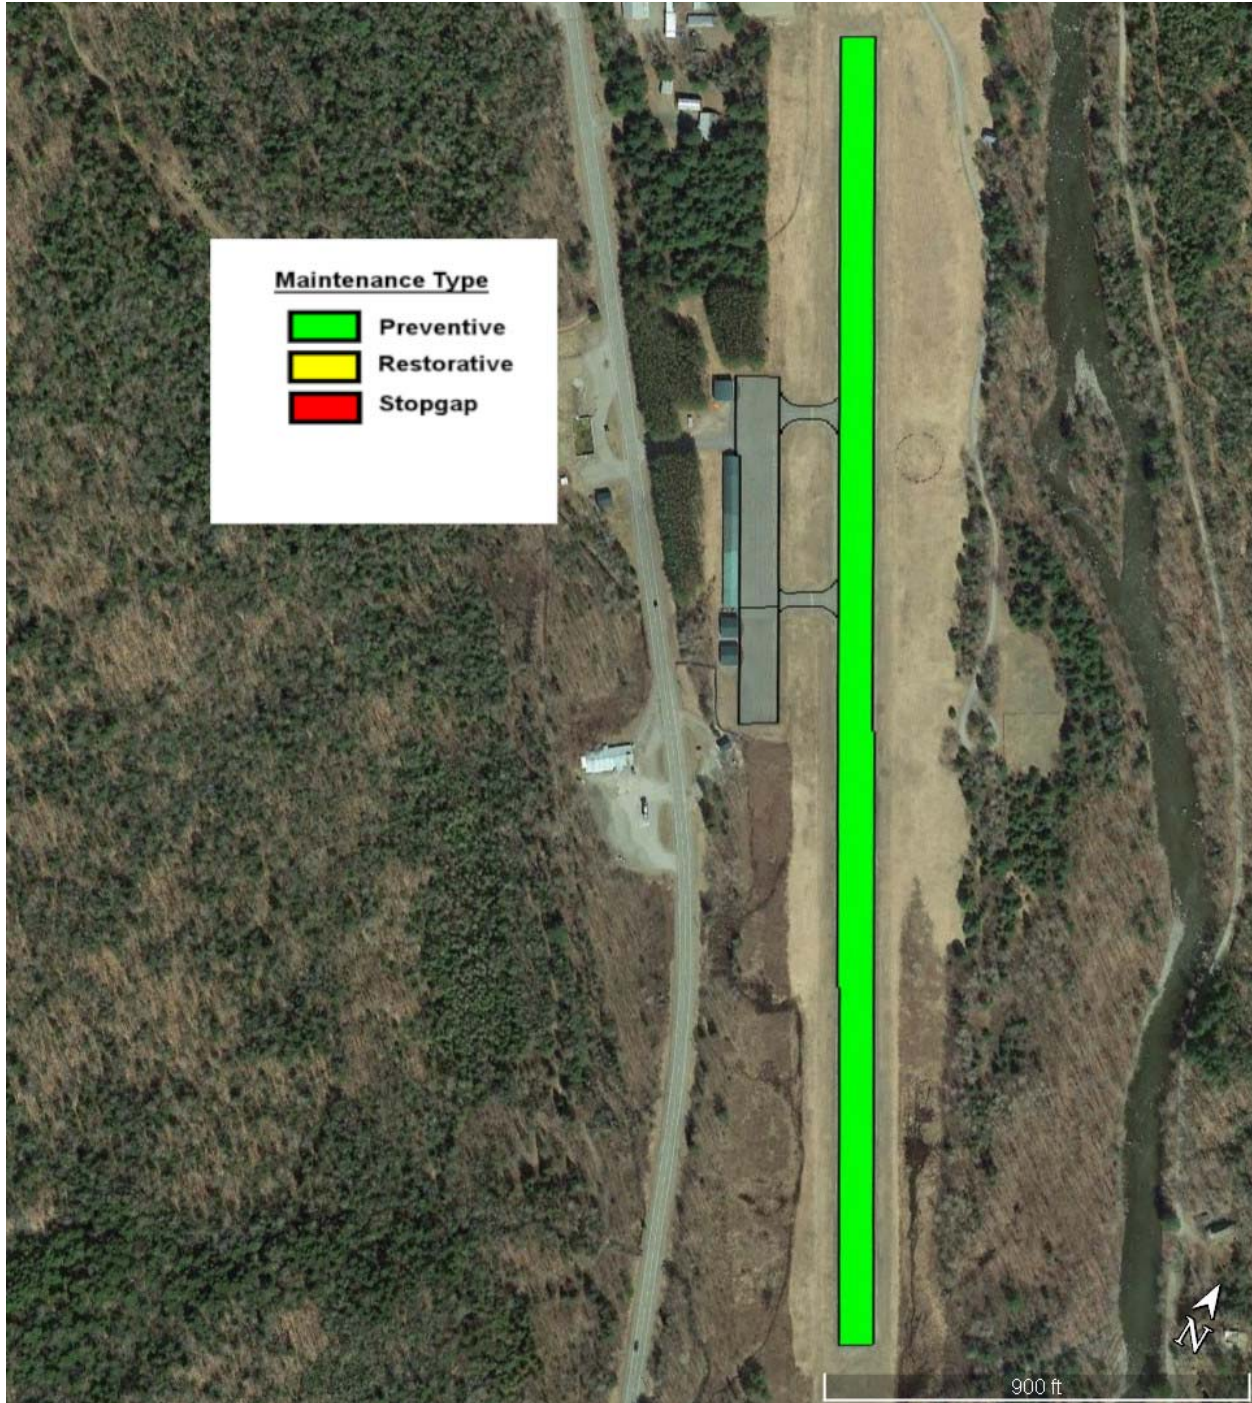
Figure 8. Maintenance type

Branch	Section	Work Type	Quantity	Unit	Cost
RY1735	001	Crack Sealing - AC	1,208	Ft	\$1,667

Table 7 presents the summary of maintenance work quantities and estimated costs to apply the near term maintenance plan at B21. The repair quantities are based on extrapolated distress quantities from PAVER using the 2018 PCI inspection and the maintenance policy matrix as defined in appendix E.

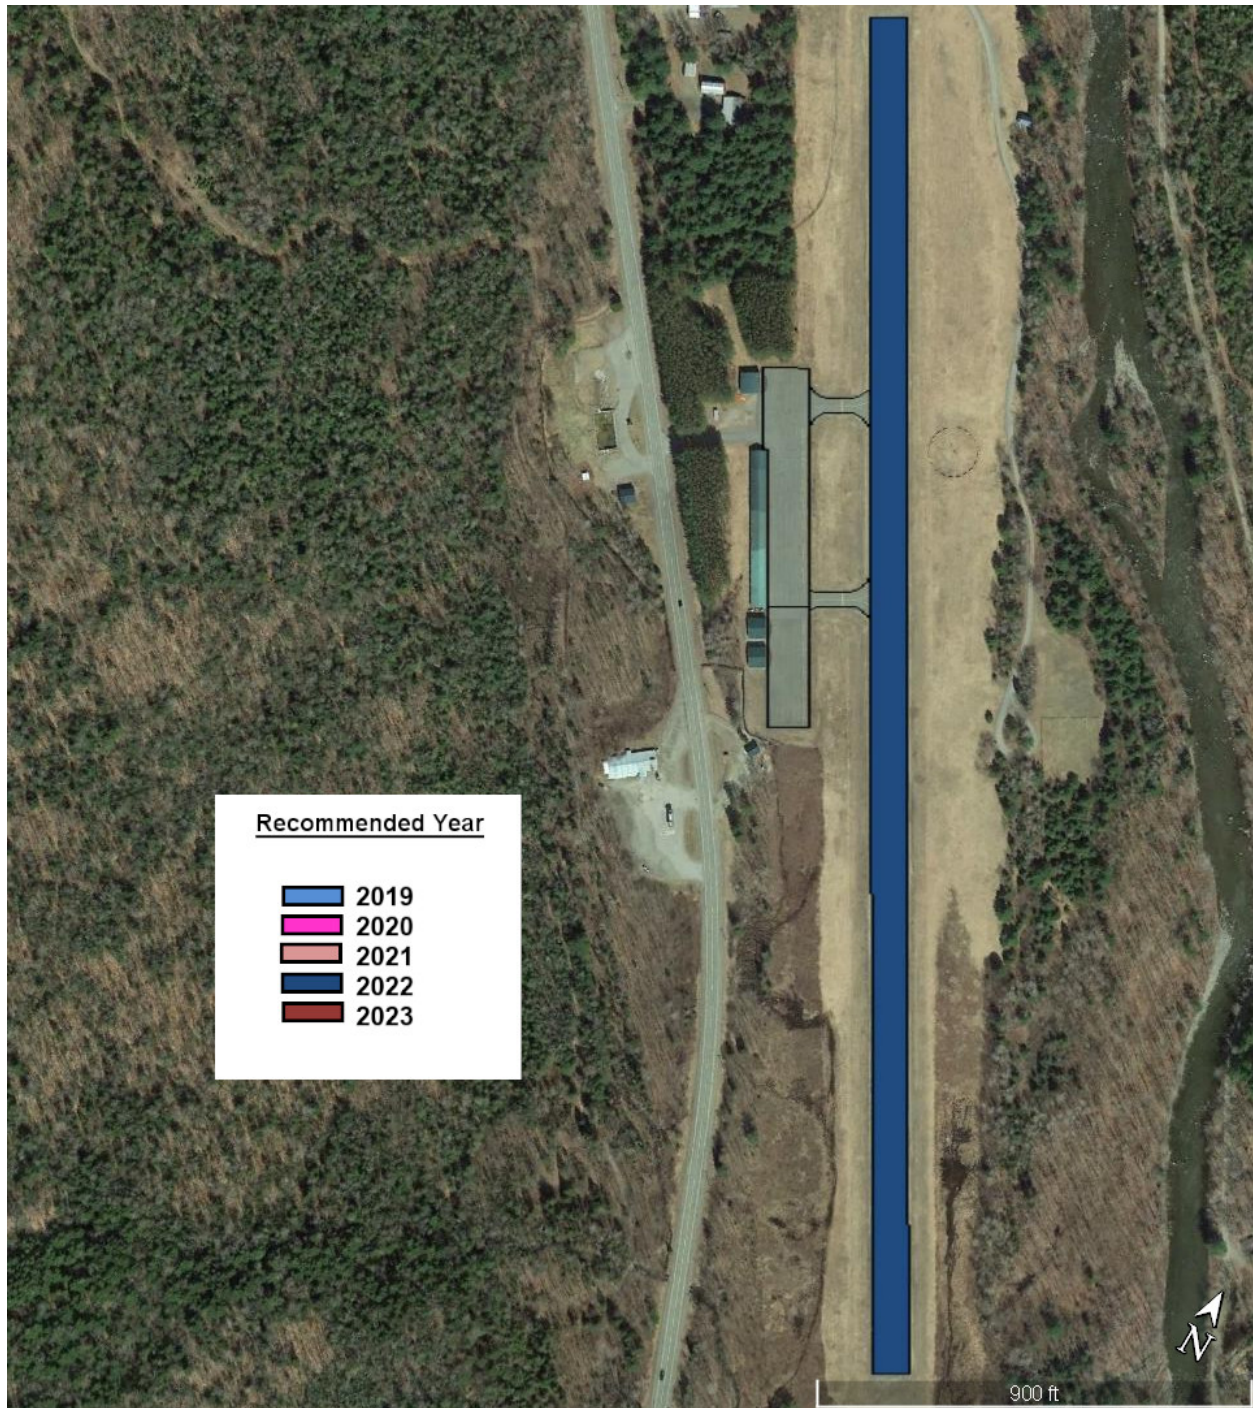
Figure 9. Major M&R

The pavement sections identified for major rehabilitation in Table 10 and shown in Figure 9 are at or are predicted to reach a condition level where major M&R should be considered. While the predicted rehabilitation timeline identifies specific sections and the general timing for the repair, more in-depth project-level studies will be needed to determine exactly how to fix each pavement (i.e. asphalt overlay, reconstruction, or some other repair alternative). Additionally, the airport may find it desirable to adjust the timing of projects to meet fiscal and operational constraints. For example, if the runway and several connector taxiways were forecast to reach the MSL in various years ranging from 2019-2023, it may be preferable to group these pavement sections into a single project.

Branch ID	Section ID	Year	Predicted PCI Before Rehab	Estimated Cost
RY1735	001	2022	69	\$577,348
<b>5-year Airport Total</b>				<b>\$577,348</b>
