Maine Department of Transportation

Pavement Condition Report

EASTPORT MUNICIPAL AIRPORT (KEPM)

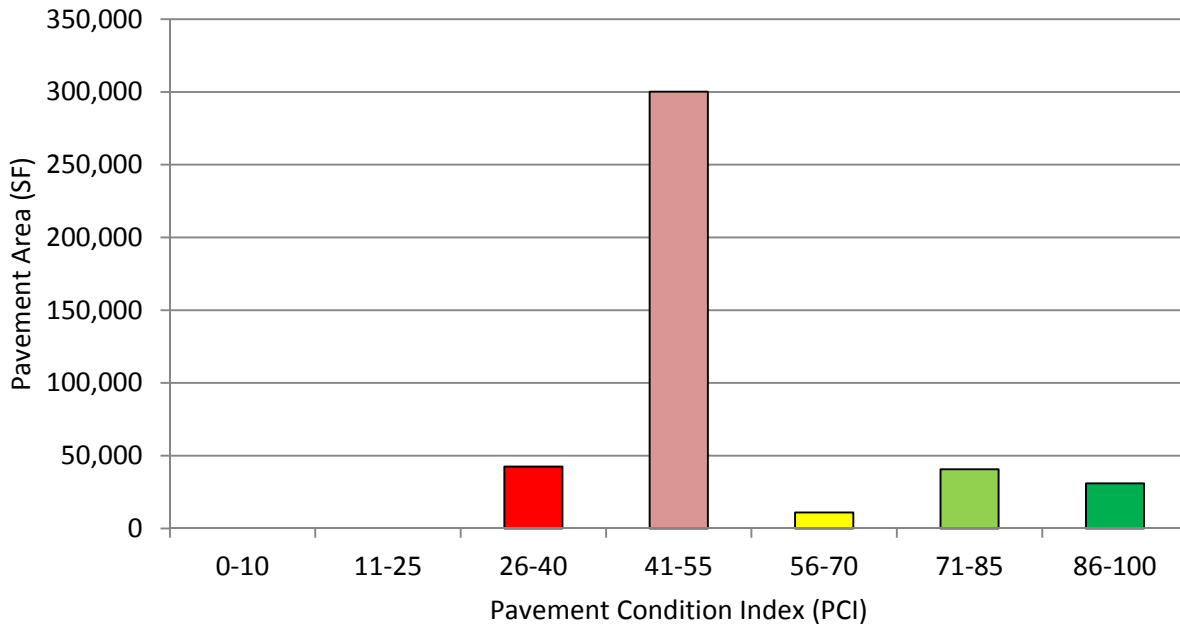
Figure 4. Condition distribution.

Figure 4 and Figure 5 present the overall PCI for EPM by area distribution and pavement use, respectively. Table 3 presents the PCI summary for each section at EPM, including the drop in PCI per year. Generally, pavement sections will deteriorate between 1 and 3 PCI points per year. Sections deteriorating at higher rates may need maintenance above the normal application rates and should be closely monitored in case major repairs become necessary earlier than expected.

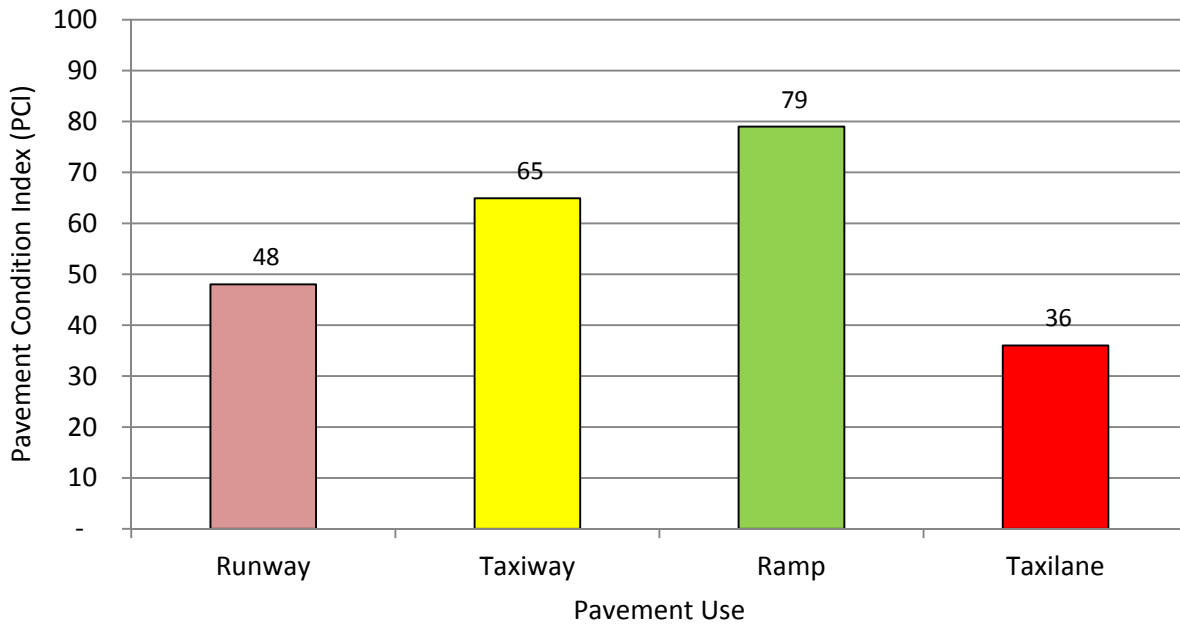
Figure 5. Area-weighted PCI by pavement use.

The average inspected Pavement Condition Index (PCI) for all the airfield pavements at EPM was 53. Runway 15-33 had an average inspected PCI of 48, which is below the MSL of 70. Taxiways had an average inspected PCI of 65, taxilanes had an average inspected PCI of 36, and aprons had an average inspected PCI of 79. A comparison of the average PCI values at EPM to the statewide average PCI values, by branch use, is shown in the figure below.

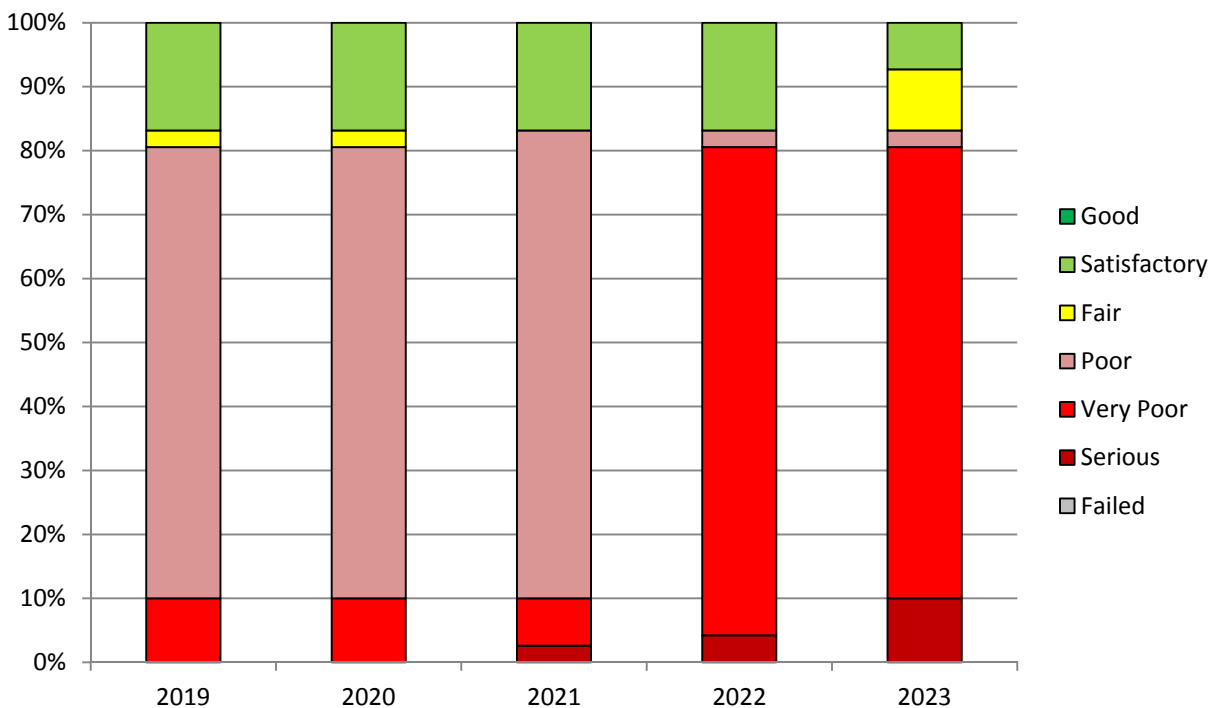
Figure 6. Projected PCI by percent area.

Figure 6 shows the projected PCI at EPM by percent area for the next 5 years assuming no maintenance or major repairs (overlays, reconstruction, etc.) are performed during that period. It shows how quickly the pavement network will deteriorate if no capital improvements are made. The corresponding projected PCI values for each pavement section are shown in Table 4.

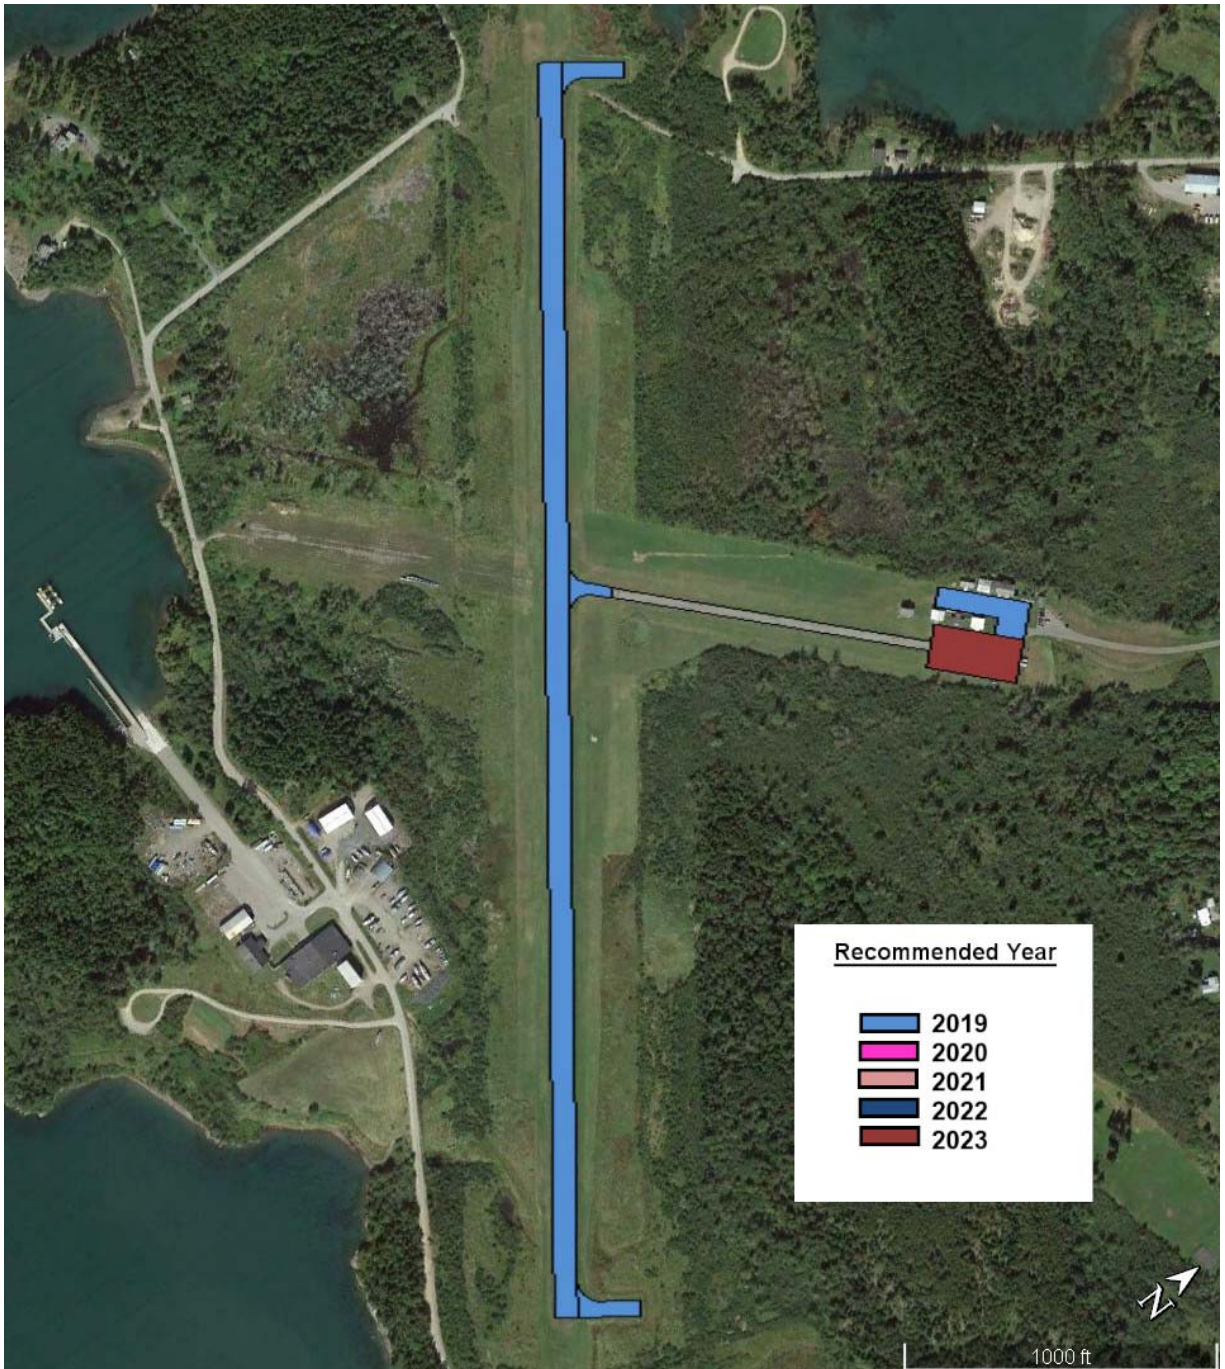
Figure 9. Major M&R

The pavement sections identified for major rehabilitation in Table 10 and shown in Figure 9 are at or are predicted to reach a condition level where major M&R should be considered. While the predicted rehabilitation timeline identifies specific sections and the general timing for the repair, more in-depth project-level studies will be needed to determine exactly how to fix each pavement (i.e. asphalt overlay, reconstruction, or some other repair alternative). Additionally, the airport may find it desirable to adjust the timing of projects to meet fiscal and operational constraints. For example, if the runway and several connector taxiways were forecast to reach the MSL in various years ranging from 2019-2023, it may be preferable to group these pavement sections into a single project.

Branch ID	Section ID	Year	Predicted PCI Before Rehab	Estimated Cost
CTA	001	2019	32	\$140,758
RTA	001	2019	28	\$225,416
RTA	002	2019	58	\$224,396
RW1533	001	2019	46	\$6,123,975
TLA	001	2019	34	\$501,831
APA	001	2023	69	\$111,922
5-year Airport Total				\$7,328,299
