Maine Department of Transportation

Pavement Condition Report

EASTERN SLOPE REGIONAL AIRPORT (KIZG)

To assist individual airports to effectively maintain their pavement infrastructure and help improve airport pavement conditions statewide, the Maine Department of Transportation (MaineDOT) contracted with DuBois & King, Inc. (D&K) to provide pavement evaluation surveys at local airports. Assisting D&K on this effort was Applied Research Associates, Inc. (ARA). This report documents the pavement condition at Eastern Slopes Regional Airport (IZG) in November 2018.

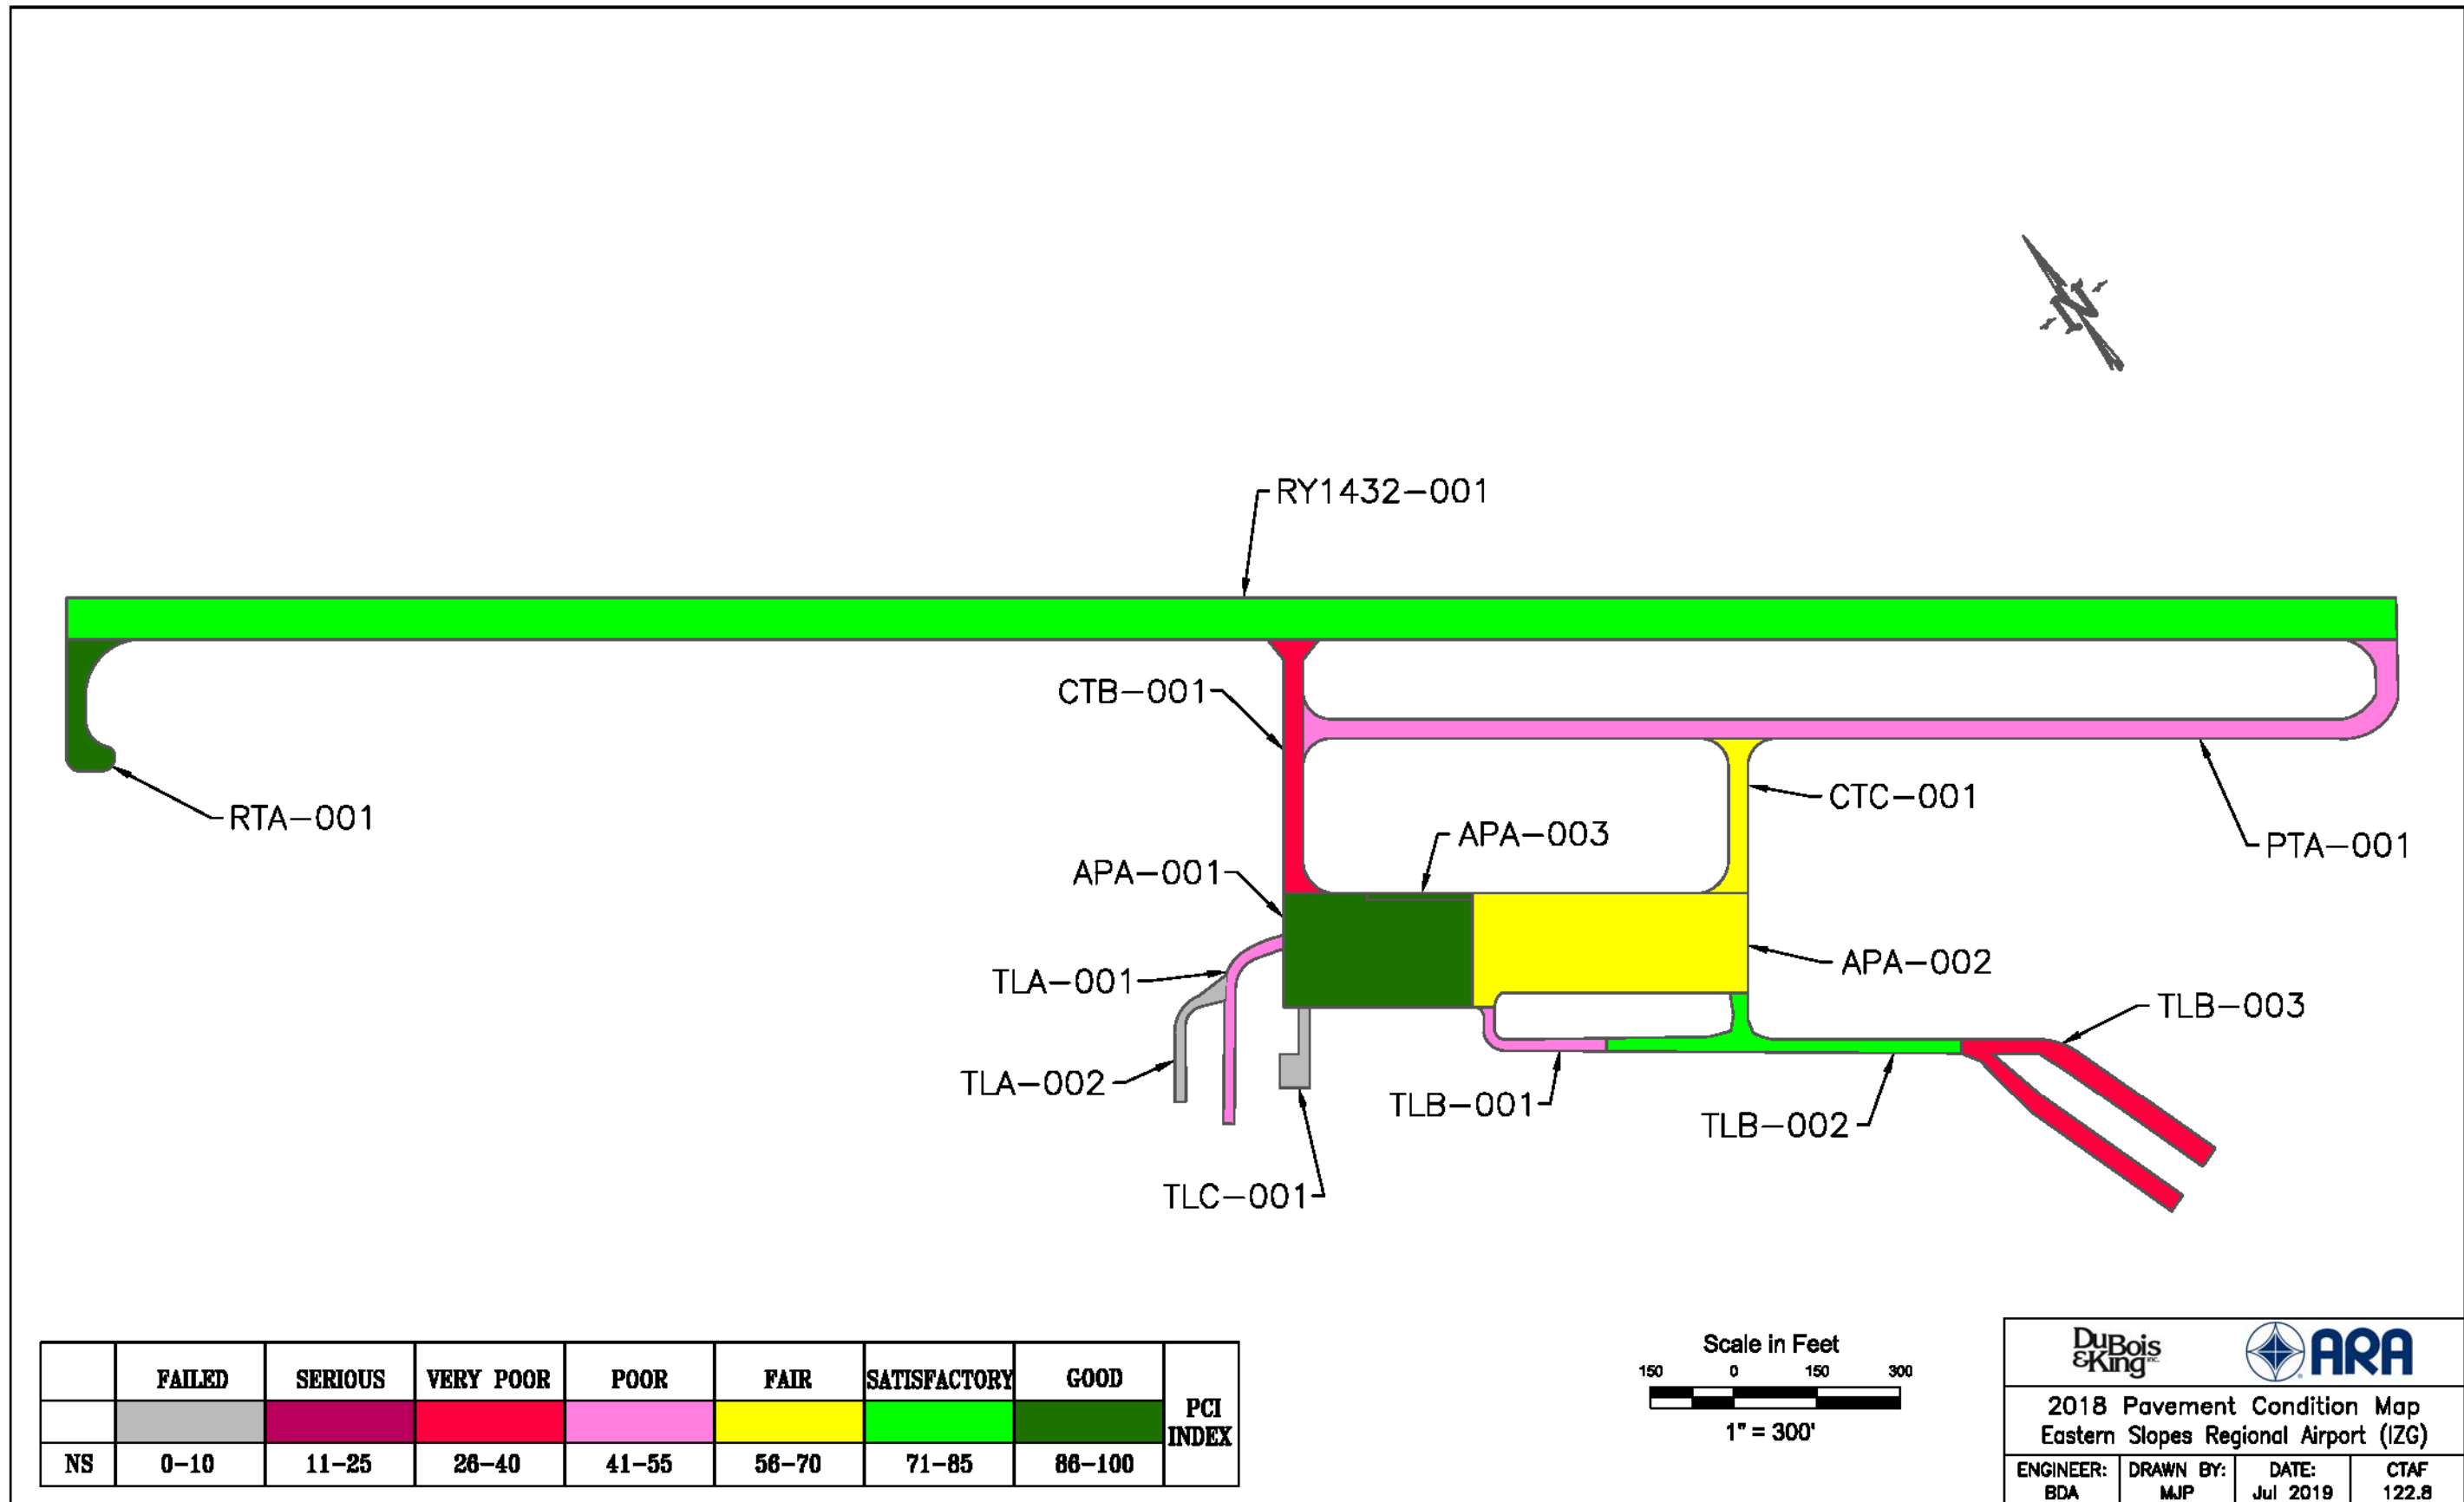
Figure 7. 2018 PCI Map at Eastern Slopes Regional Airport (IZG)

The average inspected Pavement Condition Index (PCI) for all the airfield pavements at IZG was 70. Runway 14-32 had an average inspected PCI of 79, which is above the MSL of 70. Taxiways had an average inspected PCI of 57, taxilanes had an average inspected PCI of 46, and aprons had an average inspected PCI of 75. A comparison of the average PCI values at IZG to the statewide average PCI values, by branch use, is shown in the figure below.

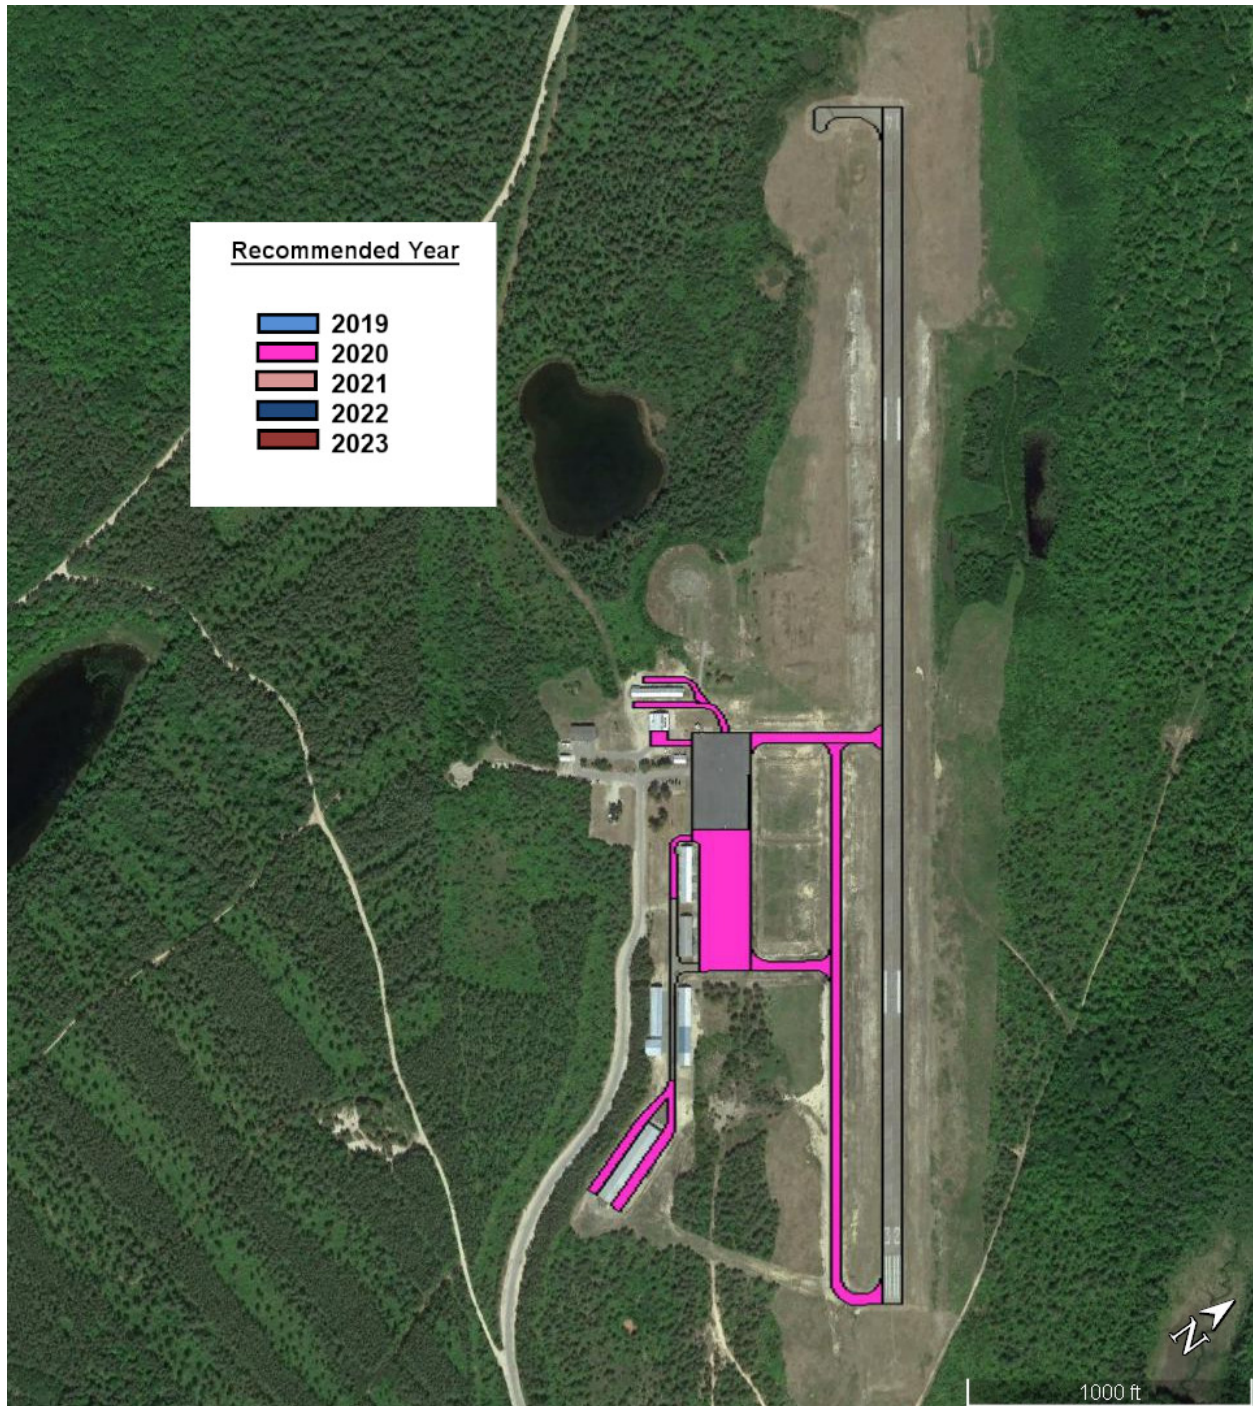
Figure 9. Major M&R

The pavement sections identified for major rehabilitation in Table 10 and shown in Figure 9 are at or are predicted to reach a condition level where major M&R should be considered. While the predicted rehabilitation timeline identifies specific sections and the general timing for the repair, more in-depth project-level studies will be needed to determine exactly how to fix each pavement (i.e. asphalt overlay, reconstruction, or some other repair alternative). Additionally, the airport may find it desirable to adjust the timing of projects to meet fiscal and operational constraints. For example, if the runway and several connector taxiways were forecast to reach the MSL in various years ranging from 2019-2023, it may be preferable to group these pavement sections into a single project.

Branch ID	Section ID	Year	Predicted PCI Before Rehab	Estimated Cost
APA	002	2020	57	\$1,839,029
CTB	001	2020	34	\$364,134
CTC	001	2020	62	\$31,762
PTA	001	2020	51	\$1,548,333
TLA	001	2020	40	\$163,197
TLA	002	2020	0	\$108,118
TLB	001	2020	50	\$116,278
TLB	003	2020	32	\$670,129
TLC	001	2020	5	\$100,978
5-year Airport Total				\$4,941,958

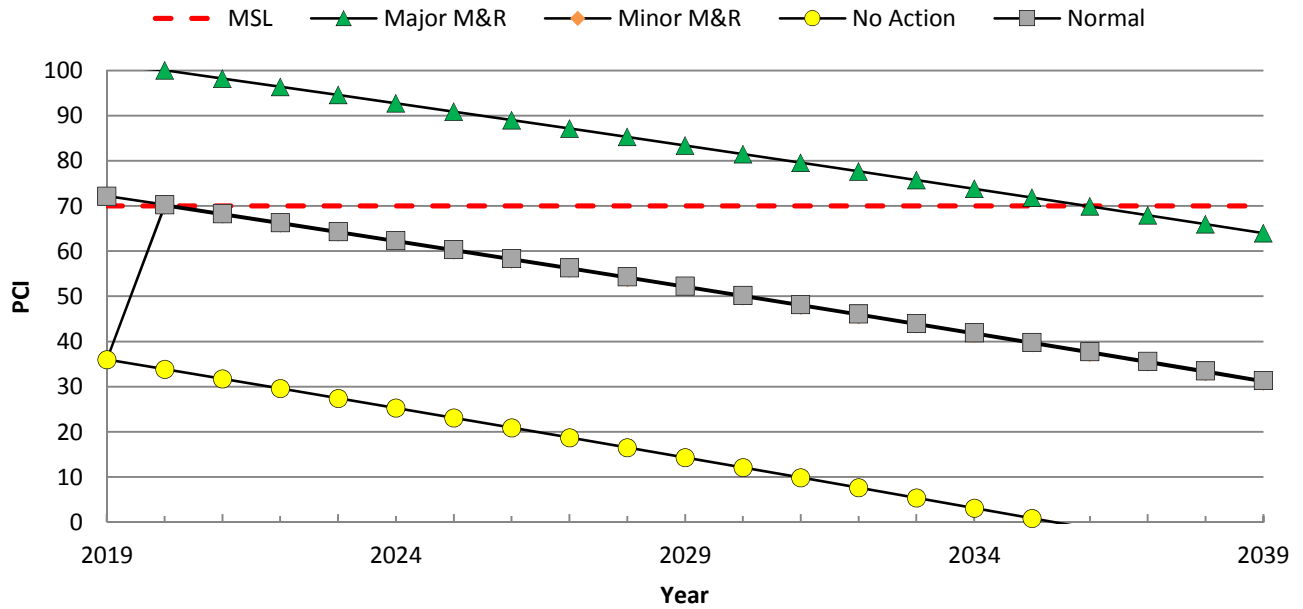
Taxilane B

⁴ The higher than average deterioration rate for TLB-003 of 4.6 PCI/Yr is due primarily to medium-severity alligator cracking.

M&R	Action	Year / Quantity	Cost (\$)	Ending PCI
Major	Major M&R	2020	670,129	100
Minor	All Minor	2020	60,056	70
1	Patching - AC Deep	3182 SqFt	59,109	-
2	Crack Sealing - AC	686 Ft	946	-
3	-	-	-	-
4	-	-	-	-
5	-	-	-	-
6	-	-	-	-
7	-	-	-	-
