Pavement Condition Report

MILLINOCKET MUNICIPAL AIRPORT (KMLT)

**DuBois
& King** inc.

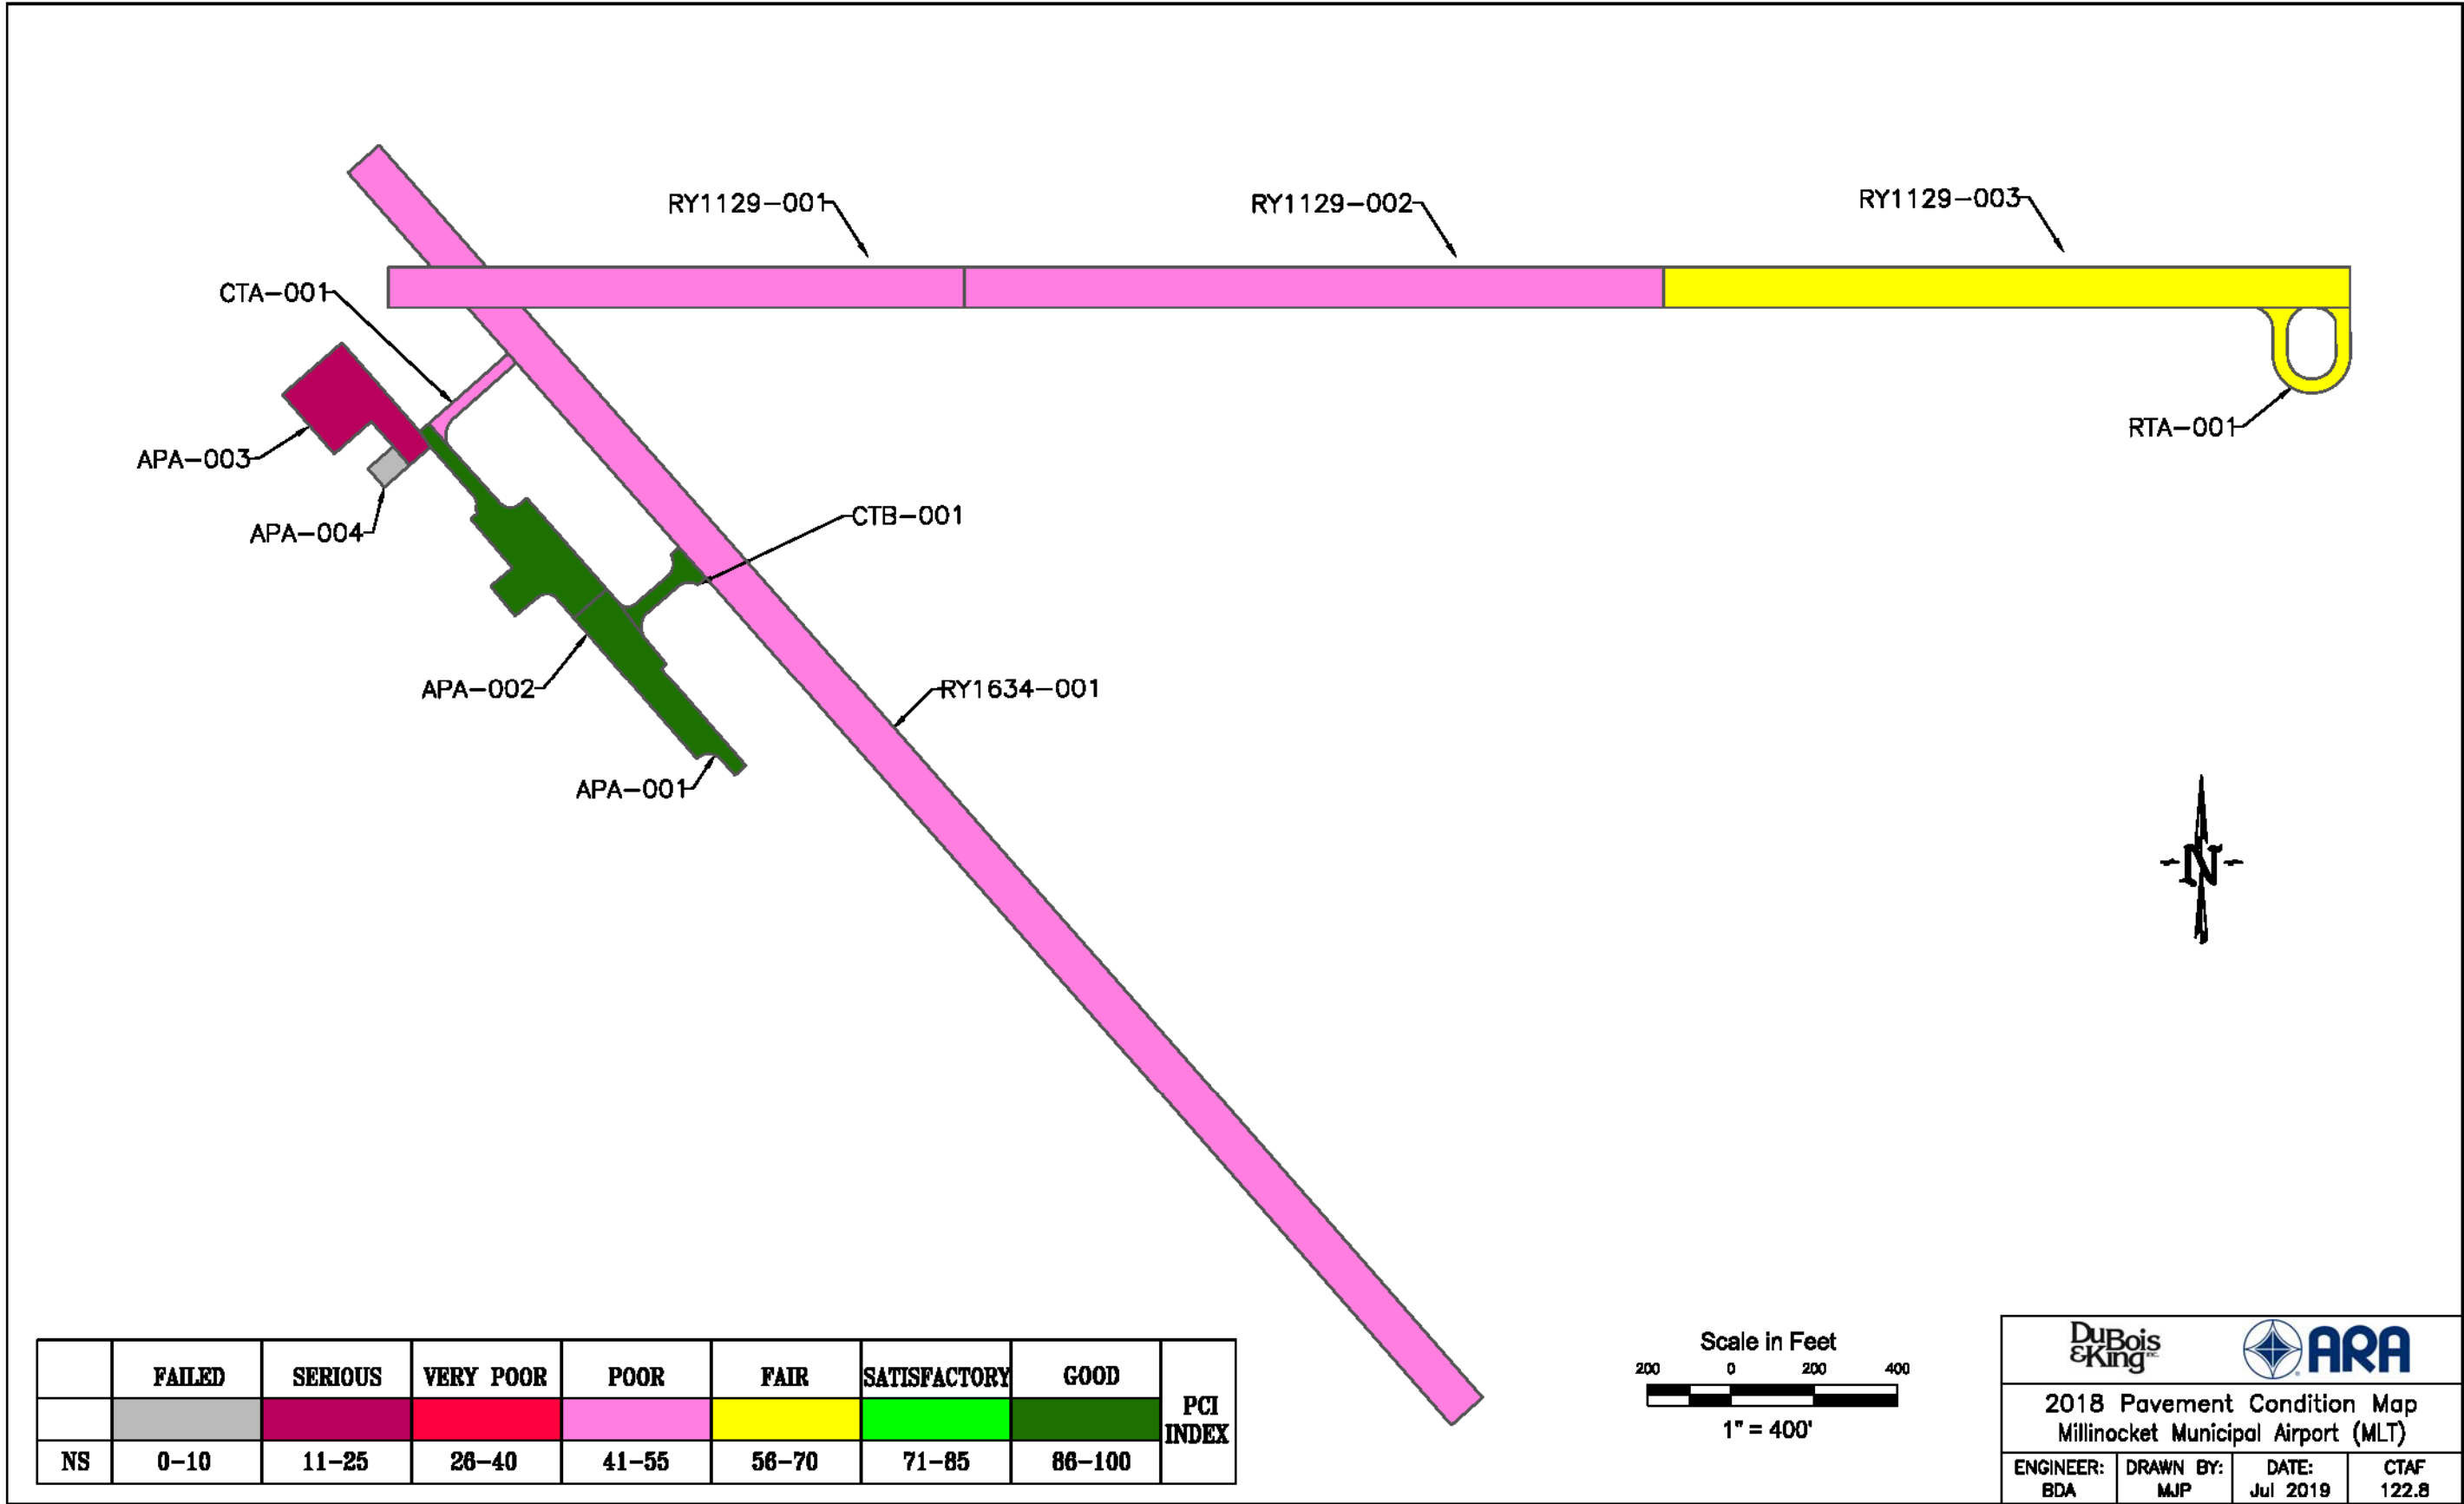
Figure 7. 2018 PCI Map at Millinocket Municipal Airport (MLT)

The average inspected Pavement Condition Index (PCI) for all the airfield pavements at MLT was 58. Runways had an average inspected PCI of 56, which is above the MSL of 70. Taxiways had an average inspected PCI of 68, and aprons had an average inspected PCI of 68. A comparison of the average PCI values at MLT to the statewide average PCI values, by branch use, is shown in the figure below.

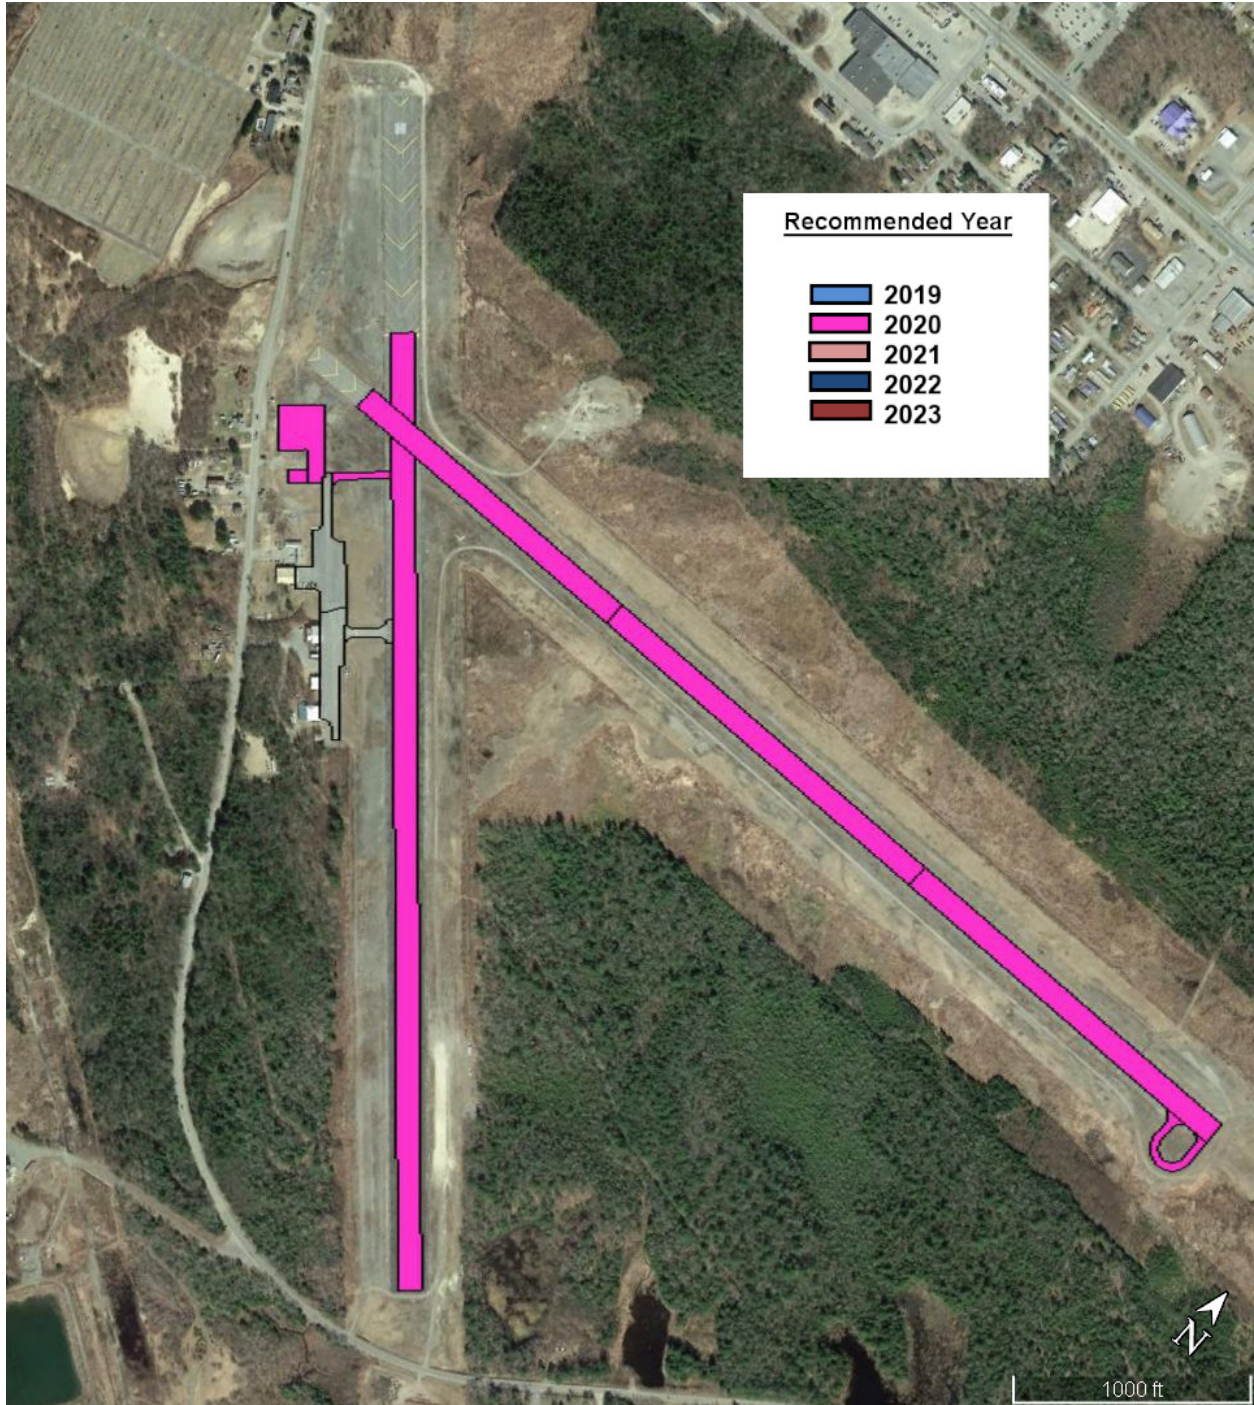
Figure 9. Major M&R

The pavement sections identified for major rehabilitation in Table 10 and shown in Figure 9 are at or are predicted to reach a condition level where major M&R should be considered. While the predicted rehabilitation timeline identifies specific sections and the general timing for the repair, more in-depth project-level studies will be needed to determine exactly how to fix each pavement (i.e. asphalt overlay, reconstruction, or some other repair alternative). Additionally, the airport may find it desirable to adjust the timing of projects to meet fiscal and operational constraints. For example, if the runway and several connector taxiways were forecast to reach the MSL in various years ranging from 2019-2023, it may be preferable to group these pavement sections into a single project.

Branch ID	Section ID	Year	Predicted PCI Before Rehab	Estimated Cost
APA	003	2020	15	\$934,304
APA	004	2020	3	\$97,918
CTA	001	2020	44	\$167,277
RTA	001	2020	57	\$360,054
RY1129	001	2020	49	\$2,821,272
RY1129	002	2020	48	\$3,427,141
RY1129	003	2020	61	\$453,463
RY1634	001	2020	50	\$7,915,064
5-year Airport Total				\$16,176,494

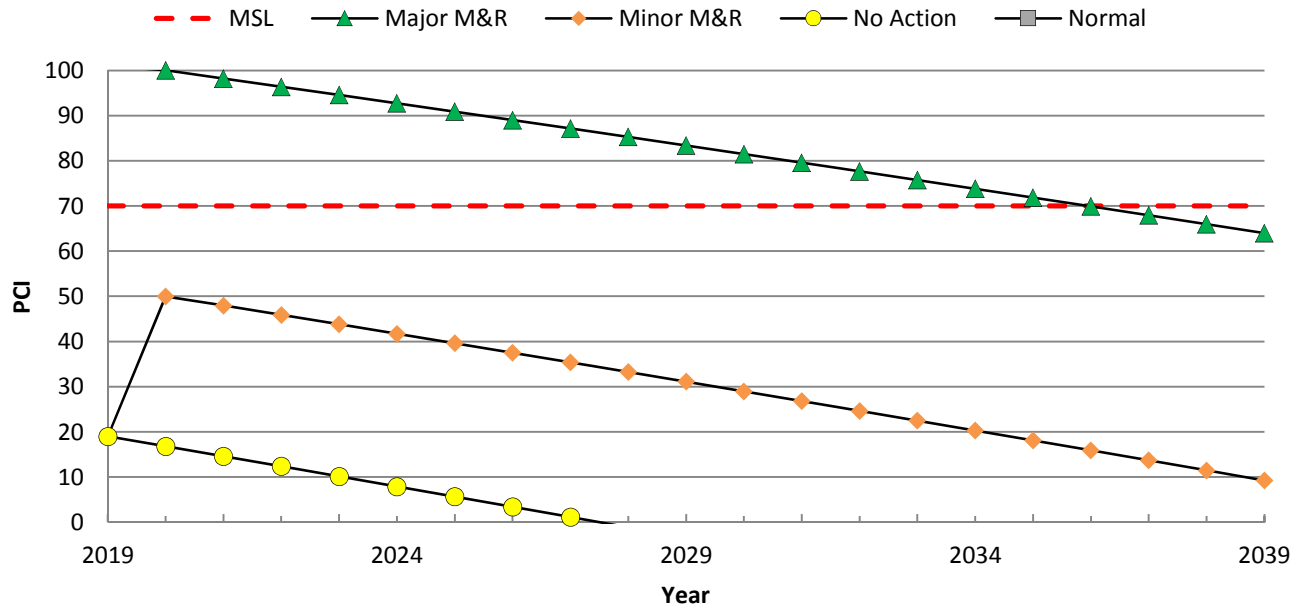
Section:	MLT::APA::003
Description:	Apron A
PaveType:	AC
Area:	45,800
Built:	1/15/1942
Age:	77yr

M&R	Action	Year / Quantity	Cost (\$)	Ending PCI
Major	Major M&R	2020	934,304	100
Minor	All Minor	2020	73	50
1	Crack Sealing - AC	13344 Ft	73	-
2	-	-	-	-
3	-	-	-	-
4	-	-	-	-
5	-	-	-	-
6	-	-	-	-
7	-	-	-	-

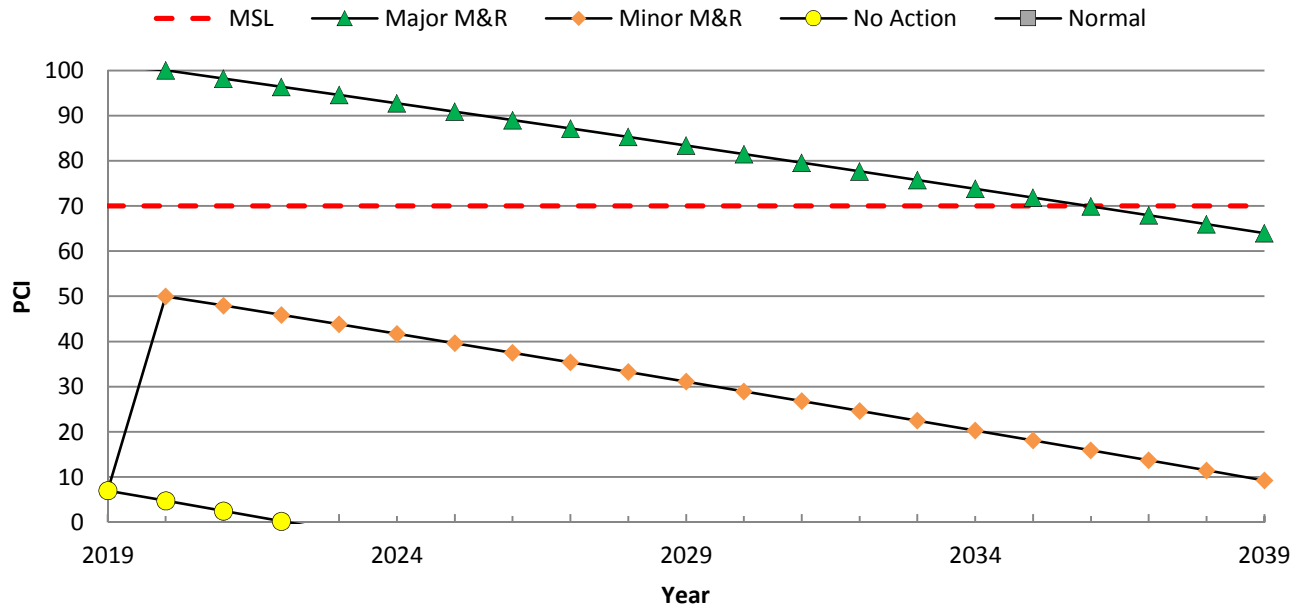
Section:	MLT::APA::004
Description:	Apron A
PaveType:	AC
Area:	4,800
Built:	1/15/1942
Age:	77yr

InspPCI:	7
InspPCI Rating:	Failed
InspDate:	10/15/2018
PCI Family:	2019 MAINE AC APRON-TLN
NormalPCI:	0
MSL:	70

M&R	Action	Year / Quantity	Cost (\$)	Ending PCI
Major	Major M&R	2020	97,918	100
Minor	All Minor	2020	1,282	50
1	Crack Sealing - AC	1326 Ft	778	-
2	Patching - AC Shallow	30 SqFt	504	-
3	-	-	-	-
4	-	-	-	-
5	-	-	-	-
6	-	-	-	-
7	-	-	-	-

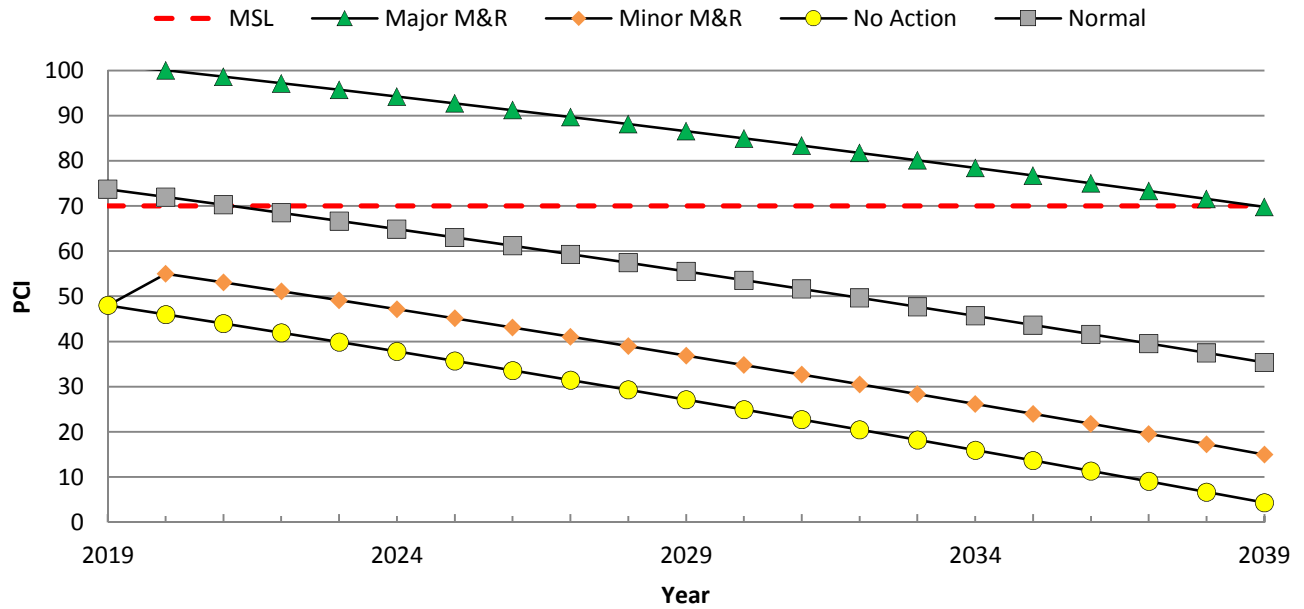
Section:	MLT::CTA::001
Description:	Connecting Taxiway A
PaveType:	AC
Area:	8,200
Built:	1/15/2002
Age:	17yr

M&R	Action	Year / Quantity	Cost (\$)	Ending PCI
Major	Major M&R	2020	167,277	100
Minor	All Minor	2020	309	55
1	Crack Sealing - AC	178 Ft	246	-
2	Surface Seal	8200 SqFt	63	-
3	-	-	-	-
4	-	-	-	-
5	-	-	-	-
6	-	-	-	-
7	-	-	-	-

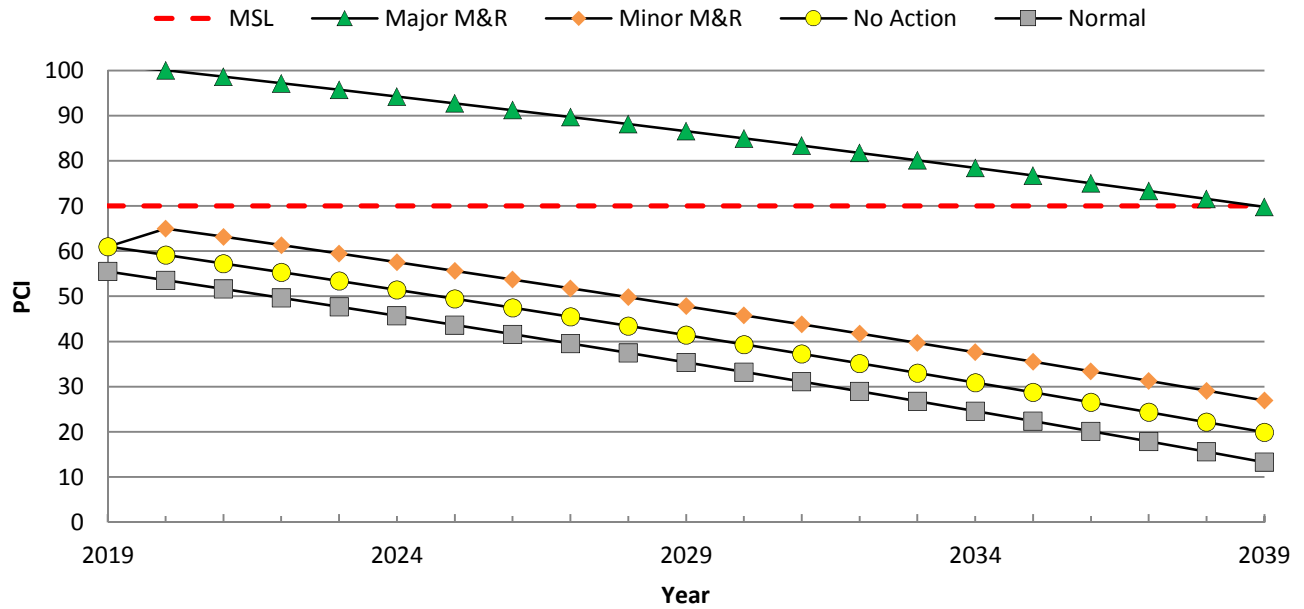
Section:	MLT::RTA::001
Description:	Runway Turnaround A
PaveType:	AC
Area:	17,650
Built:	1/15/1992
Age:	27yr

M&R	Action	Year / Quantity	Cost (\$)	Ending PCI
Major	Major M&R	2020	360,054	100
Minor	All Minor	2020	373	65
1	Surface Seal	17711 SqFt	215	-
2	Crack Sealing - AC	115 Ft	158	-
3	-	-	-	-
4	-	-	-	-
5	-	-	-	-
6	-	-	-	-
7	-	-	-	-

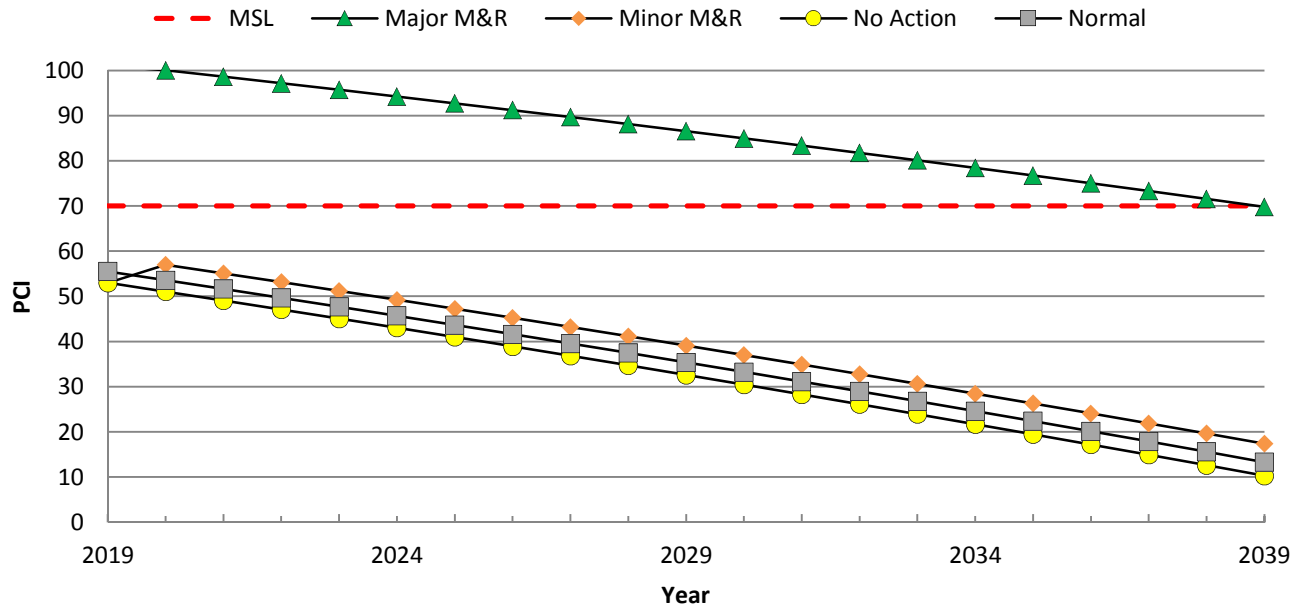
Section:	MLT::RY1129::001
Description:	Runway 11-29
PaveType:	AC
Area:	138,300
Built:	1/15/1992
Age:	27yr

M&R	Action	Year / Quantity	Cost (\$)	Ending PCI
Major	Major M&R	2020	2,821,272	100
Minor	All Minor	2020	184	57
1	Crack Sealing - AC	3070 Ft	184	-
2	-	-	-	-
3	-	-	-	-
4	-	-	-	-
5	-	-	-	-
6	-	-	-	-
7	-	-	-	-

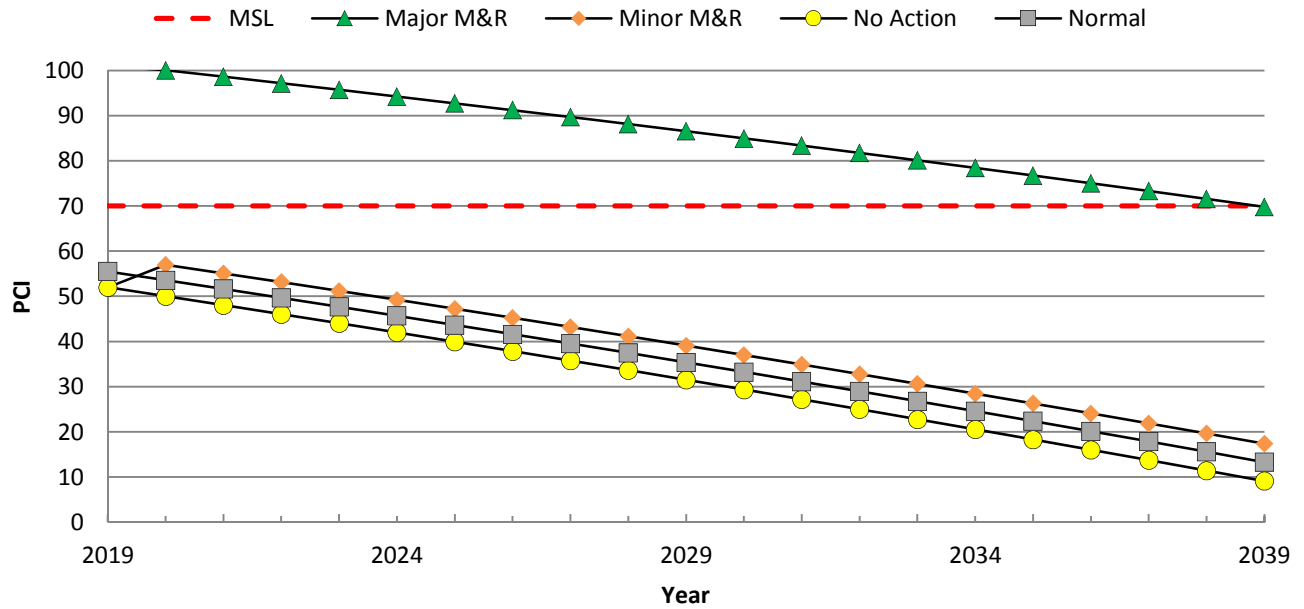
Section:	MLT::RY1129::002
Description:	Runway 11-29
PaveType:	AC
Area:	168,000
Built:	1/15/1992
Age:	27yr

M&R	Action	Year / Quantity	Cost (\$)	Ending PCI
Major	Major M&R	2020	3,427,141	100
Minor	All Minor	2020	139	57
1	Crack Sealing - AC	2405 Ft	139	-
2	-	-	-	-
3	-	-	-	-
4	-	-	-	-
5	-	-	-	-
6	-	-	-	-
7	-	-	-	-

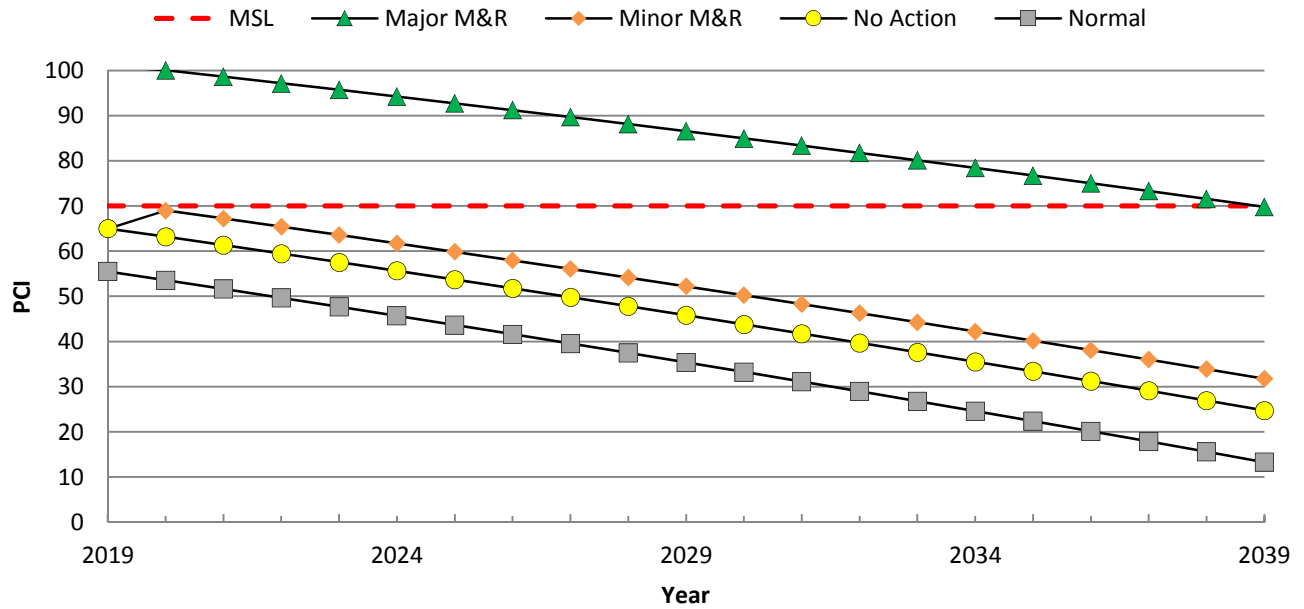
Section:	MLT::RY1129::003
Description:	Runway 11-29
PaveType:	AC
Area:	164,900
Built:	1/15/1992
Age:	27yr

M&R	Action	Year / Quantity	Cost (\$)	Ending PCI
Major	Major M&R	2020	453,463	100
Minor	-	-	-	-
1	-	-	-	-
2	-	-	-	-
3	-	-	-	-
4	-	-	-	-
5	-	-	-	-
6	-	-	-	-
7	-	-	-	-

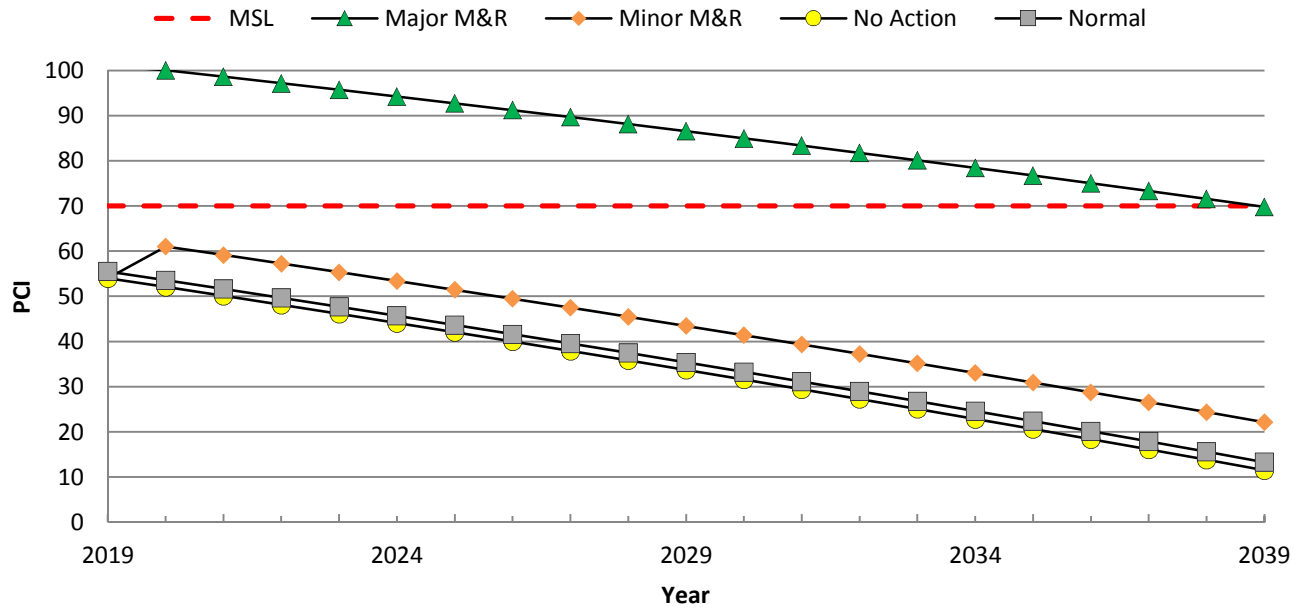
Section:	MLT::RY1634::001
Description:	Runway 16-34
PaveType:	AC
Area:	388,000
Built:	1/15/1992
Age:	27yr

M&R	Action	Year / Quantity	Cost (\$)	Ending PCI
Major	Major M&R	2020	7,915,064	100
Minor	All Minor	2020	269	61
1	Surface Seal	441 SqFt	269	-
2	-	-	-	-
3	-	-	-	-
4	-	-	-	-
5	-	-	-	-
6	-	-	-	-
7	-	-	-	-
