Maine Department of Transportation

Pavement Condition Report

CENTRAL MAINE AIRPORT OF NORRIDGEWOCK (KOWK)

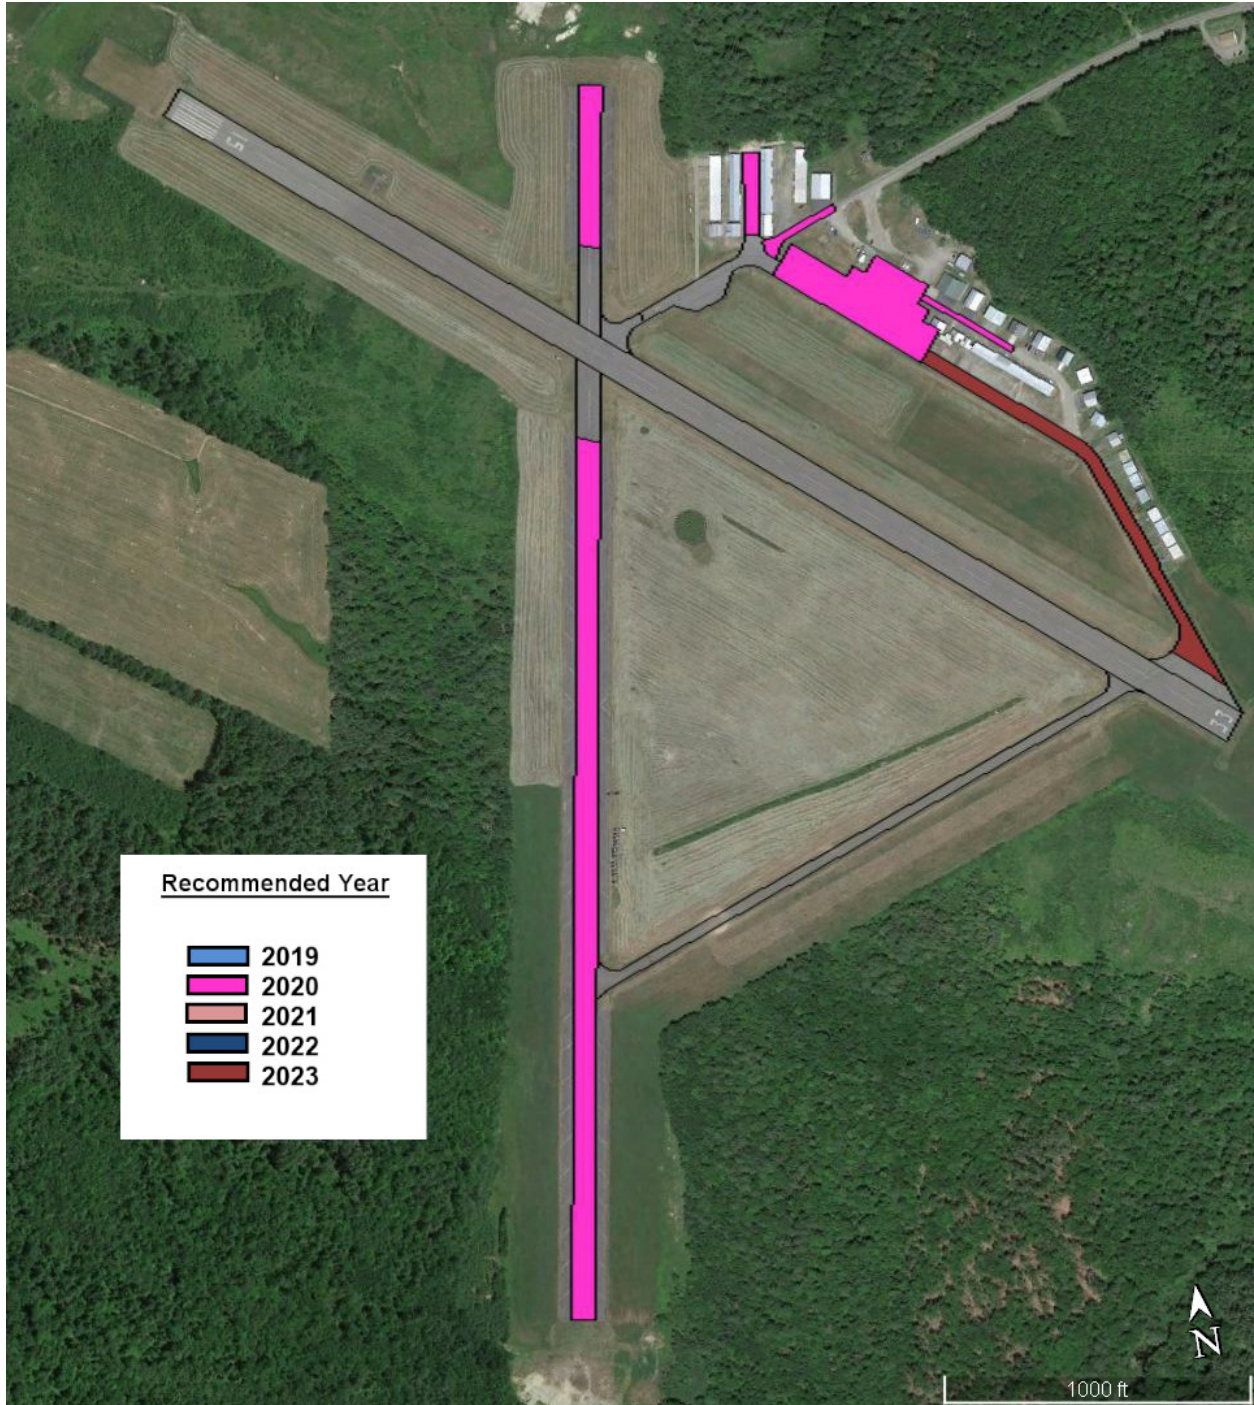
Figure 9. Major M&R

The pavement sections identified for major rehabilitation in Table 10 and shown in Figure 9 are at or are predicted to reach a condition level where major M&R should be considered. While the predicted rehabilitation timeline identifies specific sections and the general timing for the repair, more in-depth project-level studies will be needed to determine exactly how to fix each pavement (i.e. asphalt overlay, reconstruction, or some other repair alternative). Additionally, the airport may find it desirable to adjust the timing of projects to meet fiscal and operational constraints. For example, if the runway and several connector taxiways were forecast to reach the MSL in various years ranging from 2019-2023, it may be preferable to group these pavement sections into a single project.

Branch ID	Section ID	Year	Predicted PCI Before Rehab	Estimated Cost
APA	001	2020	68	\$249,694
RY0321	001	2020	65	\$695,732
TLA	001	2020	62	\$21,999
TLB	001	2020	2	\$275,395
TLC	001	2020	42	\$139,738
CTA	003	2023	68	\$183,420
5-year Airport Total				\$1,565,979

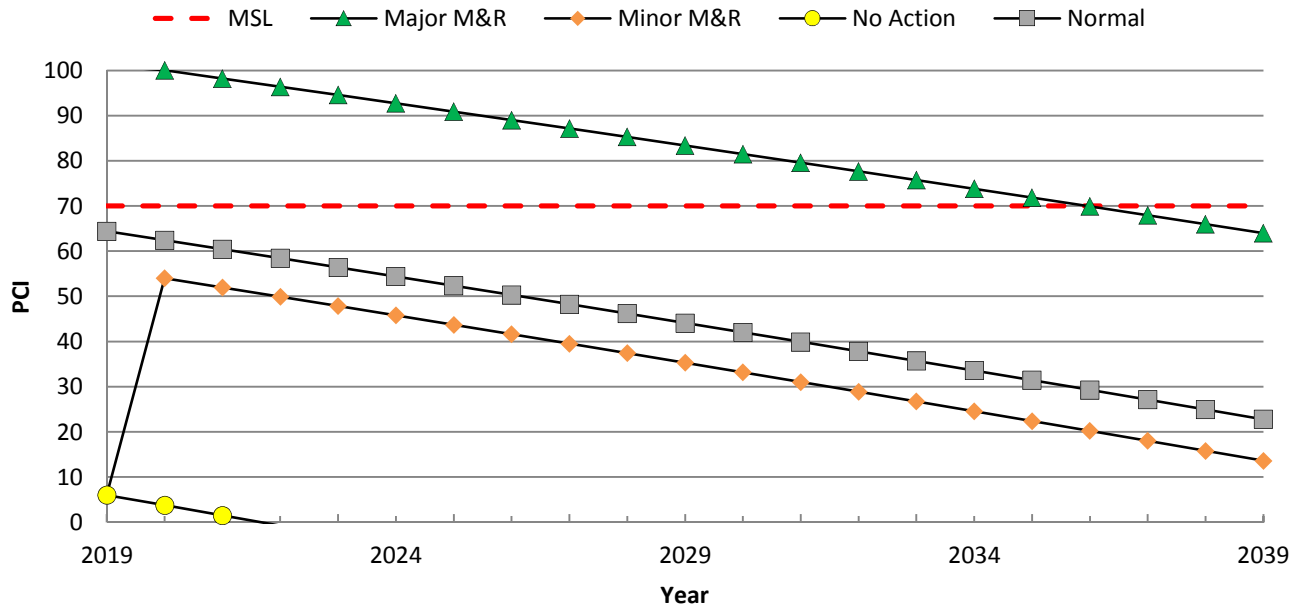
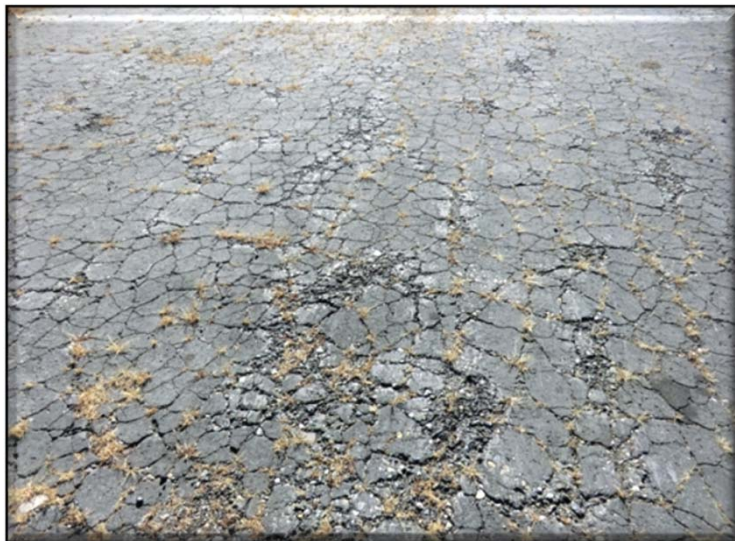
⁴ The higher than average deterioration rate of 5.2 PCI/Yr for TLB-001 is due primarily to medium-and high-severity alligator cracking.

Section:	OWK::TLB::001
Description:	Taxilane B
PaveType:	AC
Area:	13,500
Built:	1/15/2000
Age:	19yr

M&R	Action	Year / Quantity	Cost (\$)	Ending PCI
Major	Major M&R	2020	275,395	100
Minor	All Minor	2020	69,190	54
1	Patching - AC Deep	3316 SqFt	61,630	-
2	Patching - AC Shallow	292 SqFt	4,895	-
3	Crack Sealing - AC	1759 Ft	2,427	-
4	Surface Seal	390 SqFt	238	-
5	-	-	-	-
6	-	-	-	-
7	-	-	-	-
