Geologic Site of the Month
September, 1997

Aftermath of the 1996 Rockland Landslide

Text by
Maine Geological Survey

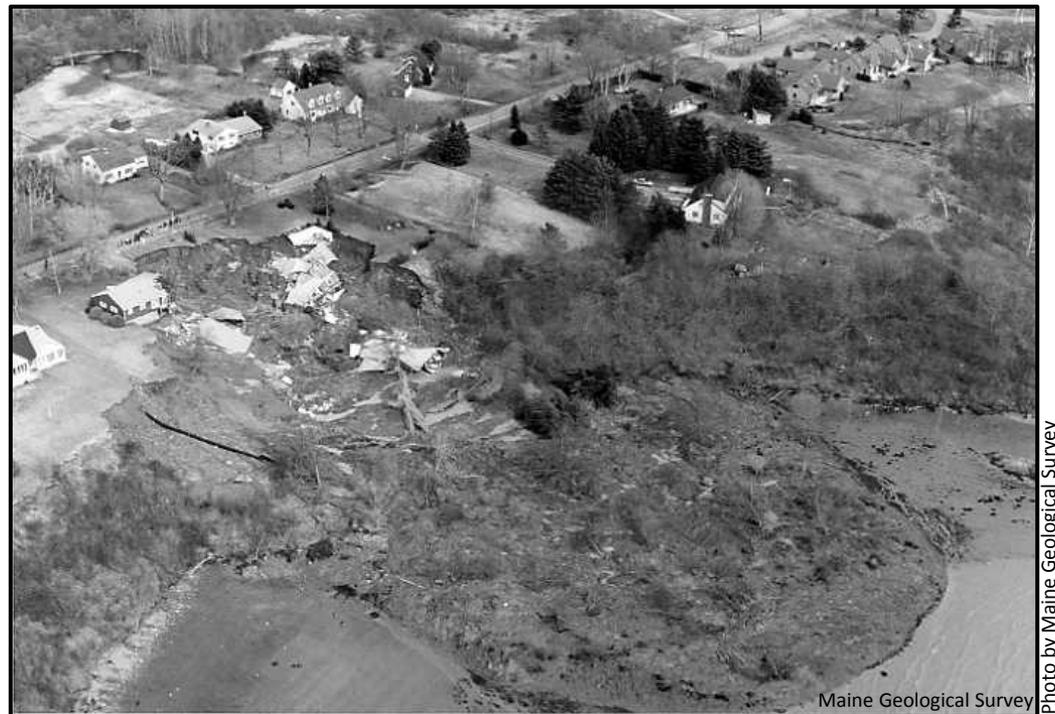
Early in the morning of April 16, 1996, a steep bluff along the north shore of Rockland Harbor slumped toward the ocean. Slumping of the bluff occurred progressively in a series of discrete landslide events. Most of the initial motion occurred between 1:15 AM and about 4:00 AM during a falling tide immediately preceding a new moon, but well before a heavy rain on the afternoon of April 16. Figure 1 is an aerial photo of the slide area taken in April of 1996.

Figure 1. Air photo of the Rockland landslide, April 1996.

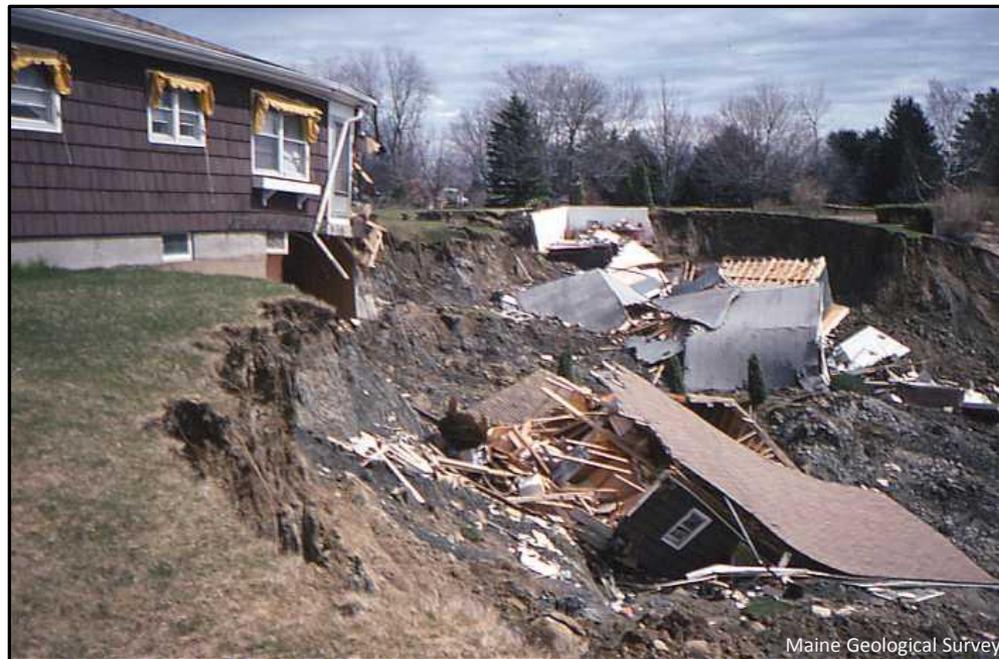
Before the landslide, the bluff top was about 50 feet above sea level and the base of the bluff ended at the high water mark. During the initial slumping events, portions of two houses collapsed into the main body of the landslide (Figure 2). These structures were about 75 feet landward of the top edge of the bluff prior to the landslide. A topographic survey by geologists from the MGS and the University of Maine determined that by the next week the slide displaced more than half an acre of the original bluff top. When it was over, the slide had moved horizontally over 400 feet onto the mudflats of the intertidal zone and had disturbed a total area of 3.5 acres.

Figure 2. Photo of the landslide showing collapsed building.

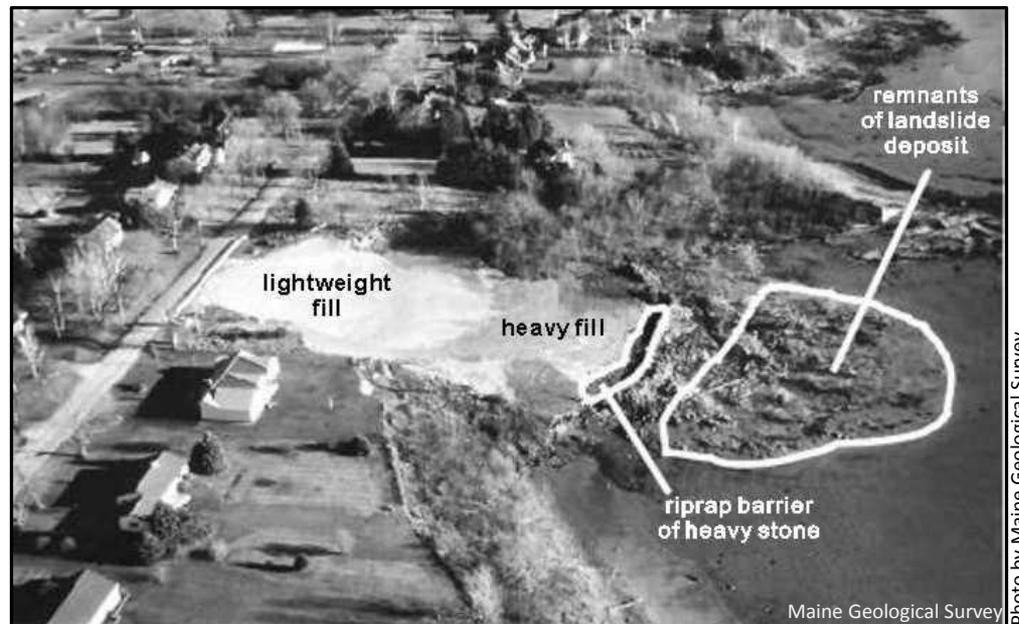
For a month following the initial slide, smaller blocks continued to fall from the steep landward slopes. These continued slope failures resulted in the enlargement of the affected area by landward progression of the vertical scarp. This progression moved the main scarp to within 15 feet of a sewer main on the seaward side of the road. Possible disruption of a city water main buried beneath the landward shoulder of the road was also of public concern. To protect the road and minimize further enlargement of the landslide area, the City of Rockland hired a private geotechnical engineering firm, R.G. Gerber-Jacques Whitford, Inc. of Freeport, ME, to undertake a stabilization project (Figure 3).

Figure 3. Photo of the Rockland landslide project showing locations of lightweight cement kiln dust, heavy rock fill, and the riprap barrier. The remnants of the slide on the tidal flat will be allowed to gradually erode.

The city received partial funding from the [Federal Emergency Management Agency \(FEMA\)](#). To buttress the road it was necessary to place fill on top of the clay that had failed during the landslide. The failed clay was very soft and unable to support heavy loads of buttressing fill, unless the fill was emplaced in a particular sequence. The toe or front of the slide had to be stabilized before the head of the slide could be filled. To begin, an access to the slide area was constructed across the remaining foundation of one of the destroyed homes. From here a road was built down to the toe of the slide. At the toe, an excavation was dug down to sea level and heavy stone riprap was emplaced to contain the buttressing fill. Heavy rock fill was placed behind the rip rap barrier on the lower part of the landslide area. On the upper part of the slope, lightweight cement kiln dust, available locally from the Dragon Cement Company, was used to cover the slide area progressively from the toe toward the headscarp. The combination of heavy fill at the bottom of the slide and lightweight fill at the top was a critical factor in the success of the stabilization process.

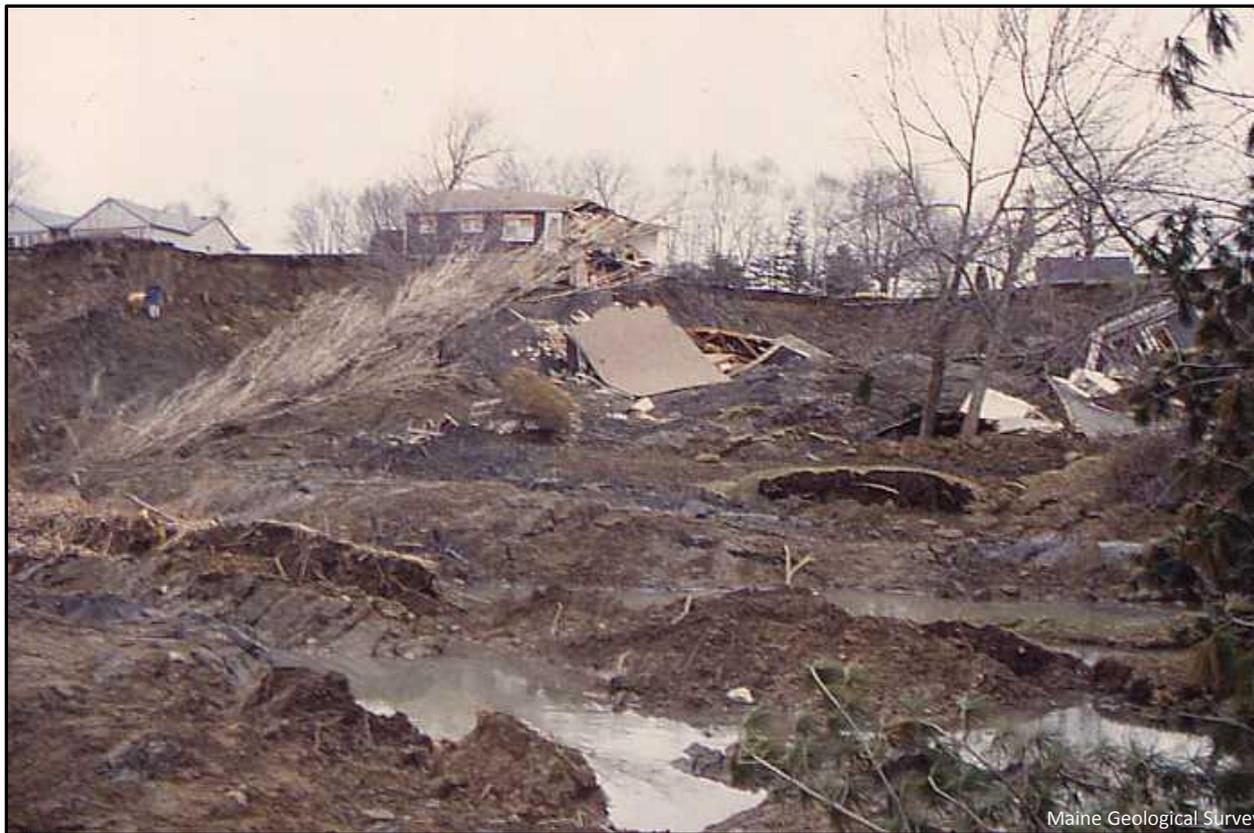
Figure 4. Photo of landslide area taken in April 1996.

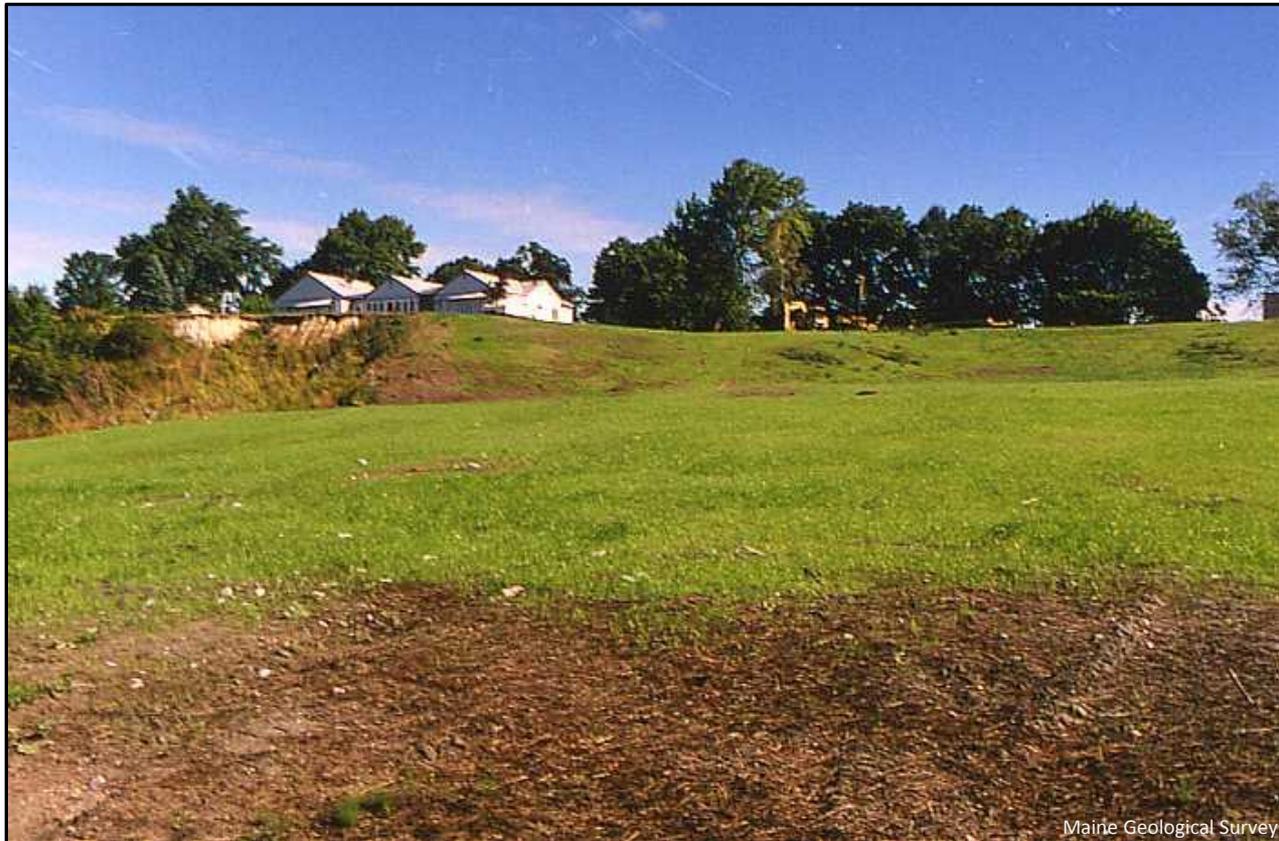
Figure 5. Landslide area after stabilization, photo taken in September 1997.

Once this fill was emplaced, topsoil from the slopes surrounding the landslide area was used to cover the fill. This topsoil excavation reduced the slope of the headscarp area to an angle that is normally stable over the long term.

Following the spreading of topsoil the entire reclaimed area was seeded with grass and mulched. Figures 4 and 5 show the slide before and after the stabilization project. Figure 4 was taken in April, 1996; Figure 5, in September, 1997.
