Memorial Bridge

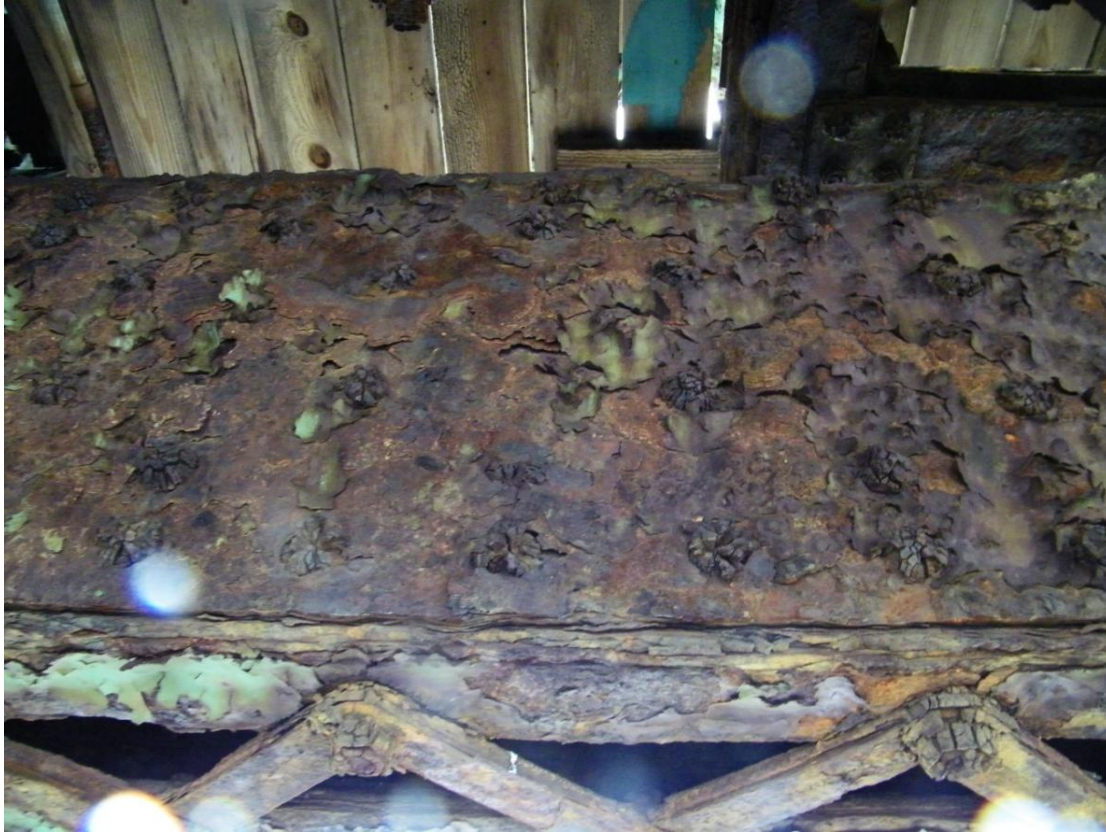
Span 2

Severe deterioration on bottom Chord L5-L6, Interior Face with
wooden sidewalk walking surface above

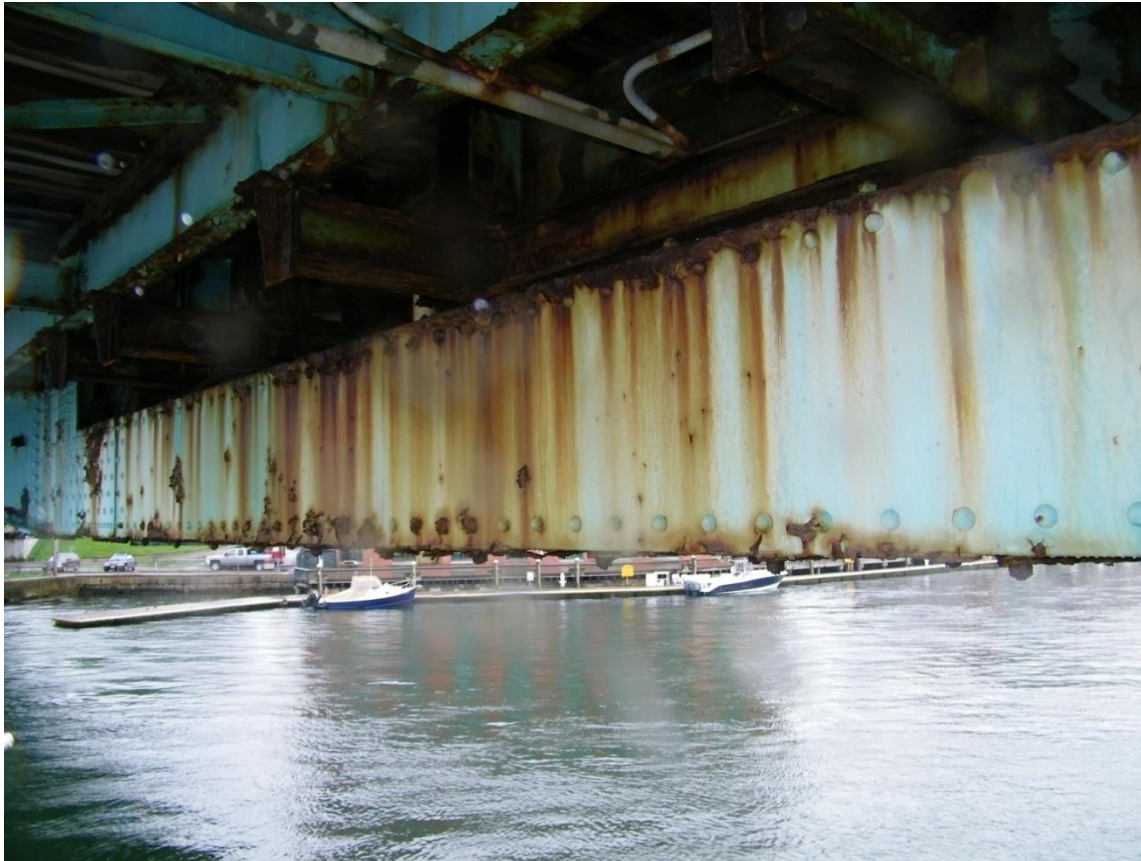
Span 1 Bottom Chord L8-L9, East Exterior Face
Typical Condition at Fixed Span Bottom Chords between panel points

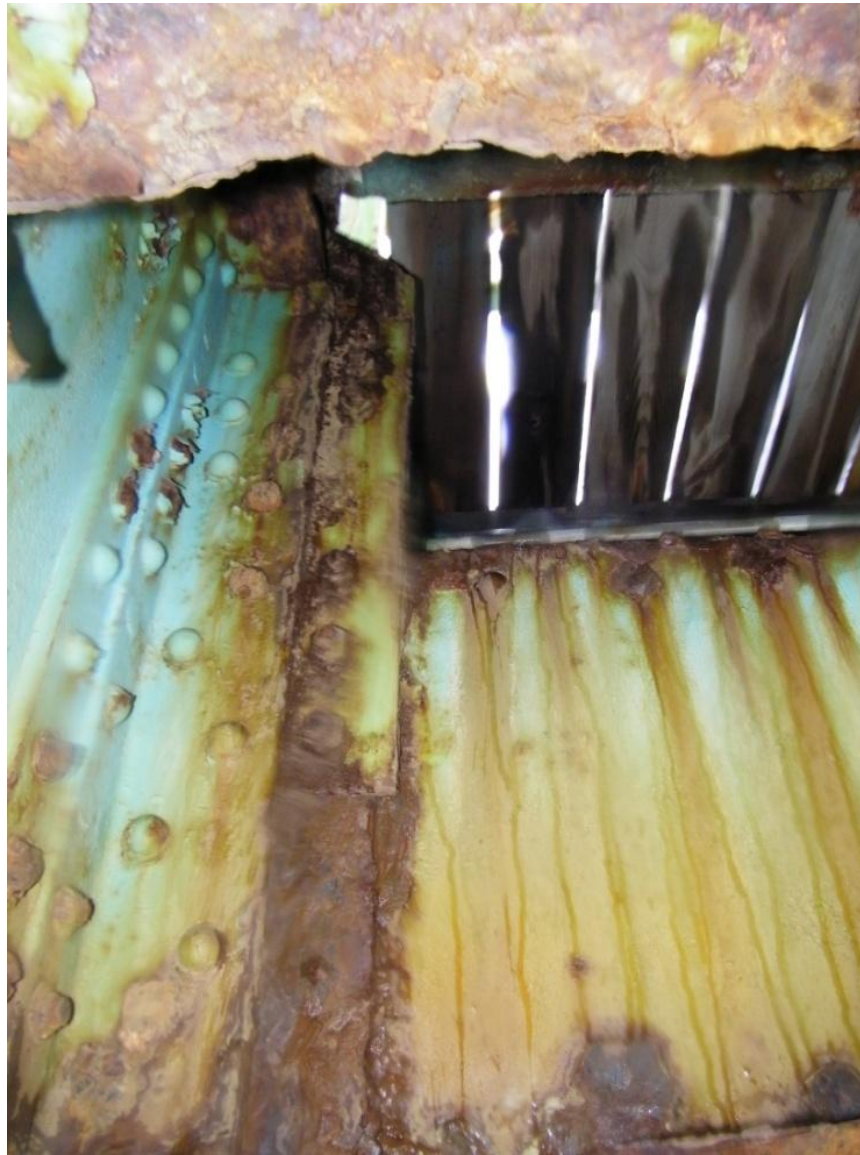
Span 1 Gusset Plate L9 East with repair, plate from previous repair
Roadway floor beam (left) framing into interior face of bottom truss chord
(right)

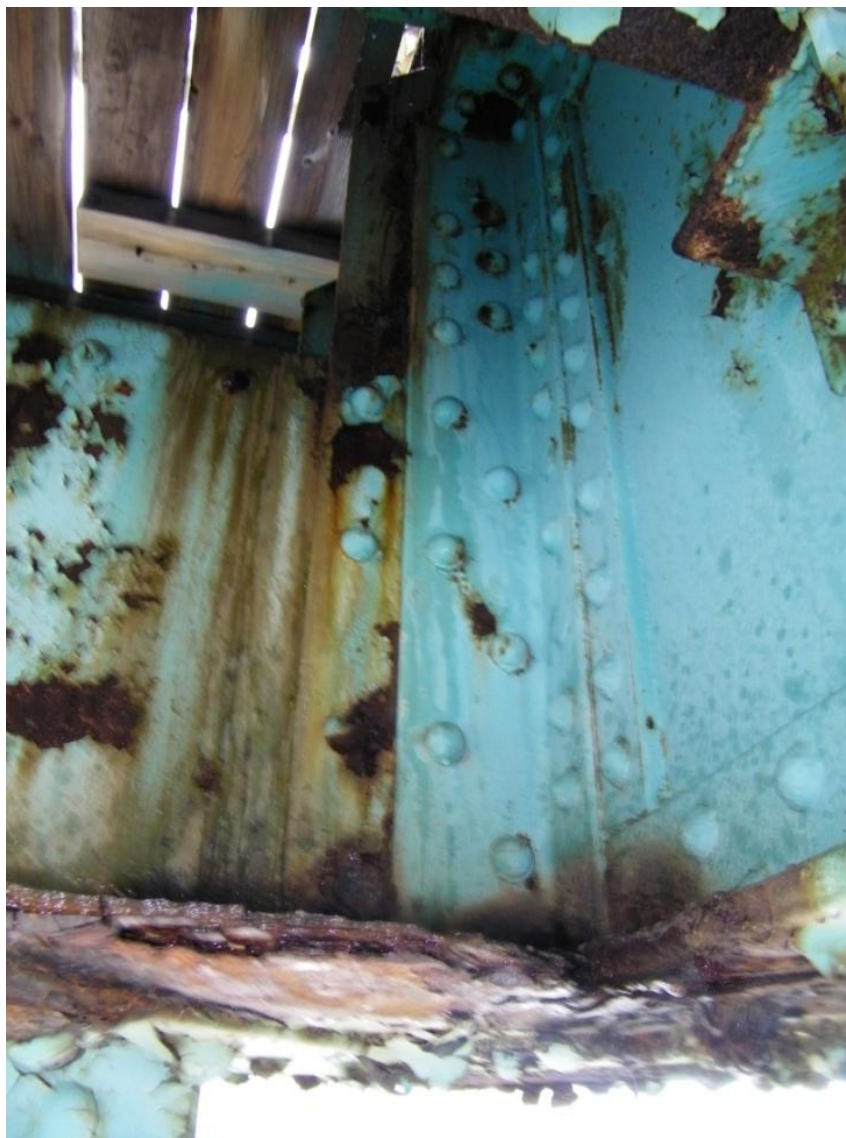
Span 1 Gusset Plate L7 East horizontal gusset plate between roadway floor beam and the fixed span truss bottom chord.

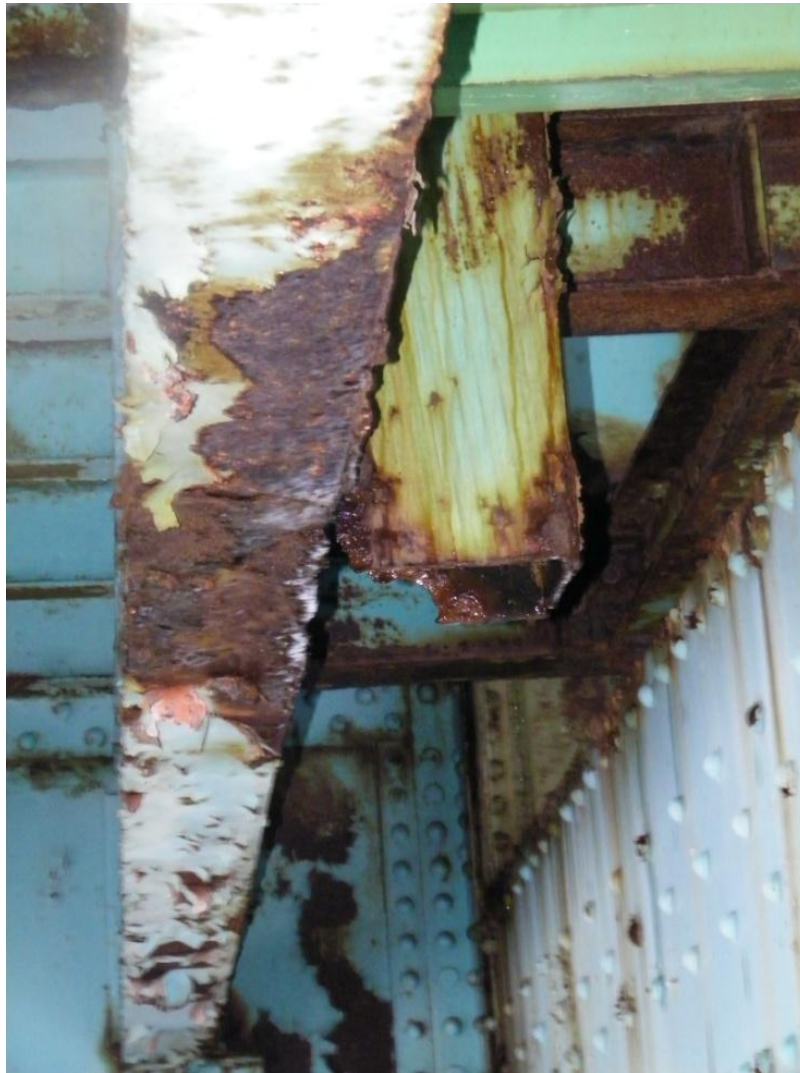
Span 1, Bay 8, Stringer 7 (East Roadway Stringer)
Typical stringer condition at metal drain pipe

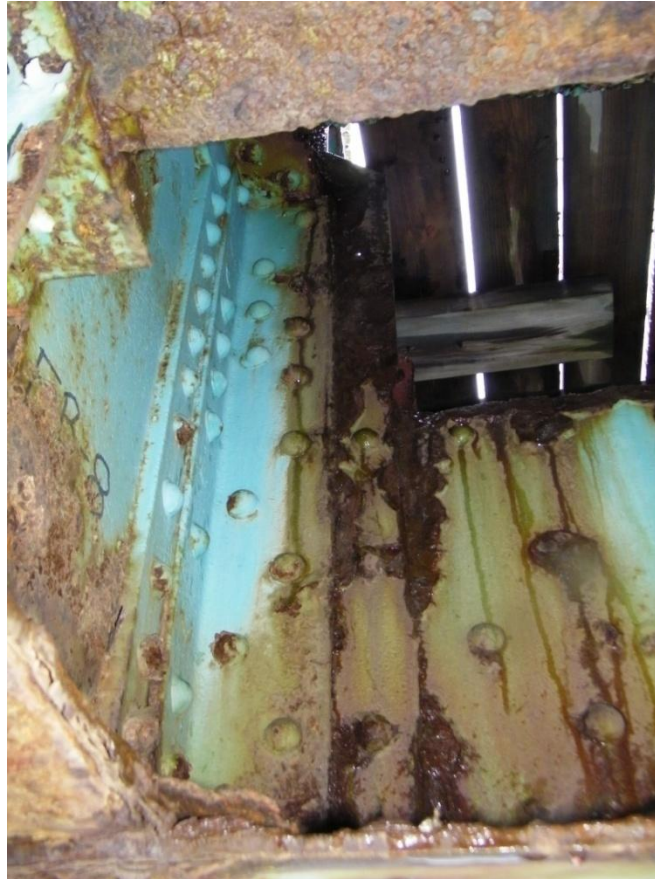
Span 1 Gusset Plate L7 East
Roadway floorbeam/bottom truss chord connection - wooden sidewalk walking surface
above

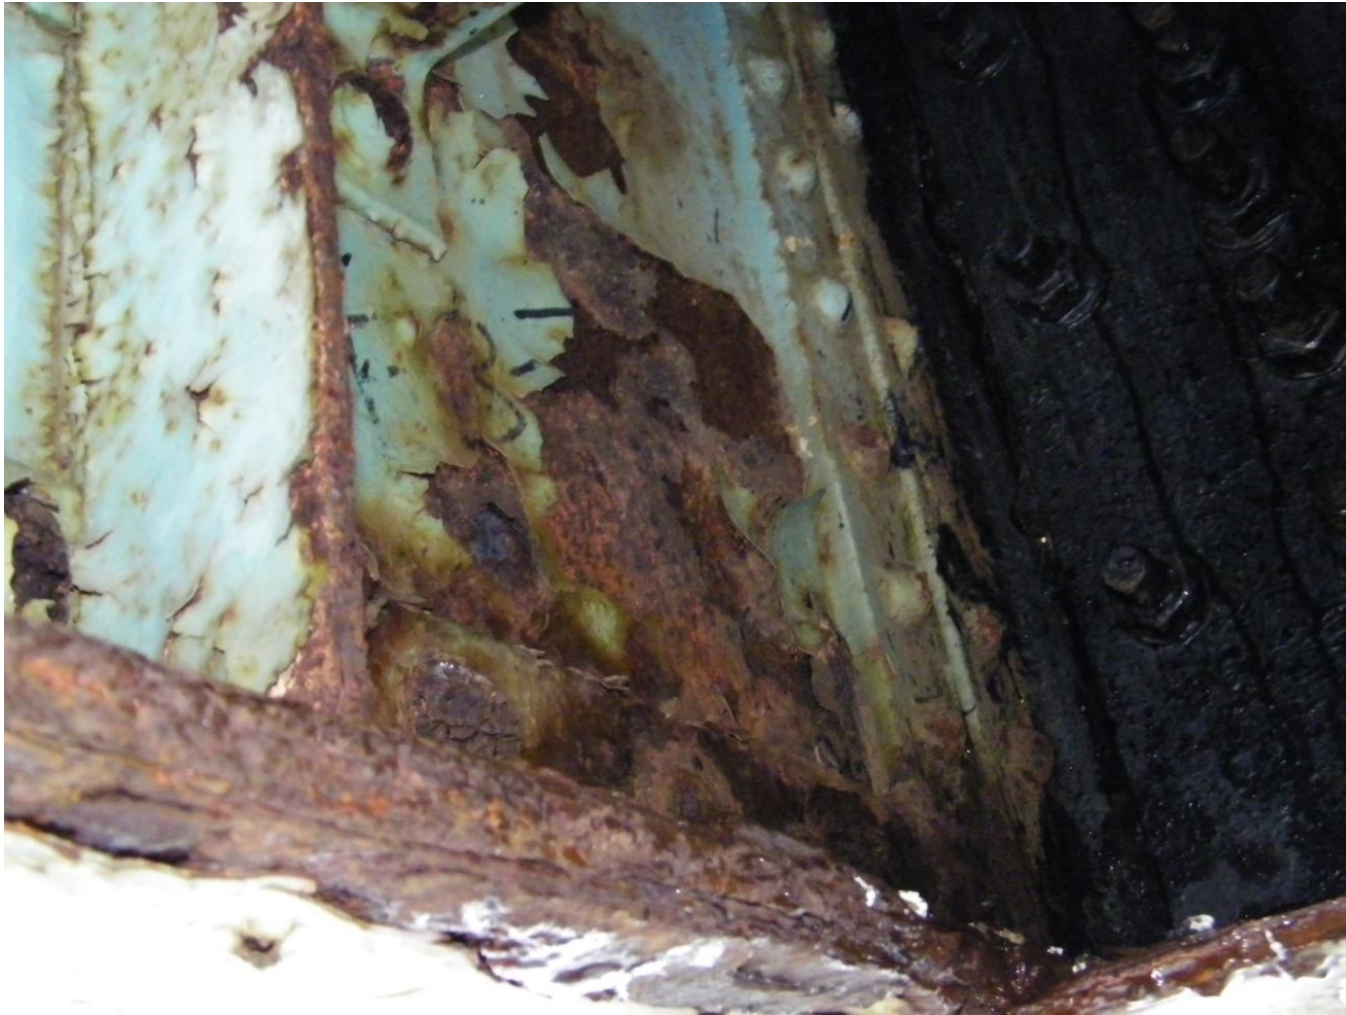
Span 1, Floorbeam 6, North Face
Typical condition in roadway floor beams near chords

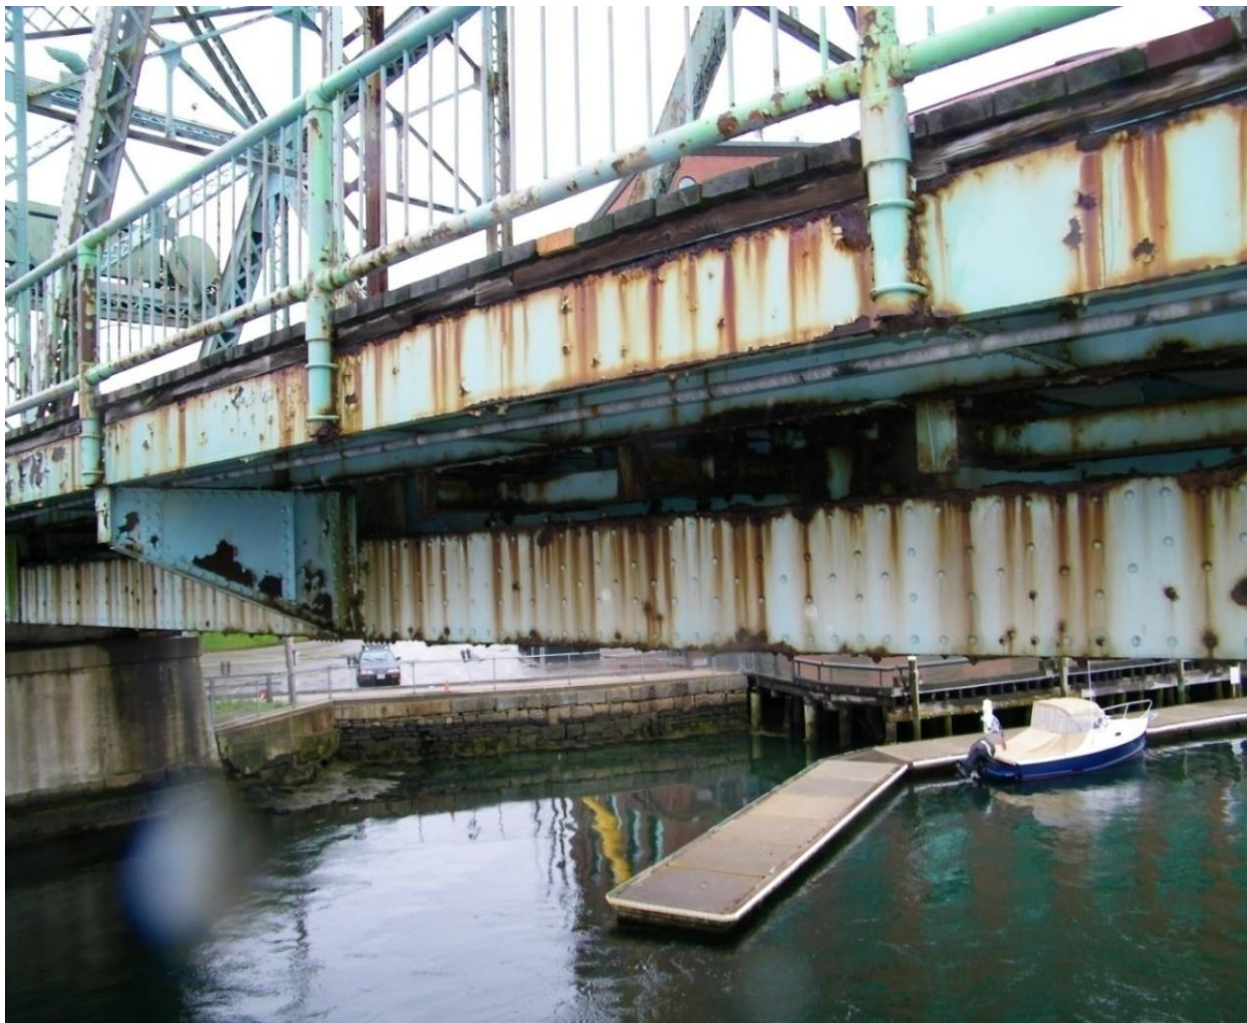
Span 1 Bottom Chord L2-L3, East Exterior Face
Typical Fixed Span Bottom Chord Condition between truss panel points

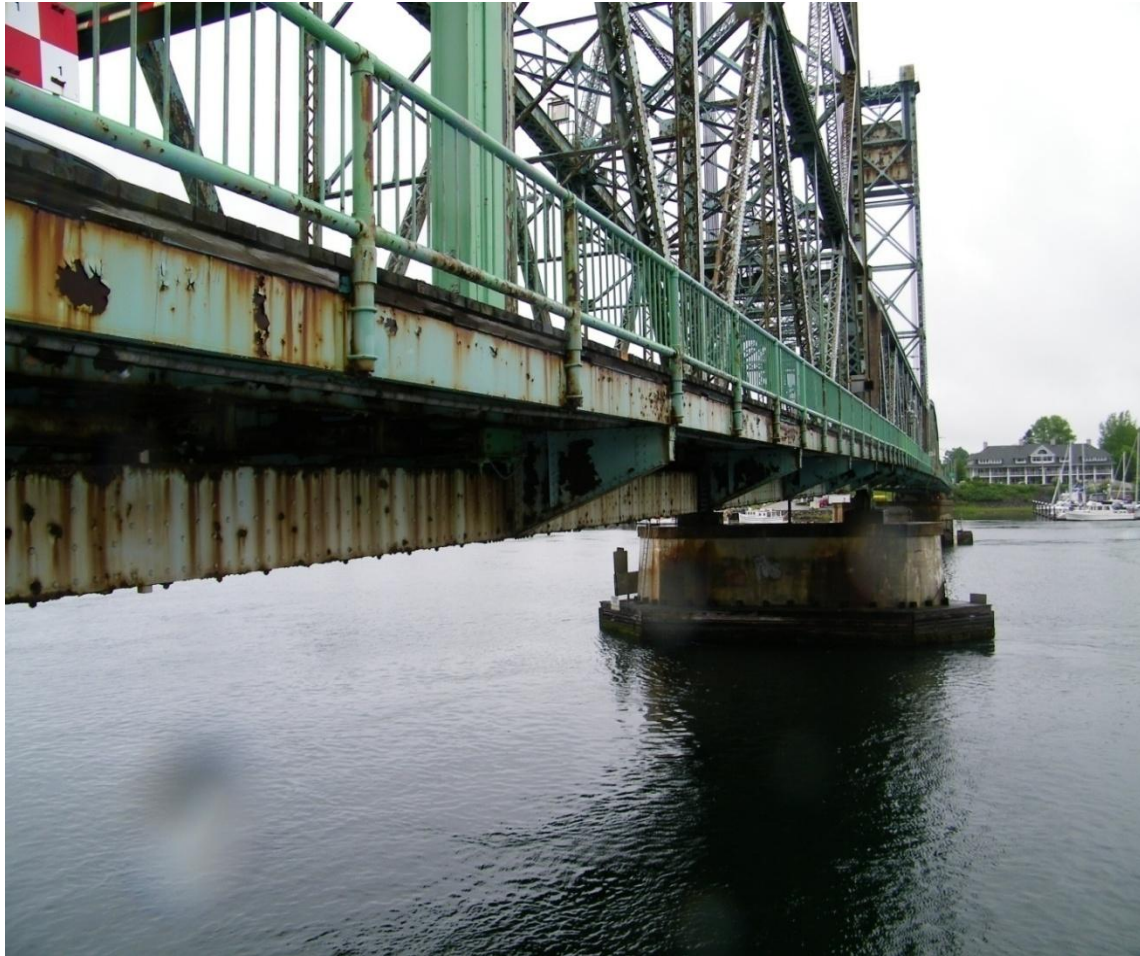
Span 1 Bottom Chord L4-L5, East Exterior Face
Typical Fixed Span Bottom Chord Condition between truss panel points

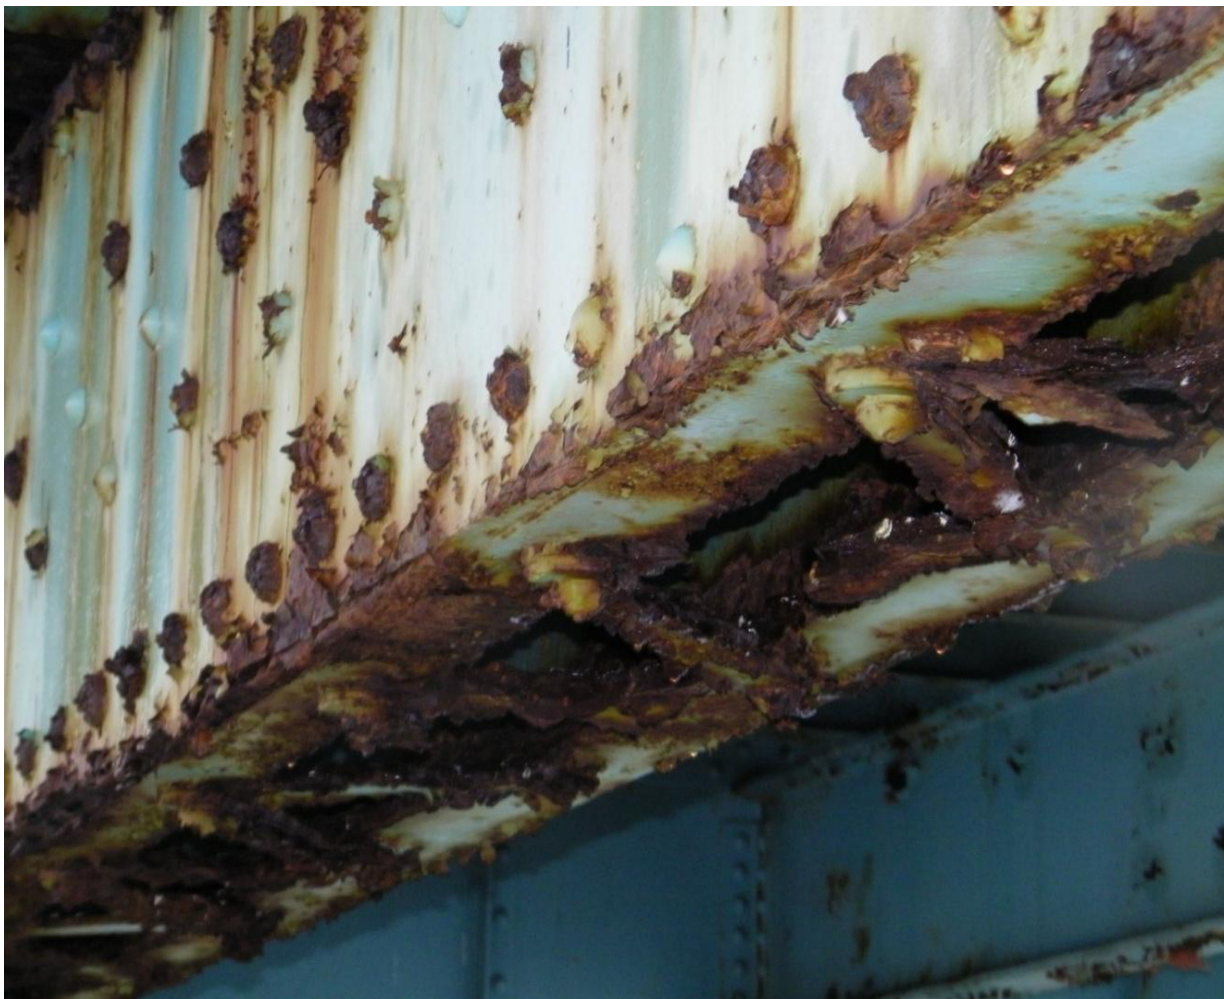
Span 3 Bottom Chord L3-L4, West Exterior Face
Typical Lacing and rivet head Deterioration

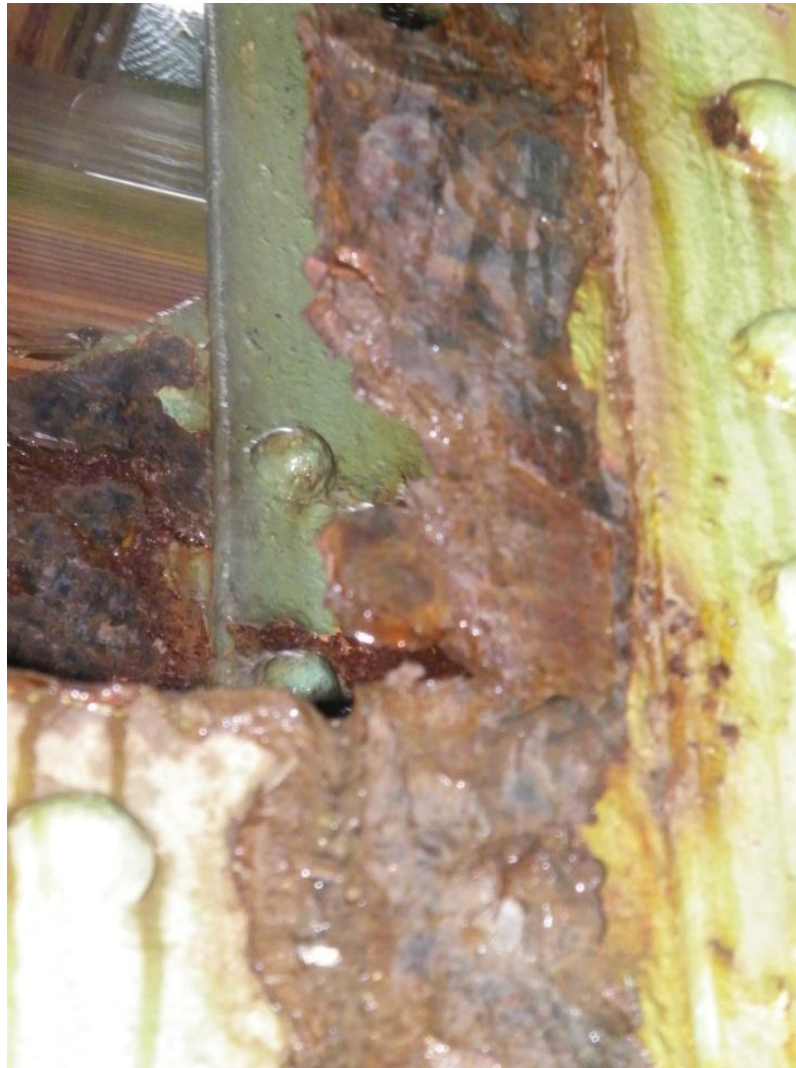
Span 3 Gusset Plate L3 East Interior with severe section loss
Roadway beam (right) framing to the bottom truss chord (lower left)

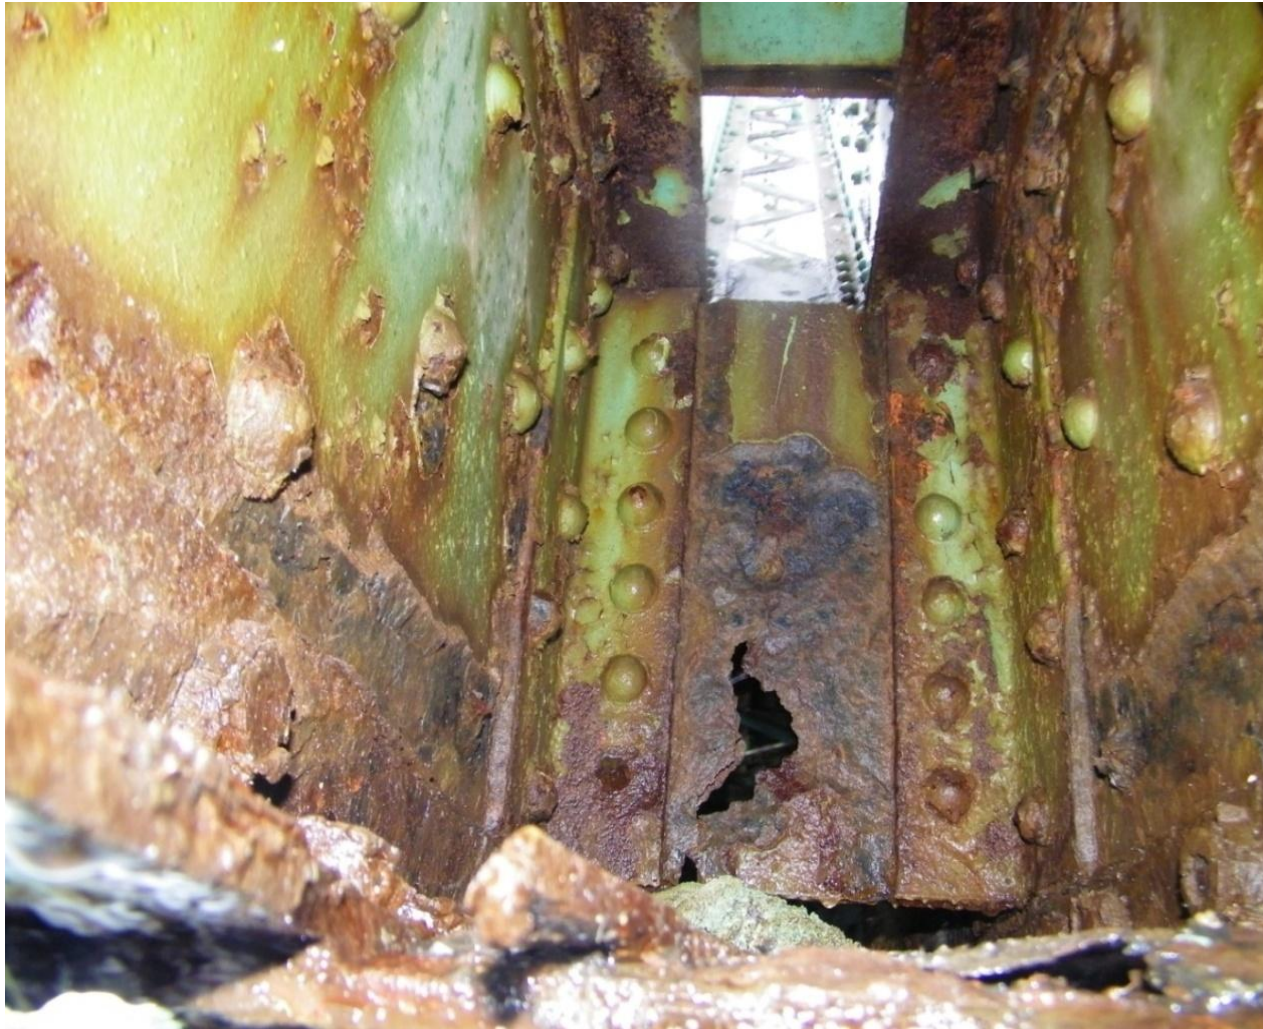
Inside of Chord at Gusset L9 in Span 3.
Deteriorated lacing in the foreground and a deteriorated internal stiffener plate center.
Truss diagonal seen just above internal stiffener plate

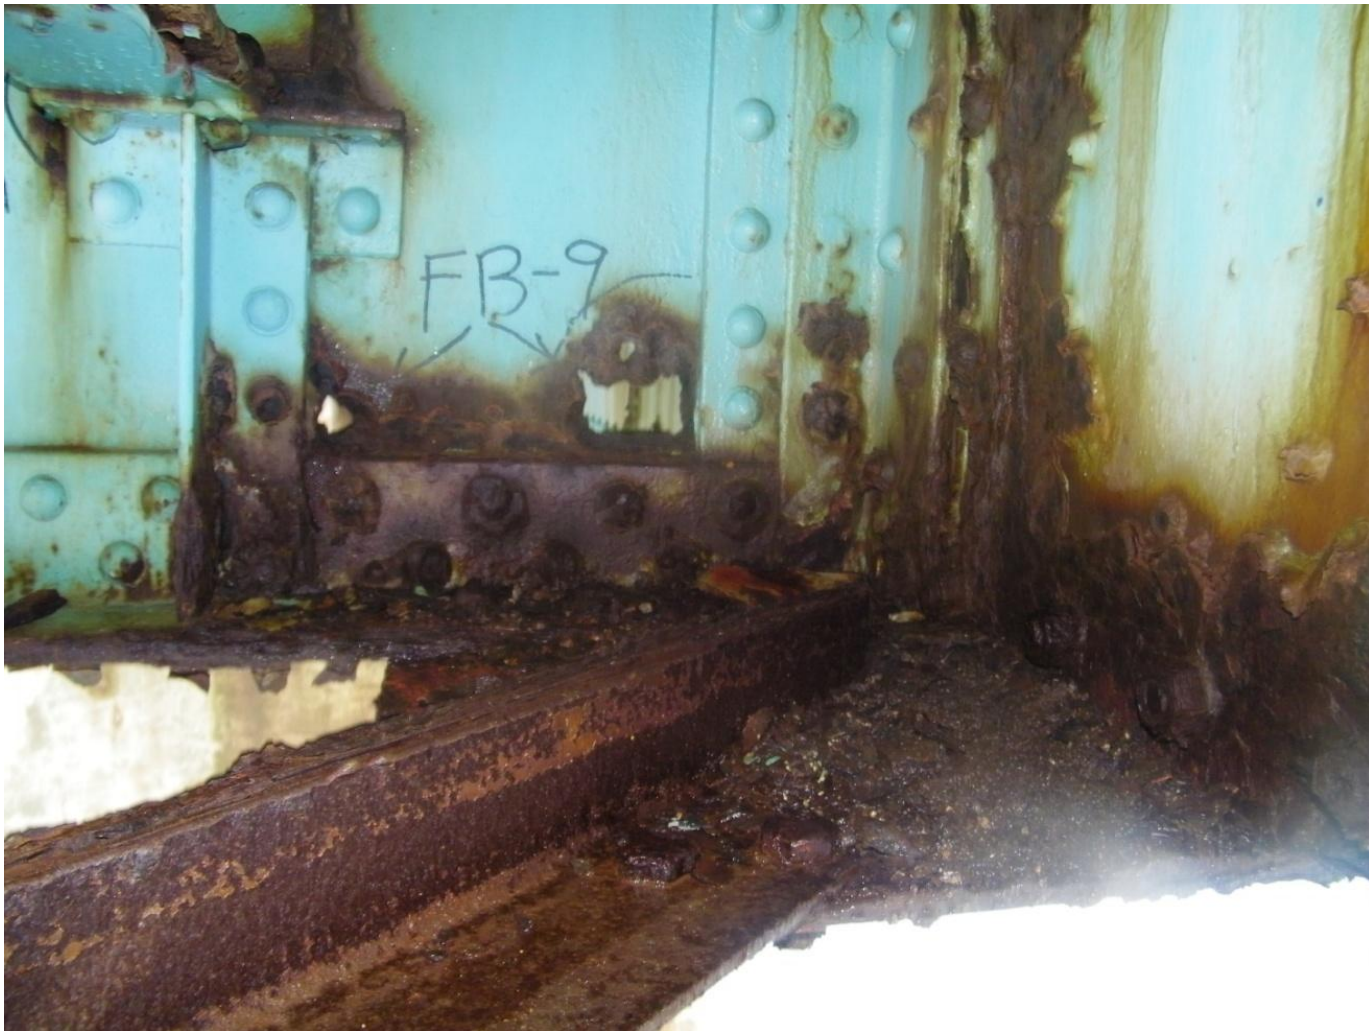
Span 3 Floorbeam 9, South Face, East End
Heavily deteriorated with holes in web of roadway floor beam
Roadway Floorbeam has been previously repaired as evidenced by bolts.

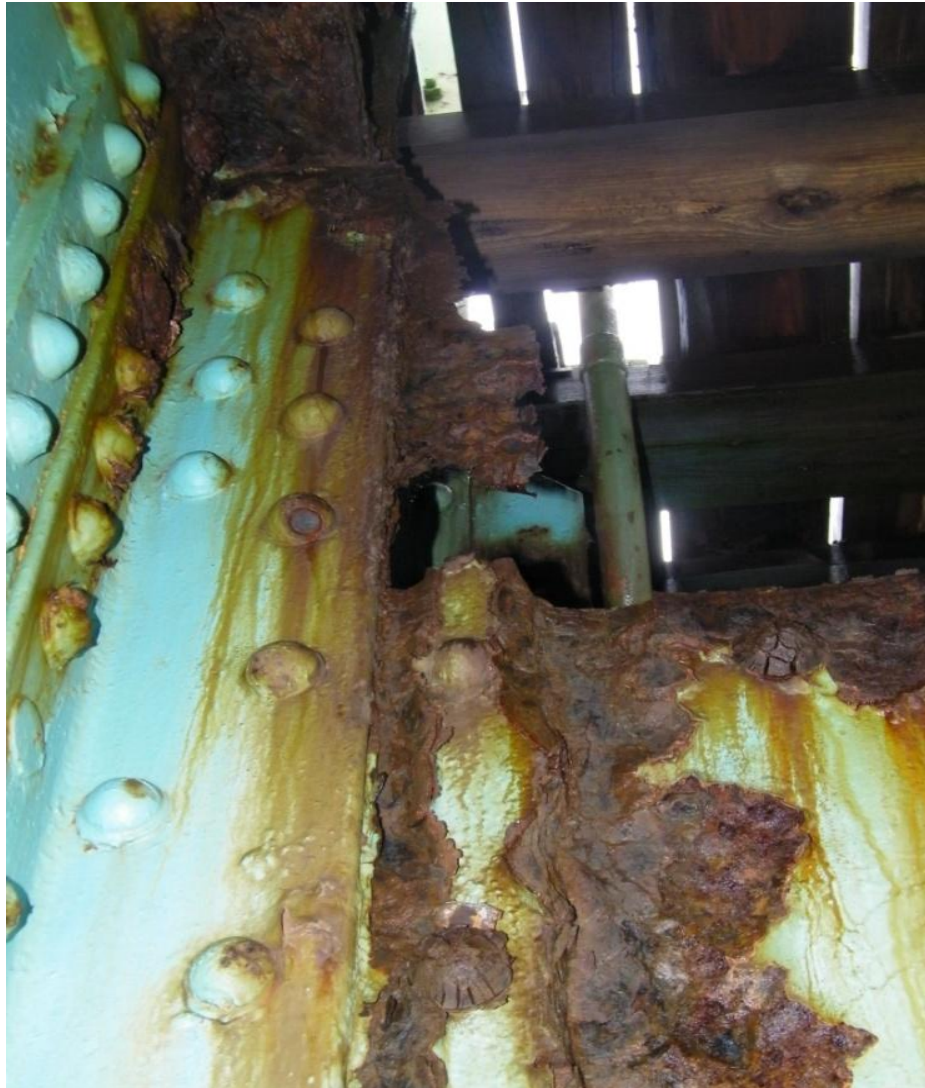
Span 3 Gusset Plate L9 East Interior face of bottom chord
with severe deterioration

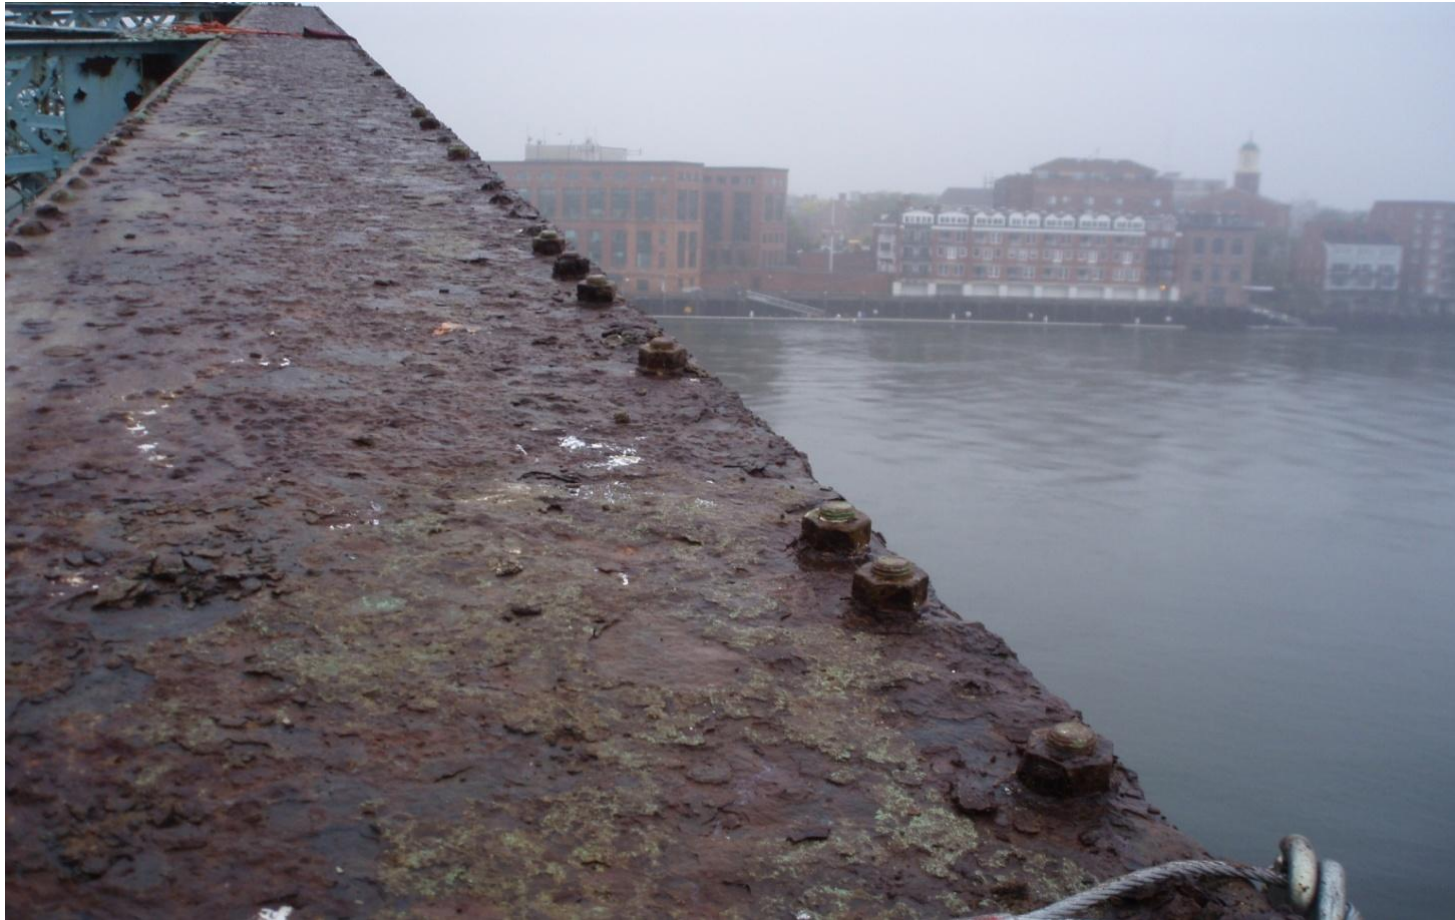
Top chord looking south from U2 looking towards Portsmouth. Rivets replaced by bolts in previous repair. Gaps between bolts suggest severely deteriorated rivet heads

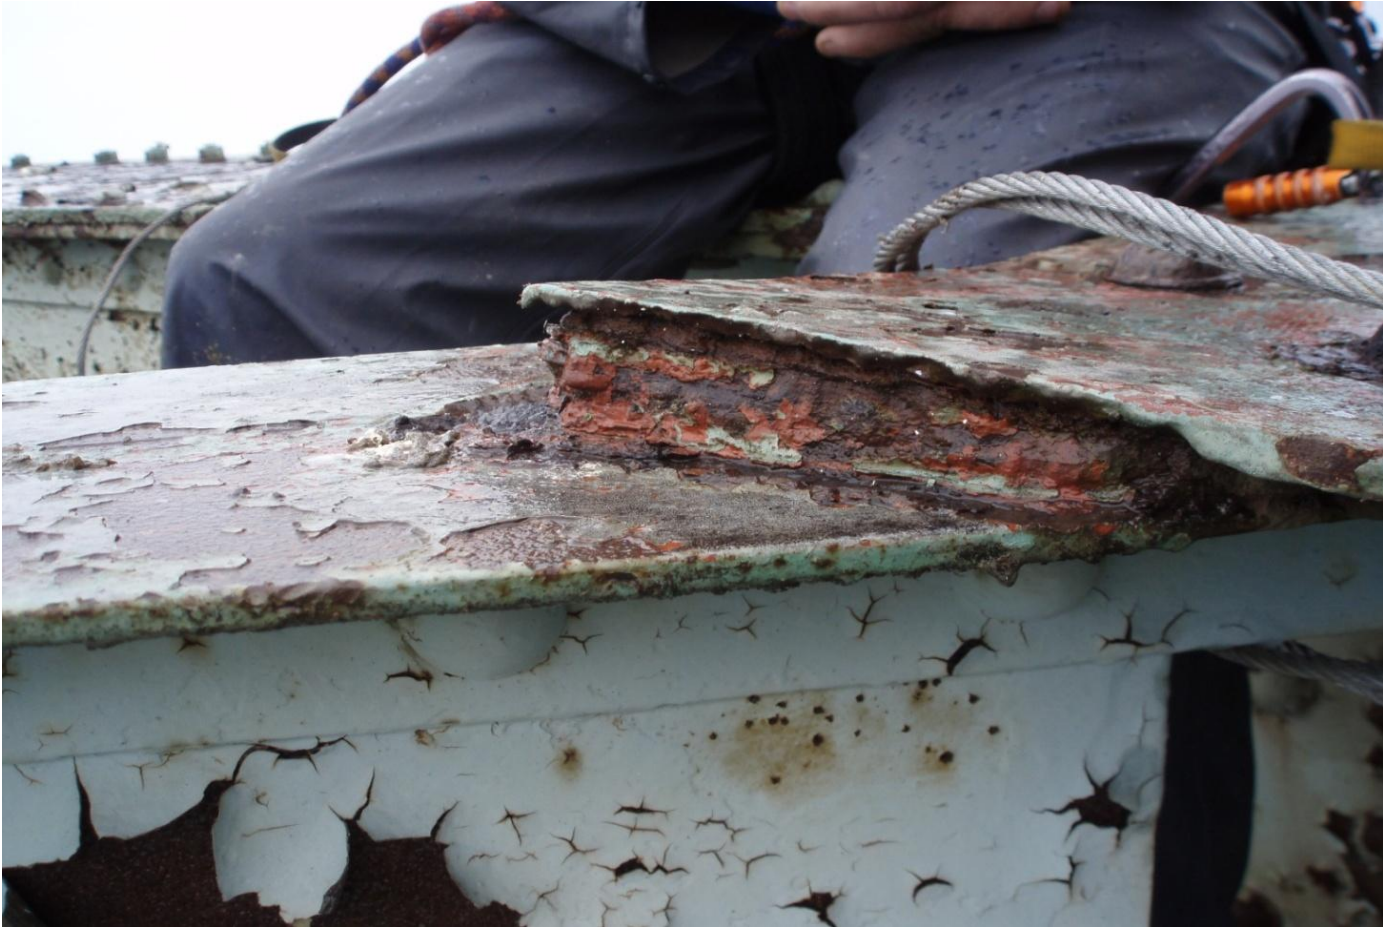
U1 Lateral bracing on top chord, typical example of 1" pack rust between gusset plate and framing members
