ROUTINE AND FRACTURE CRITICAL BRIDGE INSPECTION REPORT

**BRIDGE # 2019-ANDROSCOGGIN RIVER BRIDGE
NORTH MAIN STREET OVER ANDROSCOGGIN RIVER
PERU, OXFORD COUNTY
MAINE DOT REGION 3 (WESTERN)**

**Start Date of Inspection: 08/09/2012
Finish Date of Inspection: 08/14/2012**

**Prepared For
Maine Department of
Transportation
Bridge Maintenance Division**

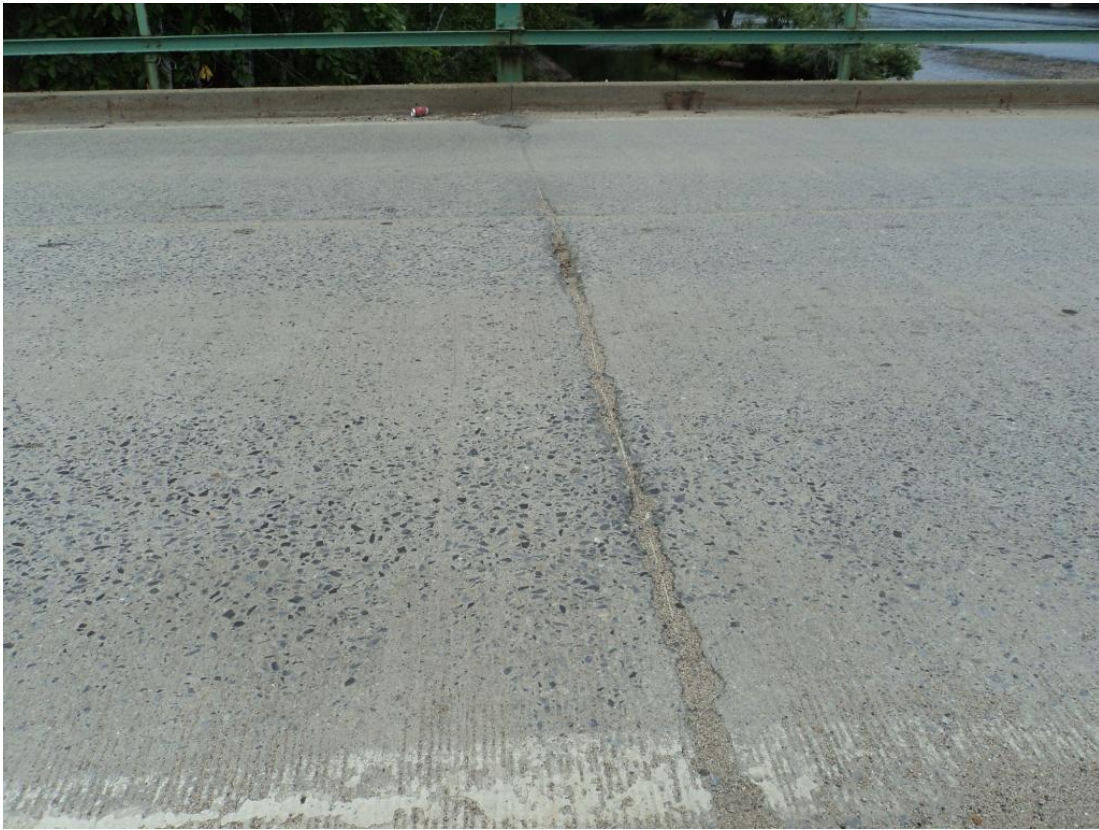
1. The transverse construction joint above FB7 in Span 3 has minor spalling of the edges of the joint for the full width of the northbound lane (Photo 5). Above FB4 in Span 3 the transverse construction joint has a one foot square spall patched with bituminous material along the west curb (Photo 6). Above FB1 in Span 3 the transverse construction joint has three small spalls patched with bituminous material (Photo 7).

Photo 5 – The transverse construction joint above FB7 in Span 3 has minor spalling of the edges of the joint for the full width of the northbound lane. Looking west.

Recommendation: Perform spall repairs to the monolithic concrete wearing surface at the three transverse construction joint locations in Span 3.

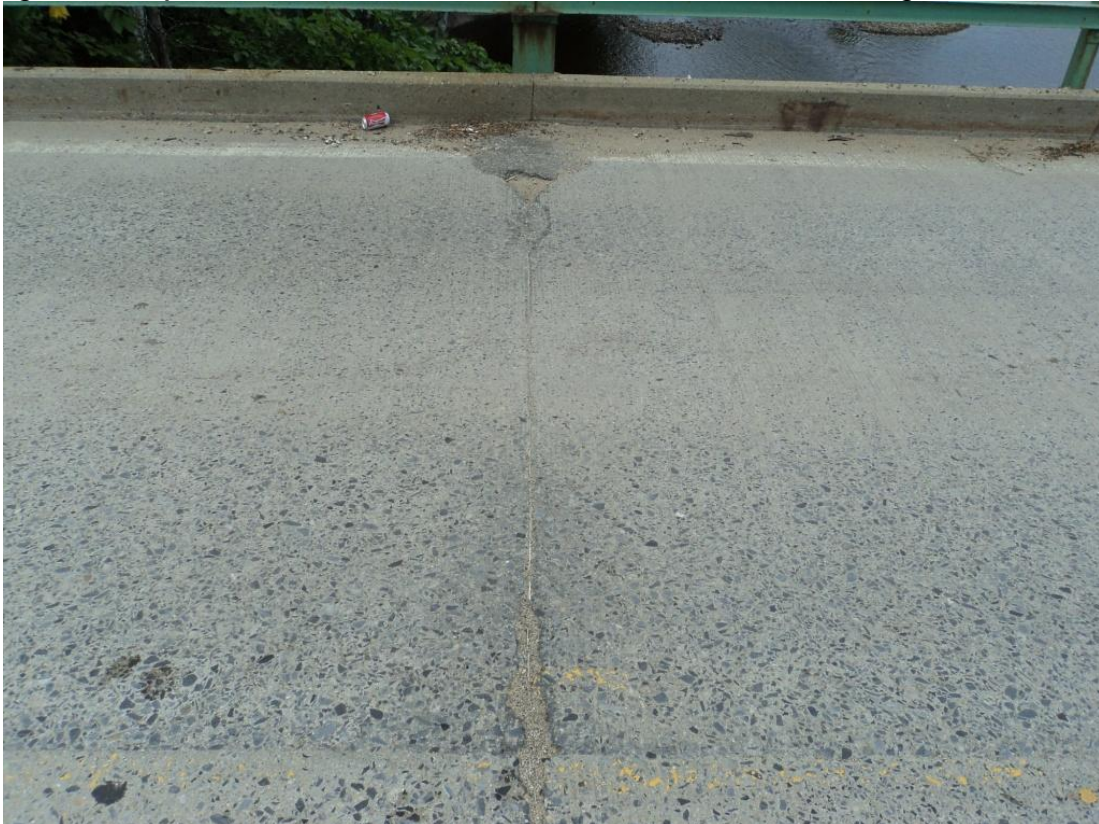
Photo 6 – Above FB4 in Span 3 the transverse construction joint has a one foot square spall patched with bituminous material along the west curb. Looking west.

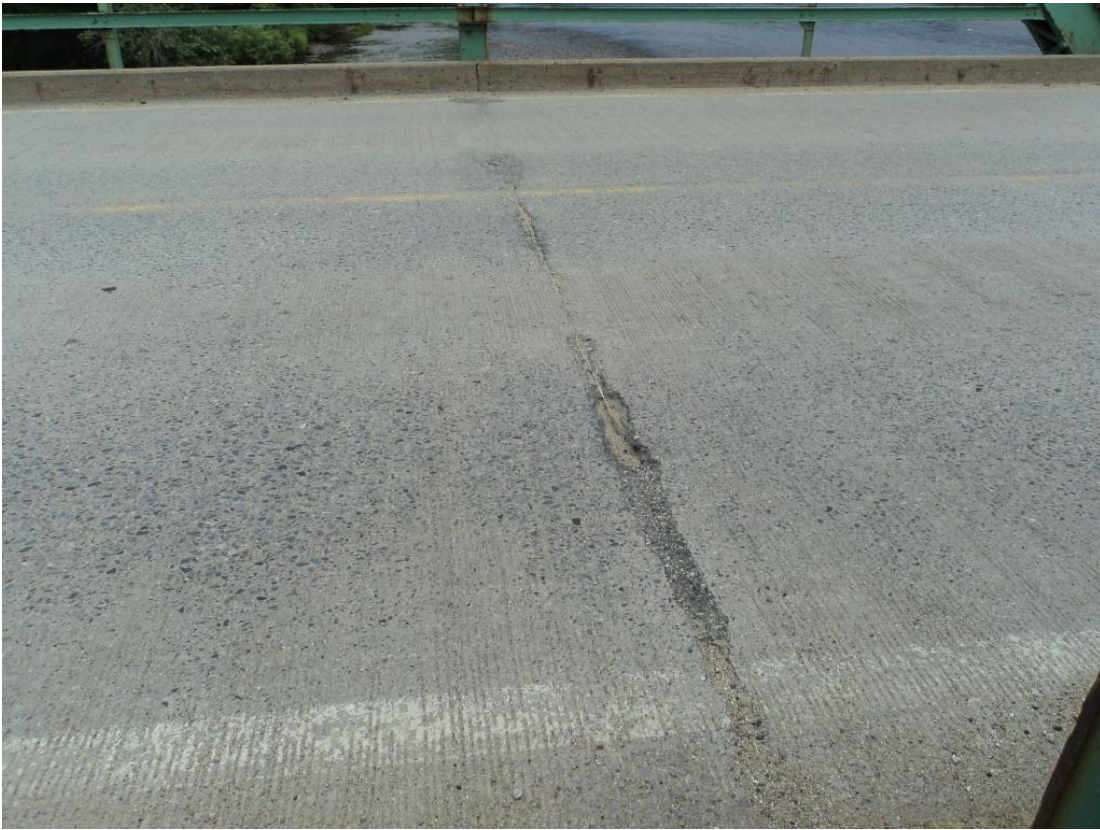
Photo 7 – Above FB1 in Span 3 the transverse construction joint has three small spalls patched with bituminous material.

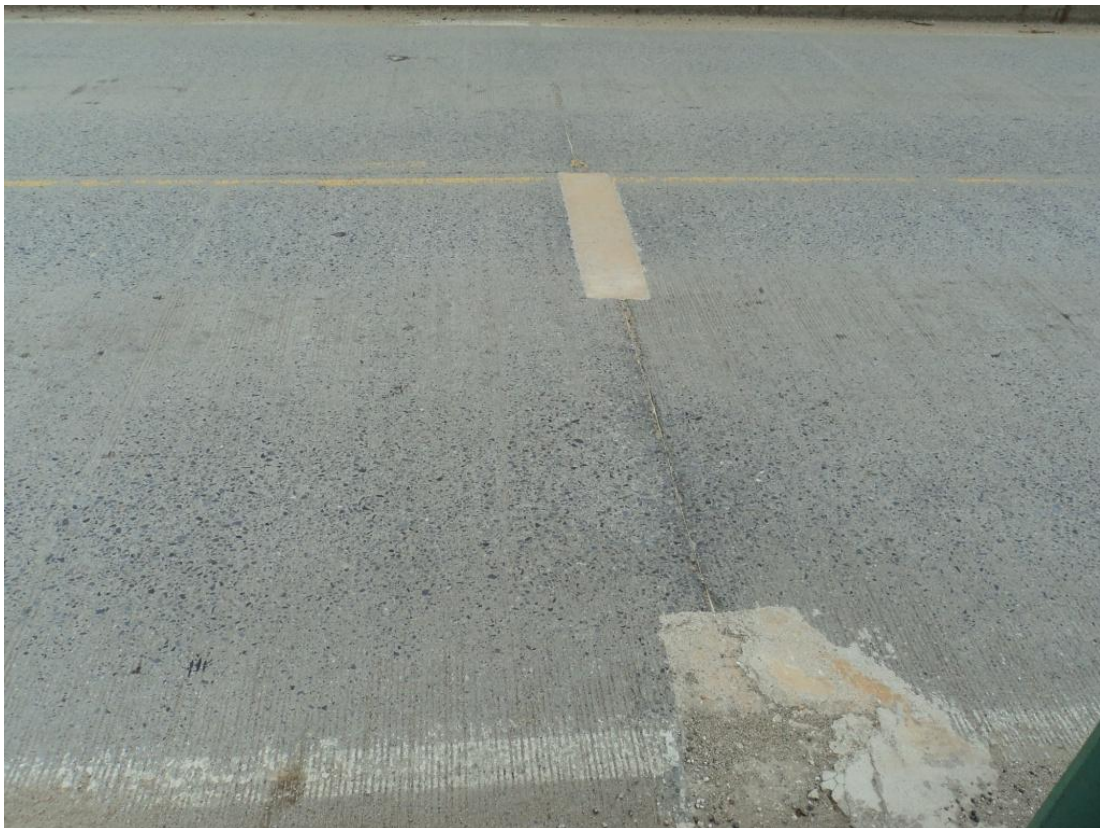
Photo 8 – Above FB7 in Span 2 the transverse construction joint has two spalls in the northbound lane measuring 1 to 2 SF in size, each patched with concrete.

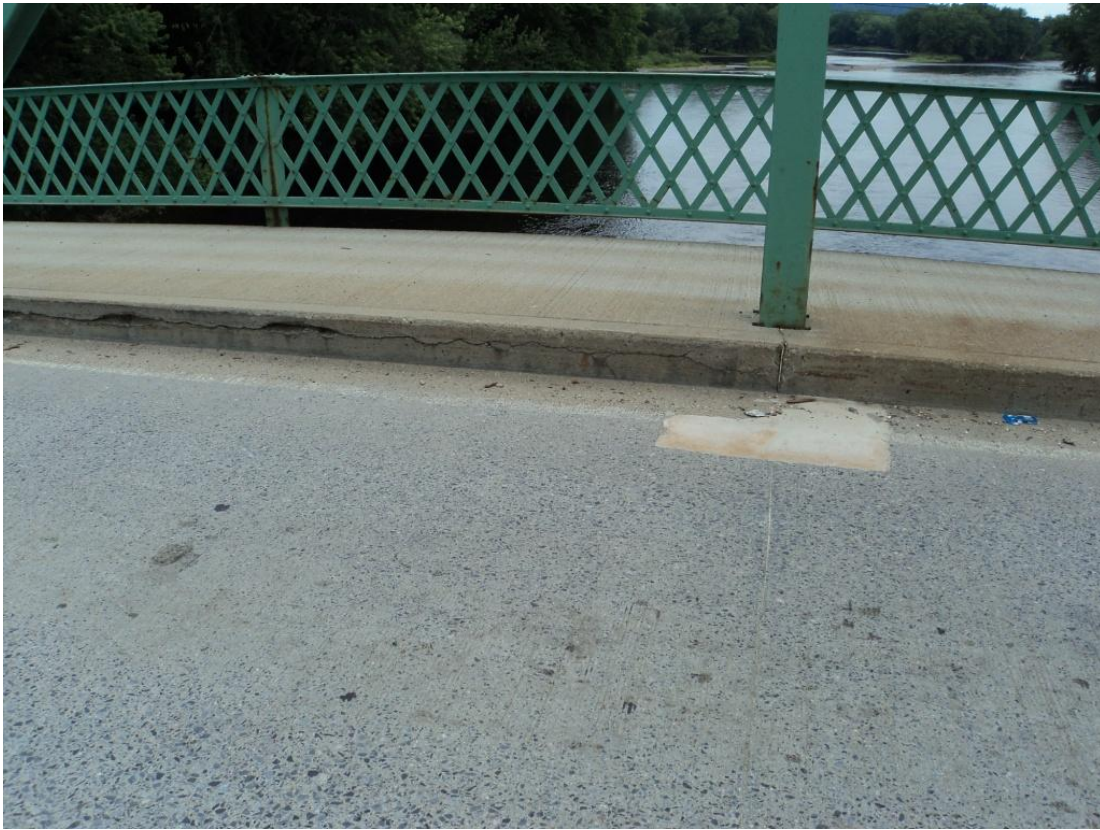
Photo 9 – Above FB7 in Span 1 the transverse construction joint has a 4 SF spall in the northbound lane along the east curb, patched with concrete. Looking east.

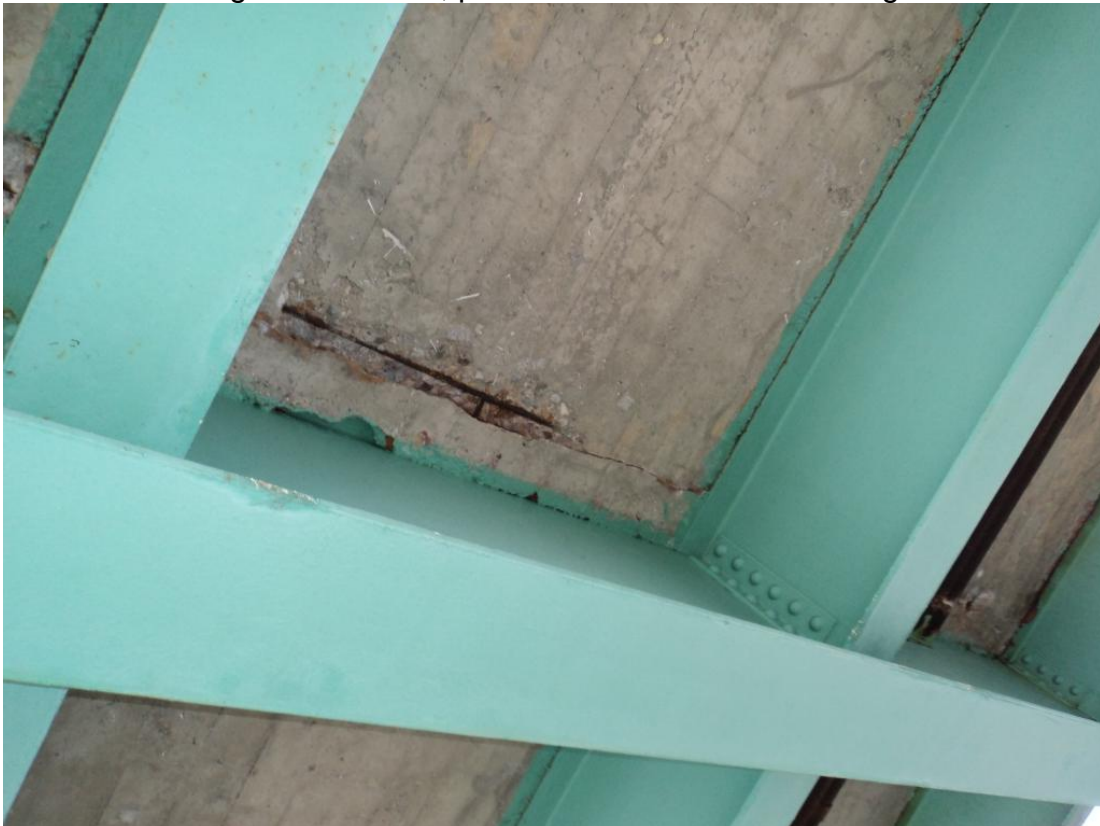
2. The underside of deck has numerous spalls with exposed reinforcing which are typically concentrated along the inboard edges of S3 and S6 (Photos 16 & 18). Additional spalls in all stringer bays are present along the floorbeam haunch zones, especially over the end floorbeams (Photos 10 & 19).

Photo 10 – Three minor spalls in the underside of deck were noted in the floorbeam haunch zones of FB6 in Span 1 in various stringer bays. View between S4 and S5.

Recommendation: Perform concrete spall repairs to the underside of deck to remove and replace unsound concrete.

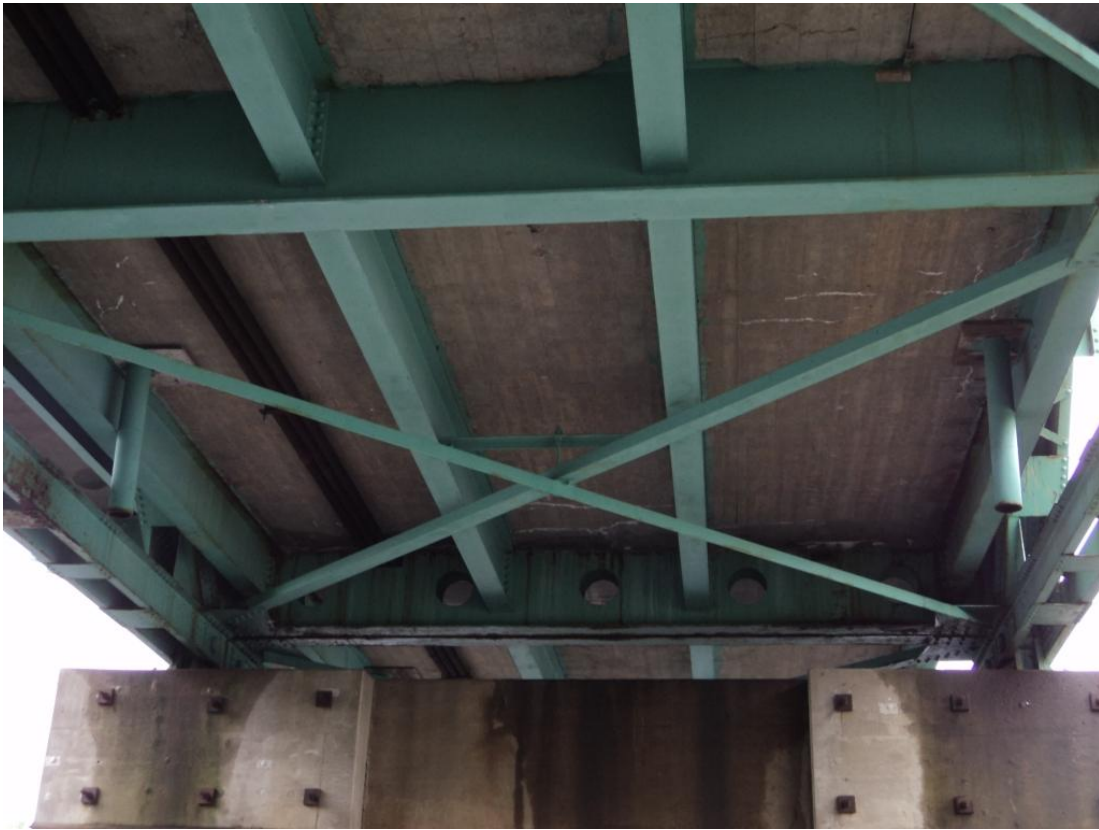
Photo 11 – Approximately ten transverse cracks with efflorescence in the underside of deck in Span 1 between FB7 and FB8, distributed in three different stringer bays.

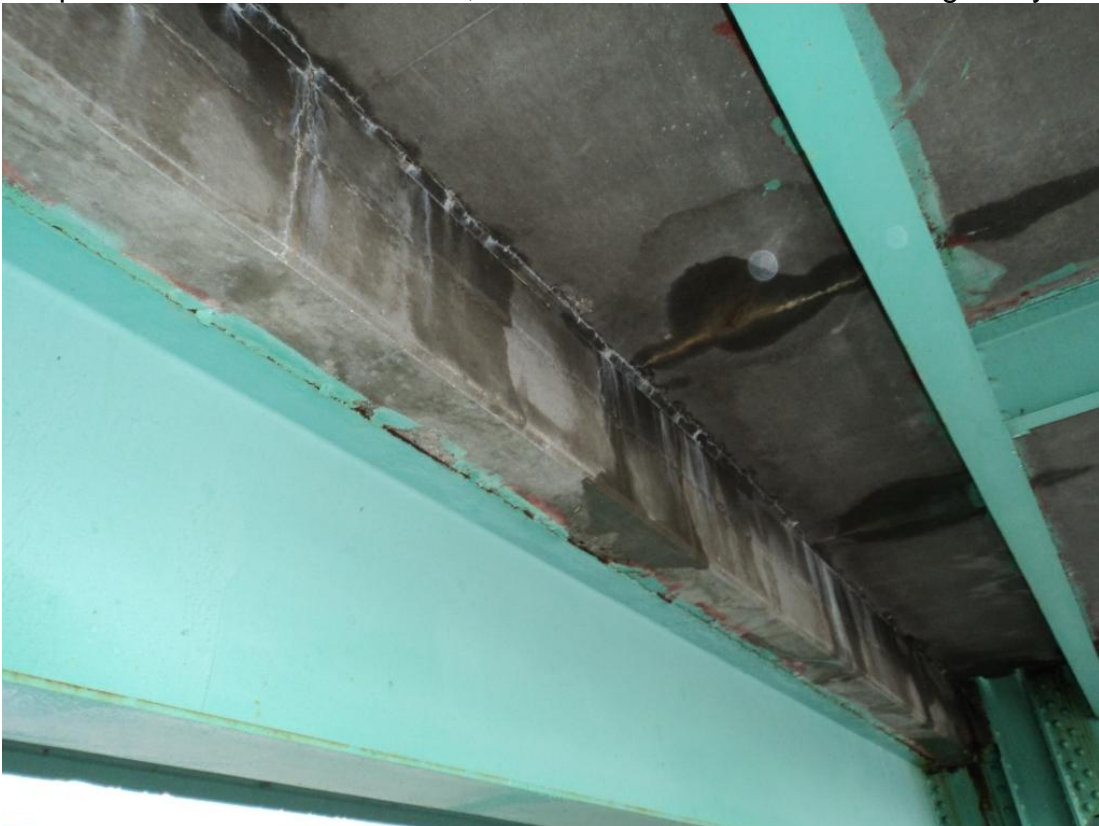
Photo 12 – In Span 2 between FB1 and FB2 two cracks with efflorescence in sidewalk slab and a longitudinal crack with efflor. along sidewalk horizontal construction joint .

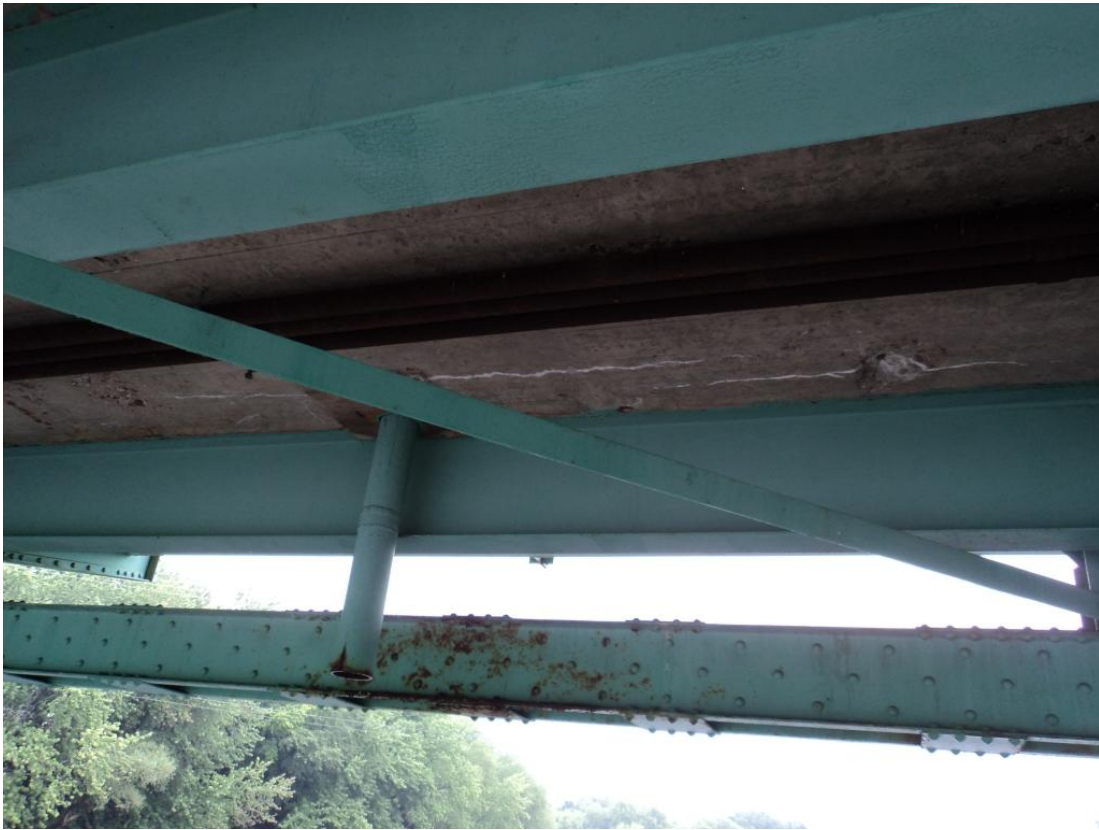
Photo 13 – In Span 2 between FB3 and FB4 a longitudinal crack with efflorescence was observed between S3 and S4 located just inboard of the east curbline. Looking east.

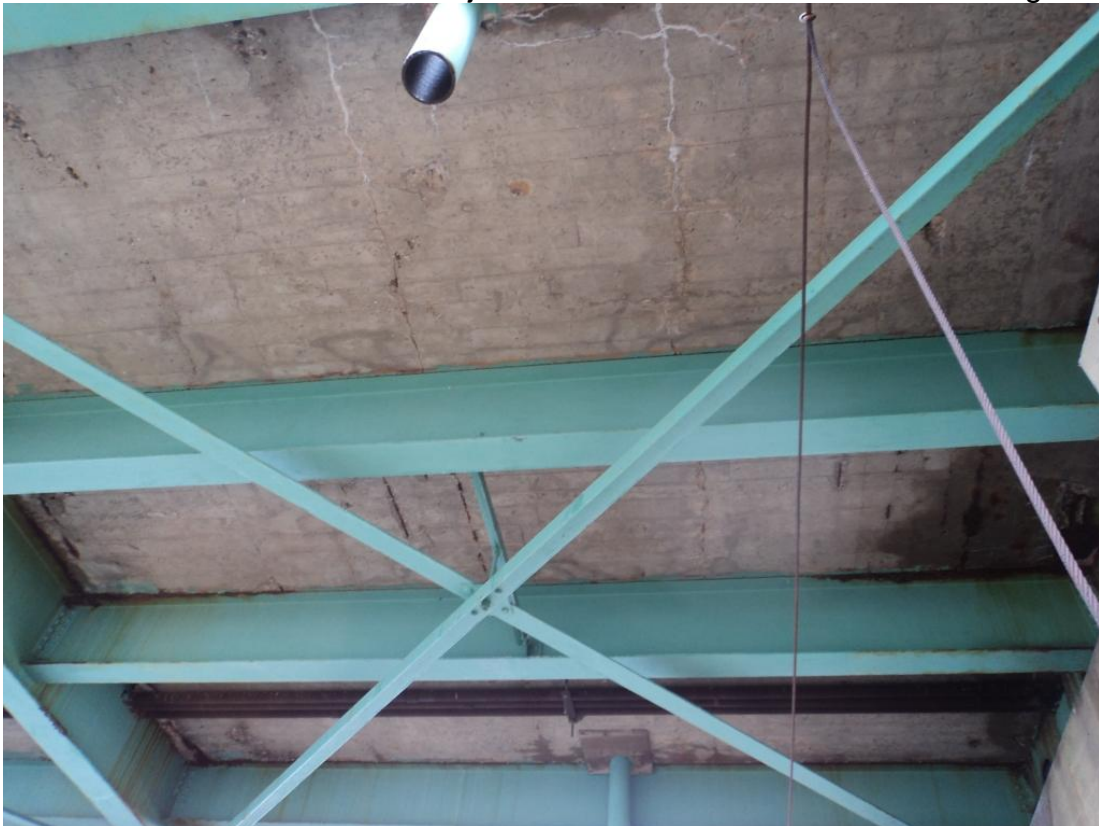
Photo 14 – In Span 2 between FB7 and FB8 four transverse cracks with efflorescence were noted between S5 and S6 in top portion of photo. Looking east.

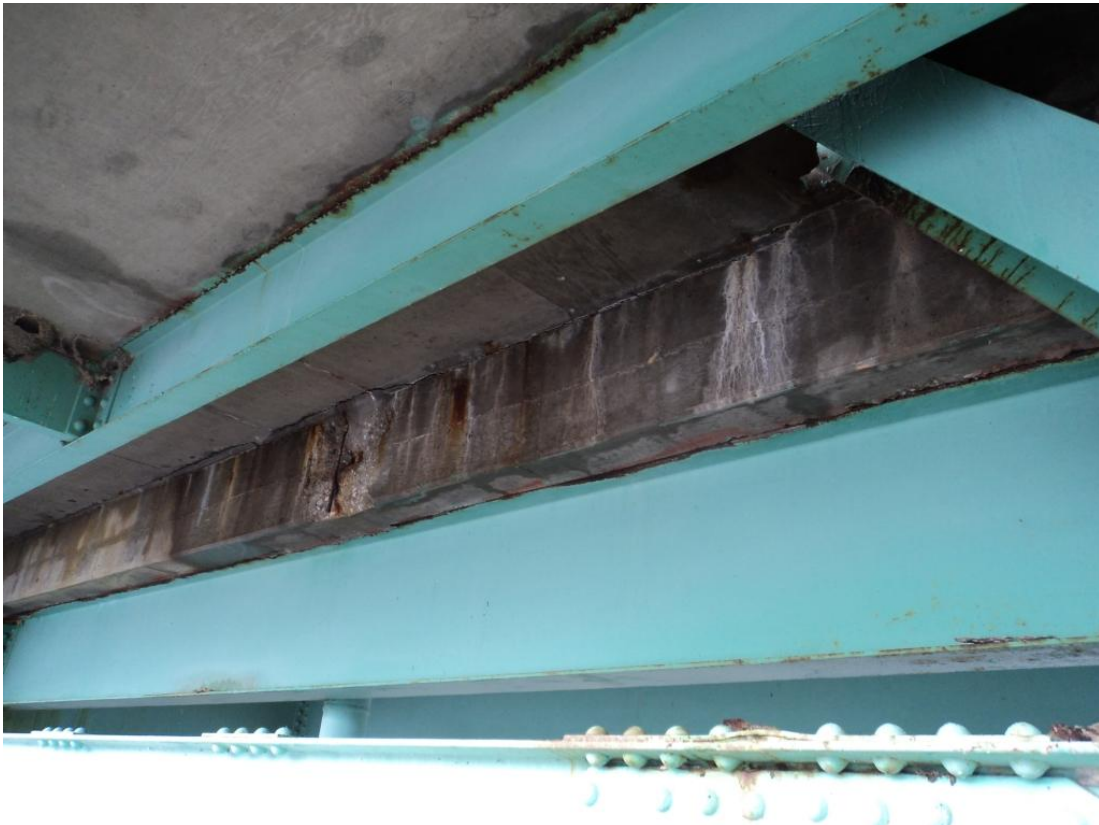
Photo 15 – A 2 foot square spall with exposed reinforcing in Span 2 between FB5 & FB6 along with efflorescence at sidewalk to deck slab construction joint. Looking southwest.

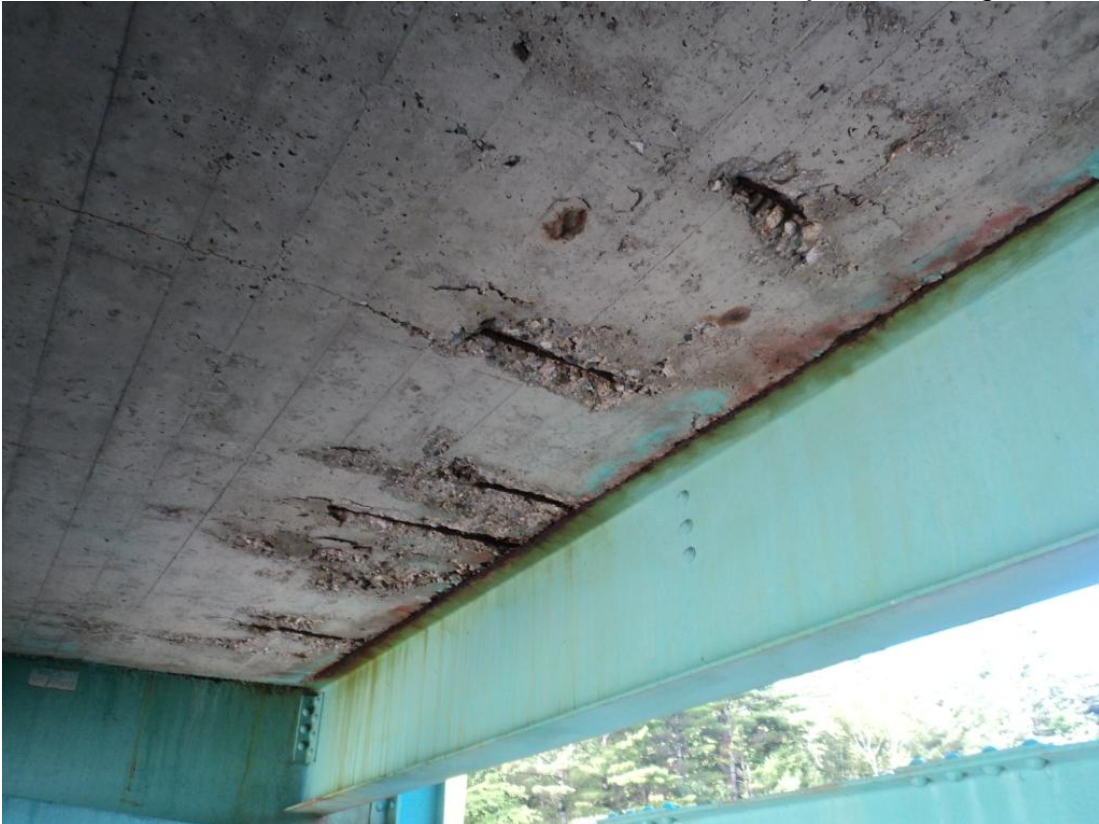
Photo 16 – In Span 3 between FB0 and FB1 five spalls with exposed reinforcing were noted between S5 and S6. View is looking south.

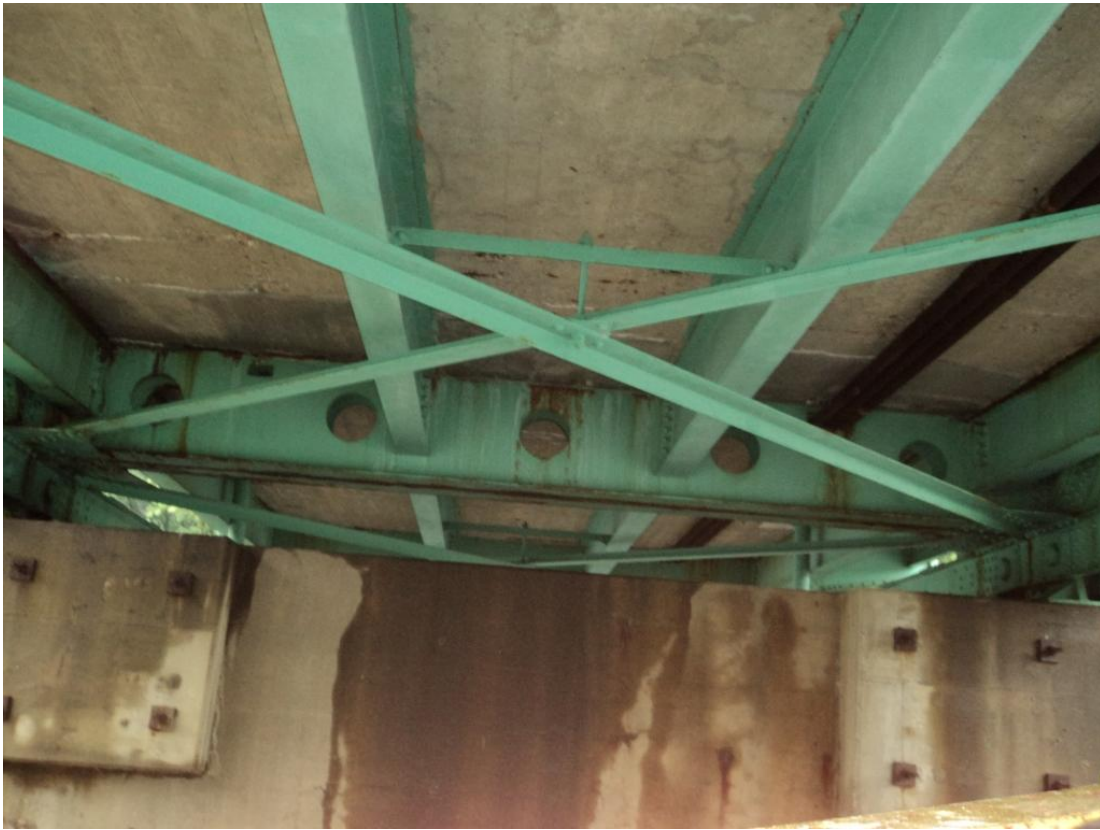
Photo 17 – Above FB0 in Span 2 all three stringer bays have been patched with repairs measuring 4 feet long by full width of the bay. Looking north at Pier 1.

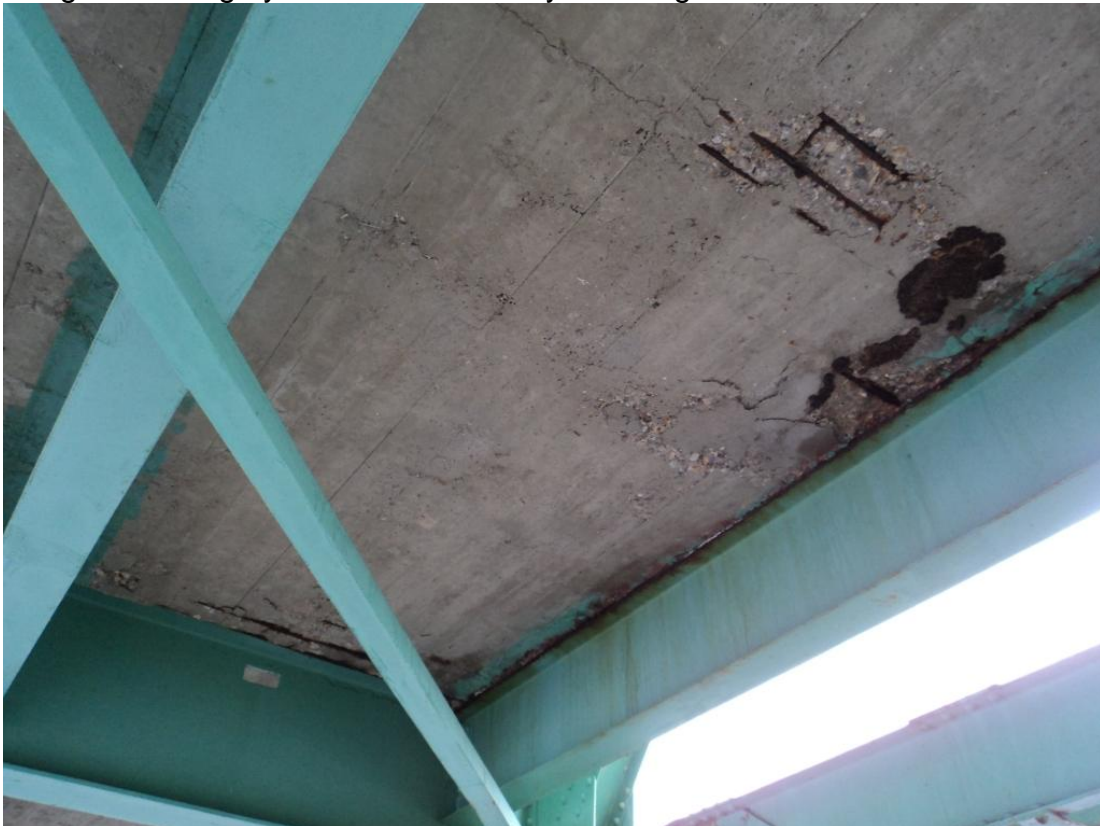
Photo 18 –In Span 2 between S5 and S6 two spalls with exposed reinforcing measuring approximately 2 feet square each, near mid-panel and at FB3. View is looking south.

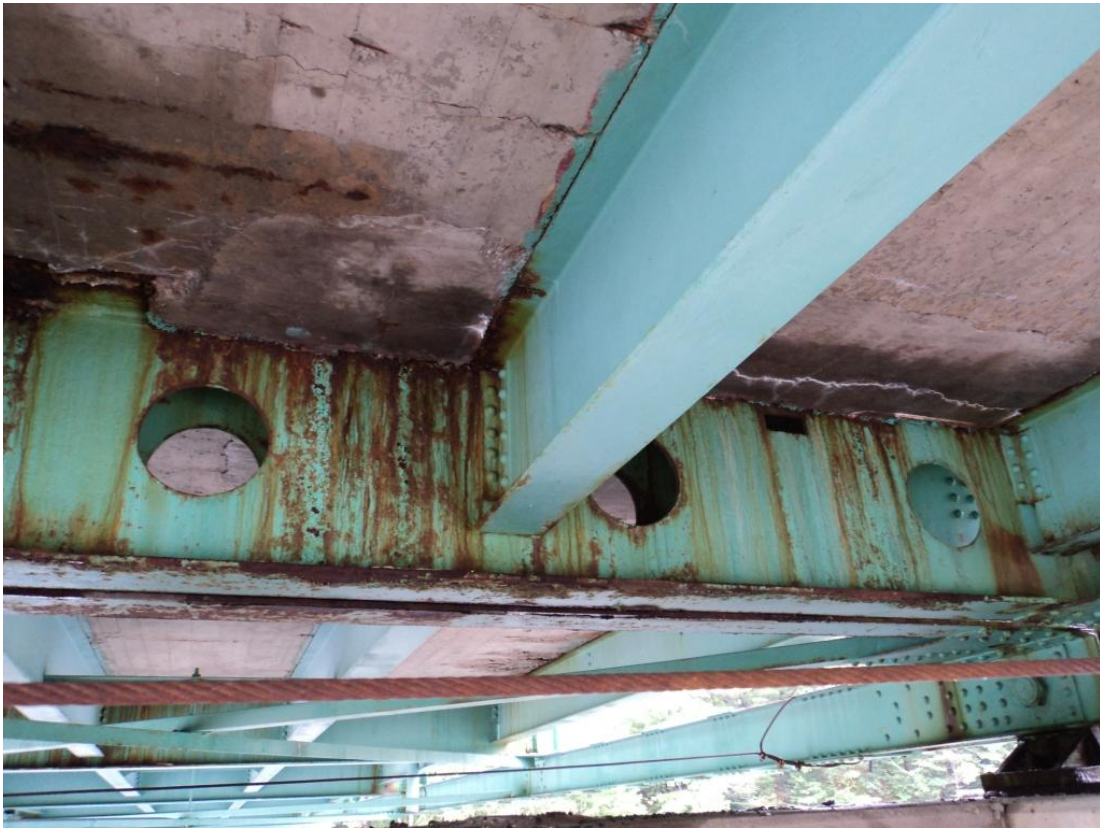
Photo 19 – Above FB8 in Span 2 a 1 foot by 2 foot spall was observed in the floorbeam haunch zone between S4 and S5 at top left. Also note concrete patches in both bays.

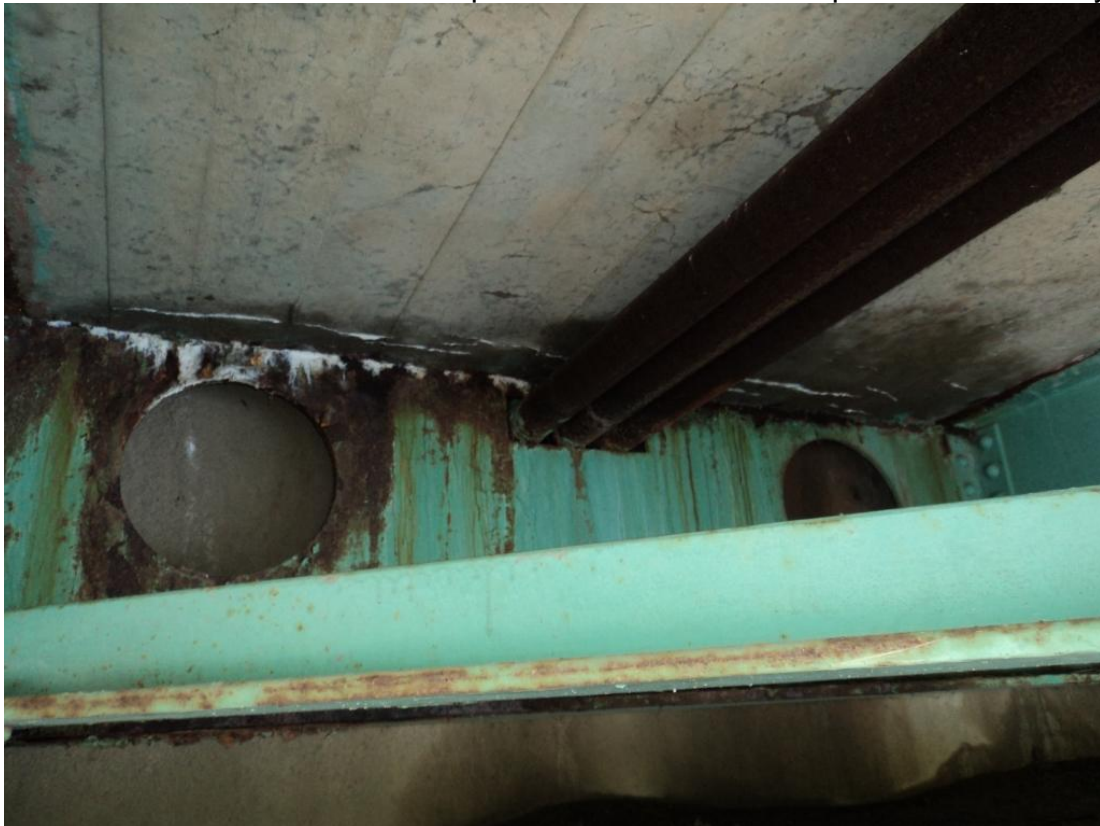
3. There is no deck joint at the south abutment and the end of the bridge deck has been removed and replaced with bituminous pavement. The bituminous pavement patch is deteriorated and settled in large areas with extensive successive patches placed, resulting in a rough riding surface over the 6-8 foot length approaching the end of the concrete bridge deck (Photo 26). Transverse cracks with heavy efflorescence were observed in the underside of deck above FB8 in Span 3 in all bays between S3 and S6 (Photo 20).

Photo 20 – Transverse cracks with heavy efflorescence were observed above FB8 in Span 3 in all bays between S3 and S6. Looking south at south abutment.

Recommendation: Perform full depth deck replacement over a five foot length of the deck at the south abutment. Reconstruct the bituminous approach pavement over a length of 10 feet at the south end of the bridge by removing and replacing the pavement full-depth to restore a smooth transition onto the bridge deck.

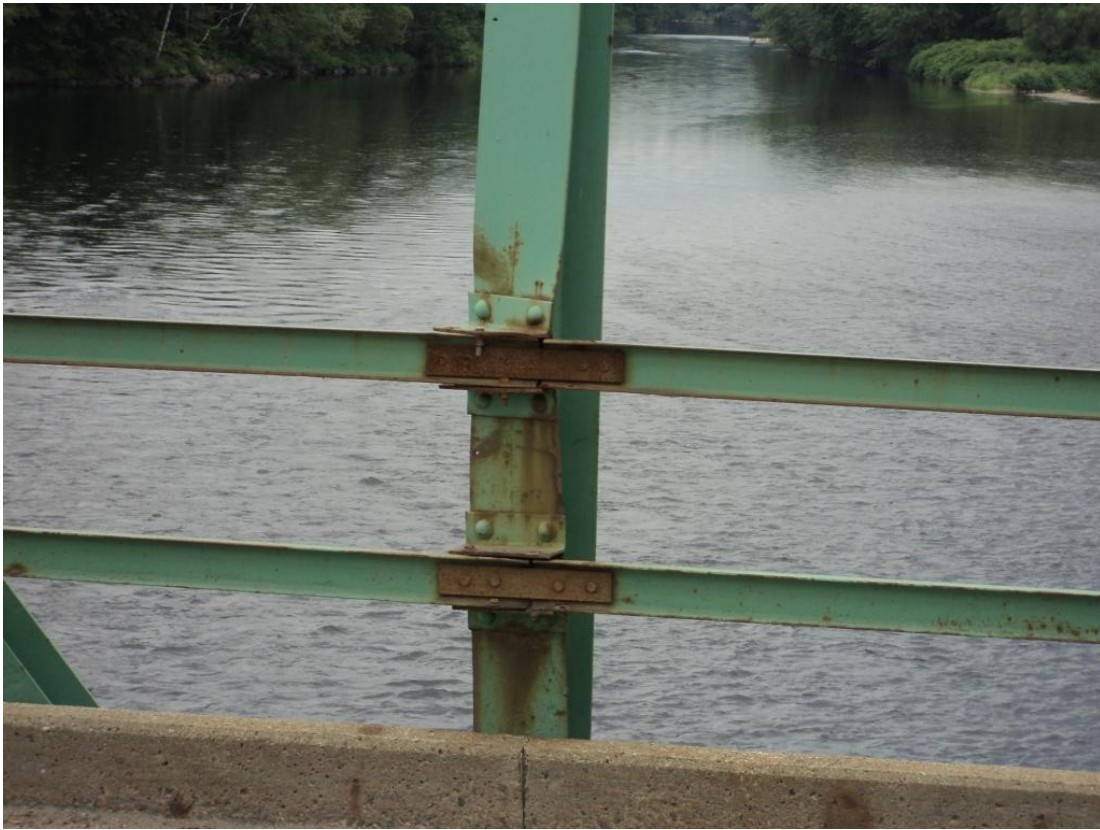
Photo 21 – West traffic railing in Span 1 at L5 has a splice in both rails to repair previous impact damage. Note truss vertical is rotated from collision damage. Looking west.

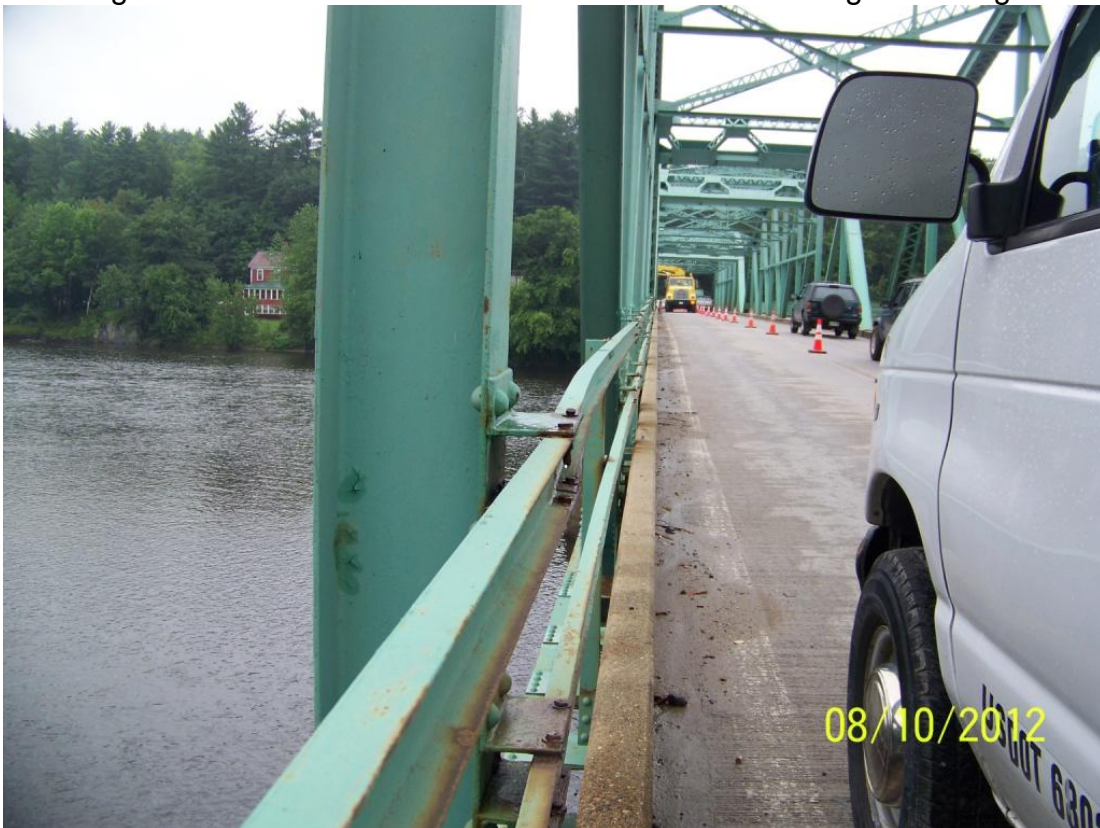
Photo 22 – Impact damage to the west traffic railing was observed in Span 3 at L5. Looking north in southbound lane.

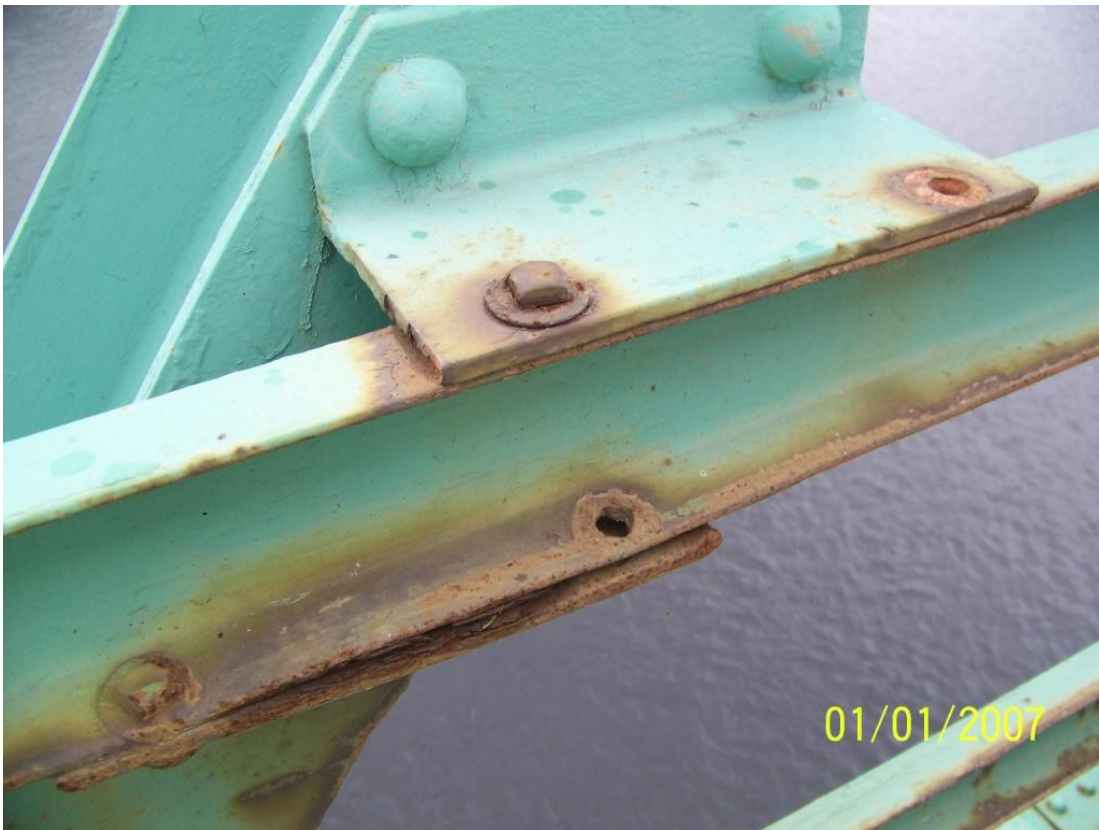
Photo 23 – A few missing bolts were observed at the connections of the railings to the attachment angles at verticals or diagonals. View is at Span 3 U3-L4.

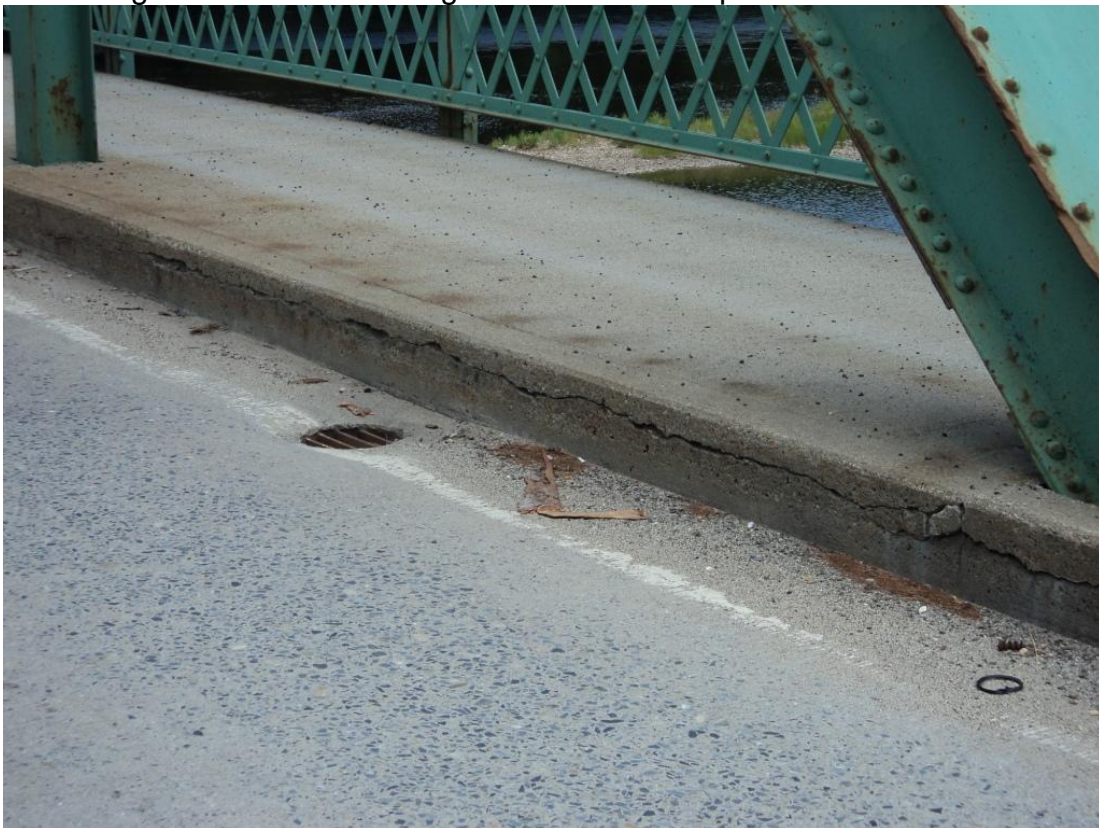
5. The east sidewalk curb face has a wide horizontal crack at the south end of Span 3 which extends along mid-height of the curb for nearly half of the length of the span (Photo 24). The east sidewalk curb face in Span 2 has a long spall with exposed reinforcing extending from L4 to L6 (Photo 25). The east sidewalk curb face has a wide horizontal crack in Span 2 which extends the full length of the panel between L6 and L7 along mid-height of the curb (Photo 9). The west curb has a 2 foot long severe spall with exposed reinforcing next to the south abutment. There are small spalls with exposed reinforcing in the west curb at both sides of the Pier 2 deck joint. There are small spalls with exposed reinforcing in both curb at both sides of the Pier 1 deck joint.

Photo 24 – East sidewalk curb face has a wide horizontal crack at south end of Span 3 which extends along mid-height of curb for nearly half of the length of the span.

Recommendation: Perform spall repairs to the east curb at the south end of Span 3, in Span 2 between L4 to L7. Perform spall repair to the west curb at the south abutment and to both curbs within 3 feet either side of the Pier 1 and 2 deck joints.

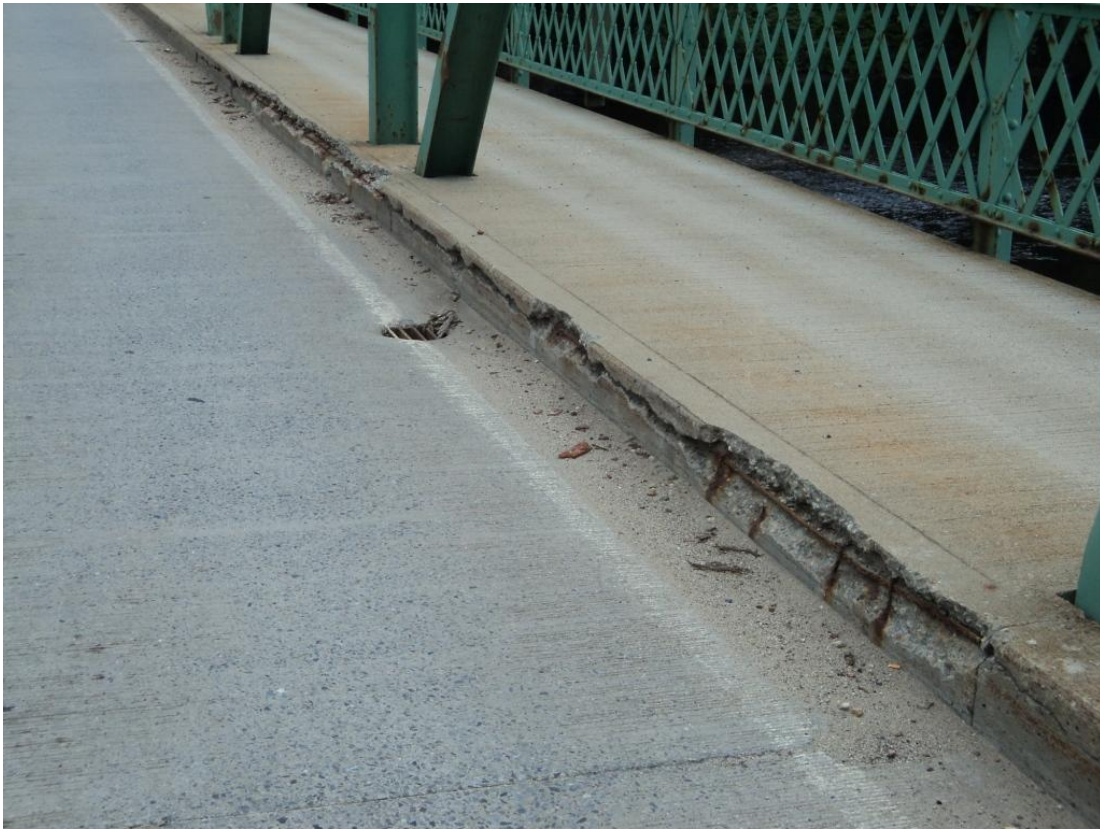
Photo 25 – The east sidewalk curb face in Span 2 has a long spall with exposed reinforcing extending from L4 to L6. Looking northeast.

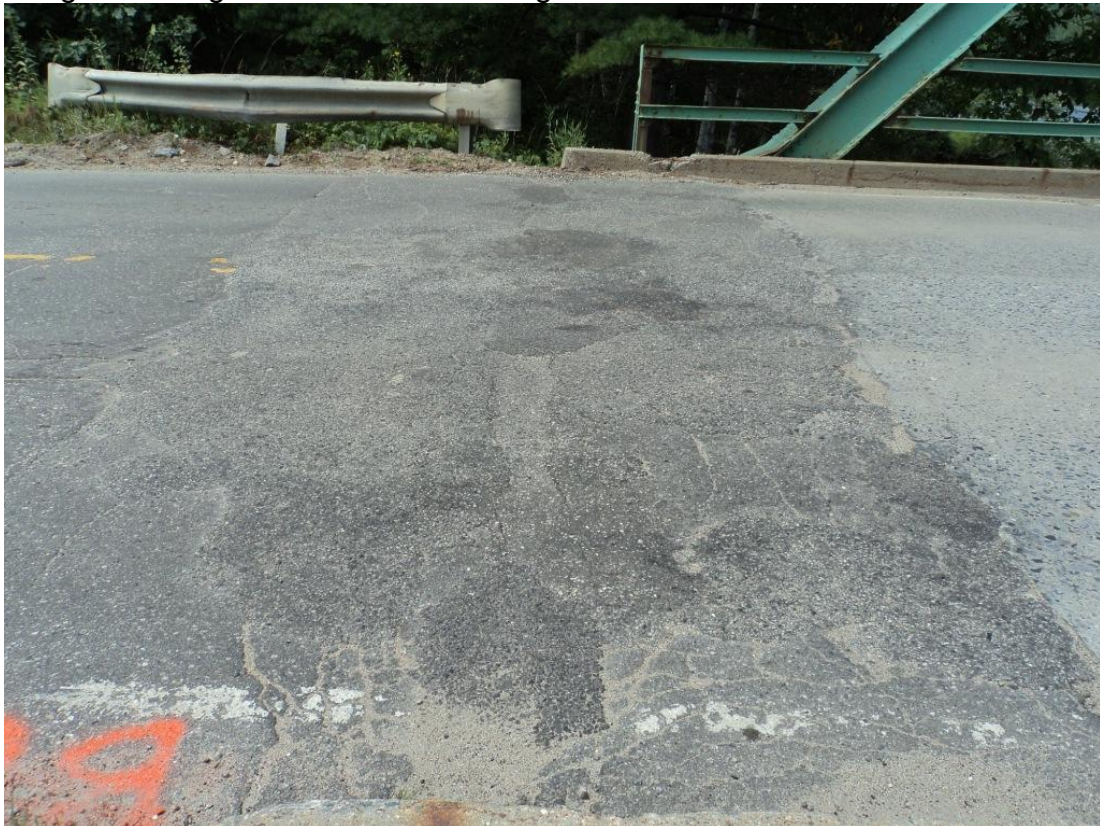
Photo 26 – South abutment bituminous pavement patch is deteriorated with extensive successive patches, resulting in a rough riding surface at the concrete bridge deck.

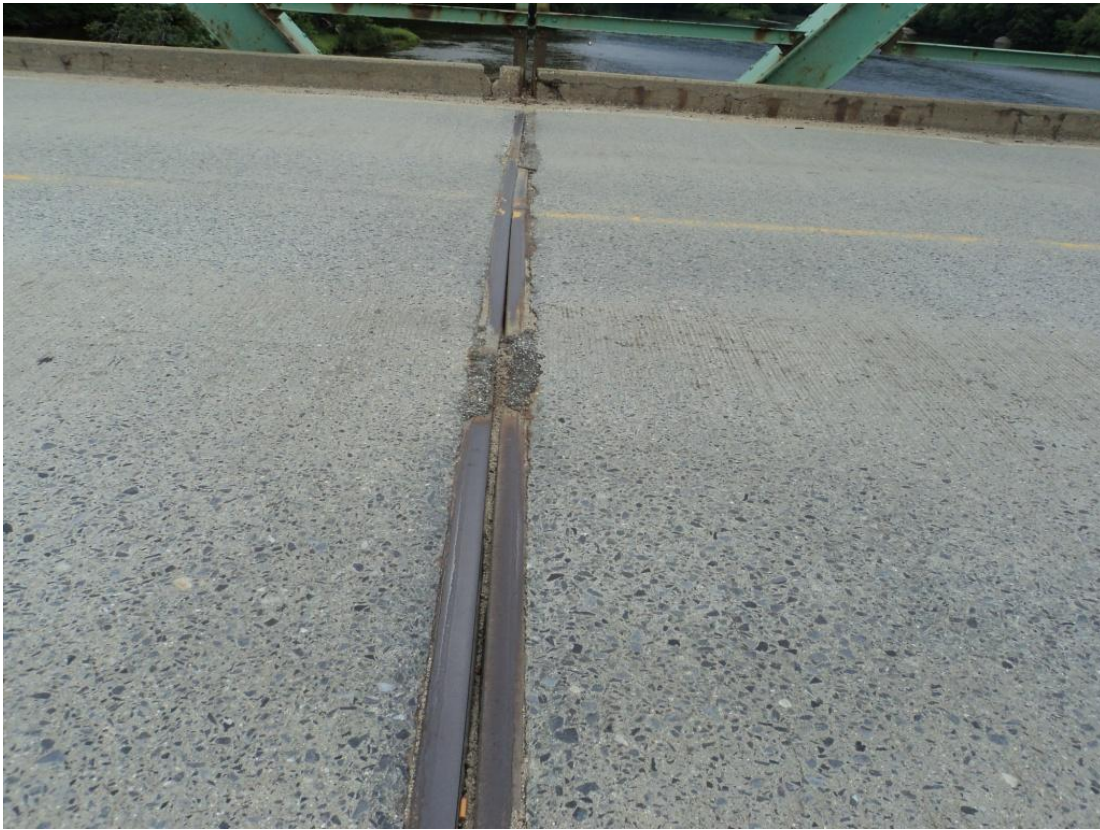
Photo 27 – Pier 2 deck joint has minor spalling with bituminous patches and the joint opening varies along the length of the joint from $\frac{3}{4}$ inches to zero at roadway centerline.
