ROUTINE AND FRACTURE CRITICAL BRIDGE INSPECTION REPORT

**BRIDGE # 2019-ANDROSCOGGIN RIVER BRIDGE
NORTH MAIN STREET OVER ANDROSCOGGIN RIVER
PERU, OXFORD COUNTY
MAINE DOT REGION 3 (WESTERN)**

**Start Date of Inspection: 08/09/2012
Finish Date of Inspection: 08/14/2012**

**Prepared For
Maine Department of
Transportation
Bridge Maintenance Division**

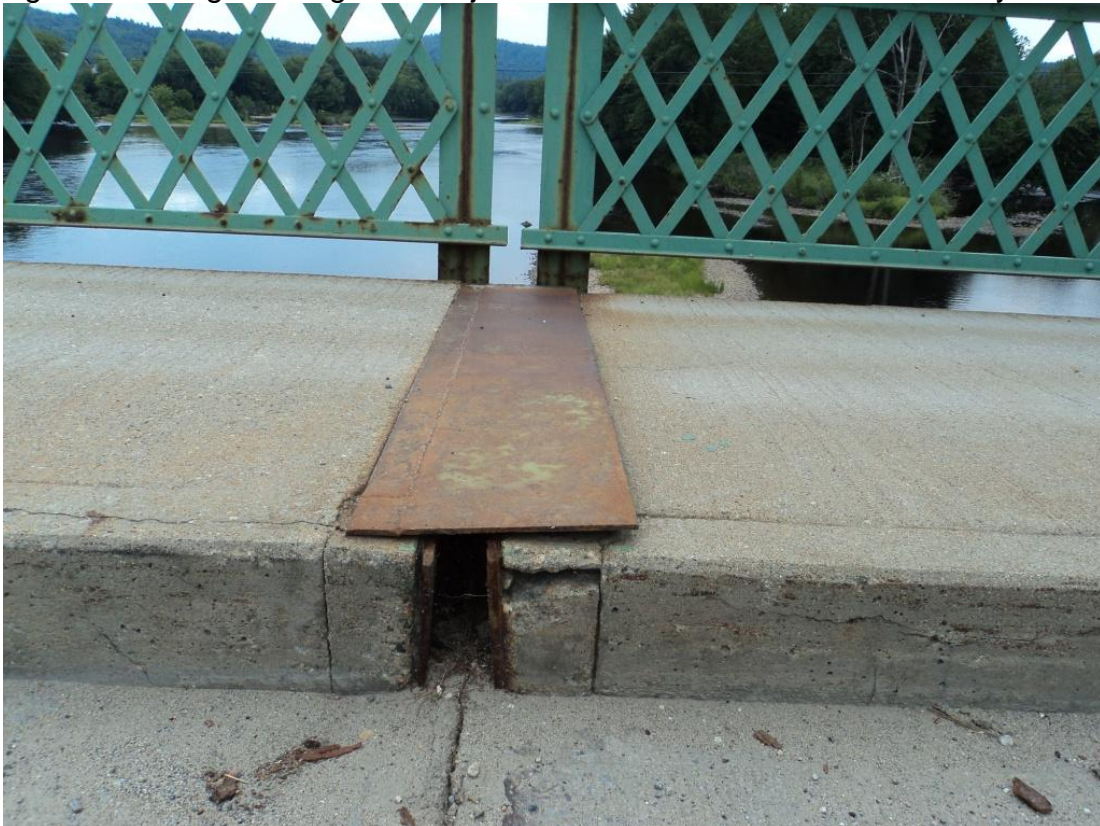
6. The sidewalk sliding plate joint at Pier 2 projects upward $\frac{3}{4}$ to one inch at the plate corner, creating a tripping hazard (Photo 28). A similar condition was observed at the Pier 1 sidewalk sliding plate joint.

Photo 28 – The sidewalk sliding plate joint at Pier 2 projects upward $\frac{3}{4}$ to one inch at plate corner, creating a tripping hazard. Similar condition was observed at Pier 1 joint.

Recommendation: Replace the sidewalk sliding plate joints at Pier 1 and 2.

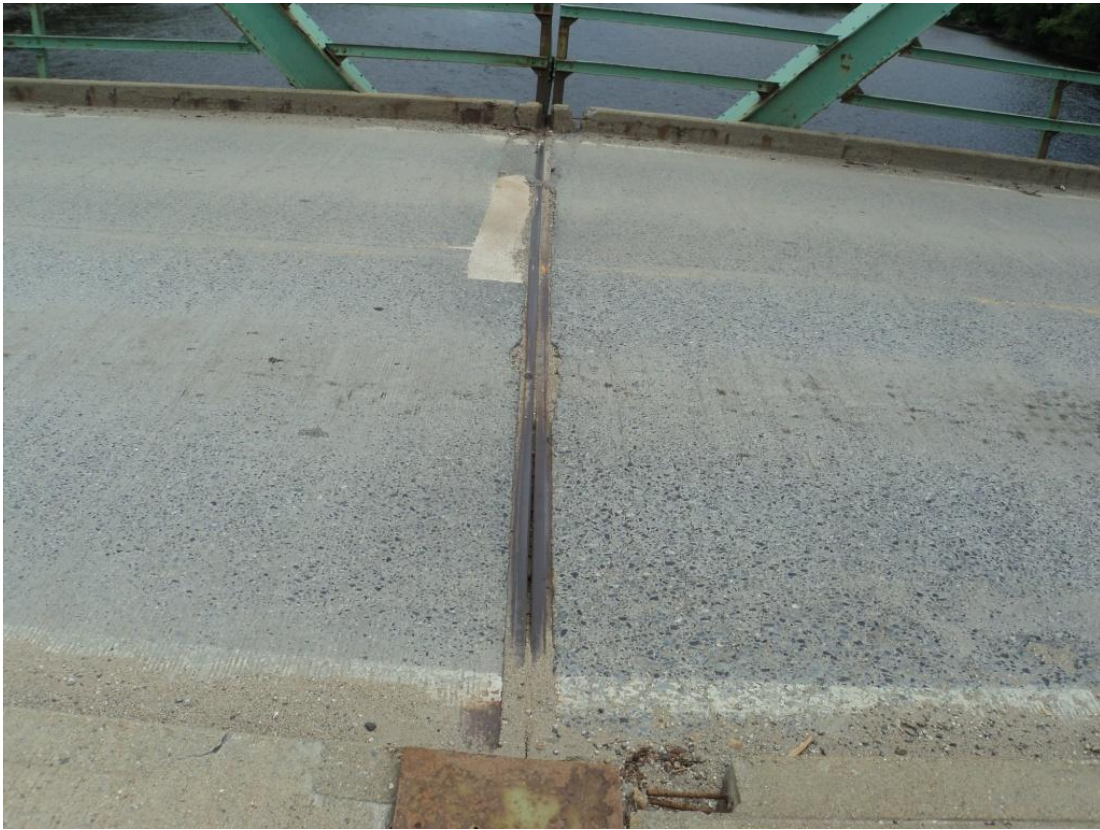
Photo 29 – The deck joint at Pier 1 has minor spalling in the near northbound lane and a one foot by 6 foot spall patched with concrete in the far southbound lane.

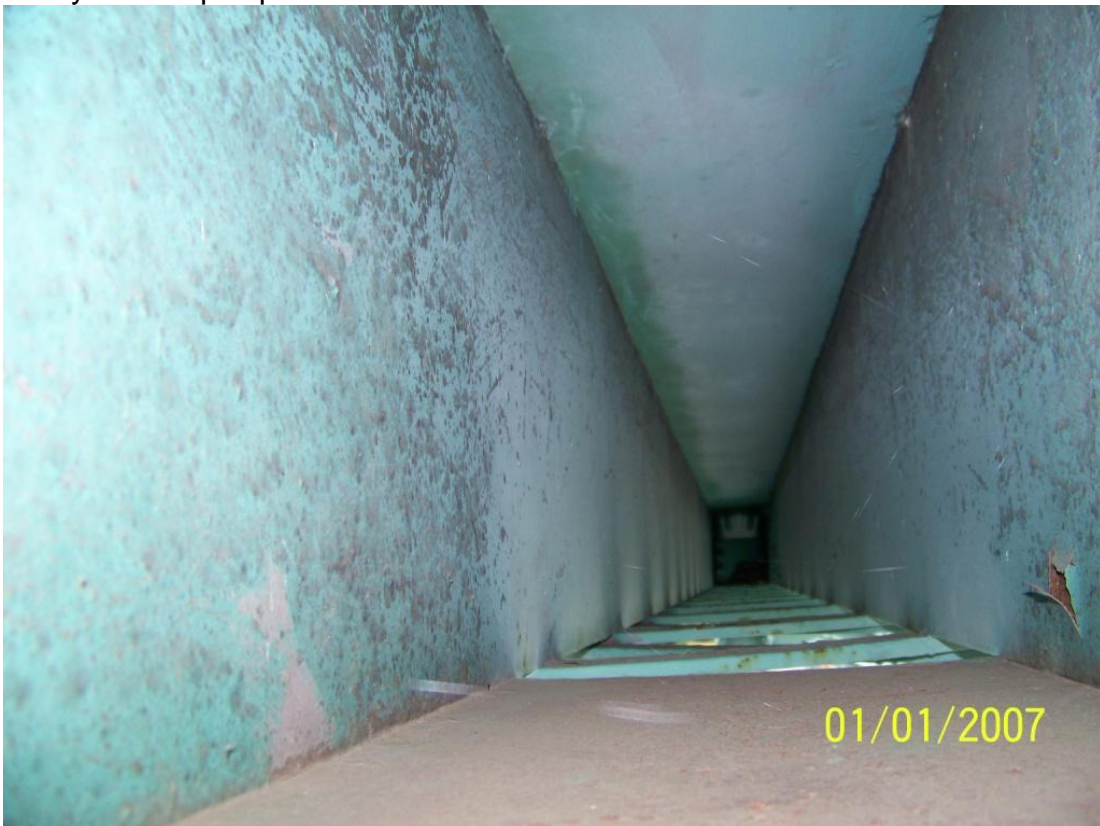
Photo 30 – Paint system is generally intact with minimal failures throughout exterior and interior surfaces of upper chords. View inside Span 3 sidewalk truss U3-U4.

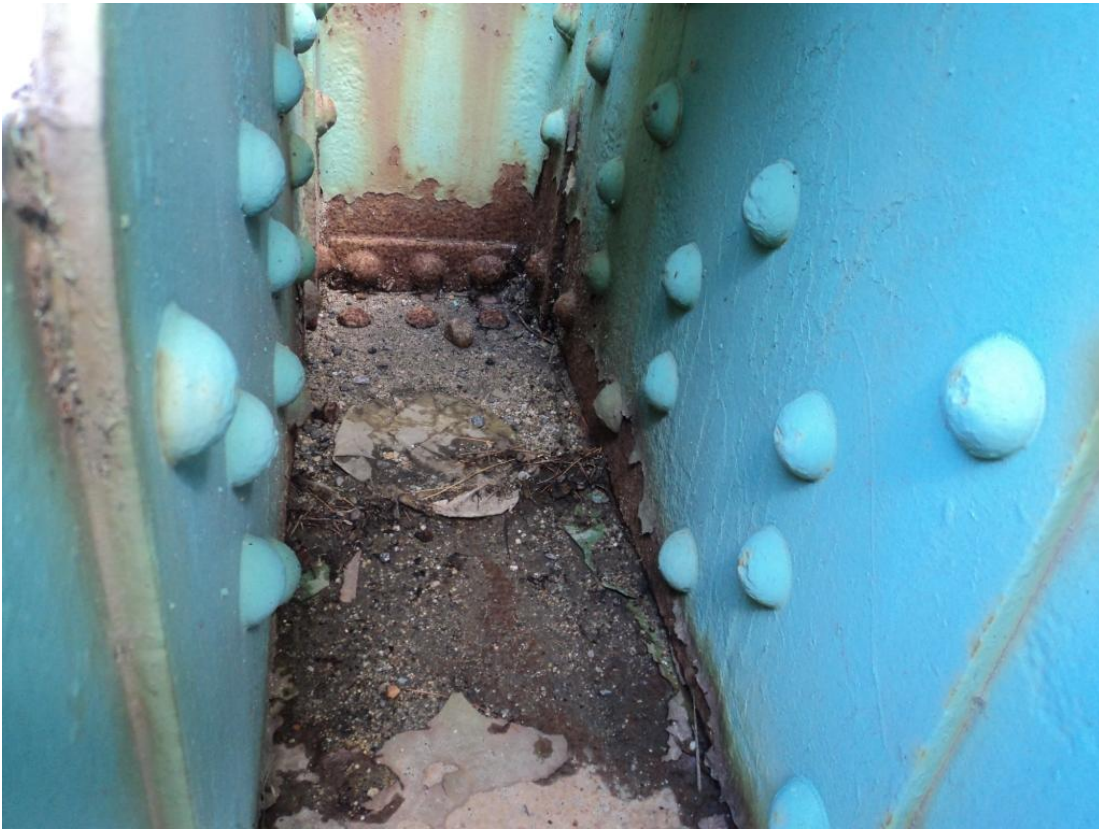
Photo 33 – Active corrosion was observed in lower chord bottom interior surfaces along with lower portions of vertical and gusset plates at sidewalk truss L6 in Span 3.

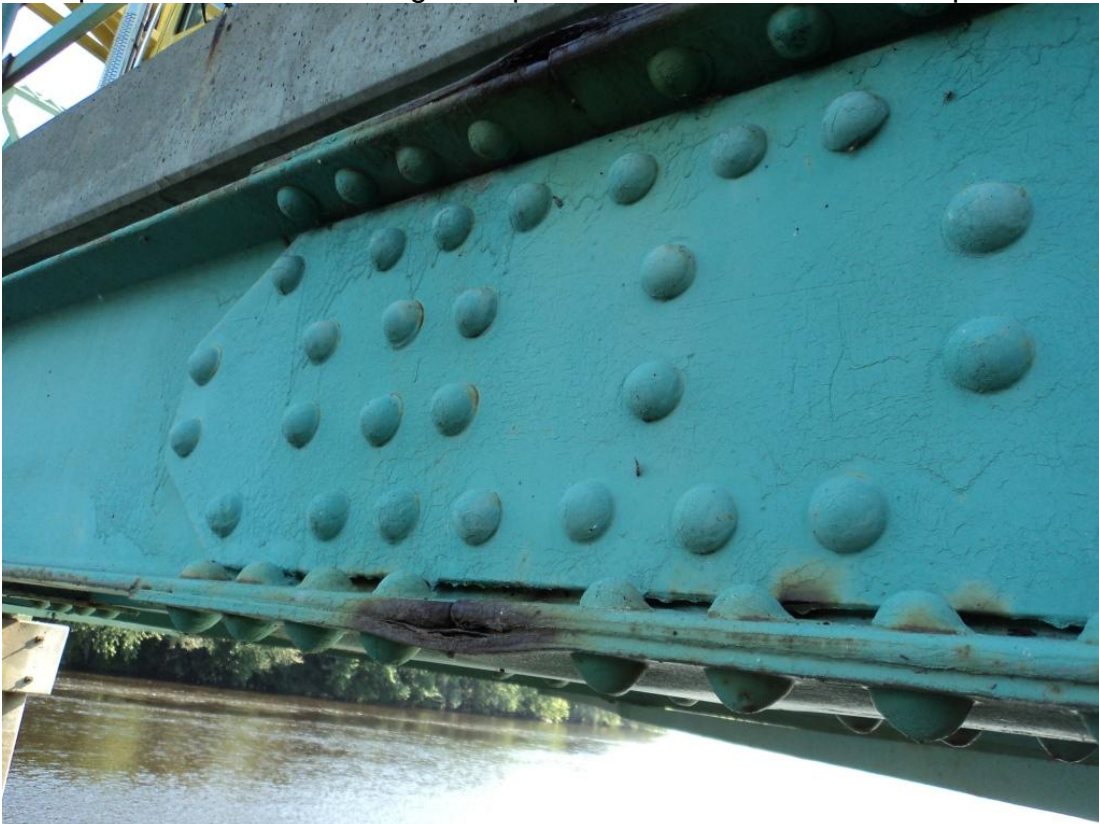
Photo 34 – Minor pack rust of the top and bottom splice plates with one inch vertical deformation was observed in the Span 3 roadway truss at the L3 lower chord splice.

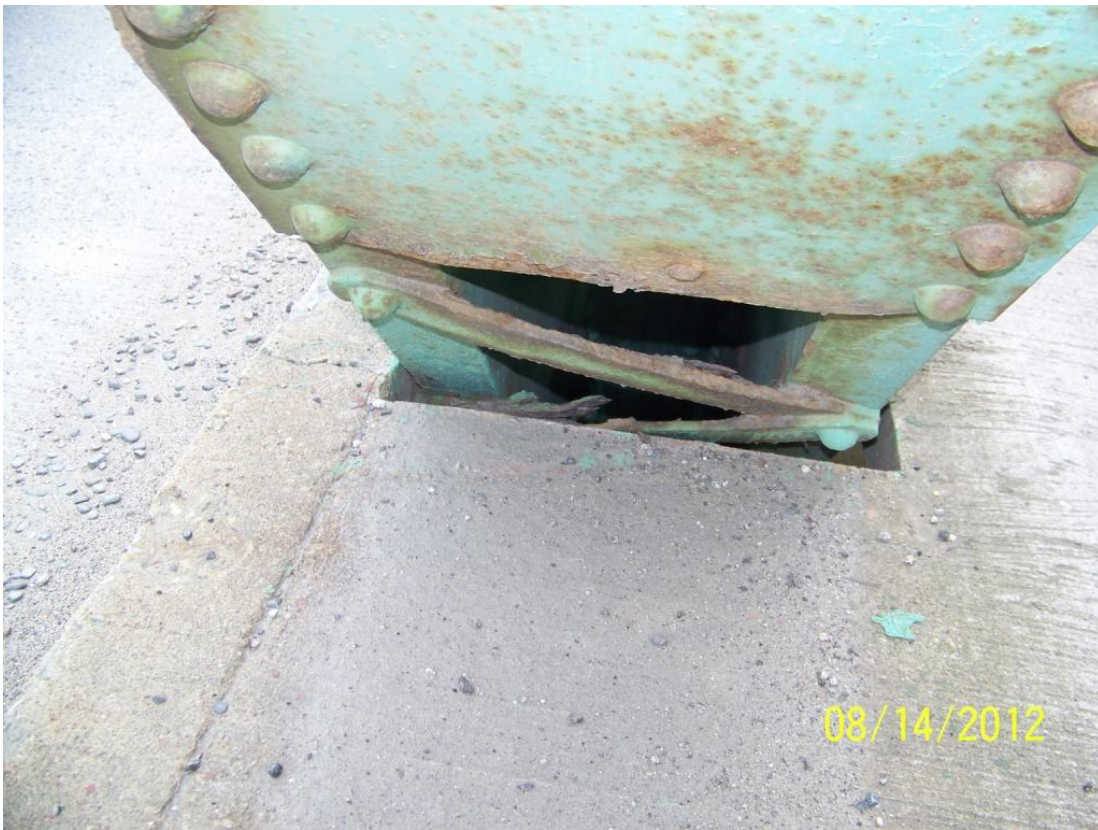
Photo 35 – At the Span 1 L0-U1 sidewalk truss end post, a severed lacing bar due to section loss was observed just below top of sidewalk level. Looking north.

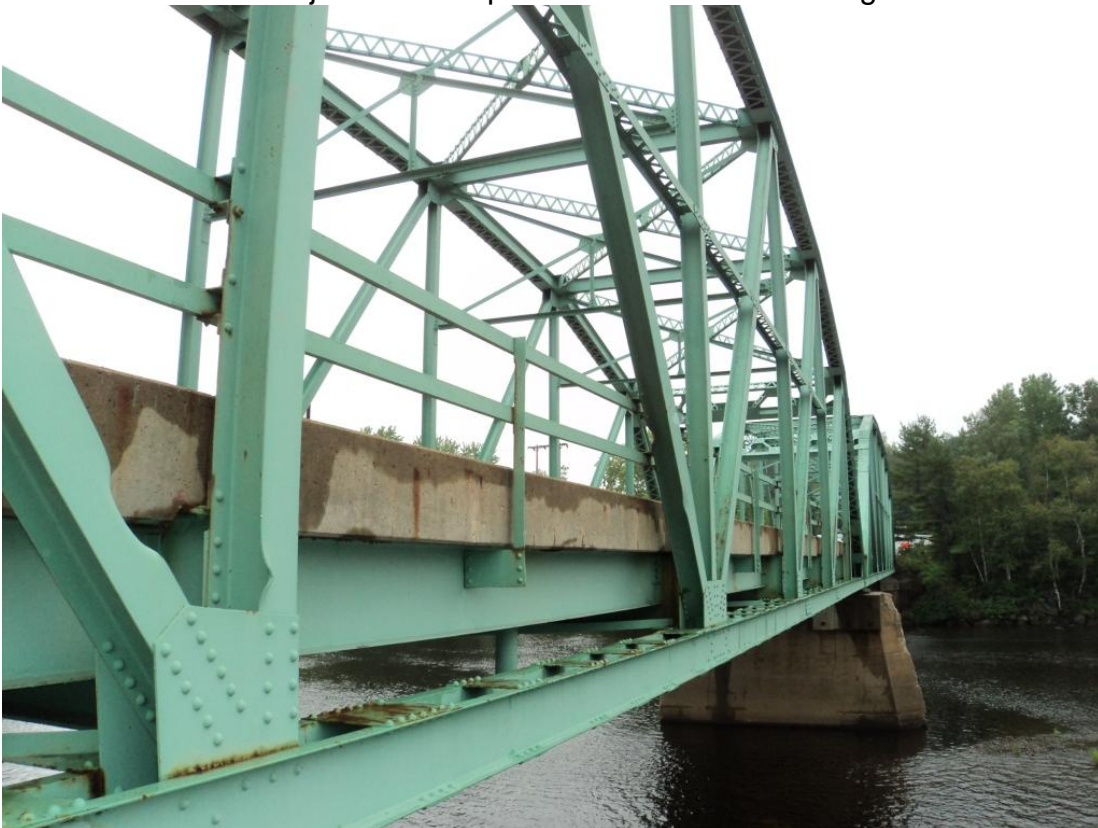
Photo 36 – At L3 in Span 2 roadway truss the vertical and diagonal have sustained damage at 2 feet above the lower chord, with localized twisting of the flanges.

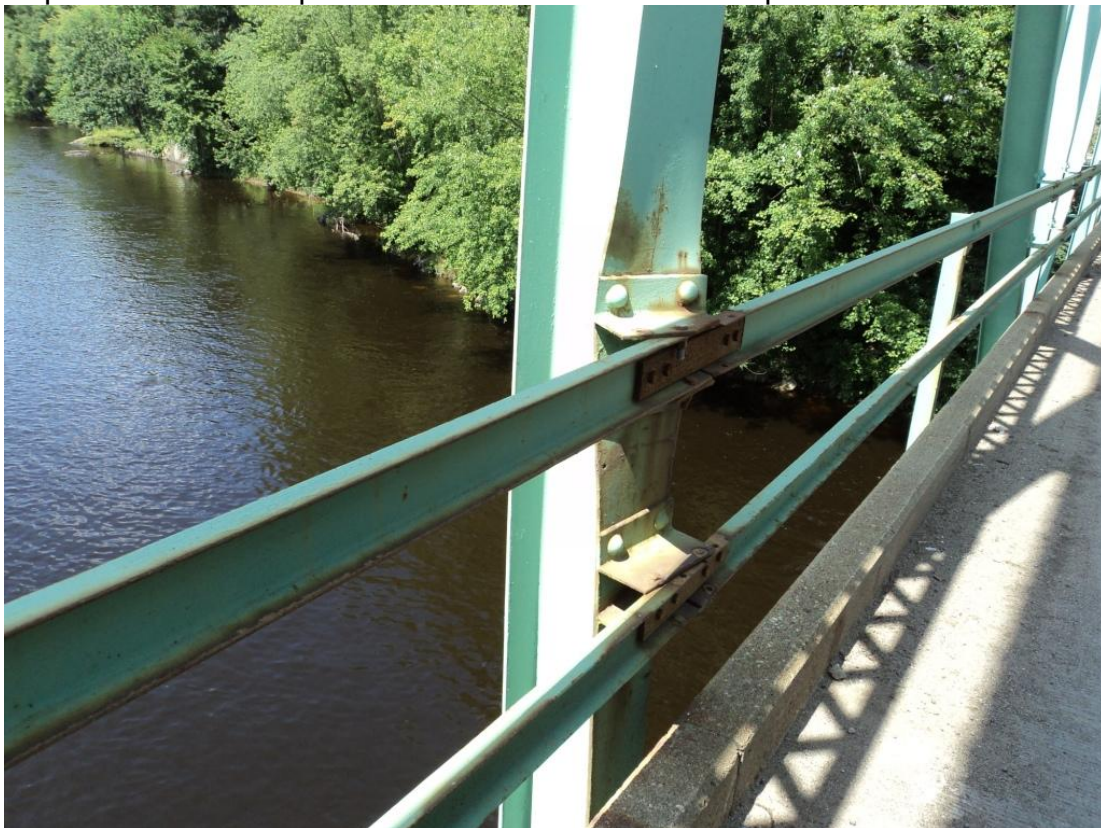
8. At L5 in the Span 1 roadway truss the vertical U5-L5 has sustained impact damage at the railing level with localized twisting of the member over a three foot length and a permanent bend in the flange tip (Photo 42). At L3 in the Span 3 sidewalk truss the vertical U3-L3 has sustained impact damage over a ten foot height of the west flange at sidewalk level with up to 3 inches of lateral displacement in the longitudinal direction and up to 1 1/2 inches of lateral displacement in the transverse direction (Photo 43). At L6 in the Span 1 roadway truss the vertical U6-L6 has sustained impact damage and a permanent bend in the flange tip (Photo 45). At L2 in the Span 2 roadway truss the vertical U2-L2 has sustained

Photo 42 –The Span 1 roadway truss U5-L5 has sustained impact damage at railing level with localized twisting over a three foot length and a permanent bend in the flange tip.

Recommendation: Since the truss verticals experience load reversal and are required to carry compressive dead loads and compressive live loads under certain live loading conditions, the impact damage could decrease the capacity of the member by reducing the compression buckling resistance to a level at which this mode of failure would govern compared to strength. The capacity of these members will be evaluated as part of the load rating to determine the need for repairs.

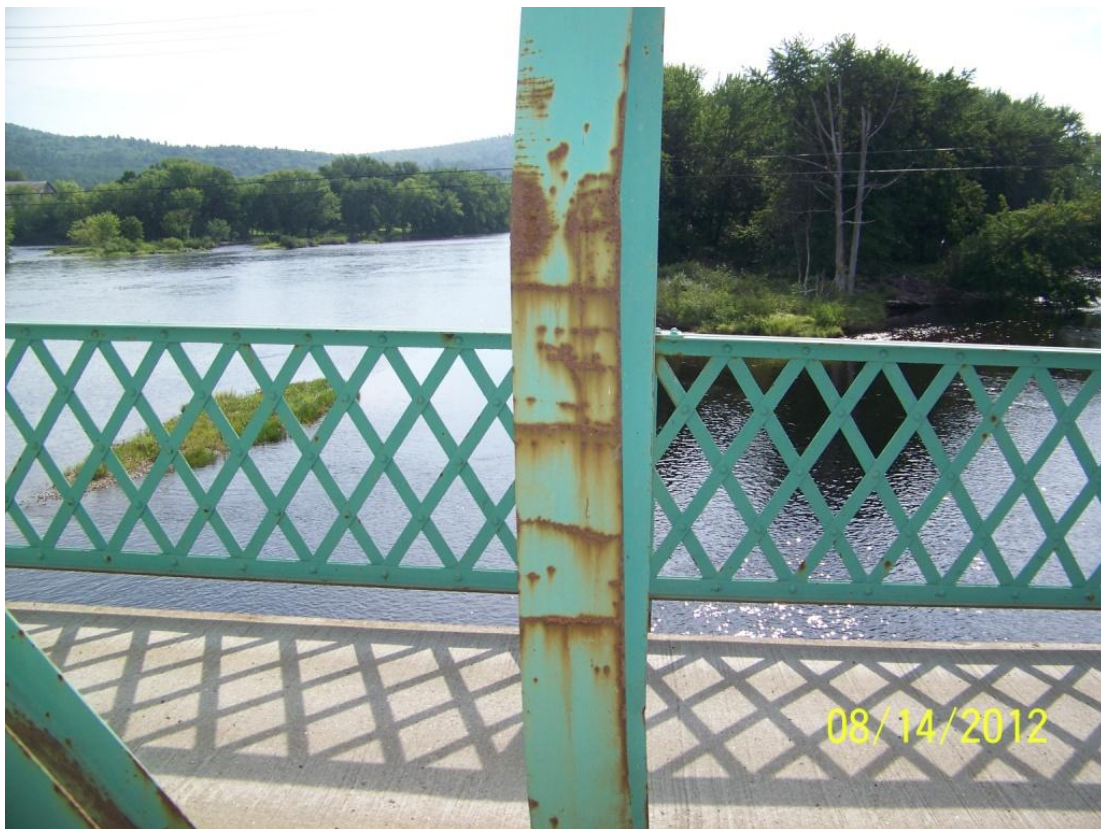
Photo 43 – Span 3 sidewalk truss U3-L3 has impact damage with up to 3 inches of lateral displacement in longitudinal direction and up to 1 1/2 inches in the transverse direction.

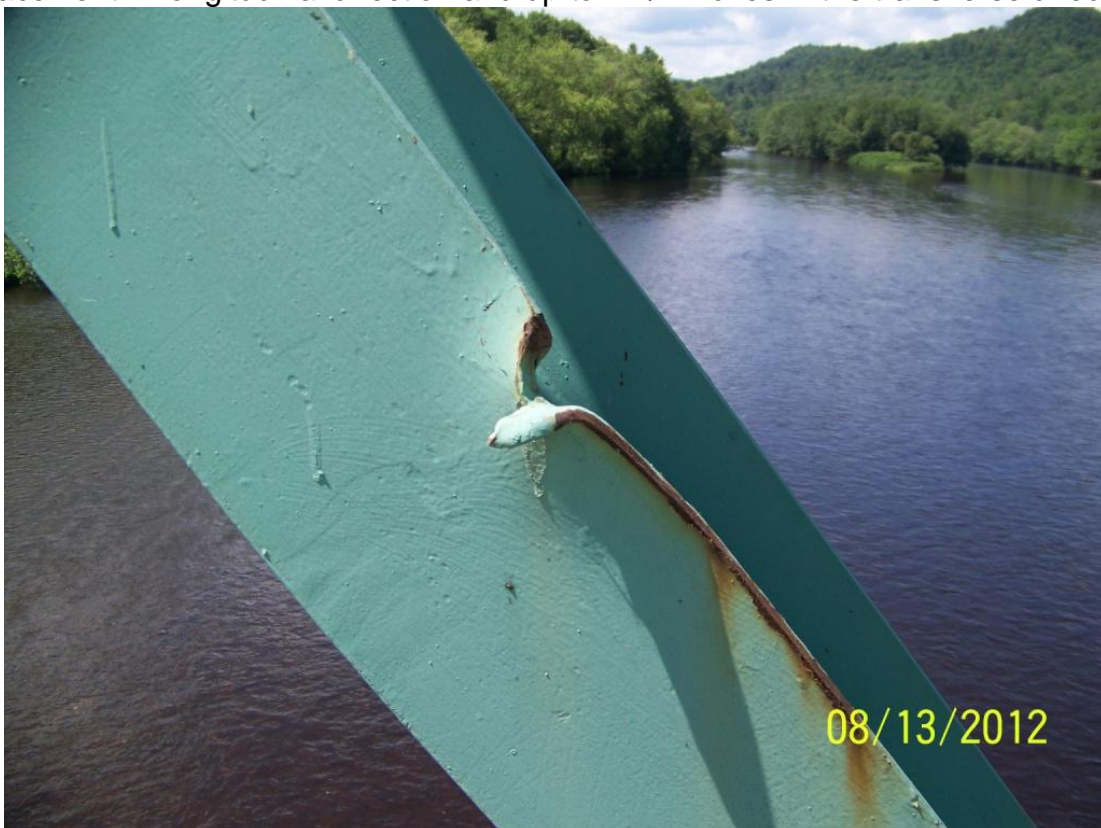
9. Impact damage to the Span 2 roadway truss L5-U6 diagonal has resulted in a notch in the flange tip which is approximately 2 inches deep (Photo 44). The damage at this location has been considered as section loss since the member is a tension diagonal. Impact damage to the Span 3 sidewalk truss U3-L4 diagonal has resulted in a notch in the flange tip which is approximately 1 inch deep.

Photo 44 – Impact damage to the Span 2 roadway truss L5-U6 diagonal has resulted in a notch in the flange tip which is approximately 2 inches deep.

Recommendation: Depending on the results from the load rating analyses, consider adding web plates to these two diagonals to restore the section loss due to the impact damage notches. In any case, notches in FCM tension members are significant FSD's. Hence, the notches should be removed and all sharp edges should be ground smooth.

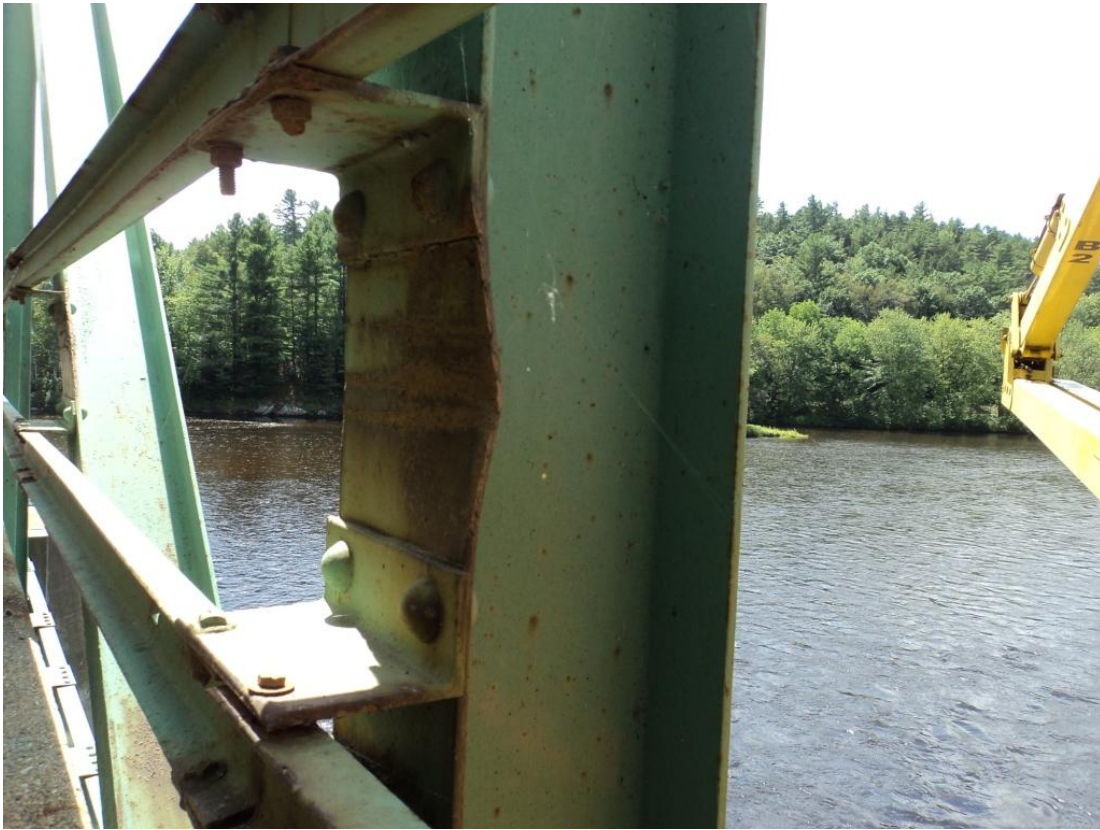
Photo 45 – At L6 in the Span 1 roadway truss the vertical U6-L6 has sustained impact damage and a permanent bend in the flange tip. Looking south.

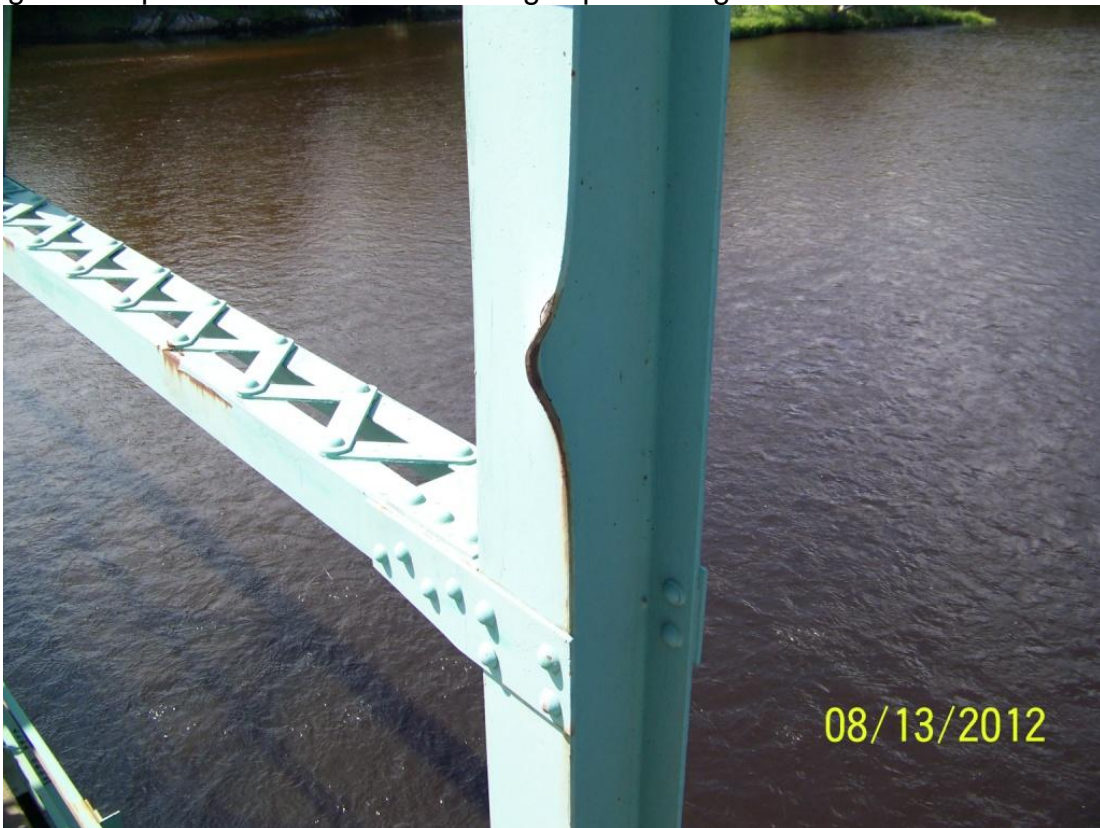
impact damage and a permanent bend in the flange tip of 1 ½ inches over a length of two feet (Photo 46).

Photo 46 – At L2 in the Span 2 roadway truss the vertical U2-L2 has sustained impact damage and a permanent bend in the flange tip of 1 ½ inches over a length of two feet.

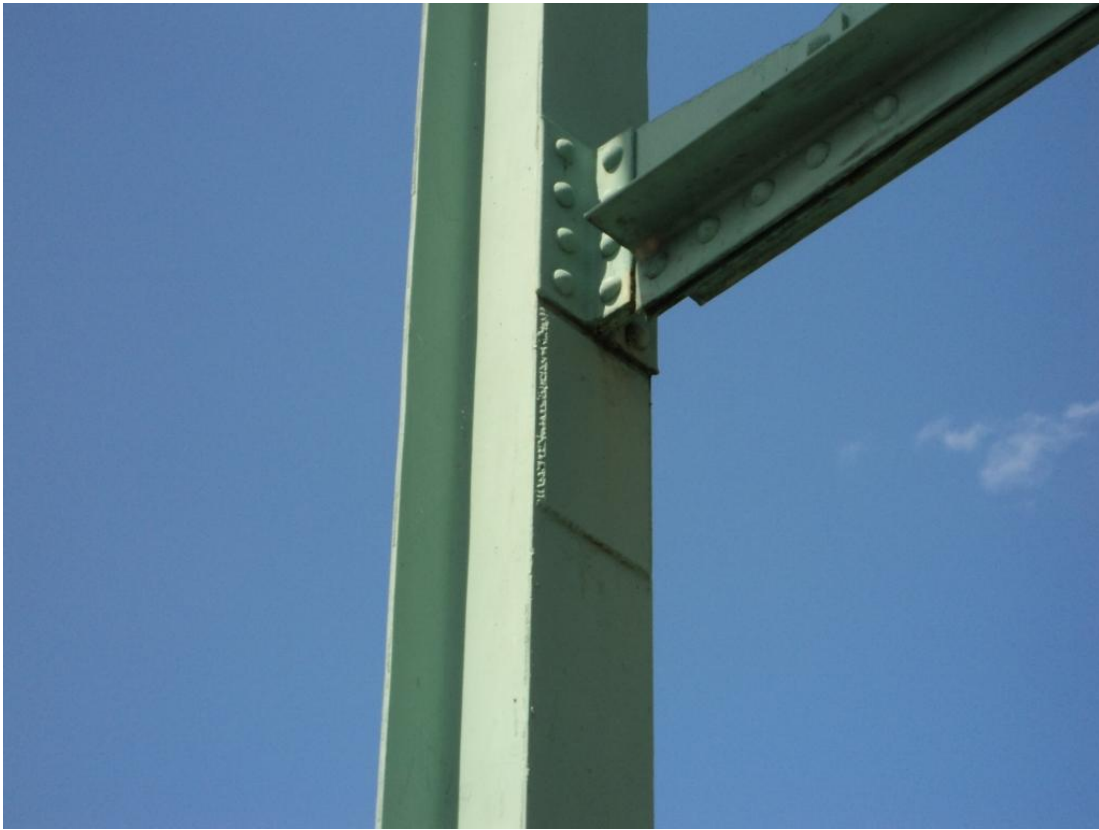
Photo 47 – Field-welded plates added to many verticals just below existing lower transverse sway frame members to cover open holes of original sway frame connections.

Recommendation: Re-inspect all field weld locations in the vertical FCM's during future biennial bridge inspection cycles. Check for any indications of fatigue cracking initiation as part of the regularly scheduled bridge inspection cycles.

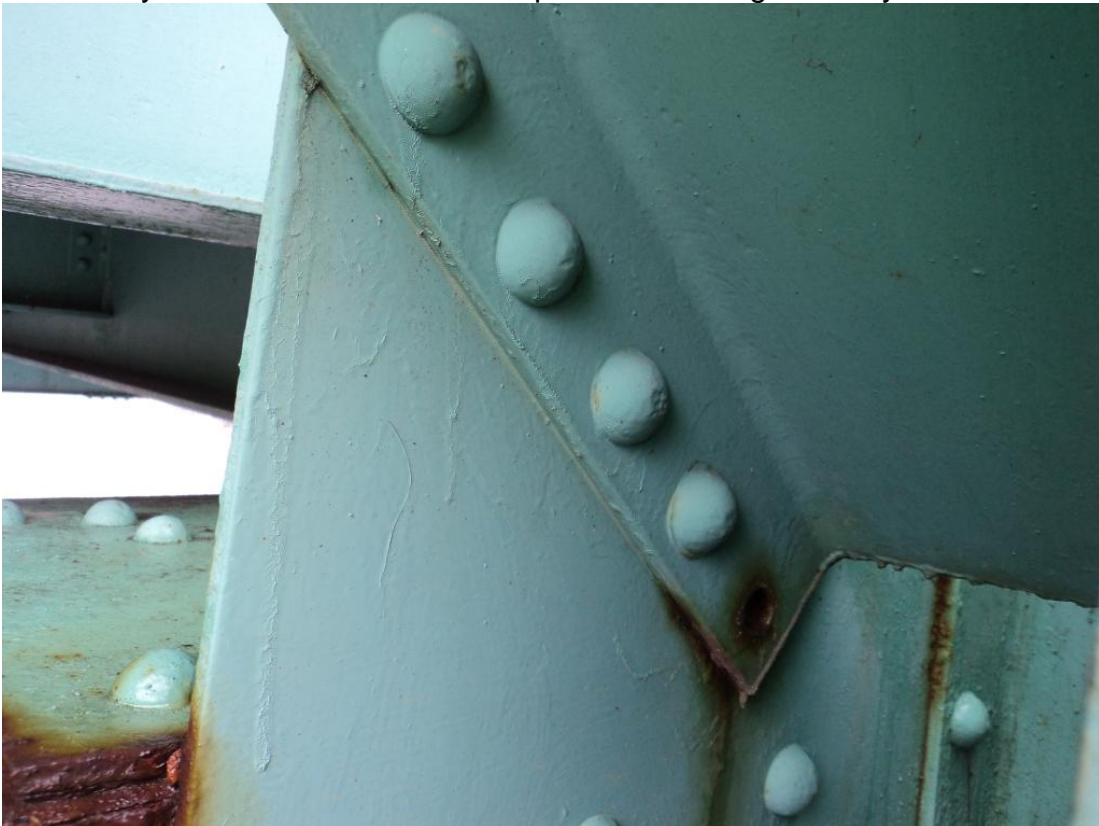
Photo 48 – The Span 2 roadway truss diagonal U1-L2 is missing a single rivet in the east face L2 gusset, leaving 19 of the original total of 20 rivets to resist the member loads.

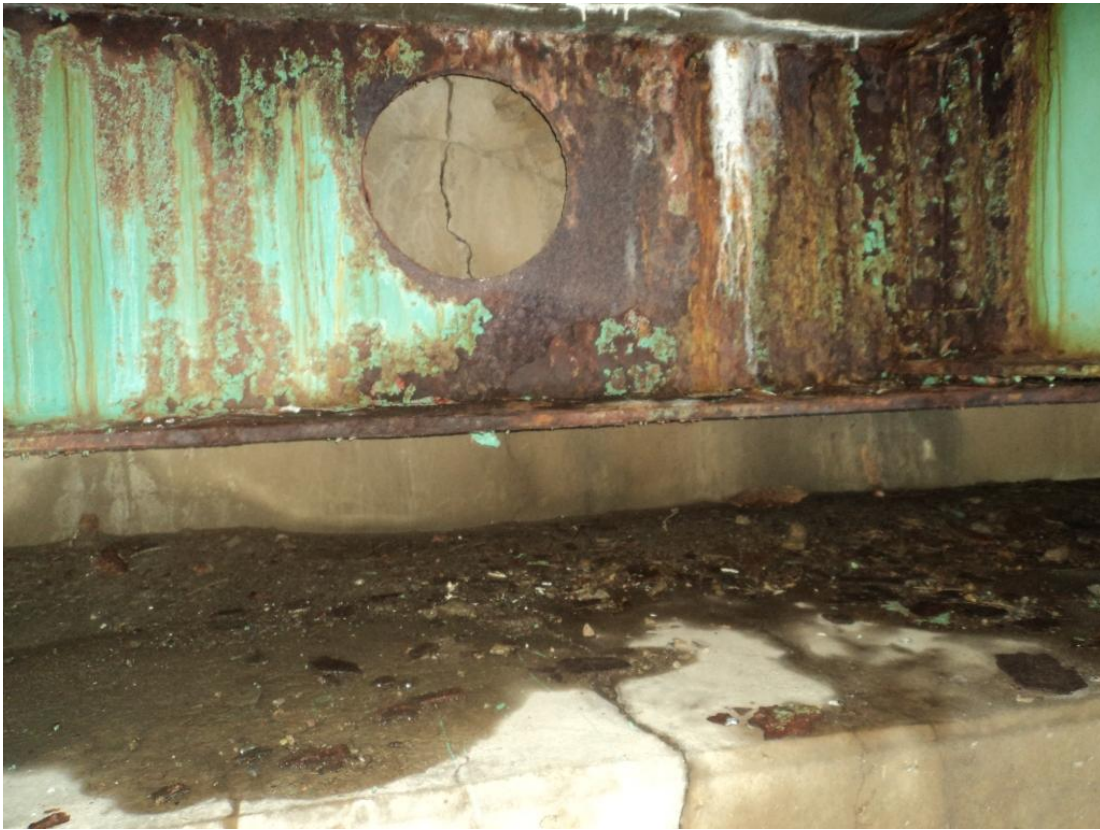
Photo 49 – The Span 3 FB8 end floorbeam has failed paint on the web and active corrosion. Looking south at south abutment between S4 & S5. Note crack in backwall.

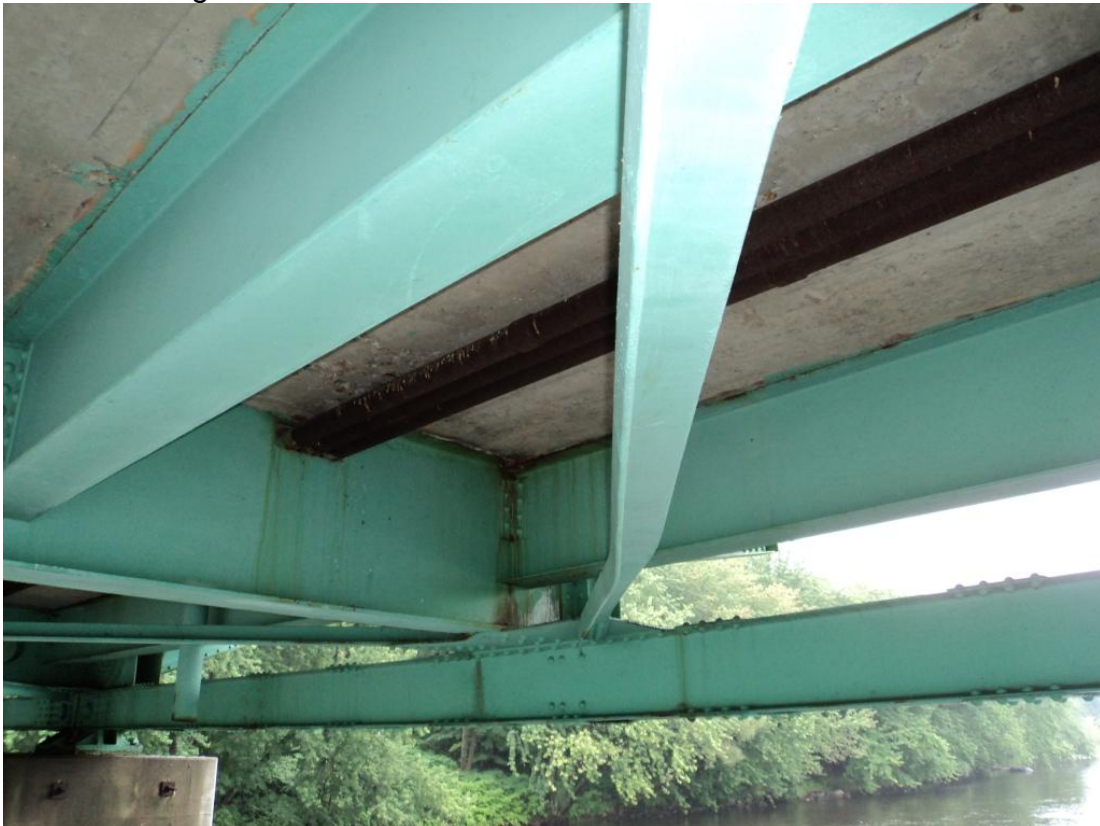
Photo 50 – Stringers generally in satisfactory condition with few defects. Note displacement in Span 2 bracing connecting FB1 sidewalk and FB2 roadway trusses.

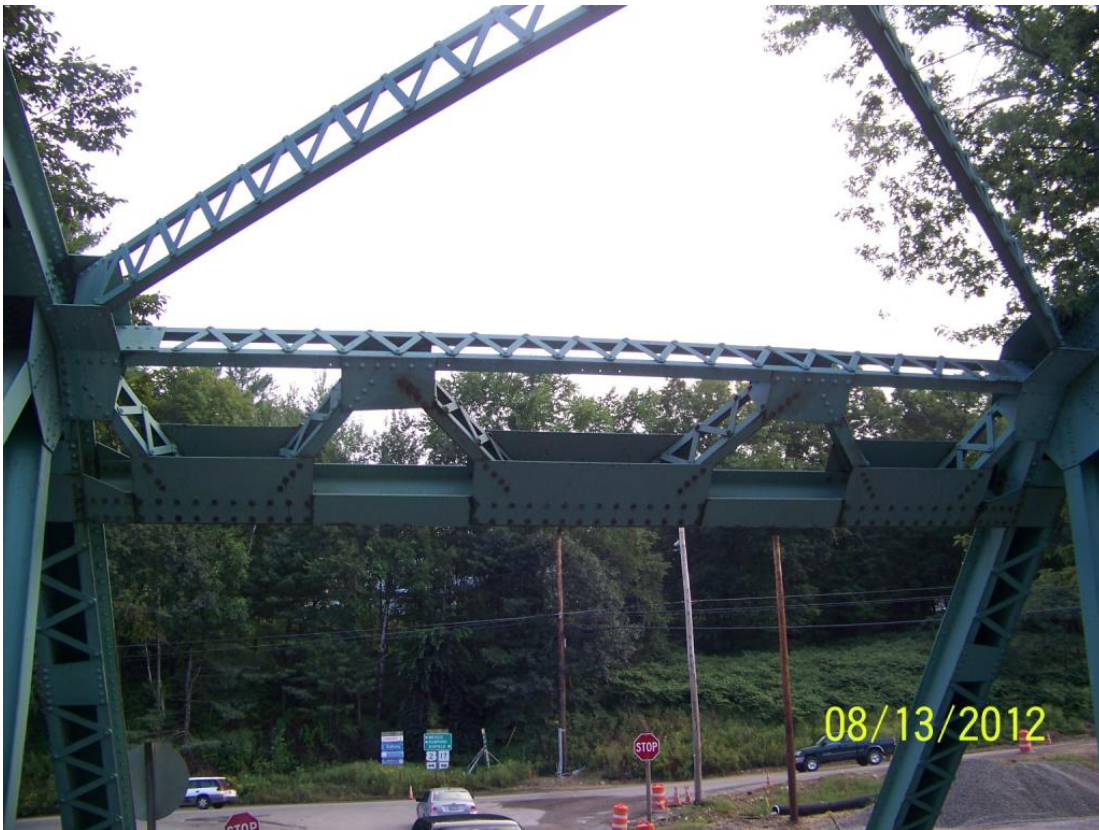
Photo 51 – The lower transverse members at portal bracing have been replaced with bolted rolled shapes at both ends of all three spans. View at north portal of Span 1.

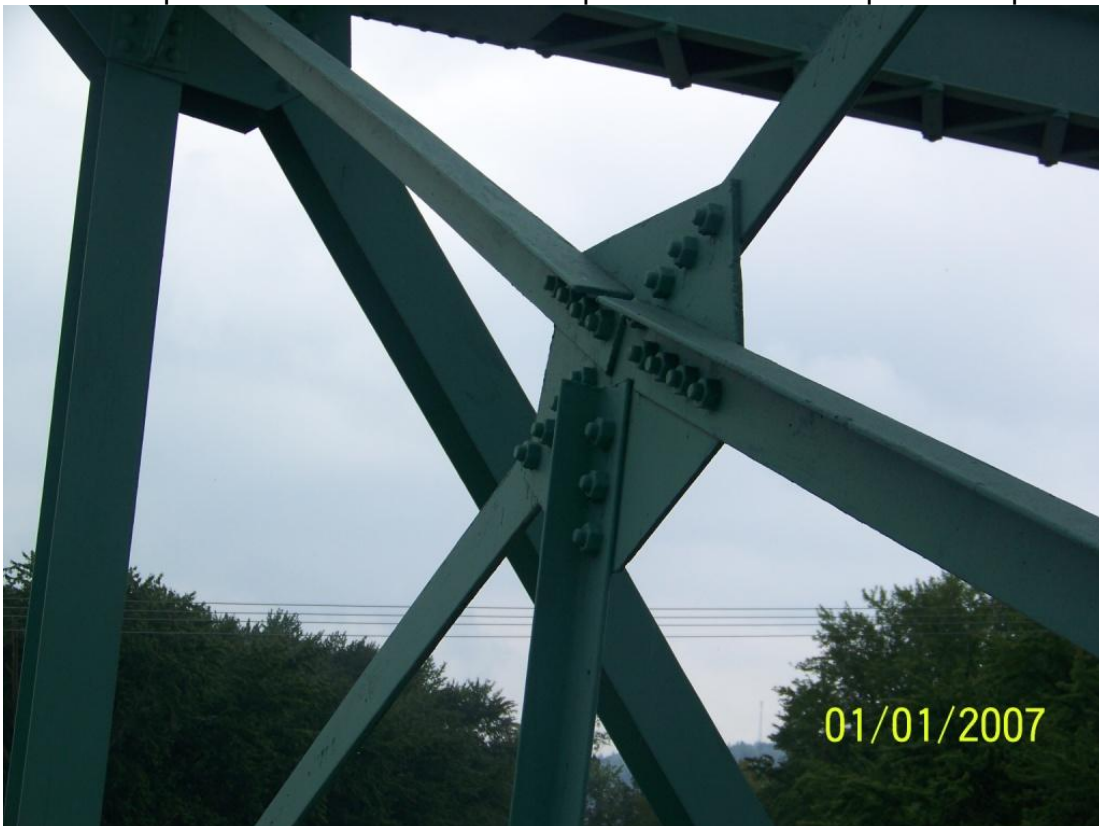
Photo 52 – High strength bolted repairs were observed in various sway frame connections including the diagonal intersection connection plate at Span 3 U3.

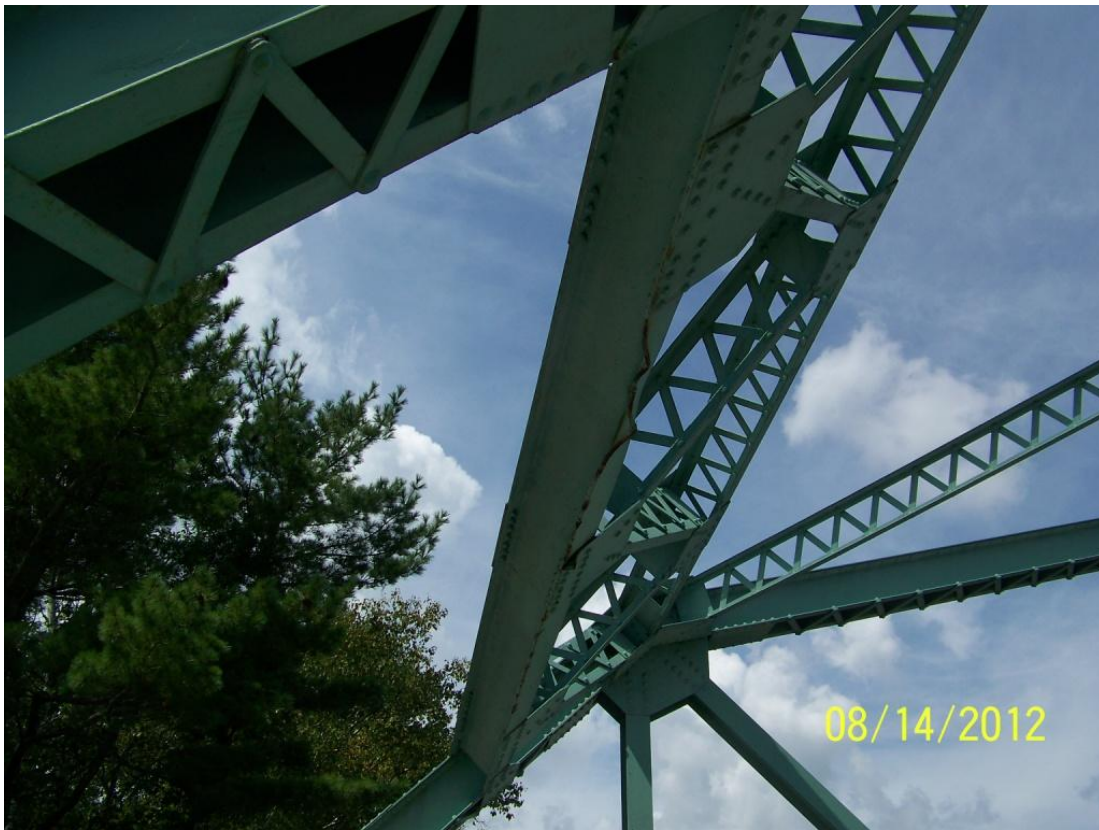
Photo 53 – Impact damage to the portal bracing at the south end of Span 3 over the northbound lane was observed.

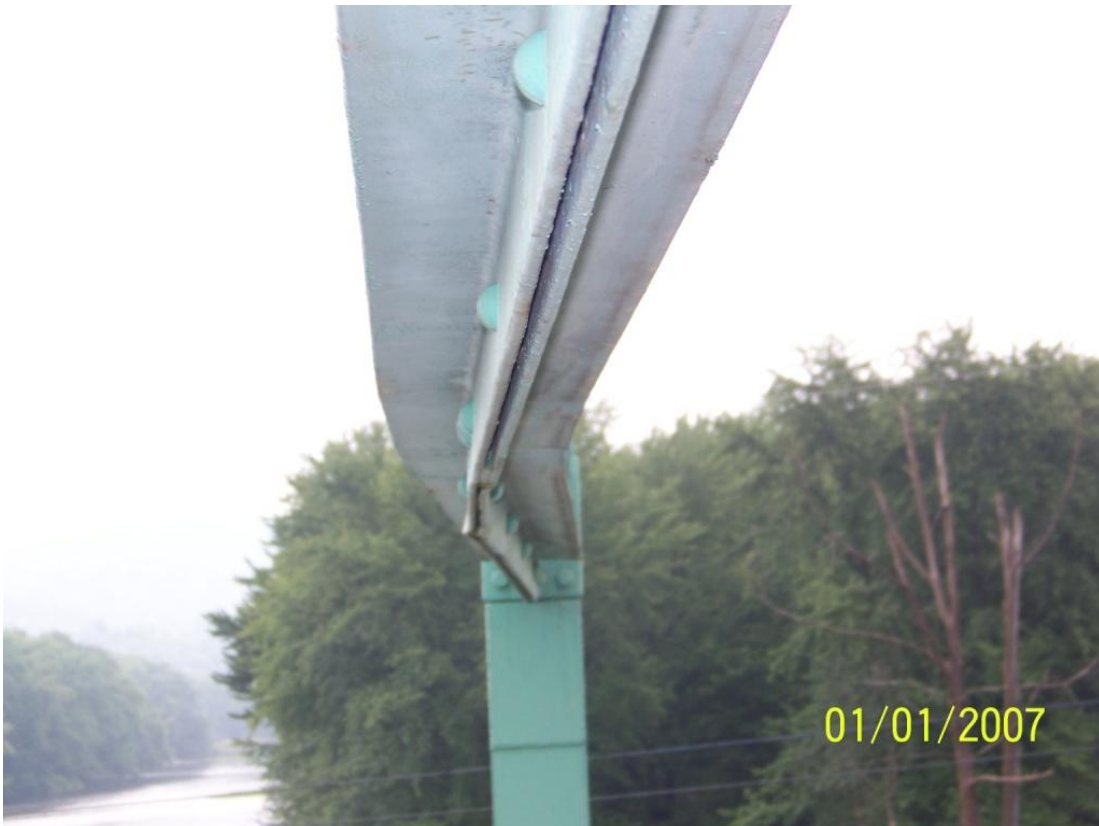
11. Impact damage to the sway frame lower transverse member along with lateral displacement of 6 inches in the horizontal plane was observed at Span 3 U3 (Photo 54). This sway frame also has a slight bend in the sway frame diagonal. Impact damage to the sway frame lower transverse member along with twisting and local vertical bends in the edges of the horizontal legs of the angle over both the northbound and southbound lanes was observed at Span 3 U4 (Photo 55). Impact damage to the sway frame lower transverse member along with lateral displacement in the horizontal plane of more than 3 inches was observed at Span 3 U6 (Photo 56). This sway frame also has a slight bend in the sway frame diagonal. Other locations of sway frame lower transverse member impact damage were observed, such as at Span 1 U2 over the southbound lane (Photo 57).

Photo 54 – Impact damage to the sway frame lower transverse member along with lateral displacement of 6 inches in the horizontal plane was observed at Span 3 U3.

Recommendation: Replace the sway frames at the four specified locations. Following completion of the sway frame replacement, the proper alignment and overall geometry of the affected panel points should be verified.

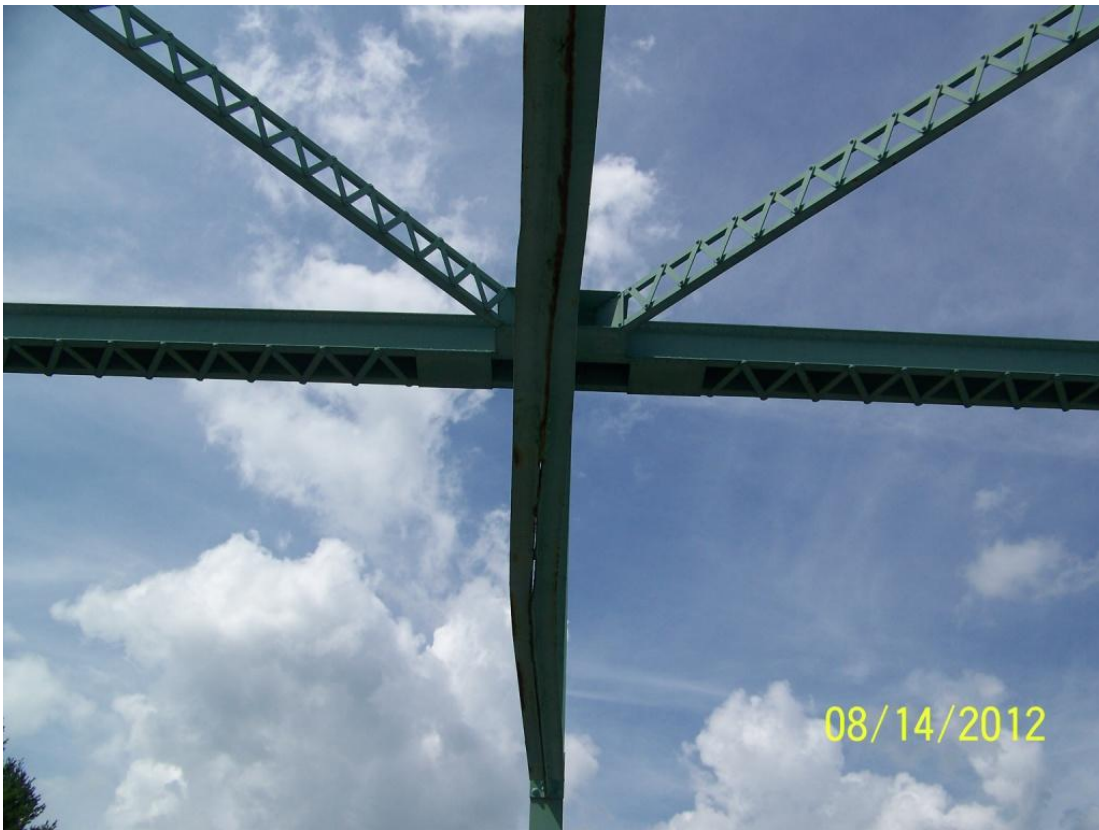
Photo 55 – Impact damage to Span 3 U4 sway frame lower transverse member along with twisting and local vertical bends in edges of horizontal legs of angles over both lanes.

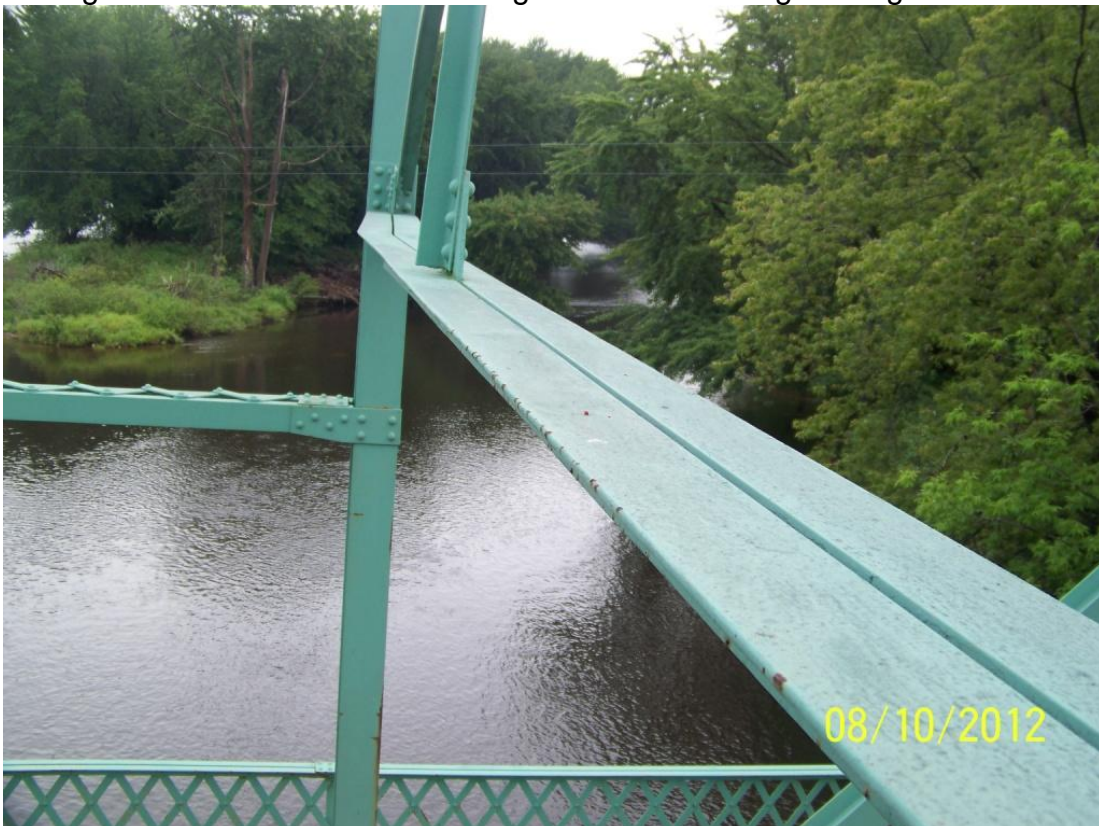
Photo 56 – Impact damage to the sway frame lower transverse member along with lateral displacement in the horizontal plane of more than 3 inches was observed at Span 3 U6.

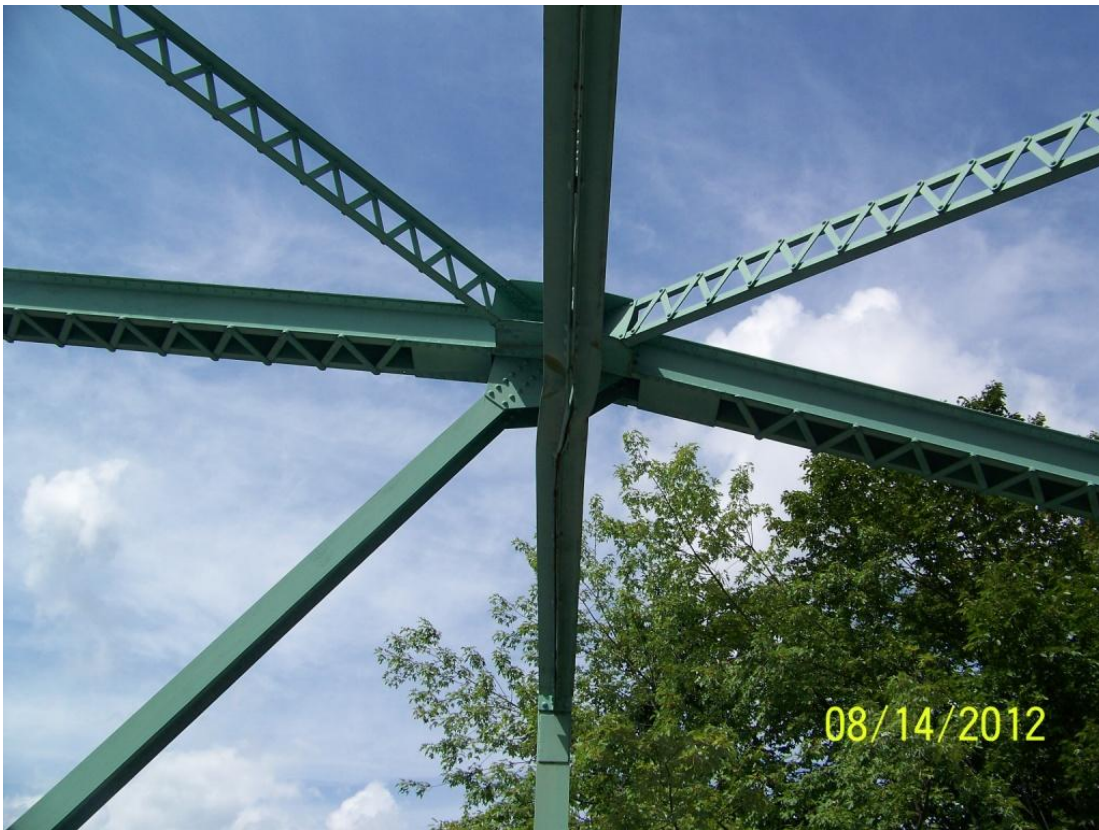
Photo 57 – Sway frame lower transverse member impact damage at Span 1 U2 over southbound lane. Also note welded plate on vertical below sway frame strut.
