ROUTINE AND FRACTURE CRITICAL BRIDGE INSPECTION REPORT

**BRIDGE # 2019-ANDROSCOGGIN RIVER BRIDGE
NORTH MAIN STREET OVER ANDROSCOGGIN RIVER
PERU, OXFORD COUNTY
MAINE DOT REGION 3 (WESTERN)**

**Start Date of Inspection: 08/09/2012
Finish Date of Inspection: 08/14/2012**

**Prepared For
Maine Department of
Transportation
Bridge Maintenance Division**

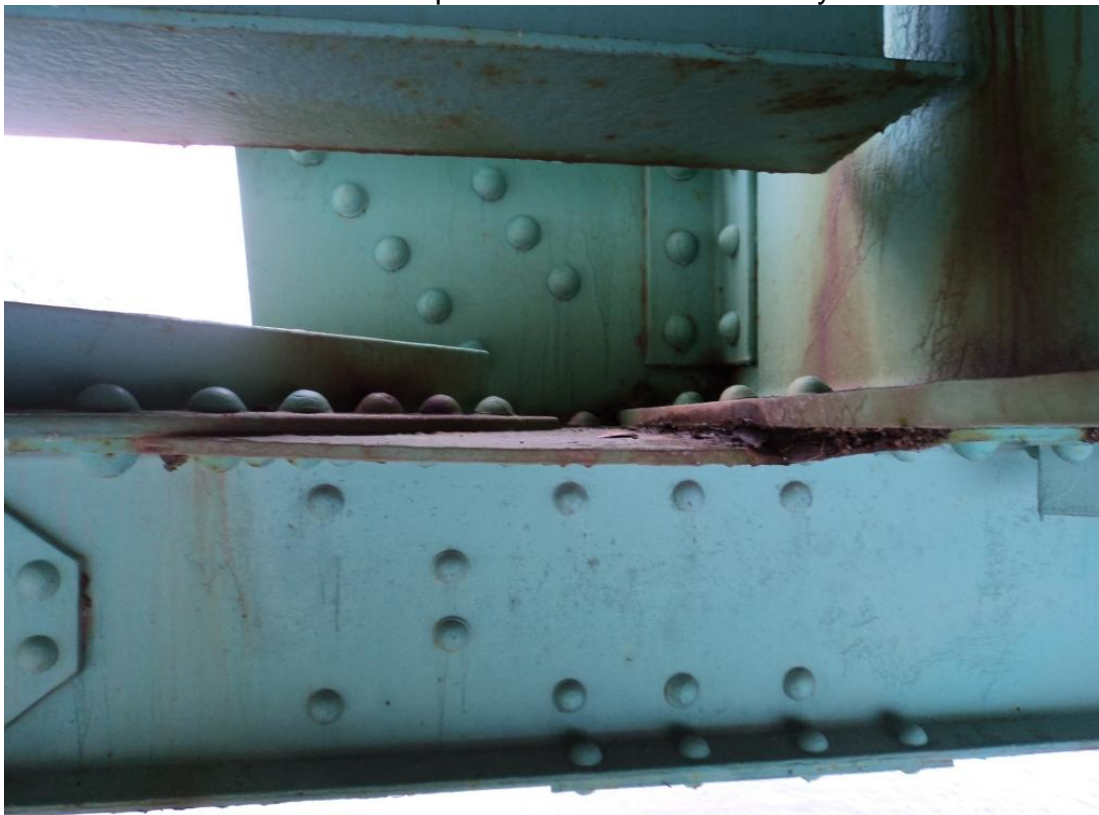
Photo 58 – In Span 2 at FB5 roadway truss lower lateral connection pack rust at floorbeam flange edge has bent the connection plate down by approximately one inch.

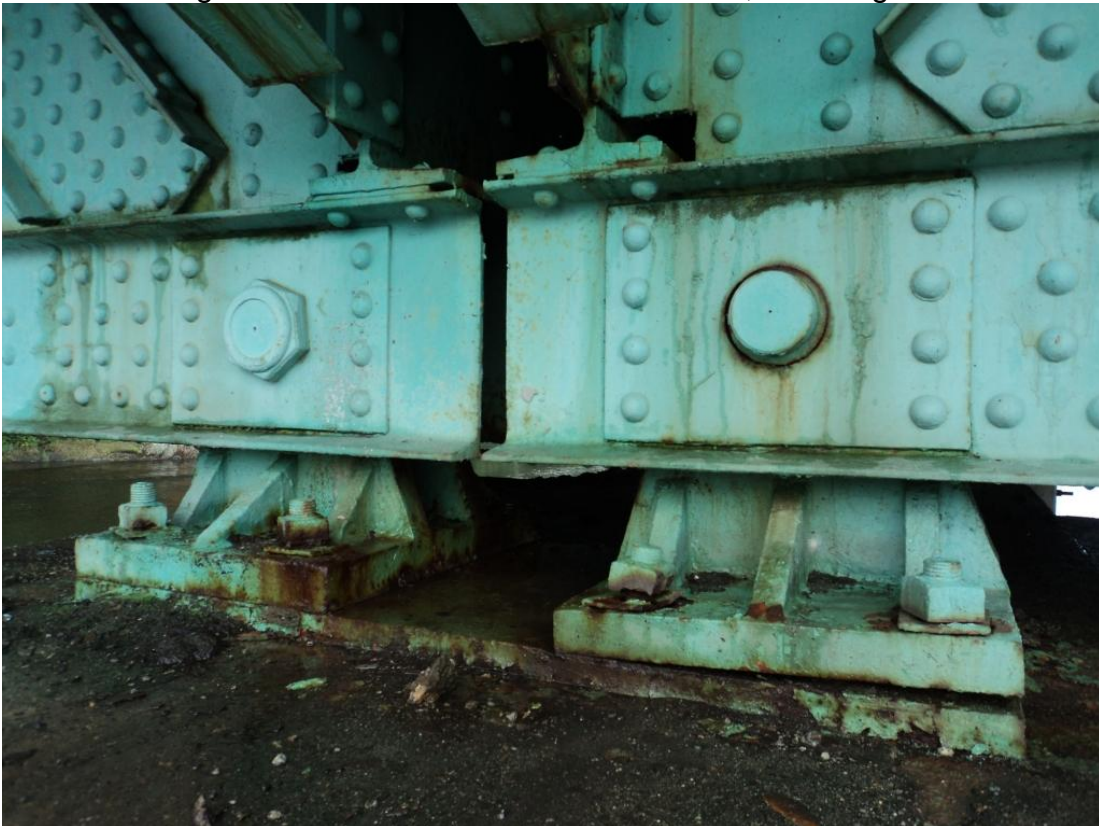
14. The bearing pin nuts are completely missing on the east faces of both truss line lower chords at the Span 2 expansion bearings on Pier 2 (Photo 62). The Span 3 sidewalk truss fixed bearing at Pier 2 has a cracked bearing pin nut on the lower chord west face and the lower half of the nut is missing (Photo 63). The bearing pin nut on the west side of the south abutment sidewalk truss bearing is cracked. The bearing pin nut on the east side of the south abutment roadway truss bearing is cracked and the lower half of the nut has fallen away completely from the face of the chord (Photo 66).

Photo 62 – The bearing pin nuts are missing on the east faces of both truss line lower chords at Span 2 expansion bearings on Pier 2. Looking west with Span 2 on right.

Recommendation: Replace the bearing pin nuts at the five specified locations.

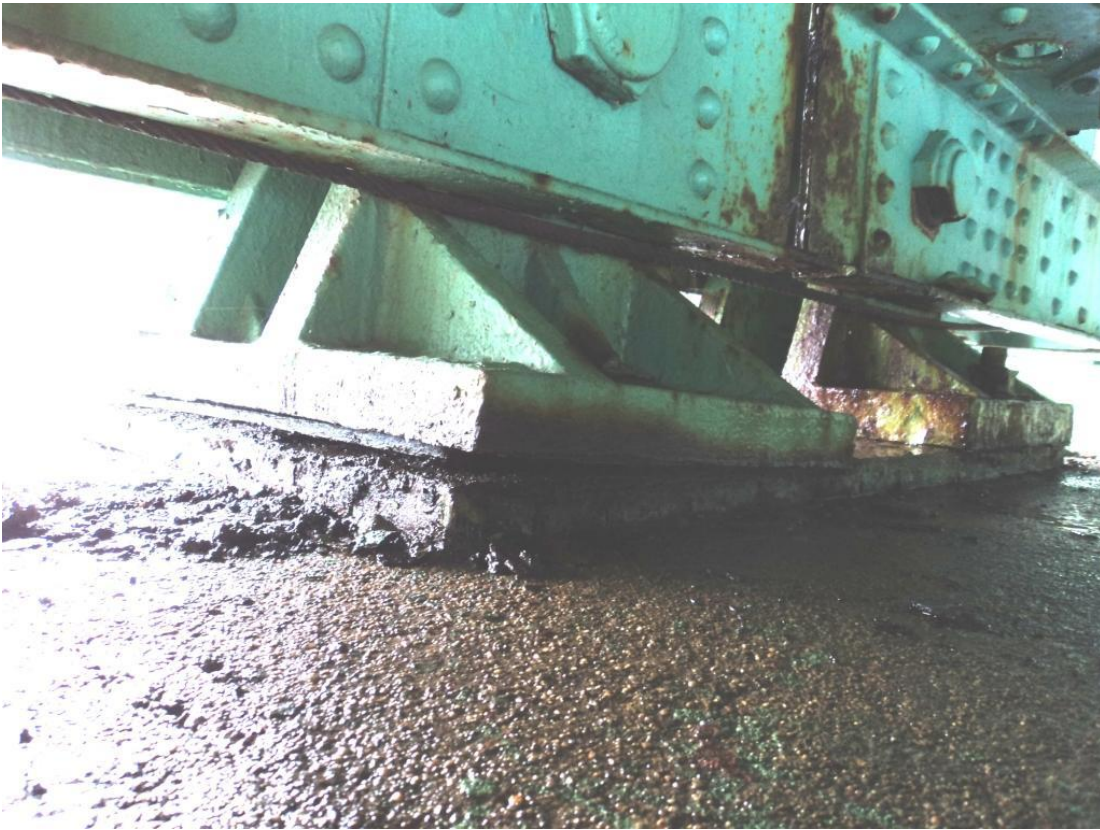
Photo 63 – Span 3 sidewalk truss bearing at Pier 2 has a cracked bearing pin nut and lower half of the nut is missing (at right). Also note missing anchor bolt in Span 2 bearing.

Recommendation: Core drill and grout new anchor bolts at the two specified locations.

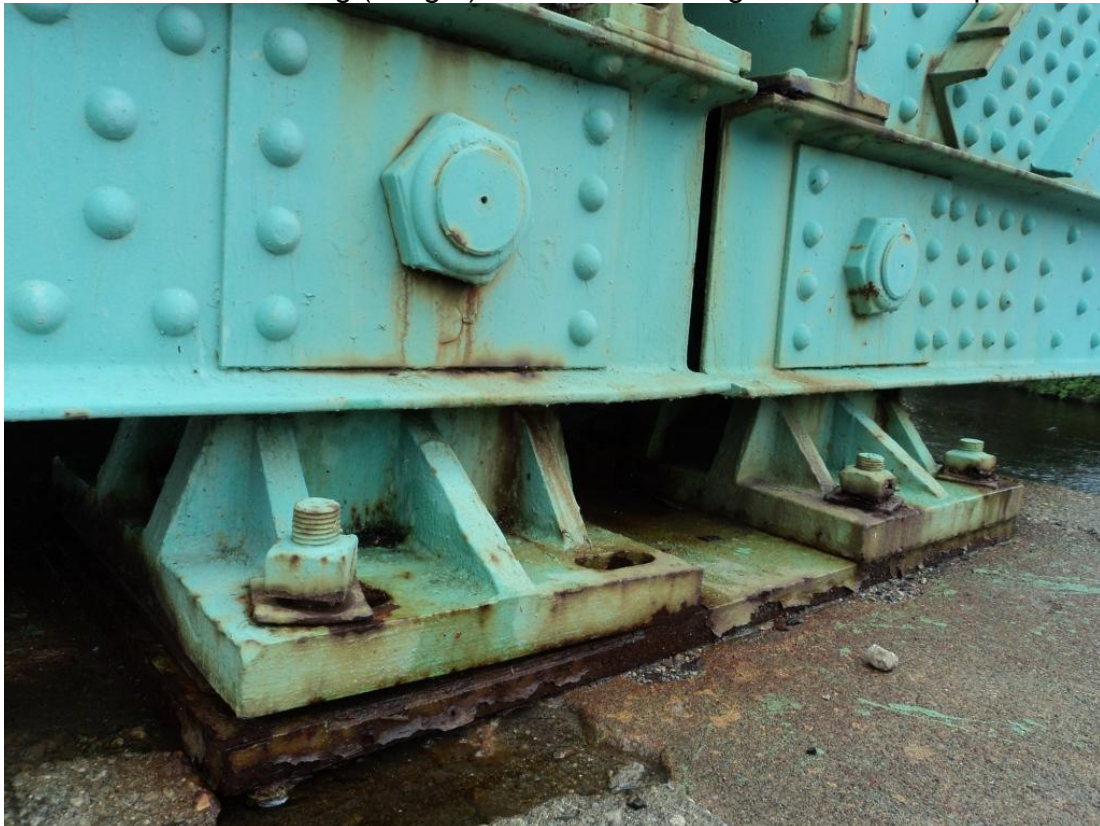
15. The Span 2 sidewalk truss expansion bearing is missing the single west side anchor bolt (Photo 63). The Span 2 roadway truss expansion bearing on Pier 2 is missing the southwest corner anchor bolt (Photo 64).

Photo 64 – The Span 2 roadway truss expansion bearing on Pier 2 is missing the southwest corner anchor bolt. Looking southeast with Span 2 on left, Span 3 on right.

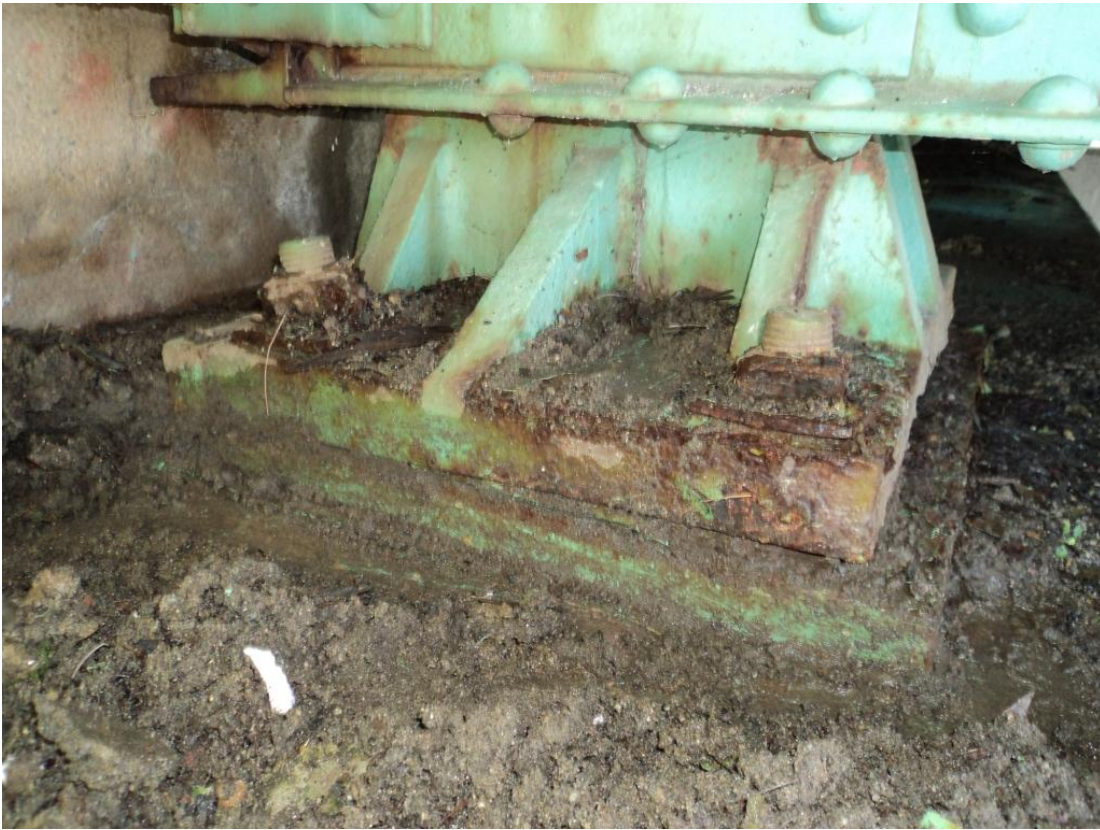
Photo 65 – South abutment expansion bearings have heavy 3-4 inch deep debris accumulations around the bearing and also filling the anchor bolt expansion slots.

Recommendation: Remove the debris accumulations from around the south abutment and Pier 1 expansion bearings as well as from the expansion slots to restore free thermal movements.

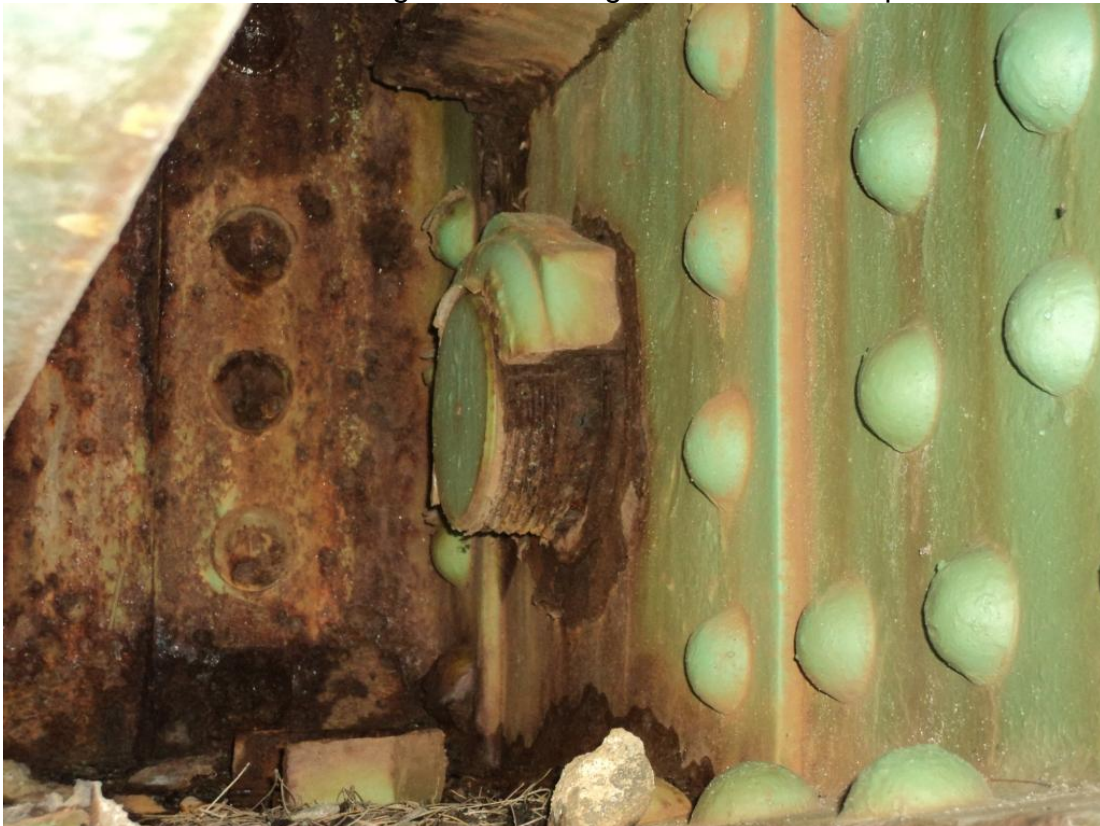
Photo 66 – The bearing pin nut on the east side of the roadway truss bearing is cracked and the lower half of the nut has fallen away completely from the face of the chord.

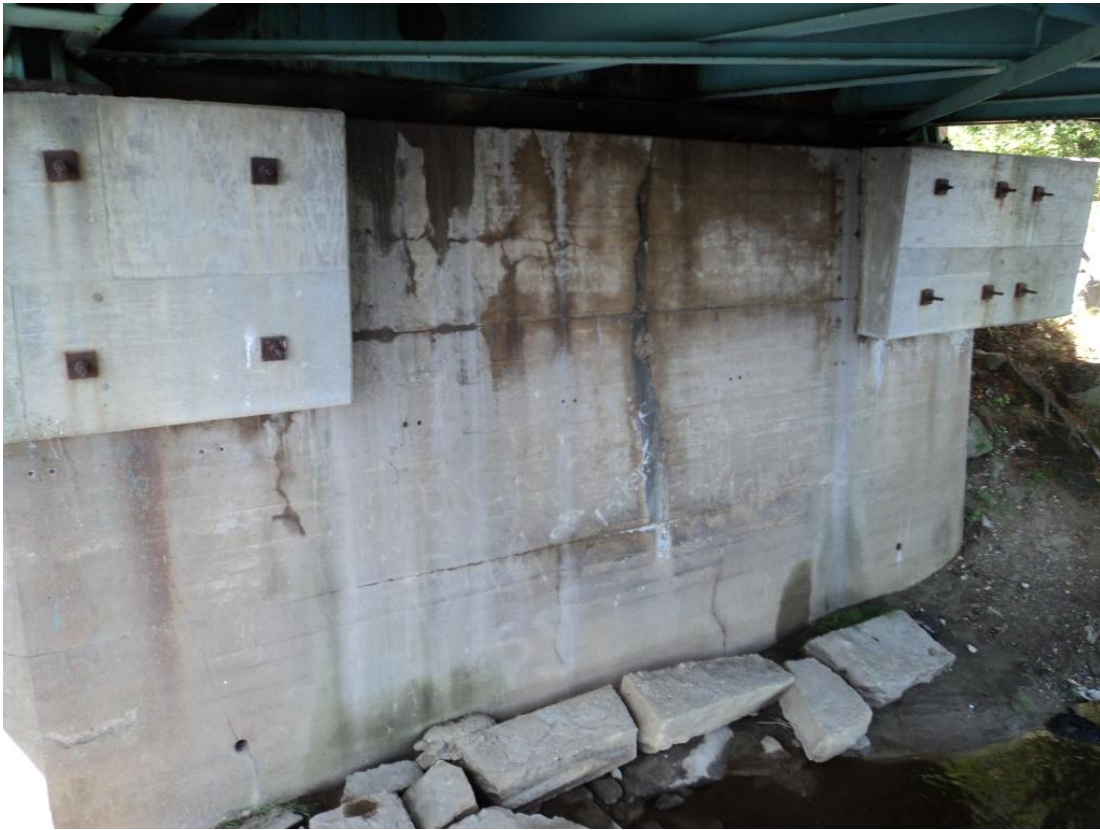
Photo 67 – Both abutments have been retrofitted with Dywidag post-tensioned concrete encasement repairs immediately below both truss bearings. View at south abutment. Also note wide vertical crack in breastwall at centerline of bridge and two lower cracks.

Recommendation: Perform epoxy crack injection to repair the cracks in the south abutment and the three specified wingwalls. Perform spall repairs to remove and replace unsound concrete at the two spalls in the southeast wingwall as well as at the large spall in the southwest wingwall.

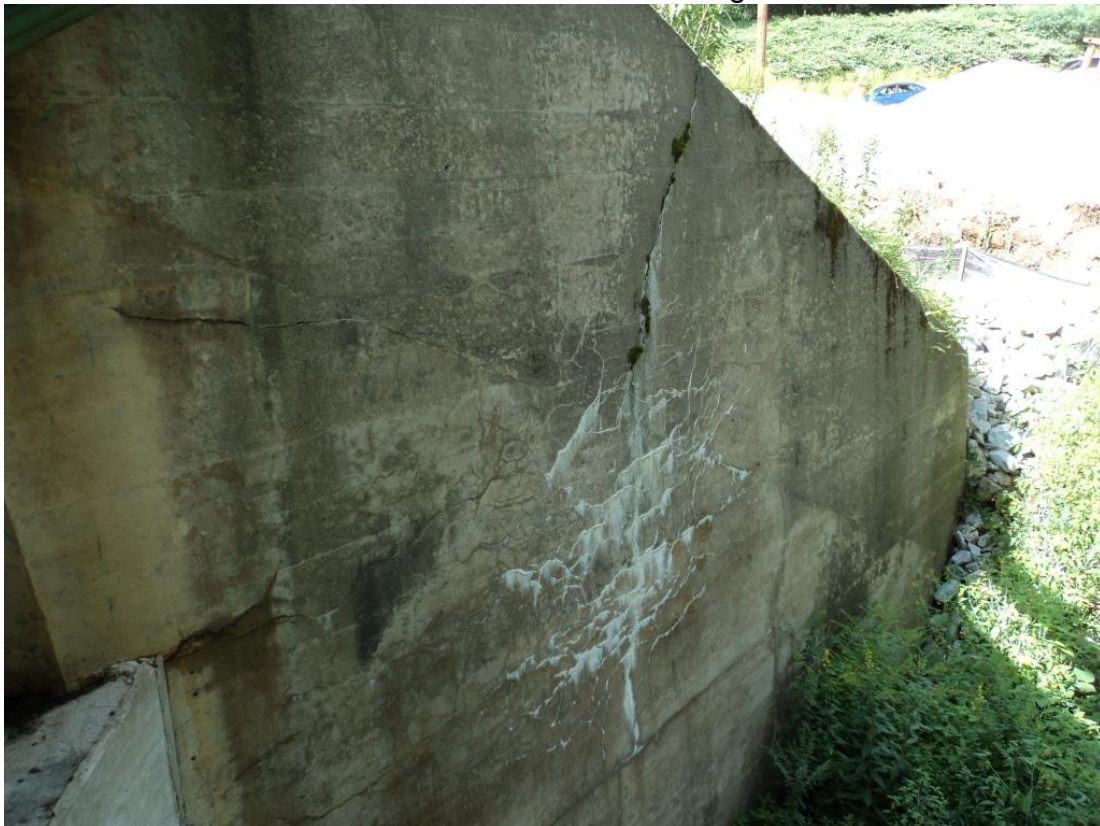
Photo 68 – The northeast wingwall has map cracking with efflorescence.

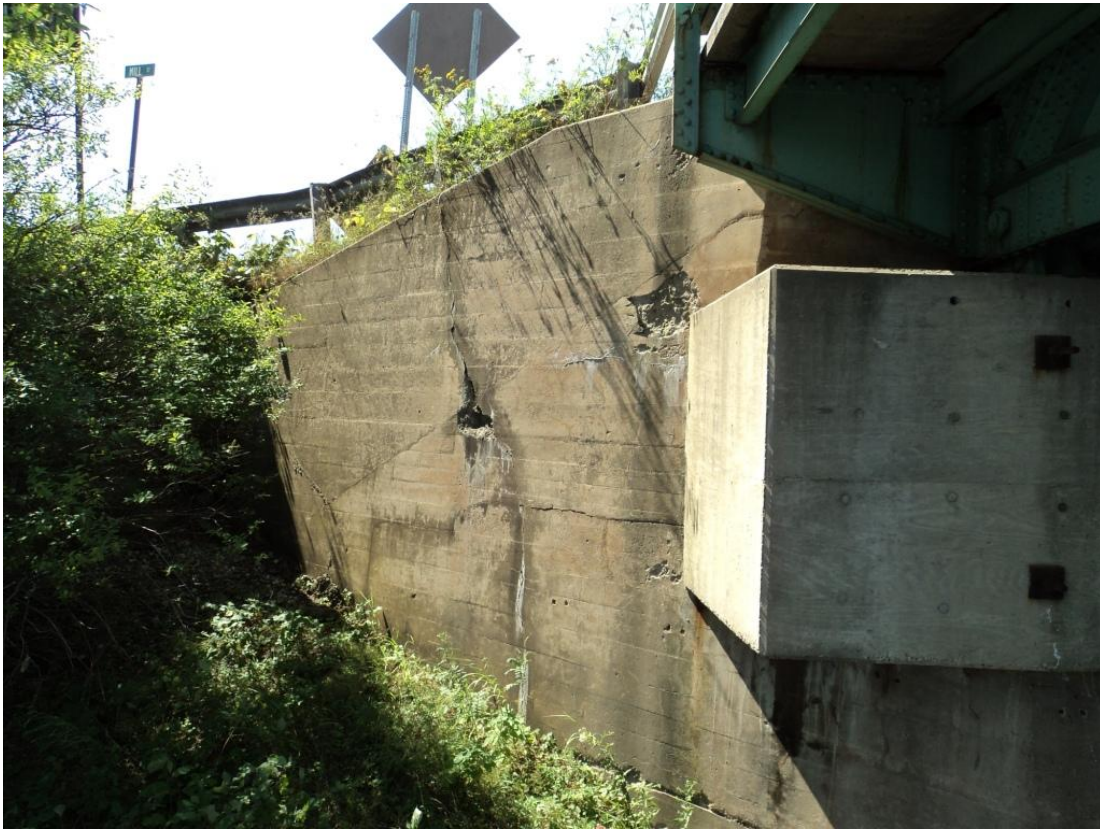
Photo 69 – The southeast wingwall is in fair condition with two spalls less than 2 SF each in size and a medium vertical crack extending from the top to the base.

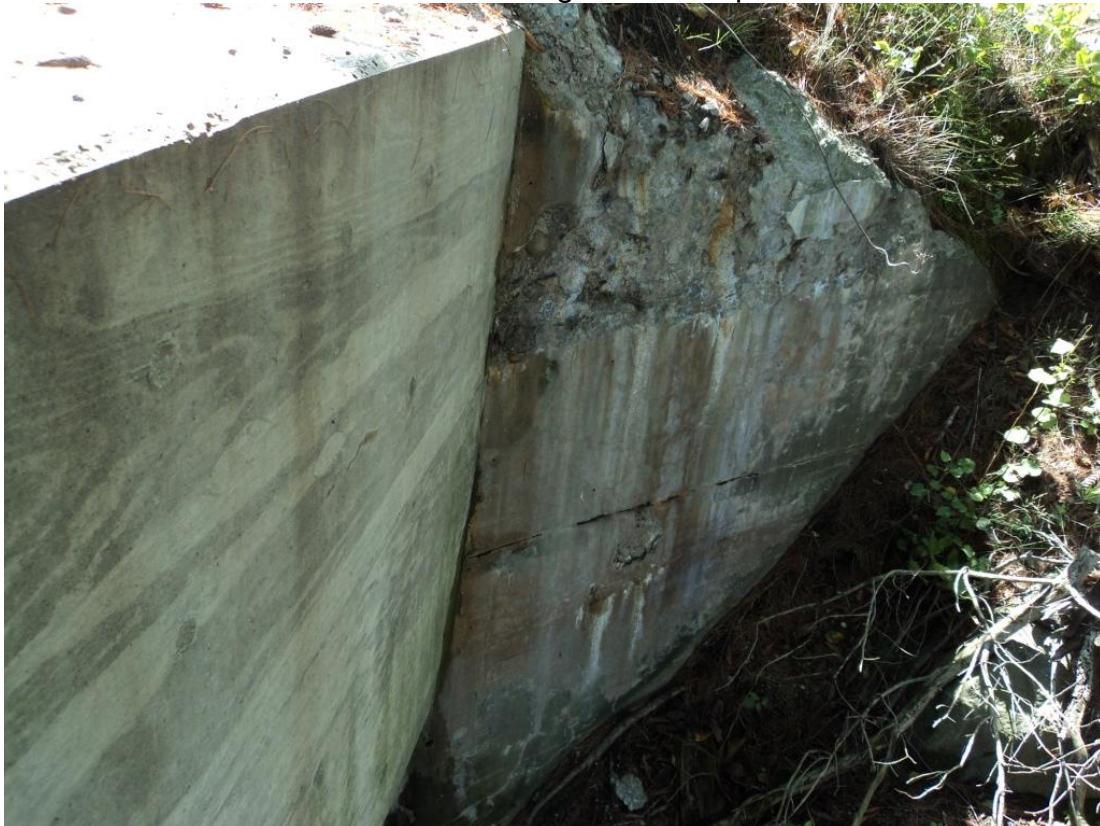
bridge seat and continues upward over the full height of the backwall (Photo 49). The south abutment backwall has severe map cracking outboard of the roadway truss along with heavy spalling in the sloped top portion. The northeast wingwall has map cracking with efflorescence (Photo 68). The southeast wingwall is in fair condition with two spalls less than 2 SF each in size and a medium vertical crack extending from the top to the base (Photo 69). The southwest wingwall is in poor condition with a large deep spall continuous along the top for full length of the wingwall (Photo 70).

Photo 70 – The southwest wingwall is in poor condition with a large deep spall continuous along the top for full length of the wingwall.

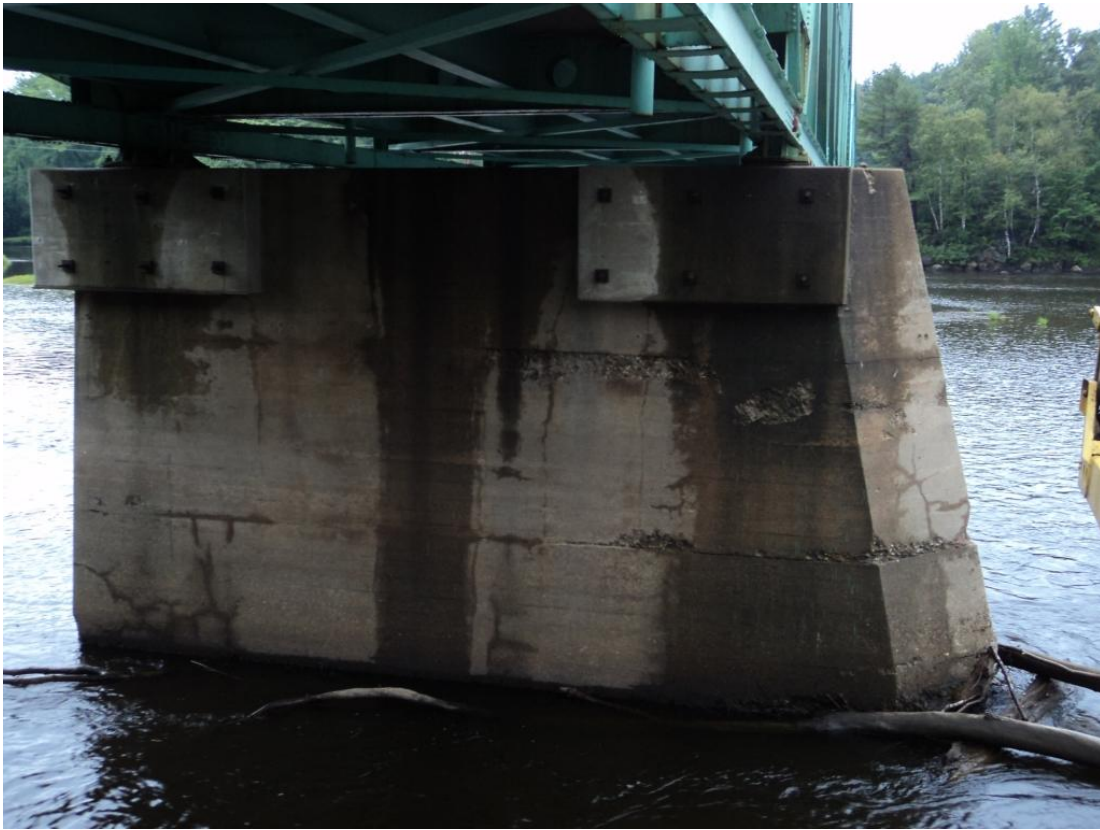
Photo 71 – Both faces of both piers have been previously retrofitted with Dywidag post-tensioned concrete encasement repairs immediately below both truss bearings.

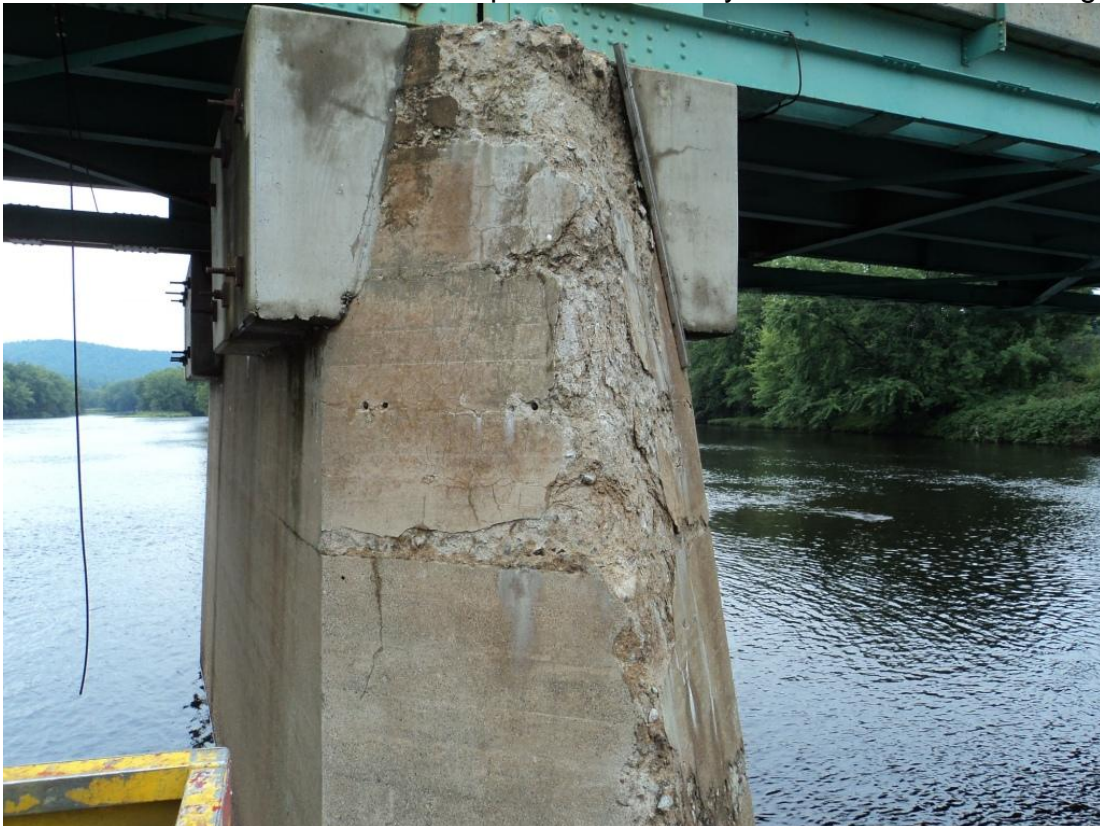
17. The west end of Pier 2 has a zone of spalls and scaling along the full height of the icebreaker edge (Photo 72).

Photo 72 – The west end of Pier 2 has a zone of spalls and scaling along the full height of the icebreaker edge. Looking east in the downstream direction at upstream end of pier.

Recommendation: Perform spall repairs to remove and replace unsound concrete at the Pier 2 icebreaker edge.

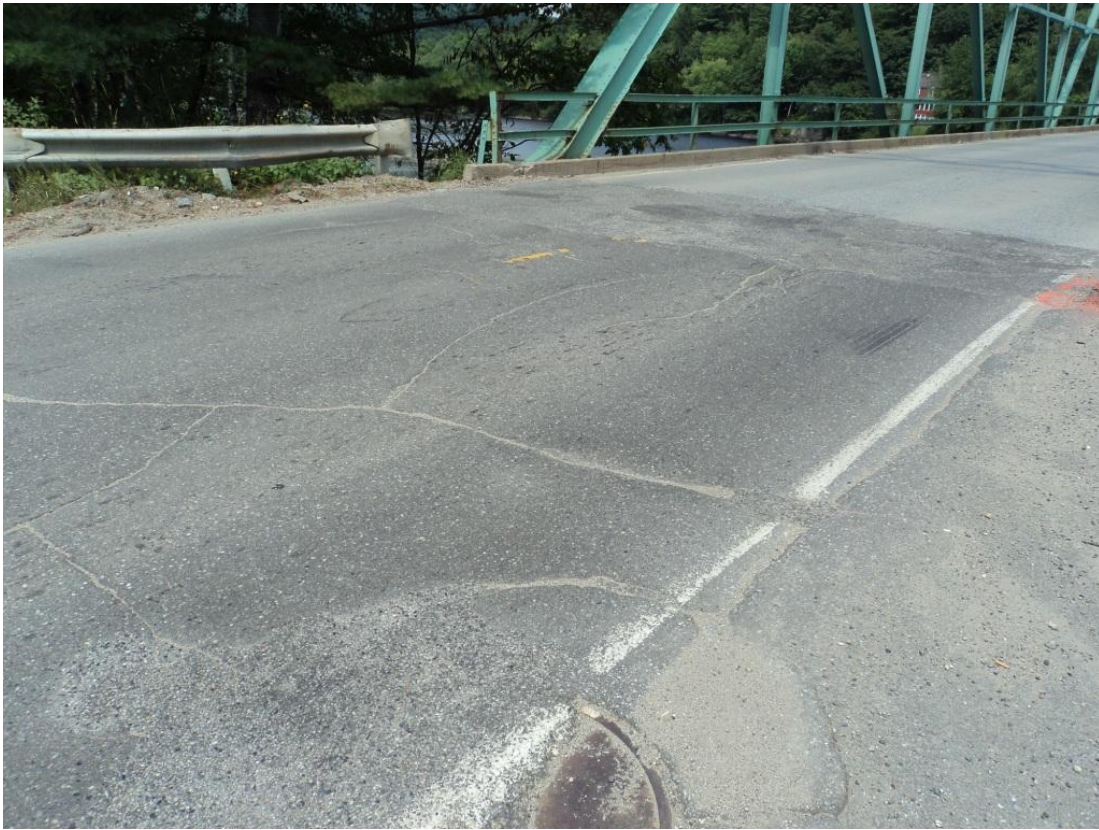
Photo 73 – The south approach pavement has numerous wide cracks and depressions which result in a rough surface. Also note substandard southwest corner guiderail.

Recommendation: Replace the existing guiderails within 25 feet of each corner of the bridge with properly stiffened guiderail conforming to current standards. Install missing guiderail in the northwest corner

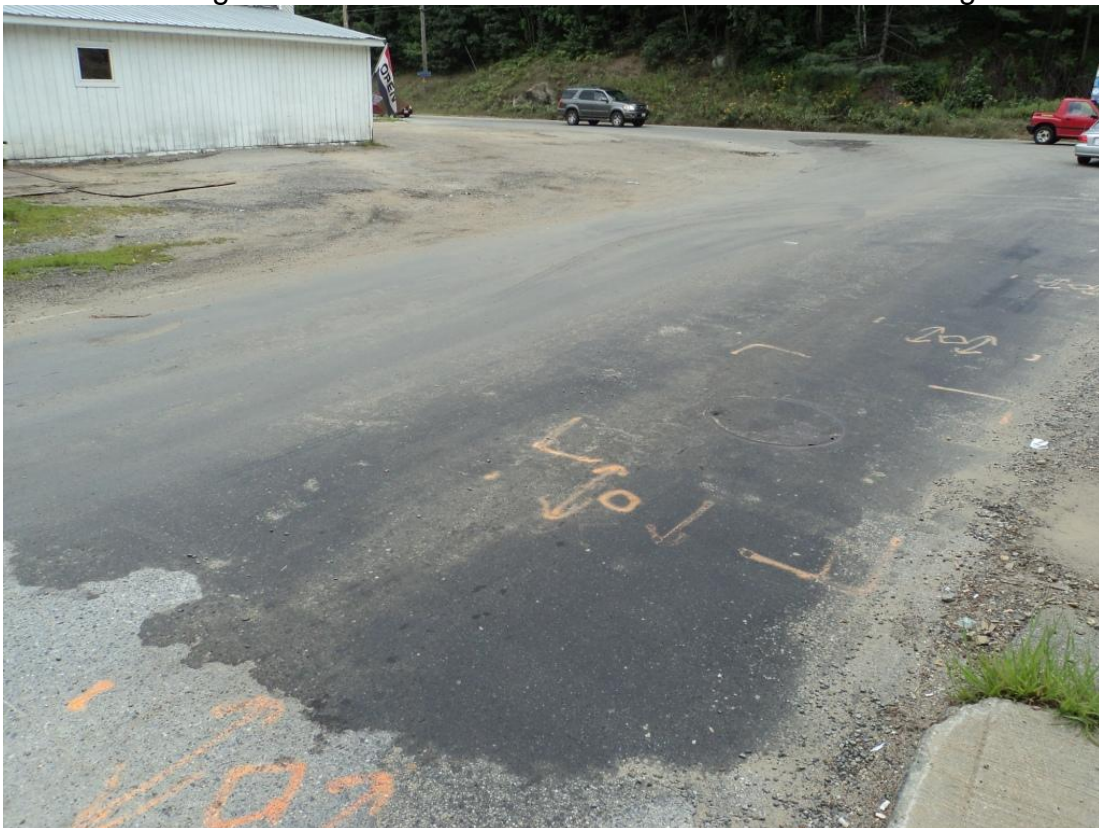
Photo 74 – At time of inspection there was an active construction project underway along US 2 which appeared to include resurfacing work to north approach still to be completed.

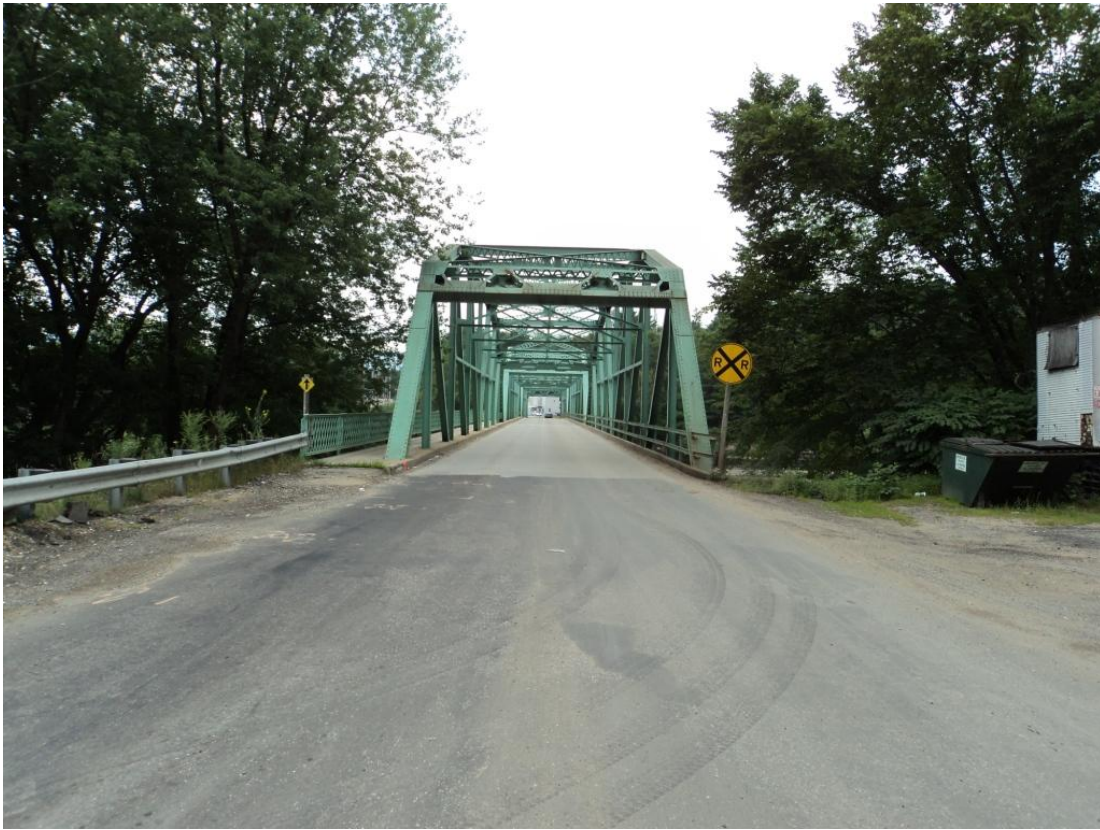
18. The approach guiderails at the southwest and southeast corners are substandard due to lack of stiffening in the transition zones and lack of proper attachments to the bridge railings (Photo 73). The approach guiderail at the northeast corner is also substandard due to lack of stiffening in the transition zone and lack of proper attachment to the bridge railing (Photo 75). The northwest bridge corner is missing guiderail entirely (Photo 75).

Photo 75 – Approach guiderail at the northeast corner is substandard due to lack of stiffening and proper attachment to bridge railing. Northwest corner is missing guiderail.

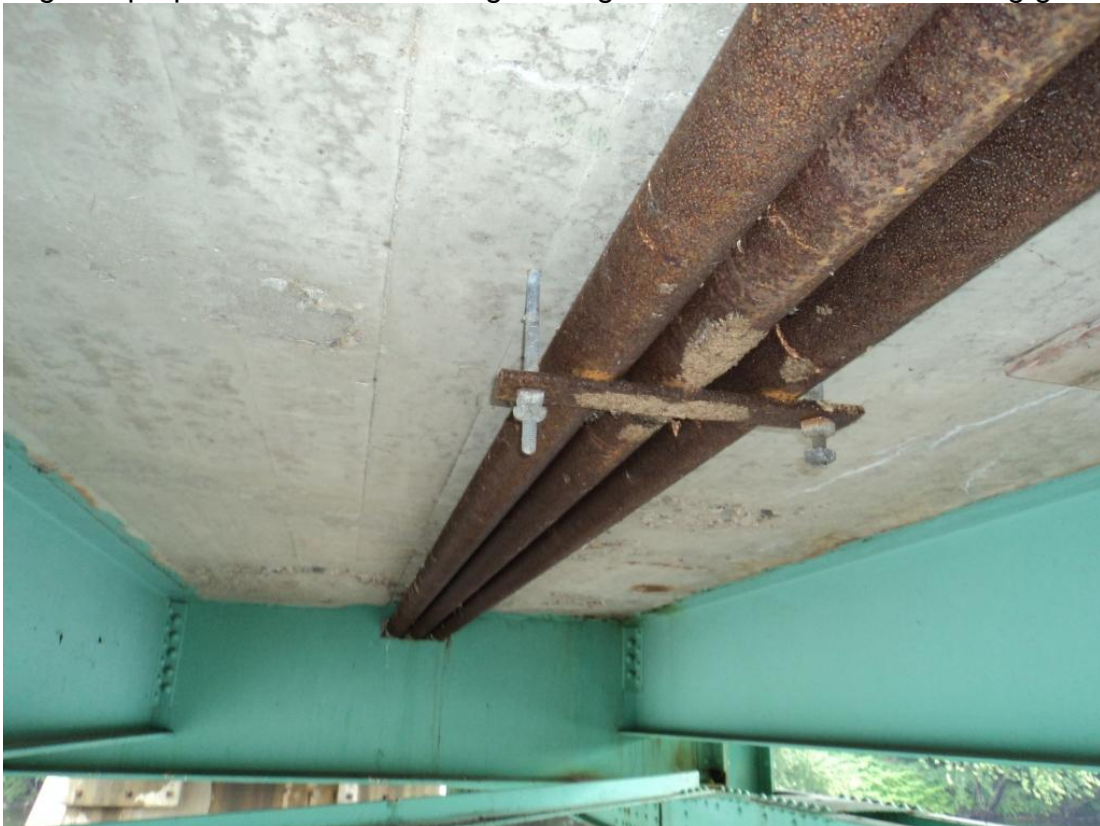
Photo 76 – Three under-deck utility pipe conduits are located between S3 and S4 running full length of the bridge. Looking north. Note hanger rods embedded in deck.

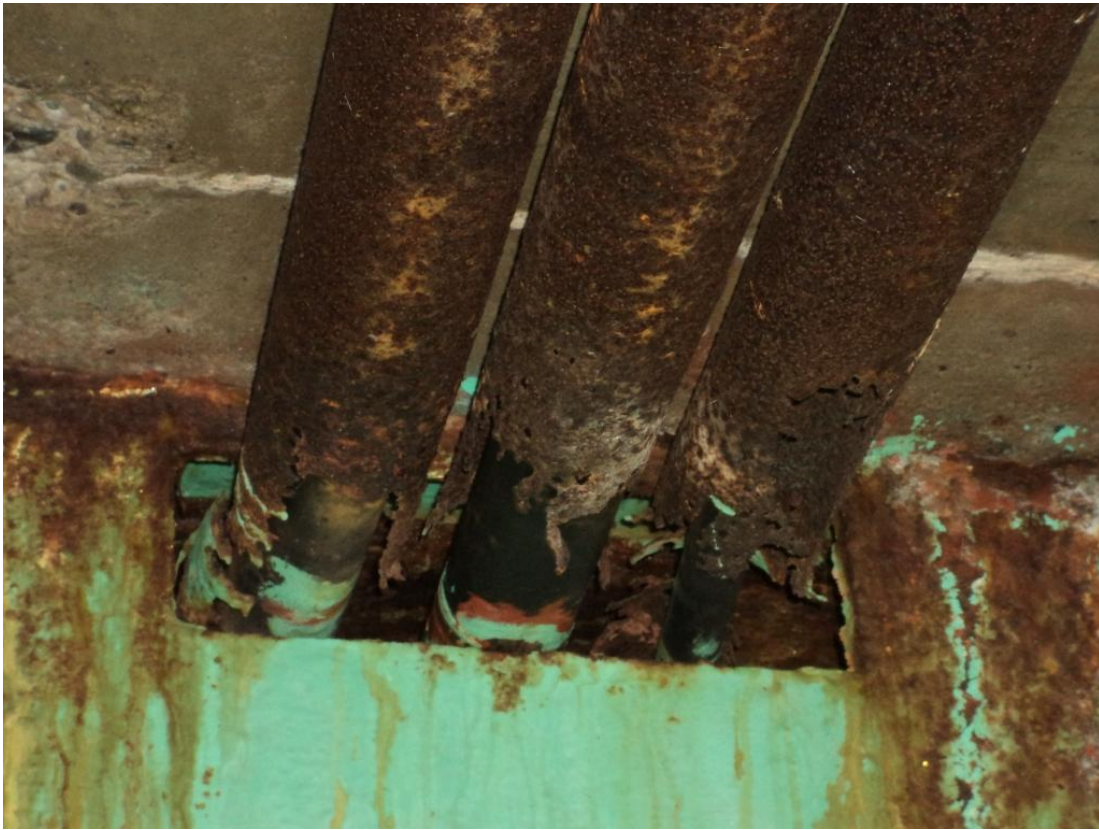
Photo 77 – At the FB8 end floorbeam in Span 2 the three metallic conduits are severely corroded and completely perforated, exposing the electrical cables over a one foot length.
