State of Maine
Mackworth Island
Renovations Phase 1

Falmouth, Maine

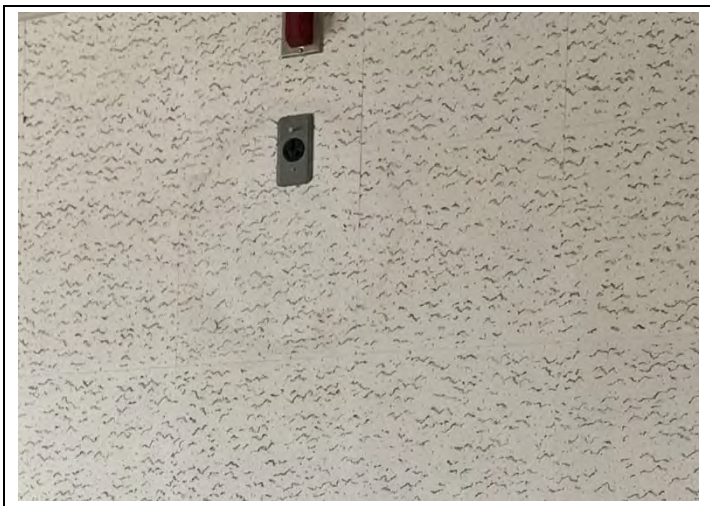
5. HG10 ACM 1' x 1' Fixed Wall Tiles, Fissure and Dot Style, Building G, Acoustic Room

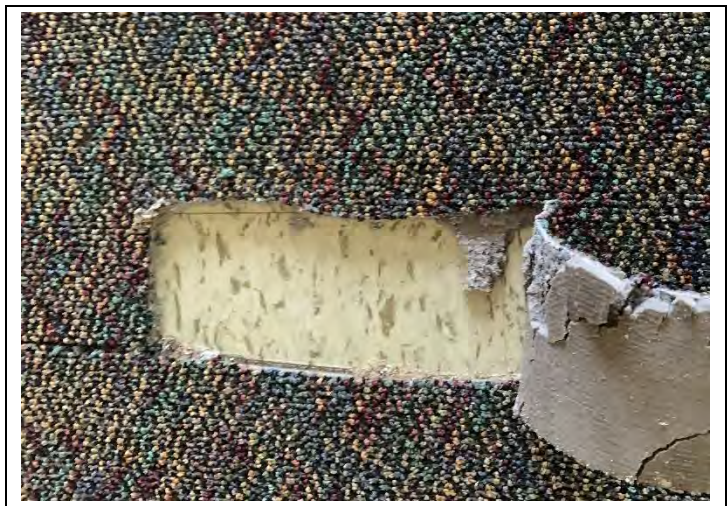
6. HG13, HG21 & HG2D ACM – Building G, 12" Vinyl Floor tile with mastic, under carpets

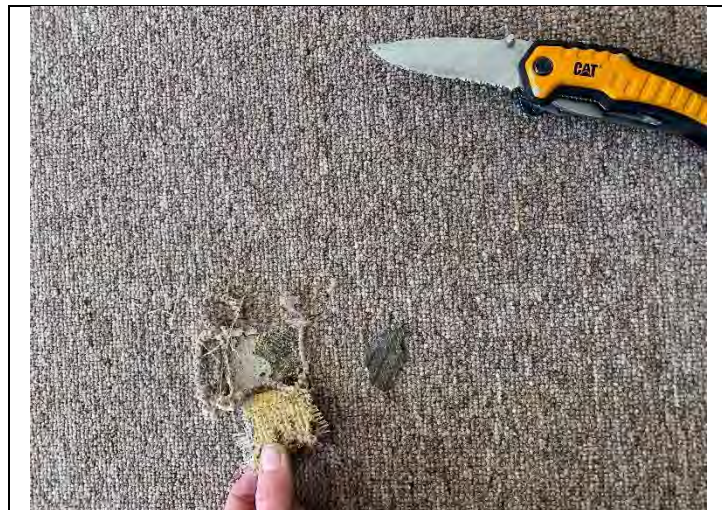
10. HG3 ACM Carpet Adhesive, found in hallway space of Building G, on concrete

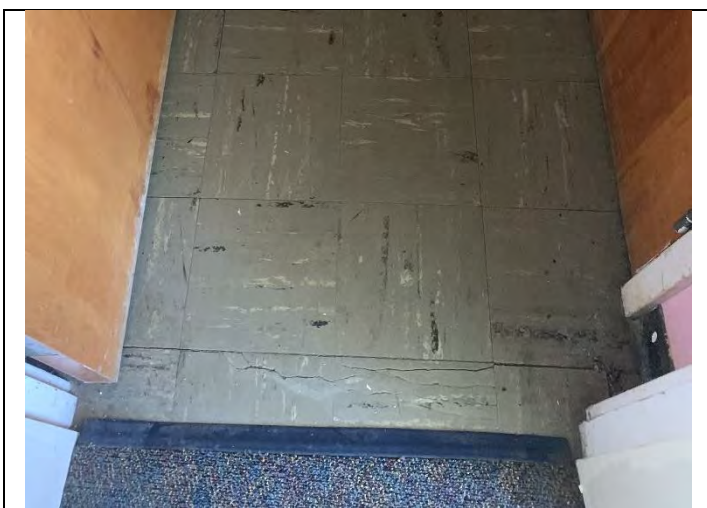
11. HG6 Grey 9" Floor tile with Mastic, in bathroom, kitchen and closets spaces throughout classrooms of Building G, to include under carpet and 12" Floor Tile

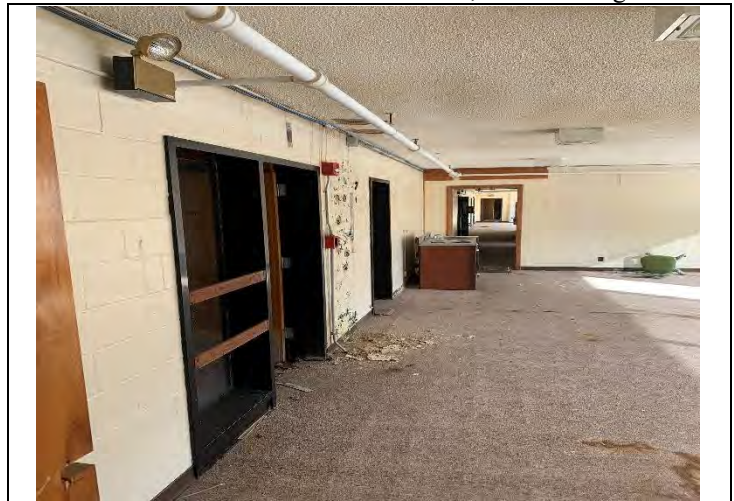
16. Building B 2nd floor carpet – showing imprint of loose and damaged 9" ACM Vinyl Floor Tile underneath - throughout

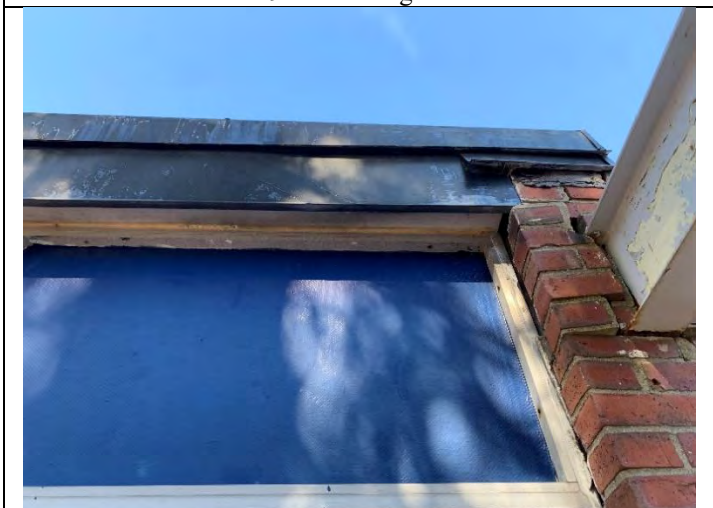
17. ACM Transite Transoms over Fire Doors, Building G, SW Exterior

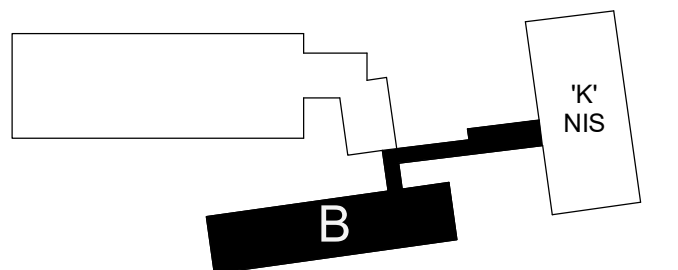
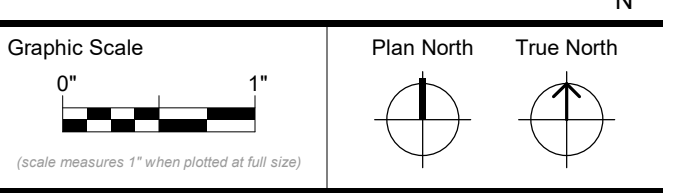
PRELIMINARY NOT FOR CONSTRUCTION

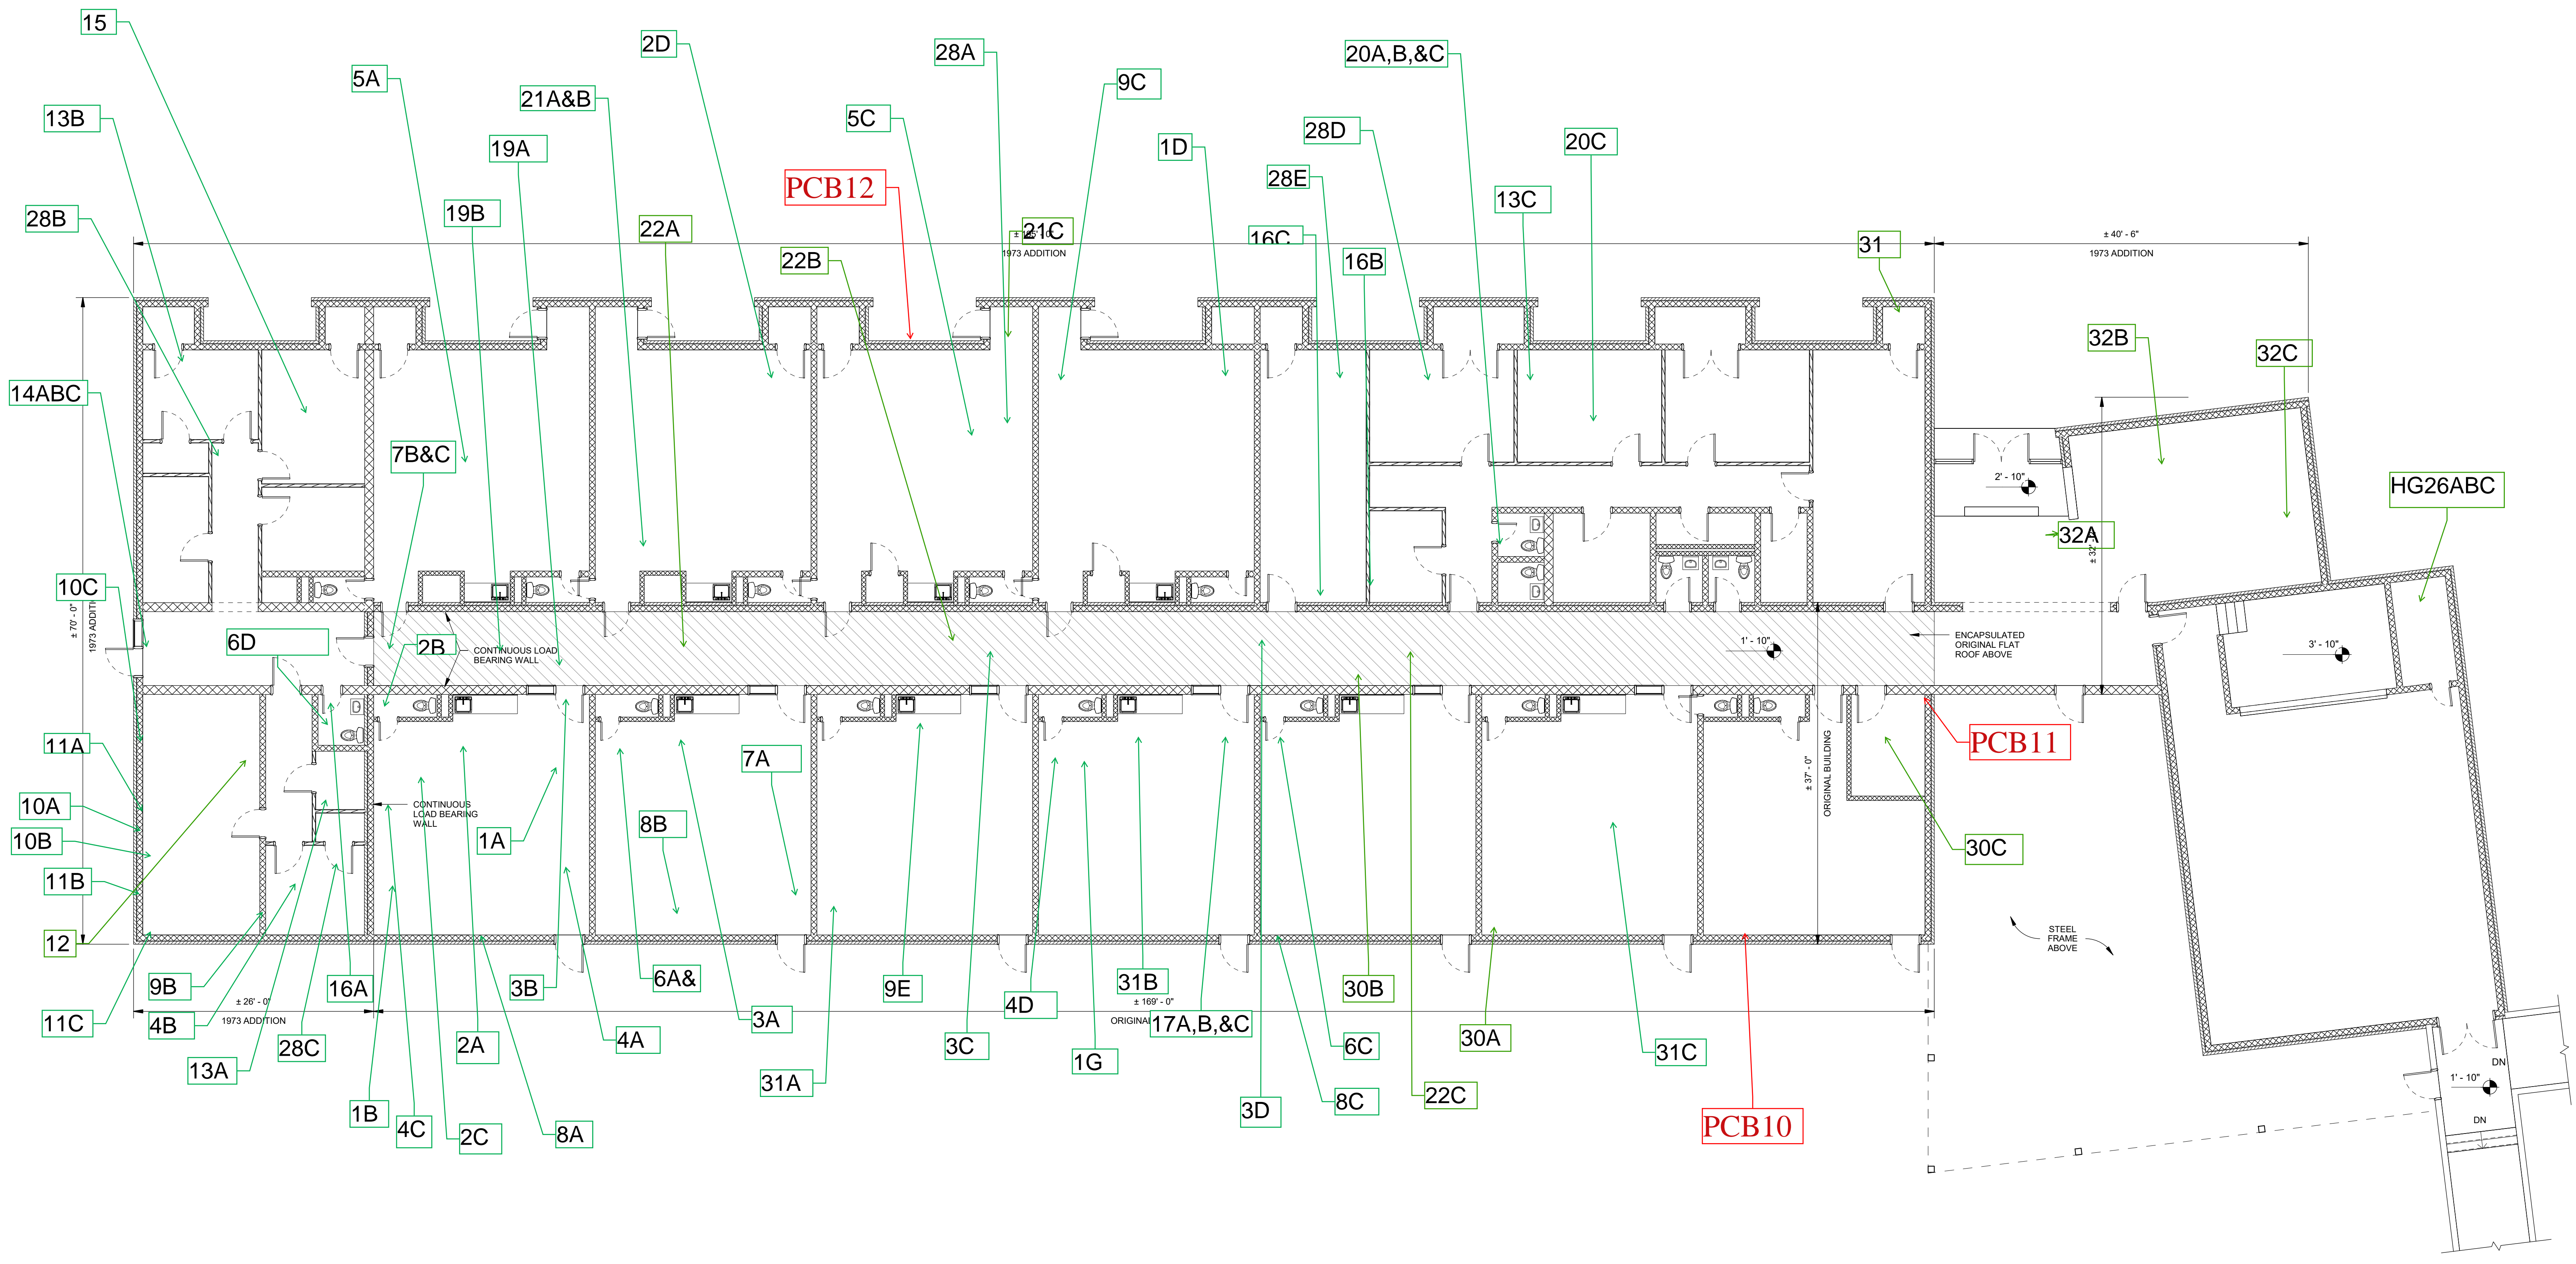
- ANY ASSOCIATED UTILITIES SERVING BUILDINGS 'B' AND 'G' FROM DISTRIBUTION THAT ALSO CONNECTS TO OTHER BUILDING IS TO BE DISCONNECTED WITH NO DISRUPTION OF SERVICE TO OTHER BUILDINGS. DISCONNECT WORK TO BE COORDINATED WITH OWNER AND UTILITY PROVIDER PRIOR TO ASSOCIATED WORK.

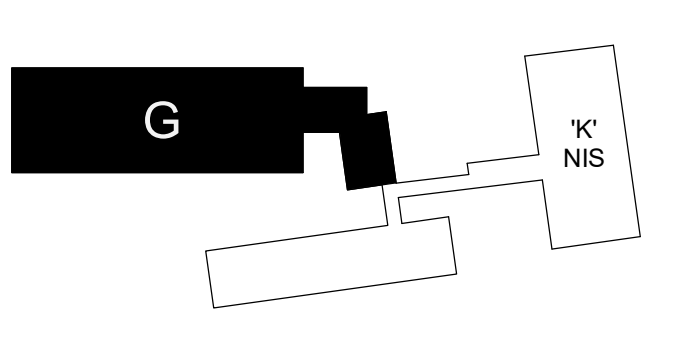
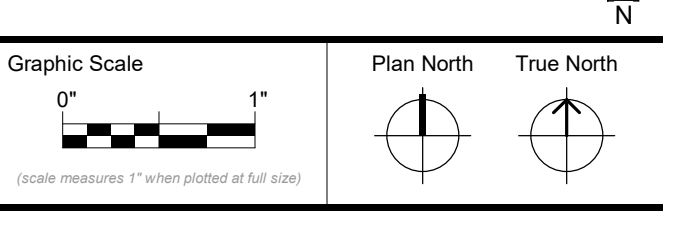
PRELIMINARY
NOT FOR
CONSTRUCTION

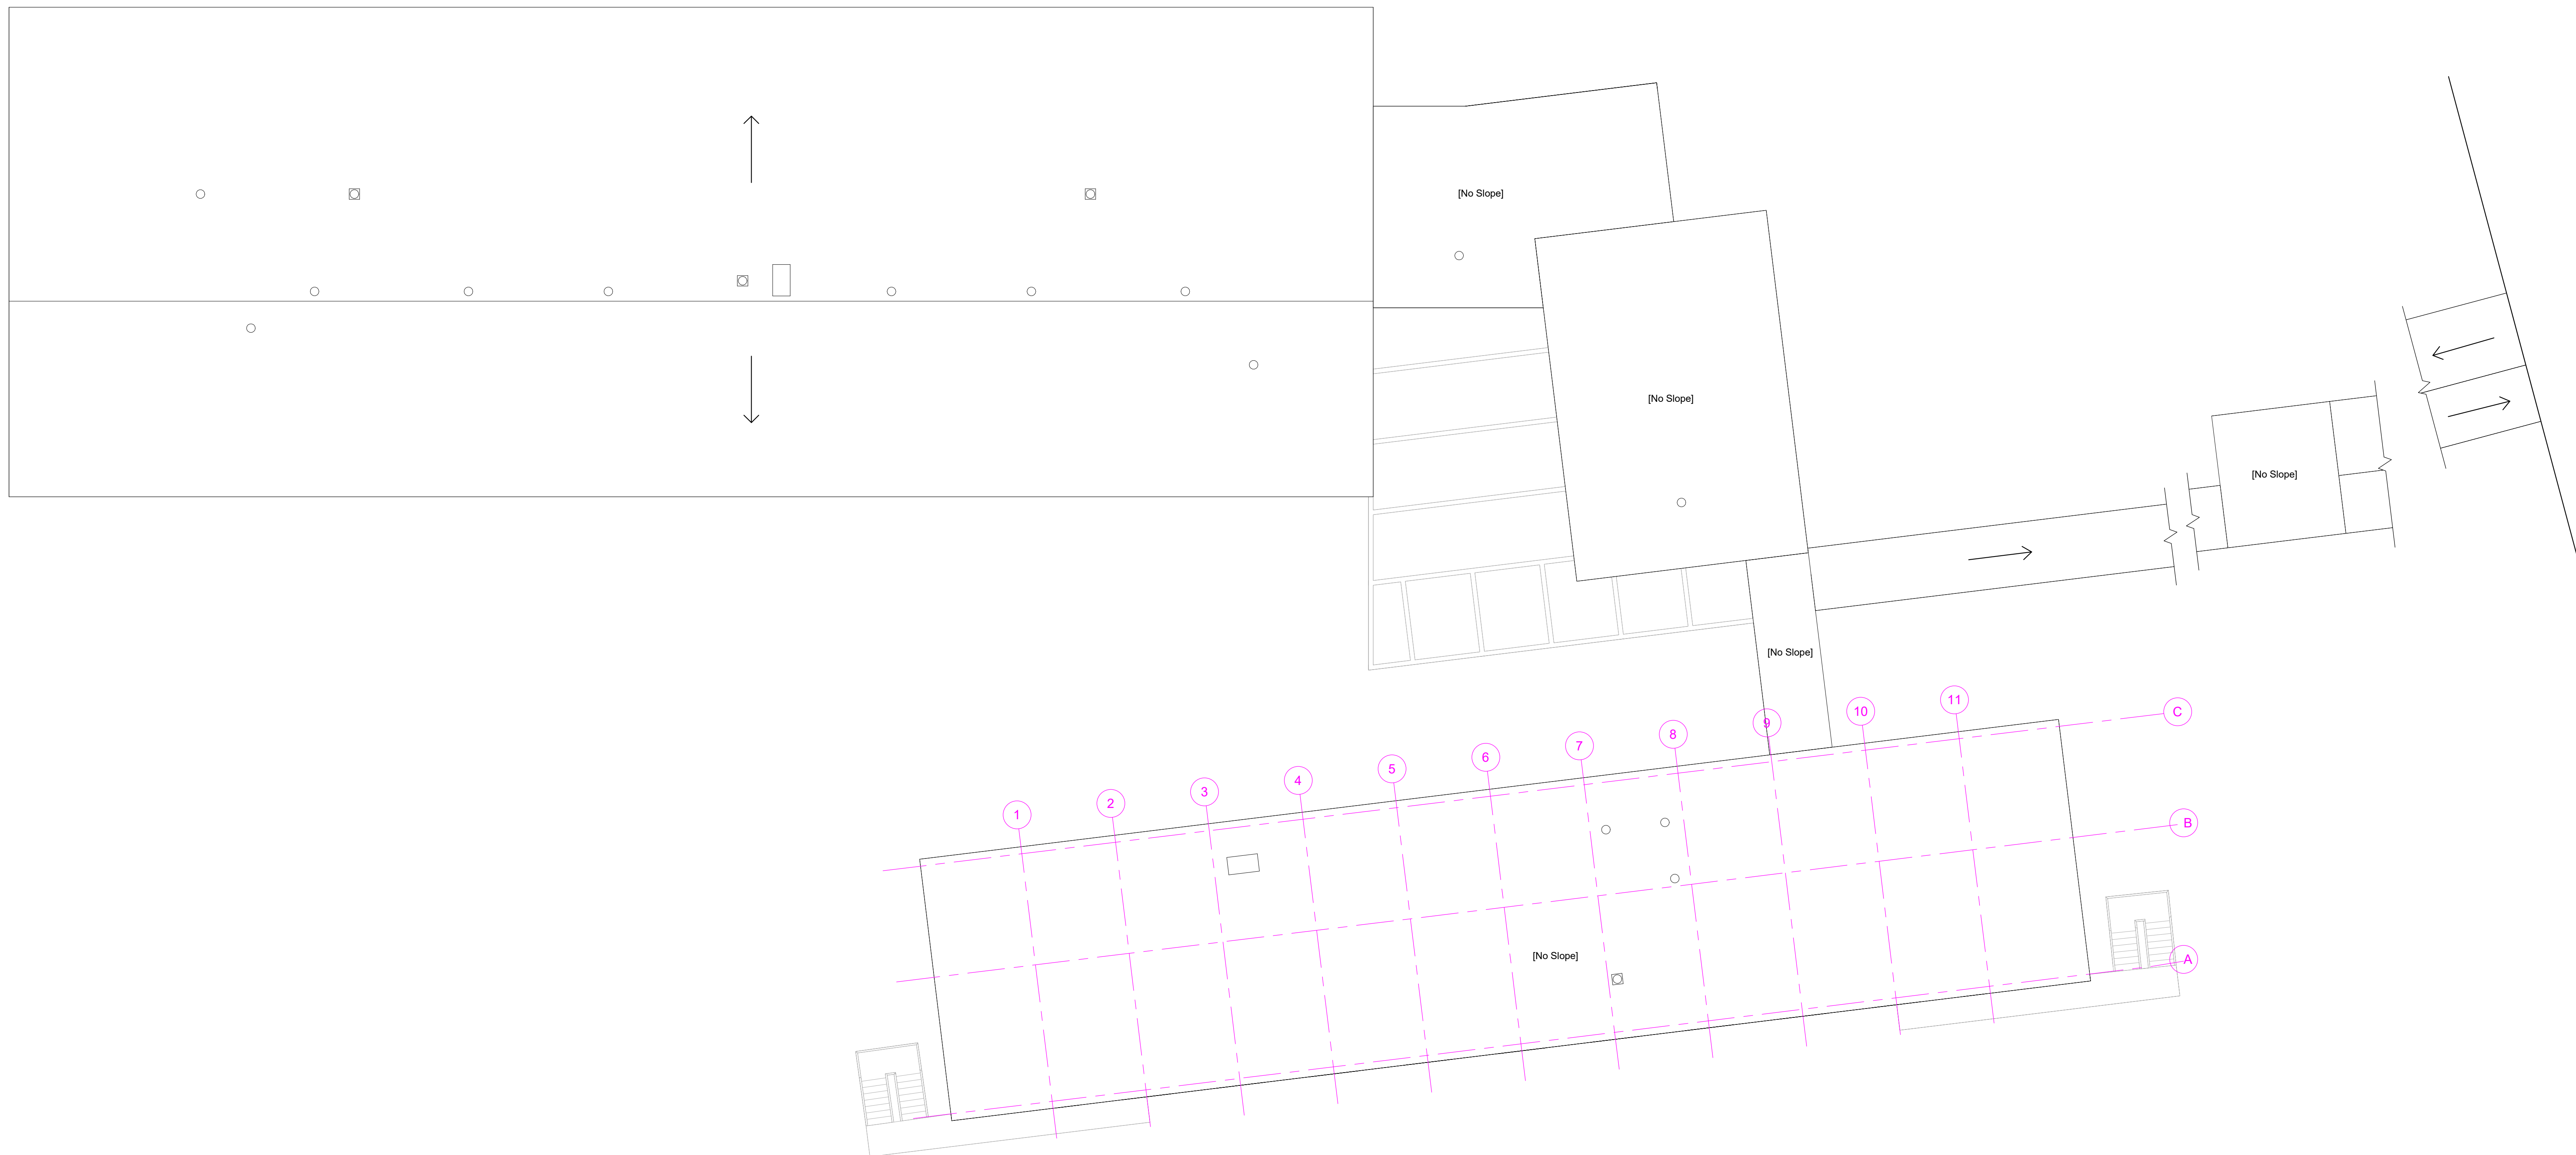
9. ANY ASSOCIATED UTILITIES SERVING BUILDINGS 'B' AND 'G' FROM DISTRIBUTION THAT ALSO CONNECTS TO OTHER BUILDING IS TO BE DISCONNECTED WITH NO DISRUPTION OF SERVICE TO OTHER BUILDINGS. DISCONNECT WORK TO BE COORDINATED WITH OWNER AND UTILITY PROVIDER PRIOR TO ASSOCIATED WORK.

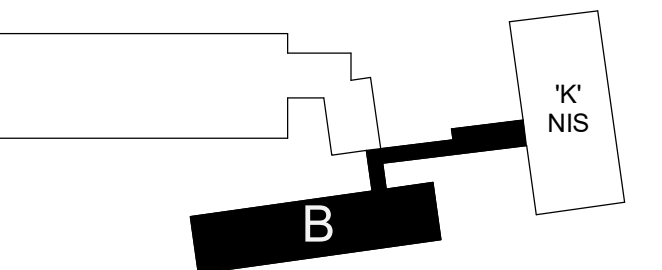
PRELIMINARY
NOT FOR
CONSTRUCTION

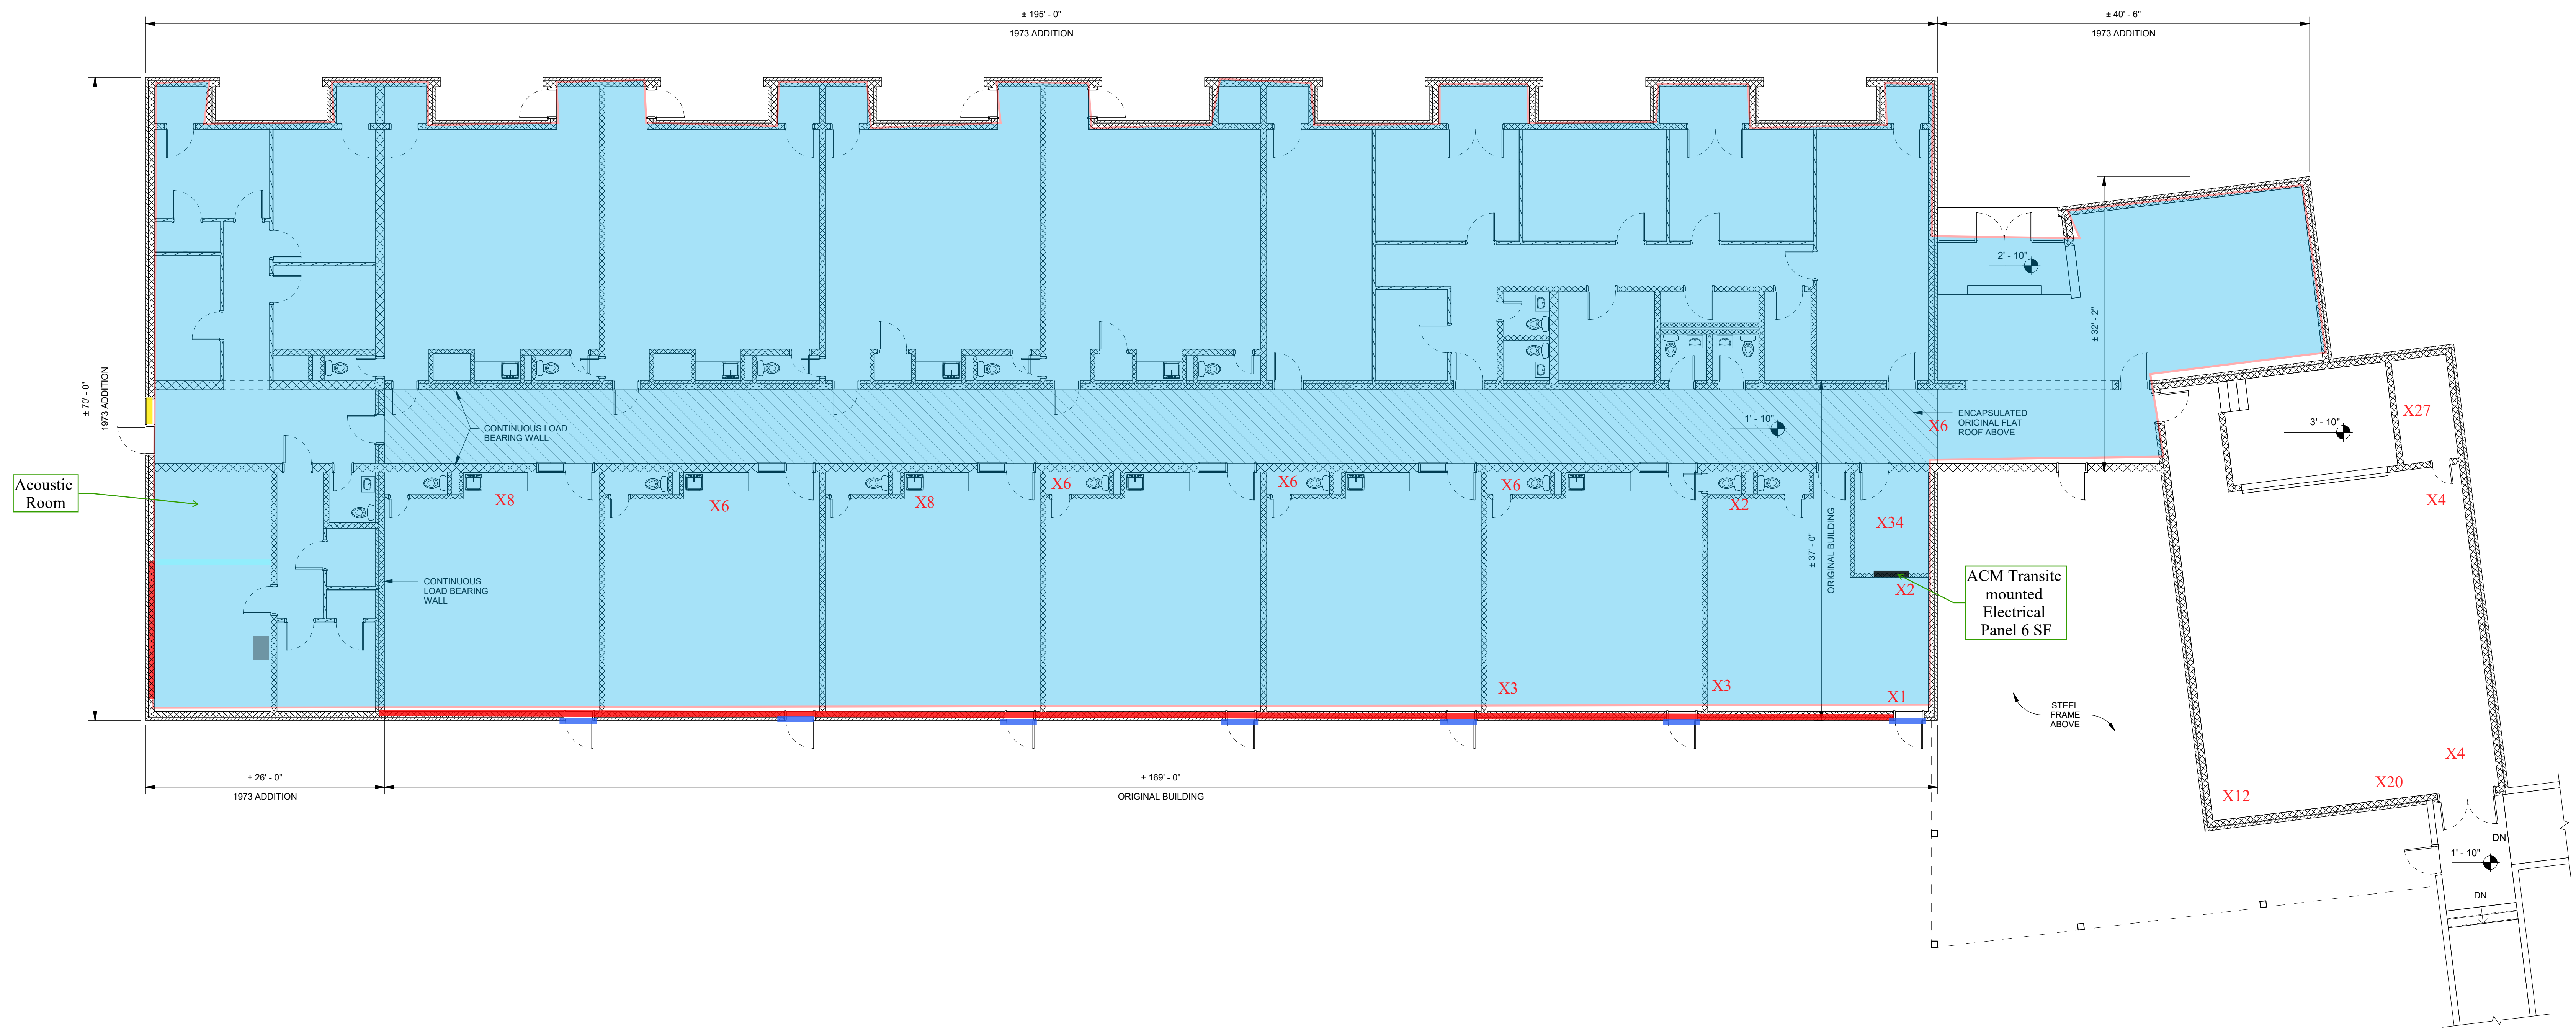
8. ANY ASSOCIATED UTILITIES SERVING BUILDINGS 'B' AND 'G' FROM DISTRIBUTION THAT ALSO CONNECTS TO OTHER BUILDING IS TO BE DISCONNECTED WITH NO DISRUPTION OF SERVICE TO OTHER BUILDINGS. DISCONNECT WORK TO BE COORDINATED WITH OWNER AND UTILITY PROVIDER PRIOR TO ASSOCIATED WORK.

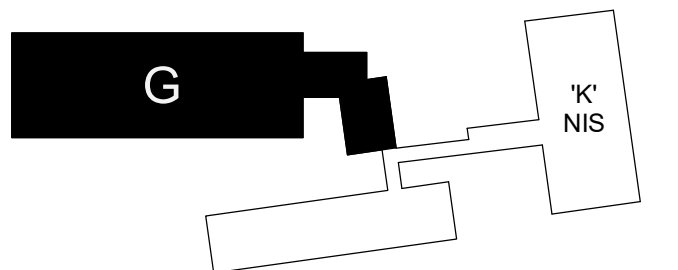
PRELIMINARY
NOT FOR
CONSTRUCTION

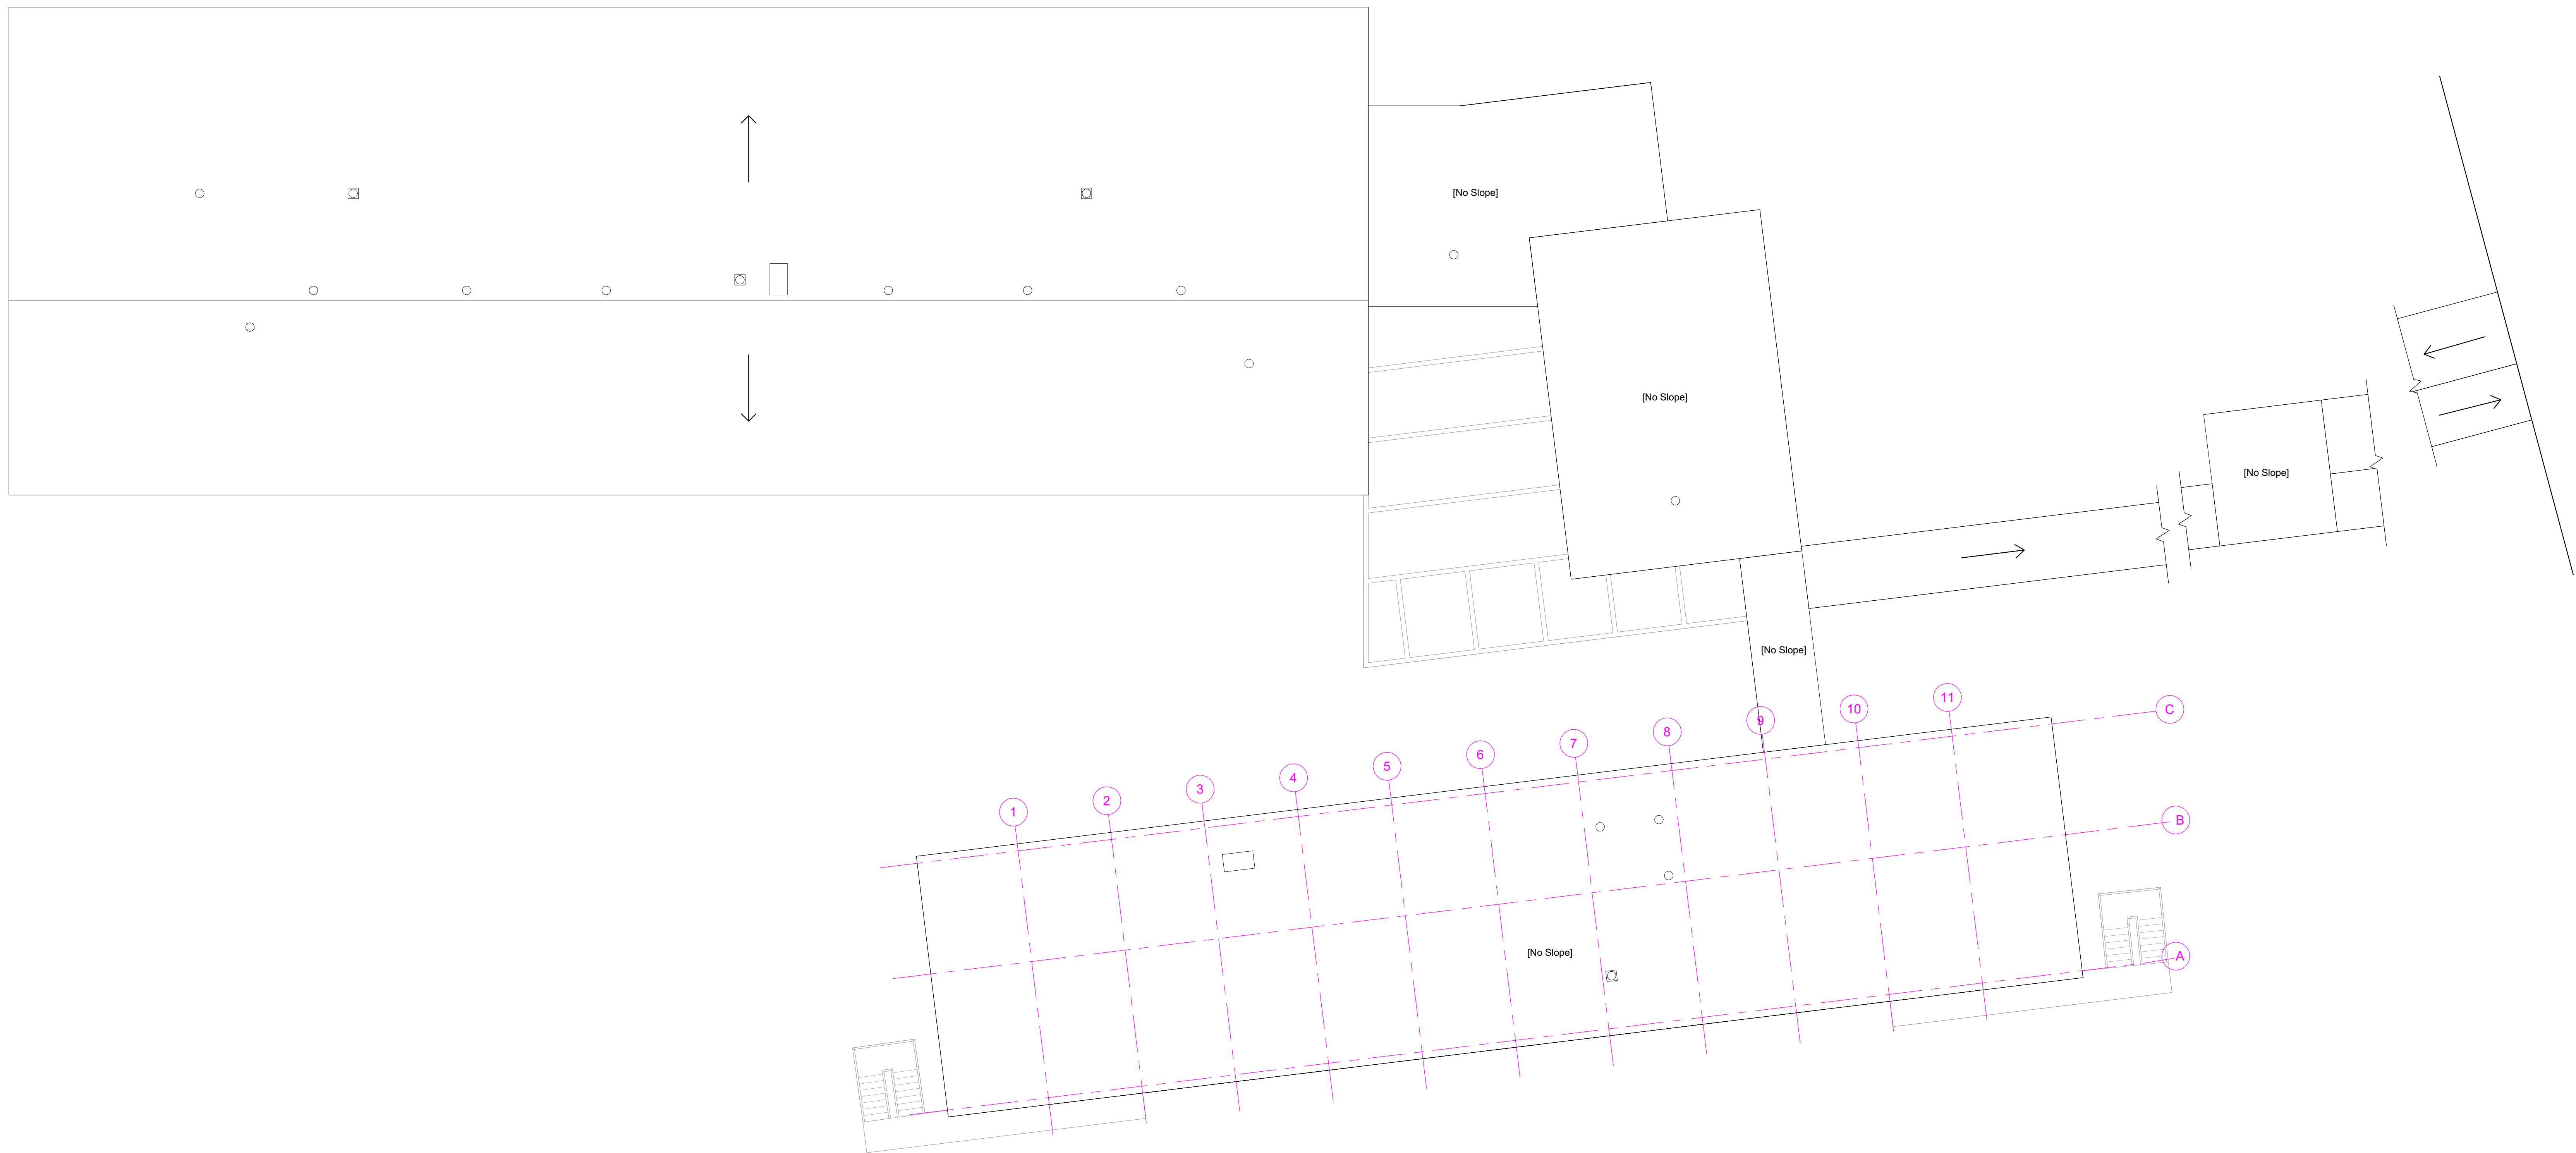
- ANY ASSOCIATED UTILITIES SERVING BUILDINGS 'B' AND 'G' FROM DISTRIBUTION THAT ALSO CONNECTS TO OTHER BUILDING IS TO BE DISCONNECTED WITH NO DISRUPTION OF SERVICE TO OTHER BUILDINGS. DISCONNECT WORK TO BE COORDINATED WITH OWNER AND UTILITY PROVIDER PRIOR TO ASSOCIATED WORK.

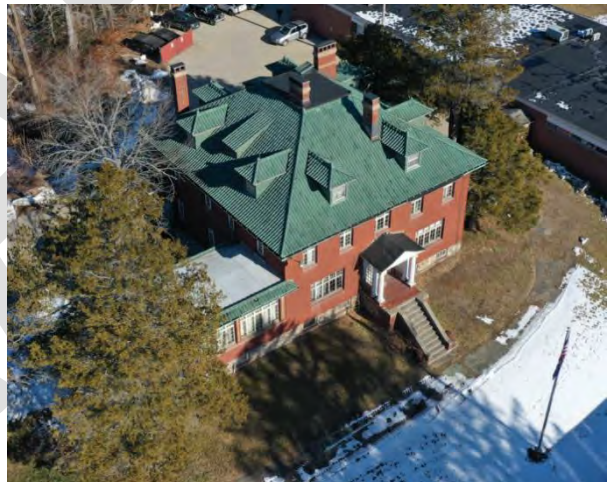
Image 1: View of the Mansion at the Governor Baxter School for the Deaf.

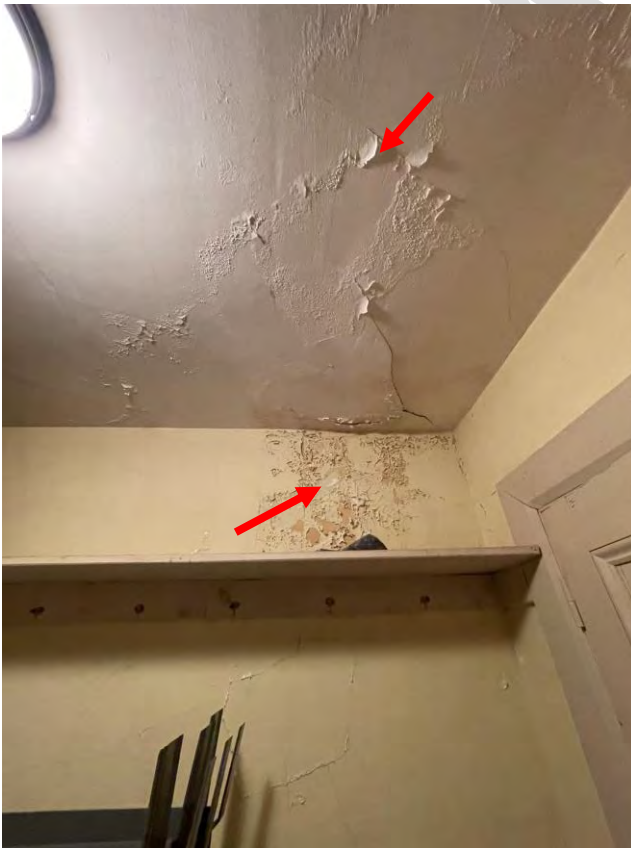
Image 6: View of water damage at second floor closet ceiling and wall.

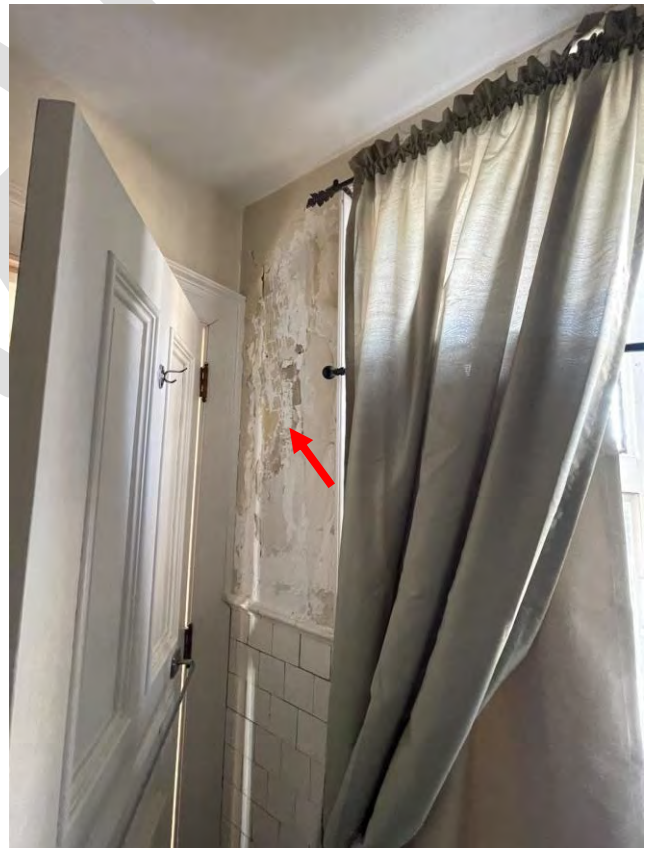
Image 7: View of water damage at first floor bathroom wall-southwest corner. Behind the bathroom door.

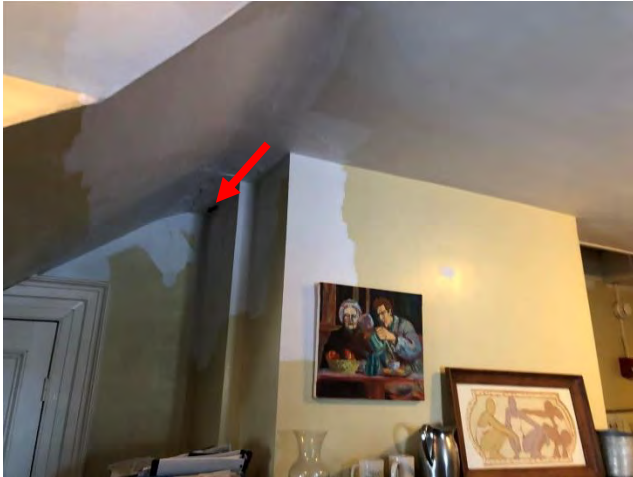
Image 8: View of water damaged plaster patching

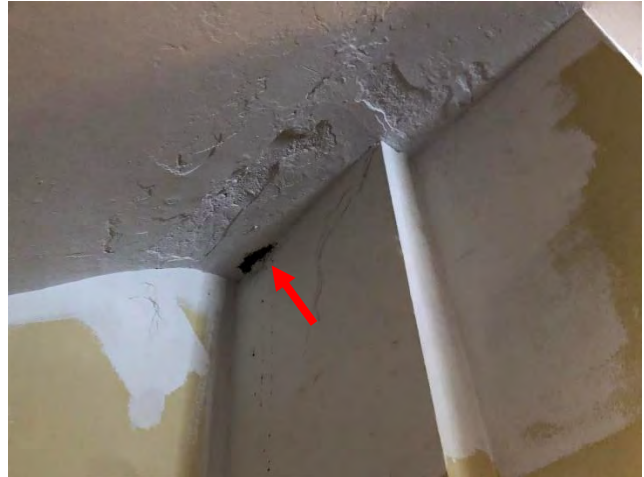
Image 9: View of damaged plaster ceiling

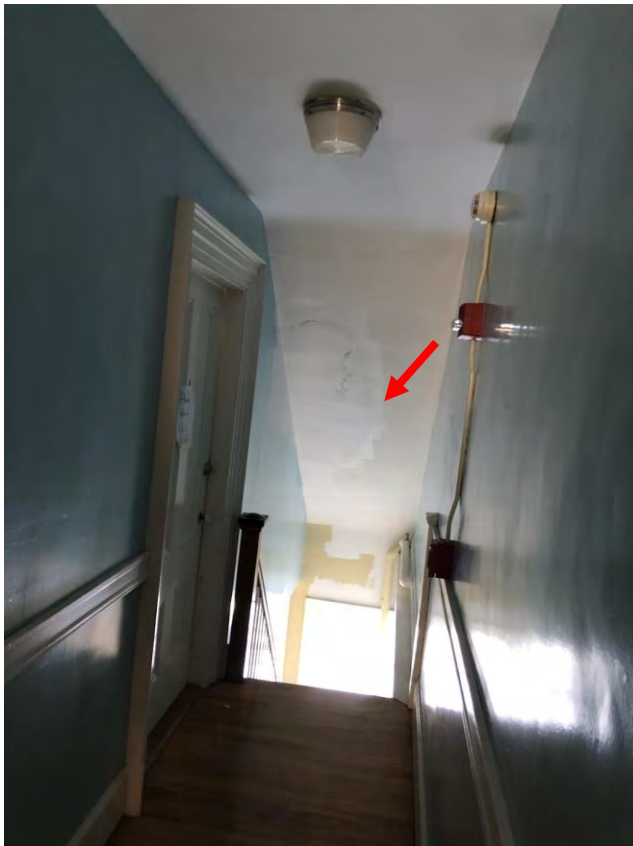
Image 10: View of water damaged ceiling in stairway

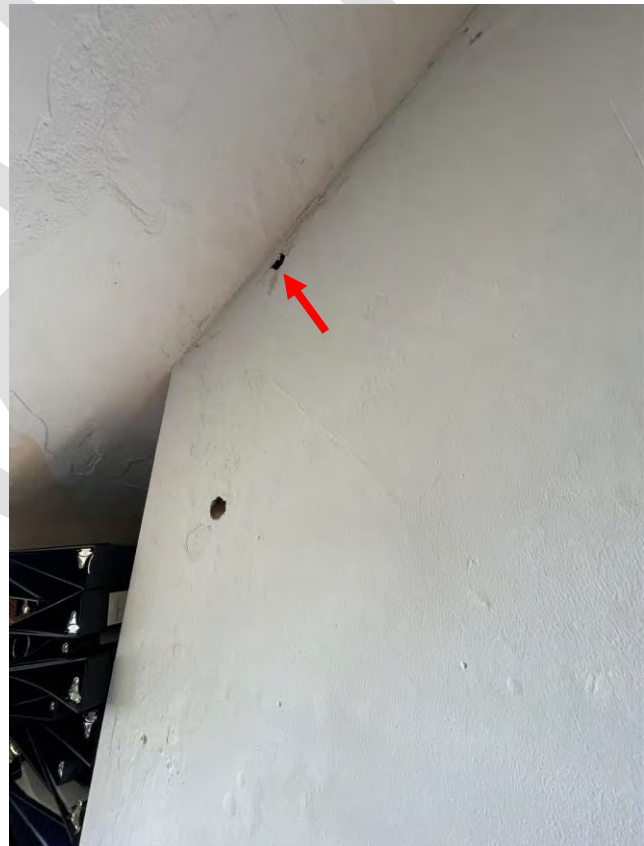
Image 11: View of water damaged plaster.

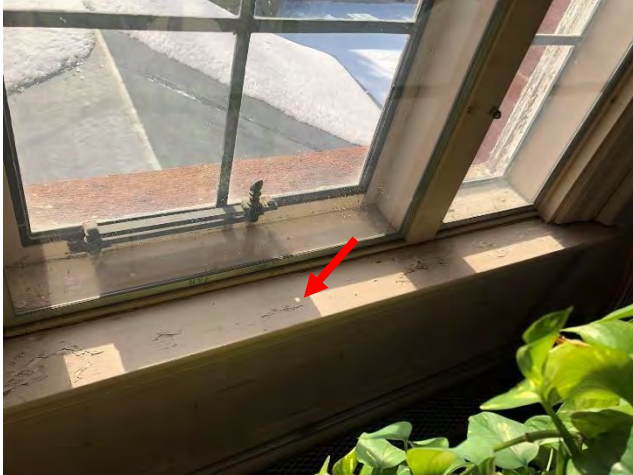
Image 12: View of painted interior windowsill with blistered and peeling paint.

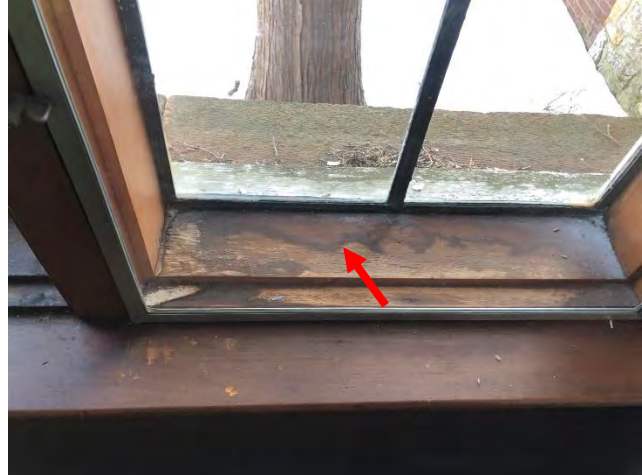
Image 13: View of interior bare wood windowsill with water-stained wood.

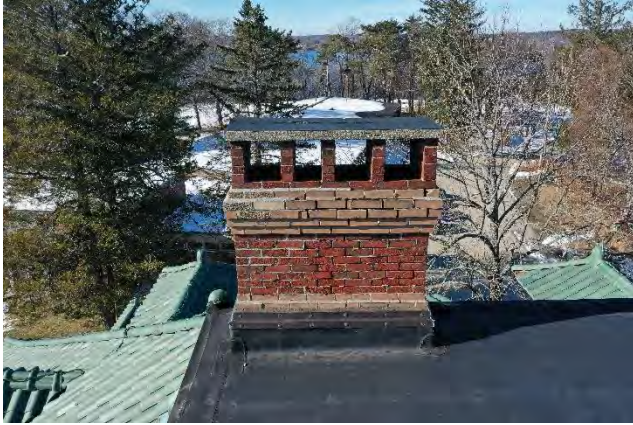
Image 14: View of chimney #1 that includes mortar deterioration, loose and displaced brick, poorly matched brick and mortar repairs.

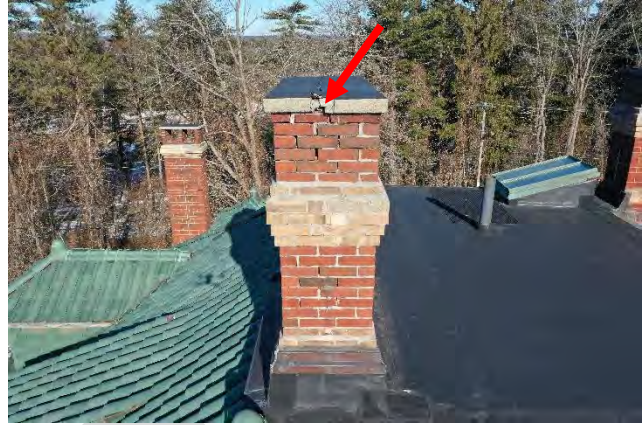
Image 15: View of chimney #1 that includes cracked cast stone cap, deteriorated and missing mortar, and poorly matched brick and mortar repairs.

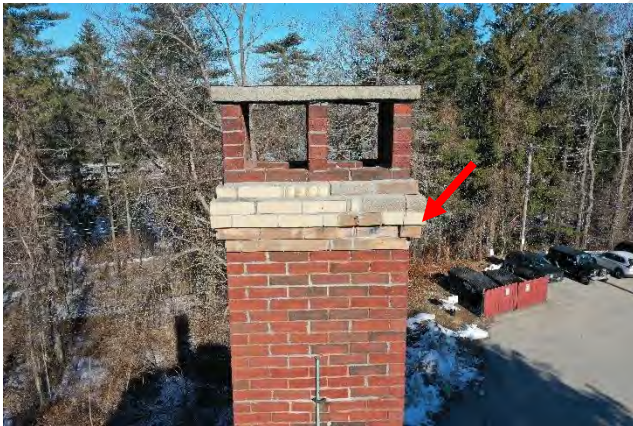
Image 16: View of chimney #2 that includes mortar deterioration, loose and displaced brick, and poorly matched brick and mortar repairs.

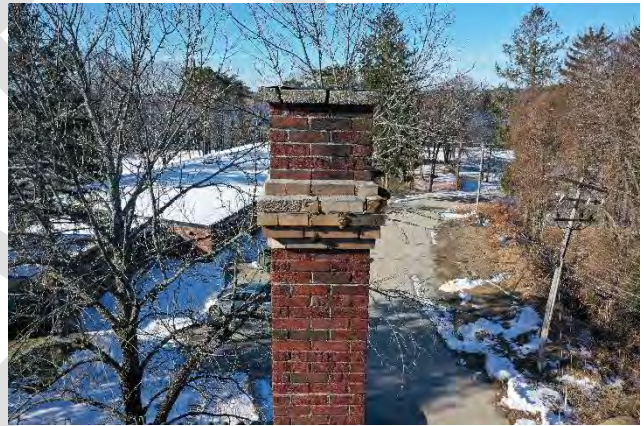
Image 17: Side view of chimney #2 that includes deteriorated mortar joints, loose and displaced brick at the yellow brick banding and cracked cap.

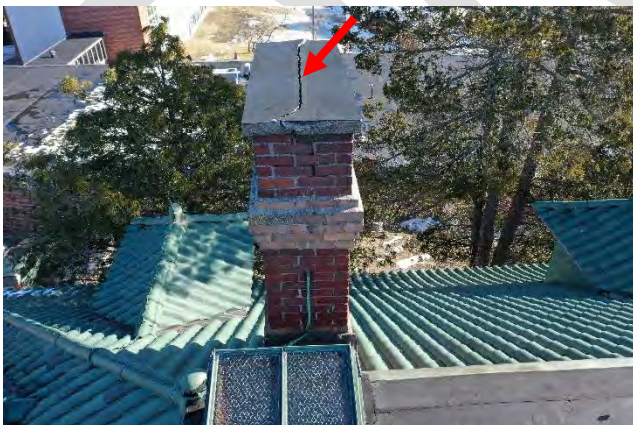
Image 18: View of chimney #3 that includes cracked cast stone cap, severe mortar deterioration and poorly matched brick and mortar repairs.

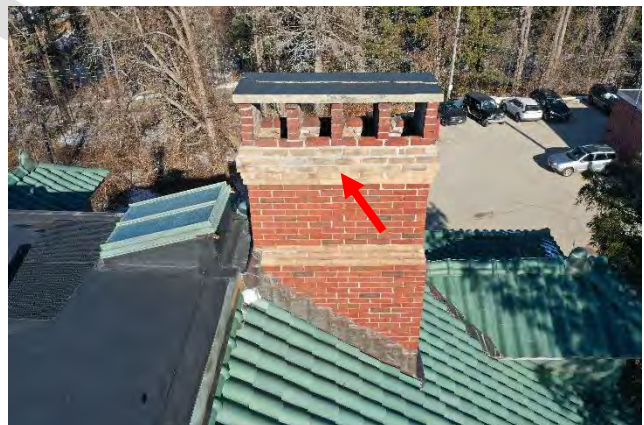
Image 19: View of chimney #3 that includes mortar deterioration in the yellow brick corbelling.

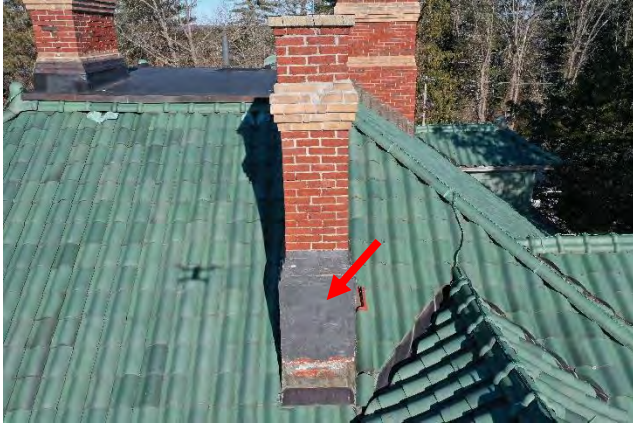
Image 20: View of chimney #4 with bituminous mastic repairs.

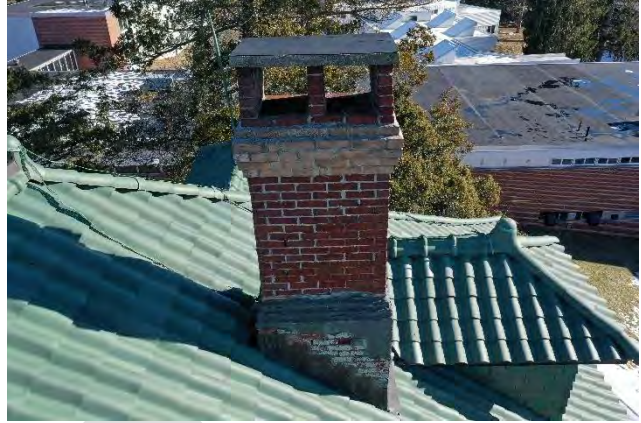
Image 21: View of chimney #4 that appears to have been rebuilt but with poorly matching and applied mortar. Also, notice bituminous mastic repairs.

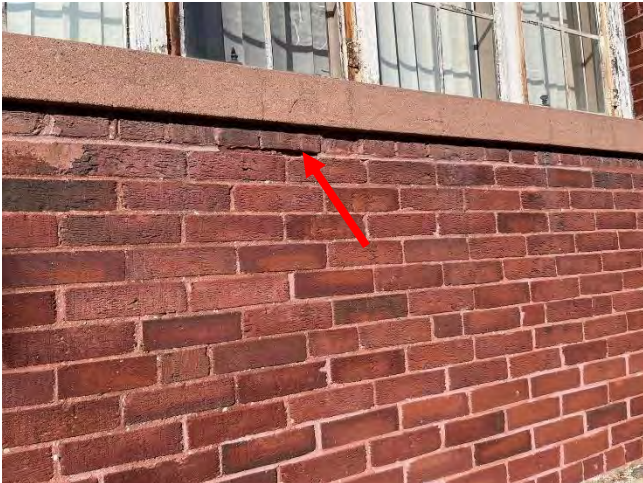
Image 22: Typical view of the existing red brick masonry and cast stone sill. Notice deteriorated mortar joint.

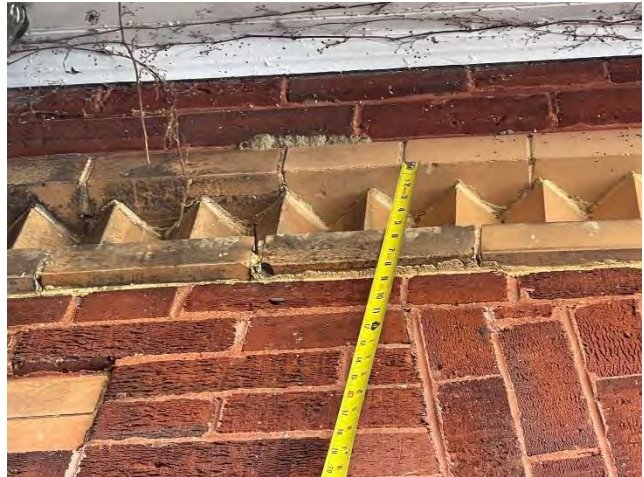
Image 23: View of decorative yellow brick banding with deteriorated mortar joints.

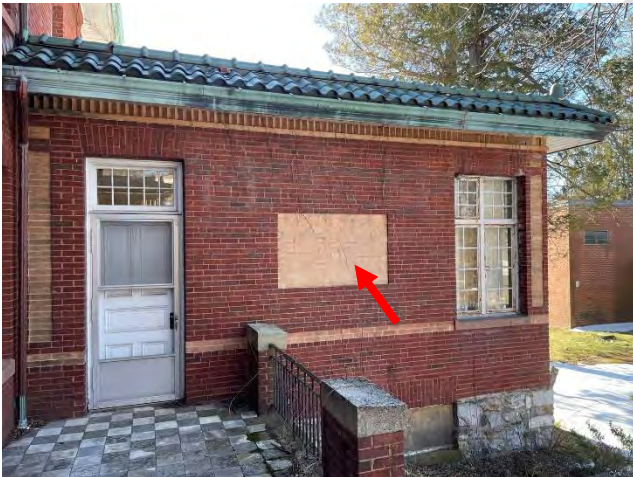
Image 24: Typical view of decorative yellow brick inlay.

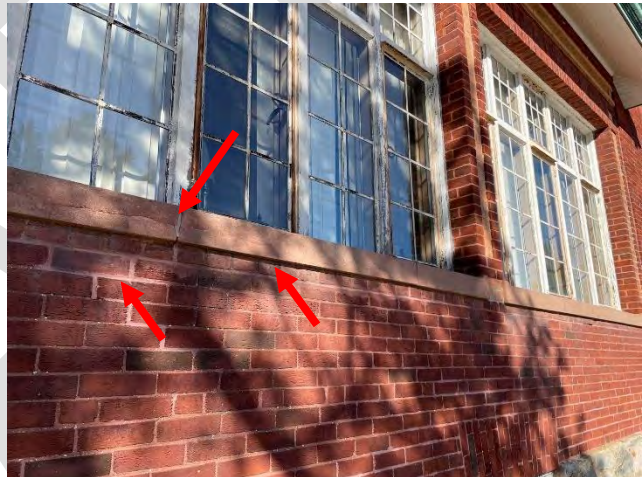
Image 25: View of cracked cast stone sills, spalled brick and poor mortar match at repair locations.
