State of Maine
Mackworth Island
Renovations Phase 1

Falmouth, Maine

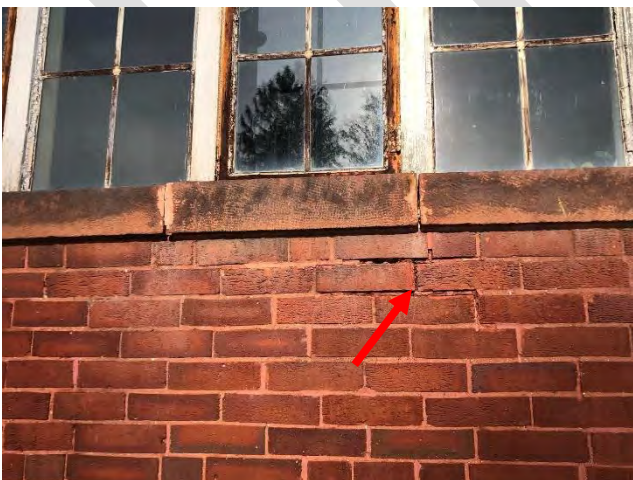
Image 26: View of eroded brick and cast stone sill mortar joints.

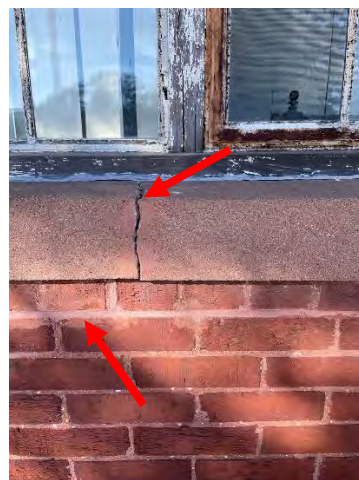
Image 27: View of crack cast stone sill and past mortar that were poorly matched to the existing.

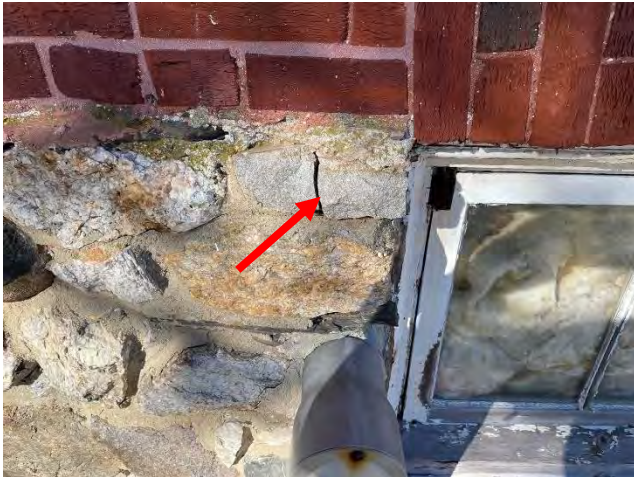
Image 28: View of cracked stone in foundation

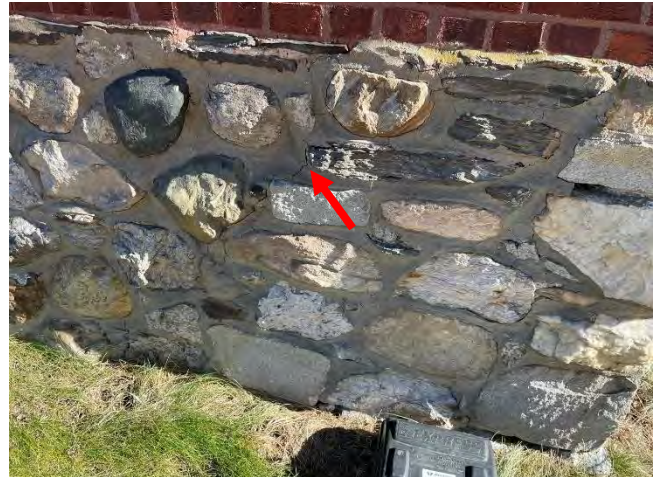
Image 29: Typical view of the existing stone foundation wall. Note the transverse crack in the mortar.

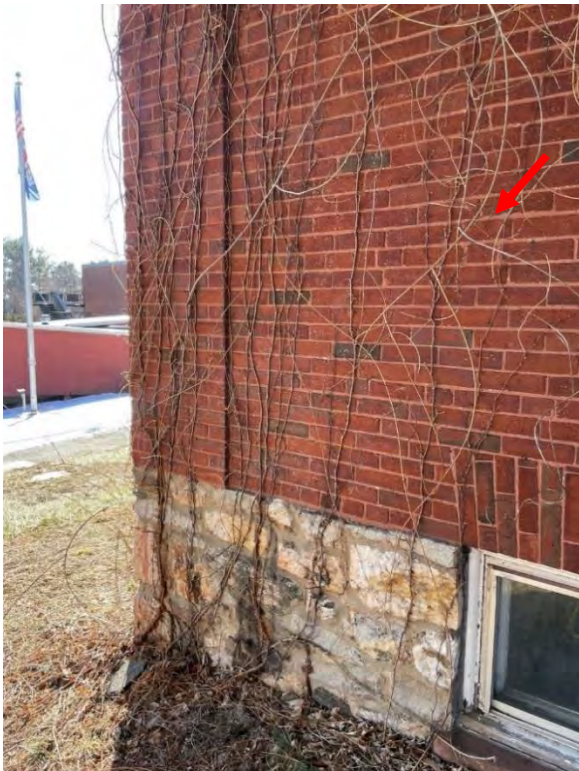
Image 30: View of vines growing against the southeast corner of the foundation.

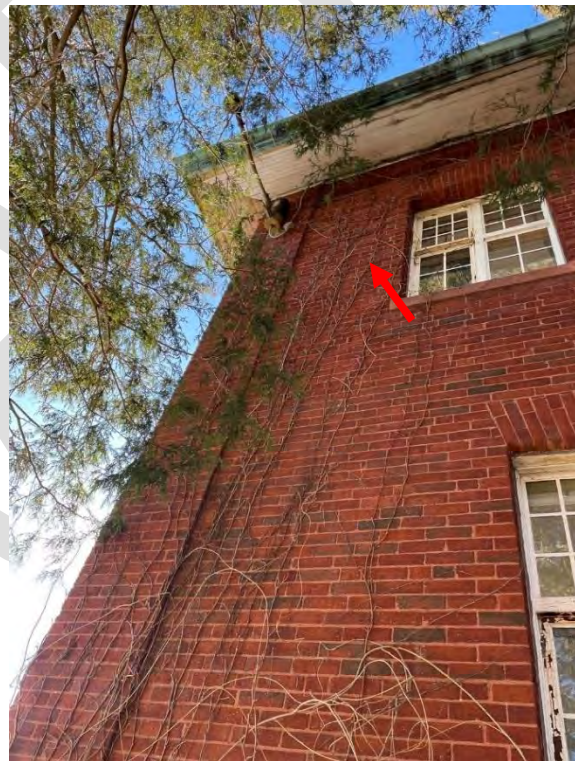
Image 31: View of vines growing up the brick wall near the southeast corner

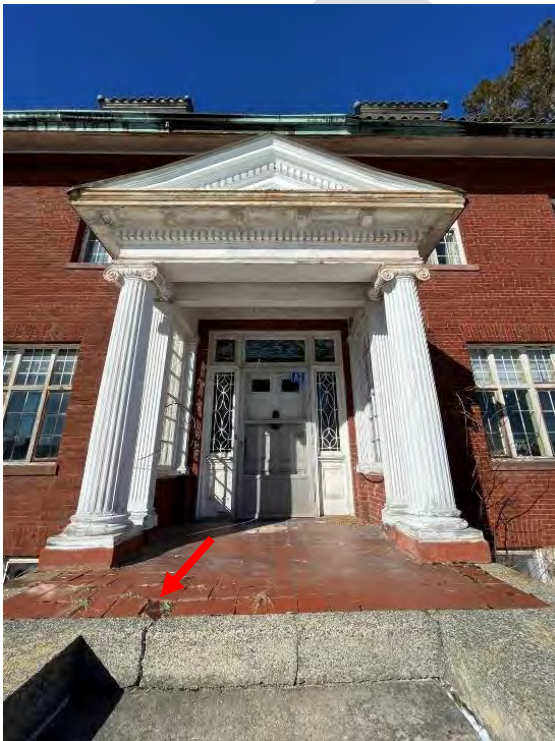
Image 32: Overall view of the south entrance with broken, displaced, and uneven clay tile pavers and cracked concrete steps.

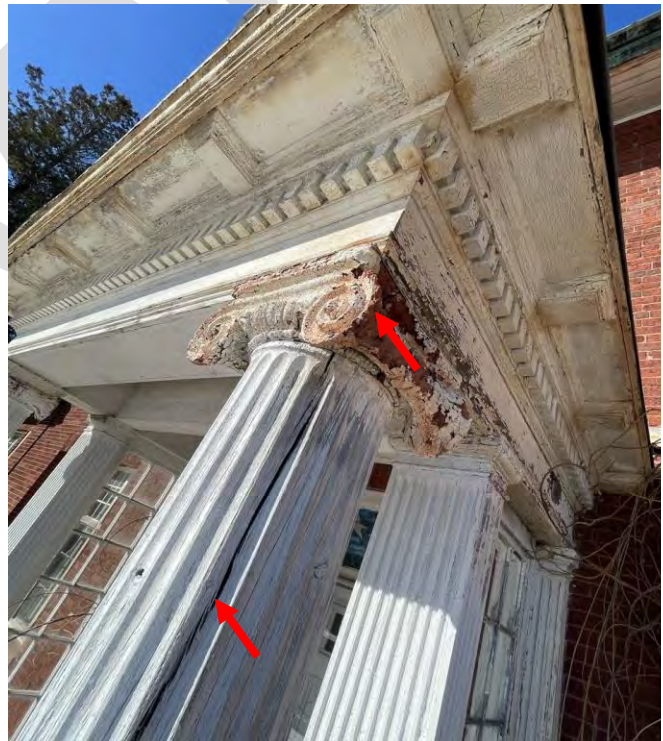
Image 33: View of the Ionic column volute and abacus that are severely deteriorated. Also notice the painted wood column is split.

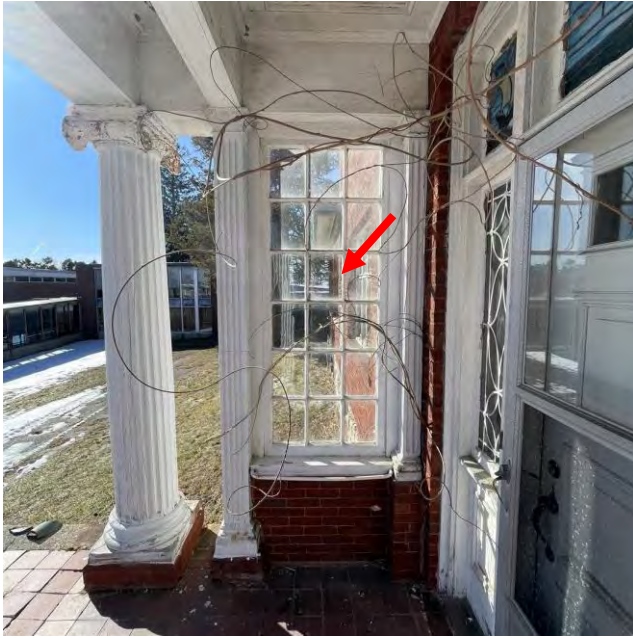
Image 34: View of the painted wood entry sidelights. Sidelights are deteriorated and missing glazing putty.

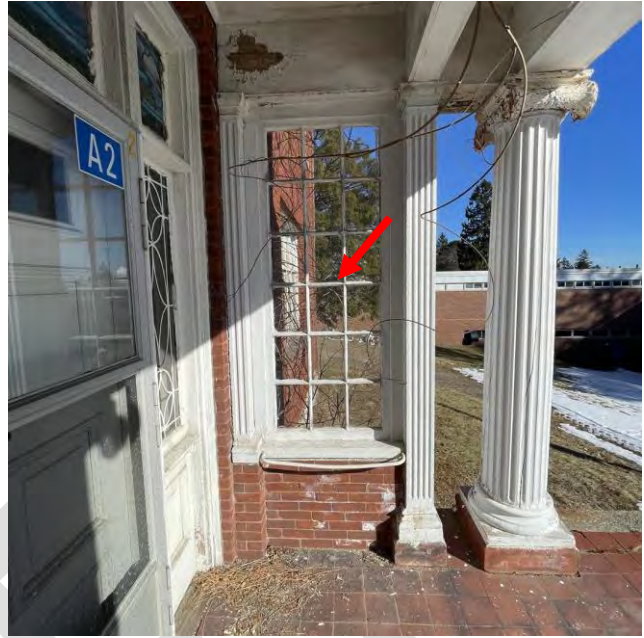
Image 35: Opposite image 30.

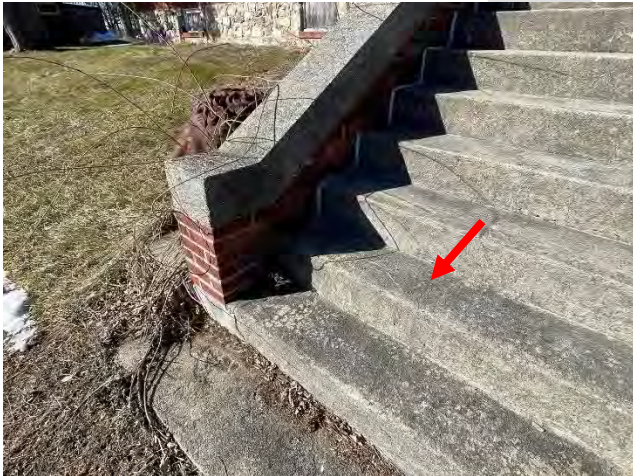
Image 36: View of typical organic and environmental staining

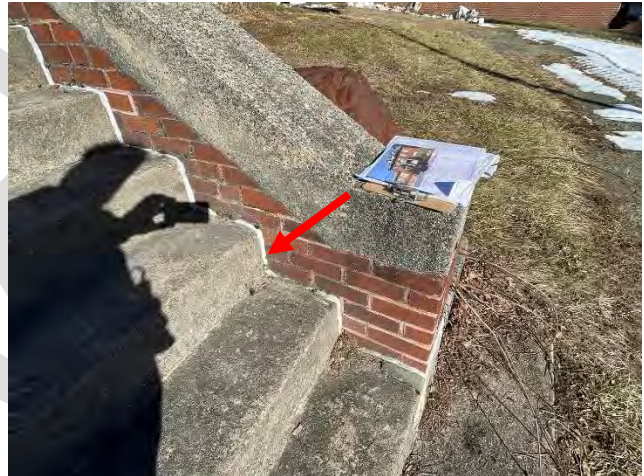
Image 37: View of deteriorated joint sealant between stair steps and the brick masonry.

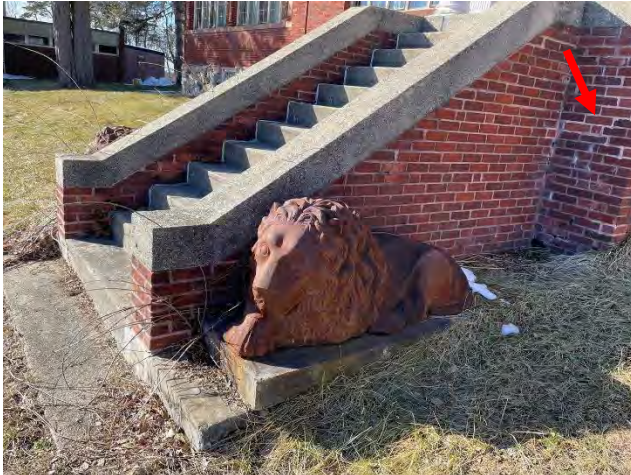
Image 38: View of sidewall including deteriorated mortar joints, spalled brick, and poorly matched mortar repairs. Notice the south entrance is flanked by two (2) cast iron lion sculptures perched on cast stone plinths.

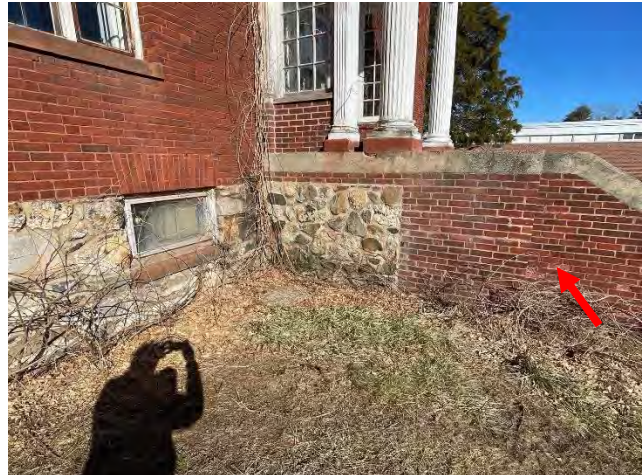
Image 39: View of opposite sidewall including deteriorated mortar joints, spalled brick, and poorly matched mortar repairs.

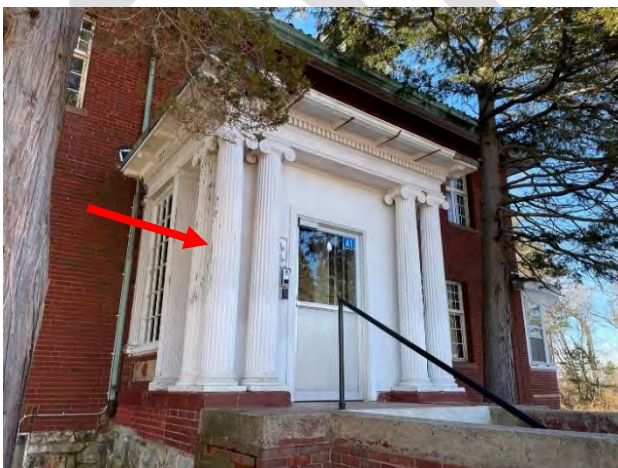
Image 40: Overall view of East entryway including enclosed breezeway with aluminum entrance door. Also notice peeling paint on the wood columns.

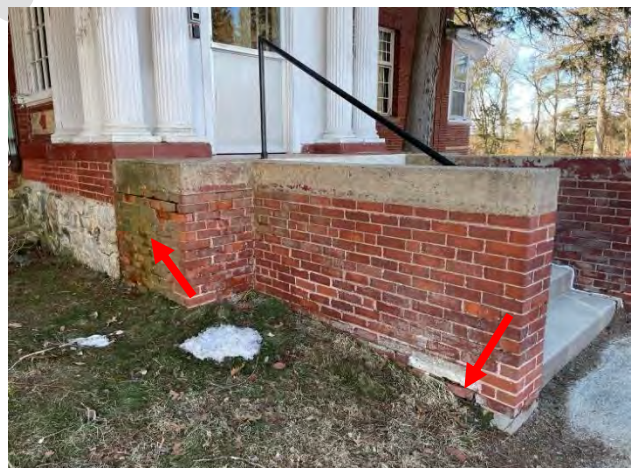
Image 41: View of deteriorated brick masonry and organic algae staining on the brick masonry stair sidewalls.

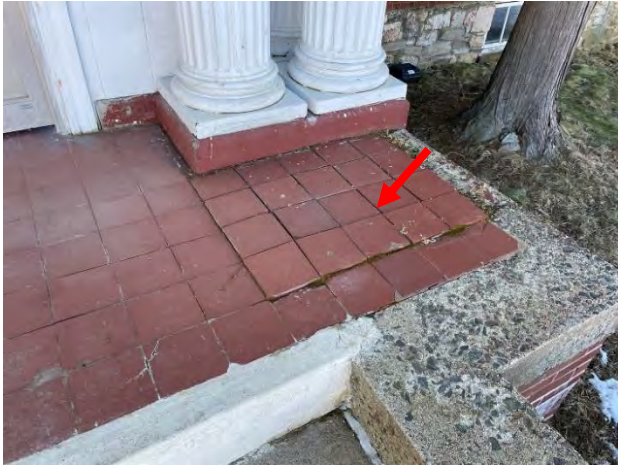
Image 42: View of broken, displaced, and uneven tile pavers.

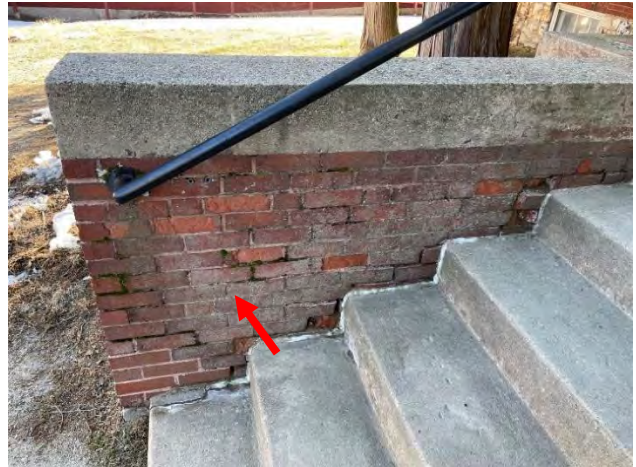
Image 43: View of deteriorated brick masonry stair sidewall including eroded mortar joints, spalled and displaced brick, and deteriorated joint sealant.

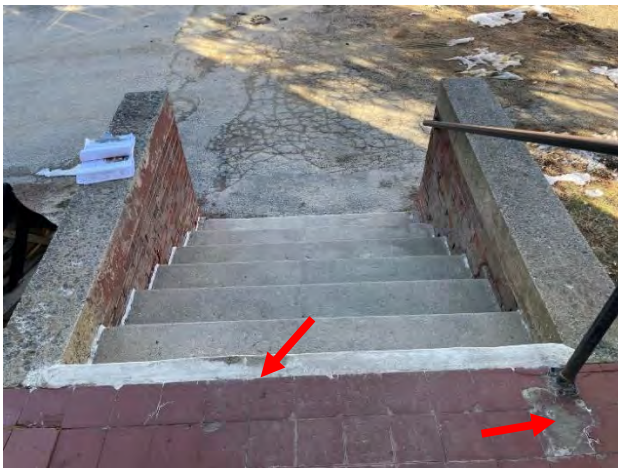
Image 44: View of poor patching at top step and railing base

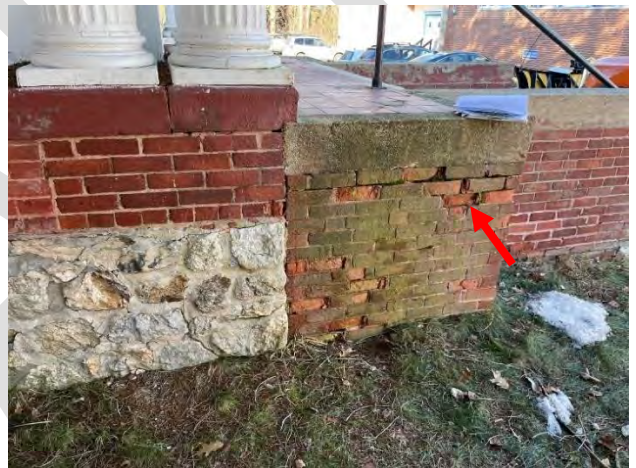
Image 45: View of side of porch including mortar deterioration, spalled and displaced brick, and algae growth.

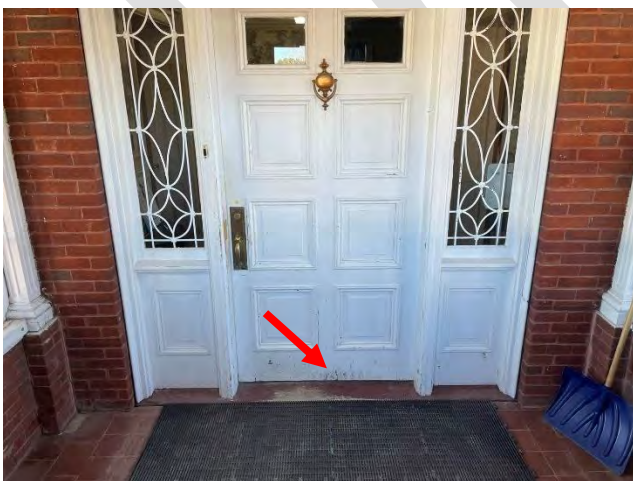
Image 46: View of exterior door within the enclosed breezeway including peeling paint.

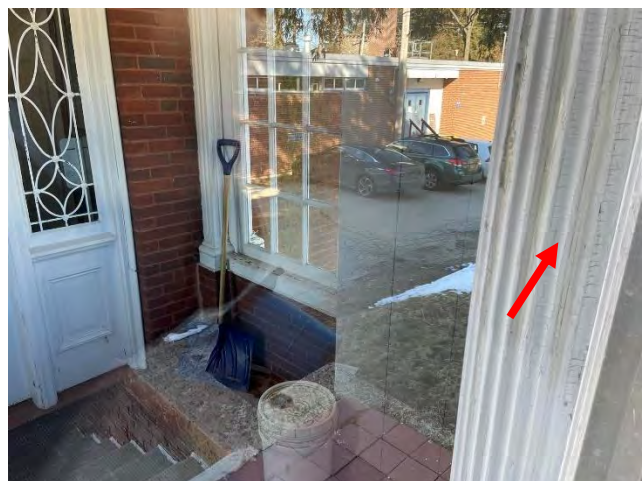
Image 47: View of interior of breezeway including cracked and peeling painted wood column.

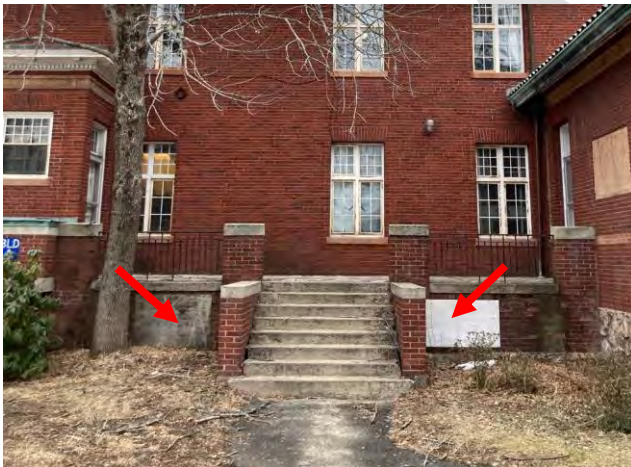
Image 48: Overall view of West entrance, including boarded up basement windows.

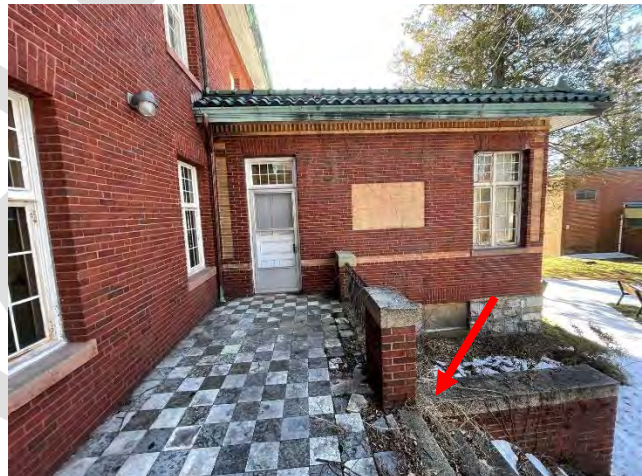
Image 49: Partial view of West entrance including environmental and atmospheric staining and plant growth.

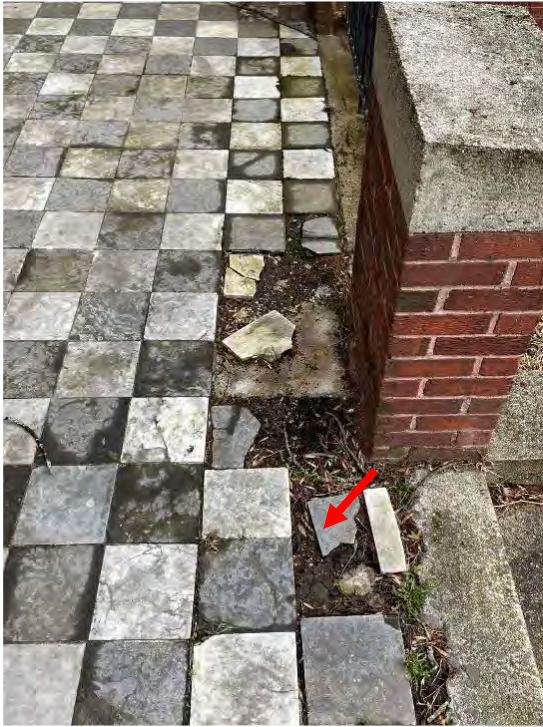
Image 50: View of marble tile pavers that are delaminated, broken, and displaced unevenly.

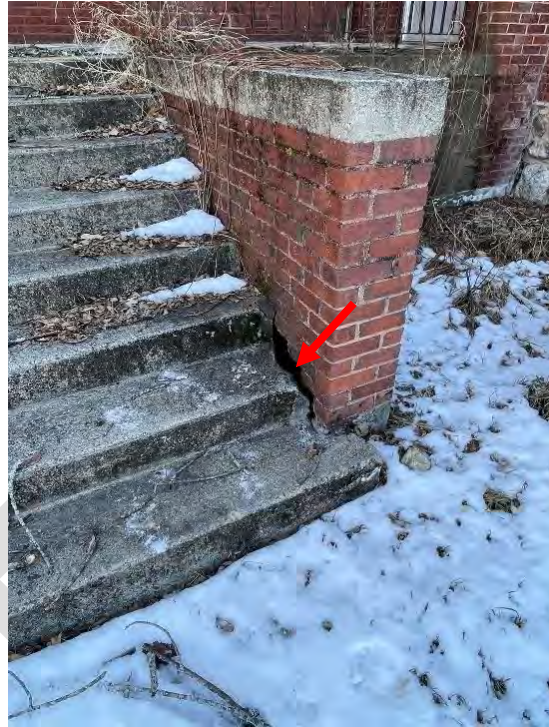
Image 51: View of deterioration of the concrete foundation, deteriorated and missing brick and mortar joints, missing joint sealant at steps, as well as dormant vine growth.

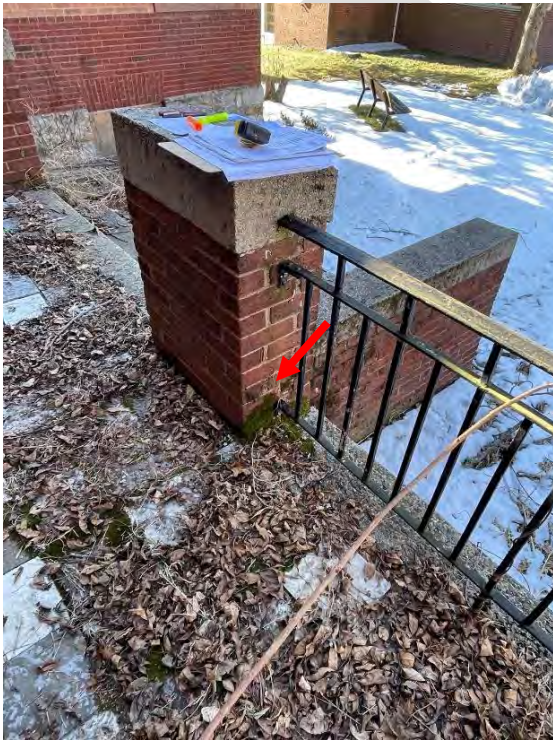
Image 52: View of accumulating organic debris and growth near

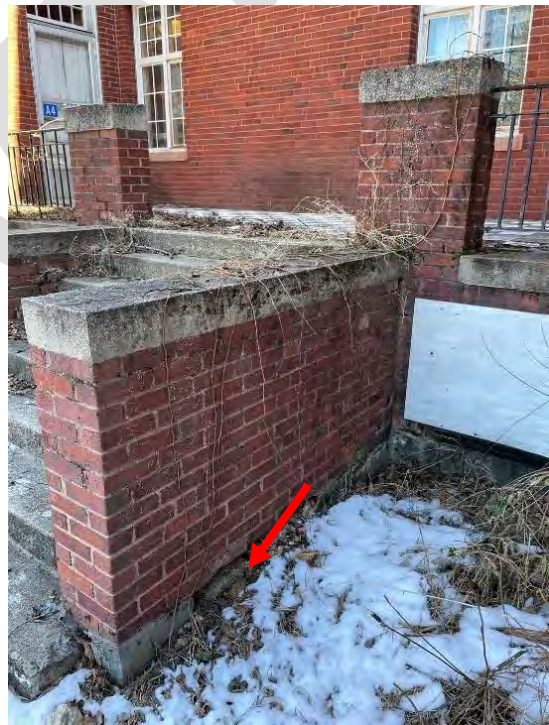
Image 53: View of eroded foundation, including deteriorated and missing brick.

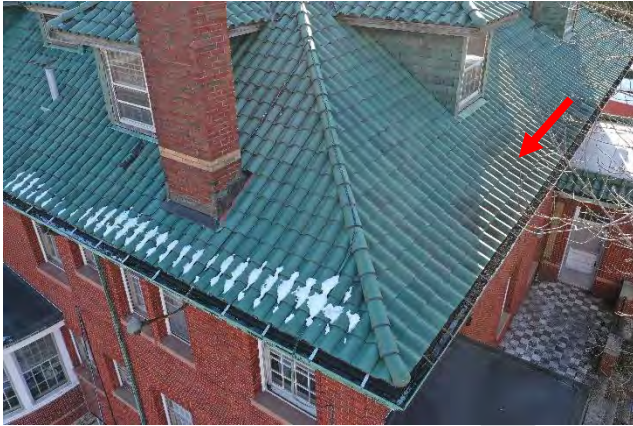
Image 54: View of terra cotta roof including atmospheric staining.

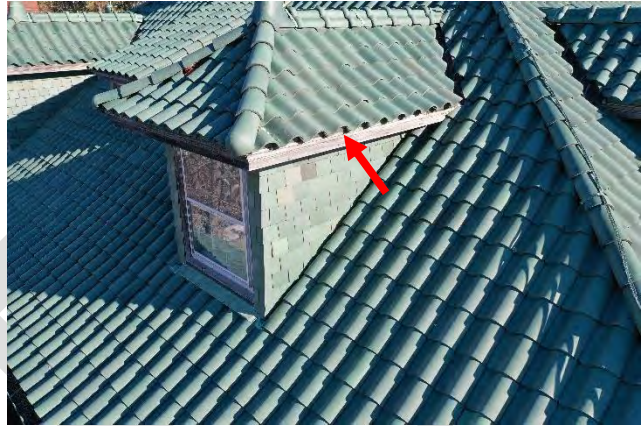
Image 55: View of typical dormer. Wood trim at eave and windows are bare wood.

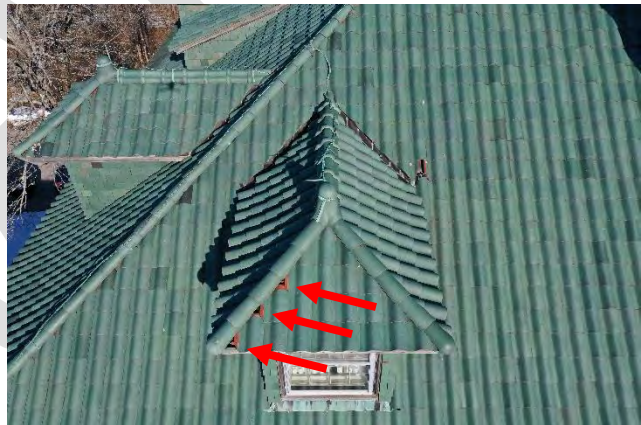
Image 57: Another typical view of the Terra Cotta Spanish tile roofing including hip and ridge caps and finials. Notice the broken terra cotta tiles.

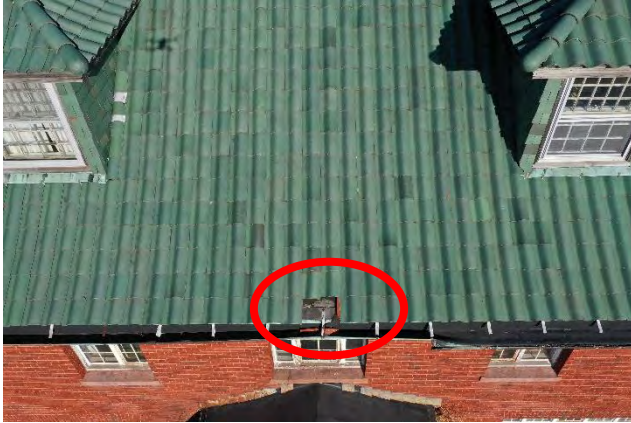
Image 58: View of broken and missing roofing tiles at the gutter roof edge of the south elevation.

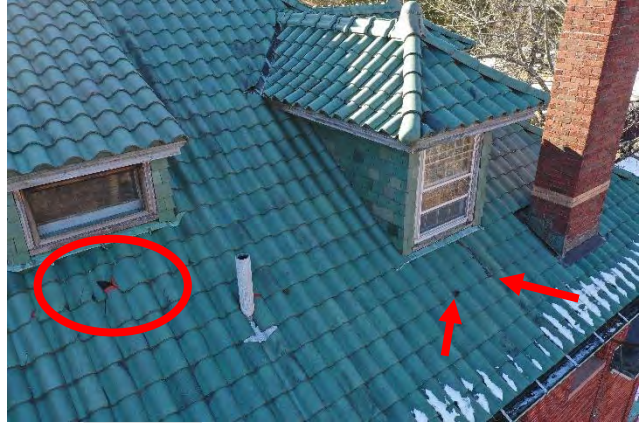
Image 59: View broken roofing tiles and roof mastic repairs.

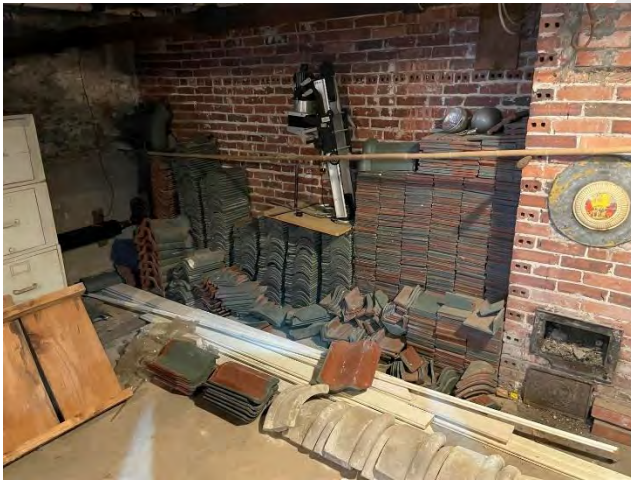
Image 60: View of stockpiled terra cotta tiles in basement.

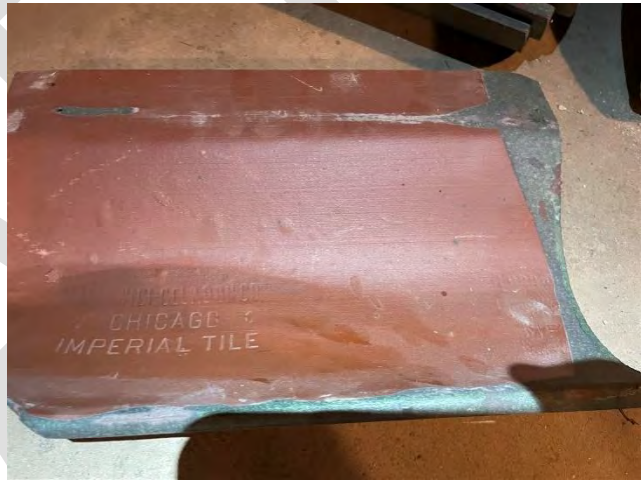
Image 61: View of terra cotta tile backside labeled "Chicago Imperial Tile." The tiles were manufactured by the Ludowici Roof Tile company.

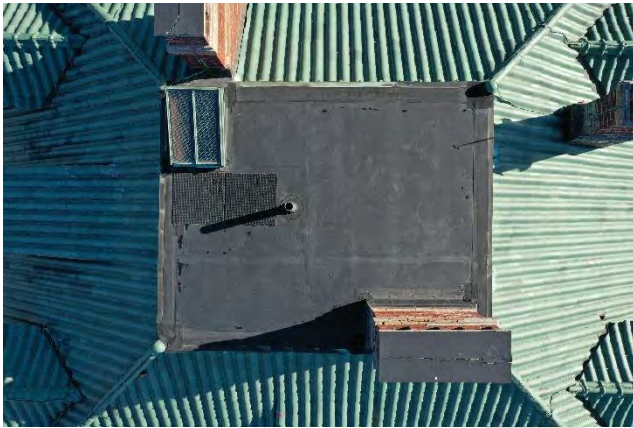
Image 62: View of upper peak roof, surrounded by the terra cotta Spanish tile roofing, that is covered with elastomeric roofing.

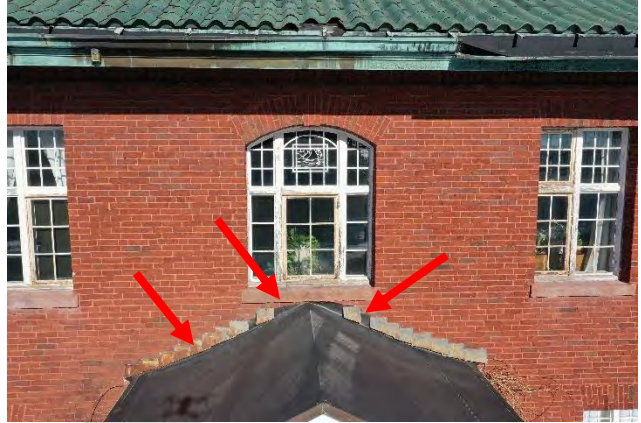
Image 67: View of the south entrance including missing and rust corroded step counterflashing. Note that the roof to wall transition where the flashing is missing is open to the weather.

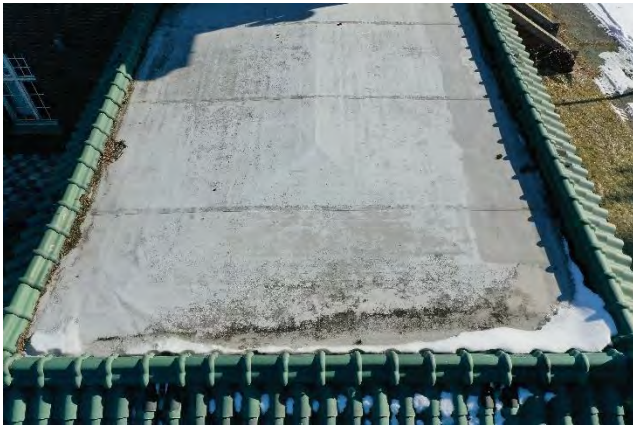
Image 68: View of the low sloped thermoplastic roofing system over the solarium roof and surrounded by terra cotta Spanish tile mansard.

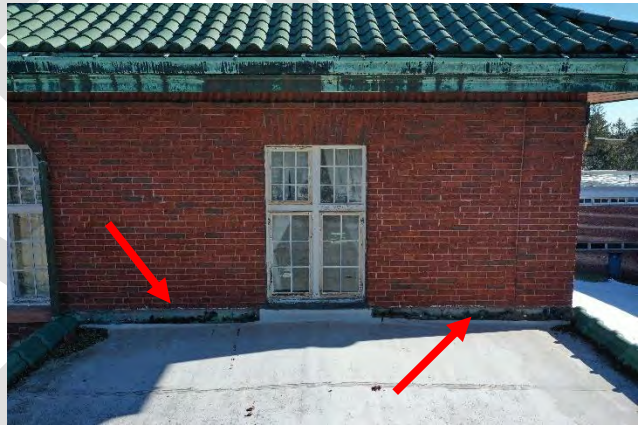
Image 69: View of the low sloped thermoplastic roofing system over the solarium roof with damaged copper throughwall flashing and deteriorated joint sealant.

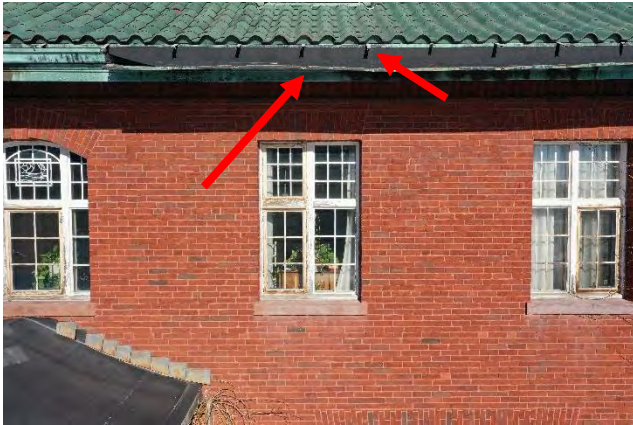
Image 70: View of damaged and broken gutter, and gutter brackets.

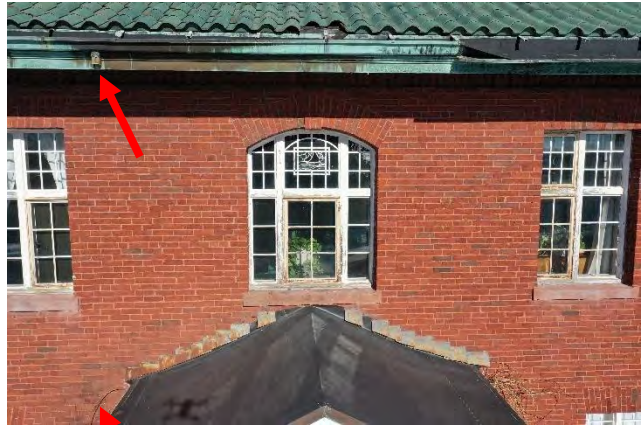
Image 71: View of missing downspout leader.

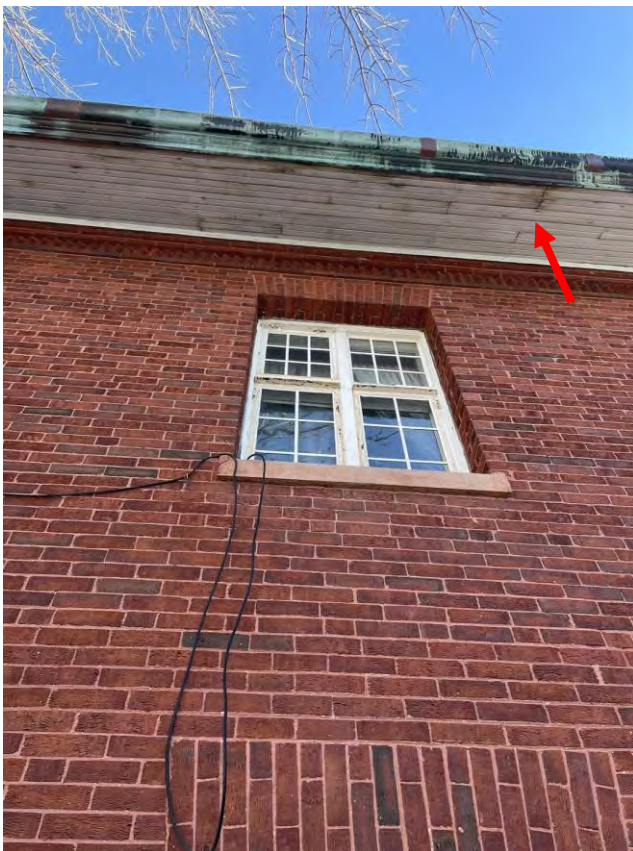
Image 72: Typical view of the existing wood bead board soffit paneling. Notice dirt and moisture staining.

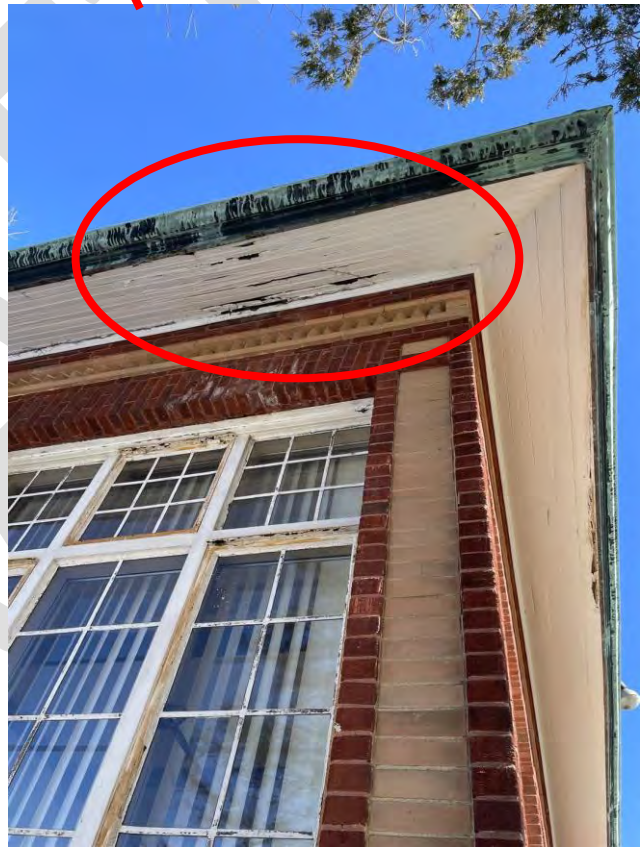
Image 73: View of the existing wood bead board soffit paneling. Notice that wood appears to be rotted and decayed.

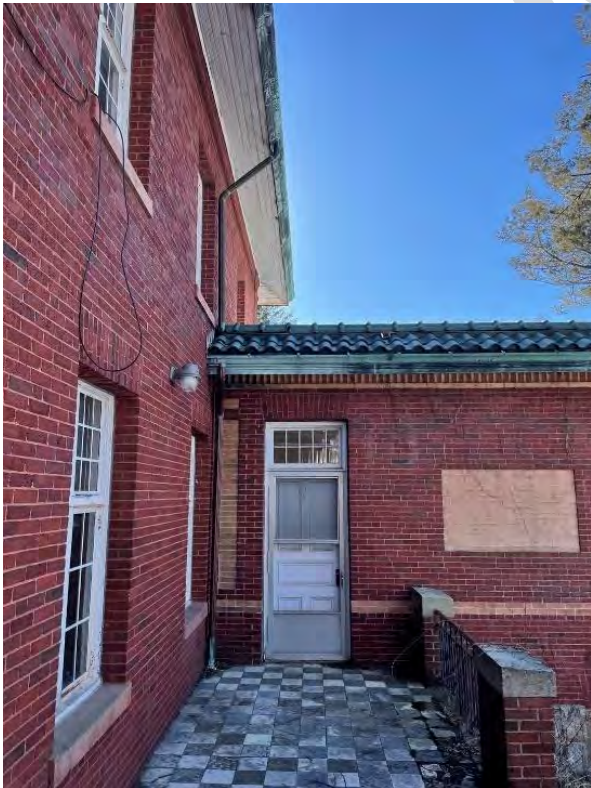
Image 74: View of entryway at west porch.

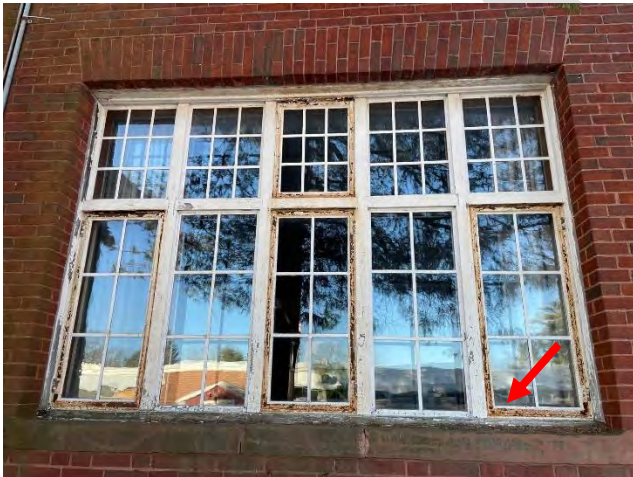
Image 78: View of steel framed windows and in wood frames notice deteriorated paint and with rust corrosion.

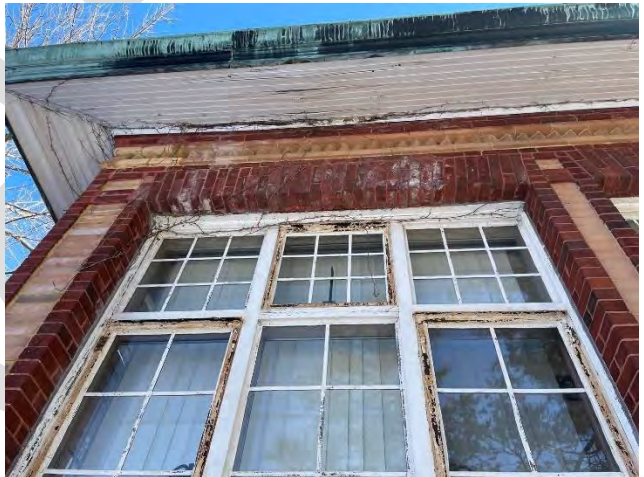
Image 79: Another view of steel framed windows and in wood frames notice deteriorated paint and with rust corrosion.

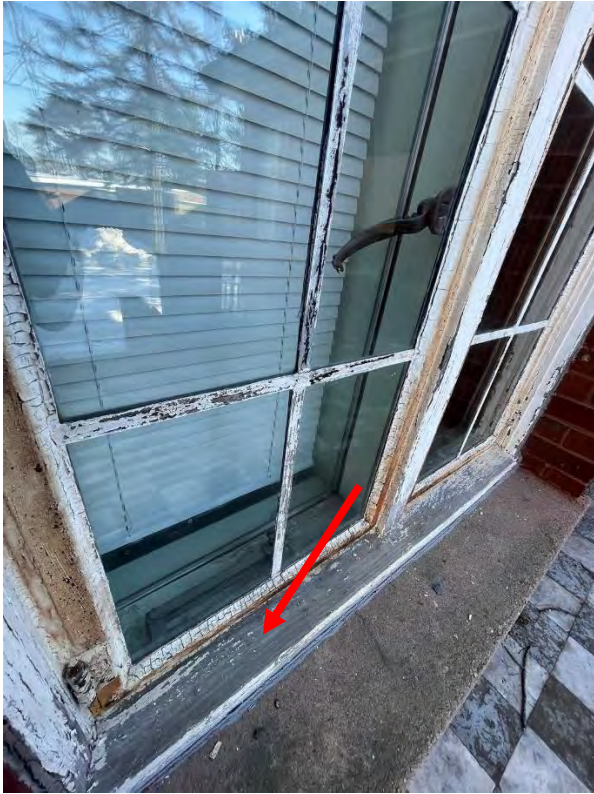
Image 80: Typical view of deteriorated paint finish and exposed bare wood.

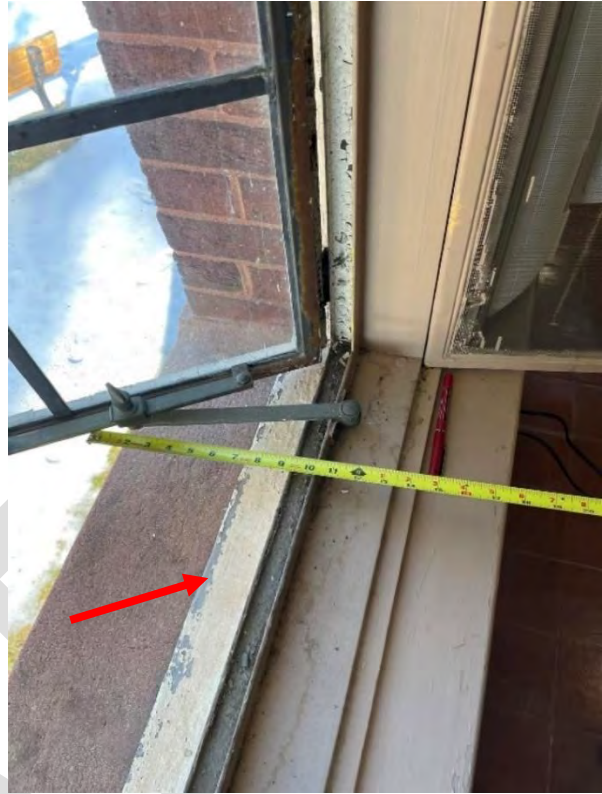
Image 81: Typical view peeling paint finish at steel window.

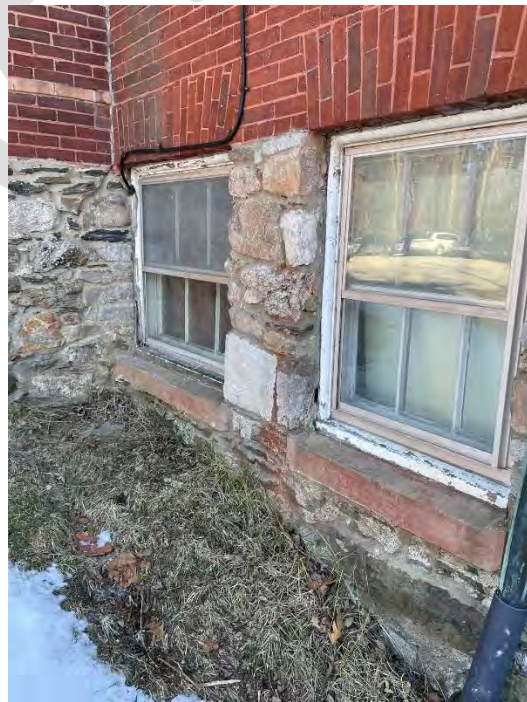
Image 83: Typical view of basement level wood windows. Notice deteriorated paint finish.

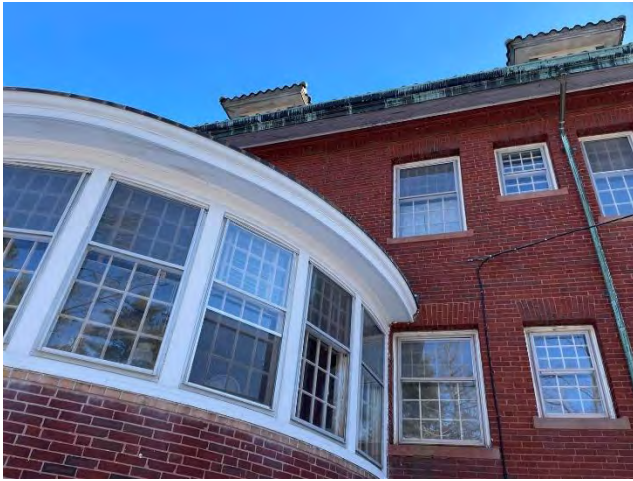
Image 84: View of typical wood framed double hung windows with storm panels.

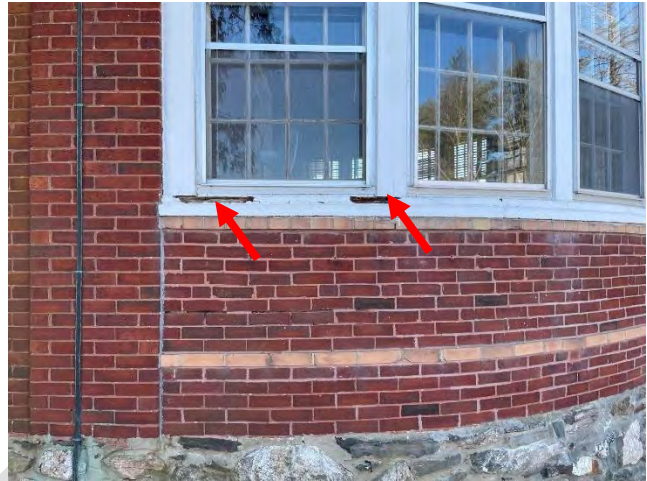
Image 85: View of rotted and decayed wood sills.

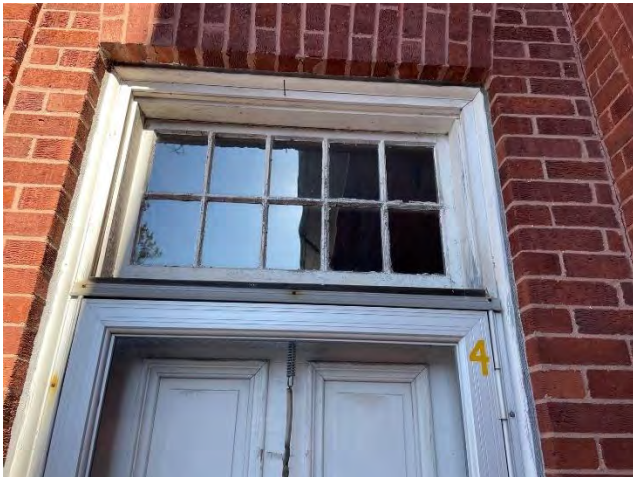
Image 86: View of typical wood transom window above entry door

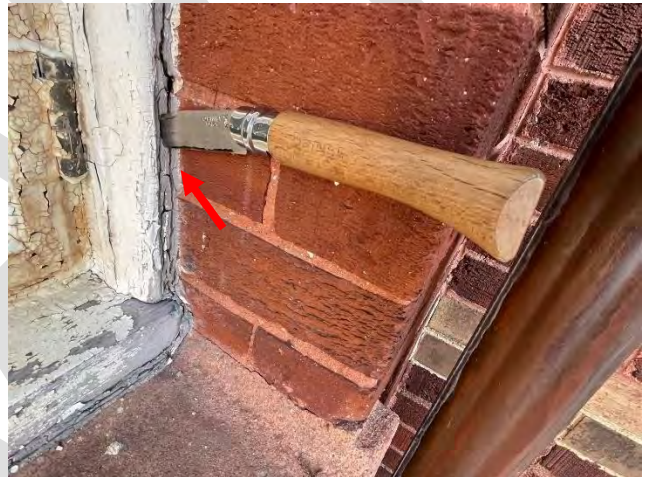
Image 87: View of typical deteriorated window perimeter sealant.

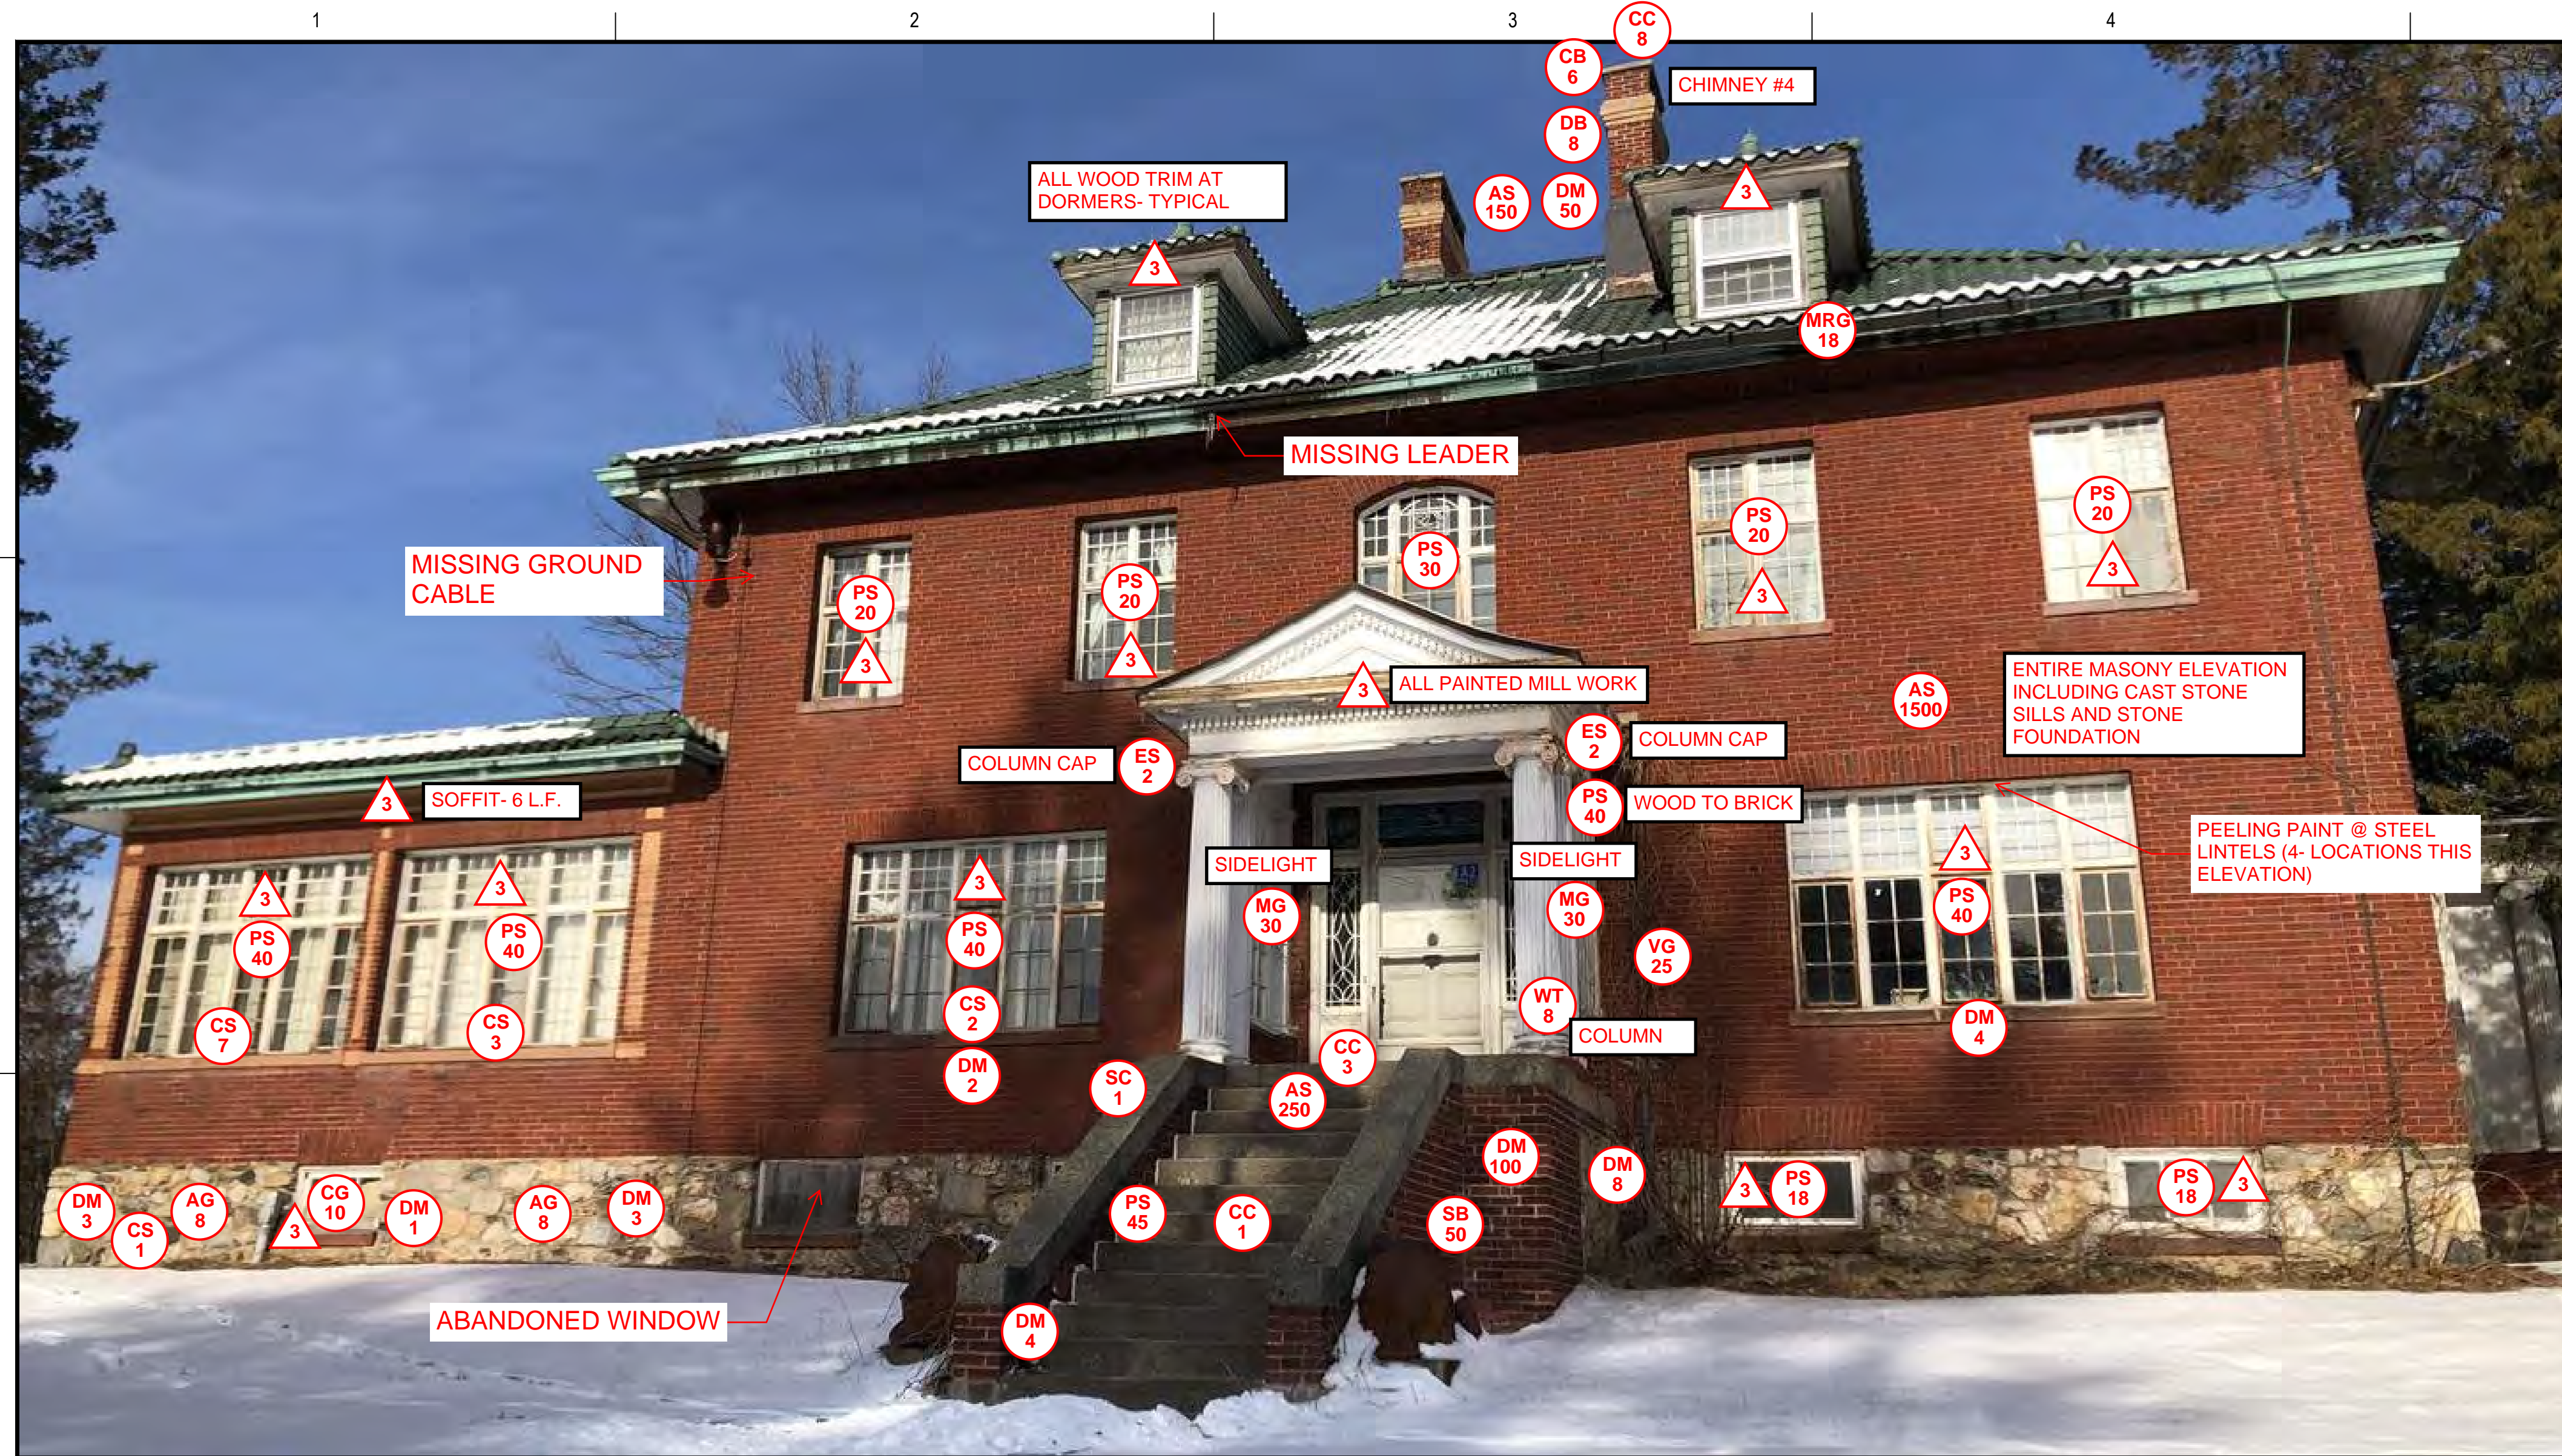
1 SOUTH ELEVATION
A202 SCALE: NOT TO SCALE
