State of Maine
Mackworth Island
Renovations Phase 1

Falmouth, Maine

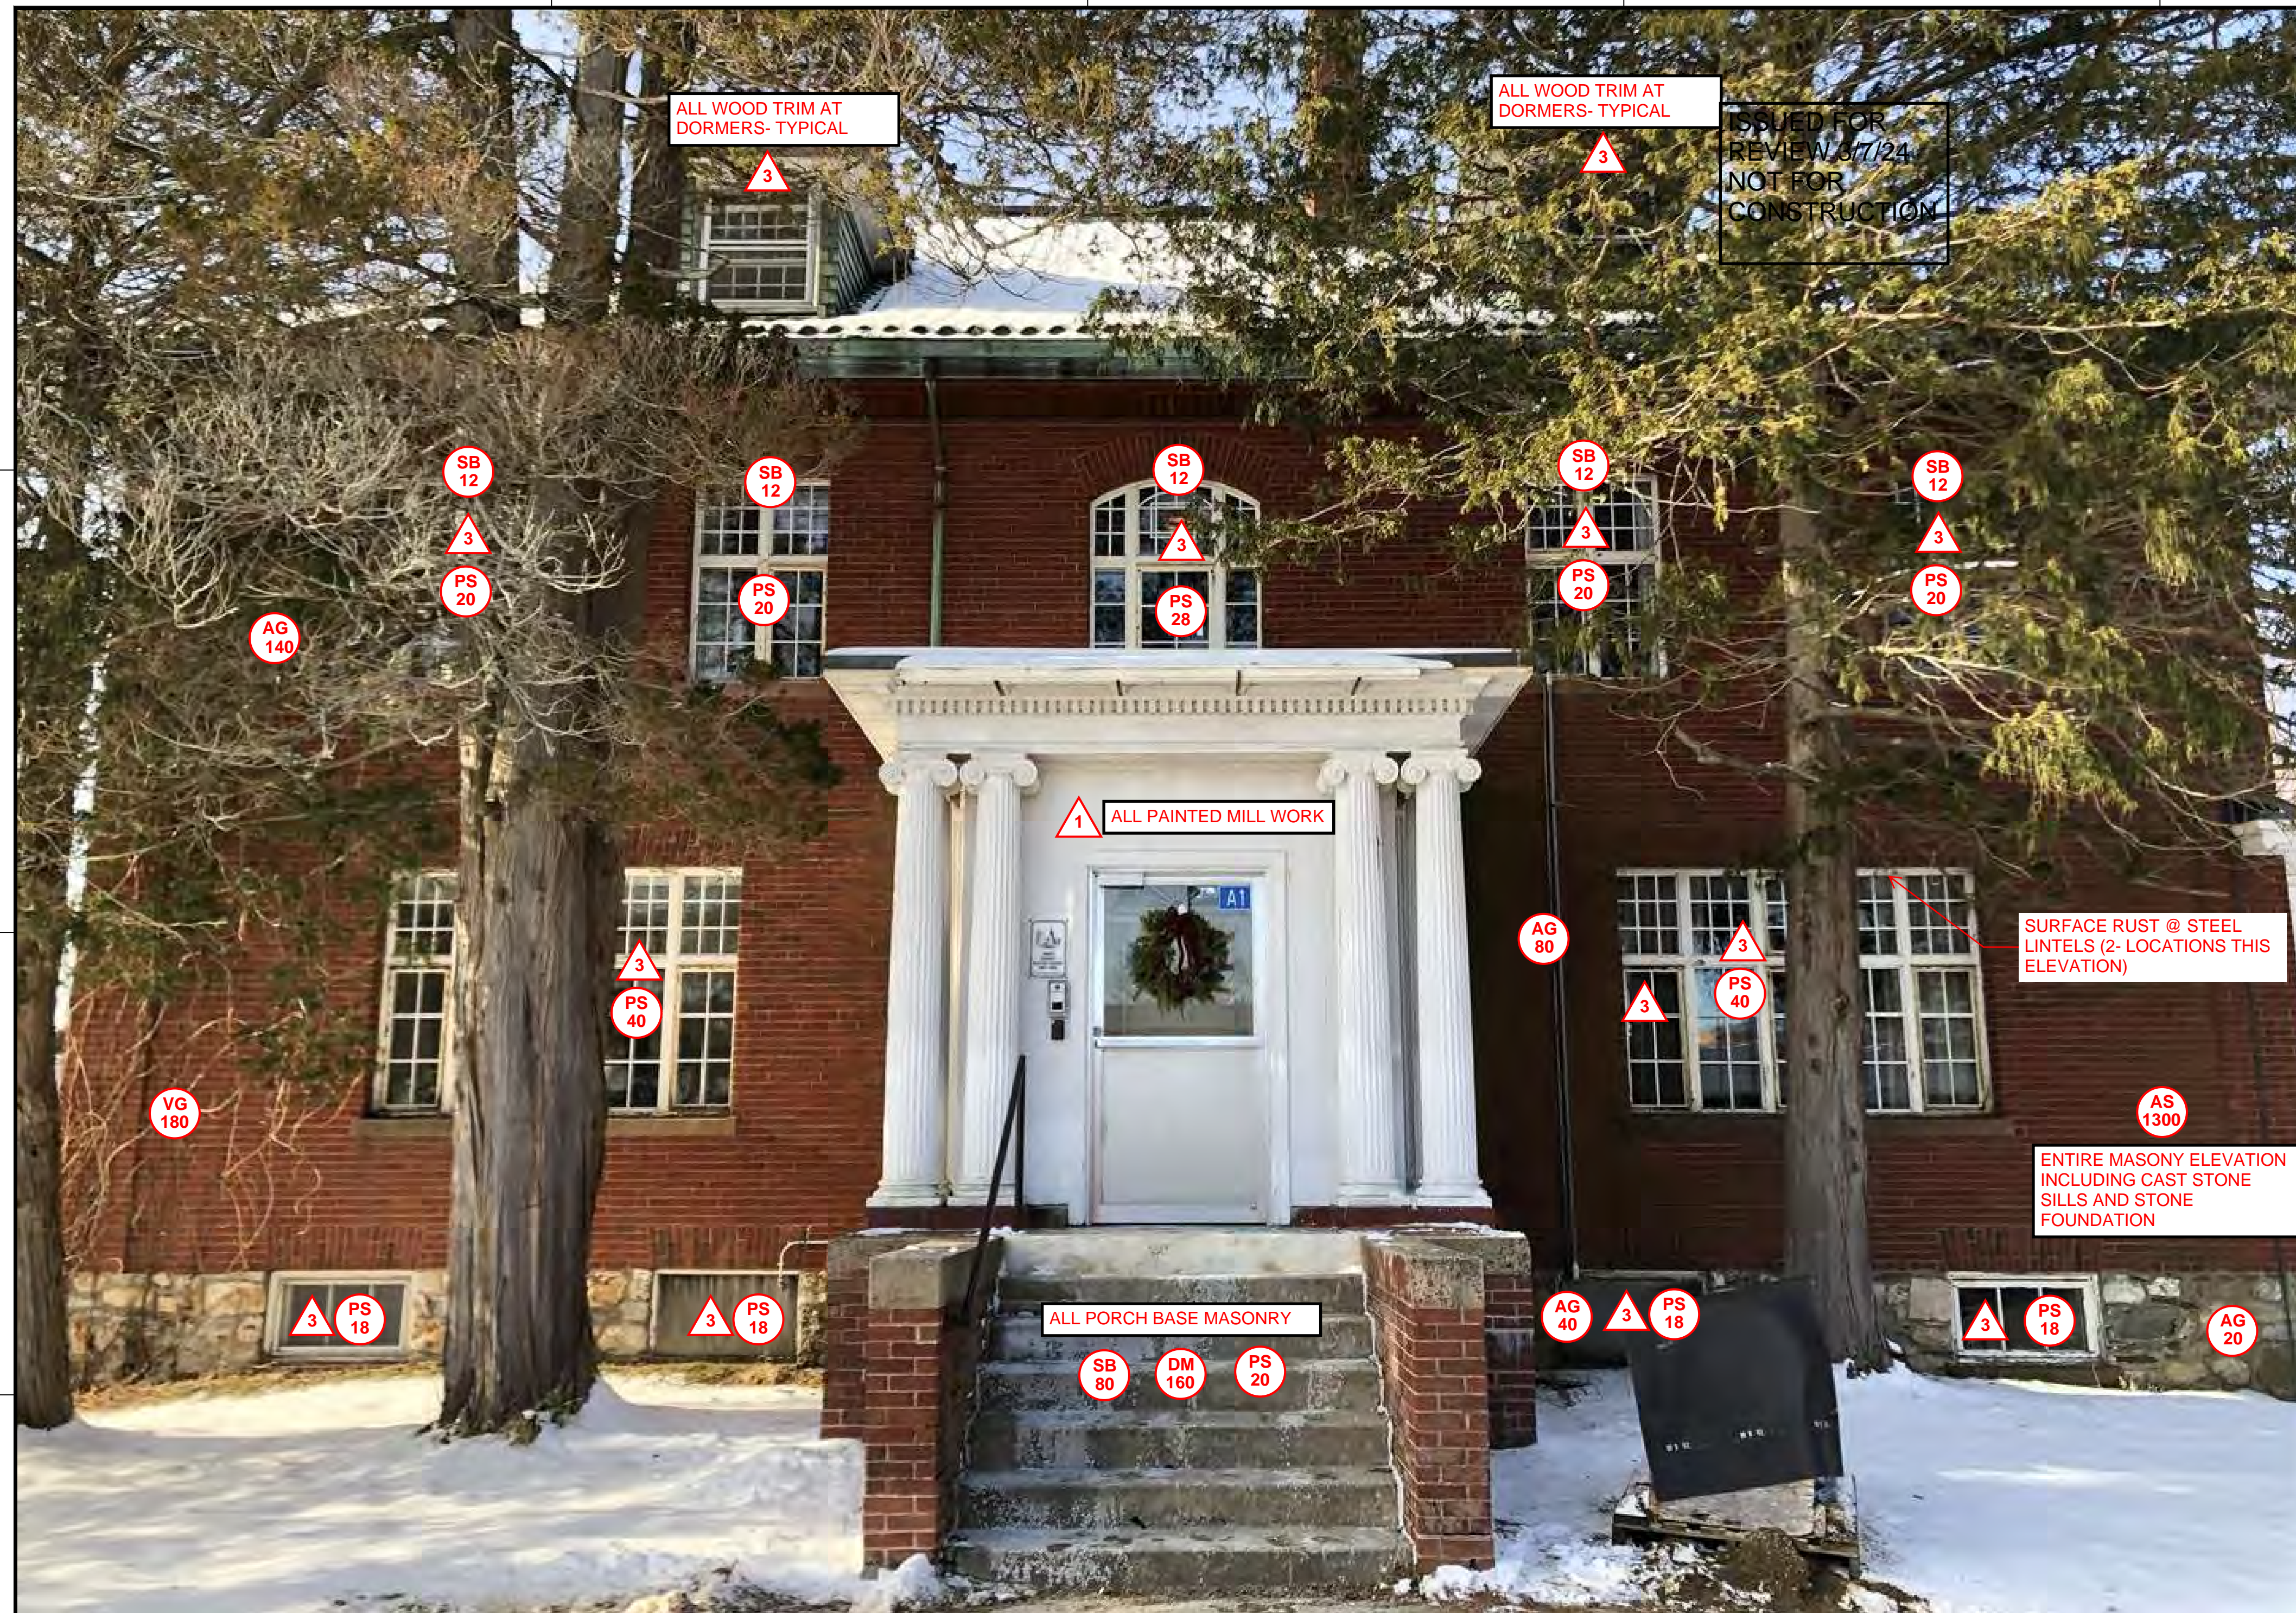
NO.	DATE	DESCRIPTION	BY
PROJECT NO.	842690		
CADD FILE	842690 A200s		
DESIGNED BY	PDG		
DRAWN BY	MRS		
CHECKED BY			
DATE	3/5/2024		
DRAWING SCALE	NOT TO SCALE		
GRAPHIC SCALE			
SHEET TITLE			
SOUTH ELEVATION			
DRAWING NO.			
A202

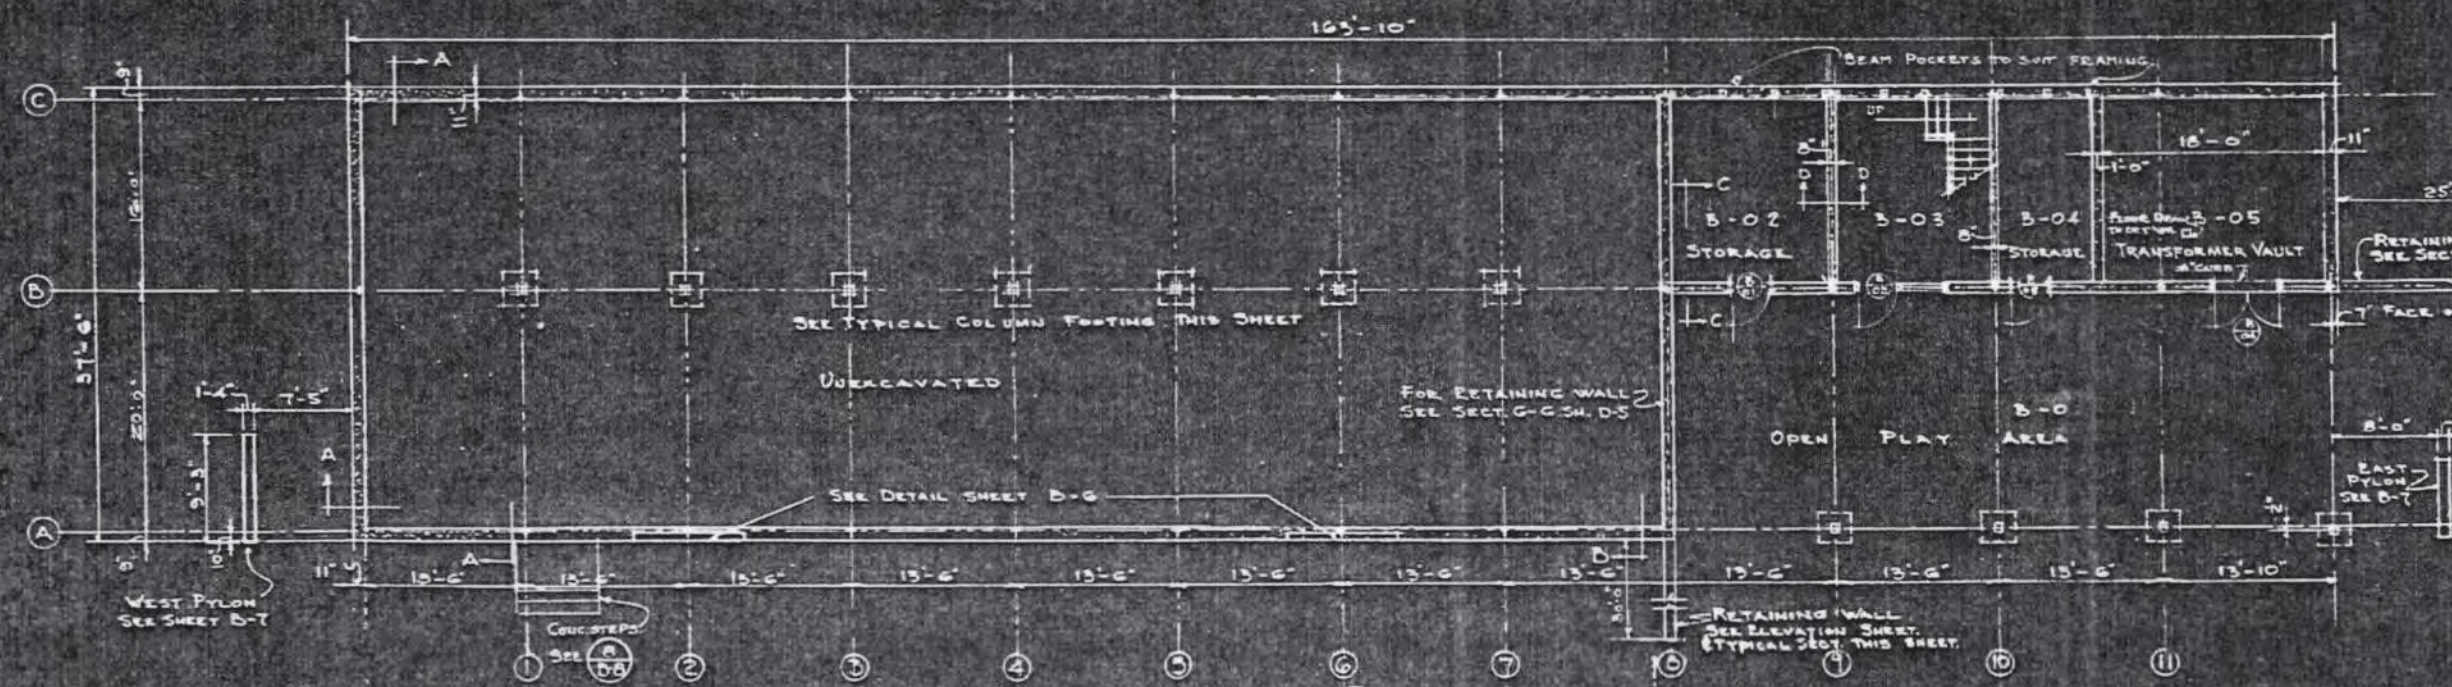
FOUNDATION PLAN
SCALE: 1/8" = 1'-0"

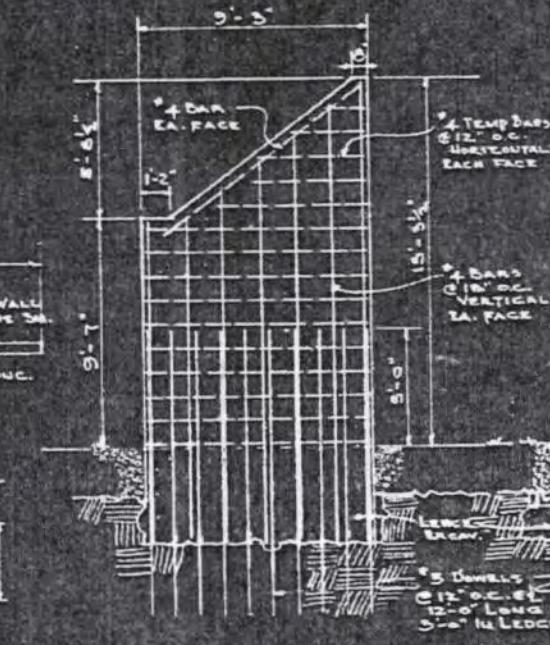
SIDE ELEVATION
STAIR PYLON (WEST)
SEE SHEET B-7

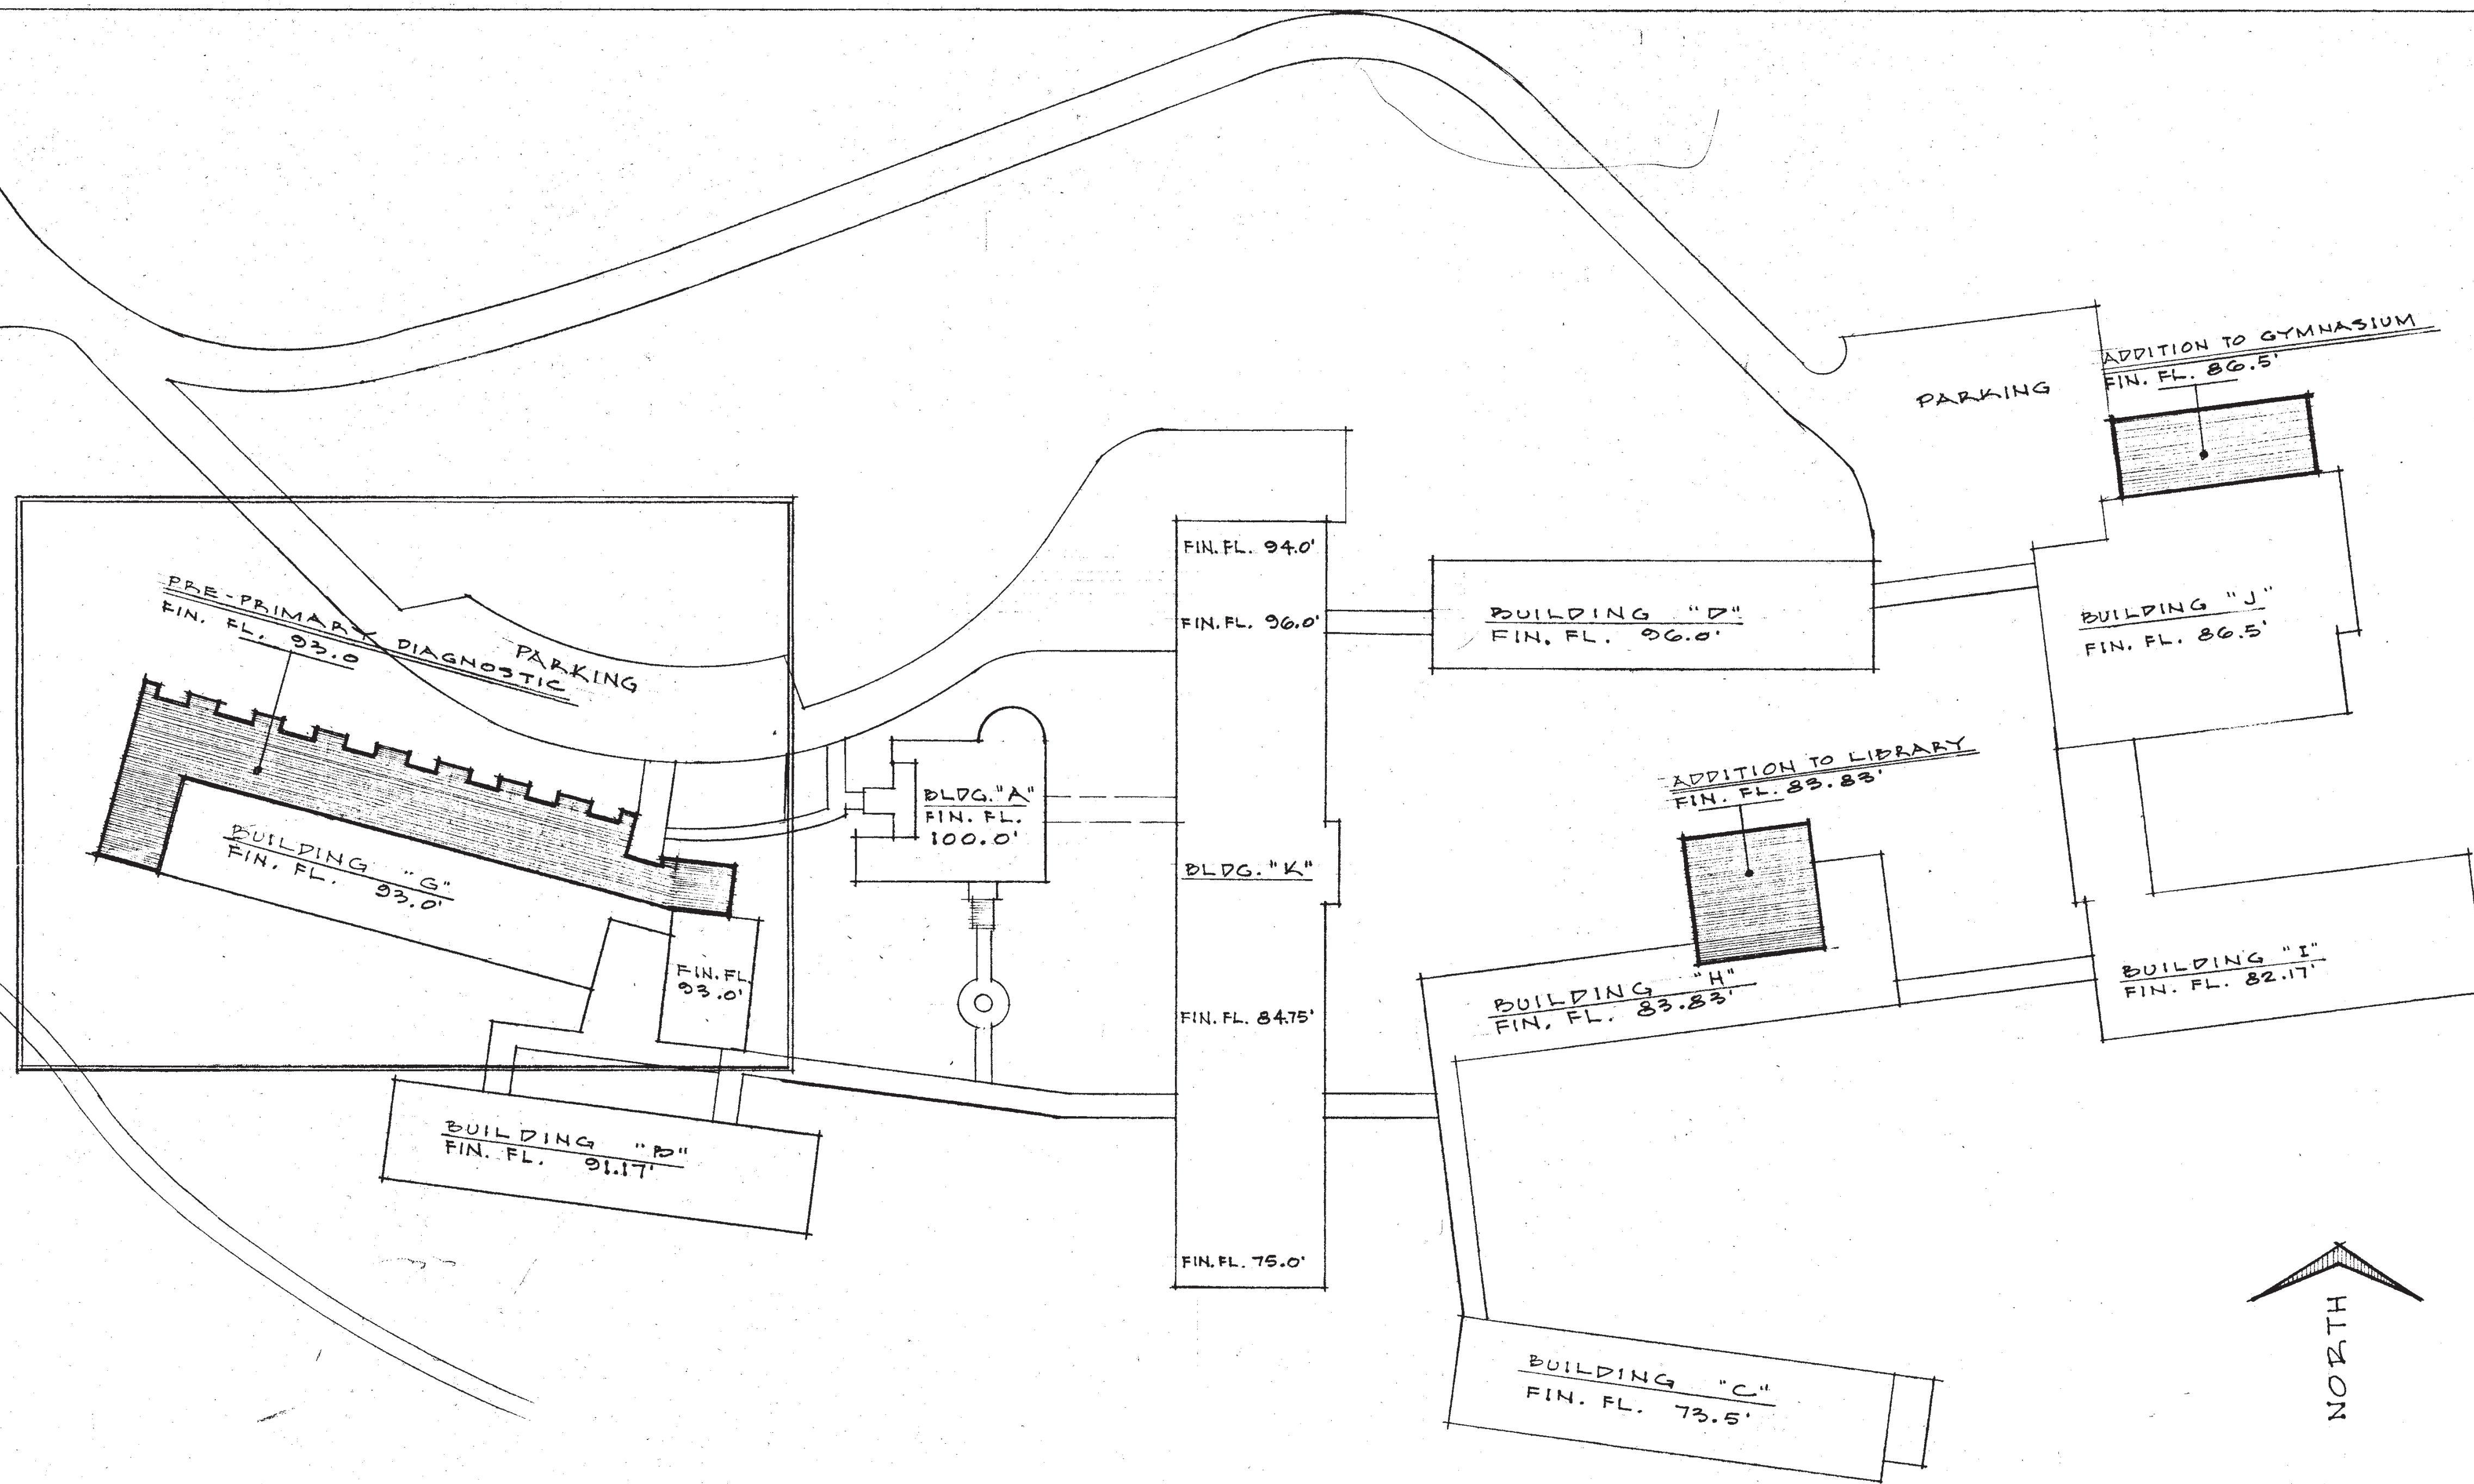
1.	LOCATION PLAN
2.	SITE PLAN & DETAILS
3.	FOUNDATION PLAN & DETAILS
4.	FRAMING PLAN
5.	FLOOR PLAN
6.	ELEVATIONS
7.	WALL SECTIONS
8.	WALL SECTIONS
9.	DOOR DETAILS
10.	1/4" CLASSROOM LAYOUT & CASEWORK DET'L
11.	PLUMBING PLAN
12.	HEATING & VENTILATING PLAN
13.	ELECTRICAL PLAN

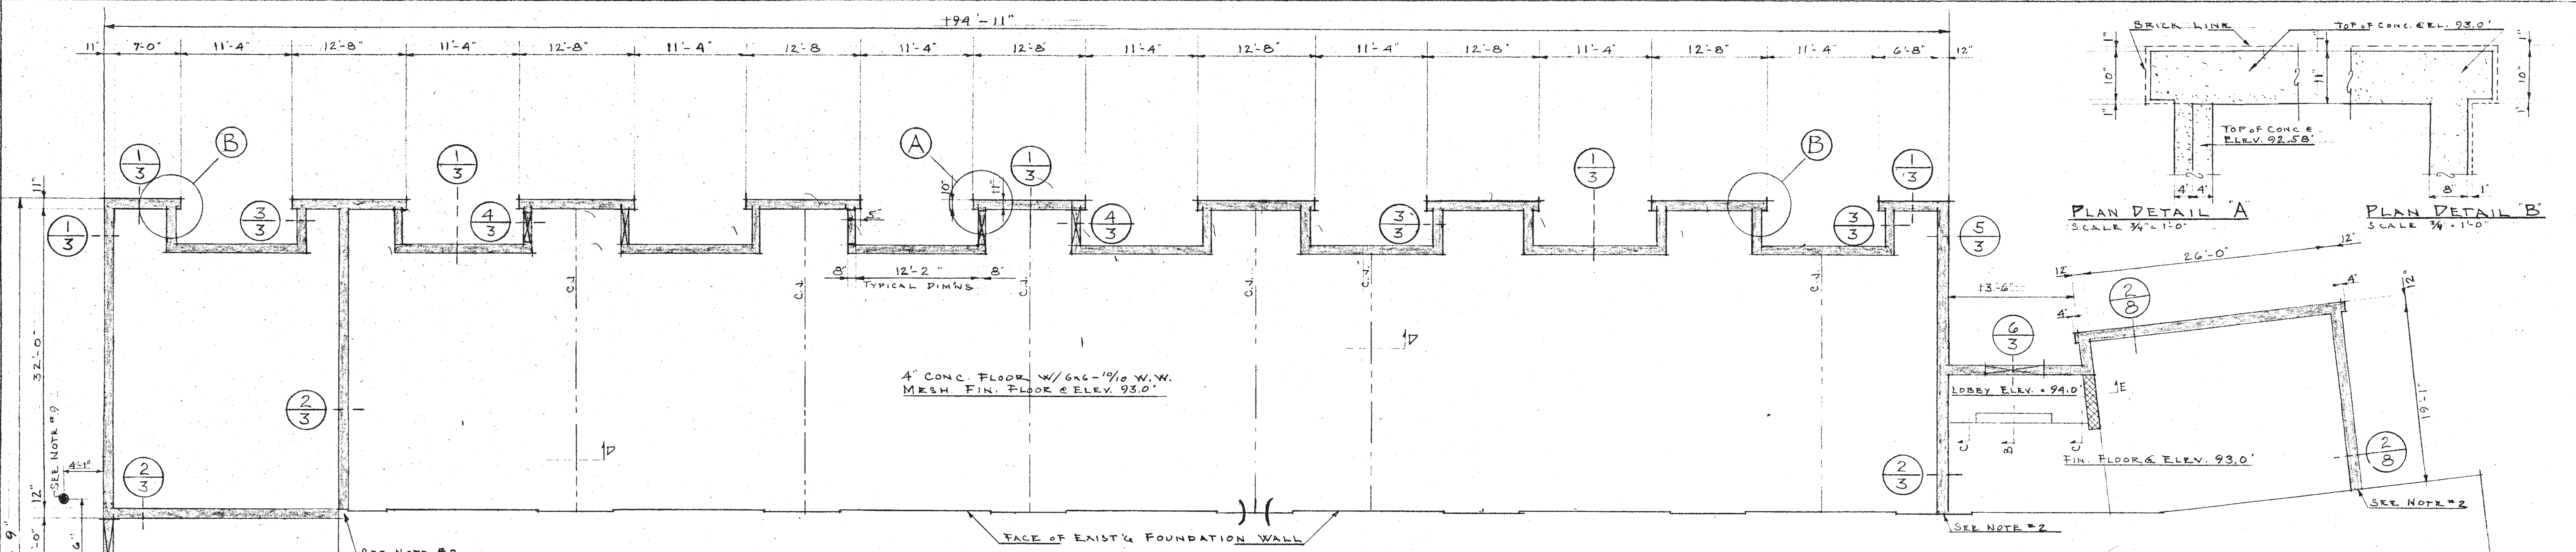
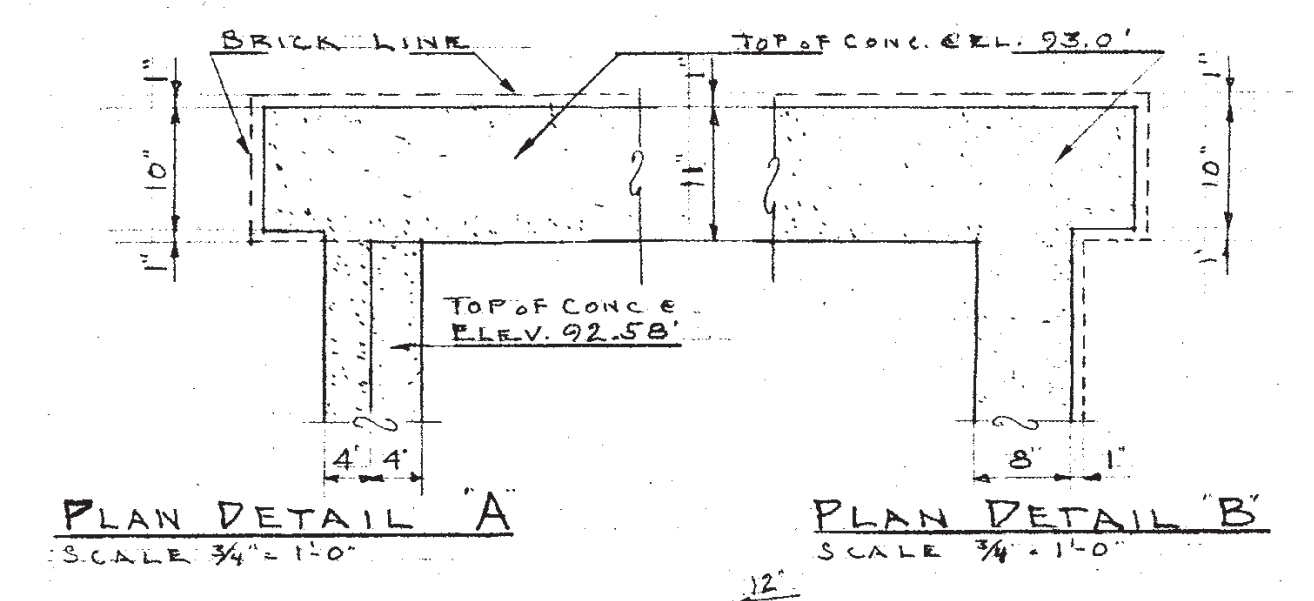
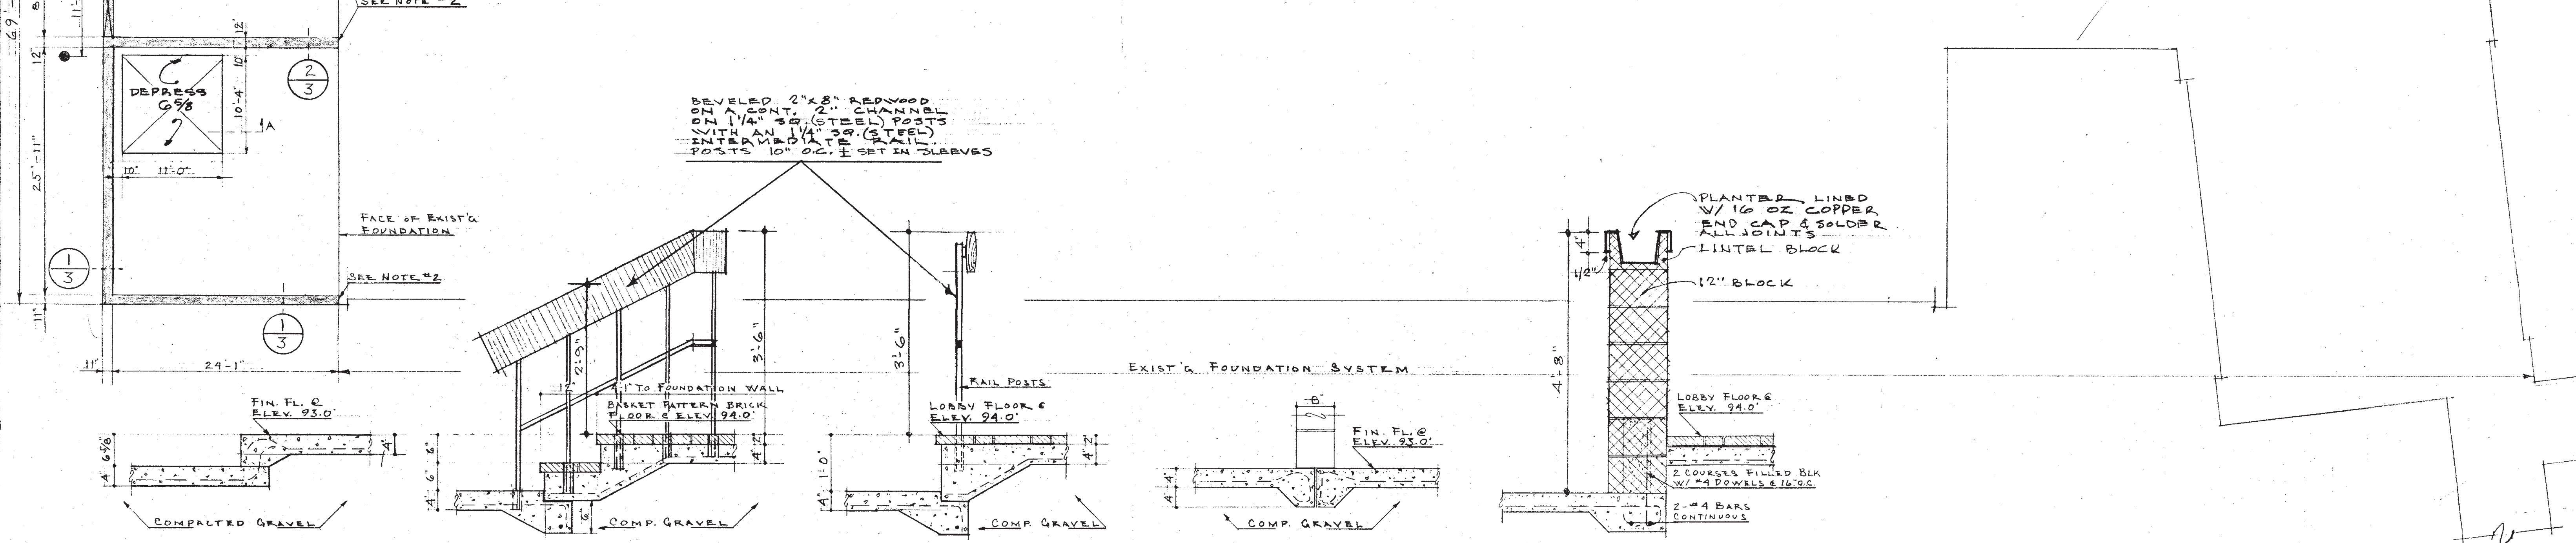
DETAIL A
SCALE 3/4" = 1'-0"

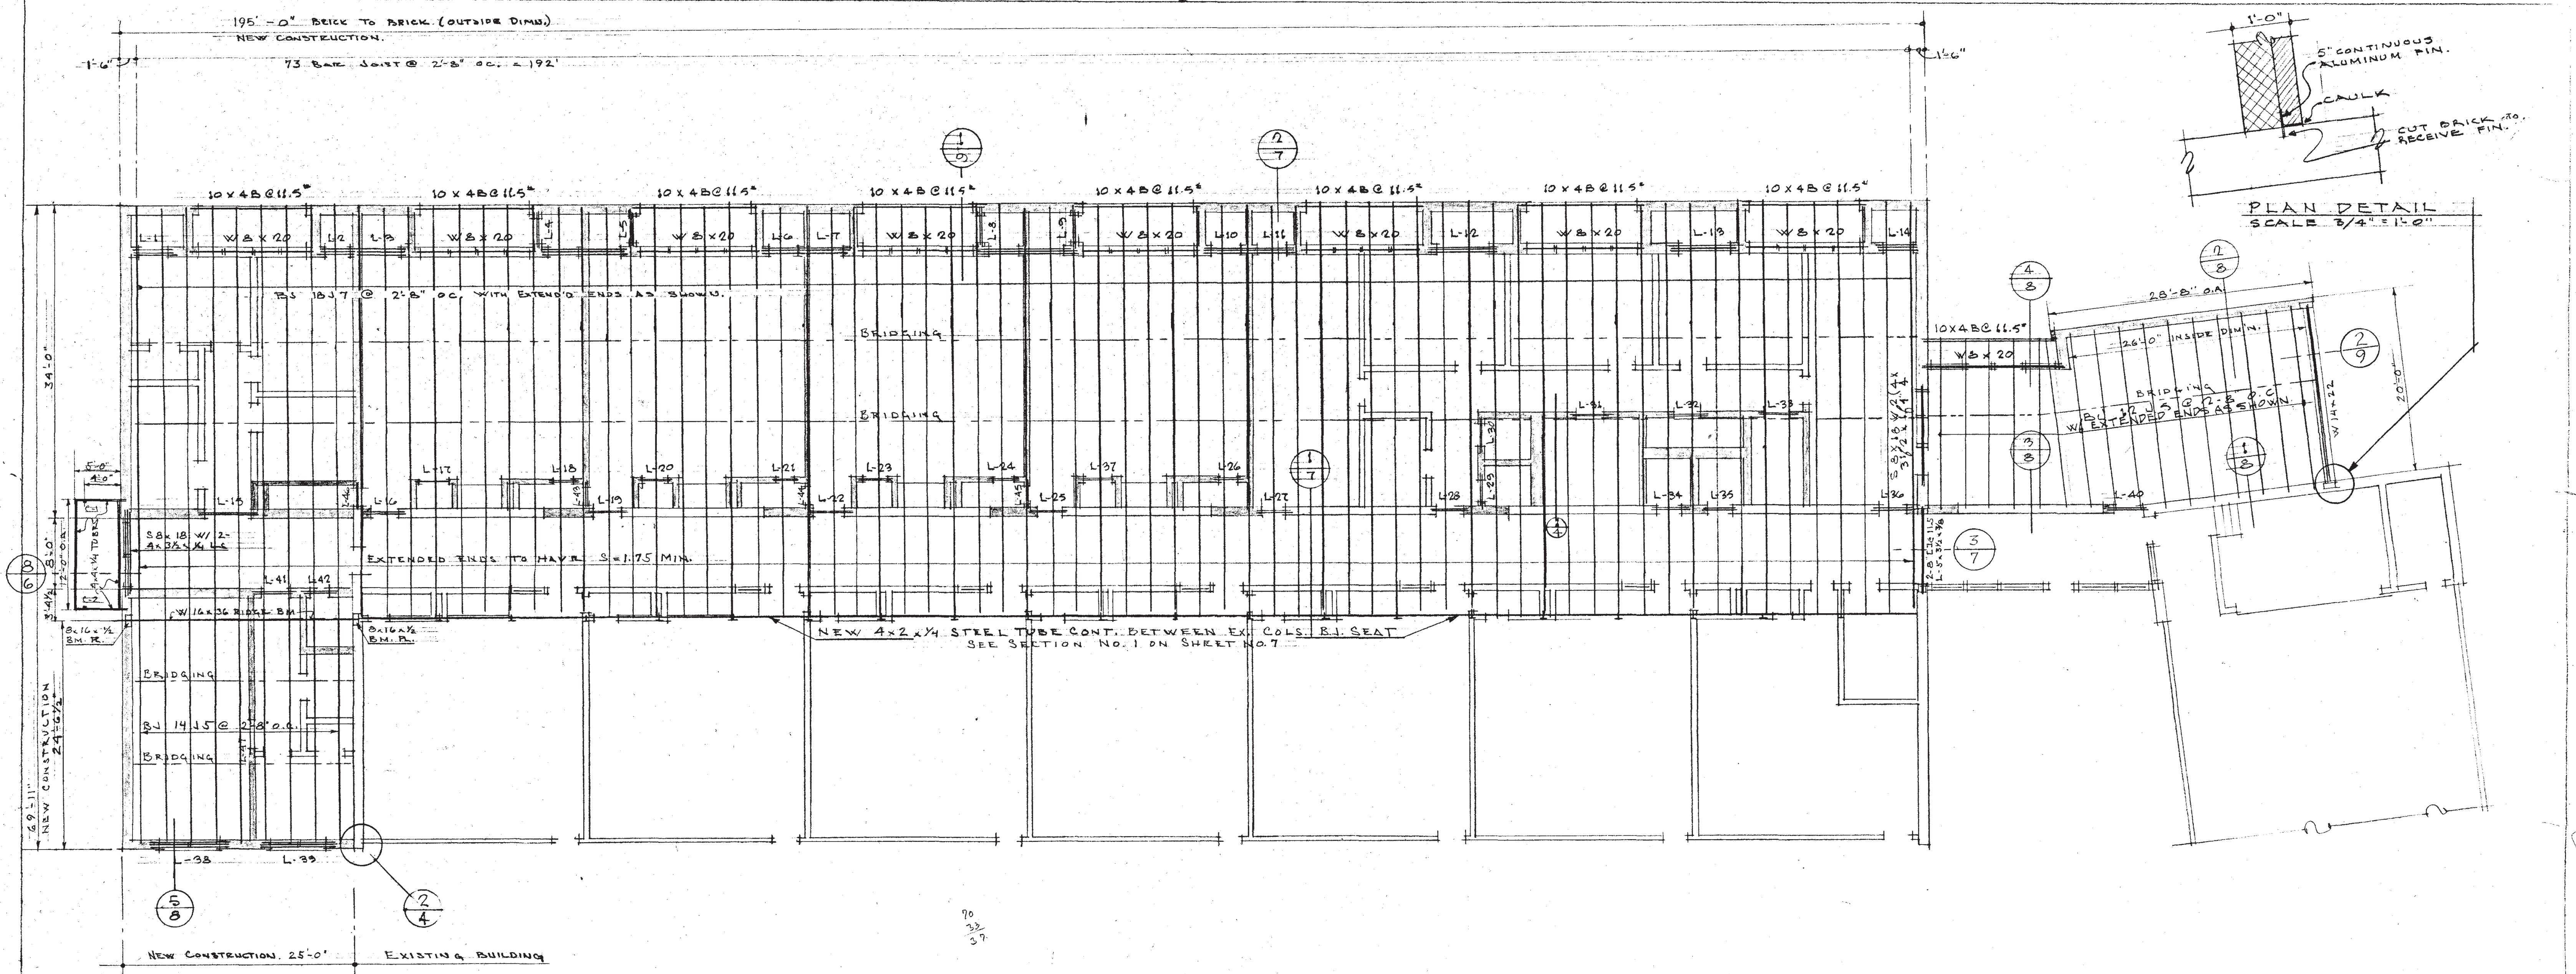
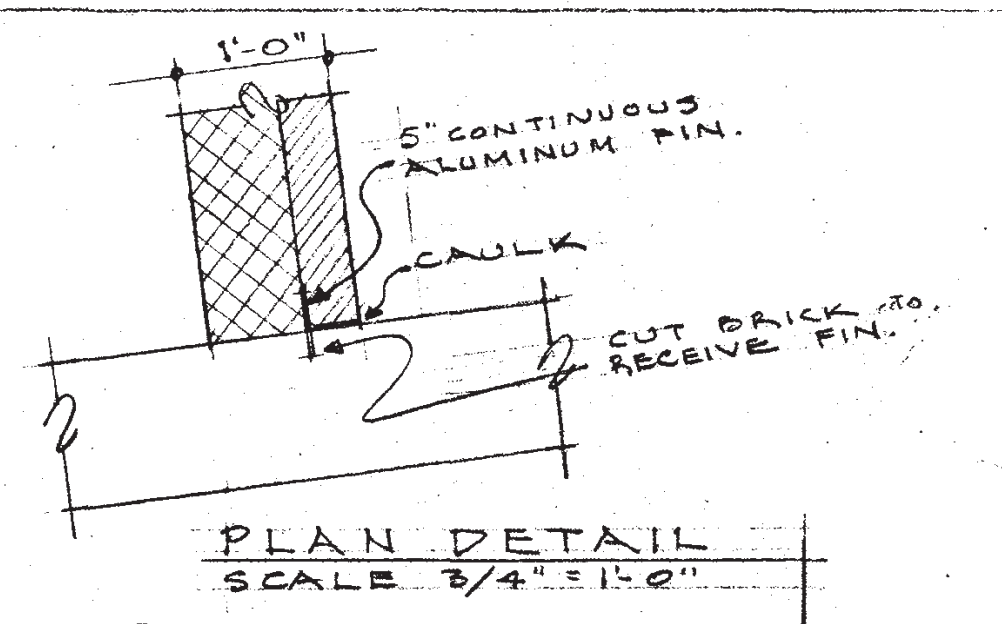
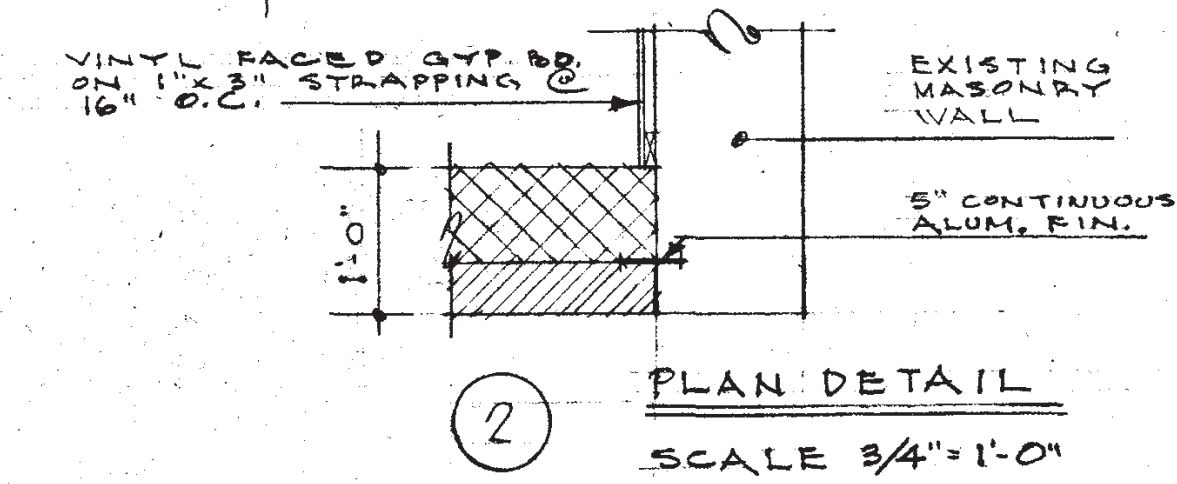
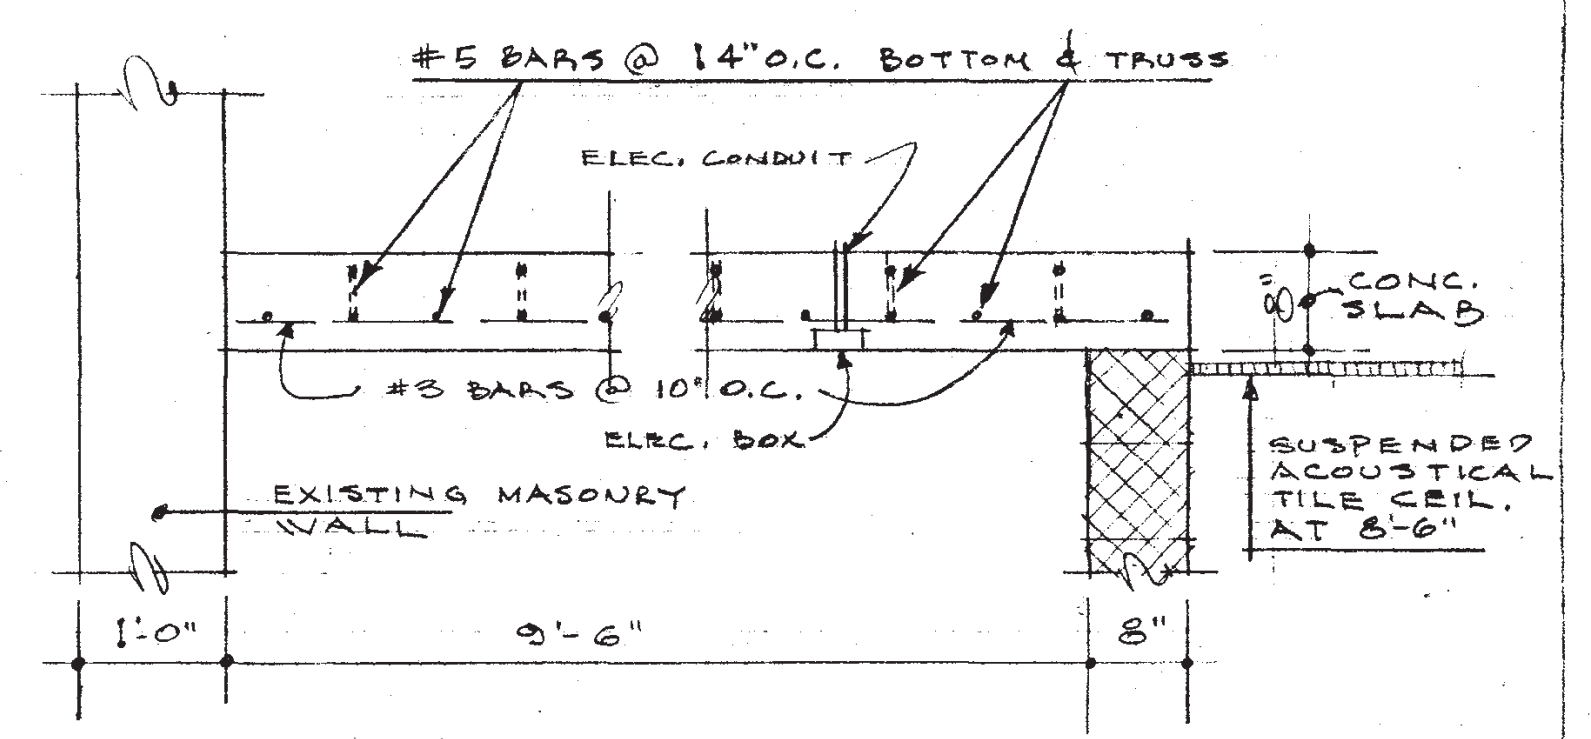
APPROVED FOR DEPT. OF HEALTH & WELFARE		APPROVED FOR DEPT. OF INSURANCE	
BY	TITLE	BY	TITLE
DATE	DATE	DATE	DATE
APPROVED FOR BUREAU OF PUBLIC IMPROVEMENTS		APPROVED FOR	
BY	TITLE	BY	TITLE
DATE	DATE	DATE	DATE
STATE OF MAINE			
TITLE PRE-PRIMARY DIAGNOSTIC CENTER GOV. BAKER STATE SCHOOL FOR THE DEAF LOCATION WACKWORTH ISLAND FALMOUTH, MAINE			
FOUNDATION PLAN AND DET'L'S.			
ARCHT'S DRAWN BY C.K.S.	SEAL	PROJECT NO. 73-6672- 5003	SHEET NO. 3 of 13
CHECKED BY H.E.S.	ALLIED ENGINEERING INC		
NO. DATE	DESCRIPTION	APPROV'D	SCALE AS NOTED
	REVISIONS	DATE	MAR. 15, 1973
		ARCHITECT-ENGINEER GORHAM, MAINE

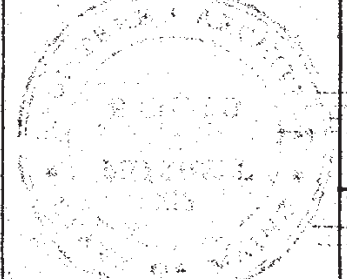
STATE OF MAINE TITLE: PRIMARY DIAGNOSTIC CENTER GOV. BAXTER STATE SCHOOL FOR THE DEAF LOCATION: MACKWORTH ISLAND PALMOUTH, MAINE TITLE THIS DWG: WALL SECTIONS			
ARCHT'S	BEAL		
DRAWN BY	Plan	PROJECT NO. 79-0671-3003	
CHECKED BY	HES	ARCHITECT-ENGINEER	
SCALE	AS NOTED	GORHAM, MAINE	
DATE	MAR. 15, 1973	SHEET NO. 8 OF 13
