State of Maine
Mackworth Island
Renovations Phase 1

Falmouth, Maine

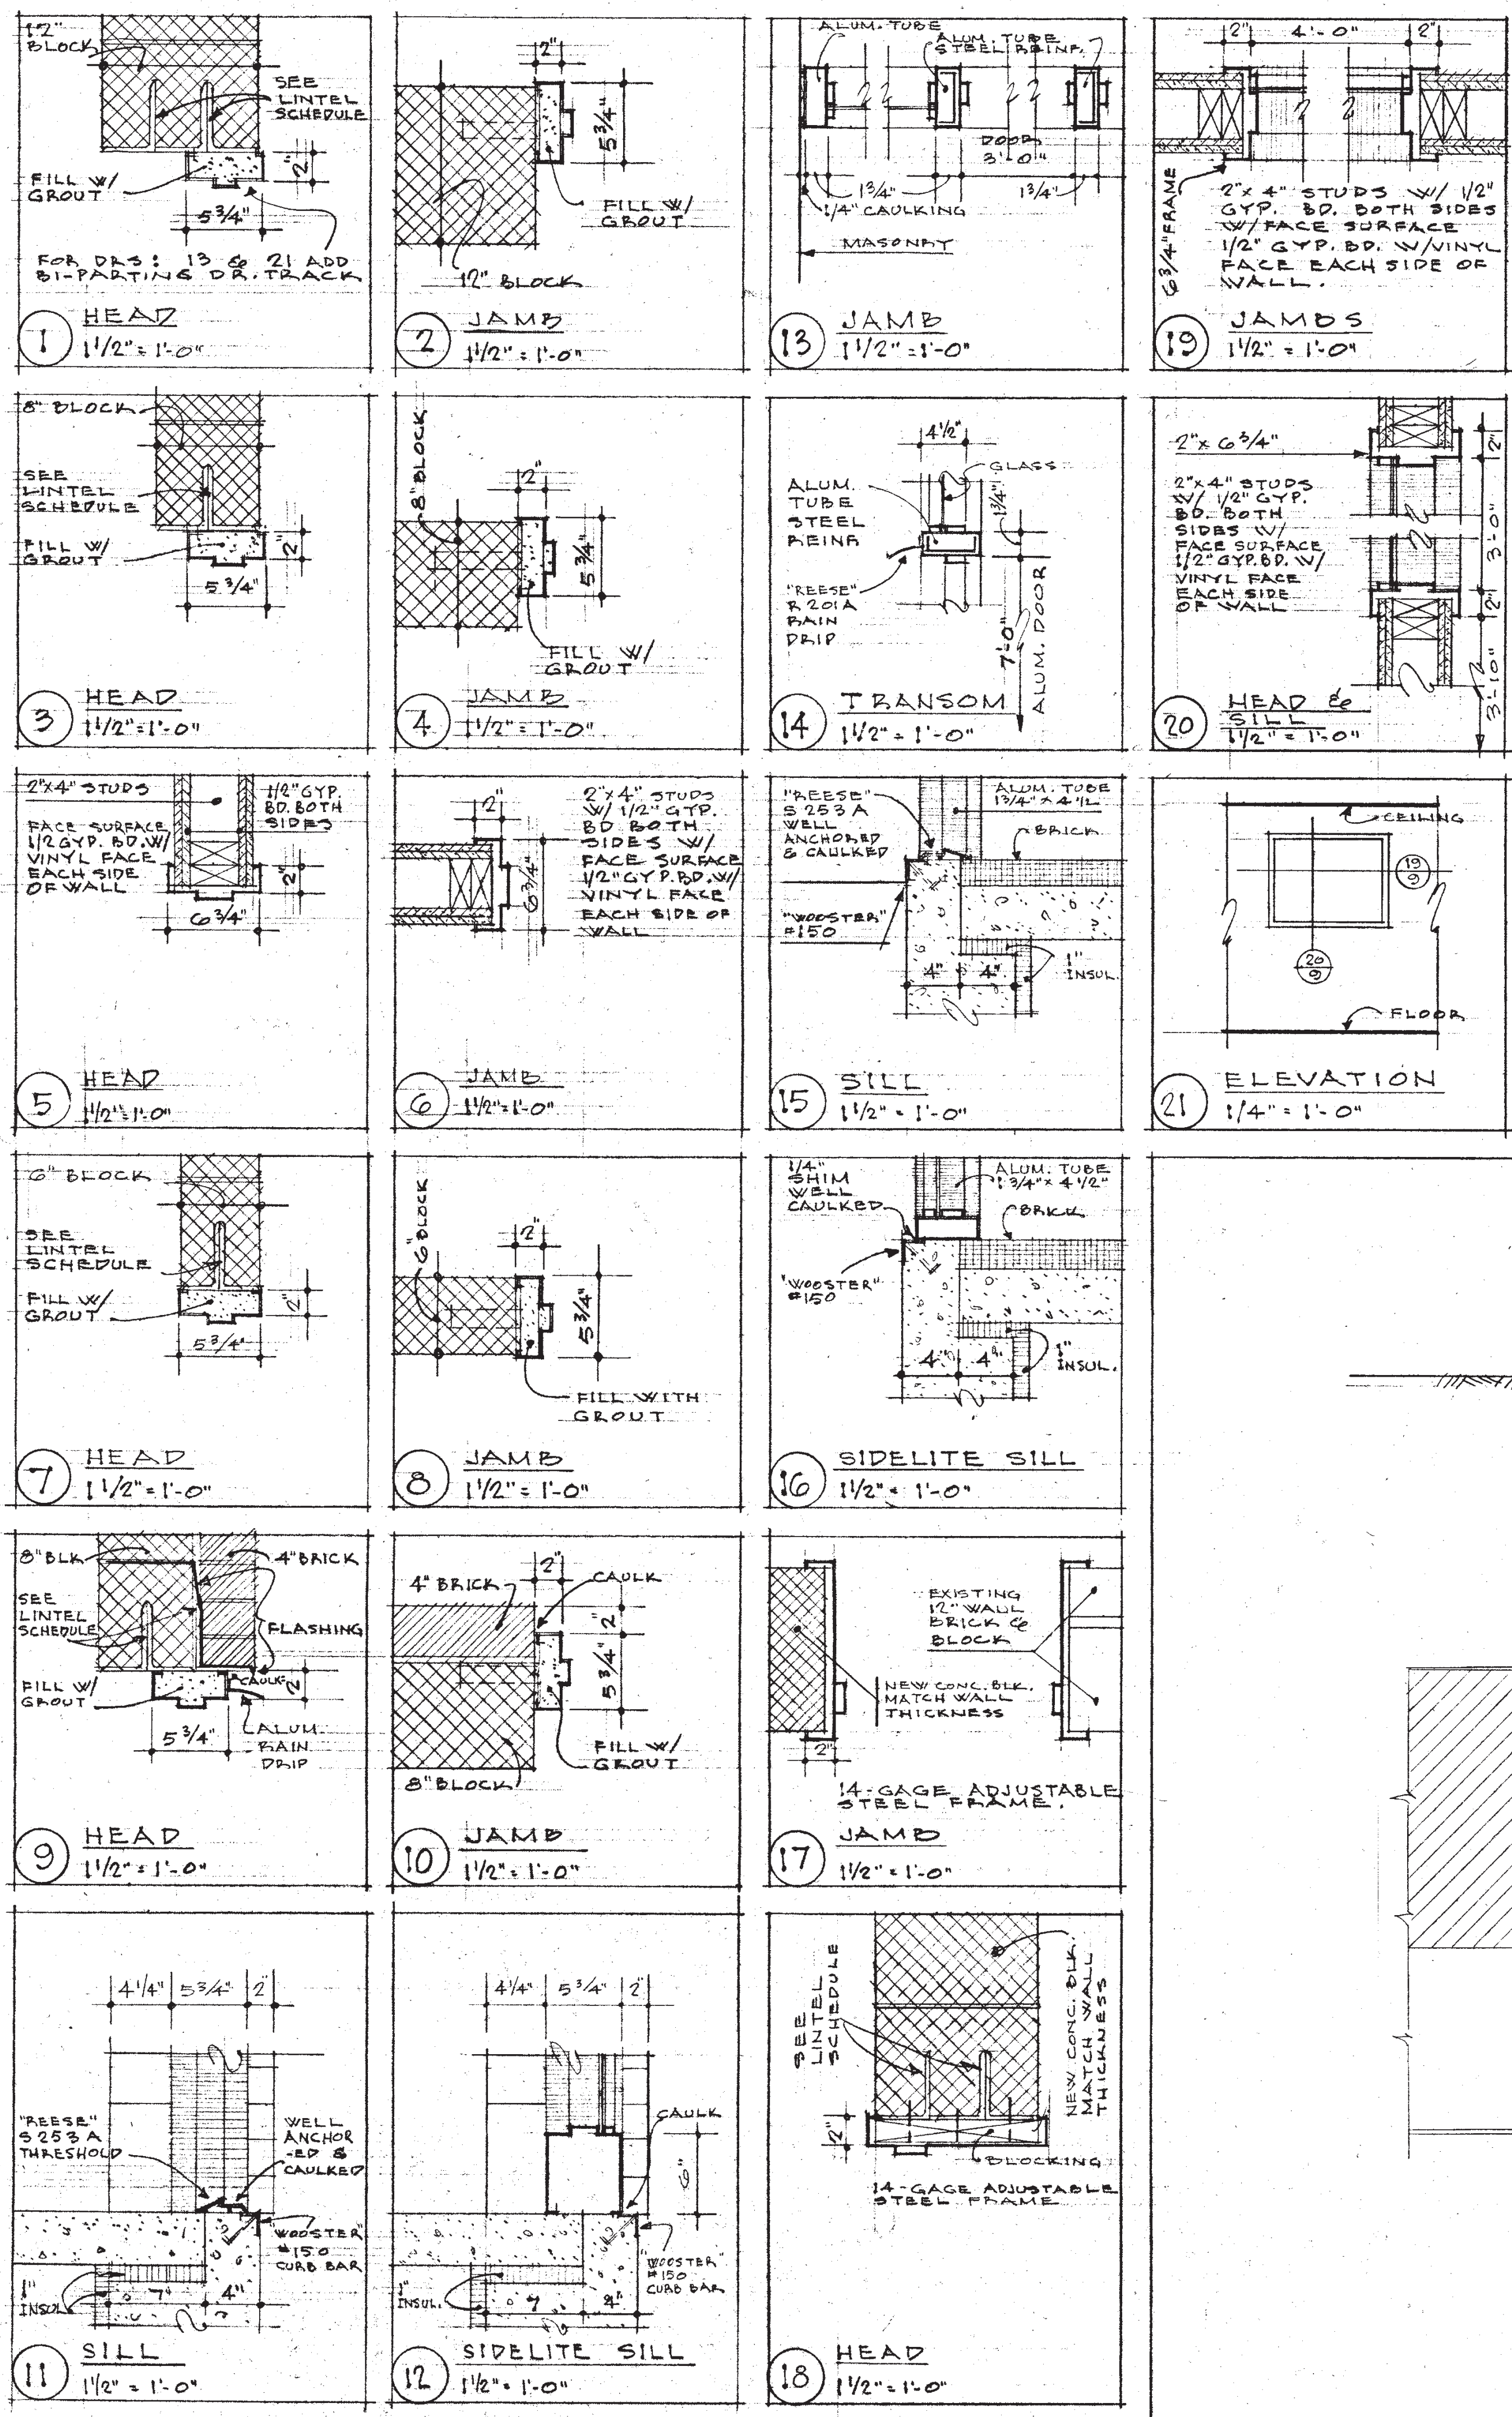
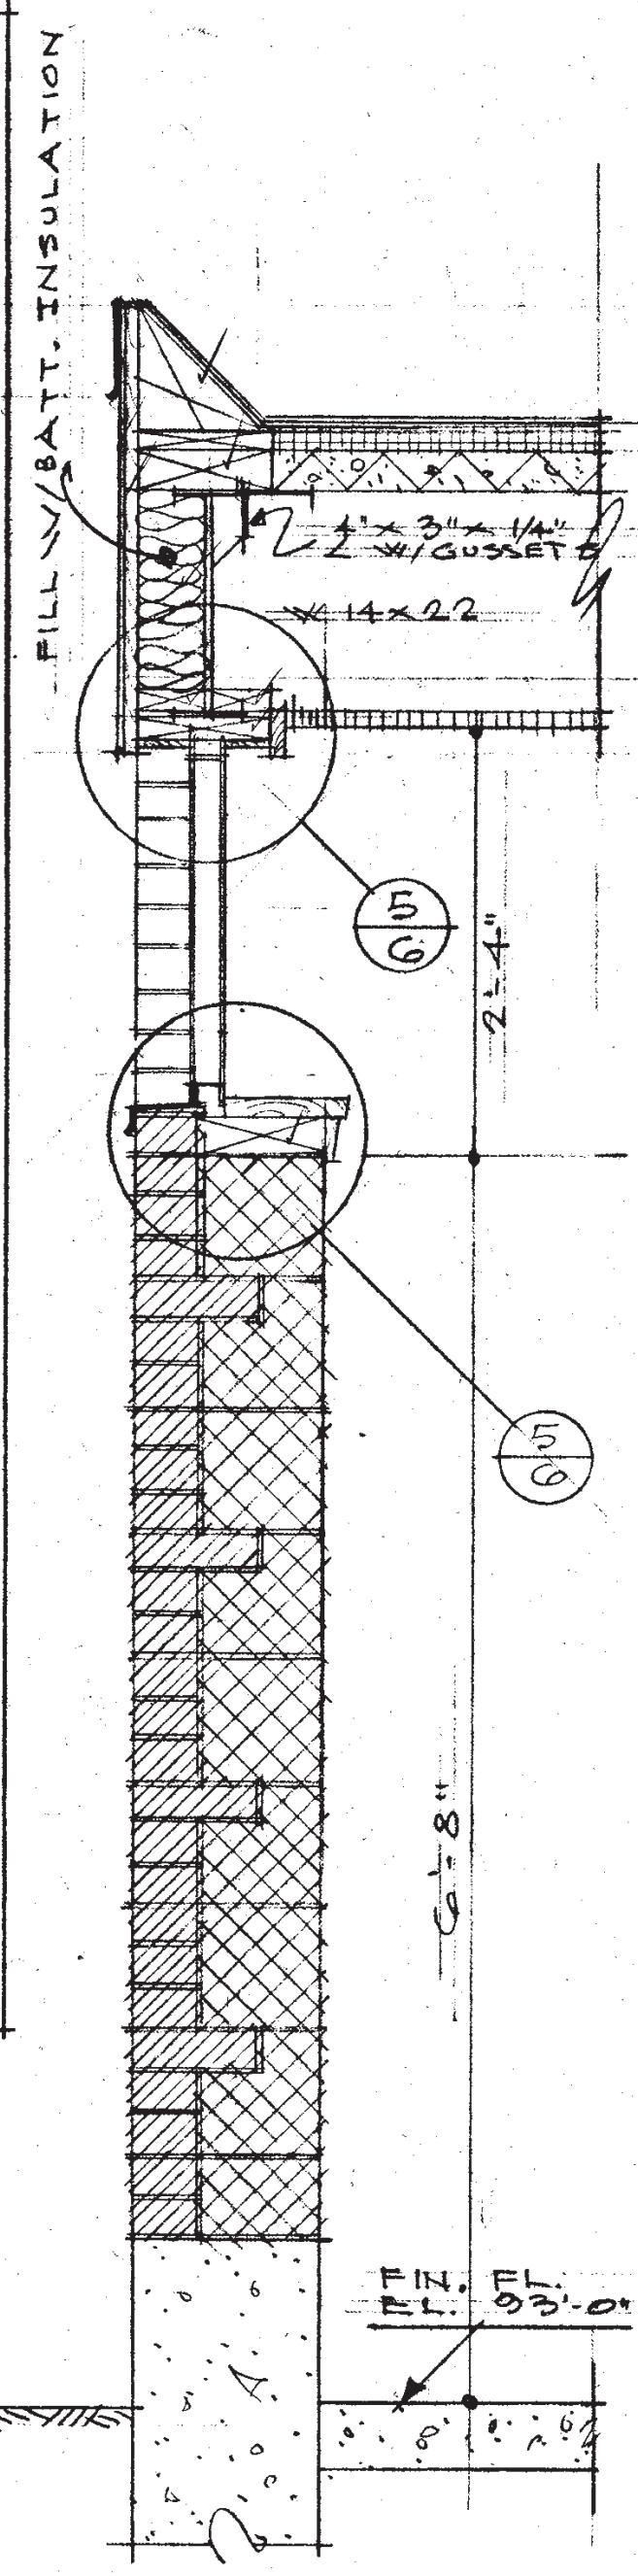
2 WALL SECTION
SCALE 1" = 1'-0"

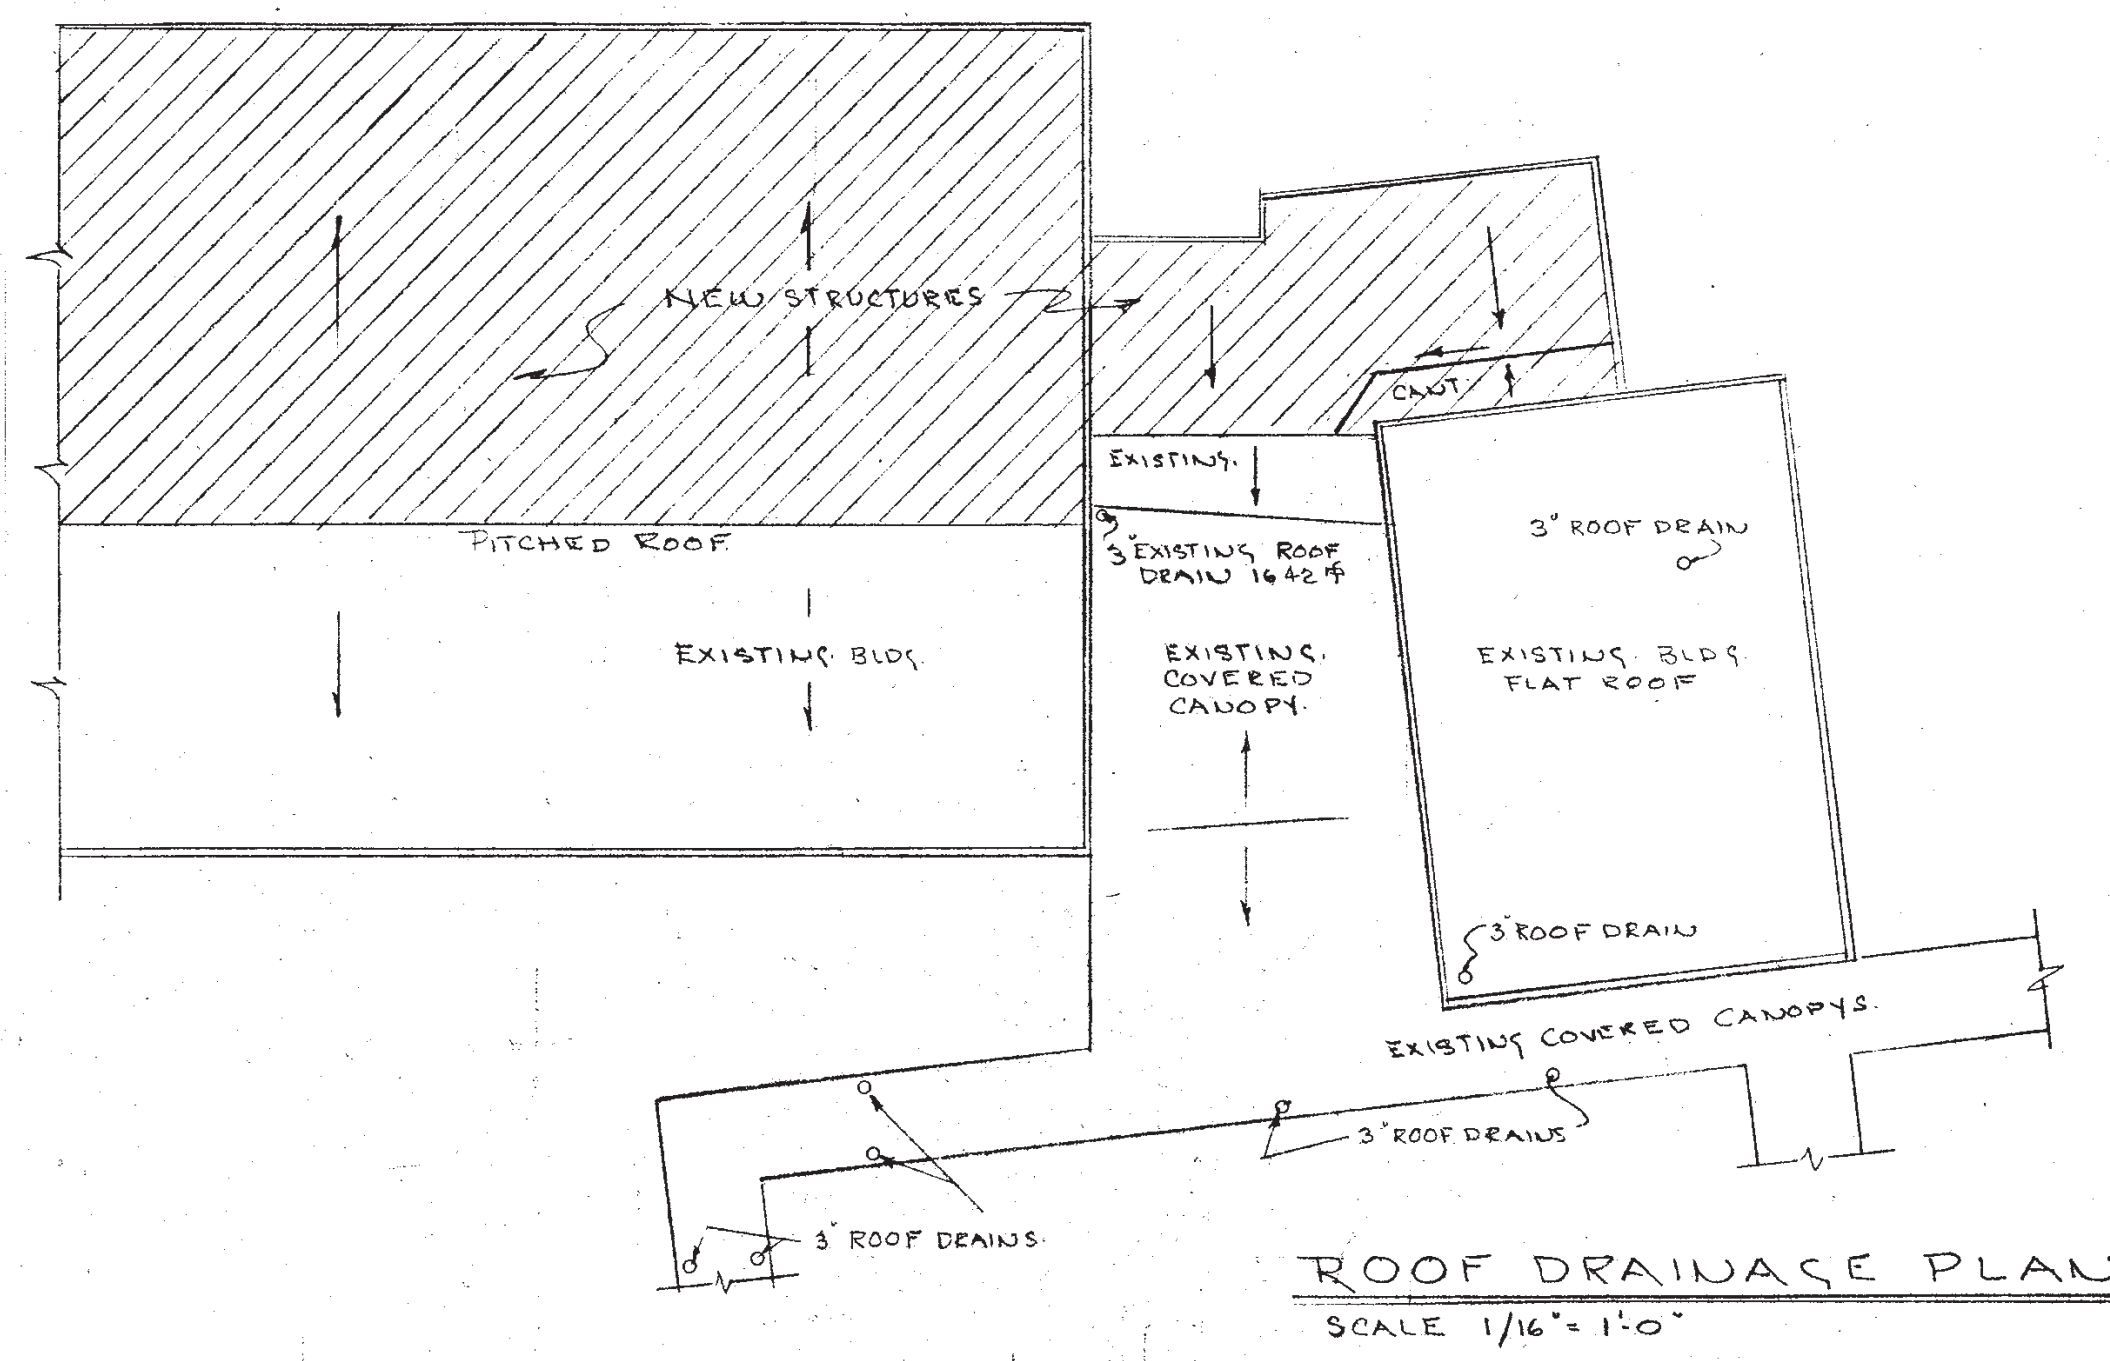
ROOF DRAINAGE PLAN
SCALE 1/16" = 1'-0"

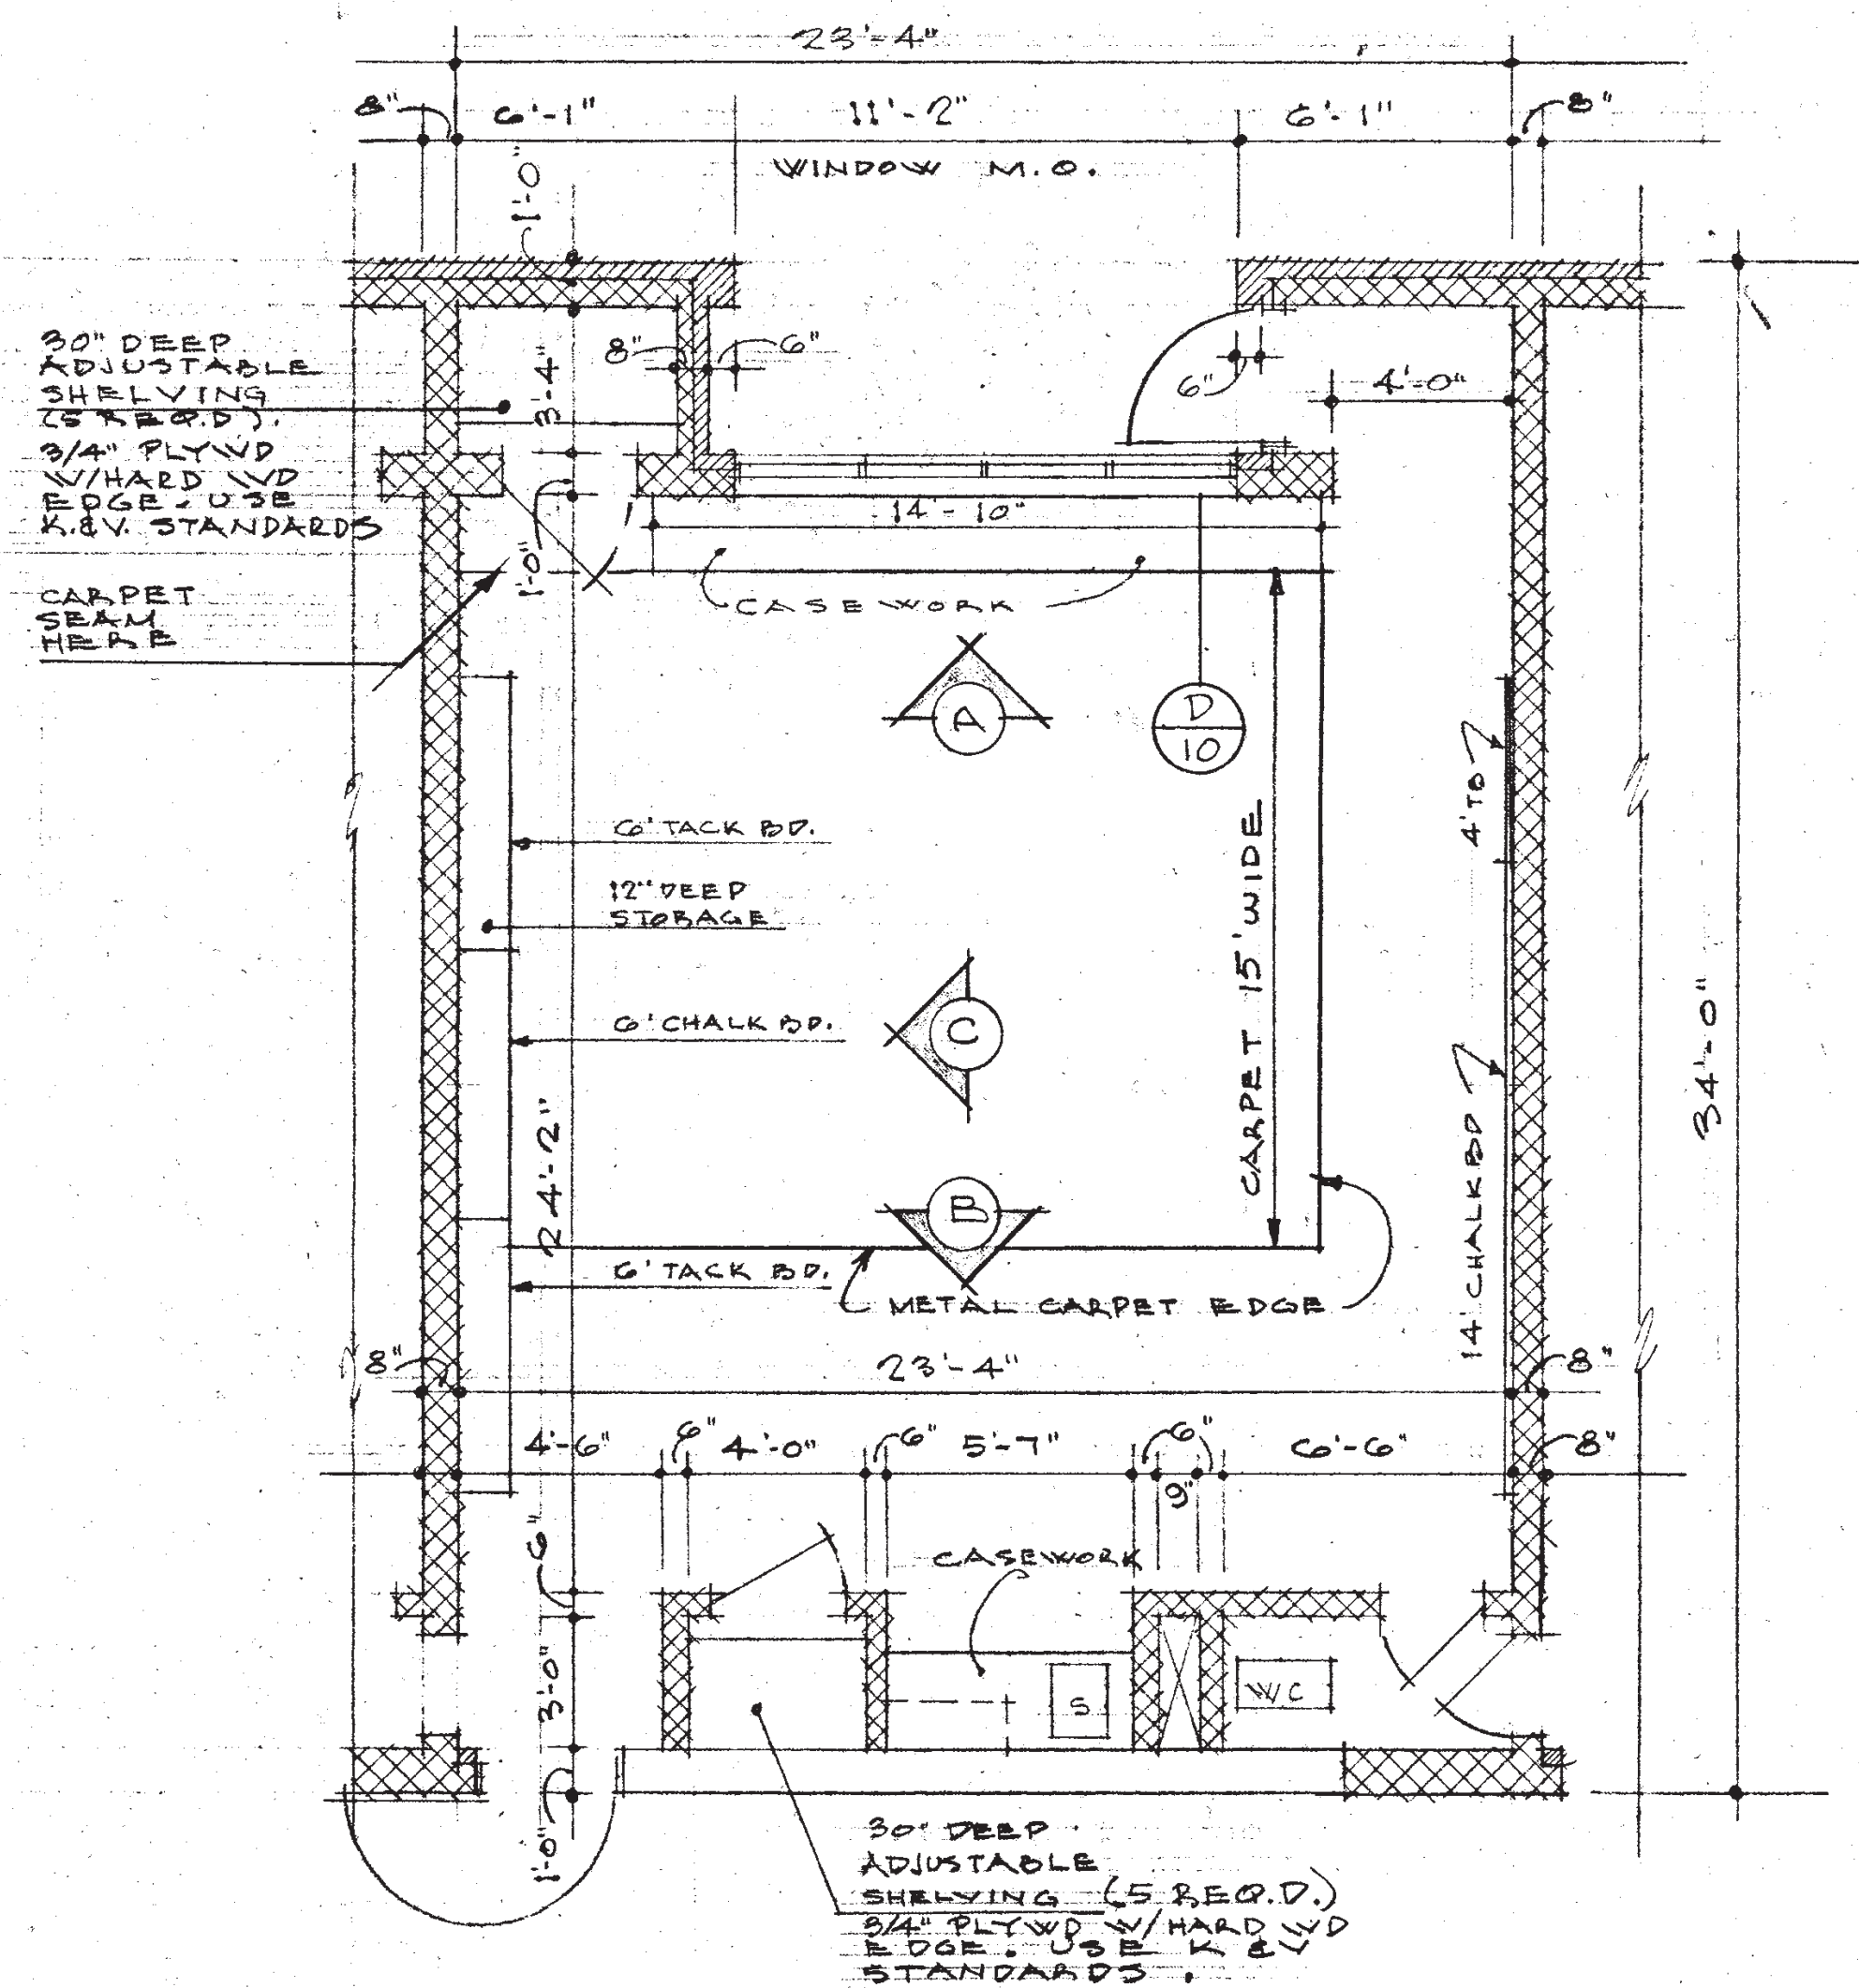
TYPICAL CLASSROOM LAYOUT
SCALE 1/4" = 1'-0"

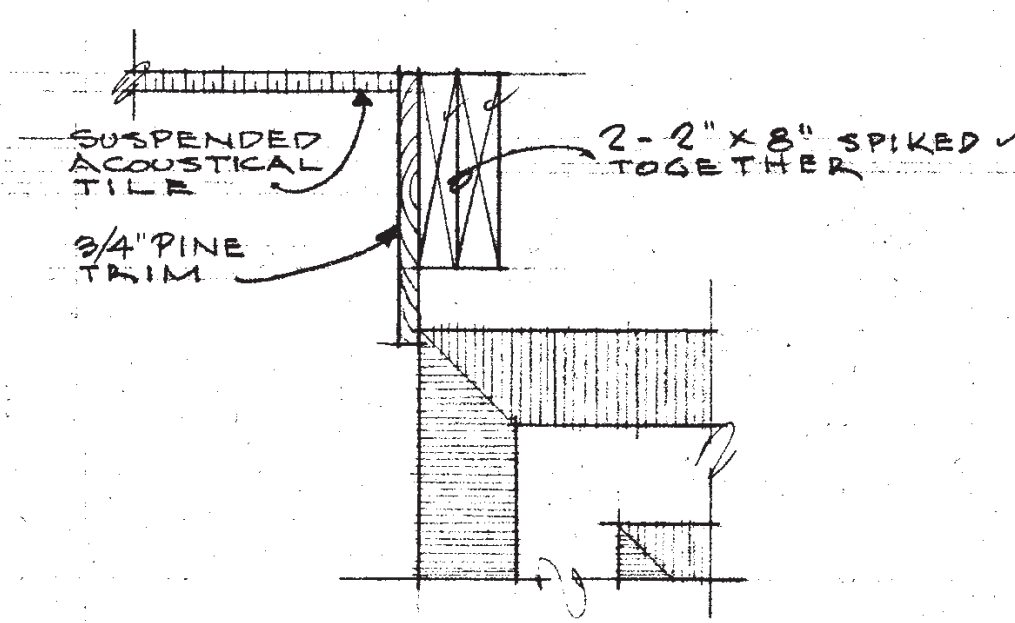
CEIL-HEAD DET. SCALE 1 1/2" = 1'-0"

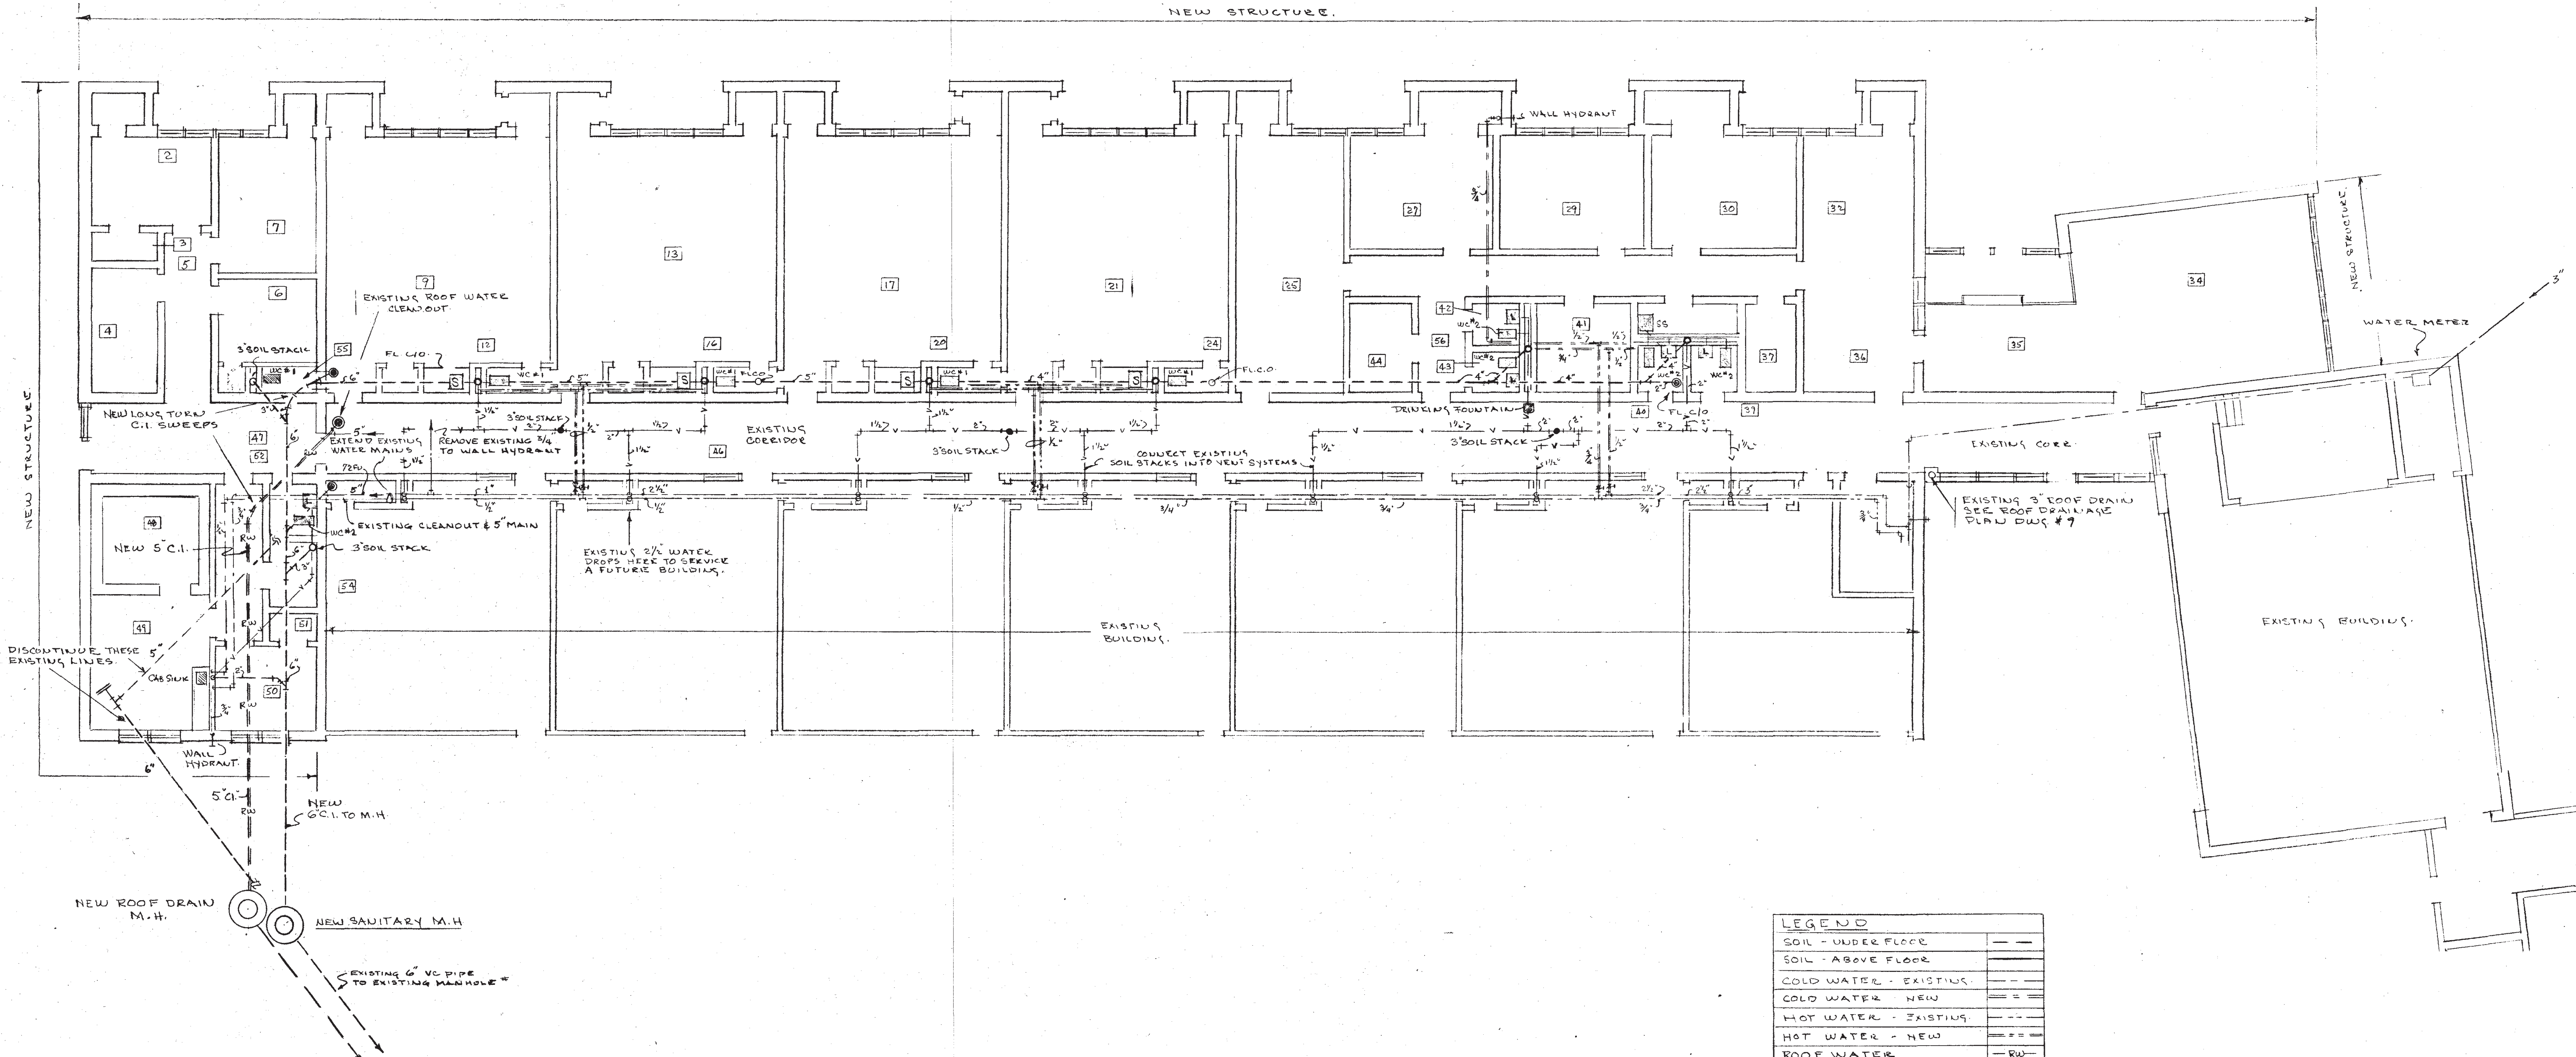
APPROVED FOR DEPT. OF HEALTH & WELFARE		APPROVED FOR DEPT. OF INSURANCE	
BY	TITLE	BY	TITLE
DATE	DATE	DATE	DATE
APPROVED FOR BUREAU OF PUBLIC IMPROVEMENTS		APPROVED FOR	
BY	DIRECTOR	BY	TITLE
DATE	DATE	DATE	DATE
STATE OF MAINE TITLE: PRE-PRIMARY DIAGNOSTIC CENTER GOV. BAXTER STATE SCHOOL FOR THE DEAF LOCATION: WACCAWORTH ISLAND FAIRMOUTH, MAINE TITLE THIS DWG: TYPICAL 1 1/2" CLASSROOM LAYOUT CASEWORK DETAILS			
ARCHT	SEAL	PROJECT NO.	73-6672-5003
DRAWN BY	R.M.P.	ALLIED ENGINEERING INC	
CHECKED BY	H.E.S.	ARCHITECT-ENGINEER	
NO.	DATE	DESCRIPTION	APPROV'D
2			
1			
SCALE: AS NOTED		DATE: MAR. 15, 1973	GORHAM, MAINE
REVISIONS			
			SHEET NO. 10 OF 13

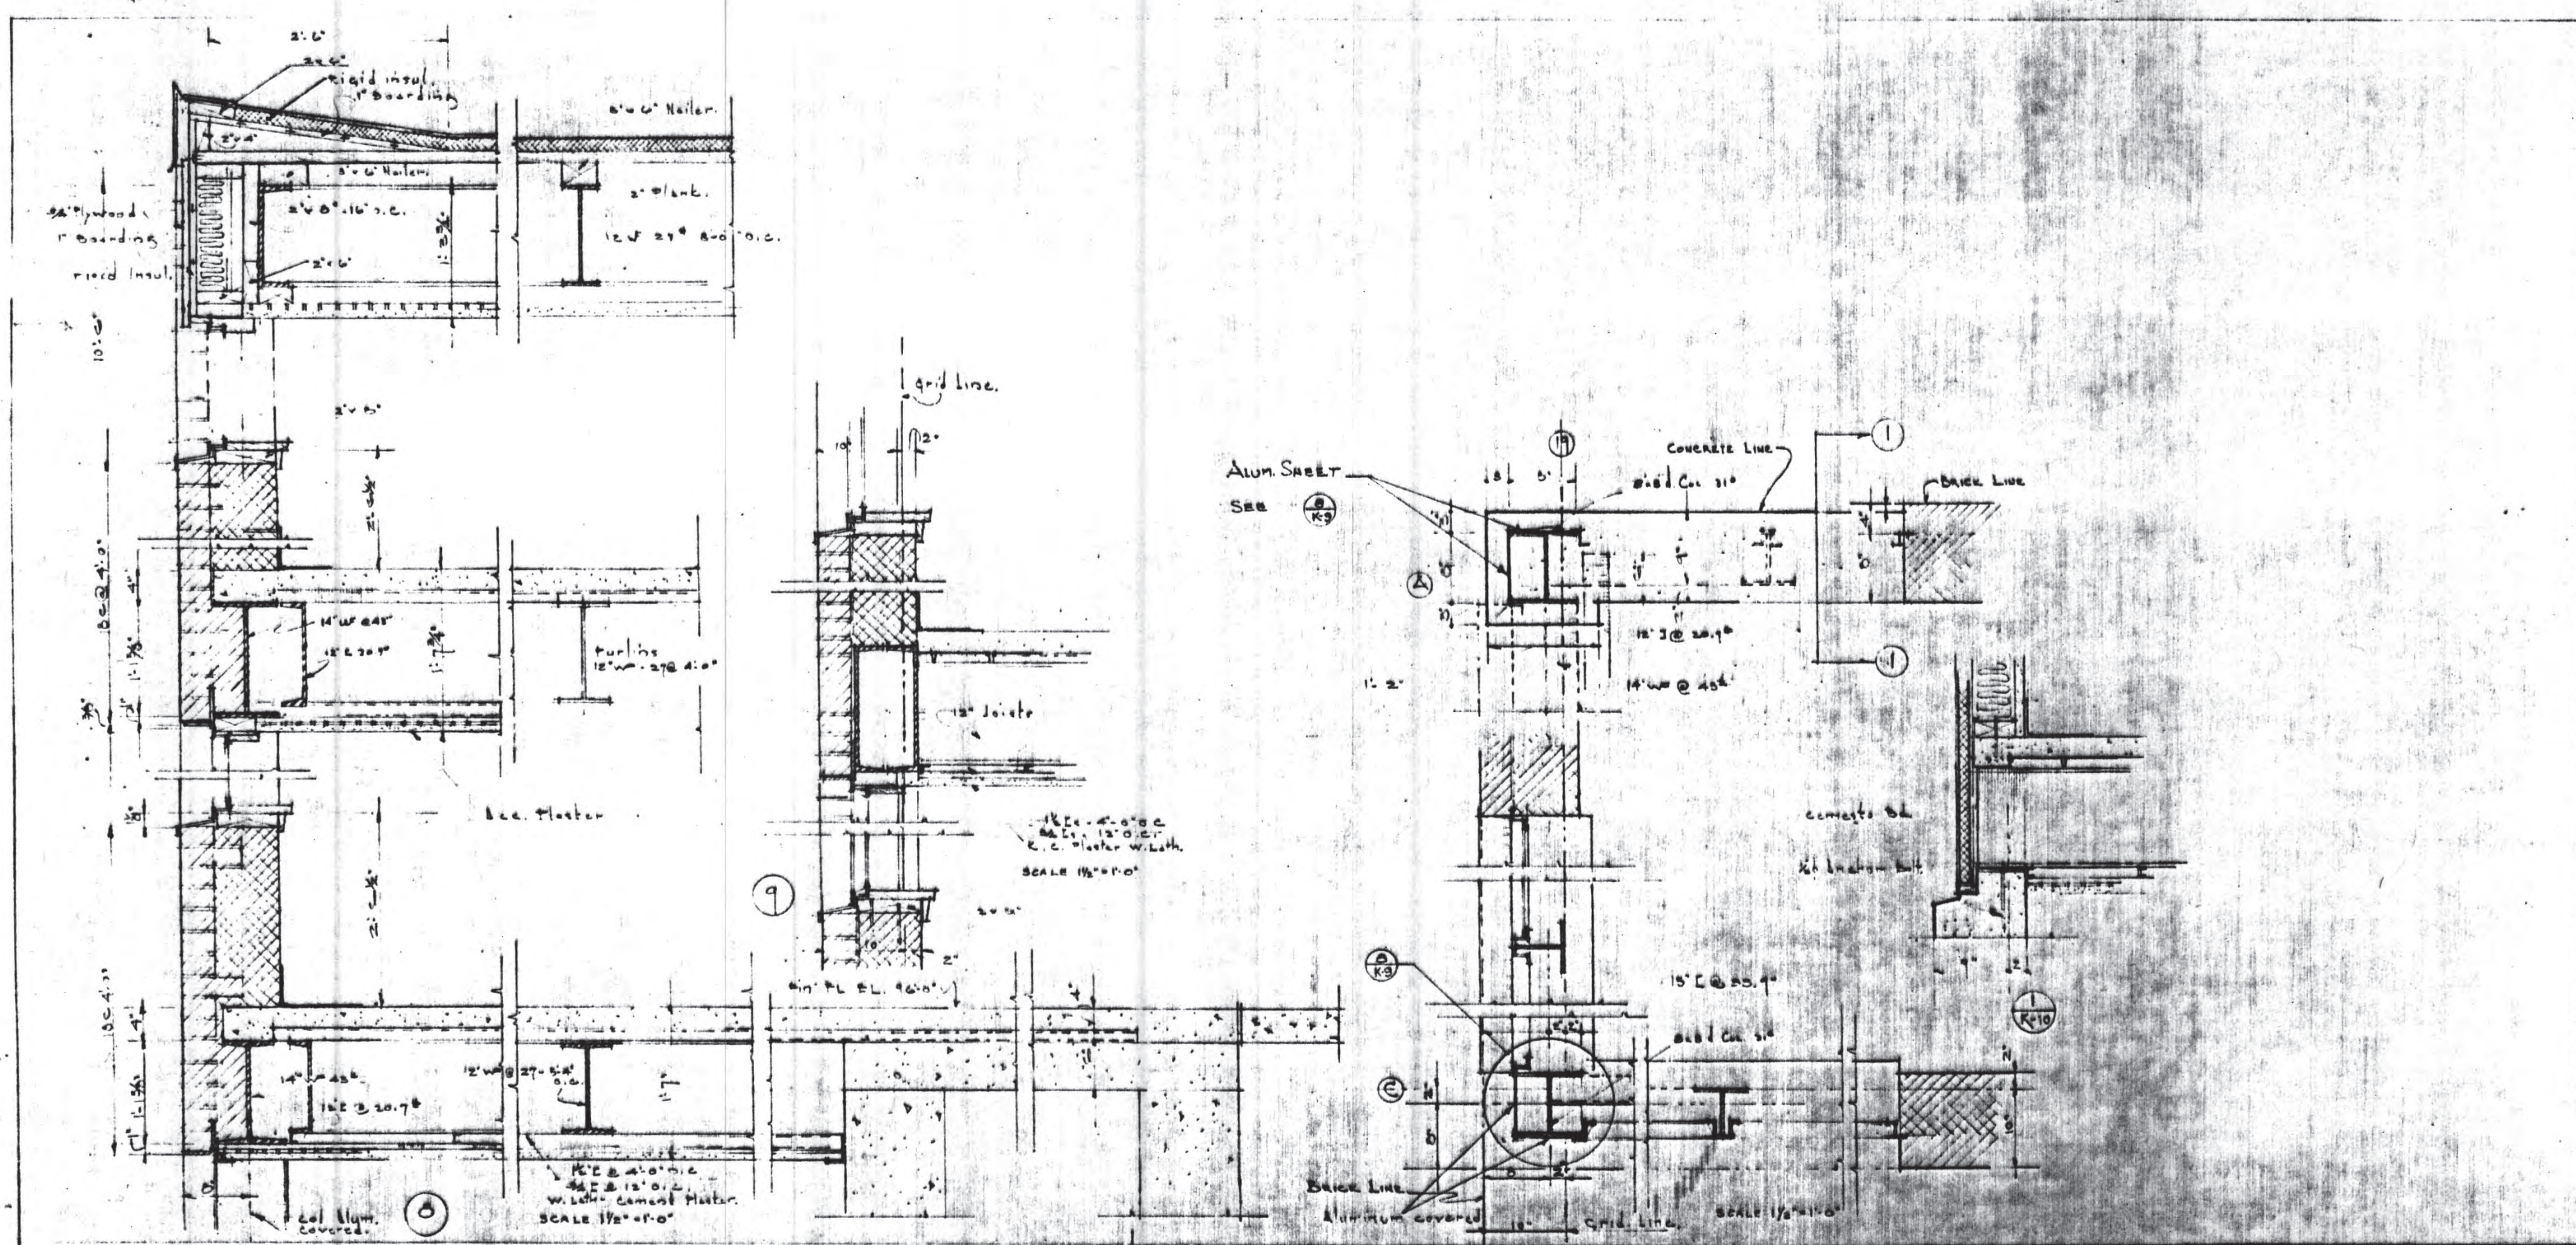
MAINE SCHOOL FOR THE DEAF
MACKWORTH ISLAND FALMOUTH MAINE

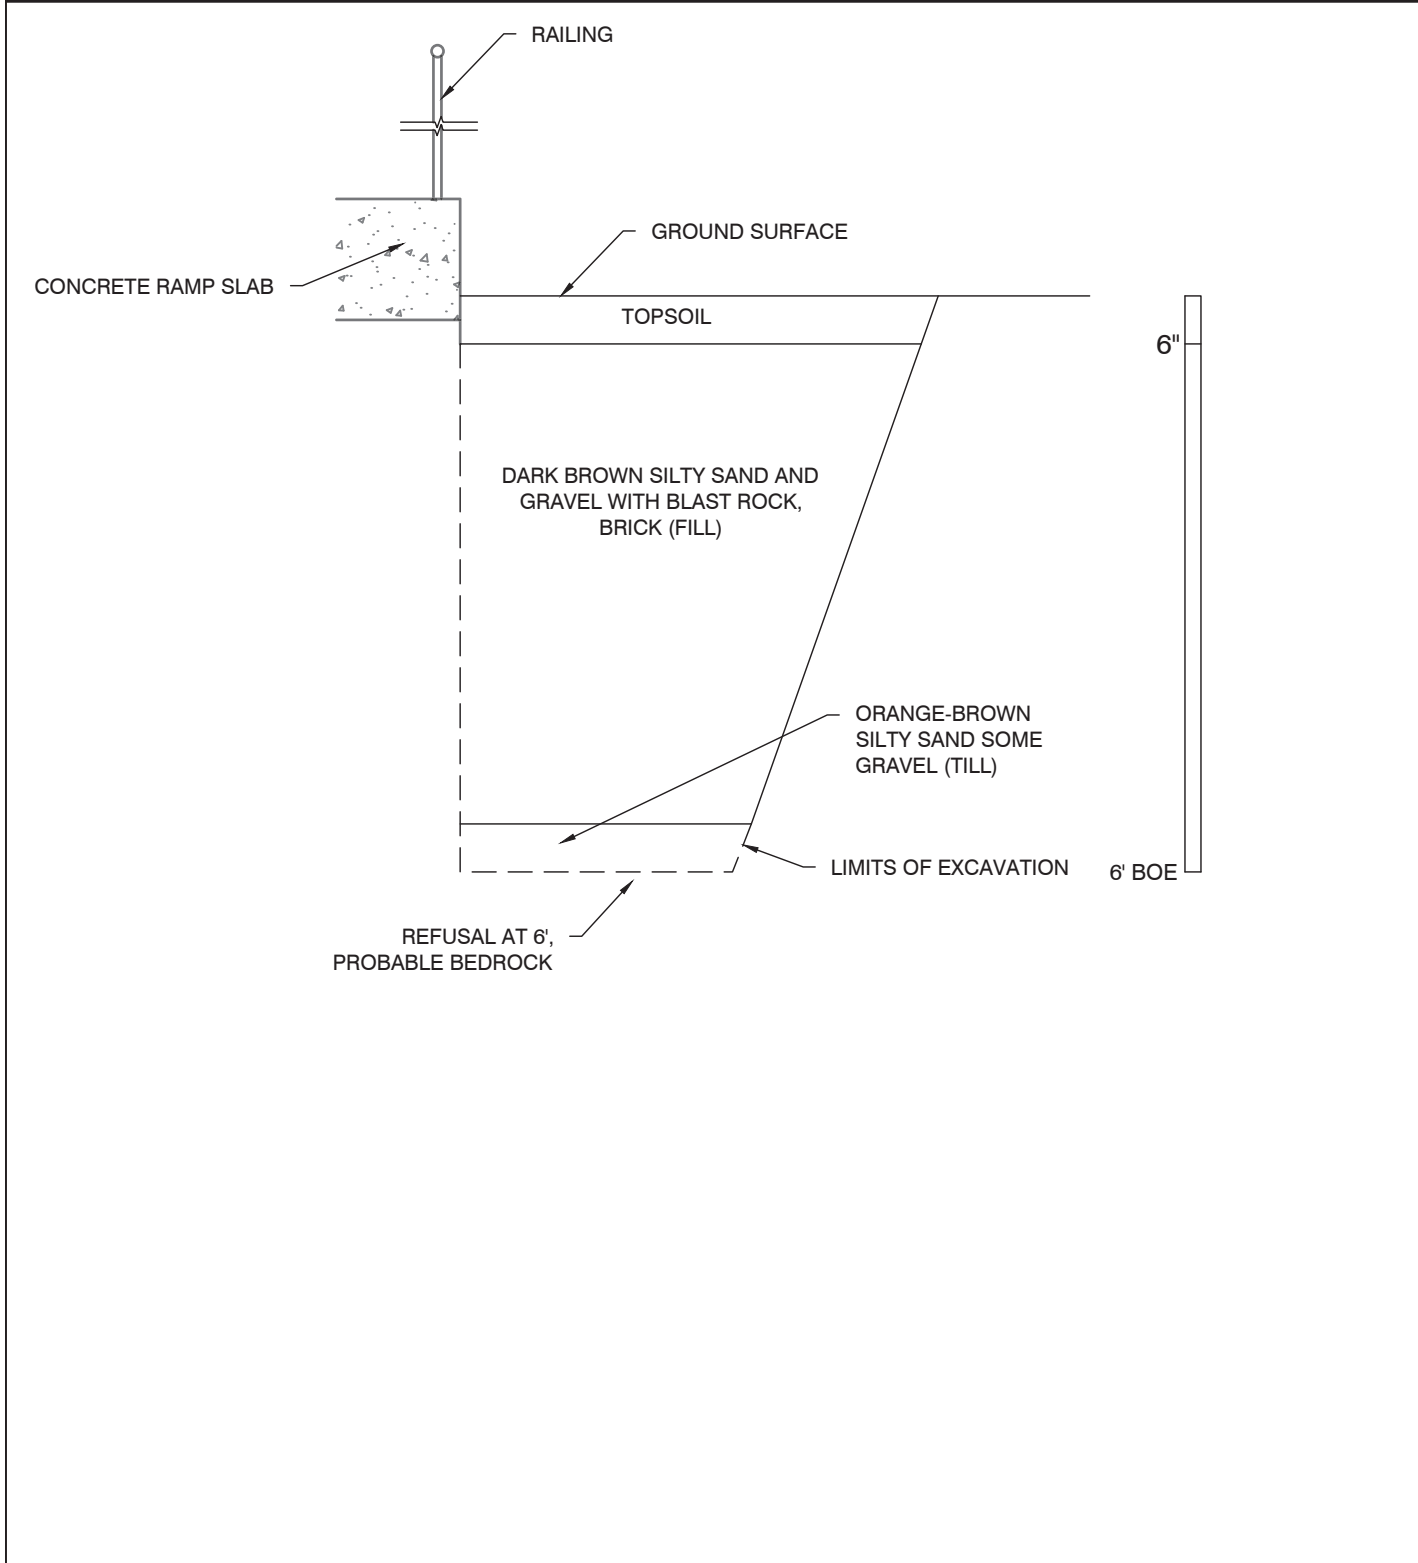
Stratification lines represent approximate boundary between soil types, transitions may be gradual. Water level readings have been made at times and under conditions stated. Fluctuations of groundwater may occur due to other factors than those present at the time measurements were made.

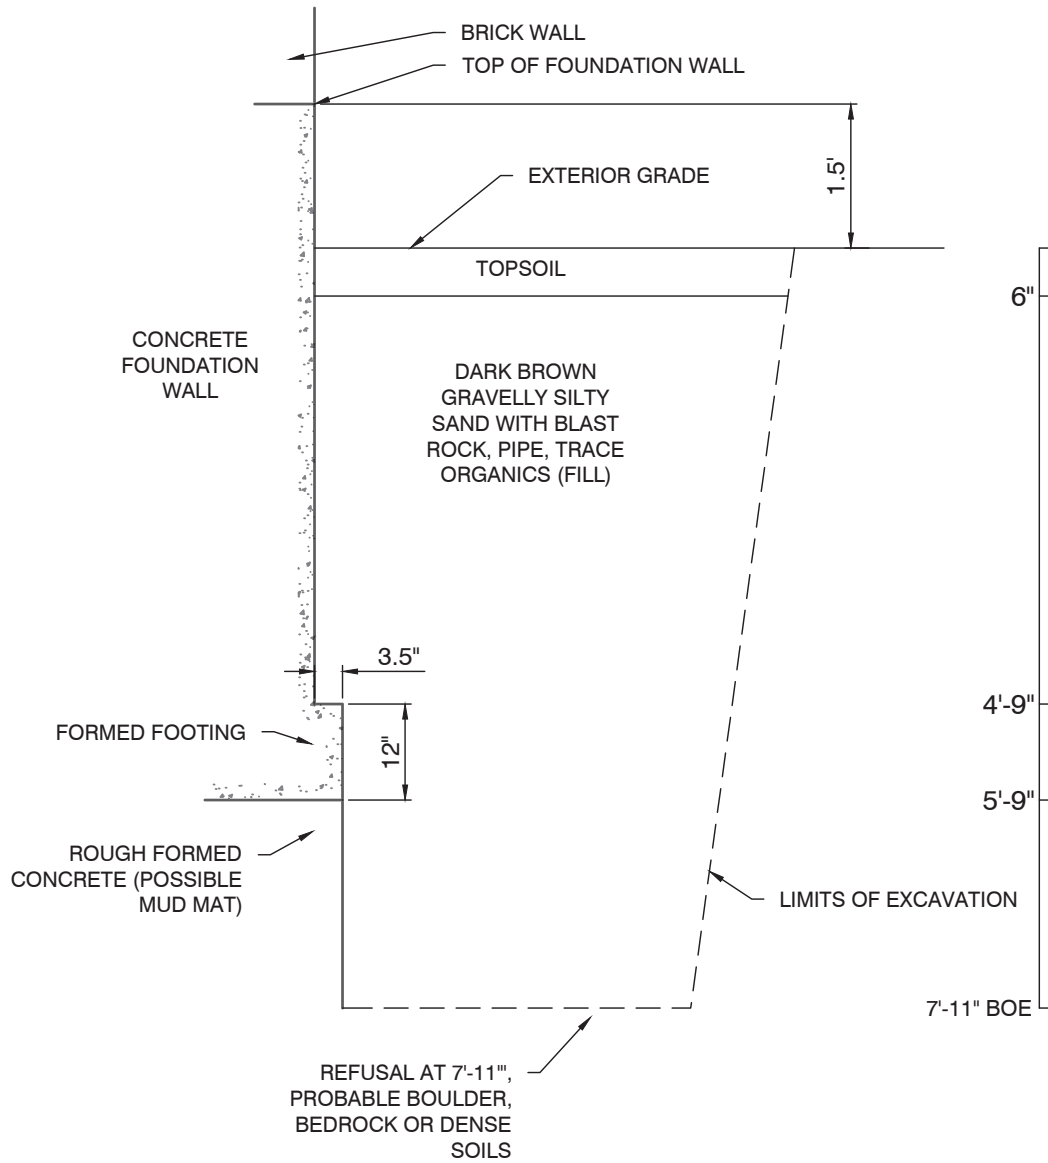
Stratification lines represent approximate boundary between soil types, transitions may be gradual. Water level readings have been made at times and under conditions stated. Fluctuations of groundwater may occur due to other factors than those present at the time measurements were made.

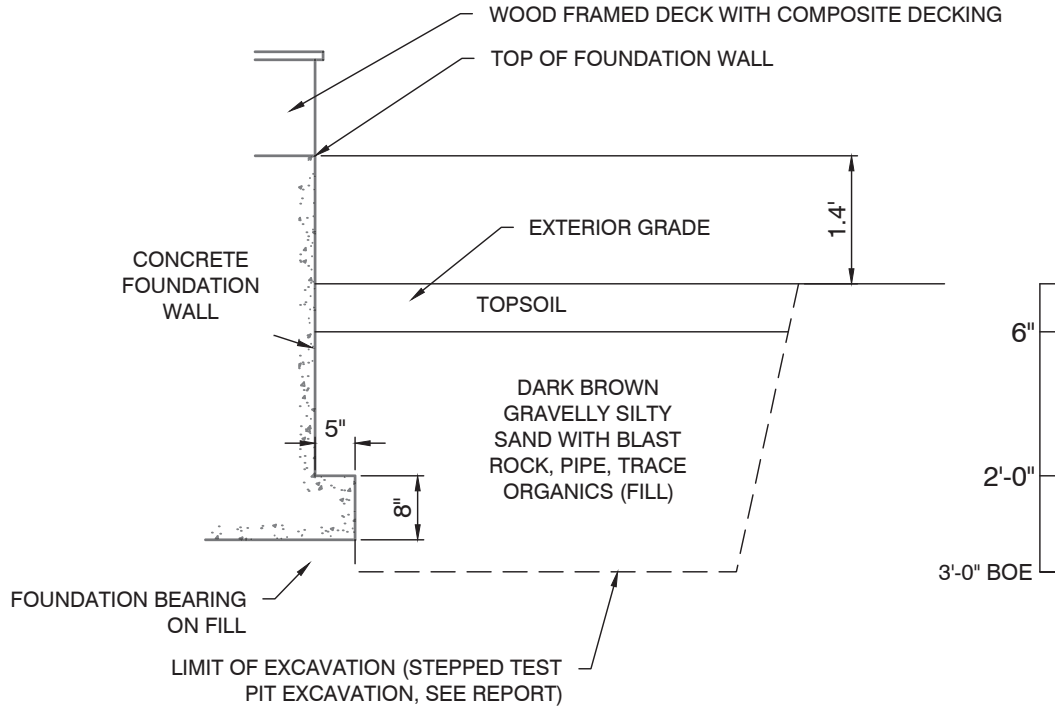
Stratification lines represent approximate boundary between soil types, transitions may be gradual. Water level readings have been made at times and under conditions stated. Fluctuations of groundwater may occur due to other factors than those present at the time measurements were made.
