State of Maine
Mackworth Island
Renovations Phase 1

Falmouth, Maine

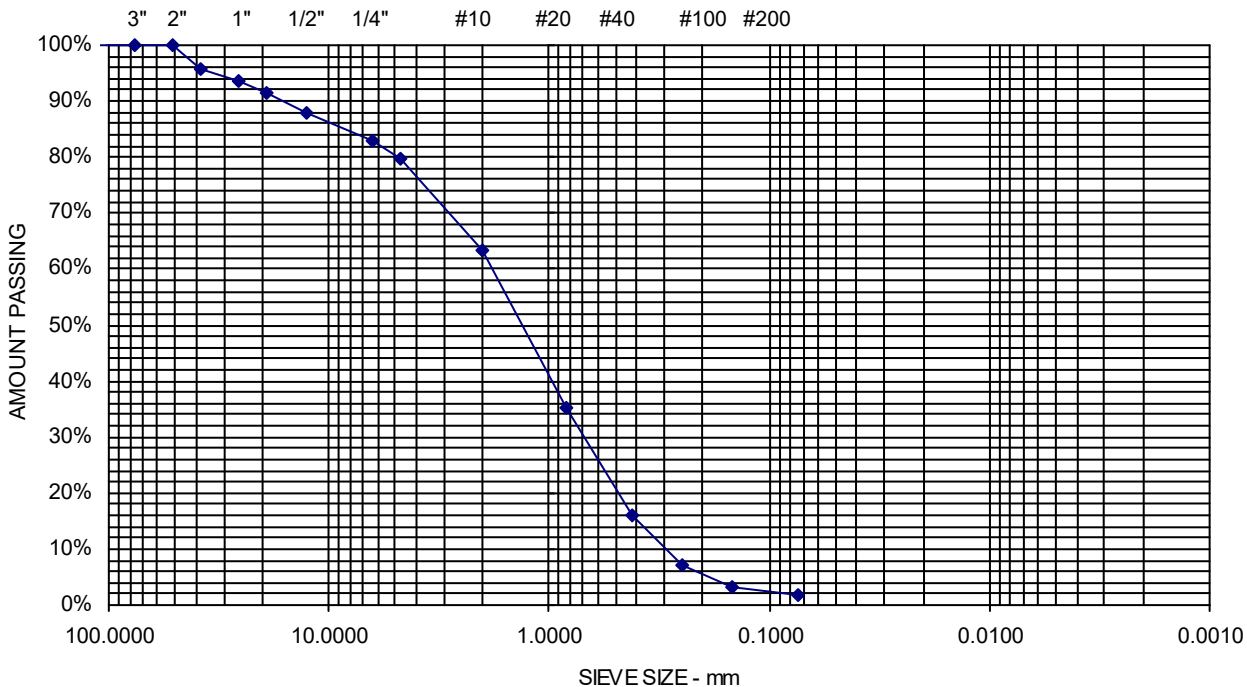
<u>STANDARD DESIGNATION (mm/μm)</u>	<u>SIEVE SIZE</u>	<u>AMOUNT PASSING (%)</u>	
150 mm	6"	100	
125 mm	5"	100	
100 mm	4"	100	
75 mm	3"	100	
50 mm	2"	100	
38.1 mm	1-1/2"	96	
25.0 mm	1"	94	
19.0 mm	3/4"	91	
12.5 mm	1/2"	88	
6.3 mm	1/4"	83	
4.75 mm	No. 4	80	20.4% Gravel
2.00 mm	No. 10	63	
850 um	No. 20	35	
425 um	No. 40	16	77.8% Sand
250 um	No. 60	7	
150 um	No. 100	3	
75 um	No. 200	1.7	1.7% Fines

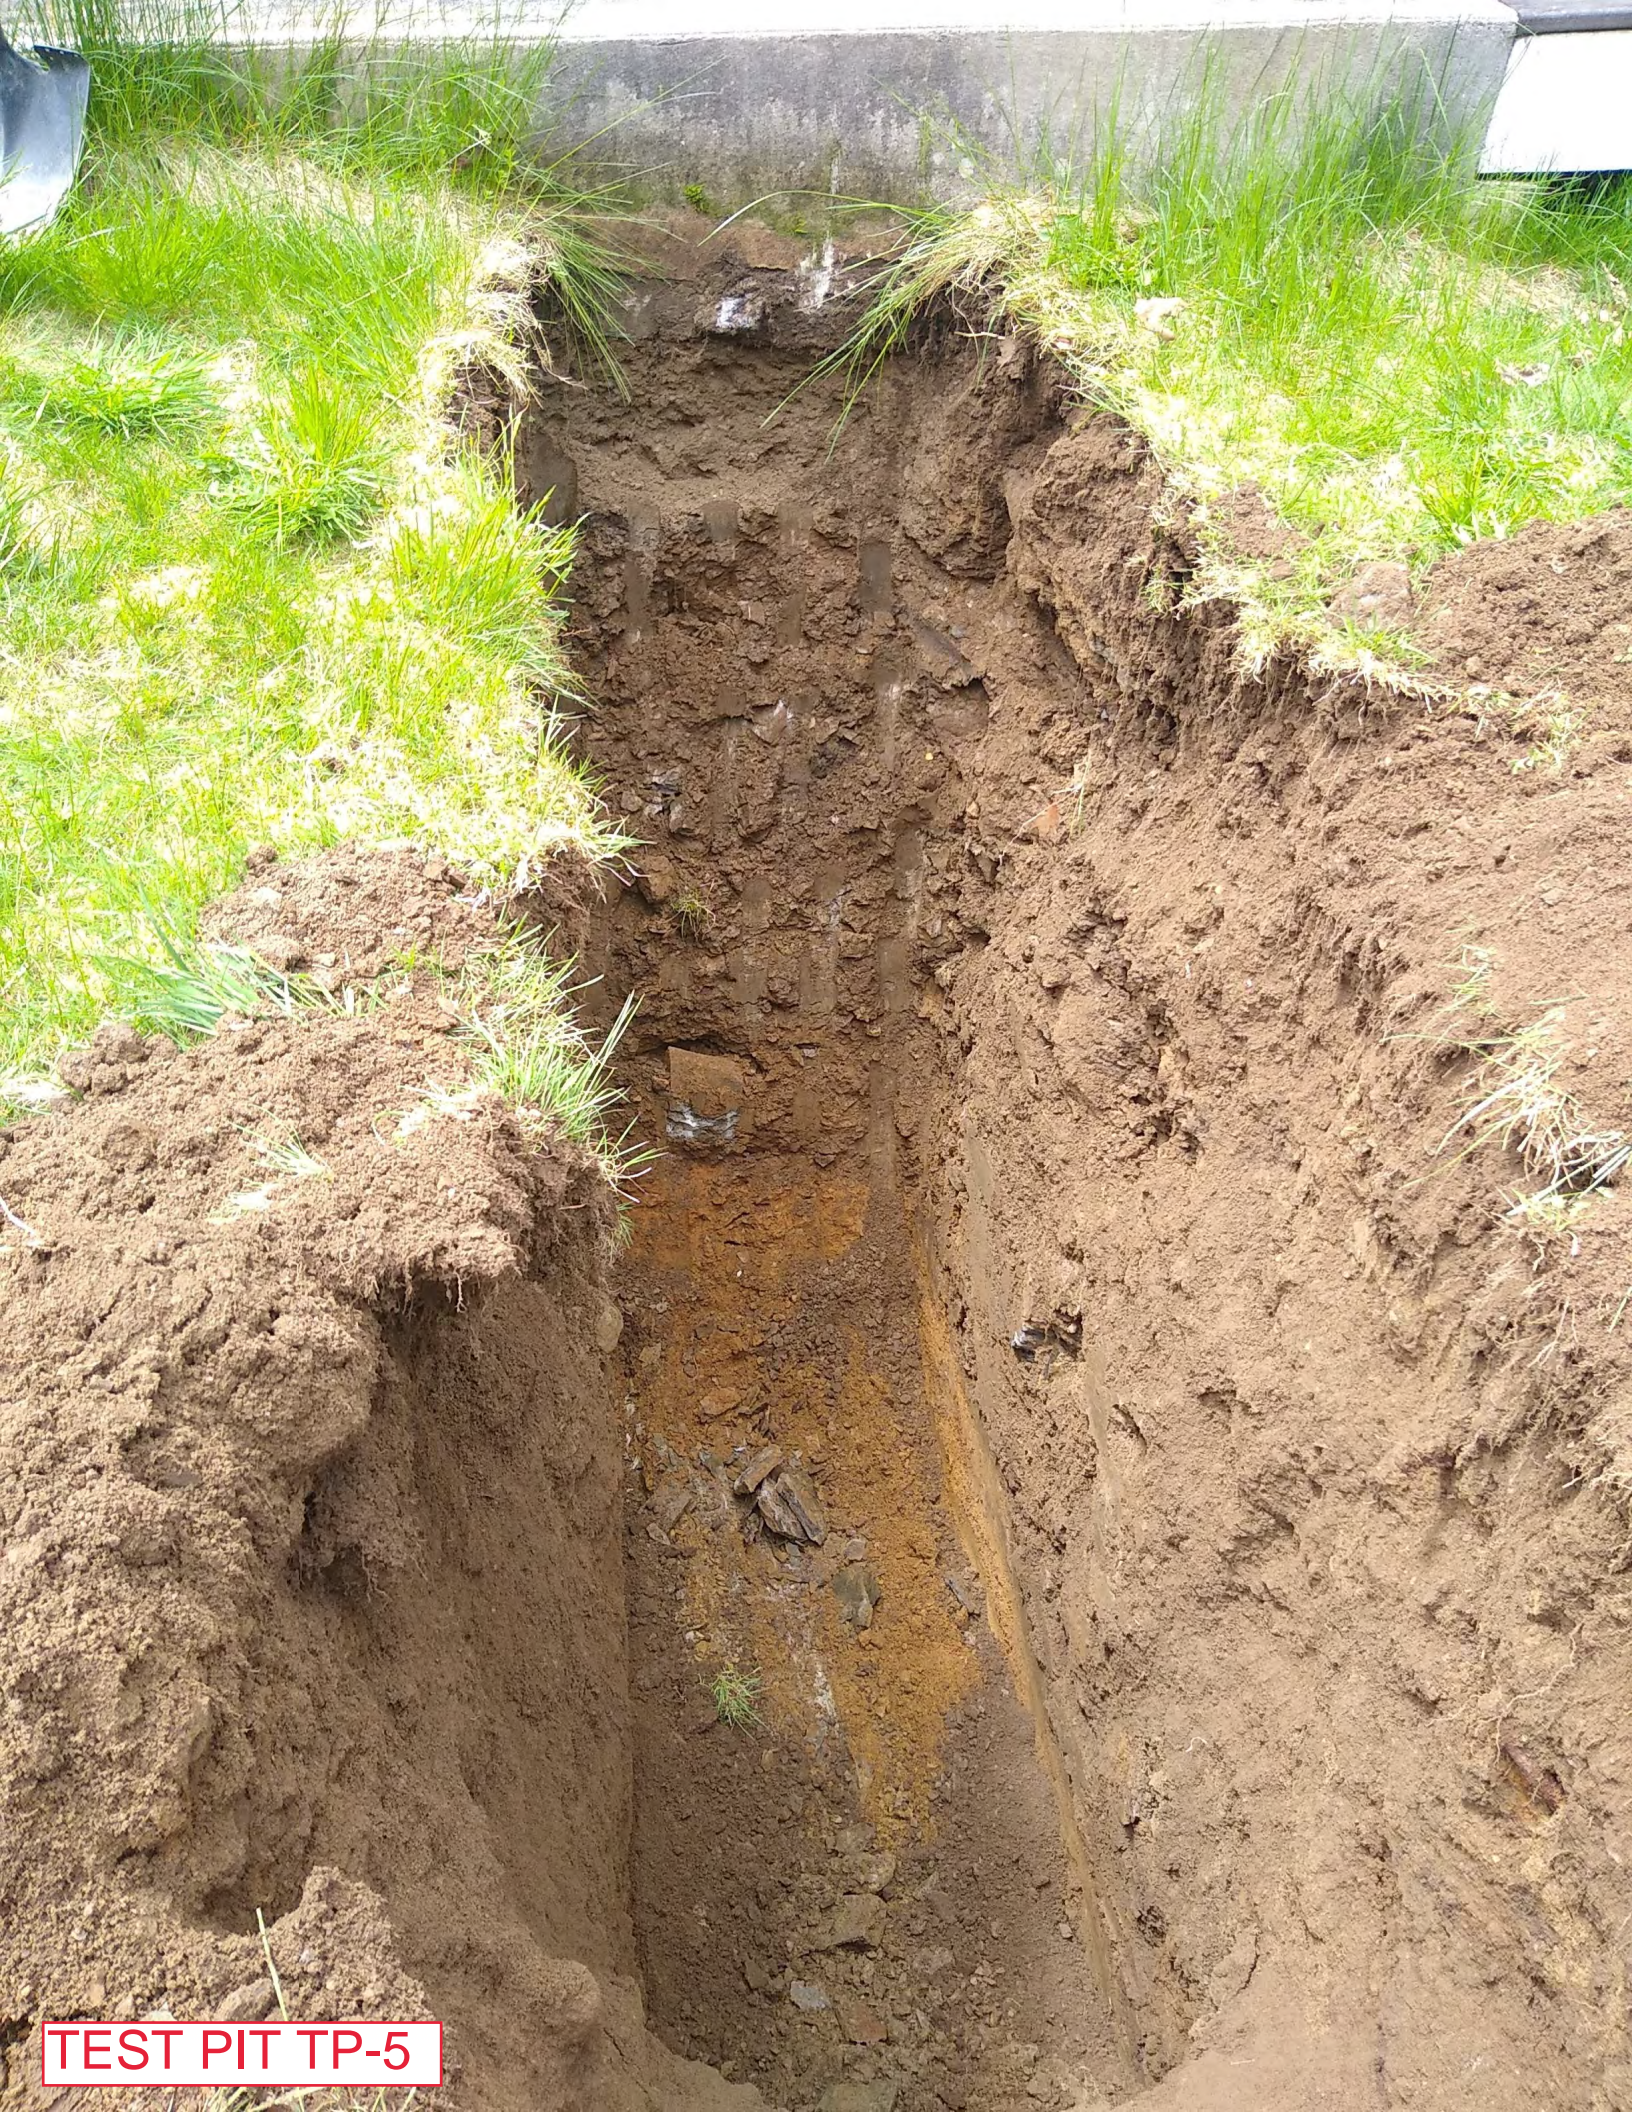
Foundation Test Pit Photographs
