Supplement #1: Summary notes for the June 24, 2020 – Rumford Falls Project MDEP Site Visit

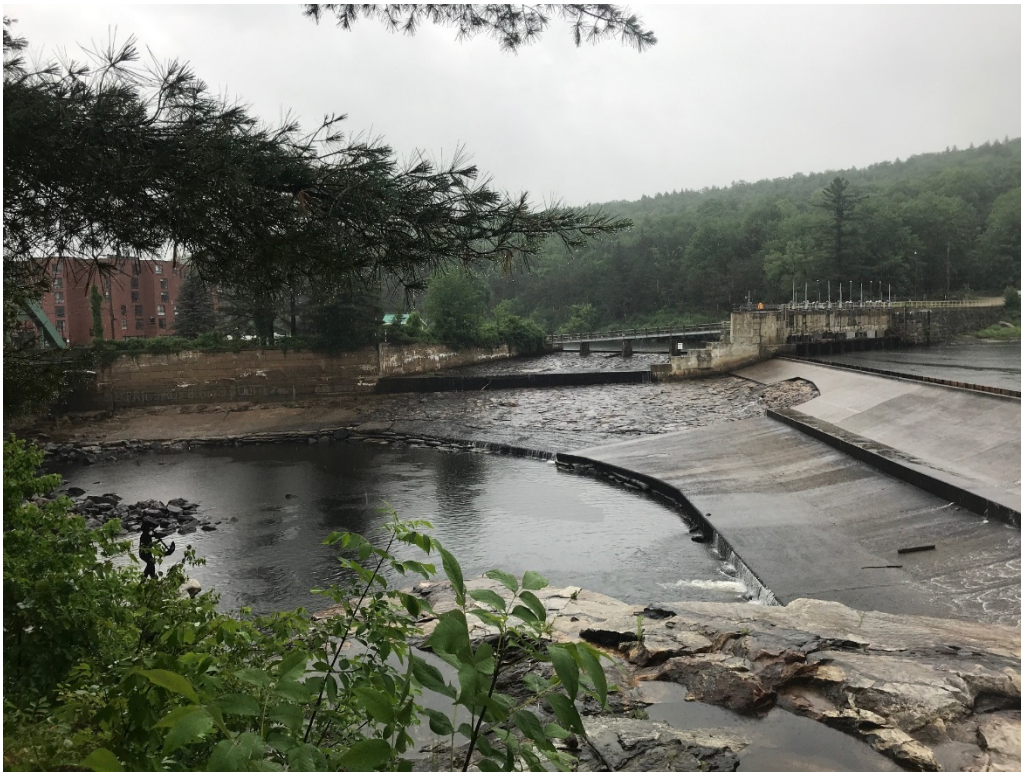
Figures 1 and 2 present conditions in the Middle Dam bypass reach at the preferred deployment location downstream of the bypass pipe and dam spouts. Based on the photographed conditions, water depths in the preferred deployment area are sufficient for continuous submergence of the continuous monitor for a two month deployment and macroinvertebrate samplers for a 28 ± 4 day deployment. Substrate in the preferred deployment location appears to be a mixture of bedrock, large and small boulder and cobble.

Figure 1. Preferred Middle Dam bypass reach logger deployment location under minimum flow conditions.

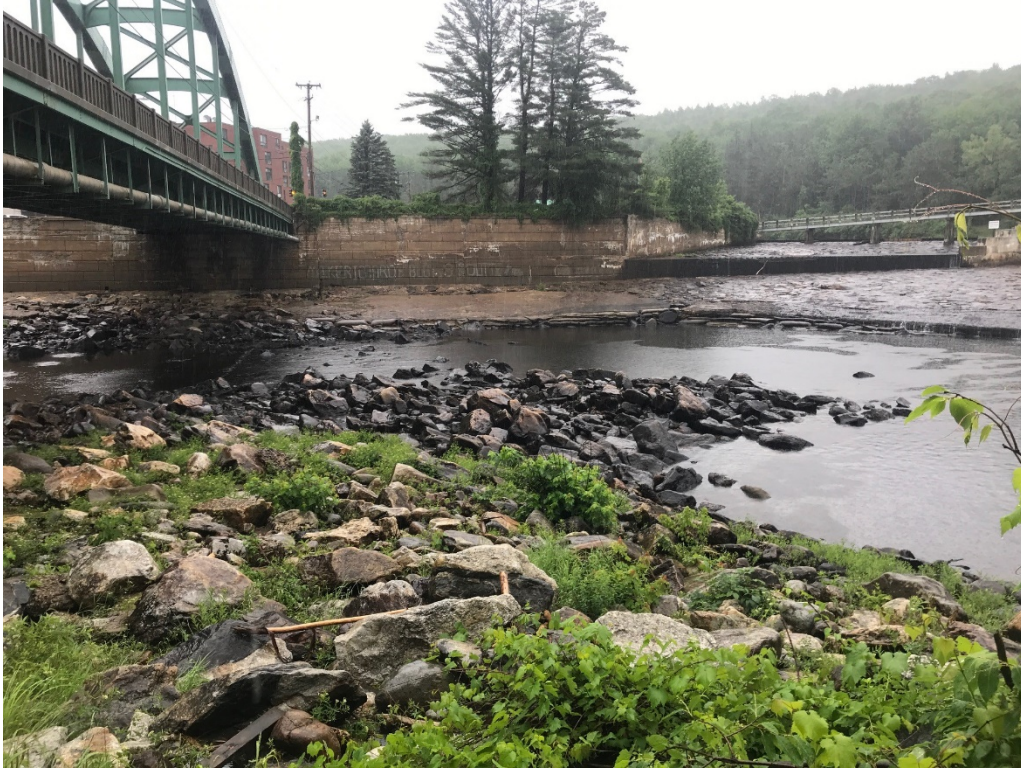
Figure 2. Preferred Middle Dam bypass reach logger deployment location under minimum flow conditions.

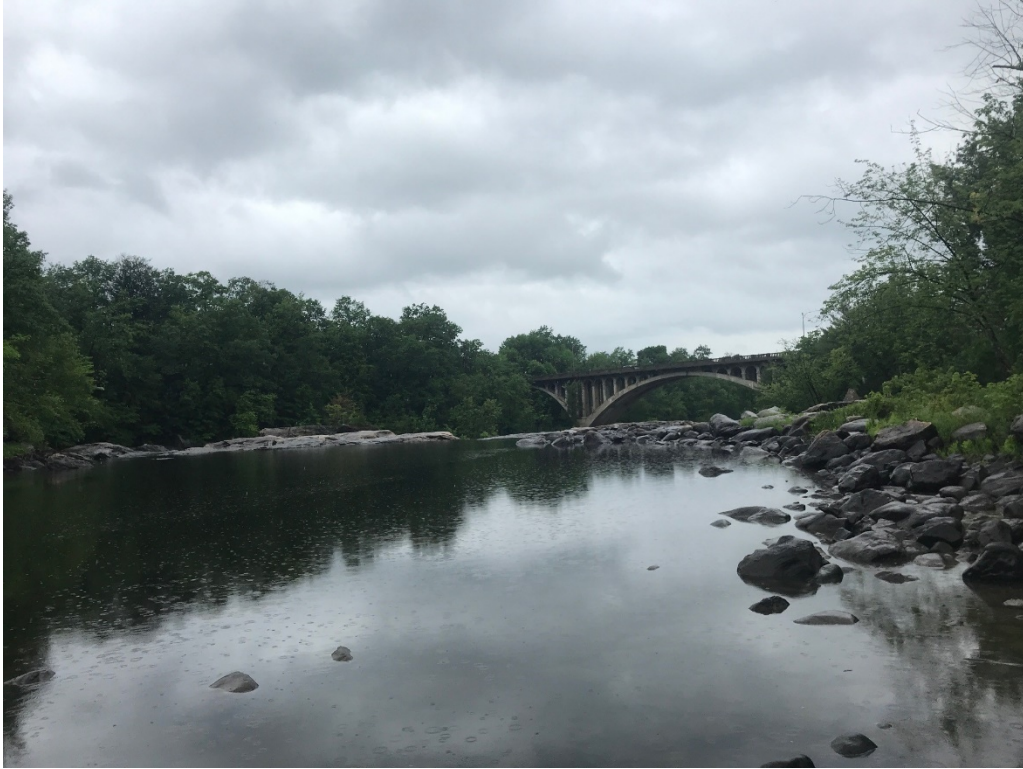
Figures 3 and 4 present conditions in the Middle Dam bypass reach at the secondary deployment location in pool habitat located just upstream of the bedrock cascade portion of bypassed reach. Based on the photographed conditions, water depths in the secondary deployment area are also sufficient for continuous submergence of the continuous monitor for a two month deployment and macroinvertebrate samplers for a 28 ± 4 day deployment. Substrate in the secondary deployment location appears to be a mixture of large and small boulder and cobble.

Figure 3. Secondary Middle Dam bypass reach logger deployment location under minimum flow conditions.

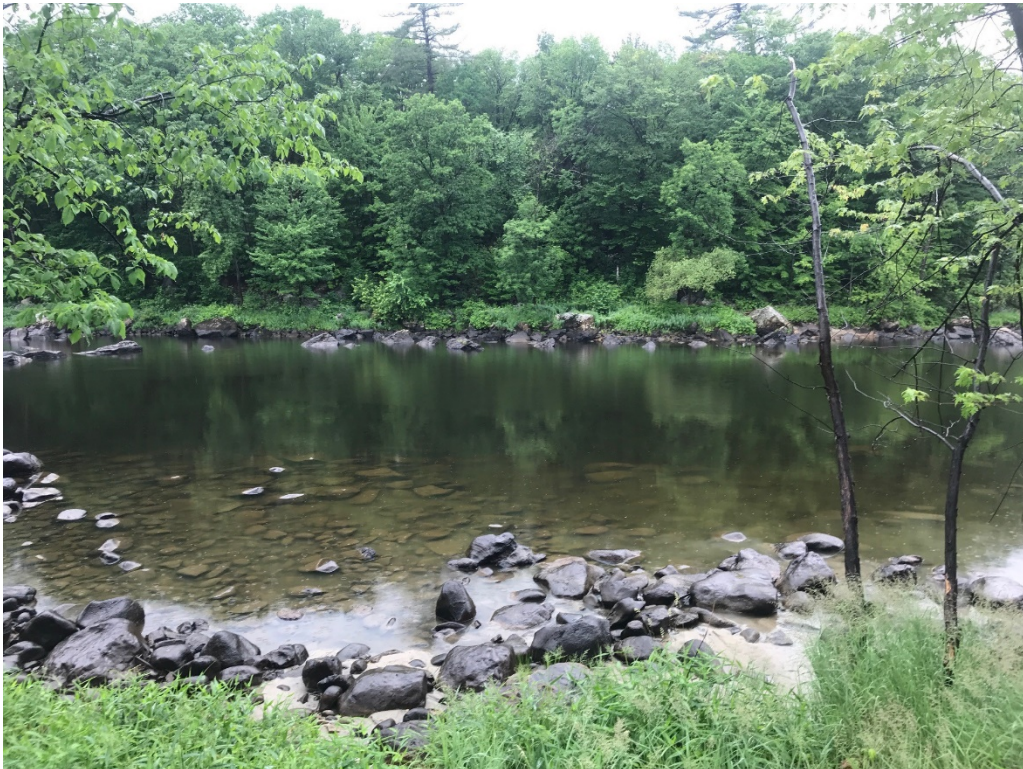
Figure 4. Secondary Middle Dam bypass reach logger deployment location under minimum flow conditions.
