December 17, 2018

Project 171.06108

RE: Hazardous Building Materials Inventory
Mason Station
Wiscasset, Maine

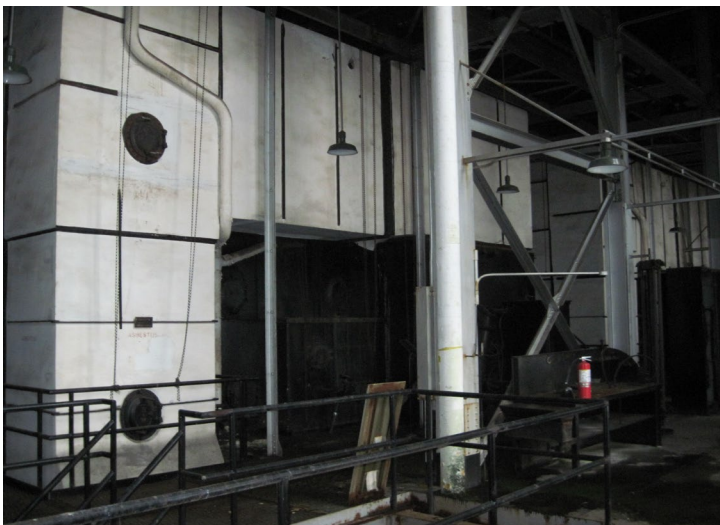
**Boiler units and ductwork with ACM thermal
jacketing/lagging**

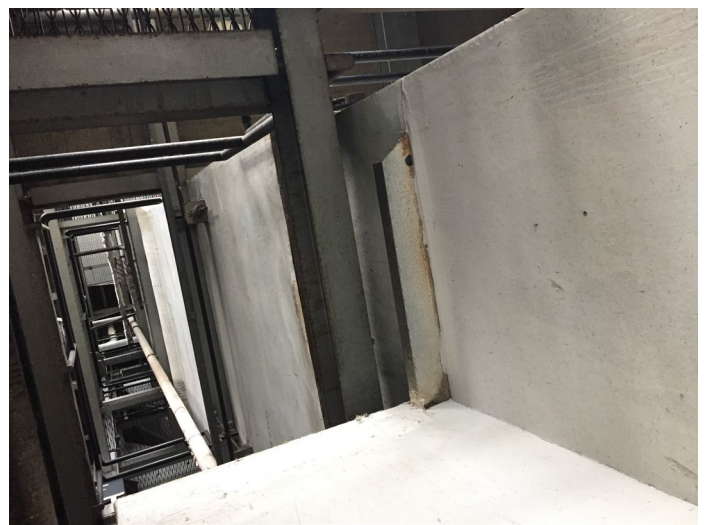
1. **ACM Lagging on Boiler/Heater/Large-unit Process Equipment:** An estimated 50,000 square feet (SF) of friable ACM jacketing was observed on boilers and other process equipment throughout the Powerhouse Building, from ground level, up to elevations ranging from three to six stories high. Material was well-labeled as asbestos-containing; no confirmatory samples were collected for laboratory analysis.

**Vertical view of ACM jacketing on multi-story boiler
process equipment**

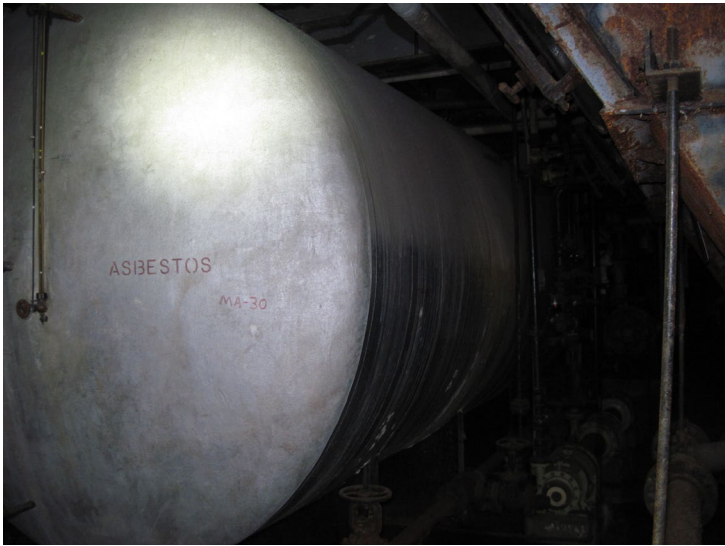
2. **ACM Jacketing on Tanks:** An estimated 6,900 SF of ACM jacketing was observed on holding tanks throughout the Powerhouse Building. It is assumed that tanks would be abated in situ, rather than removed whole-component; removal cost estimates are presented accordingly. Material was well-labeled as asbestos-containing; no confirmatory samples were collected for laboratory analysis.

One of several large-diameter tanks with ACM jacketing observed throughout Powerhouse Building

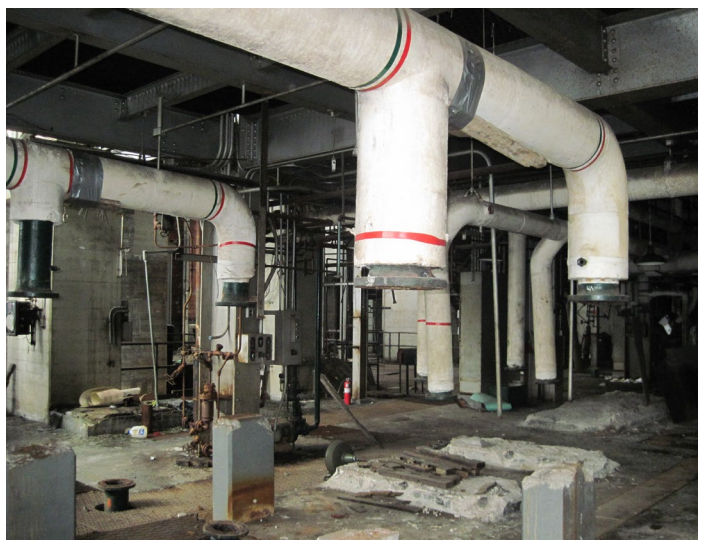
3. **ACM Insulation on Large-diameter piping (>18”D):** An estimated 15,800 SF of ACM insulation was observed on large-diameter piping and ductwork throughout the Powerhouse building. It is assumed that these materials would be abated in situ, rather than removed whole-component; removal cost estimates are presented accordingly. Material was well-labeled or banded with red, indicating that it is asbestos-containing; no confirmatory samples were collected for laboratory analysis.

Large-diameter water and steam piping observed throughout Powerhouse Building interior

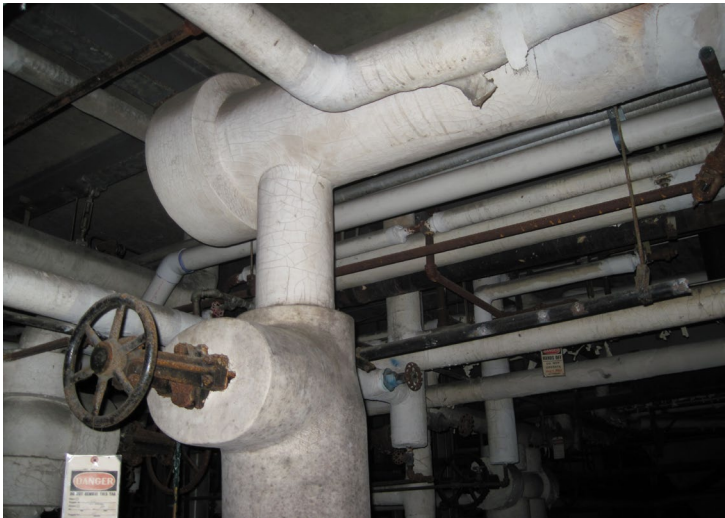
4. **ACM Insulation on Small-diameter piping (≤18”D):** An estimated 21,500 linear feet (LF) of ACM insulation was observed on small-diameter piping throughout the Powerhouse building. It is assumed that these materials would be abated using wrap-and-cut methods, rather than in situ; removal cost estimates are presented accordingly. Material was well-labeled or banded with red, indicating that it is asbestos-containing; no confirmatory samples were collected for laboratory analysis.

Small-diameter ($\leq 18''$ D) piping observed throughout Powerhouse Building interior

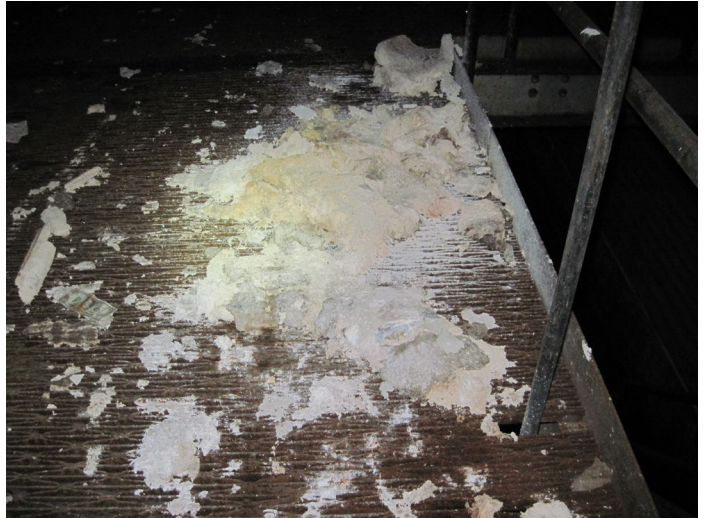
5. **ACM Debris:** Several areas of apparent asbestos debris were observed on the floors, catwalk grates, and process equipment throughout the Powerhouse Building, due to water damage or other deterioration of thermal system insulation. Exact quantities of ACM debris are not presented, rather, it is assumed that remediation of these areas would be included in the scope of abatement of the items listed above.

Asbestos-containing debris noted in several locations throughout Powerhouse Building interior

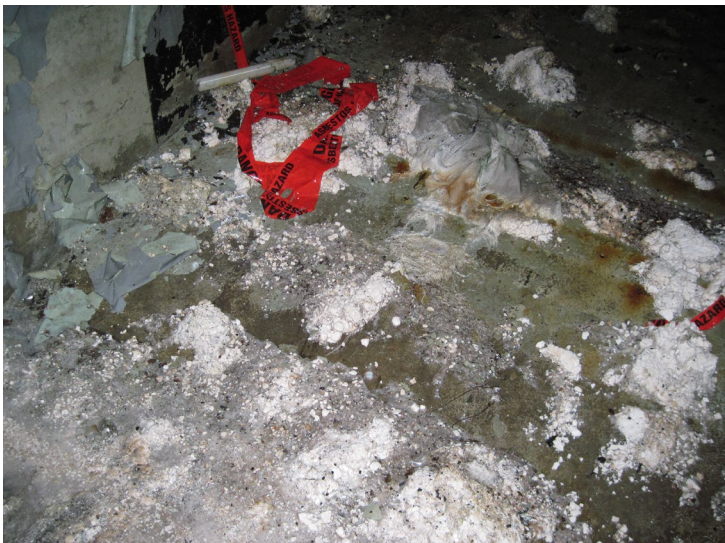
ACM debris on floor due to overhead water damage to pipe and unit insulation

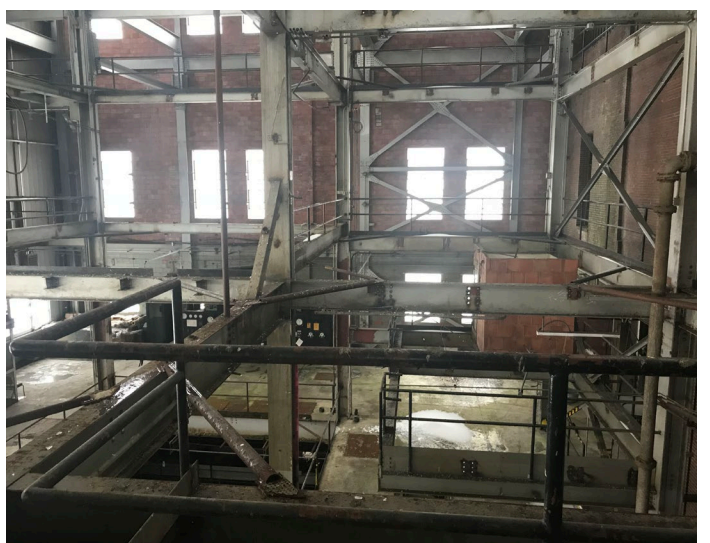
Unit #5 Area of Powerhouse building, previously cleared of large-unit equipment, piping, and most ACM.

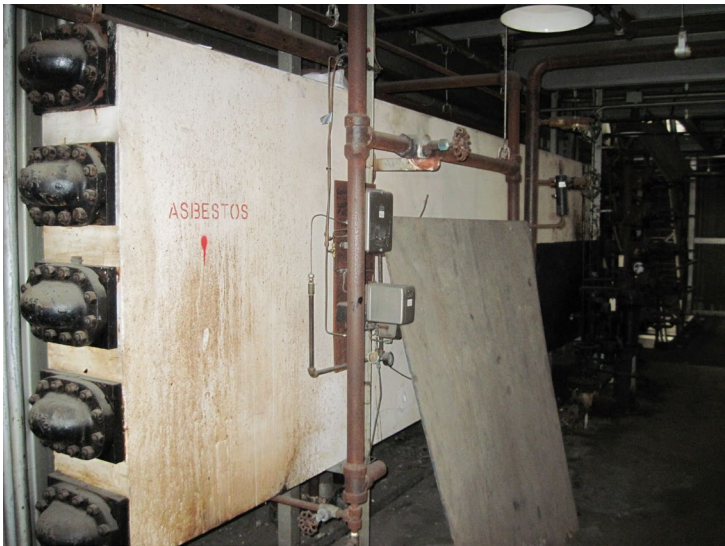
Oil heater unit appears to be only remaining ACM-insulated process equipment in Unit #5 area.

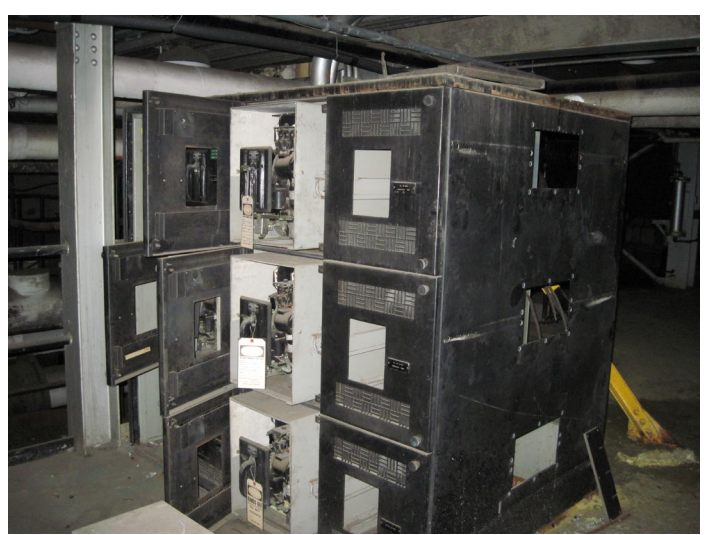
One of several electrical cabinets containing asbestos-cement paneling and other components

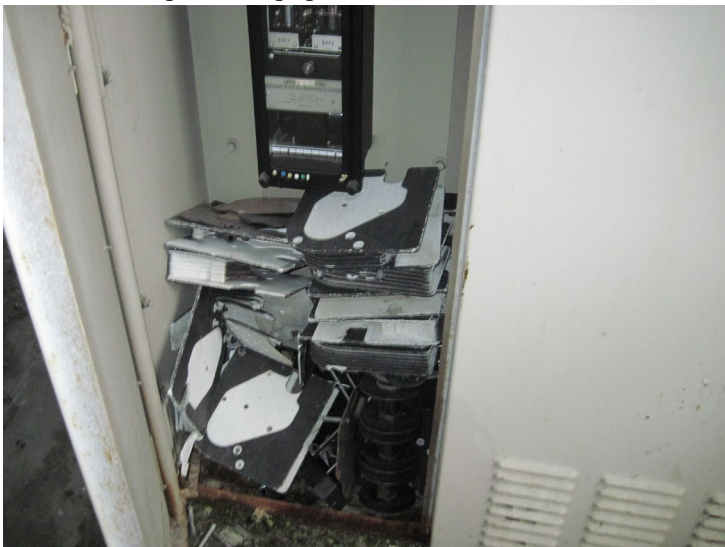
**Closer view of asbestos-cement pieces within electrical panels.
Black = sample set 16, gray = PACM**

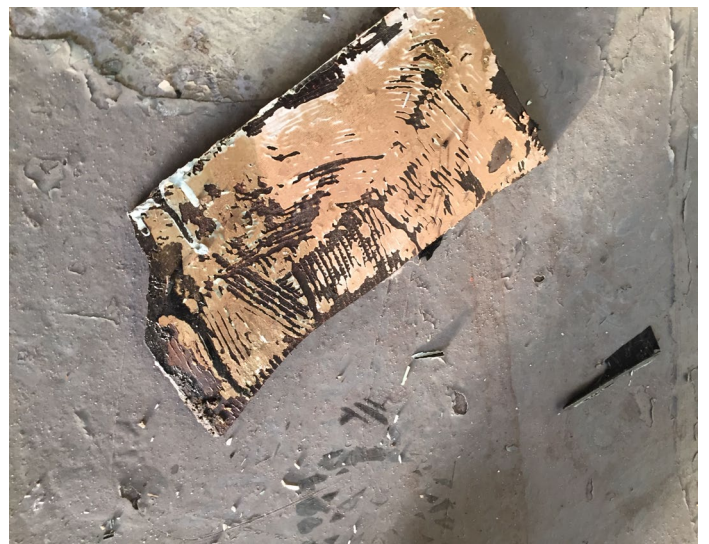
**ACM mastic on vinyl covebase, CMP Control Room interior
(Sample set 06)**

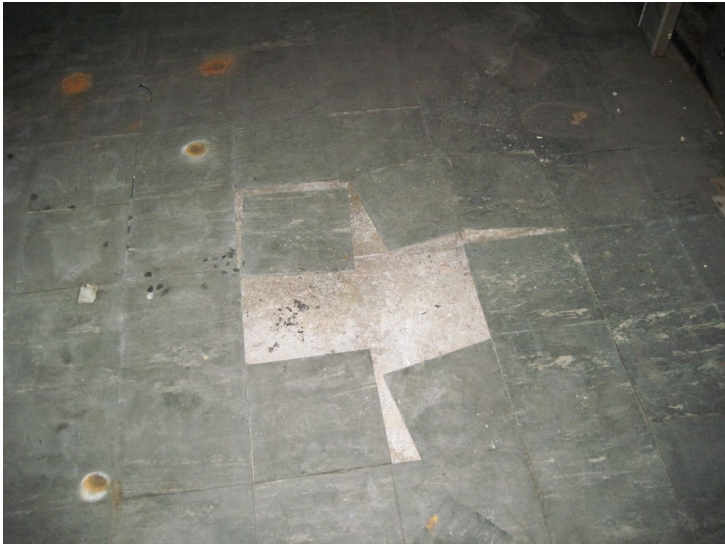
Floor tile with ACM mastic, CMP control room interior (Sample set 07)

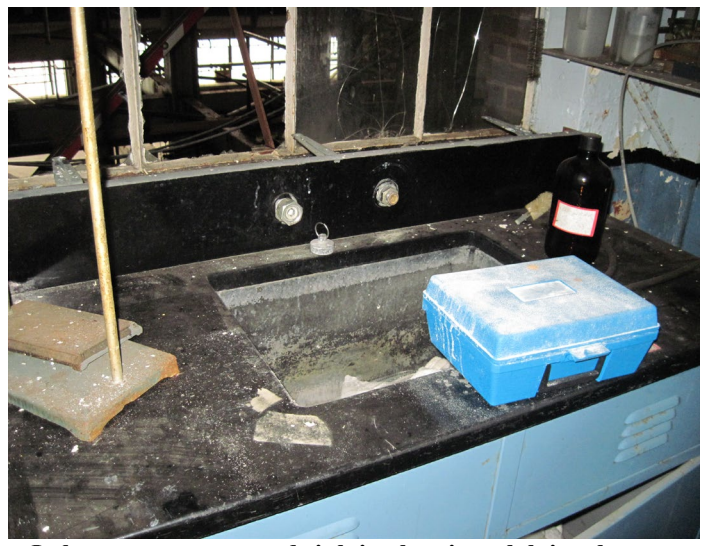
Lab countertop around sink in chemistry lab is asbestos-cement (Sample set 11)

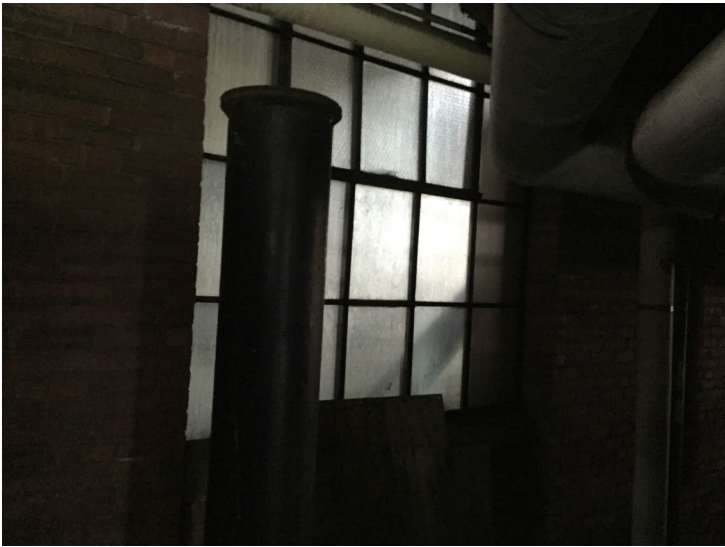
9. **Interior window glazing (sample sets 13, 14, 15, SH-01, SH-04):** The glazing compound adhering the glass panes into the fixed steel-sash window units in all sections of the Powerhouse Building, and Screen Houses 1 and 2 were identified as ACM. It is noted that the formerly exterior windows on the north and south ends of the Units 1 & 2 area are “trapped” by subsequent additions and exist on the building interior today. It is assumed that these window units would be removed whole-component rather than abated in situ; cost estimates are presented accordingly.

All steel-sash windows have ACM glazing, building wide, including interior windows “trapped” by subsequent additions.

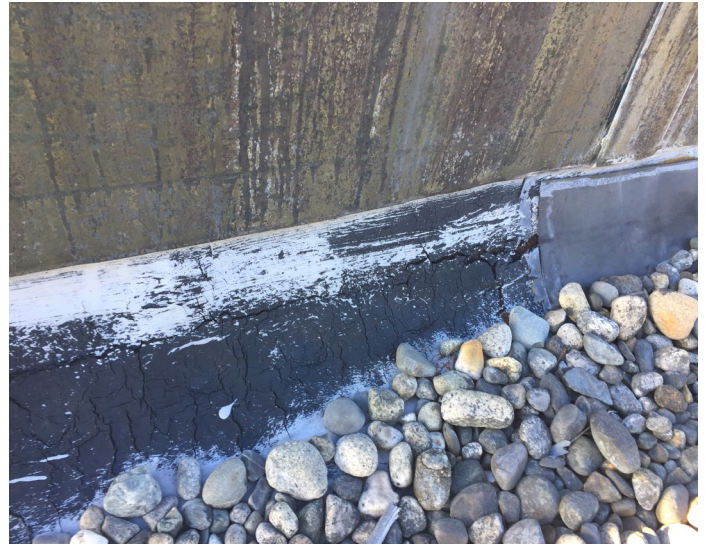
ACM roof flashing materials on rear (west) elevated roof section, and Units 3&4 upper areas (Samples R-16 - R-19)

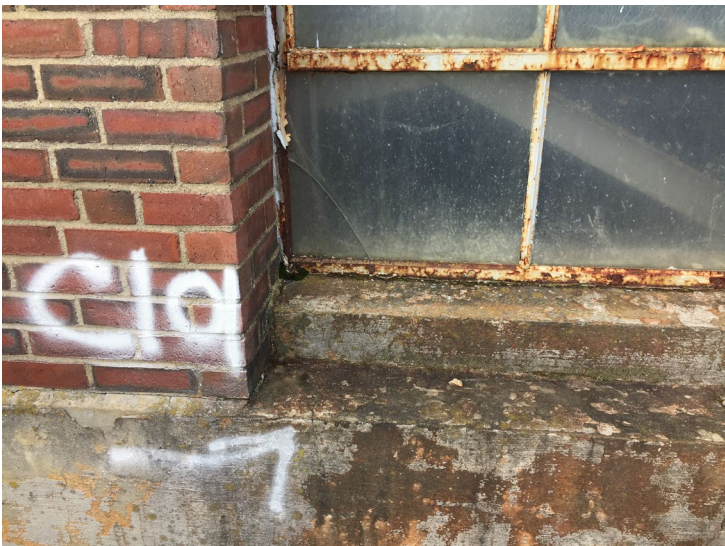
Asbestos caulk on Units 1&2 windows (Sample set C-01)

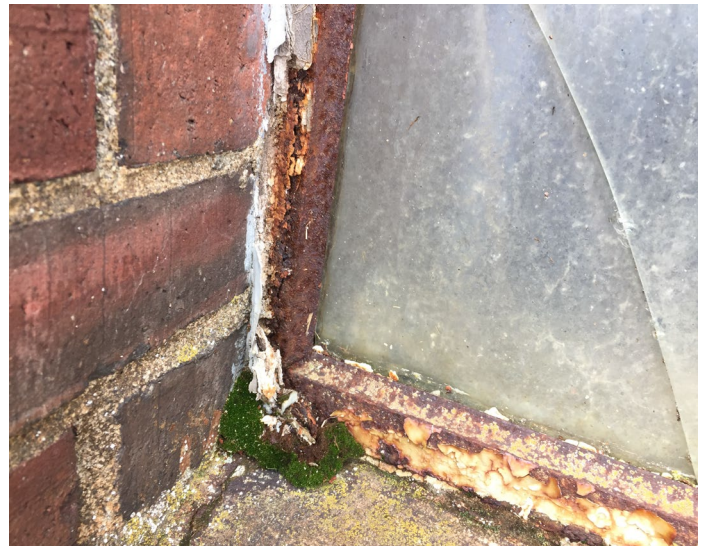
Closer view of ACM caulk on Units 1&2 windows

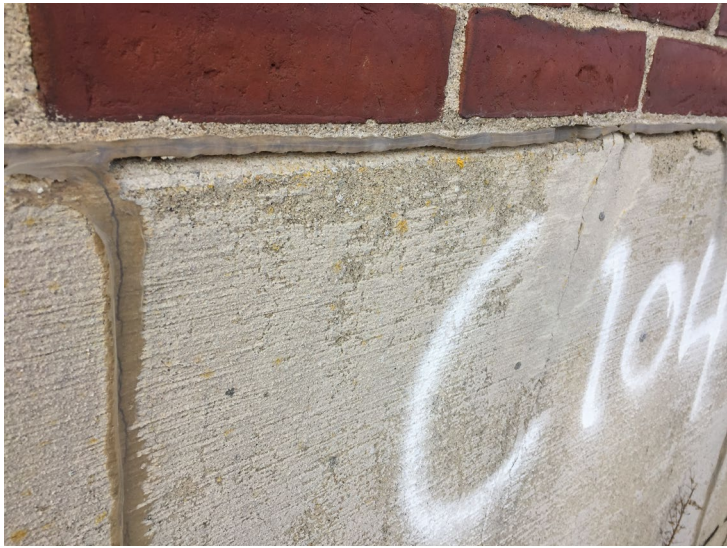
15. **Foundation repair caulk (sample sets C-04, C-10):** Limited areas of ACM caulking were observed applied to foundation cracks on the Units 3 & 4 area, east elevation exterior, and the Screen House 3 exterior.

**ACM caulk on Units 3&4 concrete foundation
(Sample set C-04)**

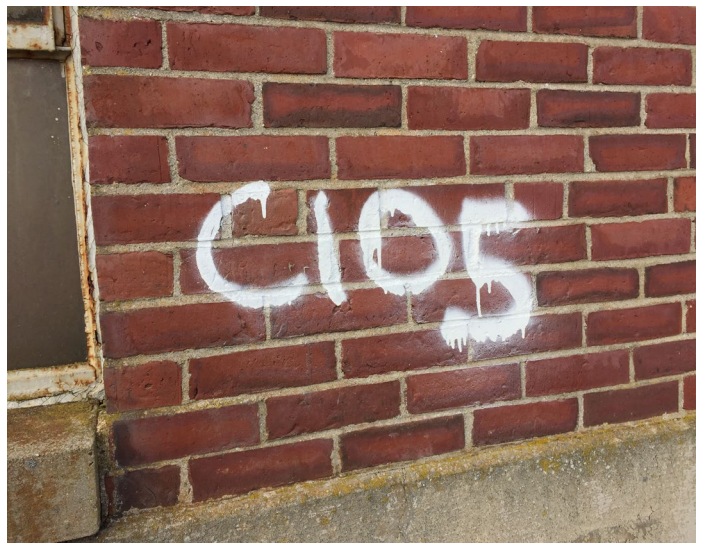
**Asbestos caulk on Units 3&4 windows, east elevation
(Sample set C-05)**

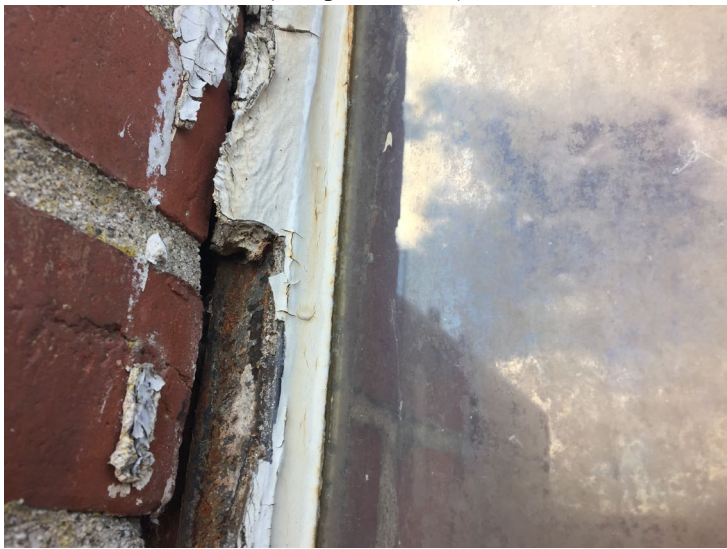
Closer view of ACM caulk on Units 3&4 windows, east side

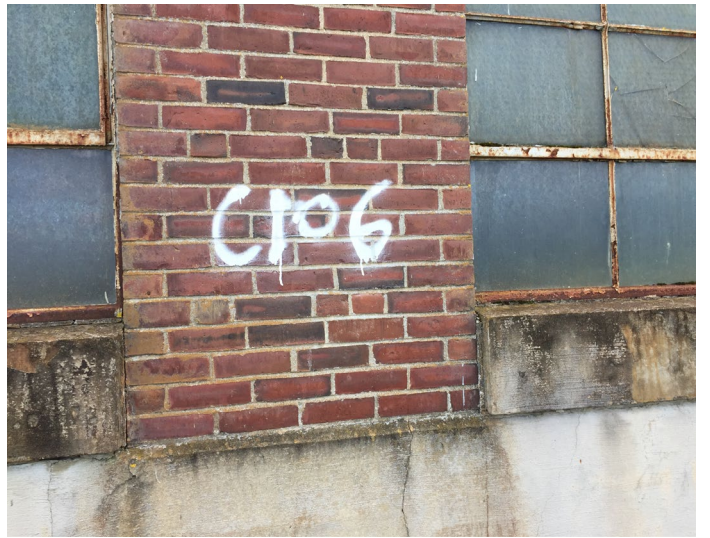
**Asbestos caulk on Units 3&4 windows, north elevation
(Sample set C-06)**

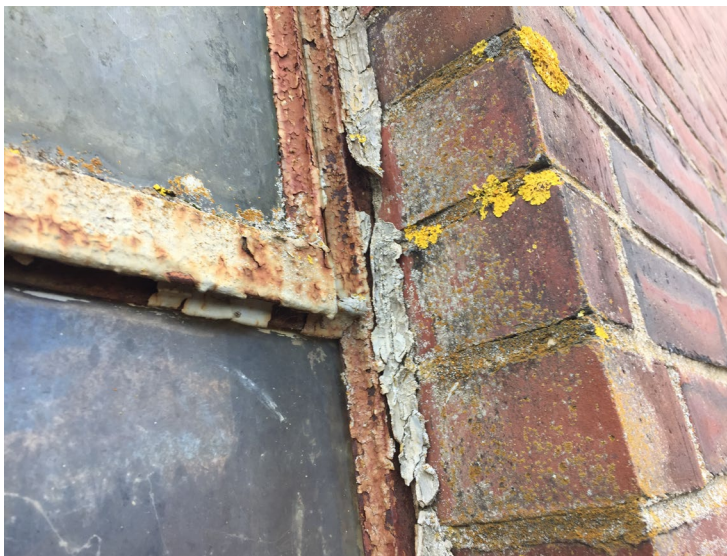
Closer view of ACM caulk on Units 3&4 windows, north side

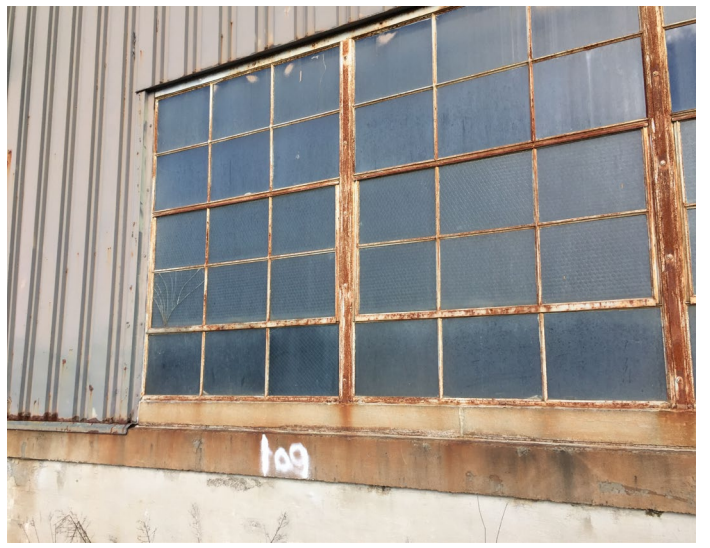
**Asbestos caulk on Unit 5 windows, south elevation
(Sample set C-09)**

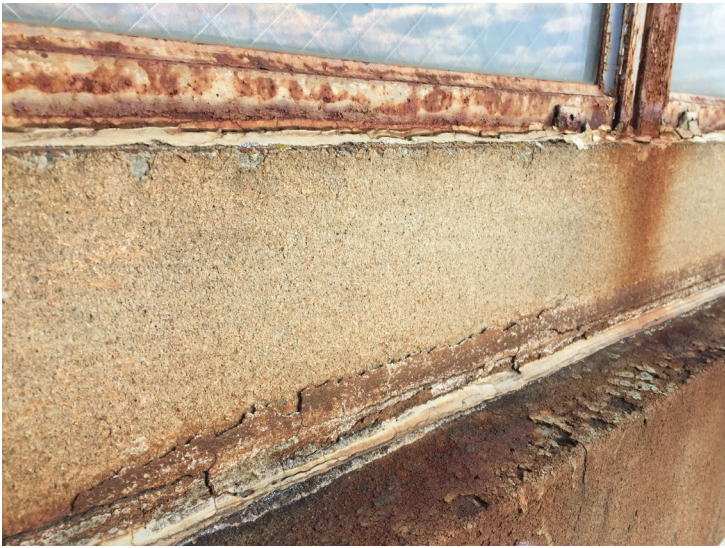
Closer view of ACM caulk on Unit 5 windows

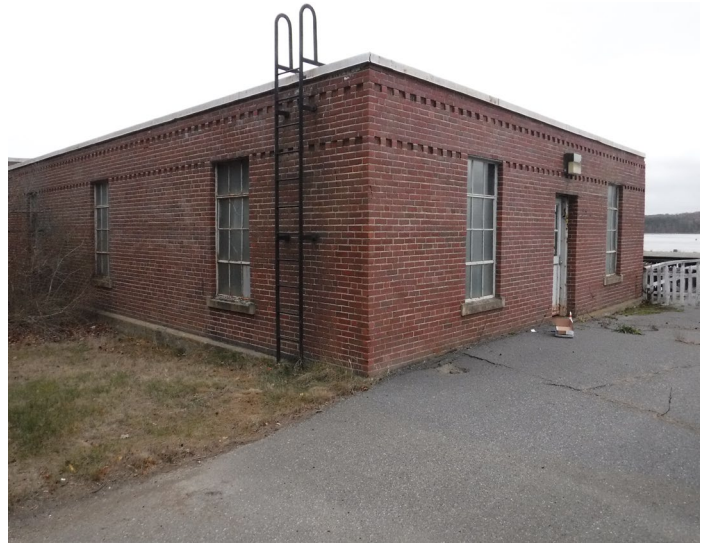
View of Screen House 1, including windows with ACM glazing (Sample set SH-04)

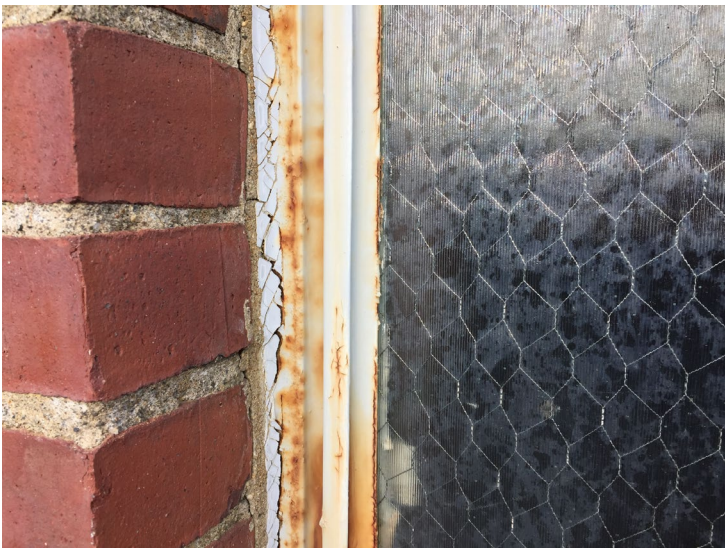
Asbestos-containing caulk on Screen House 1 exterior (Sample set C-11)

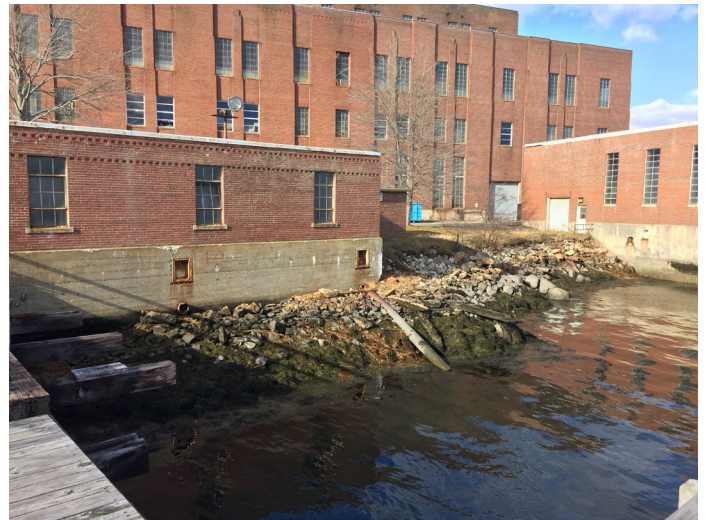
View of Screen House 1 (L) and Screen House 2 (R). Screen House 2 also has ACM window glazing (Sample set SH-01)

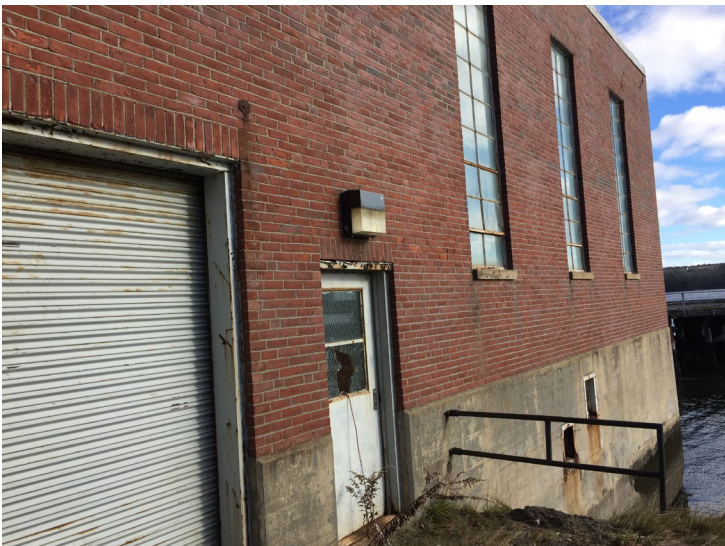
View of overhead and entry doors on Screen House 2, both with ACM perimeter caulk (Sample set C-12)

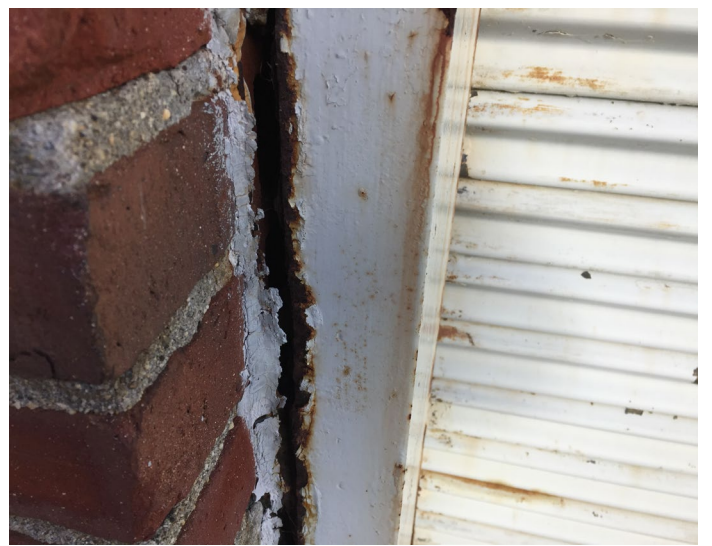
Closer view of asbestos-containing caulk on Screen House 2 exterior doors

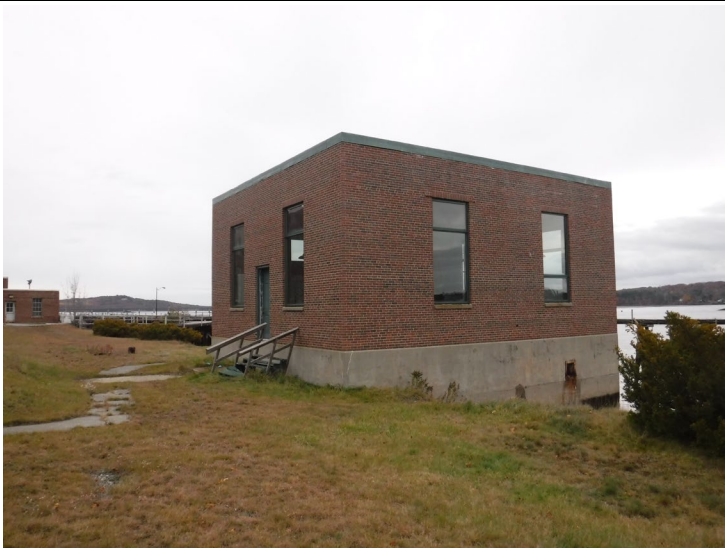
View of Screen House 3. Only ACM identified is small quantity of caulk on concrete foundation (Sample set C-10)

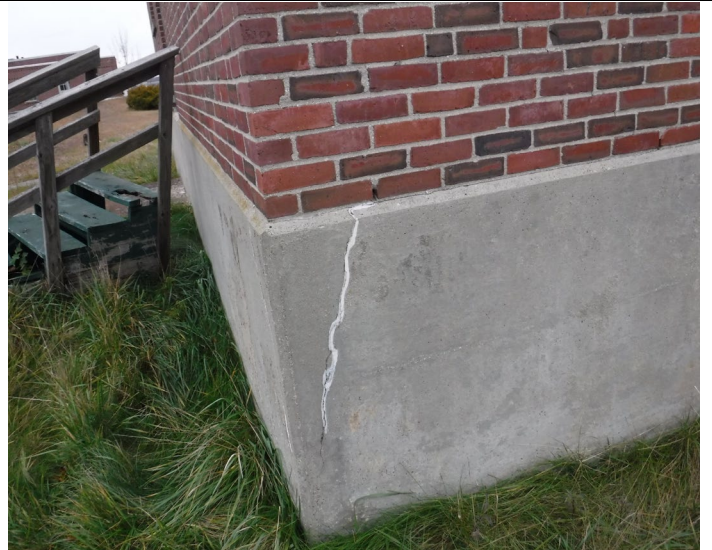
Closer view of ACM caulk on Screen House 3 exterior foundation

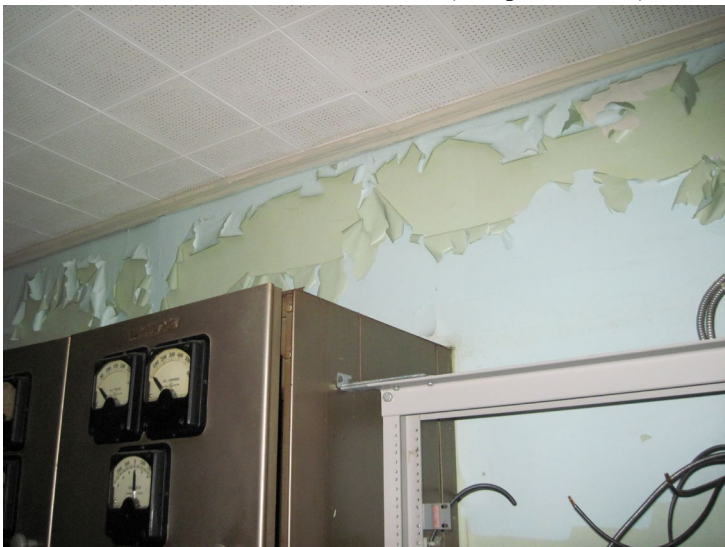
PCB-containing paint on interior plaster walls within CMP control room, 3rd floor of Powerhouse Building (Sample P-07)

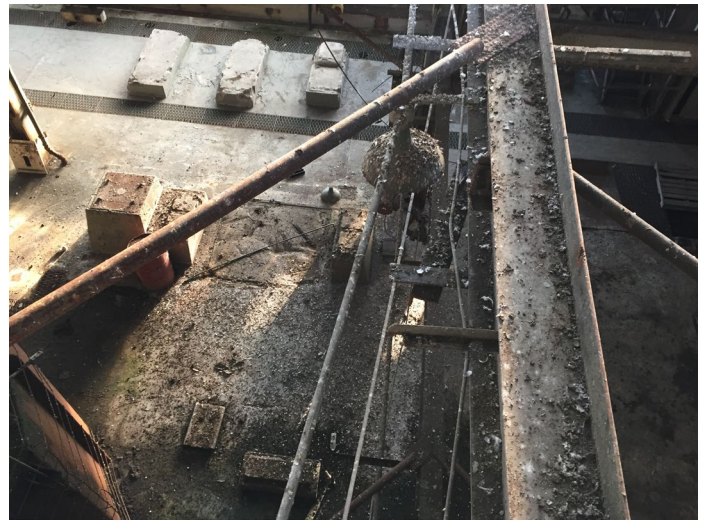
Ransom identified significant areas of pigeon droppings in several areas of the Powerhouse Building, predominantly within the Unit 5 area. Certain bird droppings are known to cause respiratory disease in humans; this material should be removed as part of any future abatement phase, in order to mitigate exposure to future construction or maintenance personnel.

View of pigeon droppings, widespread throughout Unit 5 areas, ground floor.

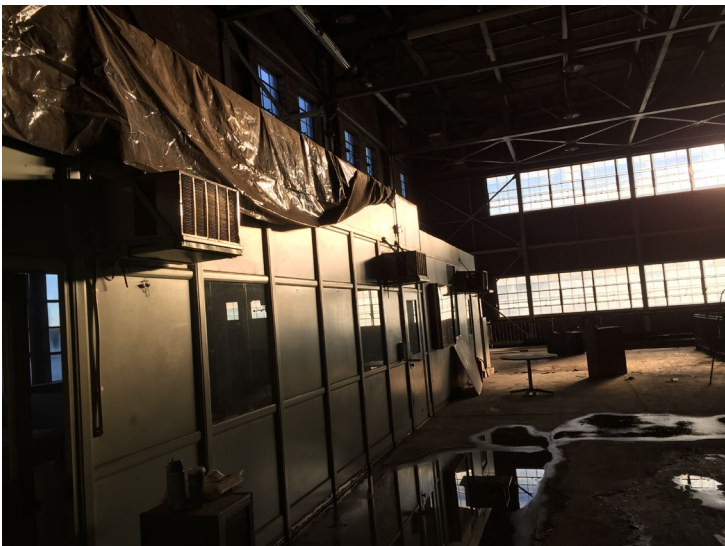
Ransom observed several assumed ODS-containing building components or fixtures as part of our inspection. If such items are to be disturbed and/or disposed during future renovation/demolition, they should be managed according to the guidance above.

Wall-mounted air conditioners observed in Powerhouse Building interior, to be managed as universal wastes.

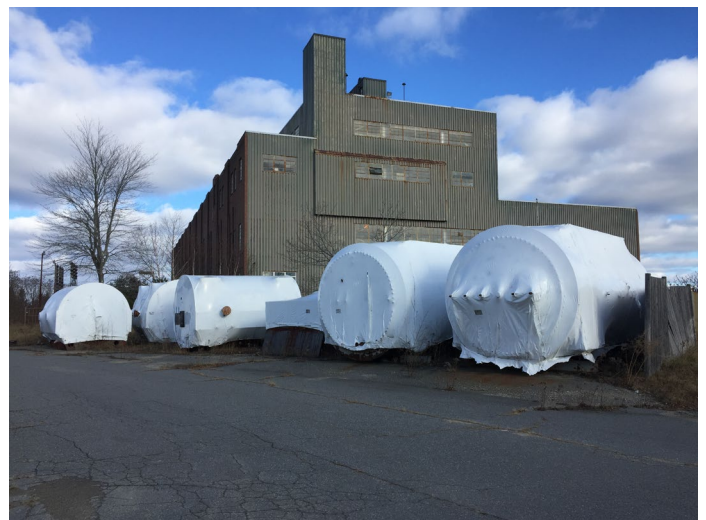
View of wrapped boiler/process equipment, staged outside Powerhouse Building. Wrapped units were not inspected.
