To: Board of Environmental Protection
Cc: Service List for Appeal of L-28397-4E-A-N
From: Jami MacNeil, Department of Environmental Protection
Date: January 15, 2021
Re: Staff request for admission of supplemental evidence in Appeal of Spinney Natural Resources Protection Act permit (#L-28397-4E-A-N) by Ervin, Bolen, Philbrick, and Weary

Jeff Spinney – Boat ramp and dock system, Alna DEP #L-28397-4E-A-N, Inspection Notes & Photos

Project Location: 126 Golden Ridge Road, Alna

Date/Time: 1/7/2021, 11am – 12pm

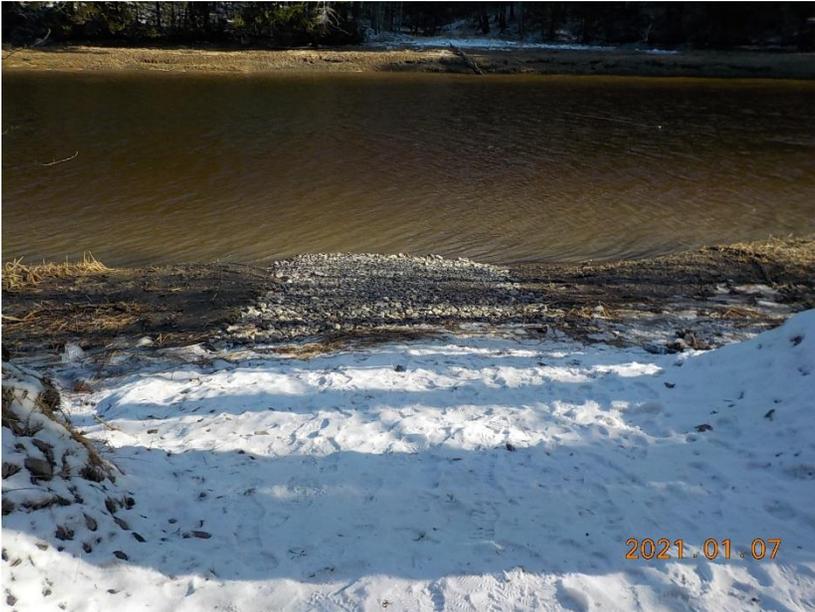
Attendees met at the licensee’s house and walked down the tote road from house to project site. Boat ramp construction was complete. DEP staff measured the ramp and found it is 12 feet wide by approximately 30 feet long (beginning approximately at the highest annual tide line (HAT) and extending towards mean low water). The immediate upland at the top of the ramp had been regraded to tie into the ramp, as proposed on the approved plans. Ramp surface (rock aggregate) appeared stable. Licensee stated that geotextile fabric was placed under the stone ramp surface (as shown in construction photos sent by licensee). Adjacent upland was covered in snow; however, pushing snow aside, hay mulch was evident underneath (also evident in construction photos). DEP staff advised that the licensee should continue to monitor the upland area during any melting events and apply additional mulch as needed.

Photo 1: Ramp, from upland

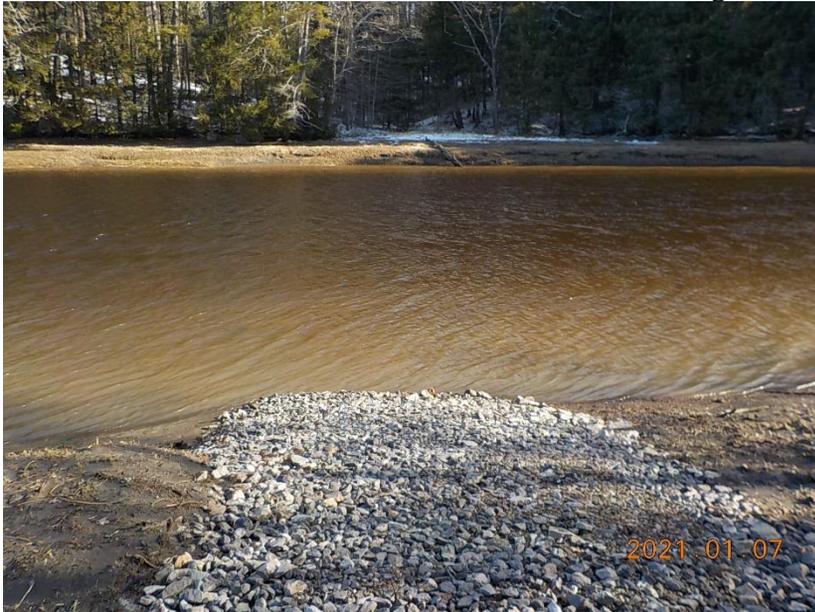
Photo 2: Ramp, lower section

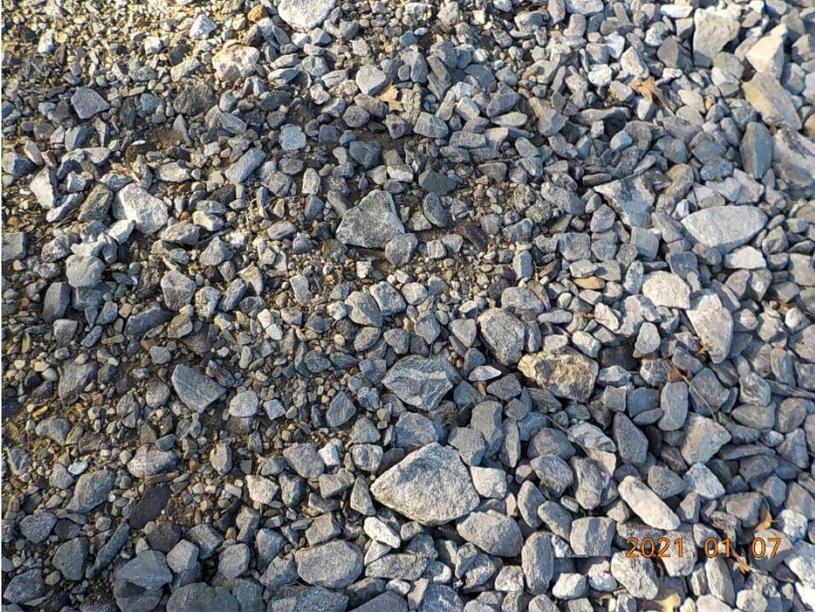
Photo 3: Ramp surface

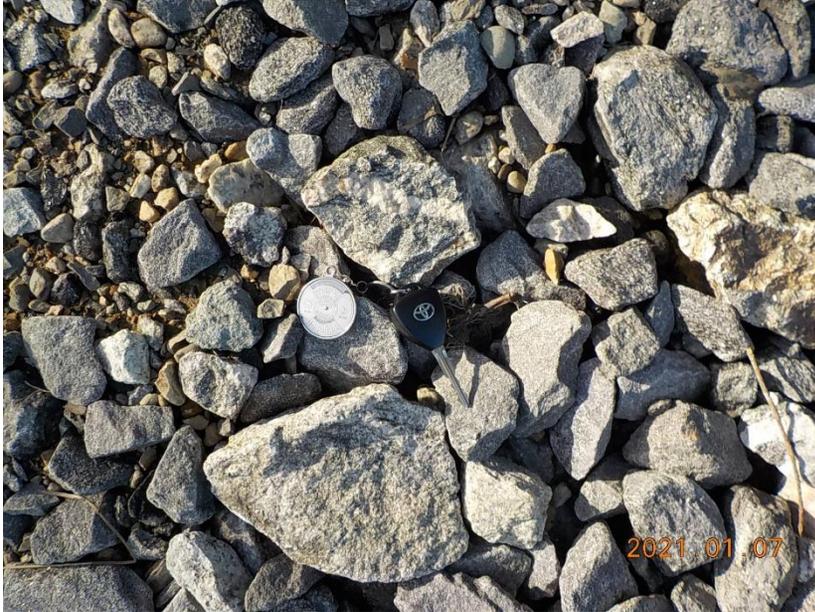
Photo 4: Ramp surface (key for scale)

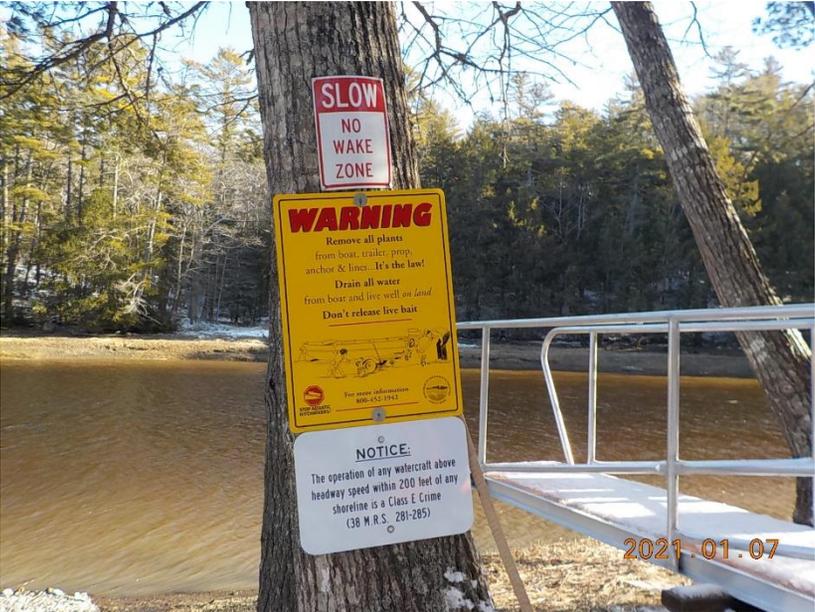
Signs advising of boating speed laws and best practices to prevent spread of invasive species were posted in a visible location at the launch area as required in the NRPA permit.

Photo 9: Signs

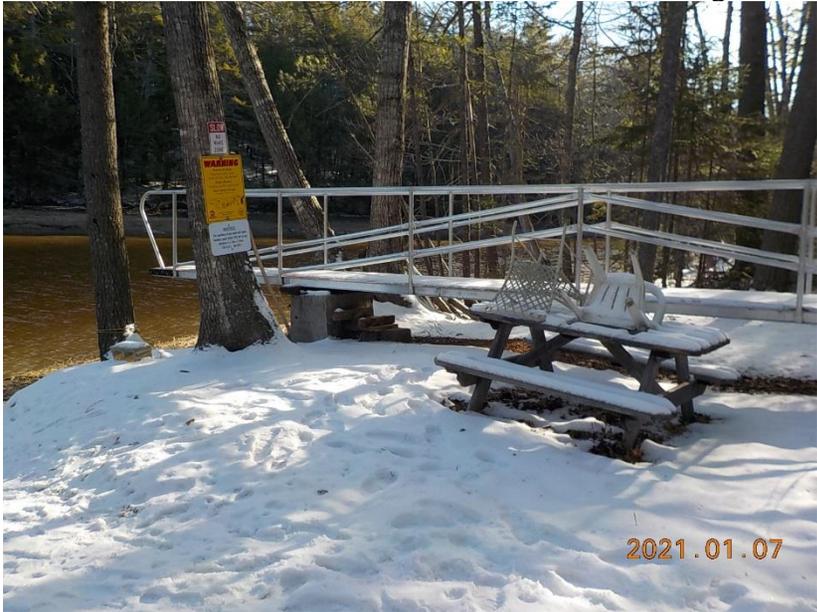
The approved seasonal floats were being stored in the upland. The approved seasonal aluminum ramp (gangway) was also in the upland, though it is slightly overhanging the coastal wetland. Staff advised the licensee to move it further onto the upland. The gangway was resting on a granite block, located in the upland several feet from the HAT line. DEP advised the licensee to move the block to a different upland location during the off-season to prevent the block from being considered a permanent structure as defined in the NRPA, and licensee agreed.

Photo 10: Aluminum ramp (gangway)

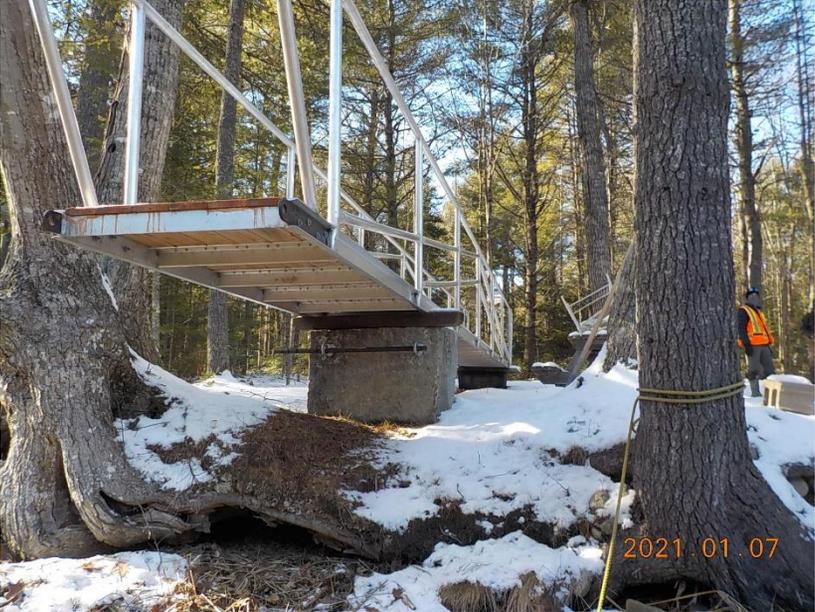
Photo 11: Granite block for gangway

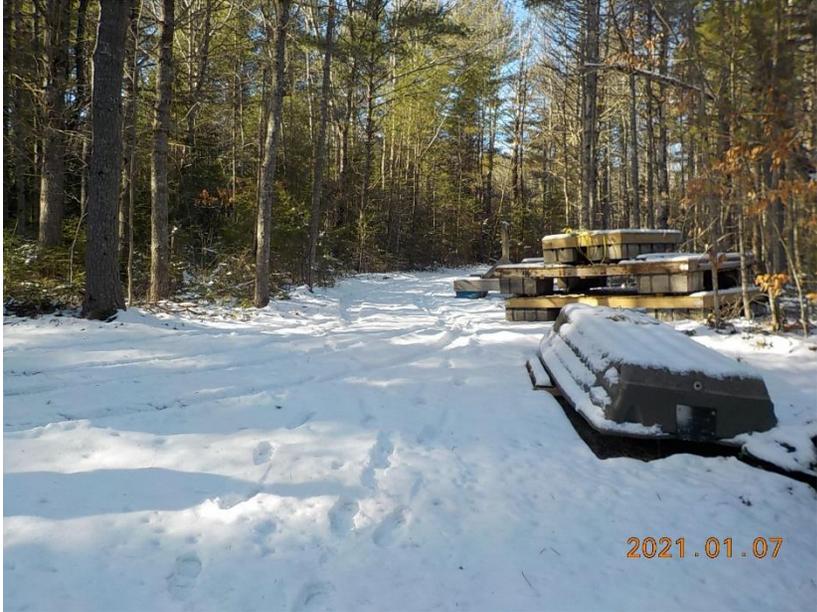
Photo 12: Floats stored in upland
