Jeff Spinney – Boat ramp and dock system, Alna DEP #L-28397-4E-A-N, Inspection Notes & Photos

Project Location: 126 Golden Ridge Road, Alna

Date/Time: 1/7/2021, 11am – 12pm

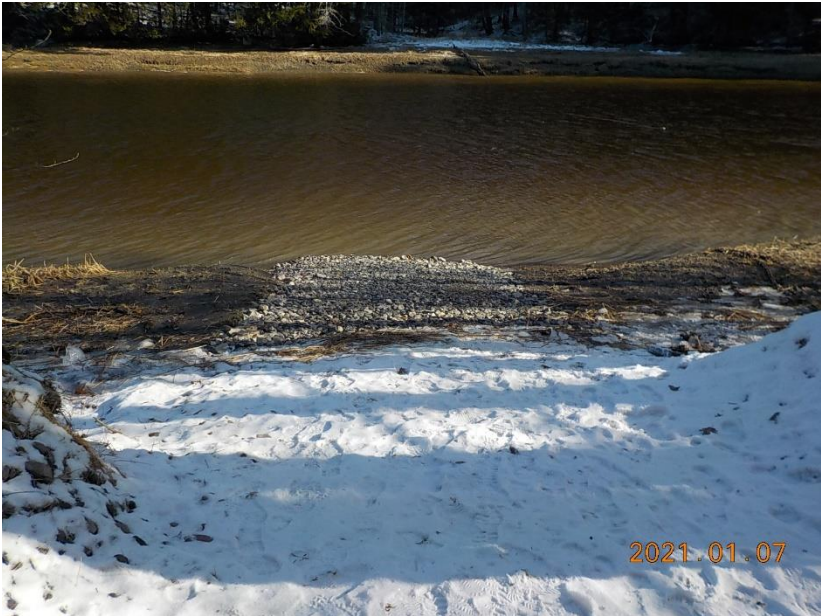
Photo 1: Ramp, from upland

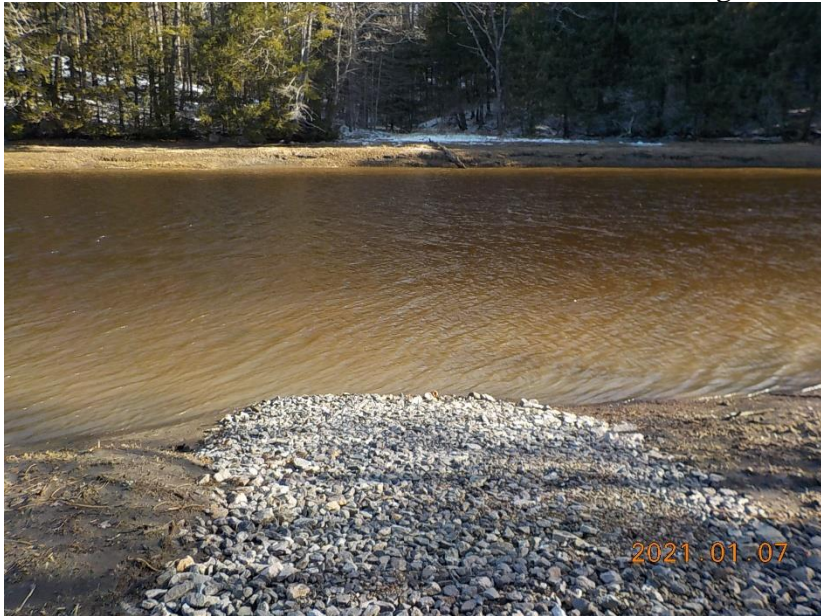
Photo 2: Ramp, lower section

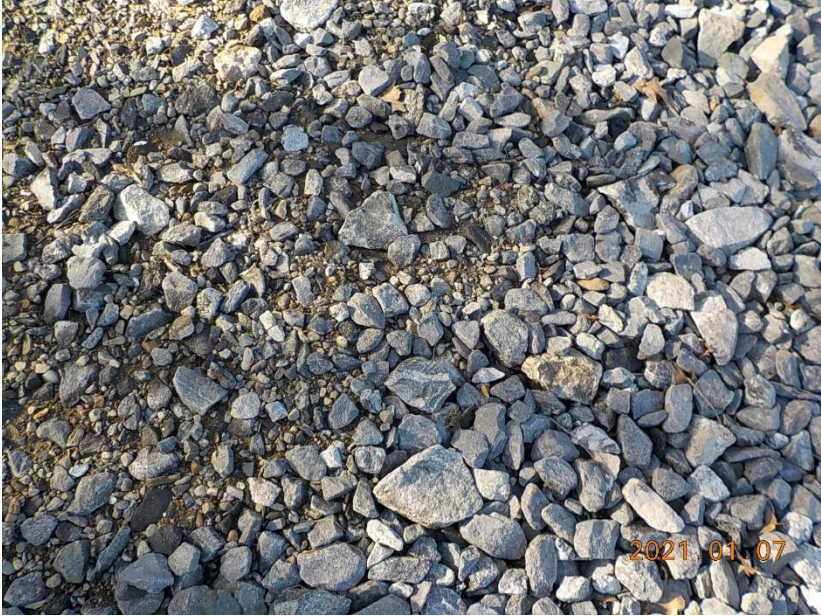
Photo 3: Ramp surface

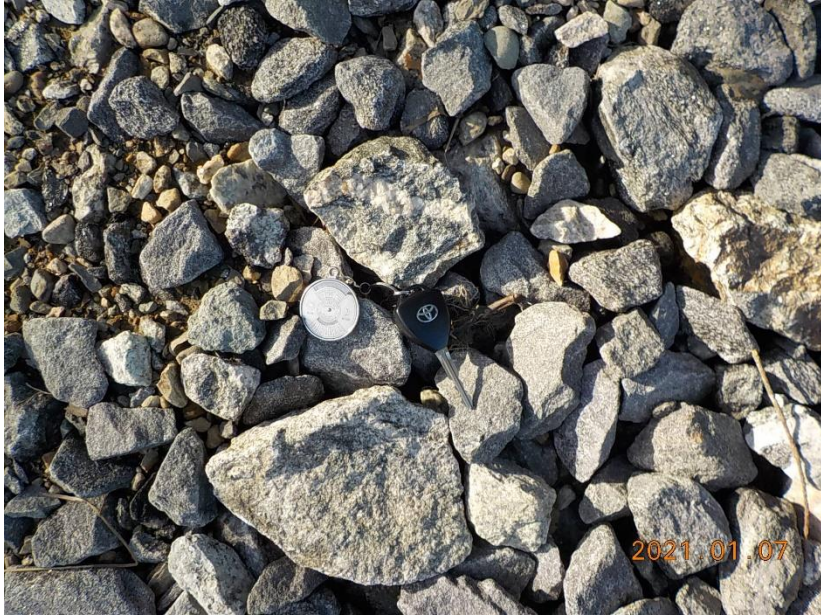
Photo 4: Ramp surface (key for scale)

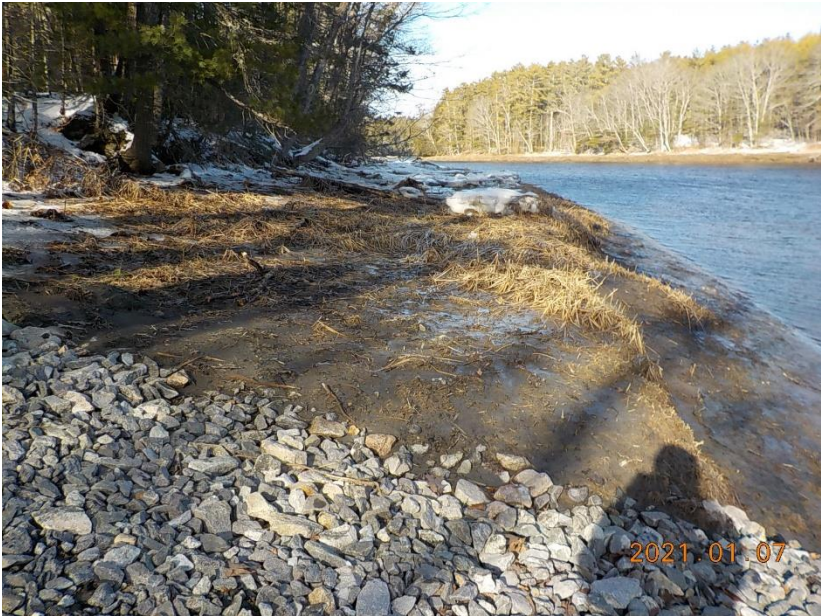
Photo 5: Looking north

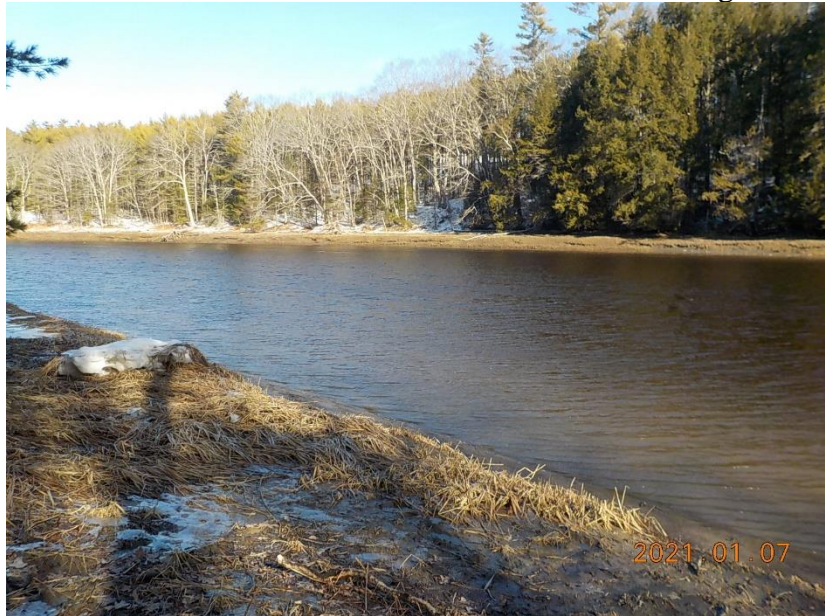
Photo 6: Looking north

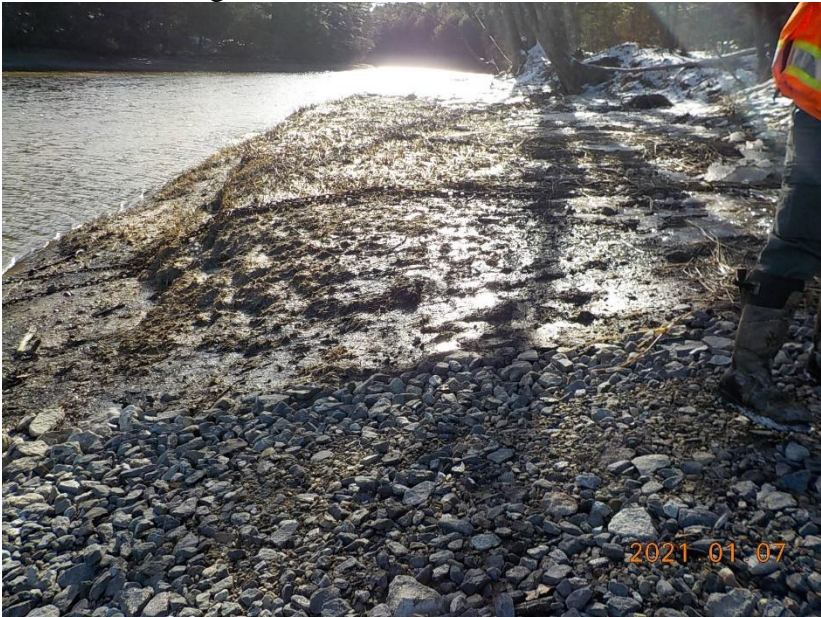
Photo 7: Looking south

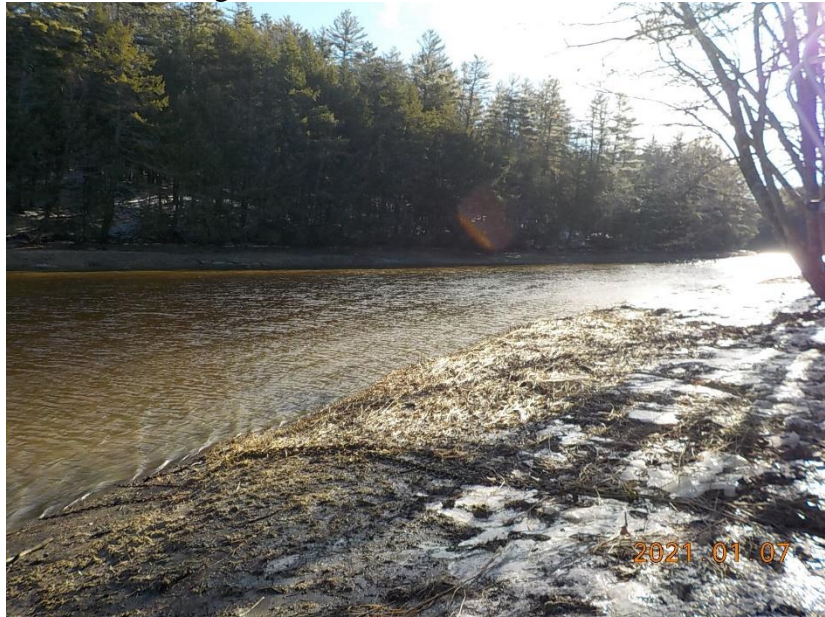
Photo 8: Looking south

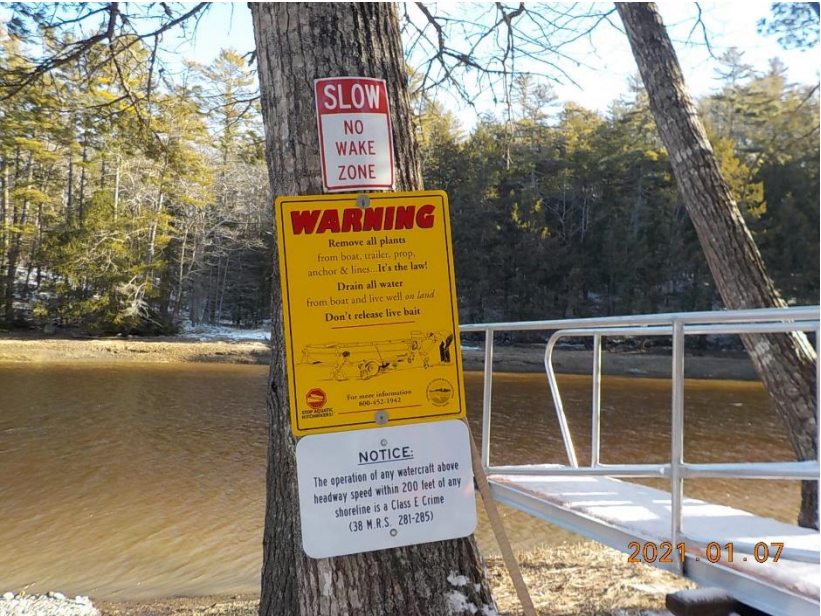
Signs advising of boating speed laws and best practices to prevent spread of invasive species were posted in a visible location at the launch area as required in the NRPA permit.

Photo 9: Signs

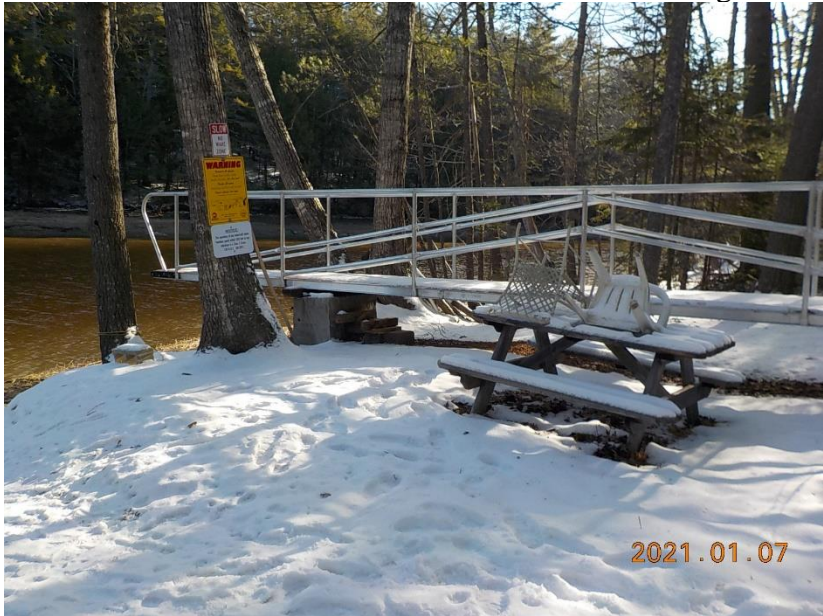
The approved seasonal floats were being stored in the upland. The approved seasonal aluminum ramp (gangway) was also in the upland, though it is slightly overhanging the coastal wetland. Staff advised the licensee to move it further onto the upland. The gangway was resting on a granite block, located in the upland several feet from the HAT line. DEP advised the licensee to move the block to a different upland location during the off-season to prevent the block from being considered a permanent structure as defined in the NRPA, and licensee agreed.

Photo 10: Aluminum ramp (gangway)

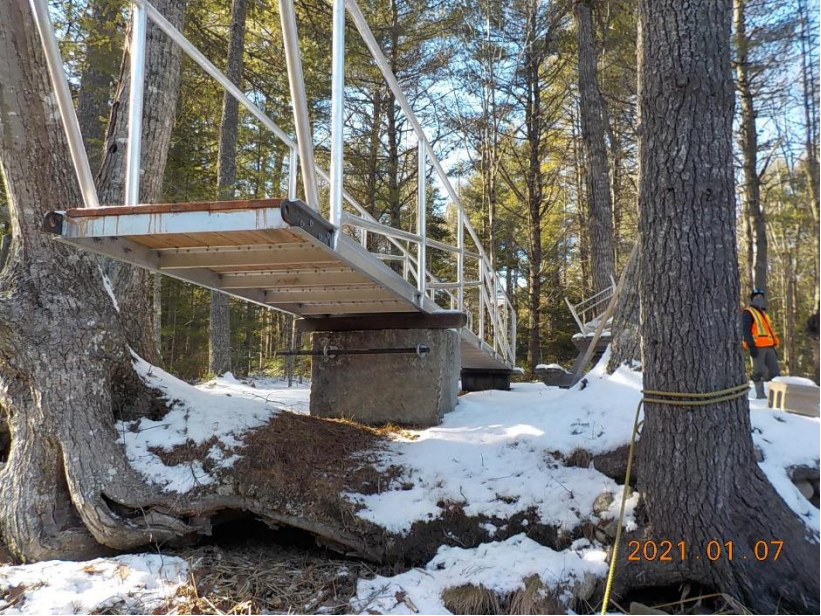
Photo 11: Granite block for gangway

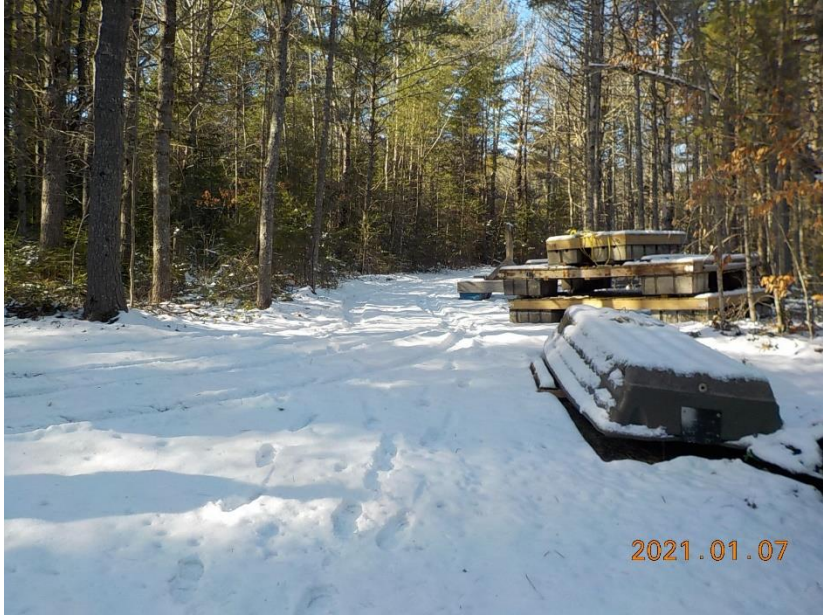
Photo 12: Floats stored in upland
