NORDIC AQUAFARMS, INC.
Belfast and Northport
Waldo County, Maine

**Assessment of the Nordic Aquafarms Permit to Satisfy
Clean Water Act Requirements**

Testimony to the Maine DEP Water Supply and Dam Evaluation

**Water Supply and Dam Evaluation
Belfast, Maine**

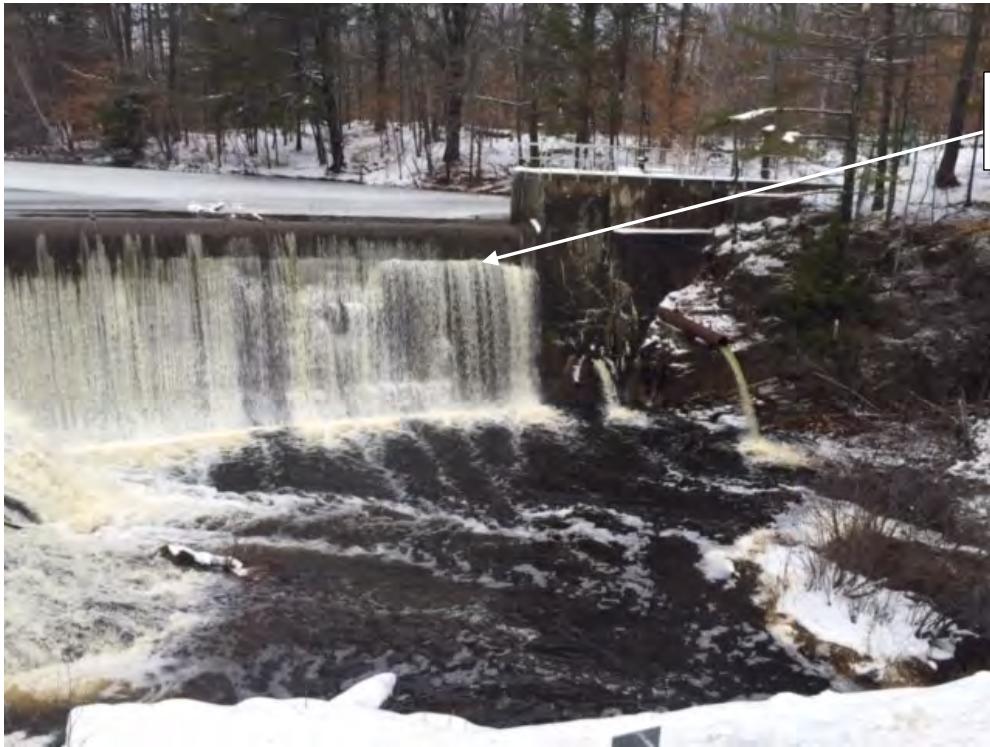
- 2017** Mr. Fred Johnson (GEI) visited Upper Dam on December 13 and observed water flowing over the top of the spillway sill (see Photos 1 and 2 in Appendix A).

Photo No. 1 – Upper Dam - Site visit in December 2017. Note water over spillway.

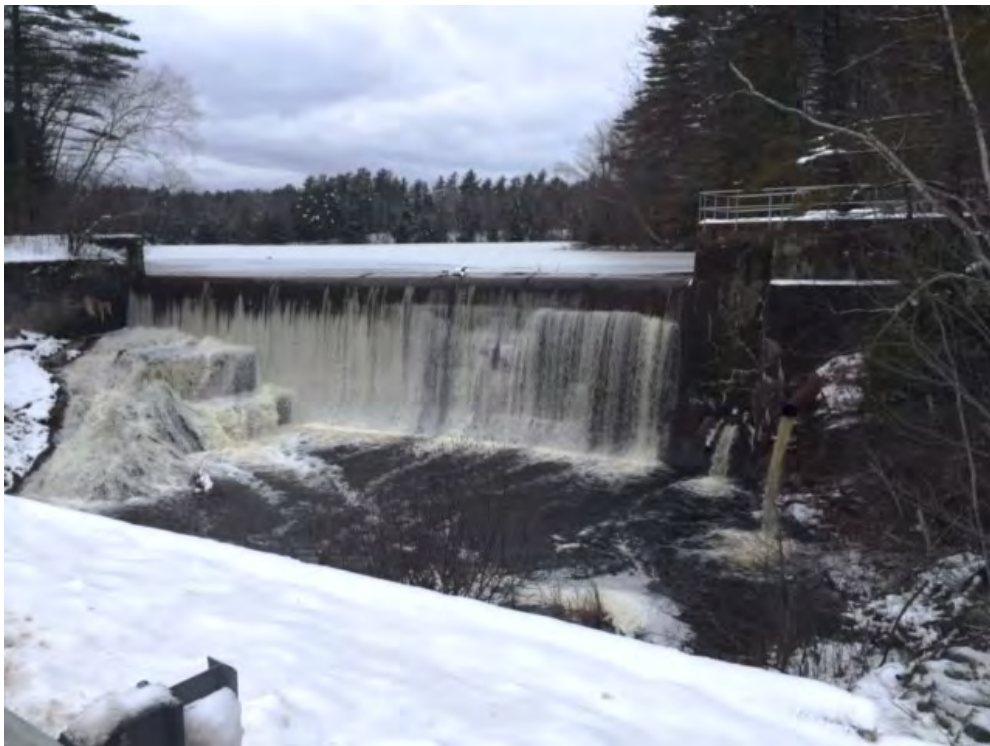
Photo No. 2 – Upper Dam - Site visit in December 2017. Note water over spillway.

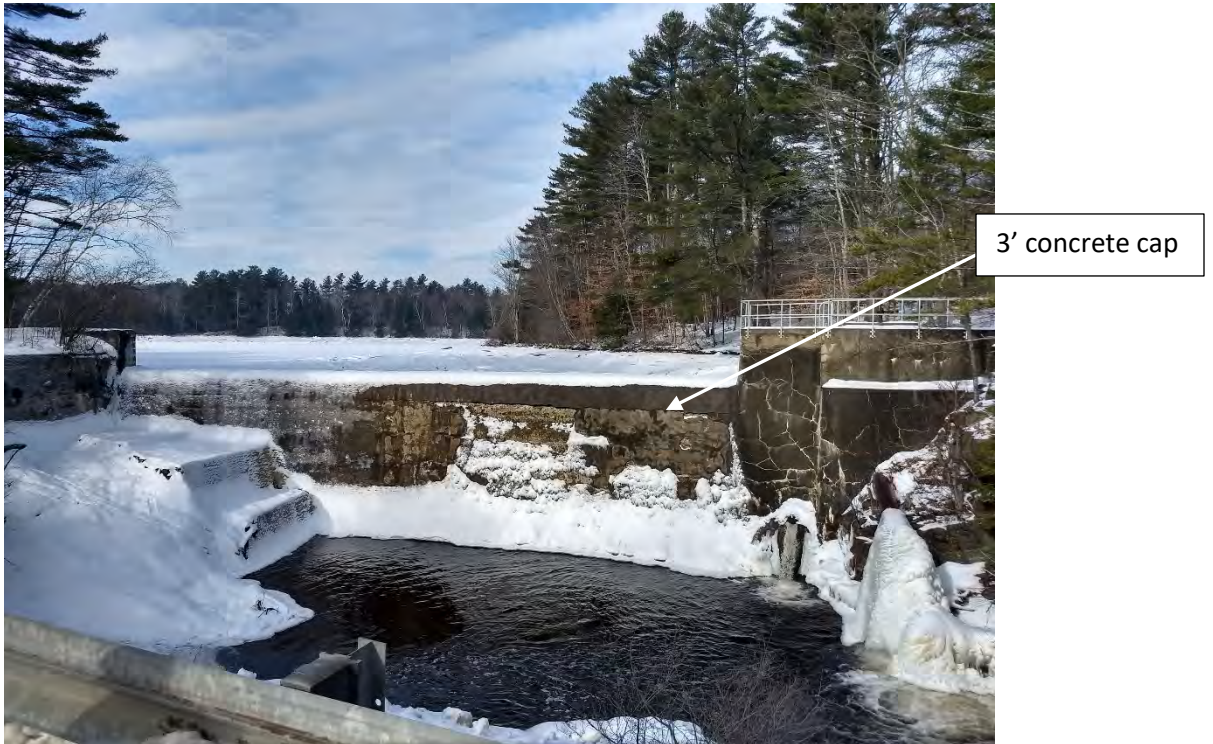
The dam was first observed from the Herrick Road bridge located about 200 ft downstream of the dam. The 18-inch and the upper outlet (higher of the 6-inch or 8-inch outlet pipes) were discharging flow at the time of the visit (Photos 3 and 4). Water was ponded at the downstream toe, so the foundation conditions at the downstream toe were not able to be observed. Bedrock outcroppings were observed on the left downstream side of the dam. Prevalent alligator cracking with some efflorescence was observed on the downstream side of the left abutment.

The horizontal construction joint for the 3-ft concrete cap was observed on the spillway (Photo 3). In the photos taken during a GEI site visit in December 2017, the flow is disturbed at the cap construction joint, indicating either leakage through the joint or an offset in the downstream face (Photos 1 and 2). A large section of the surficial gunite has been eroded off the downstream face of the spillway below the concrete cap, exposing the original concrete beneath (Photo 4). Other areas of the gunite spillway surface have spalled, and there is significant cracking of the gunite.

Photo No. 3 – Upper Dam – Downstream face. Note 18” and 8” outlets flowing.

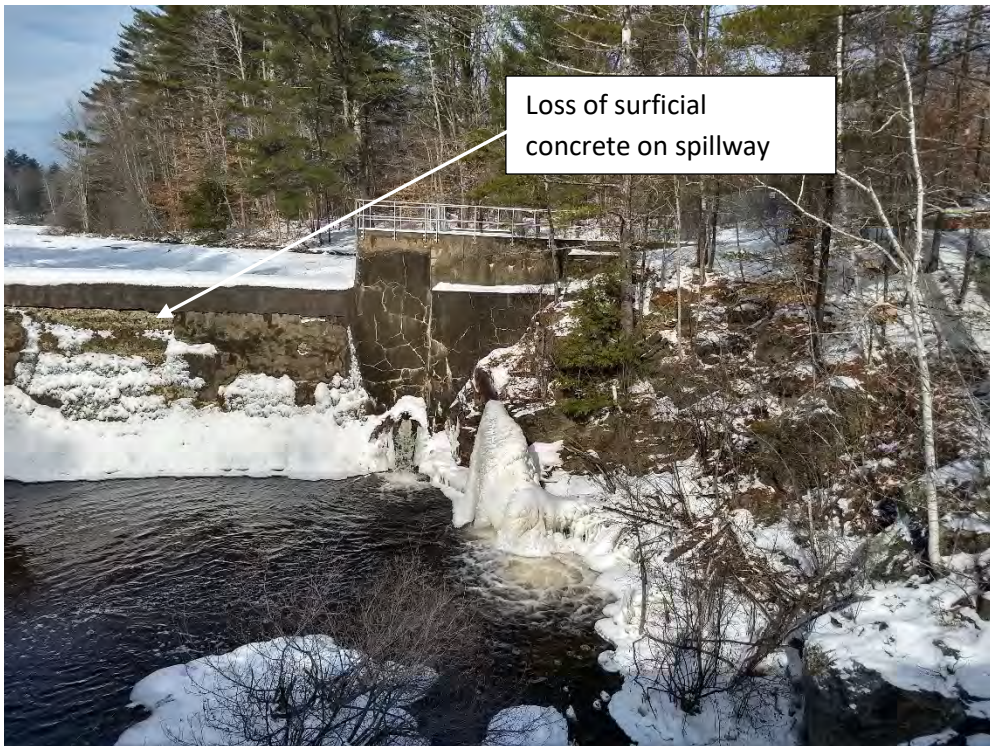
Photo No. 4 – Upper Dam – Downstream side of left abutment and spillway. Note cracks in abutment and loss of surficial concrete on spillway.

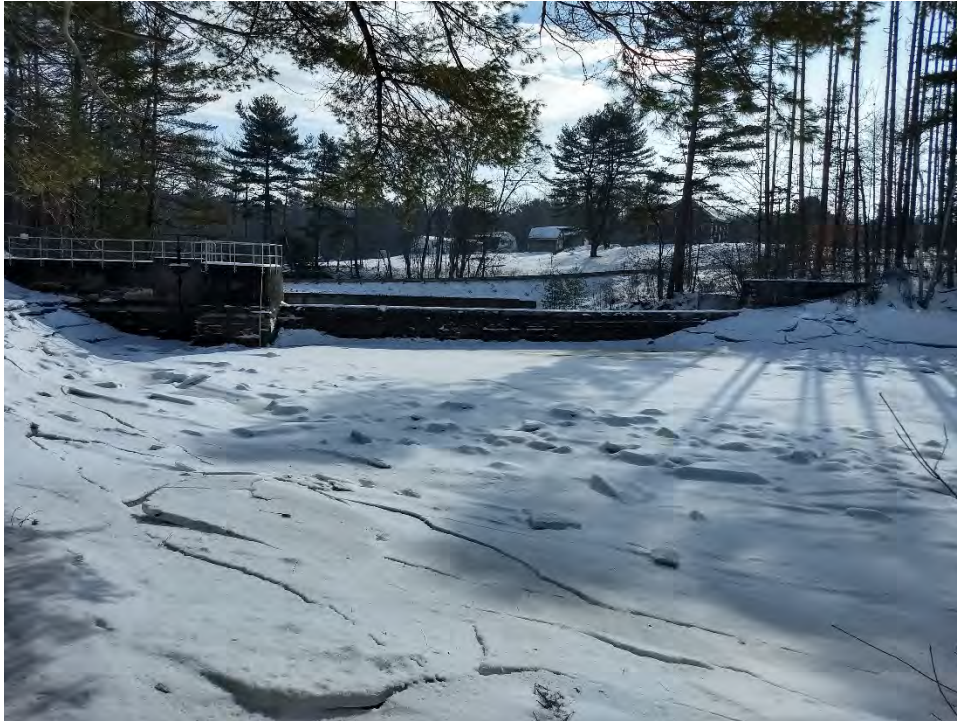
The reservoir was estimated to be approximately 6 ft below the spillway sill (Photo 5). The reservoir was ice-covered, and there was ice against the dam. The upstream left abutment and intake tower had prevalent cracking with efflorescence and spalling/loss of the gunite

Photo No. 5 – Upper Dam – Upstream face. Note reservoir approximately 6' below spillway sill.

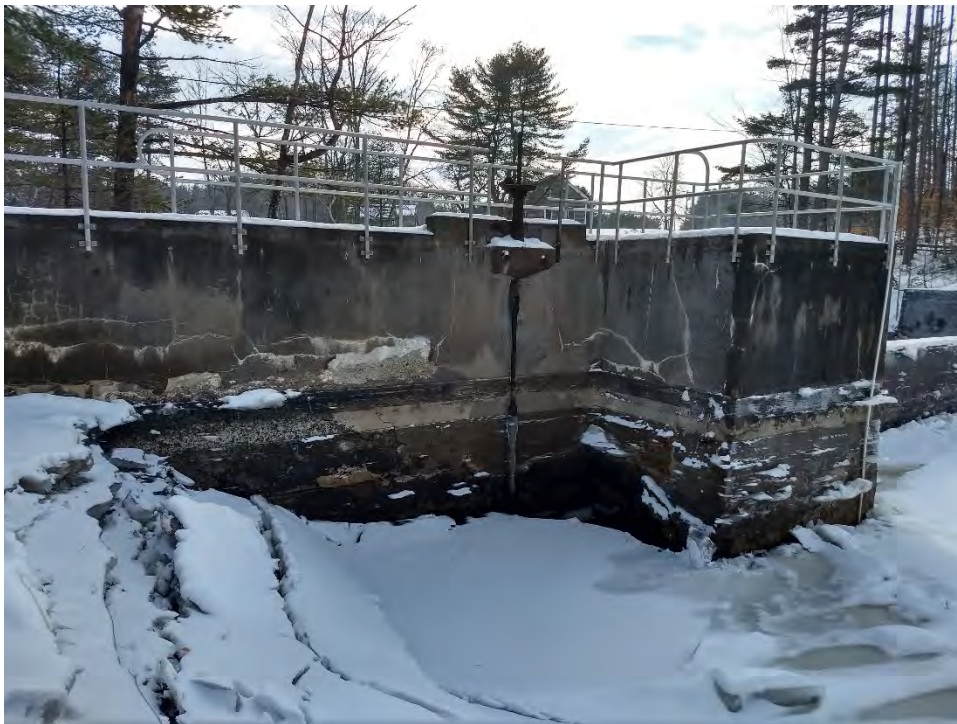
Photo No. 6 – Upper Dam – Upstream side of left abutment. Note 18" gate stem and cracking and spalling concrete.

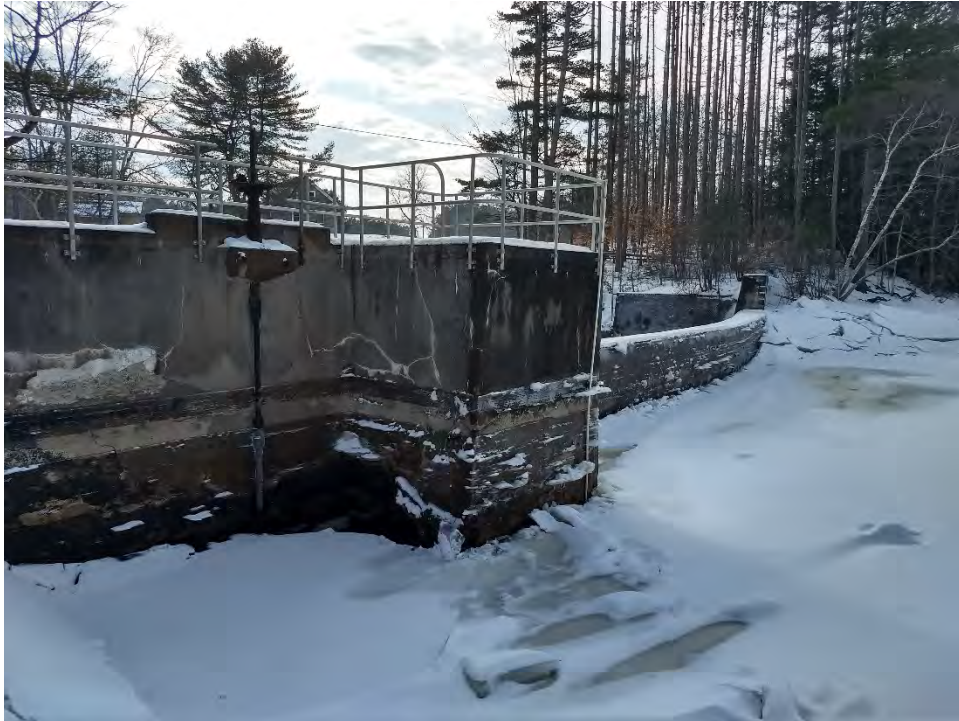
Photo No. 7 – Upper Dam – Upstream side of left abutment and spillway. Note ice against spillway face.

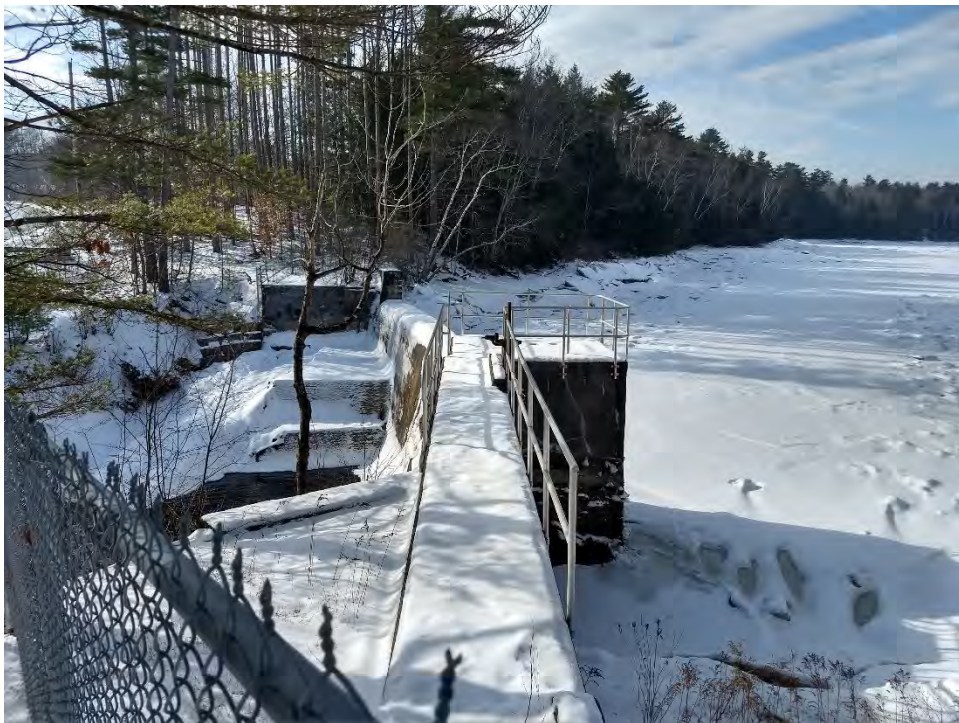
surfacing (Photos 6 and 7). There was no obvious misalignment of the crest (Photos 8 and 9). The upstream right abutment retaining wall was observed to have spalling and cracking in the gunite surface (Photos 10 and 11). There also appeared to be a failing gunite repair that was separating about 1/2-inch off the face of the wall (Photo 11).

Photo No. 8 – Upper Dam – Dam crest, looking right.

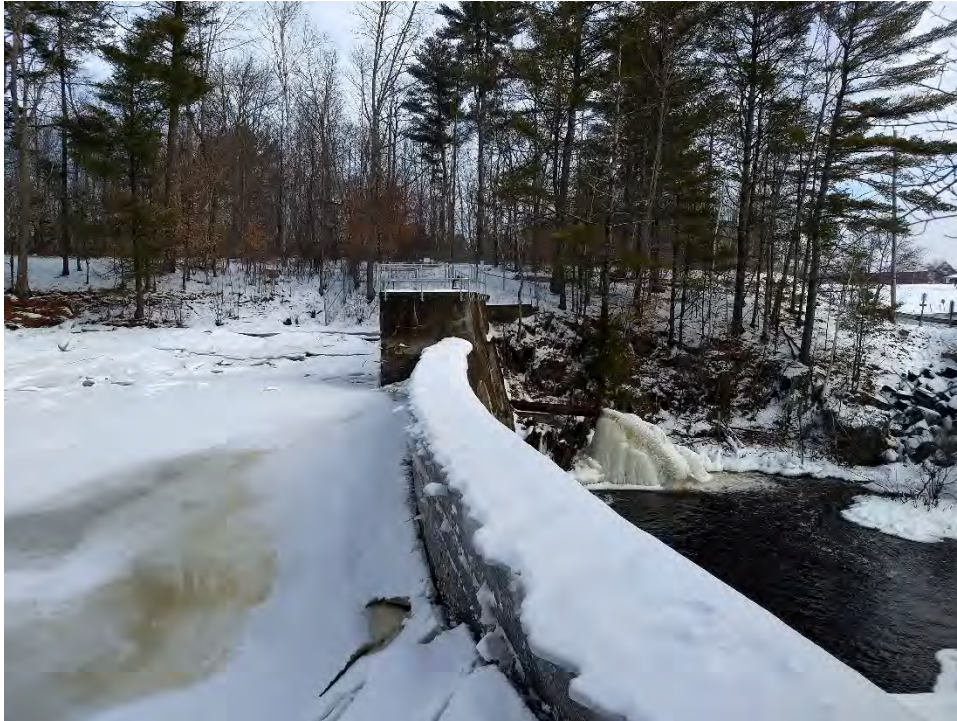
Photo No. 9 – Upper Dam – Spillway sill, looking left.

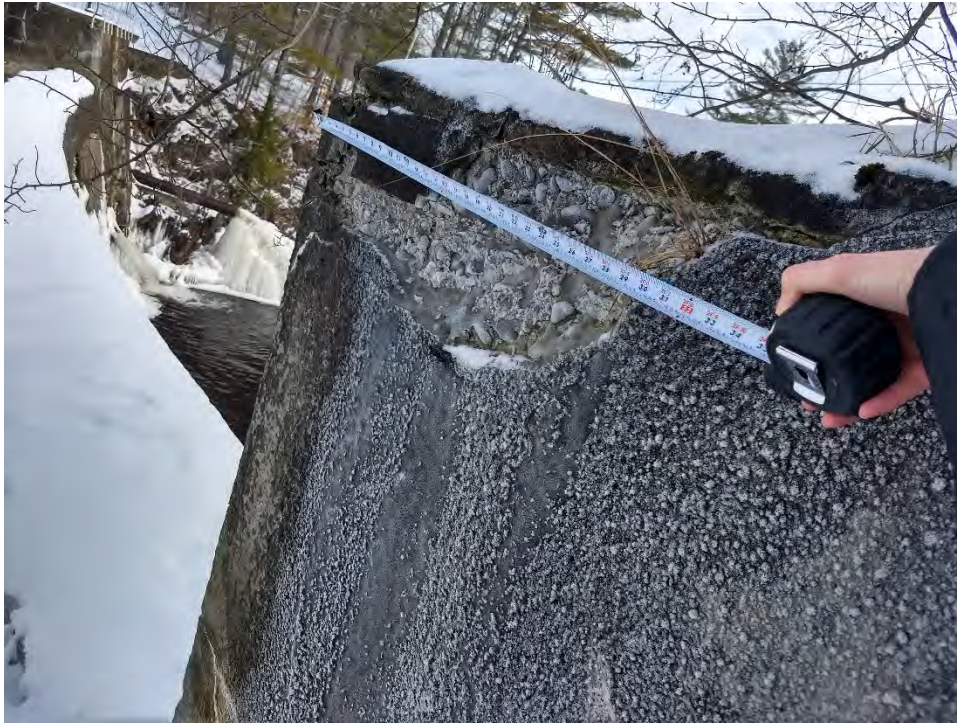
Photo No. 10 – Upper Dam – Upstream side of right abutment retaining wall. Note spalling concrete.

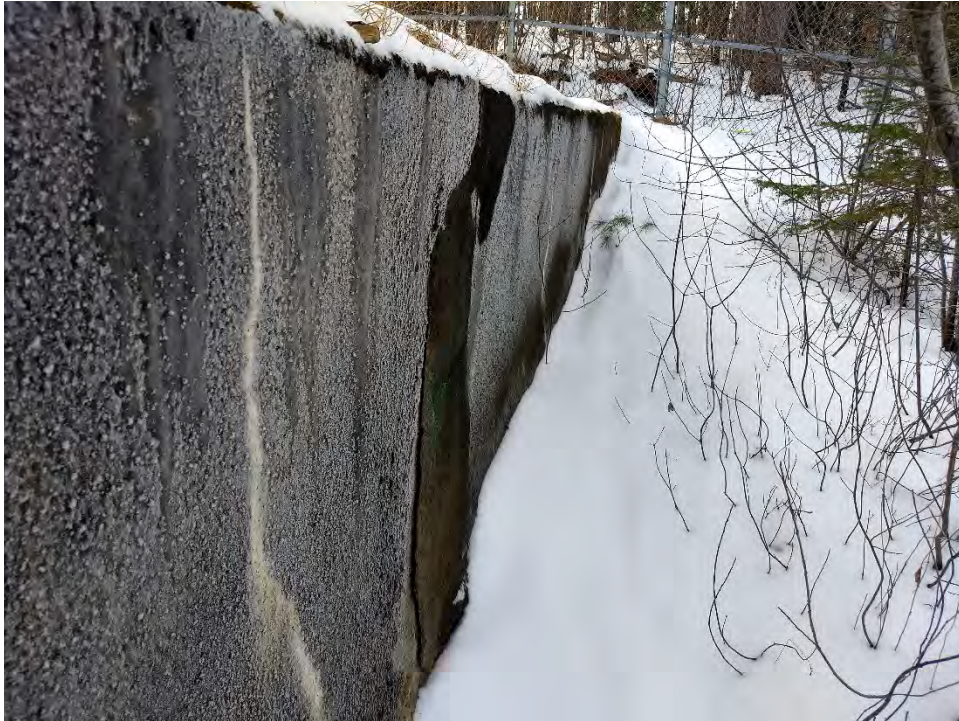
Photo No. 11 – Upper Dam – Right abutment retaining wall, looking right. Note cracking and failing concrete repairs.

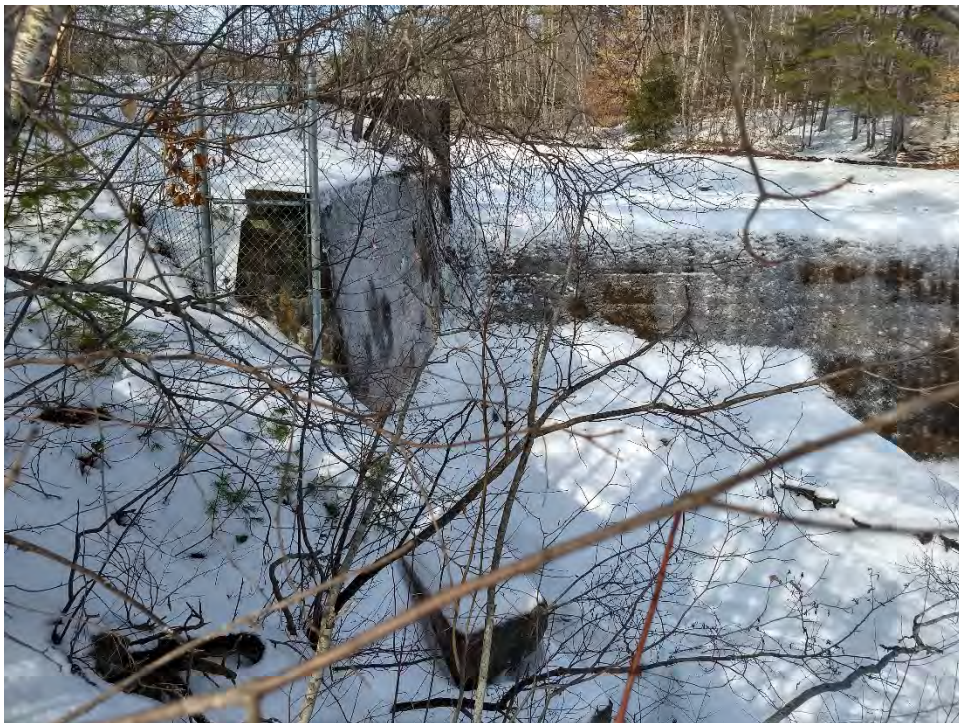
The stepped apron at the right downstream side of the spillway was covered in snow and not able to be observed with any detail (Photo 13). There was some yellowish discoloration of the ice along the contact between the spillway and lower two apron steps. Ground conditions at the right downstream embankment were not able to be observed due to the snow cover. The downstream training walls on the right side were observed from a distance but difficult to see due to the ground conditions and being unable to approach the walls (Photos 12 and 13).

Photo No. 12 – Upper Dam – Right downstream side of spillway and downstream training wall.

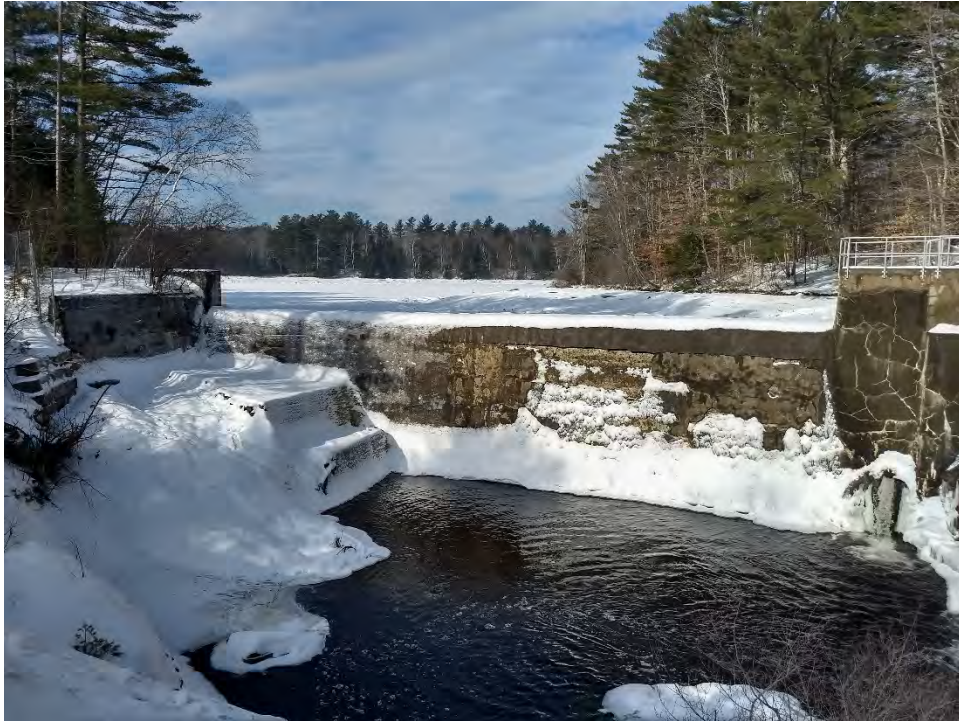
Photo No. 13 – Upper Dam – Downstream side of dam. Note right abutment training wall and concrete apron.

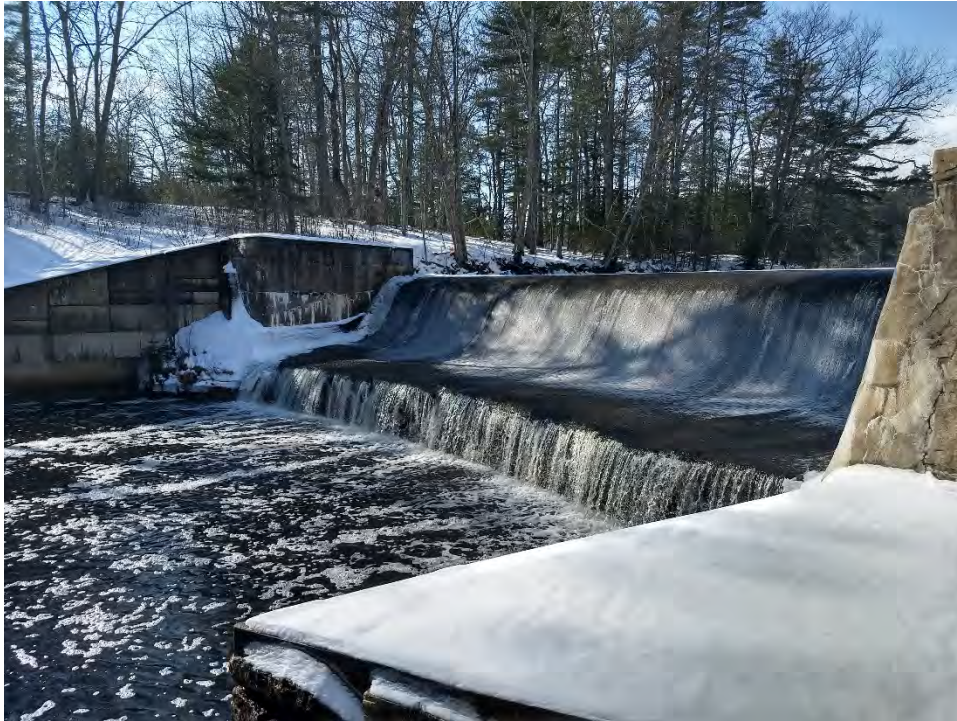
Photo No. 15 – Lower Dam – Downstream side of spillway. Note spilling by a couple of inches, vegetation on right downstream toe.

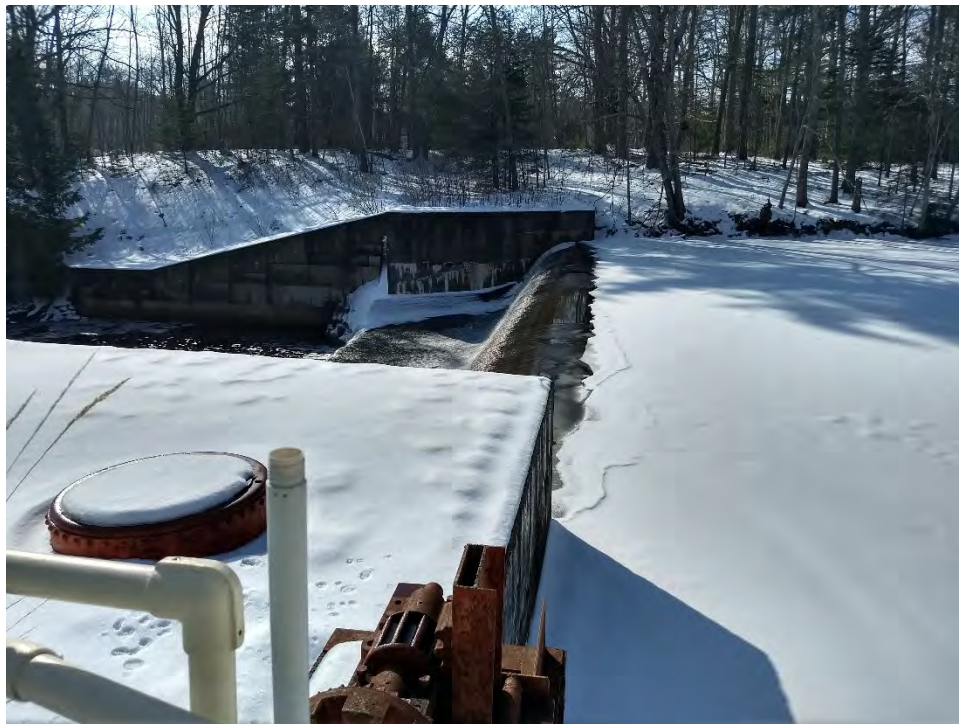
Photo No. 18 – Lower Dam – looking right. Note cracking with efflorescence on right abutment.

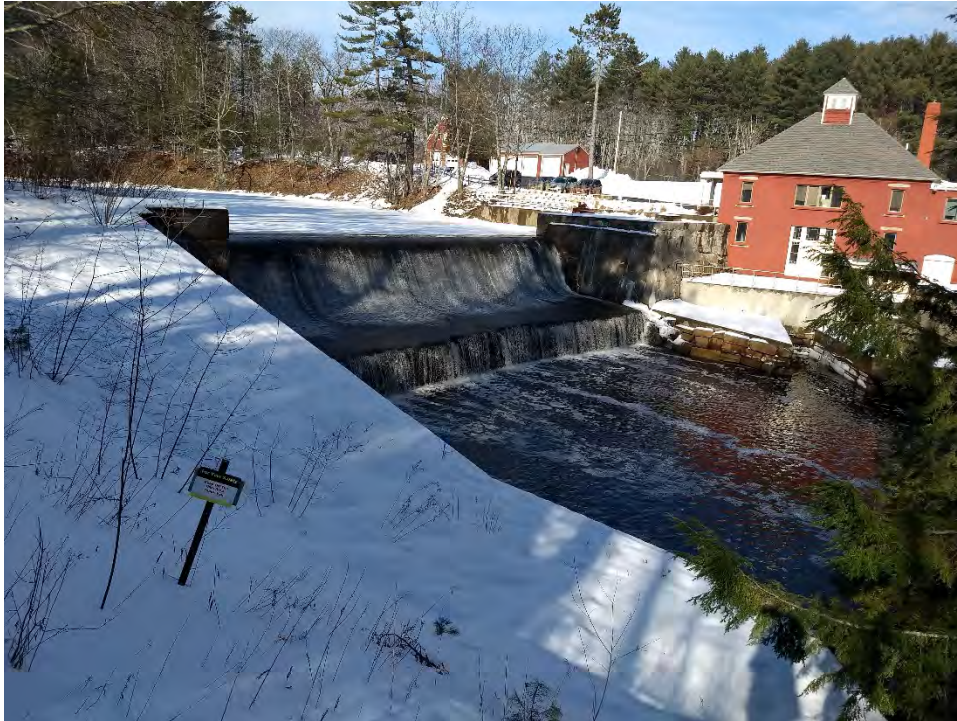
Photo No. 21 – Lower Dam – looking towards left abutment. Note cracking with efflorescence on left abutment.

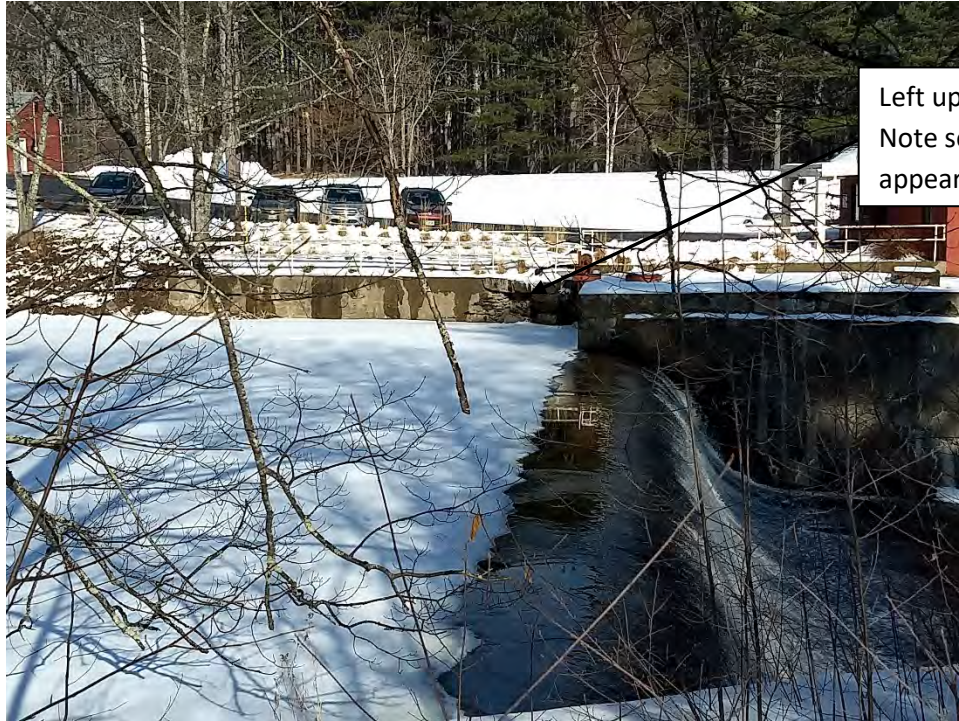
Photo No. 23 – Lower Dam – Upstream left abutment training wall. Note section where concrete facing appears to have failed.
