From: Communications.MaineDOT@maine.gov
Sent: Saturday, March 24, 2018 3:41 PM
To: Gardner, David
Subject: Frank J. Wood Project Comment

Categories: FJW

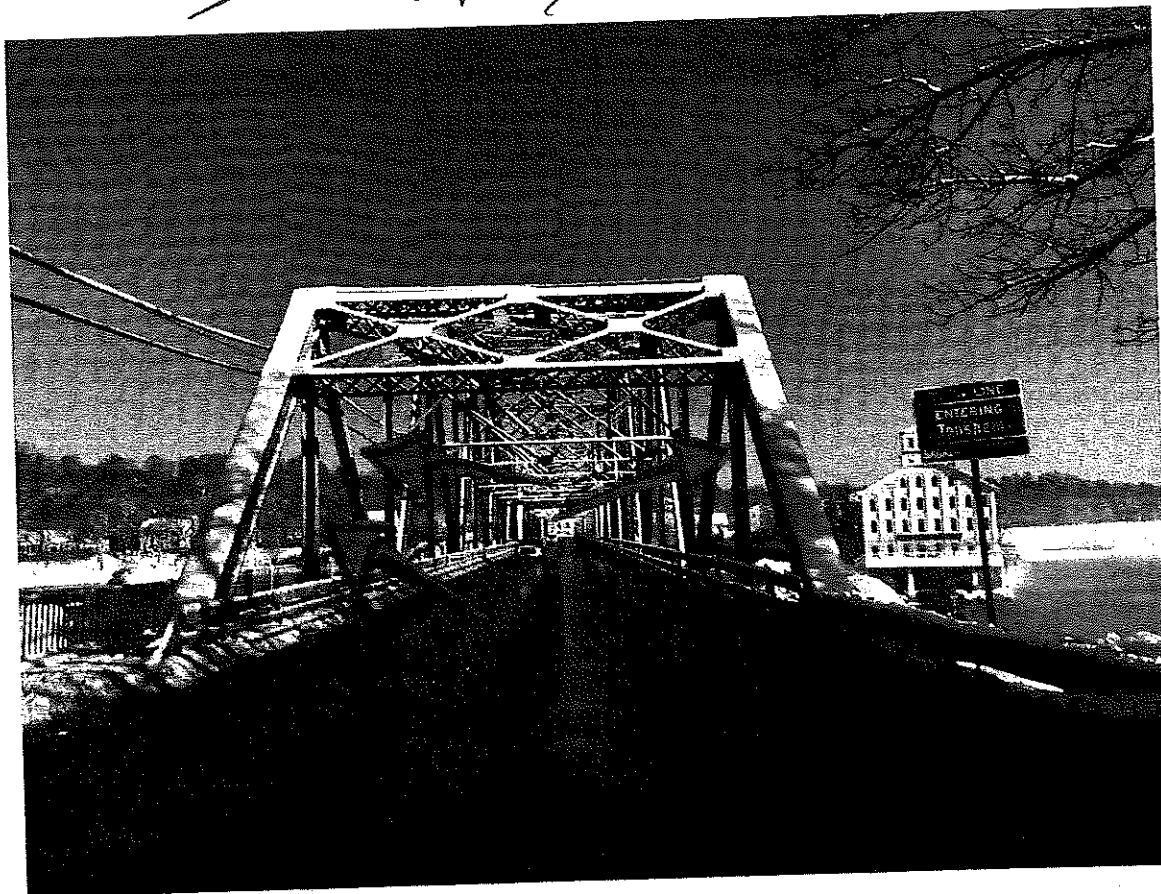
From: James Mixon mixj444@gmail.com
Subject: bridghe
Date: April 10, 2018 at 9:43 PM
To: Eleanor Leo quark2183@gmail.com

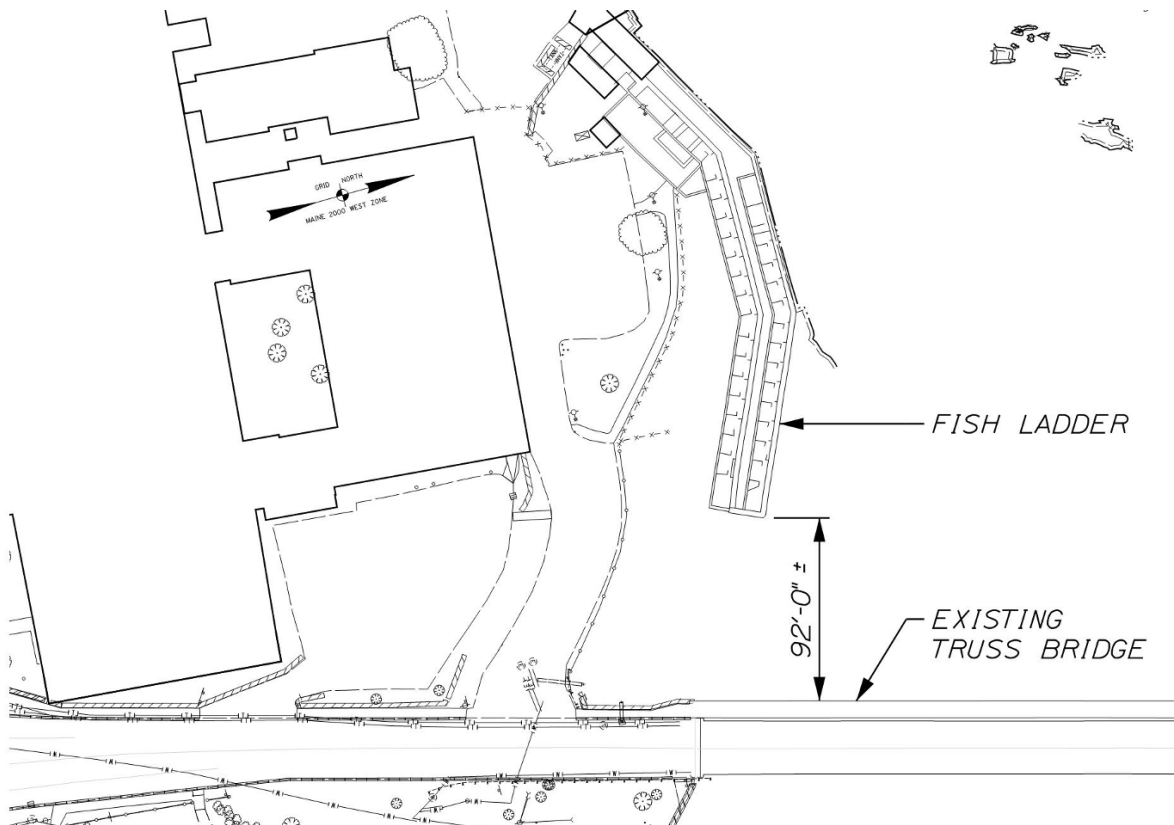
The Frank J. Wood Bridge replacement preferred alternative (Alternative 2), as proposed, is located immediately adjacent to BWPH’s Brunswick Dam, which includes a fish passage facility (Fishway). Currently, the Frank J. Wood Bridge passes just over 90 feet to the south of the Facility. The proposed bridge reconstruction and realignment would bring the bridge to within just over 30 feet of the Fishway.

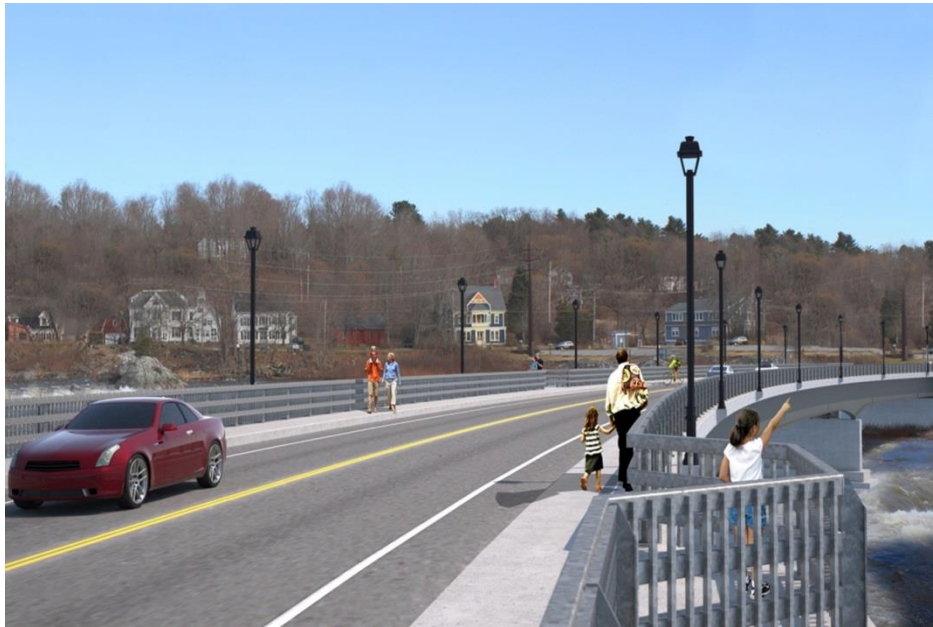
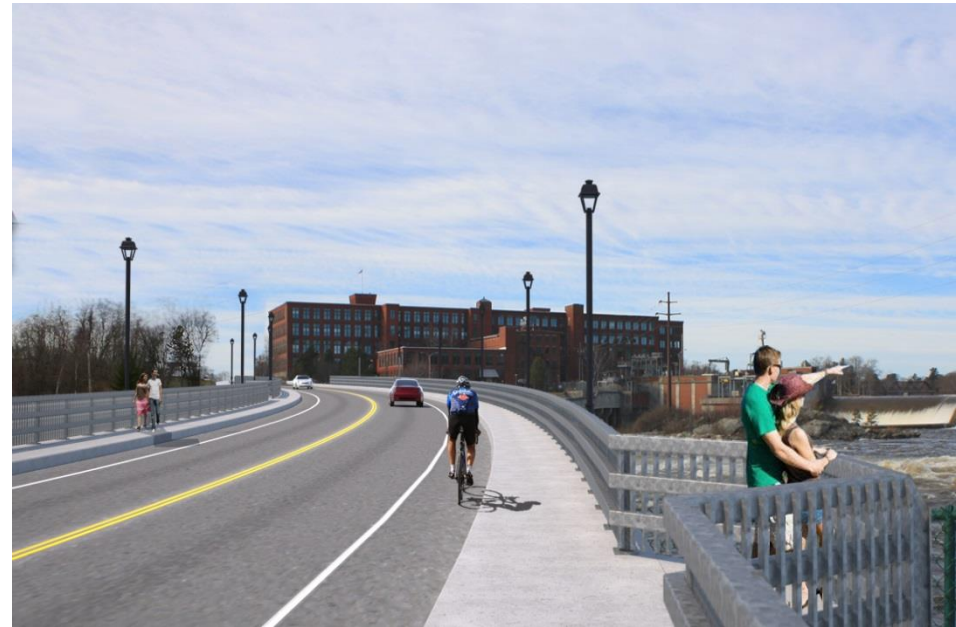
Preliminary Design Study Objectives

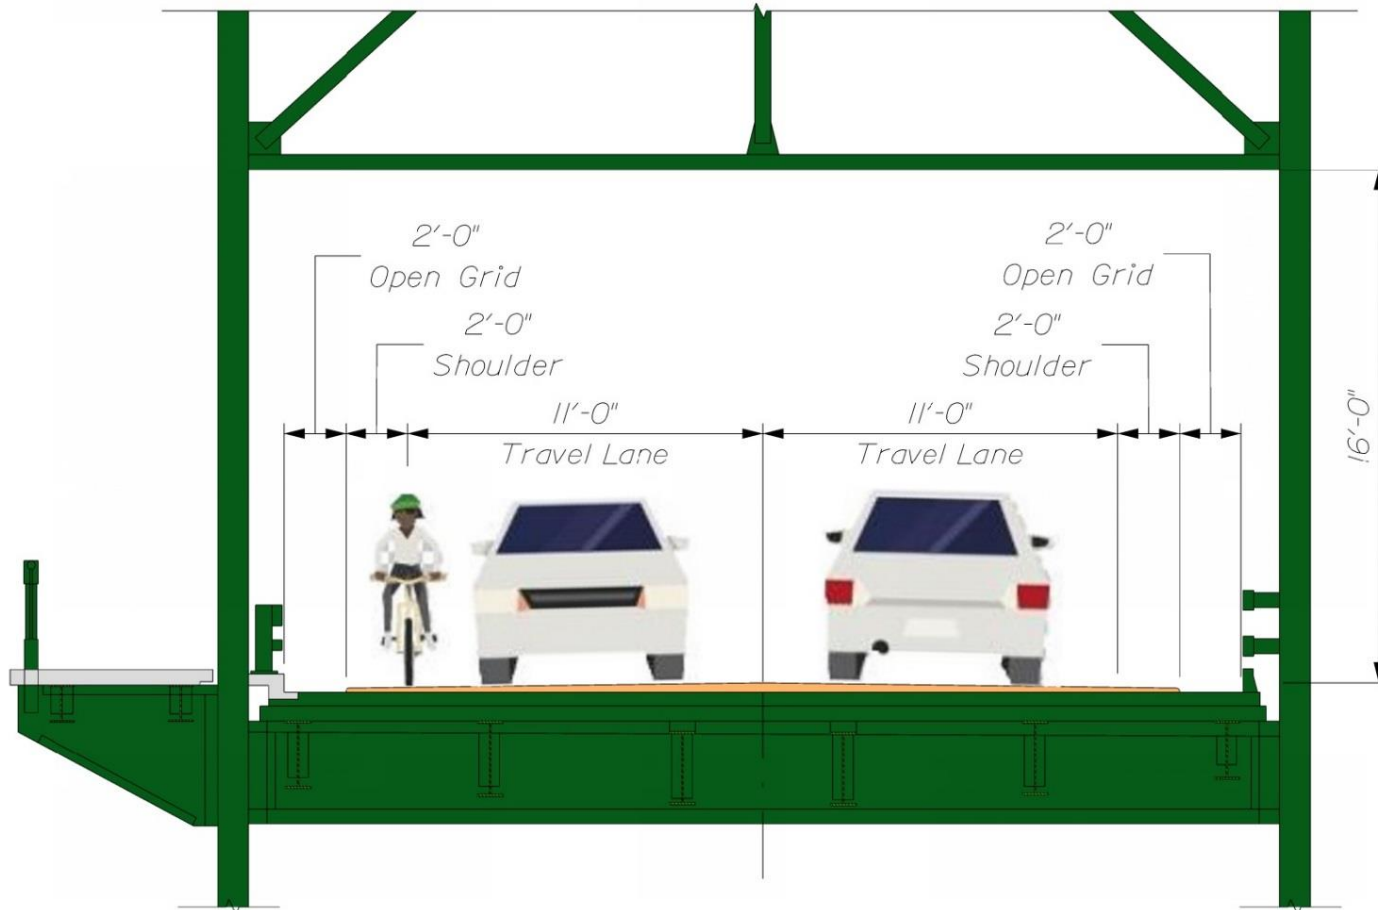
EXISTING BRIDGE SECTION

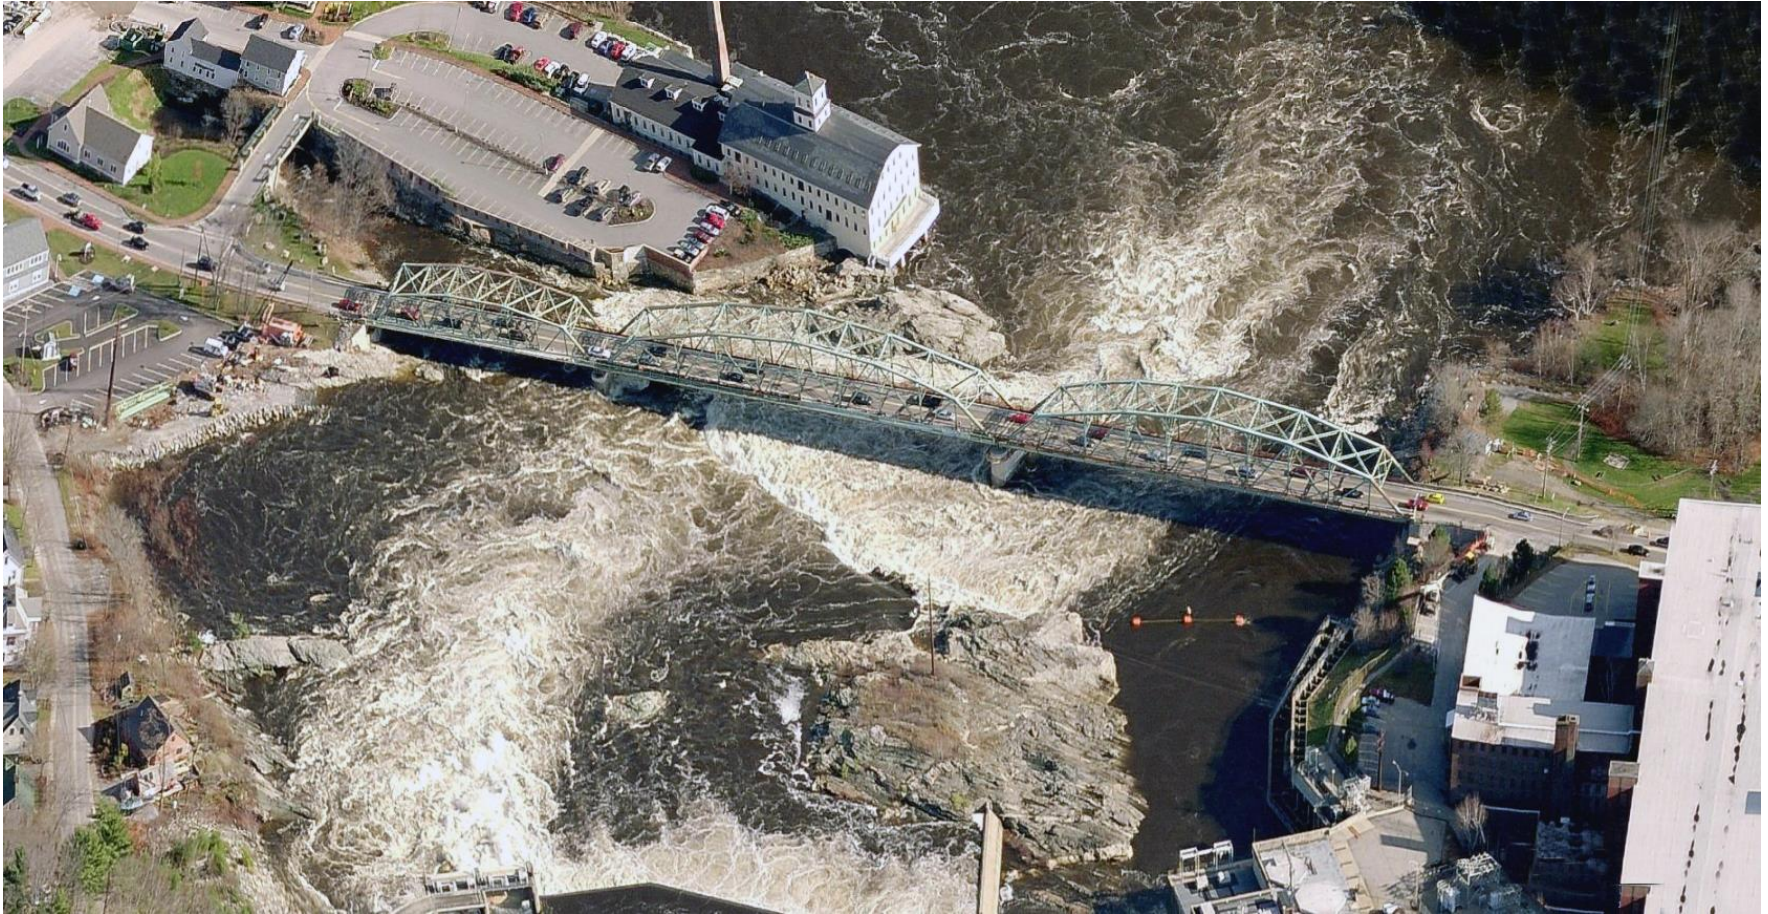
Replacement Bridge - Upstream Alignment

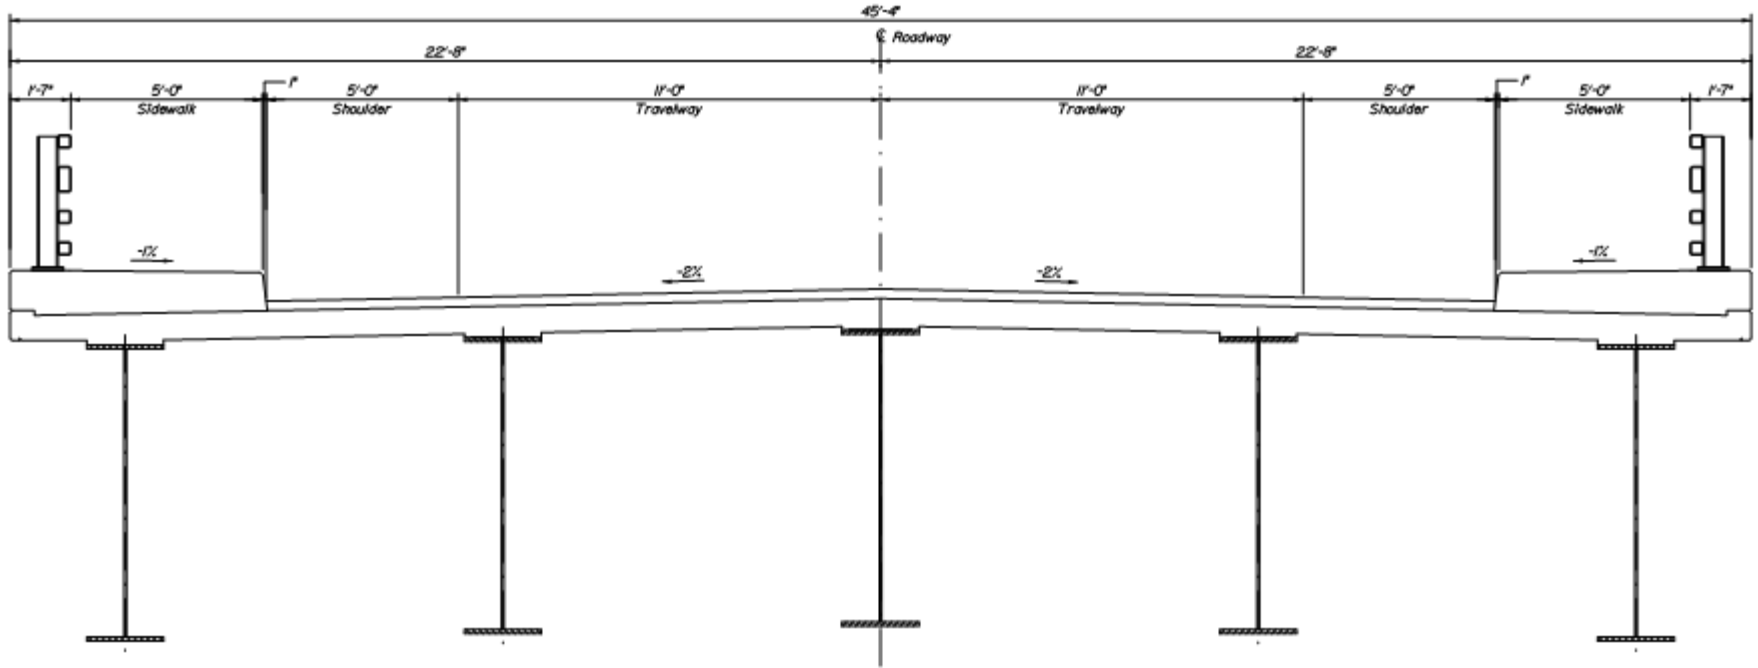
Replacement Benefits

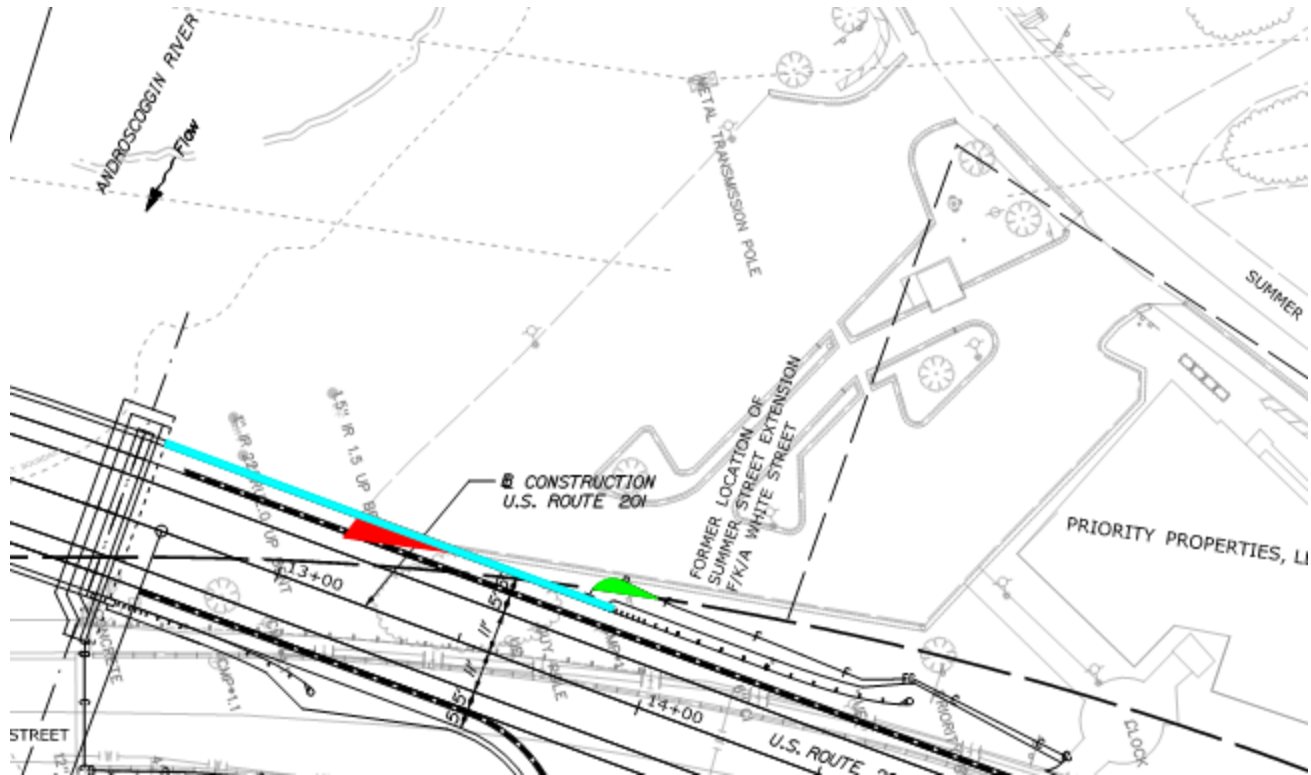
Replacement Bridge - Elevation

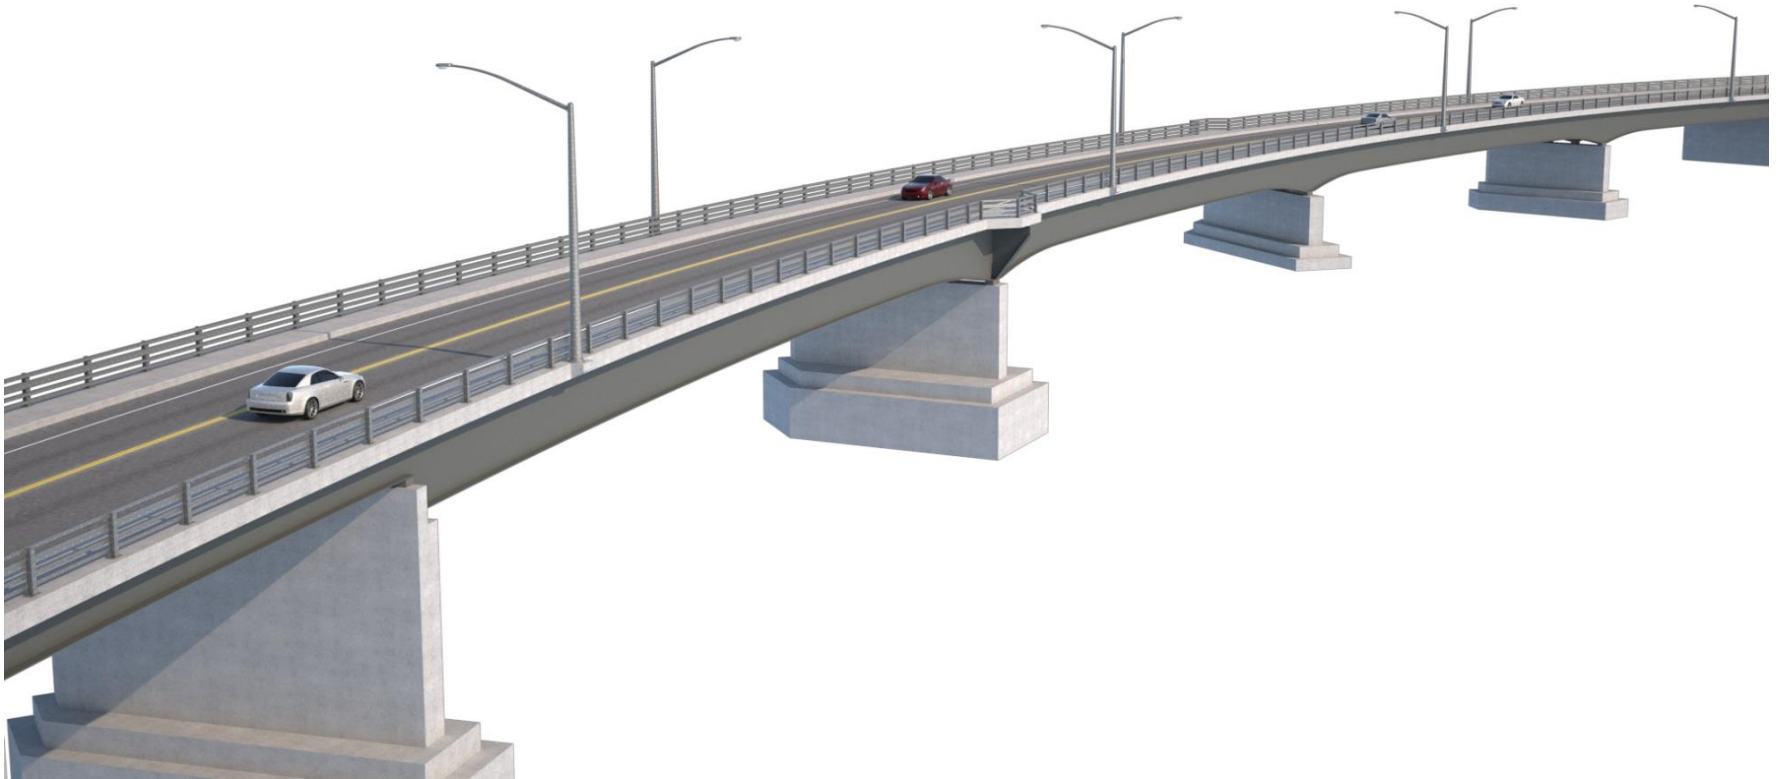
Replacement Bridge - Section

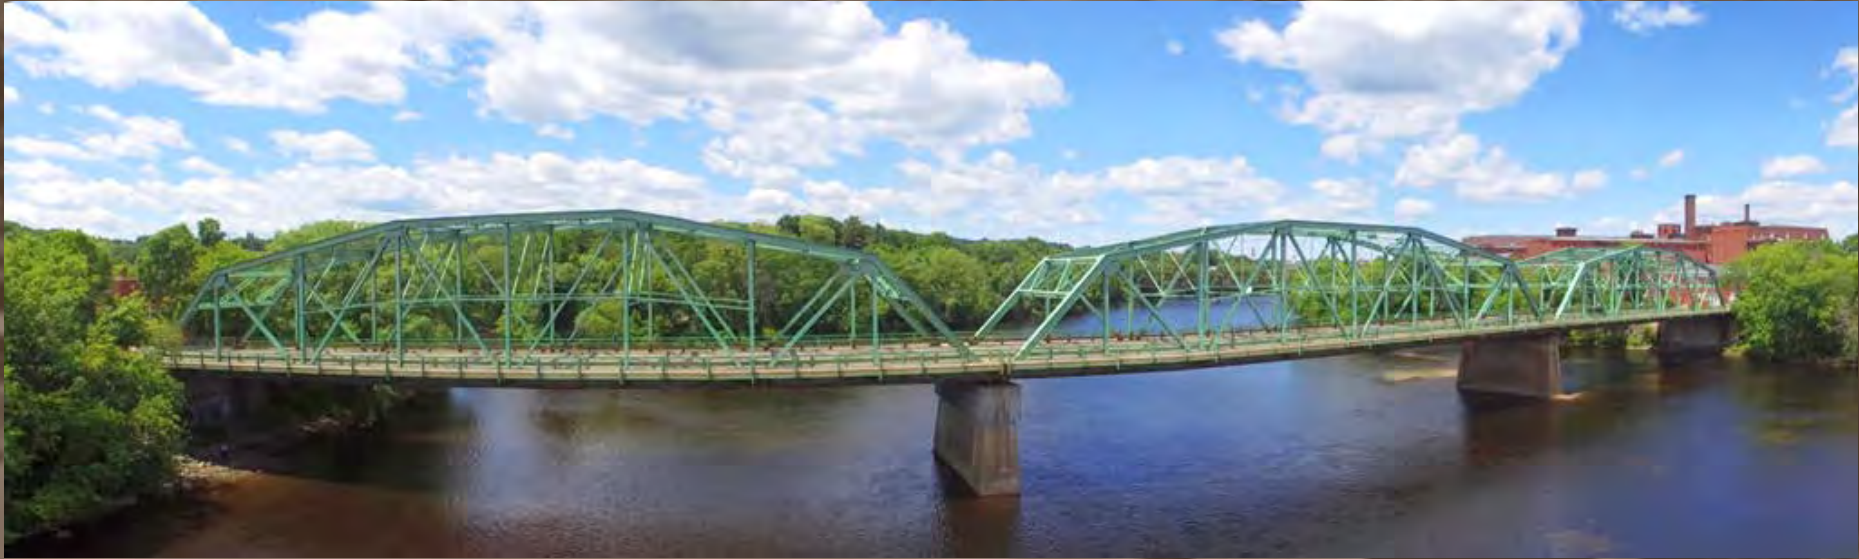
- 723 ft, three-span steel truss
- Built in 1936, pier 2 repair 1995, deck replacement 1996

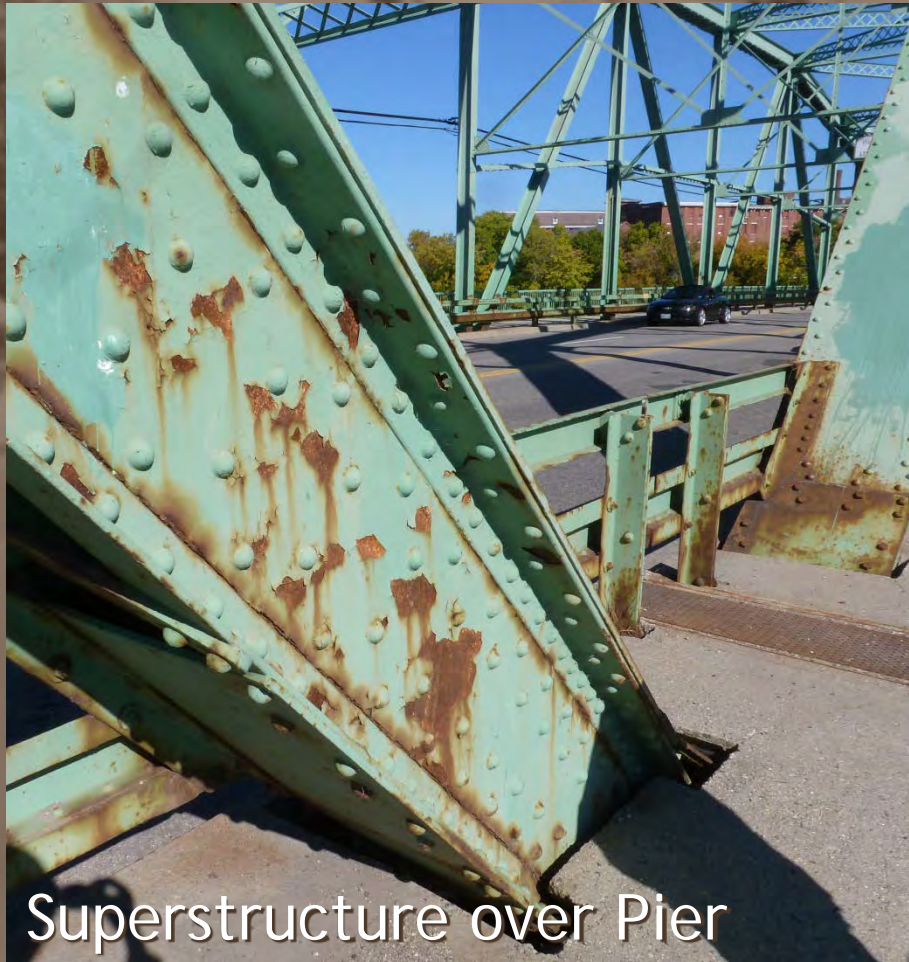
Superstructure over Pier

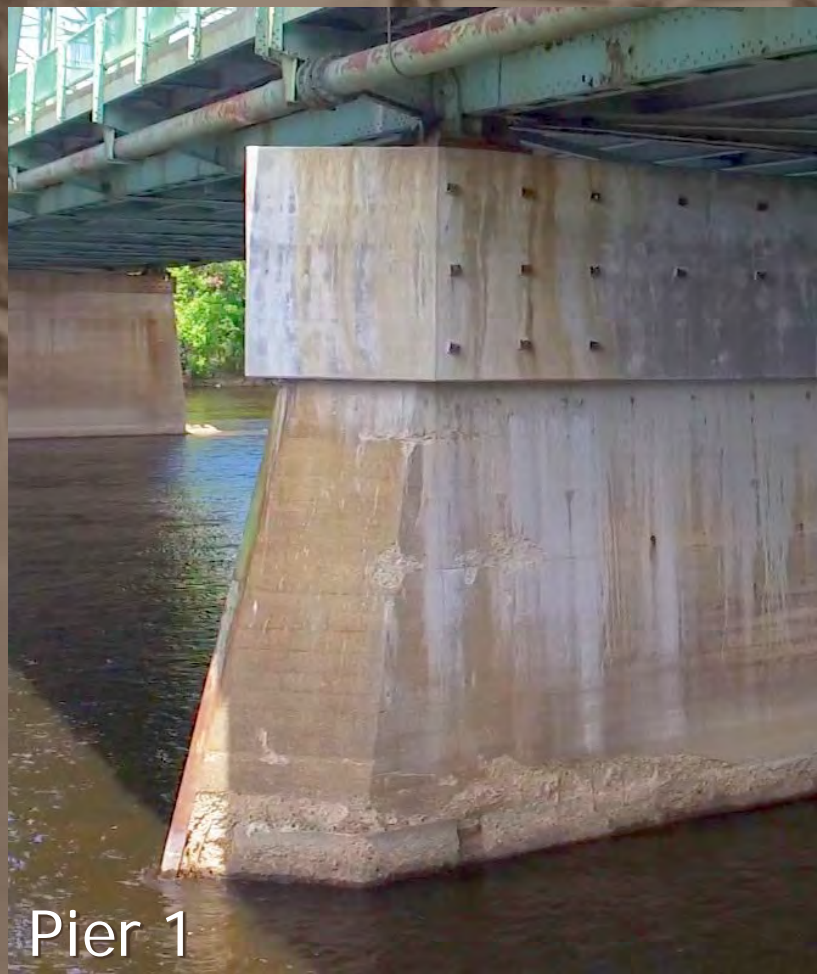
- Minor abutment repairs
- Pier 1 repair at waterline
- Pier 2 pier cap repair
 - Was repaired in 1995
 - (Pier 1 pier cap recently repaired)

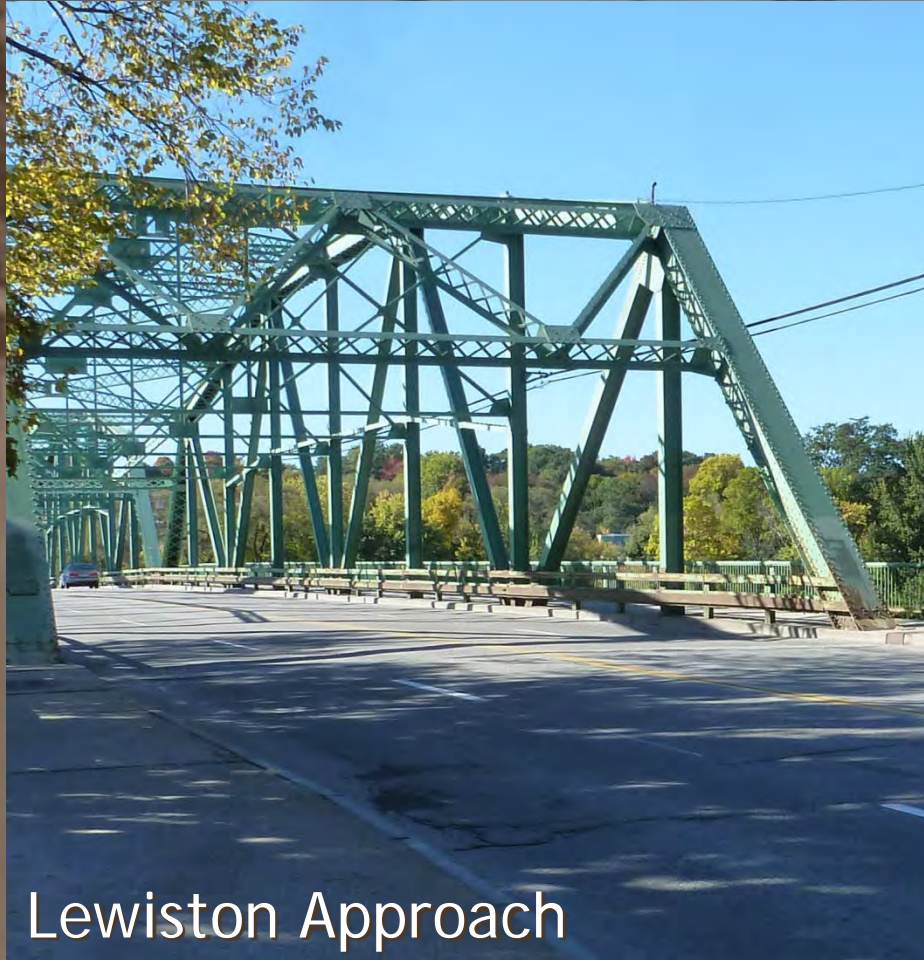
Rehabilitation Needs

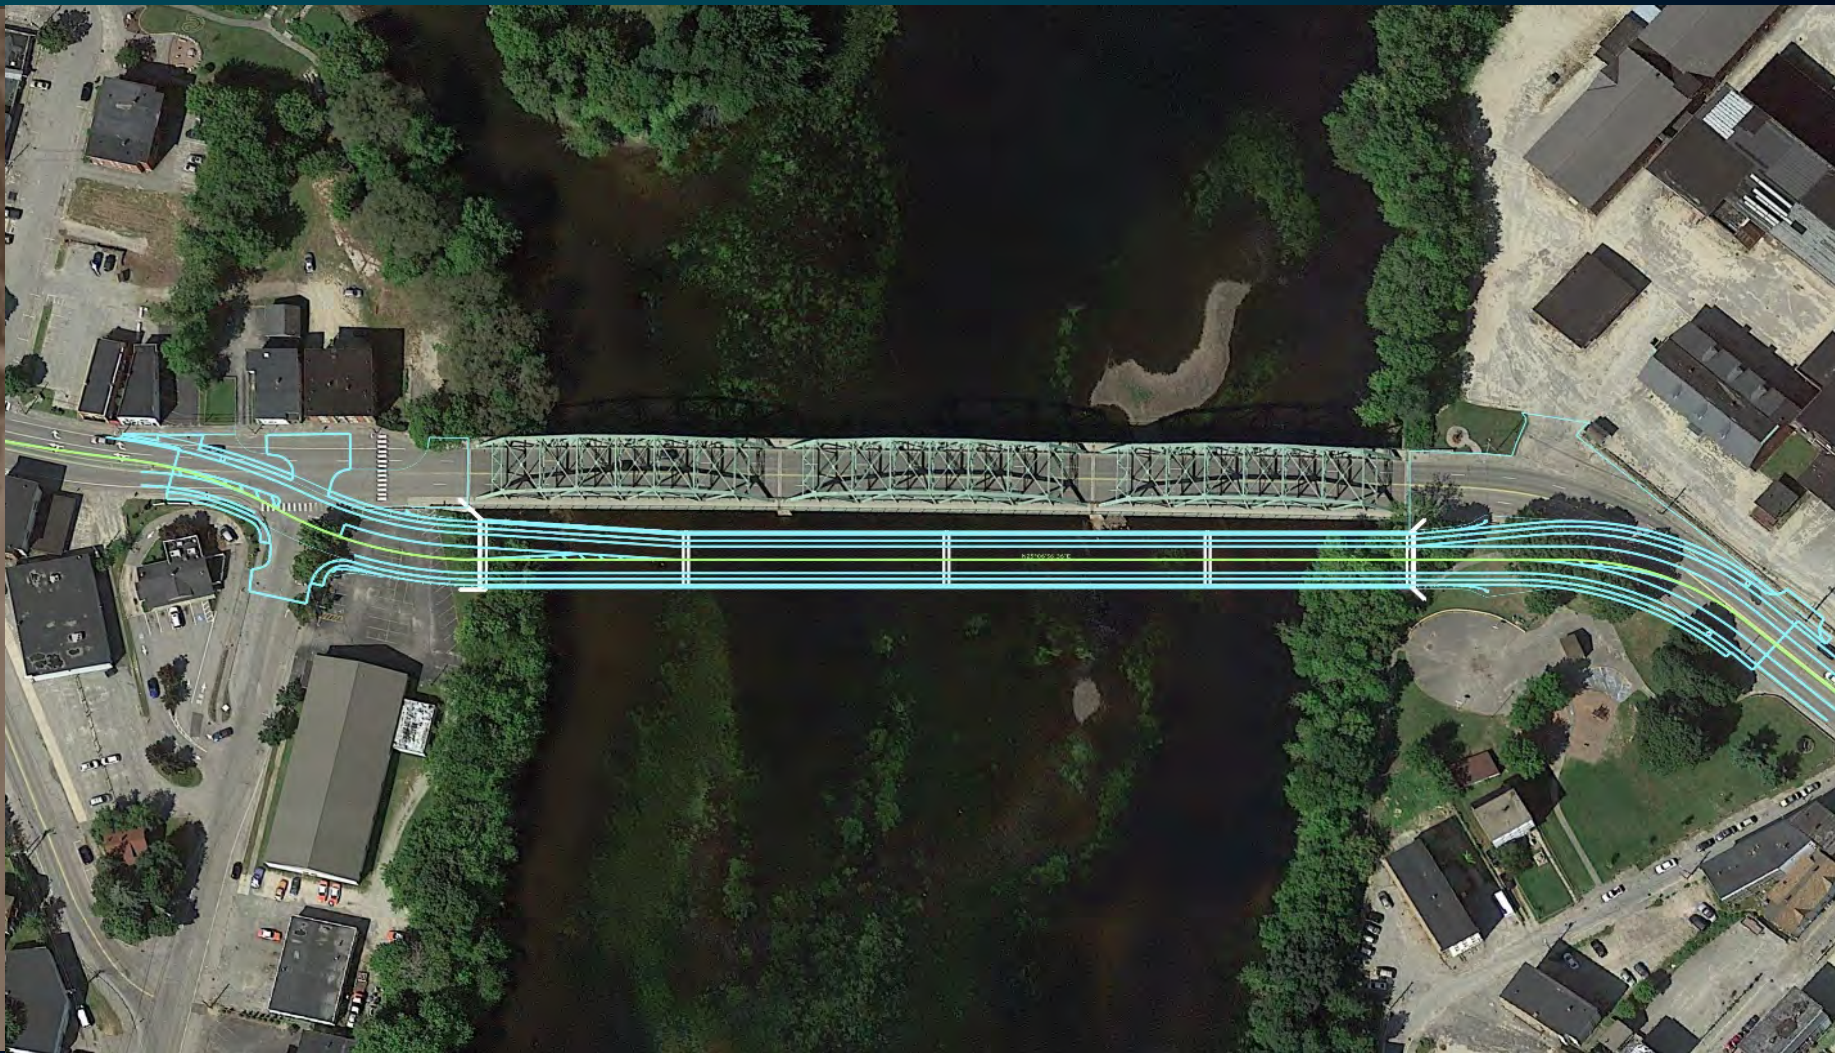
Replacement Alignment

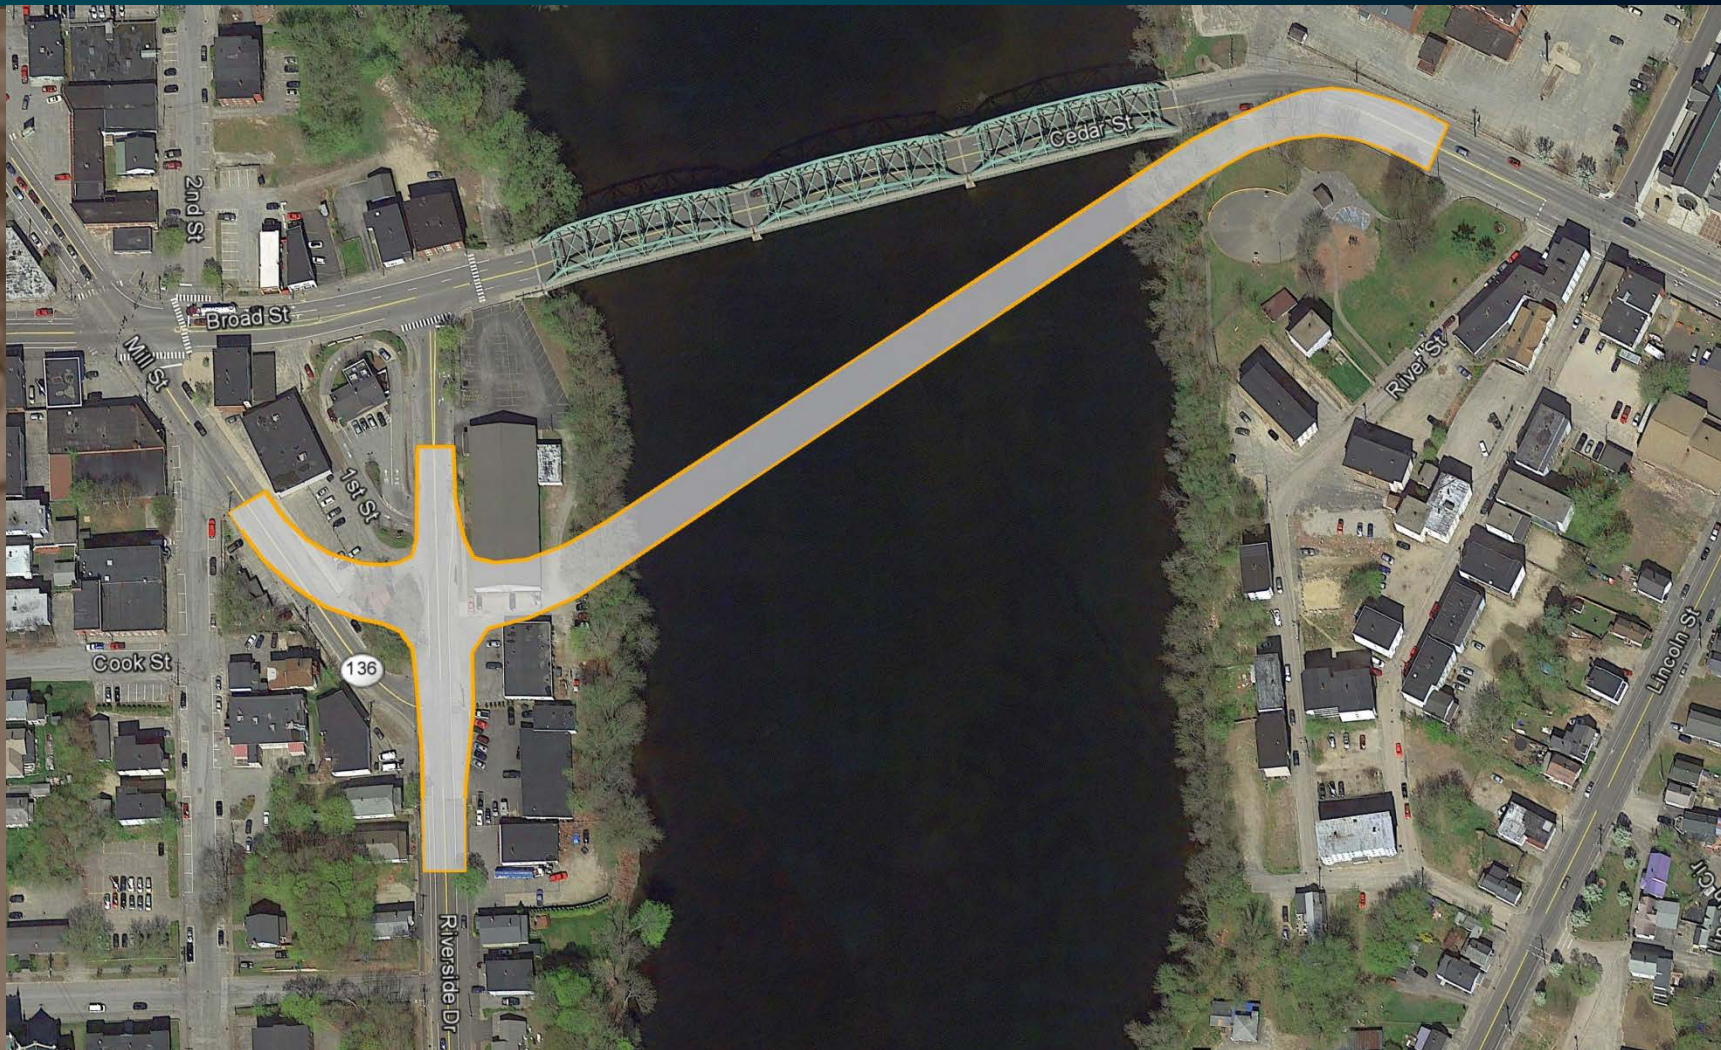
Replacement: Downstream

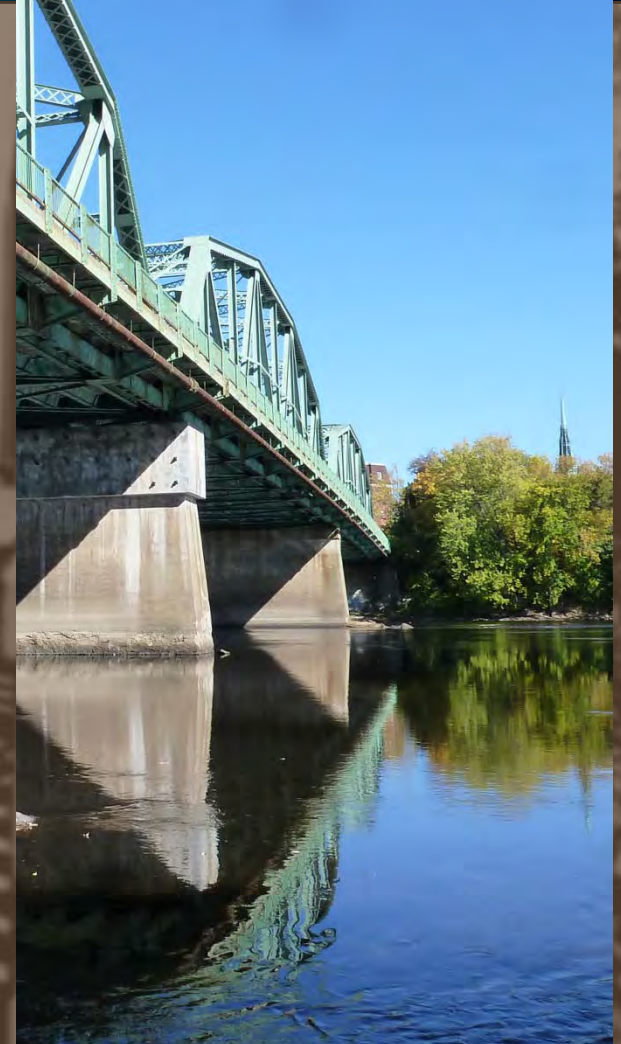
Other Considerations

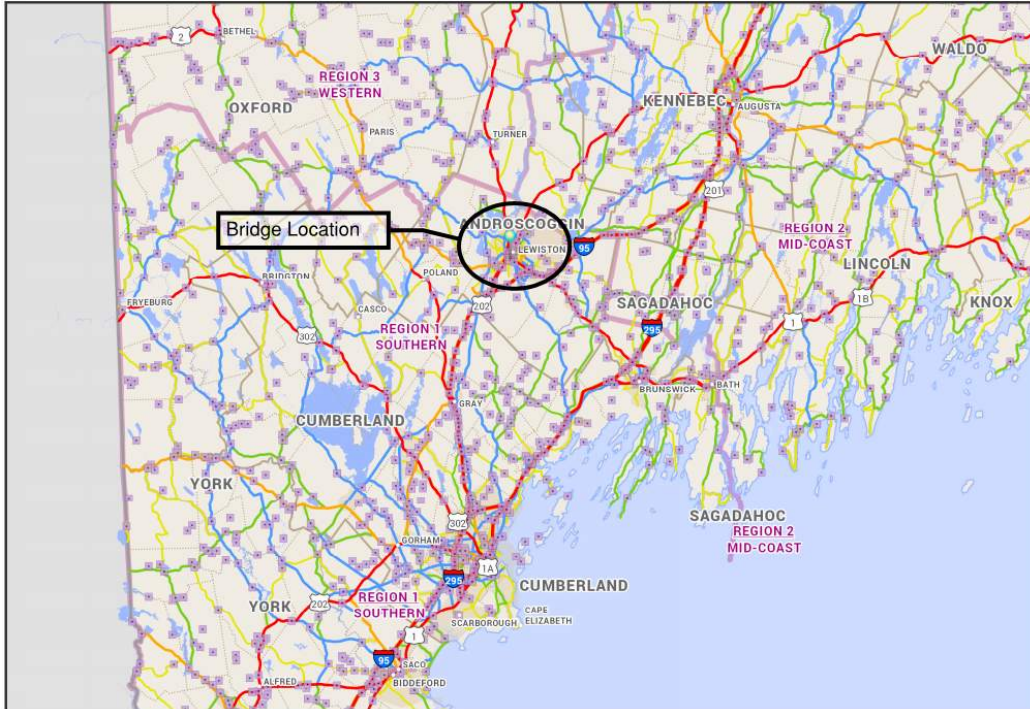
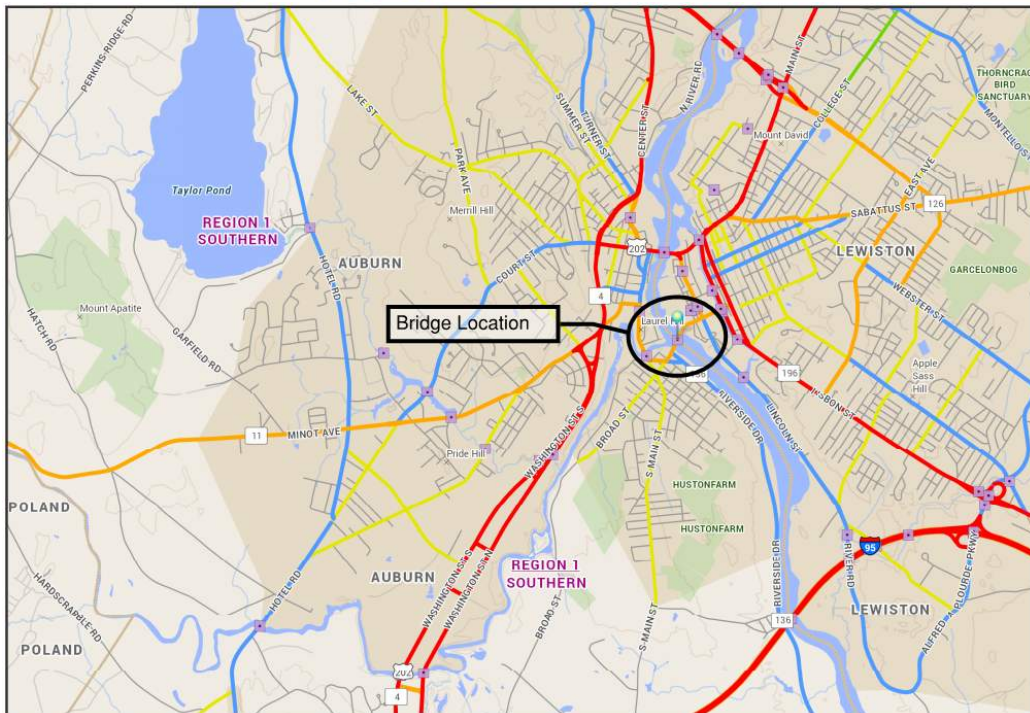
Latitude: 44° 05' 22.11" N, Longitude: 70° 13' 16.77" W

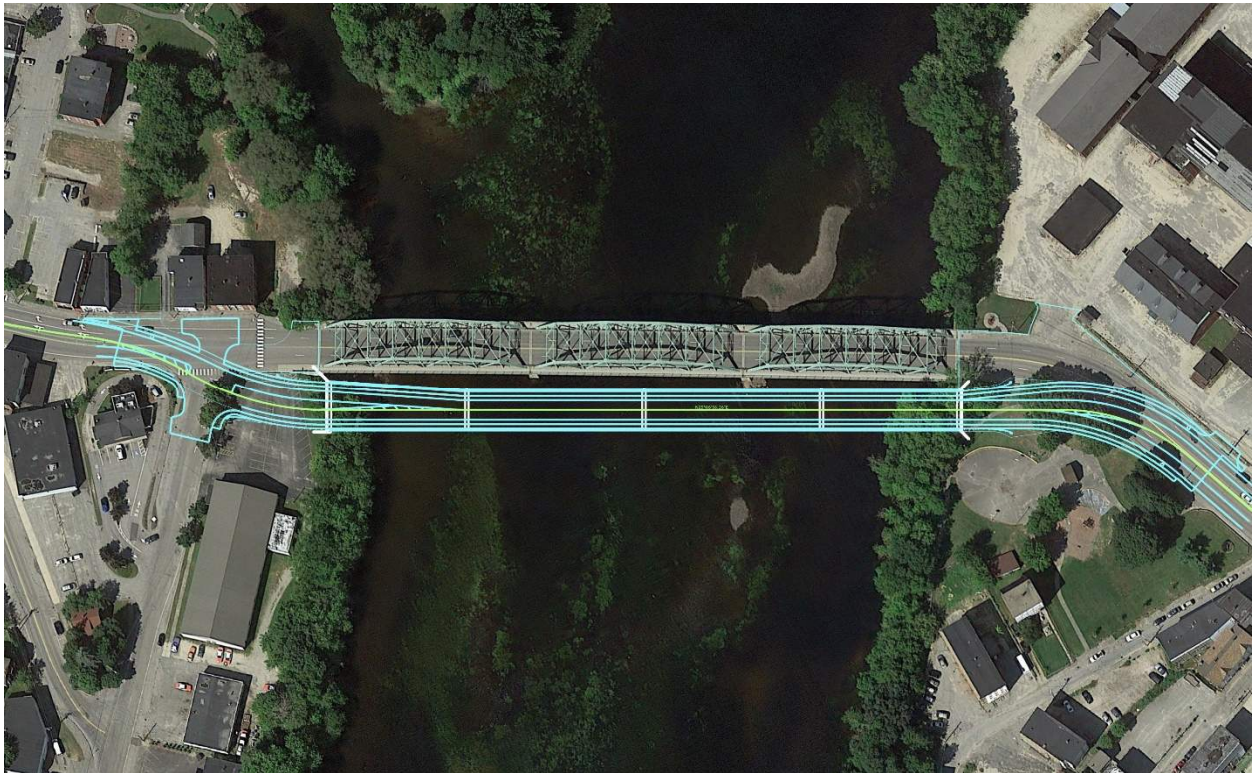
Figure 1: Replacement Alternative Alignment

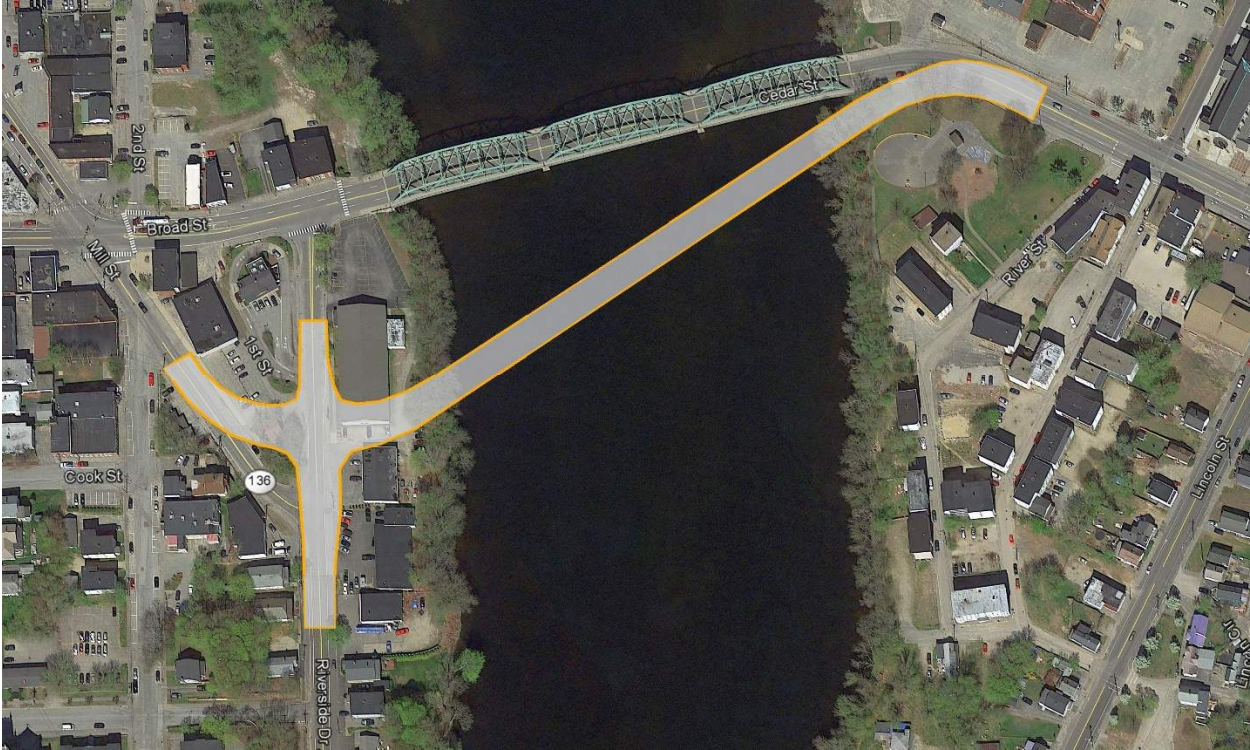
Figure 2: Downstream Conceptual Alignment

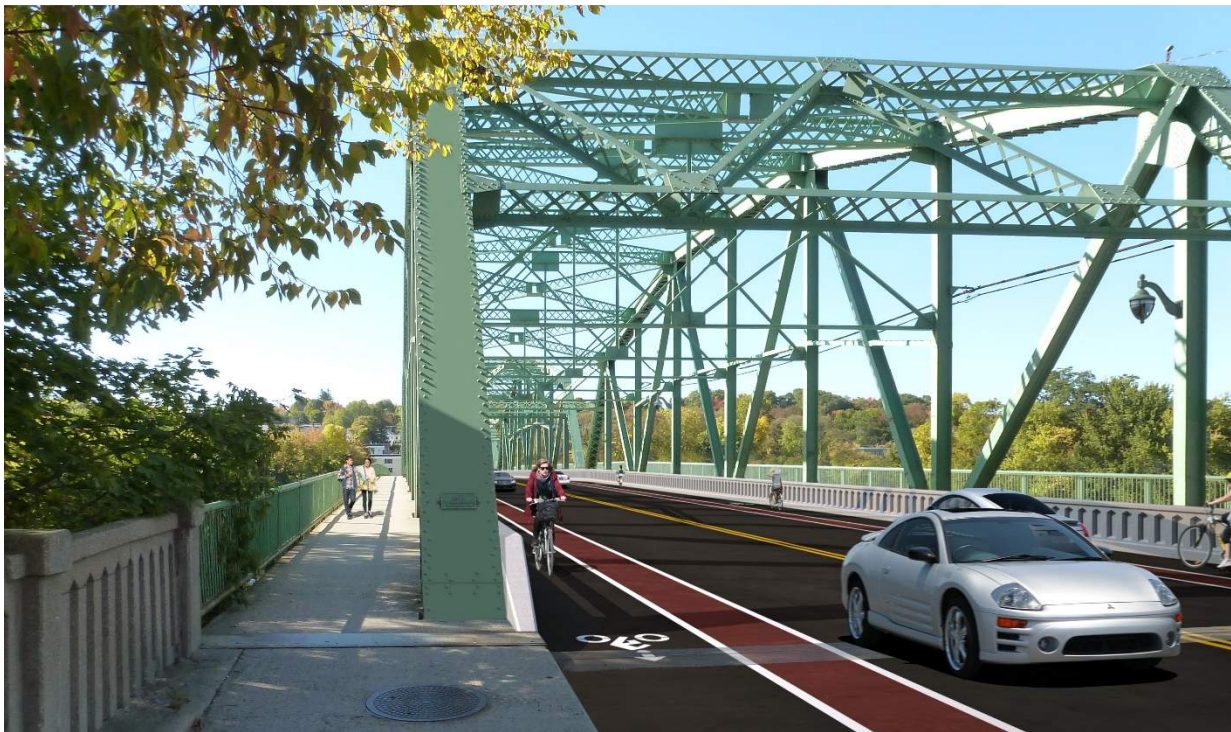
Figure 3: Rendering of Rehabilitated Bridge

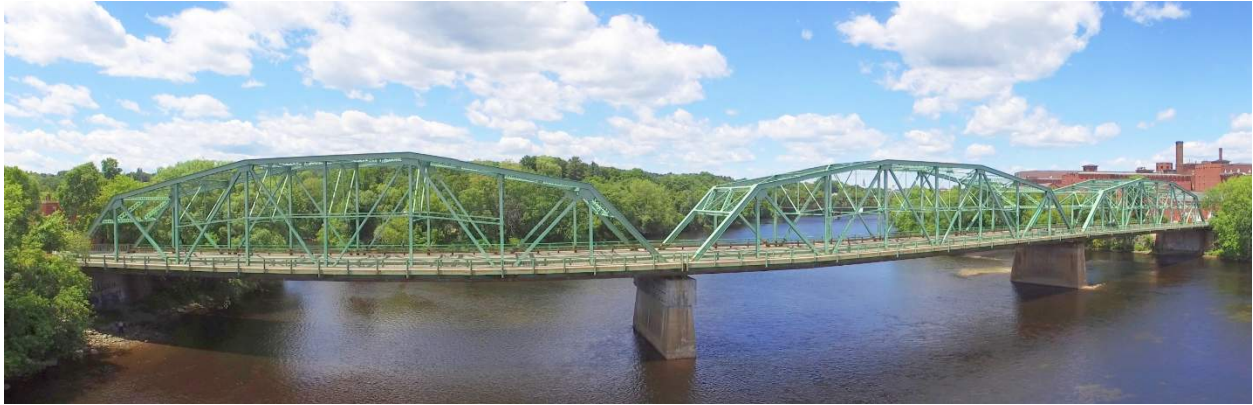
Photo 1: Panorama of Bernard Lown Peace Bridge (looking upstream)
