From: Communications.MaineDOT@maine.gov
Sent: Saturday, March 24, 2018 3:41 PM
To: Gardner, David
Subject: Frank J. Wood Project Comment

Categories: FJW

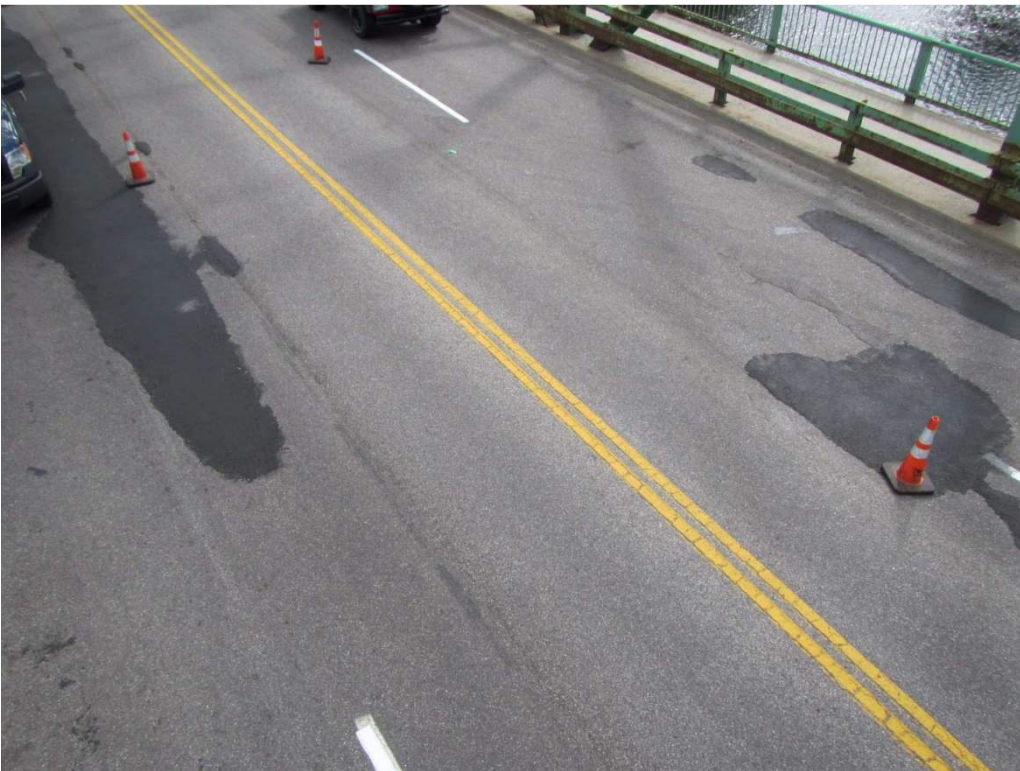
Photo 10: Wearing surface patches

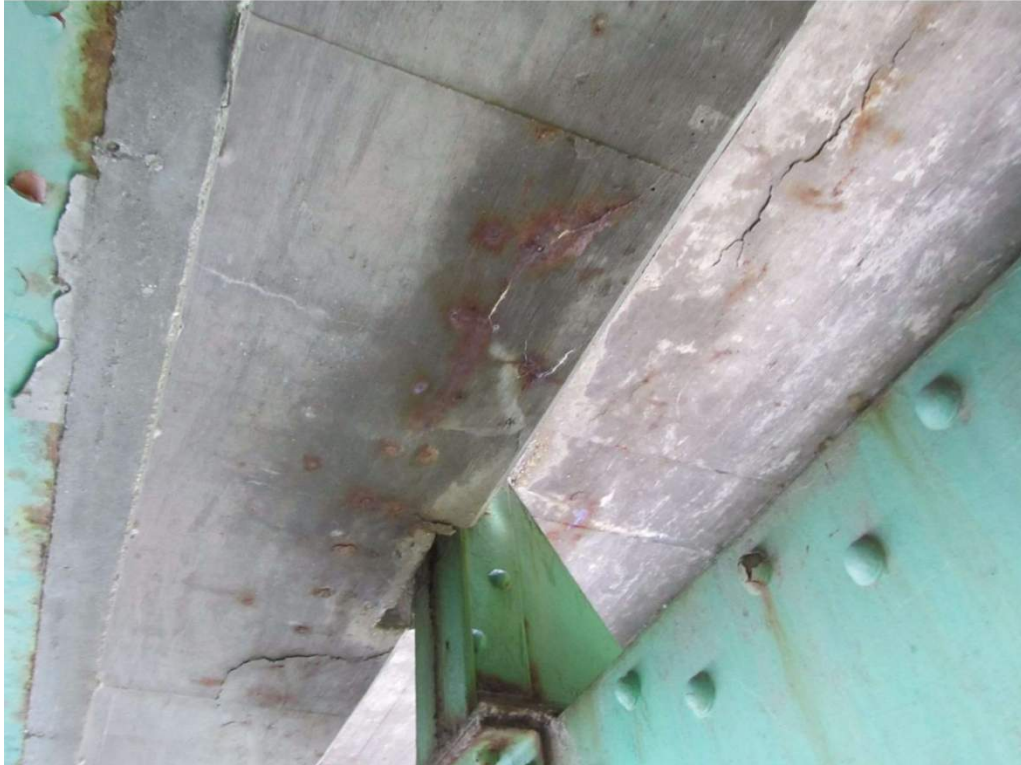
Photo 11: Deck delaminations (isolated areas – this area is around a deck penetration for a traffic rail post)

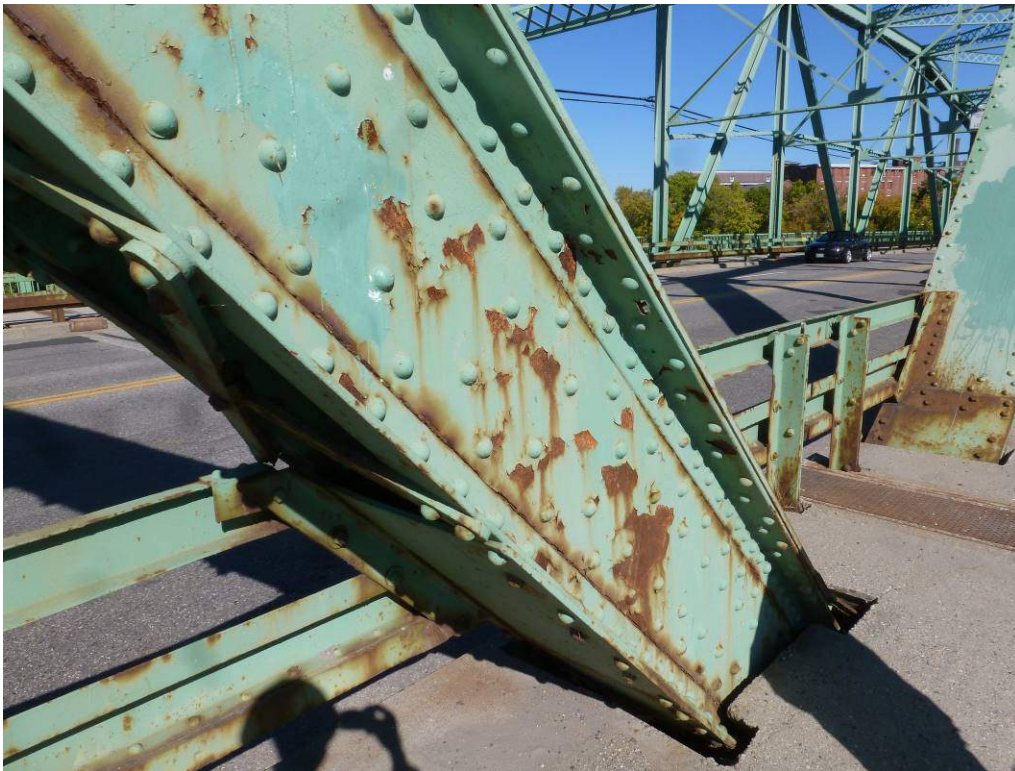
Photo 16: Typical paint condition near travelway

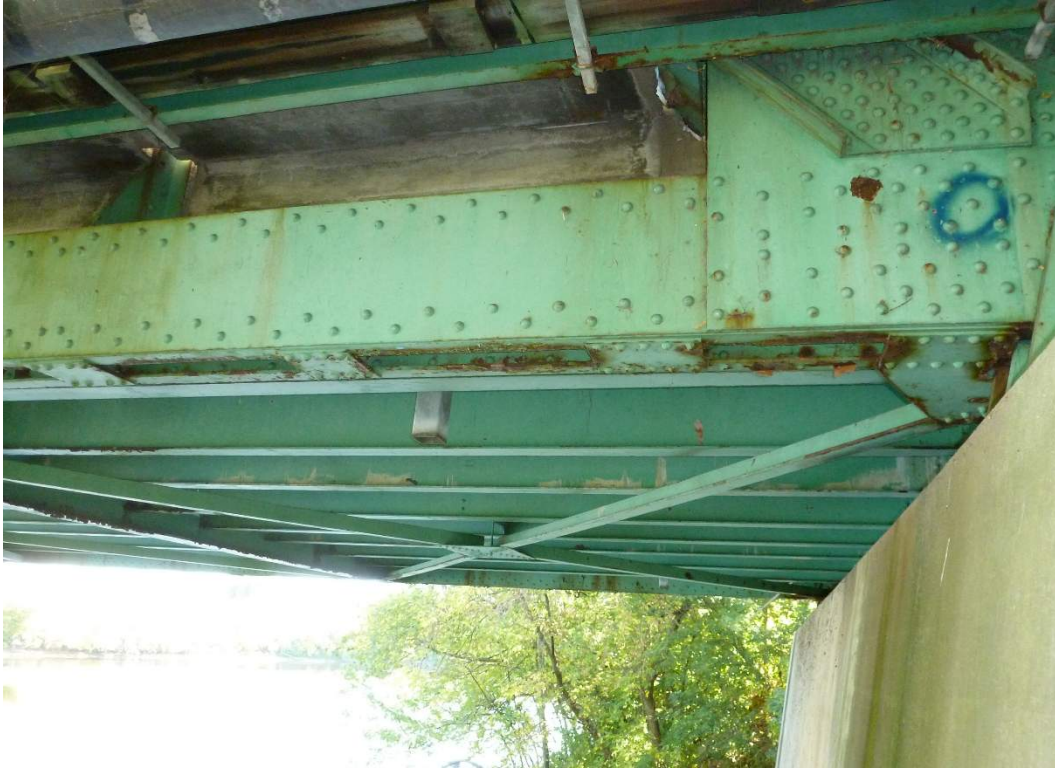
Photo 17: Typical paint condition of floor system

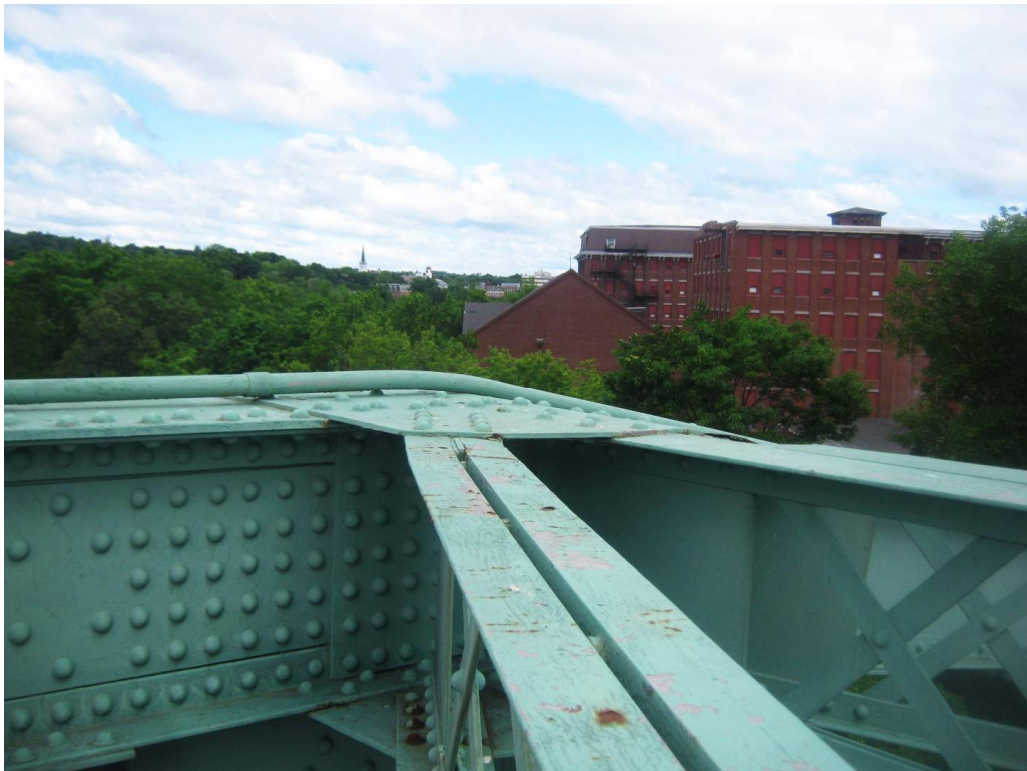
Photo 18: Typical paint condition of truss superstructure

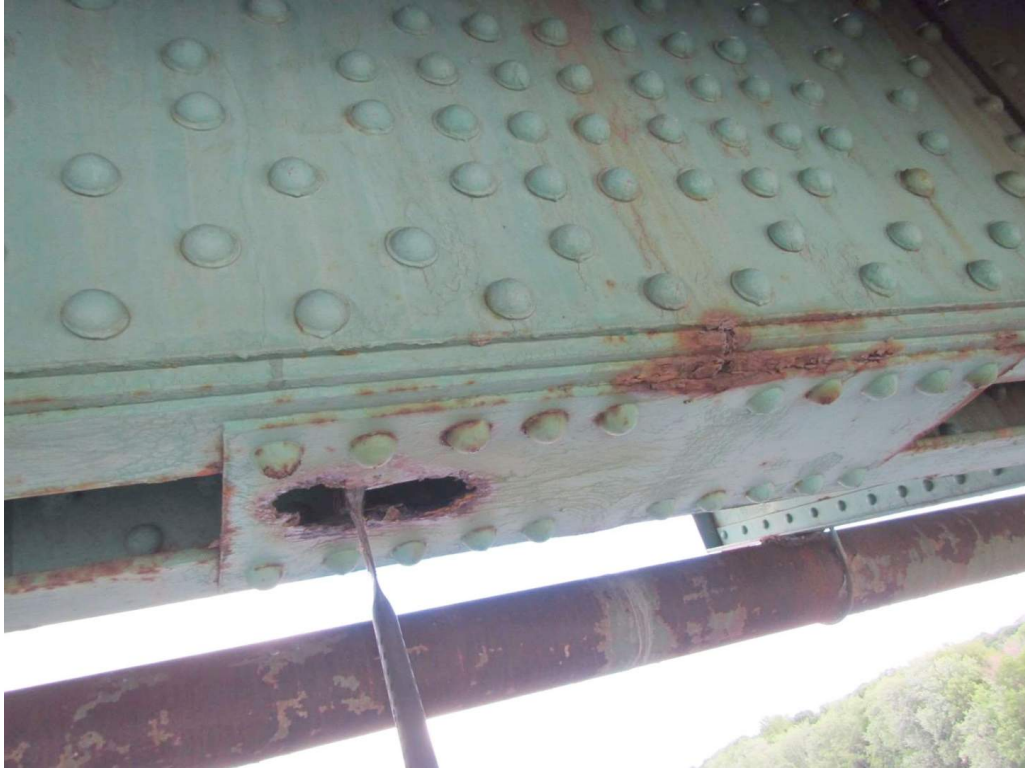
Photo 19: Hole through bottom chord bottom flange splice plate (downstream side of truss, near the end of Span 2)

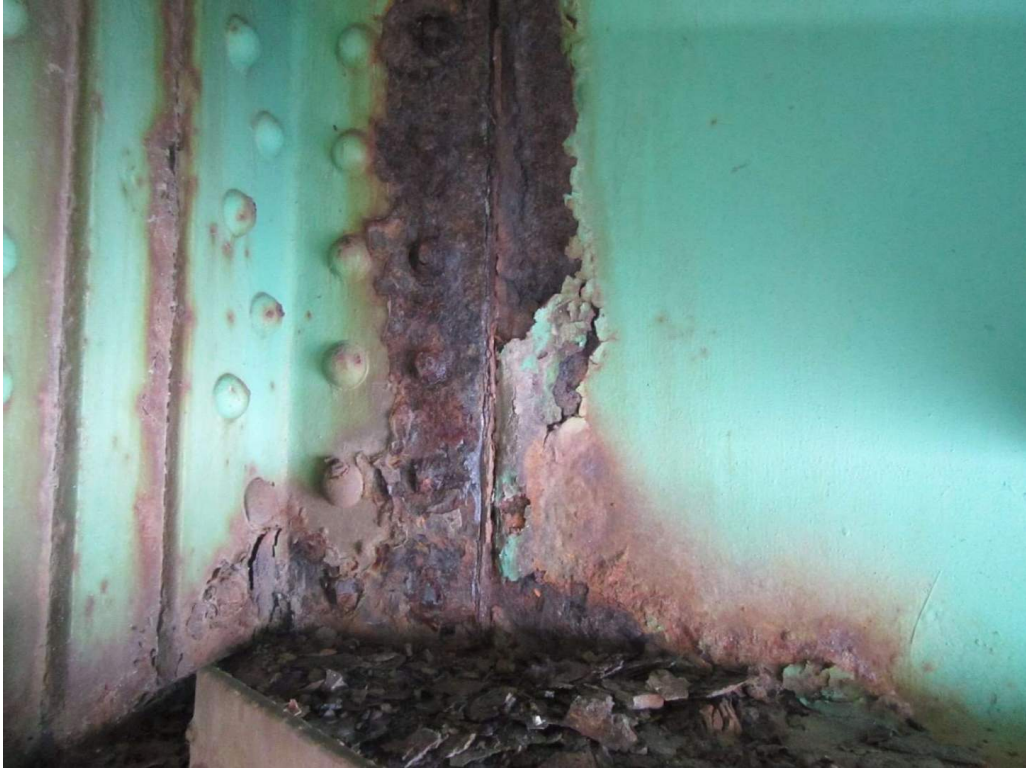
Photo 21: Floorbeam connection with deteriorated rivets

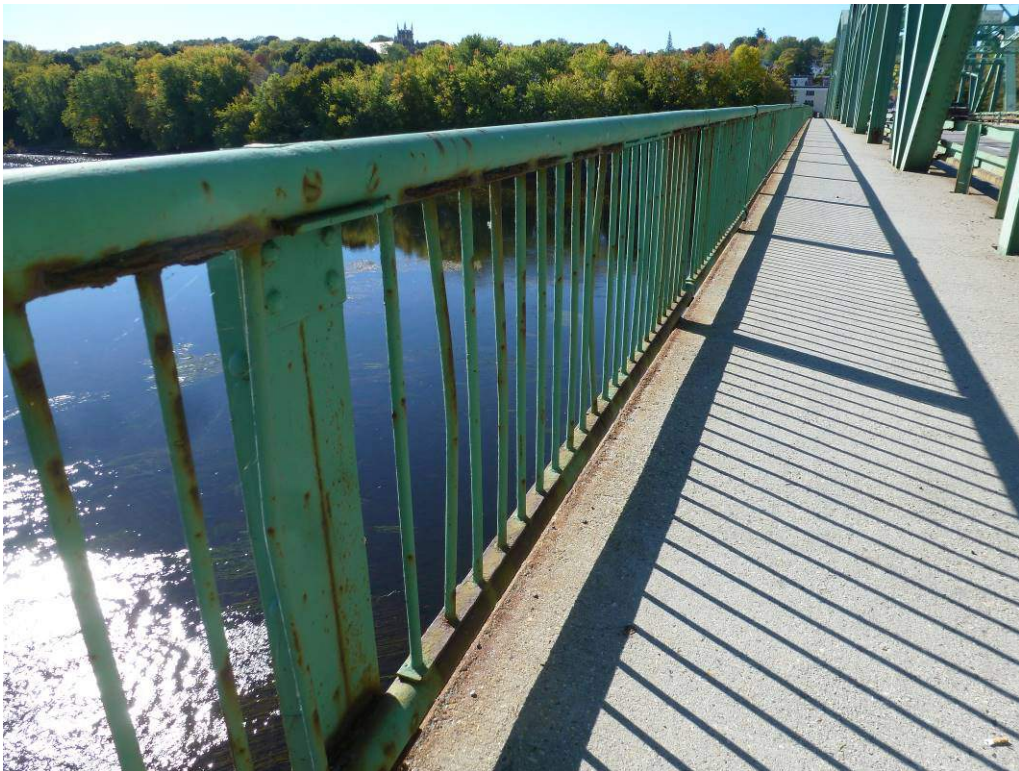
Photo 22: Sidewalk railing showing bent ballusters

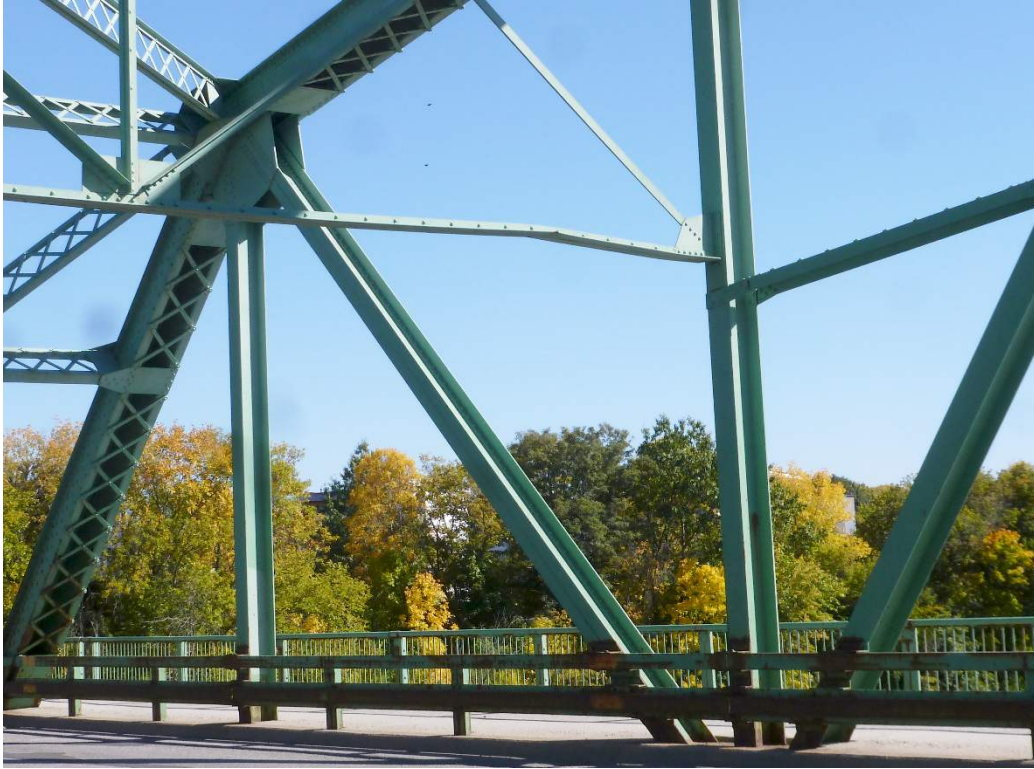
Photo 25: Damaged portal

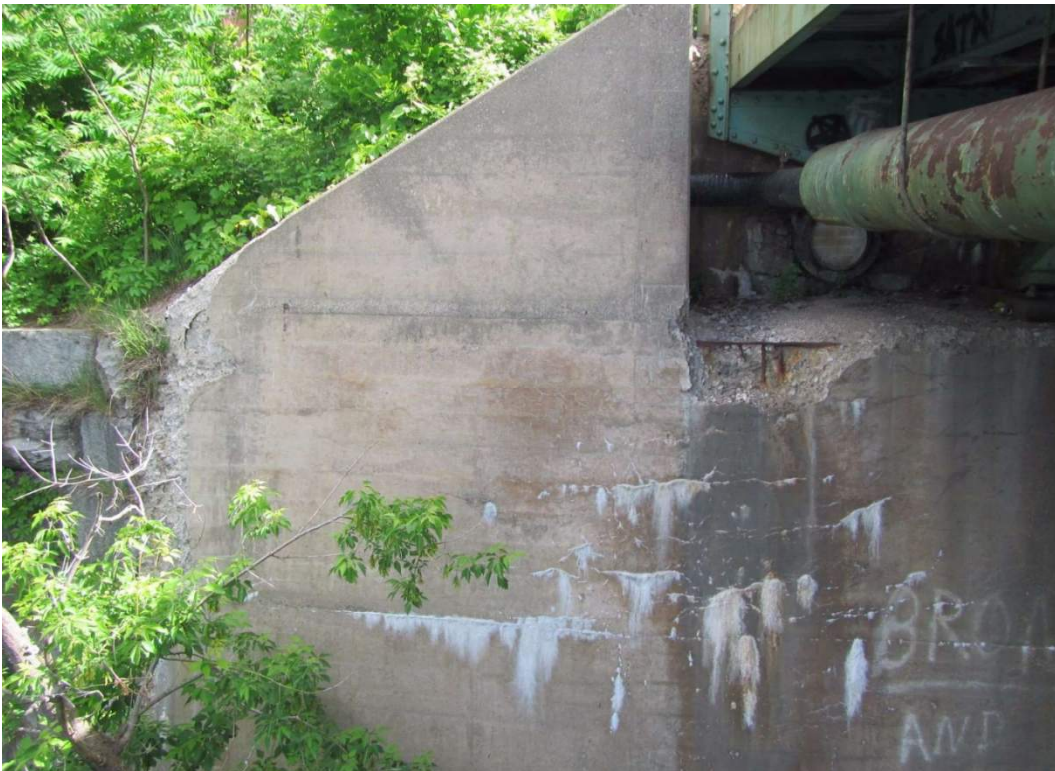
Photo 26: Abutment 2 (Lewiston end) concrete deterioration

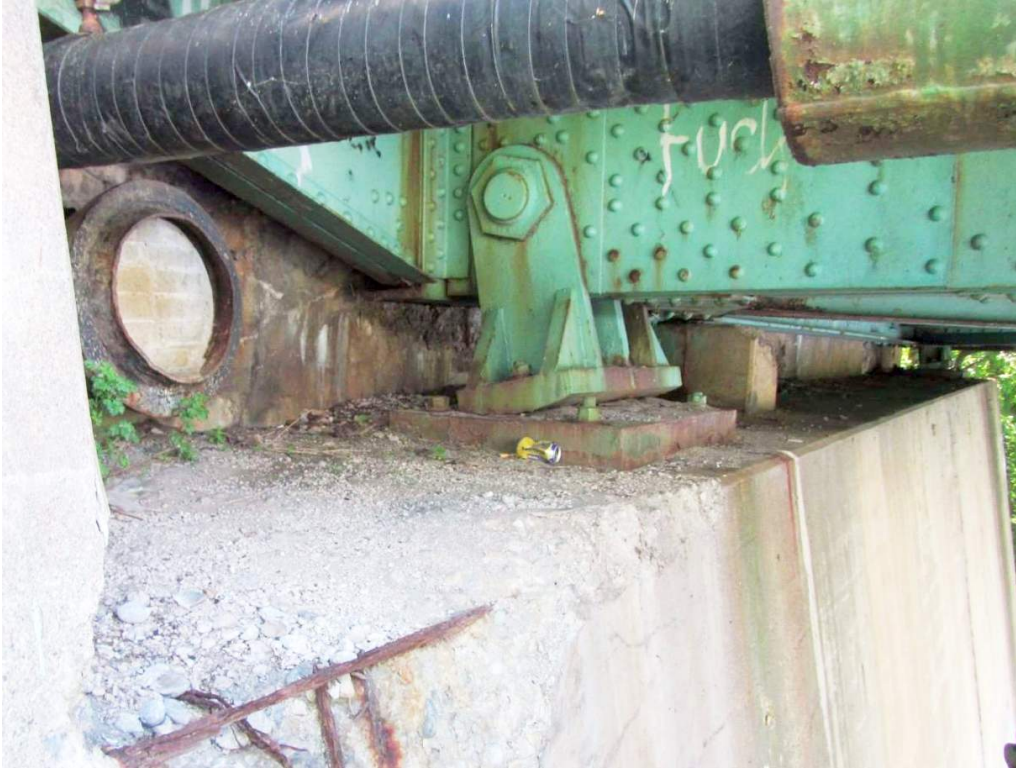
Photo 27: Abutment 2 (Lewiston end) bearings rocked out of plumb (high temperature of 73 degrees on the day this was taken)

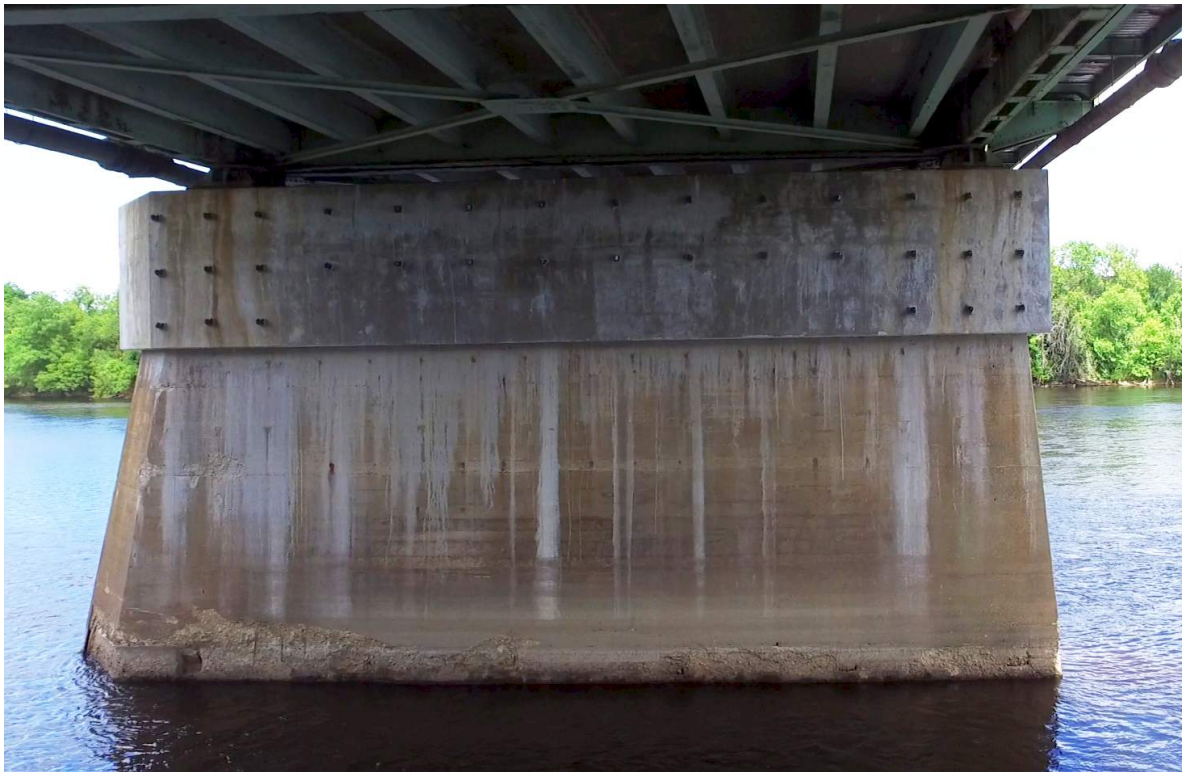
Photo 28: Pier 1 elevation view showing 2014 pier cap repair and deterioration at water line

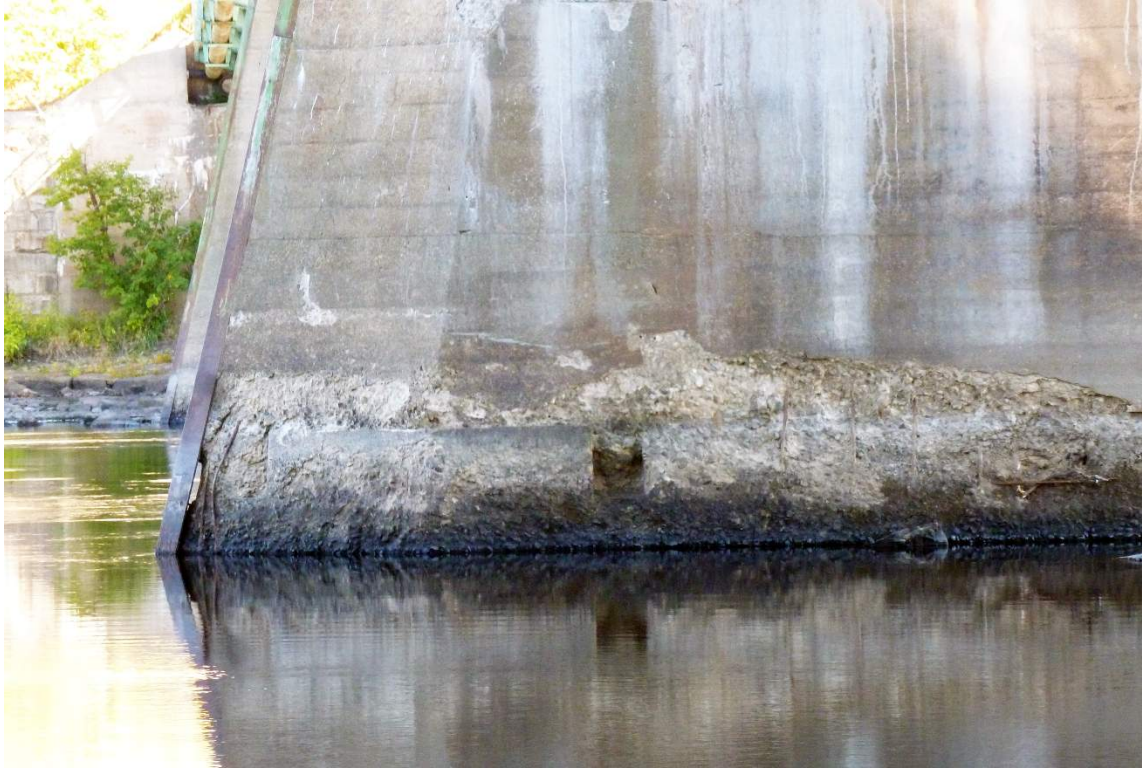
Photo 29: Pier 1 water line deterioration

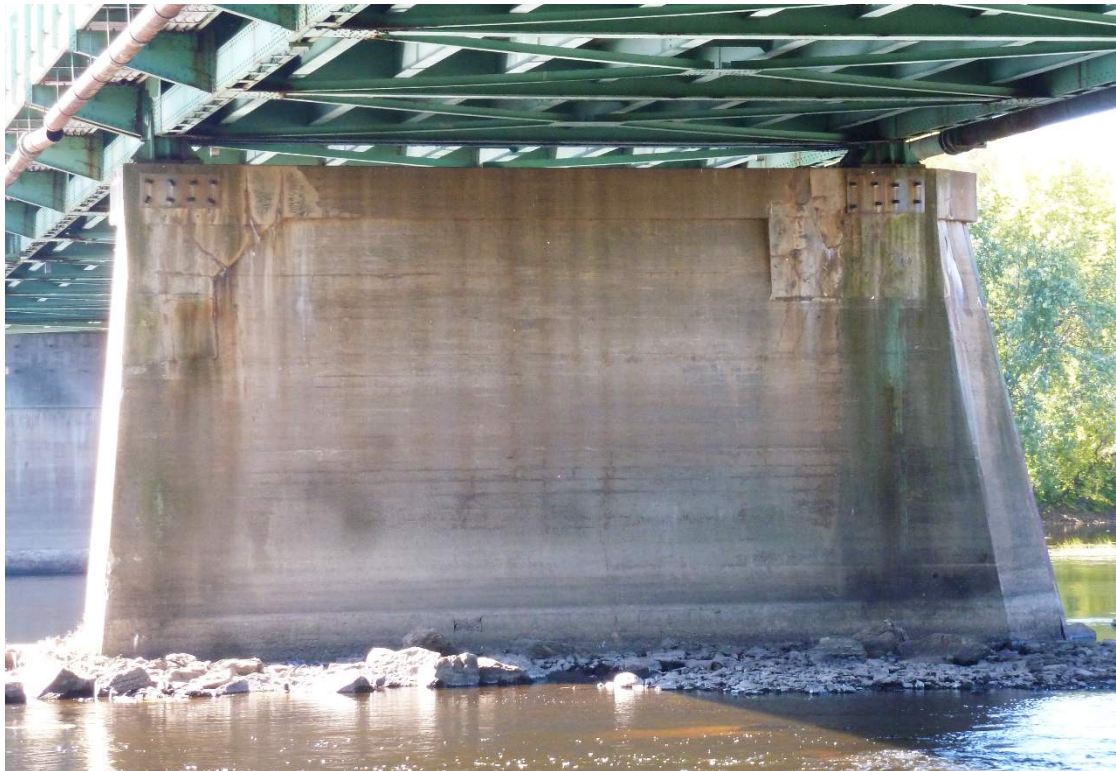
Photo 30: Pier 2 elevation showing 1995 emergency repairs

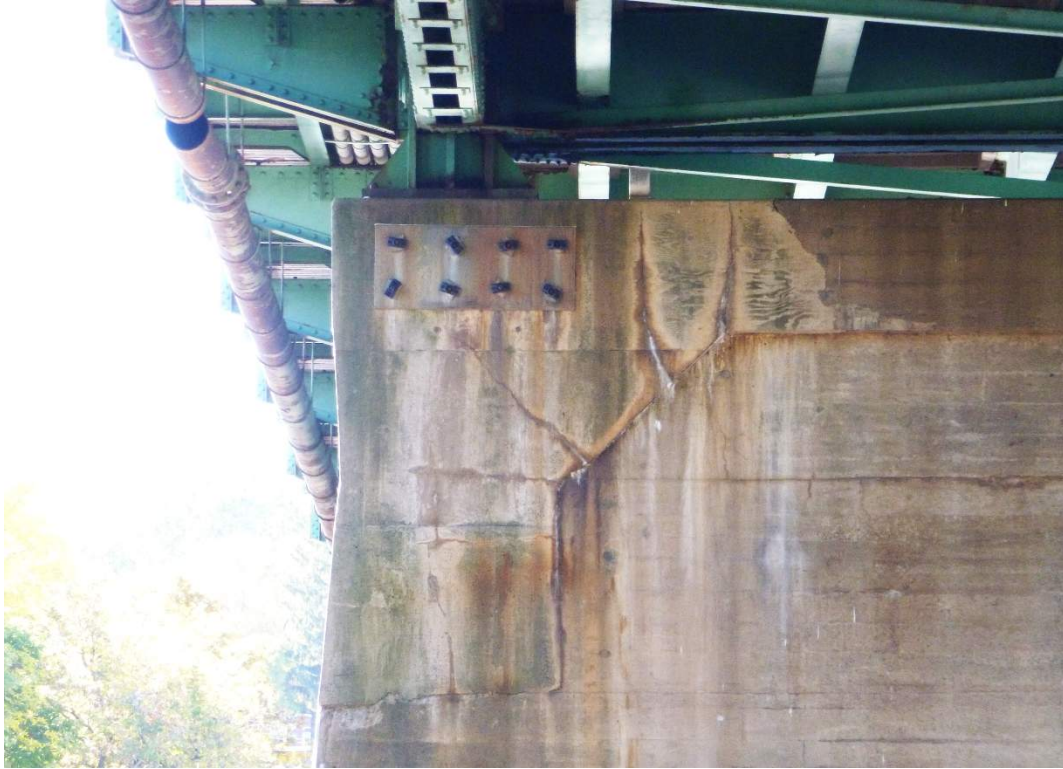
Photo 31: Pier 2 pier cap close-up showing 1995 failure location and deteriorating repair

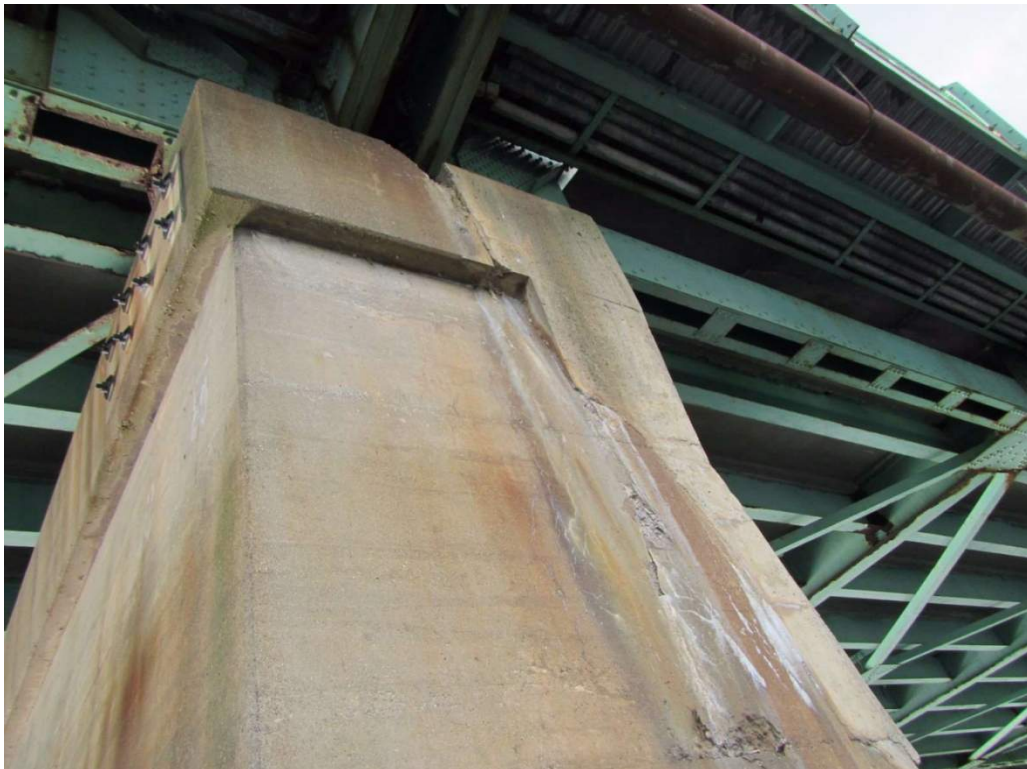
Photo 32: Pier 2 downstream end of pier

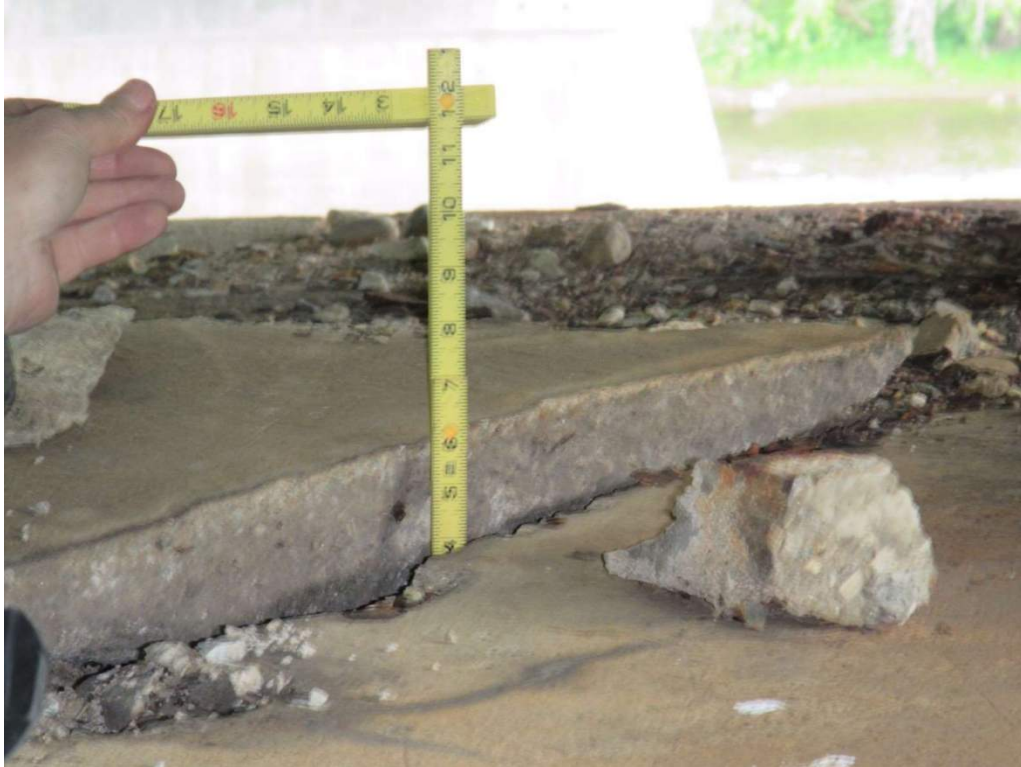
Photo 33: Pier 2 pier cap cracking and soft concrete

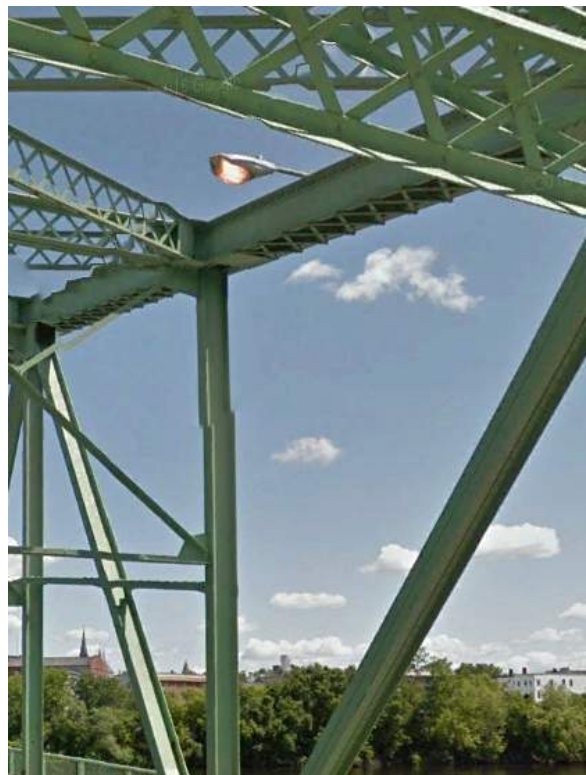
Photo 34: Existing bridge lighting
(From Google Streetview)

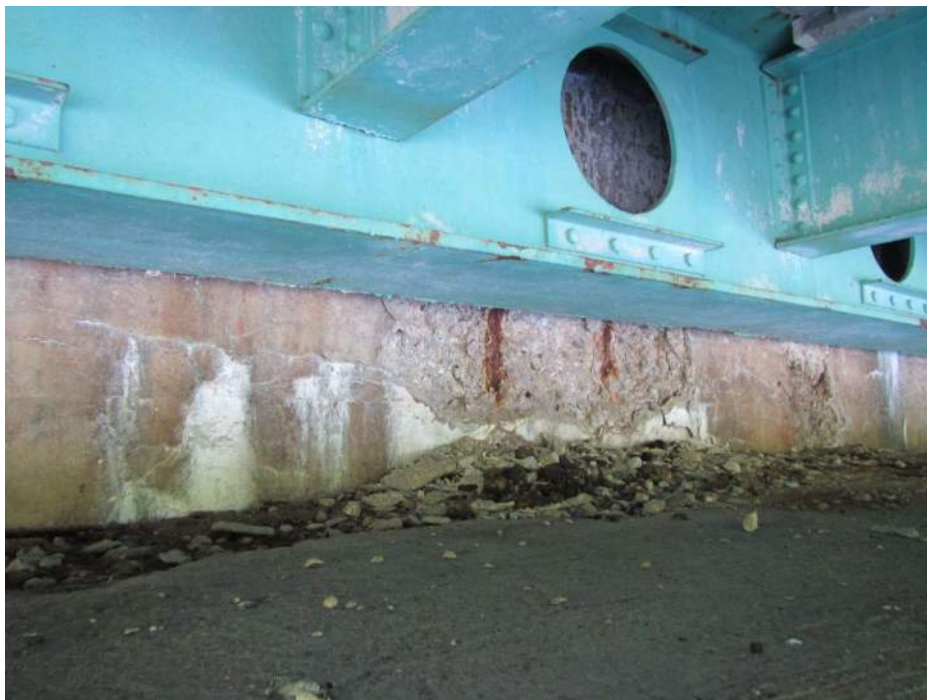
Description East abutment bearings rocked back and spalling with exposed rebar

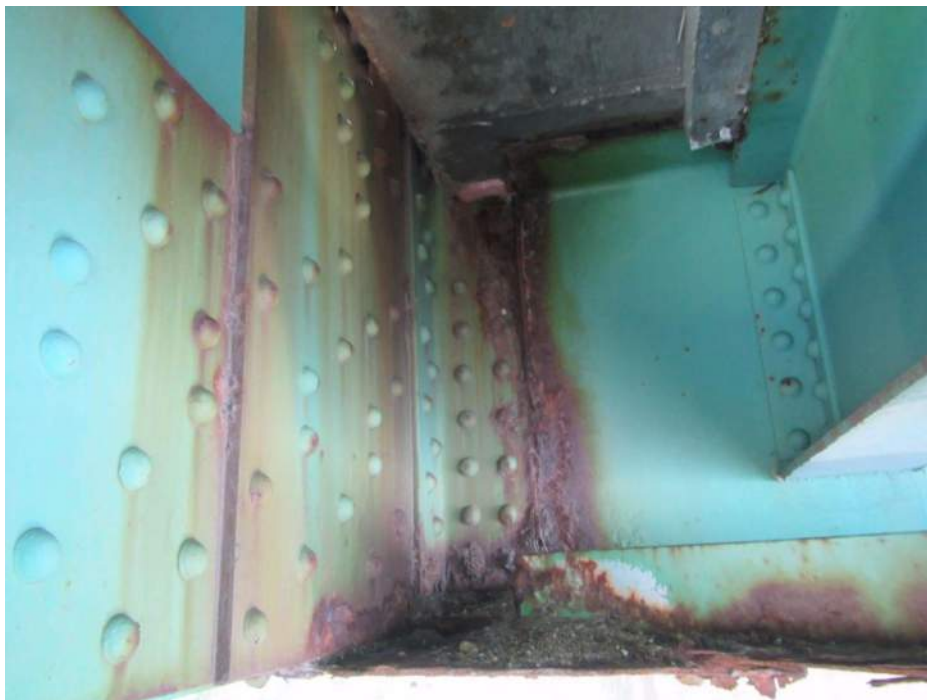
Description East abutment construction joint with spalling and delams

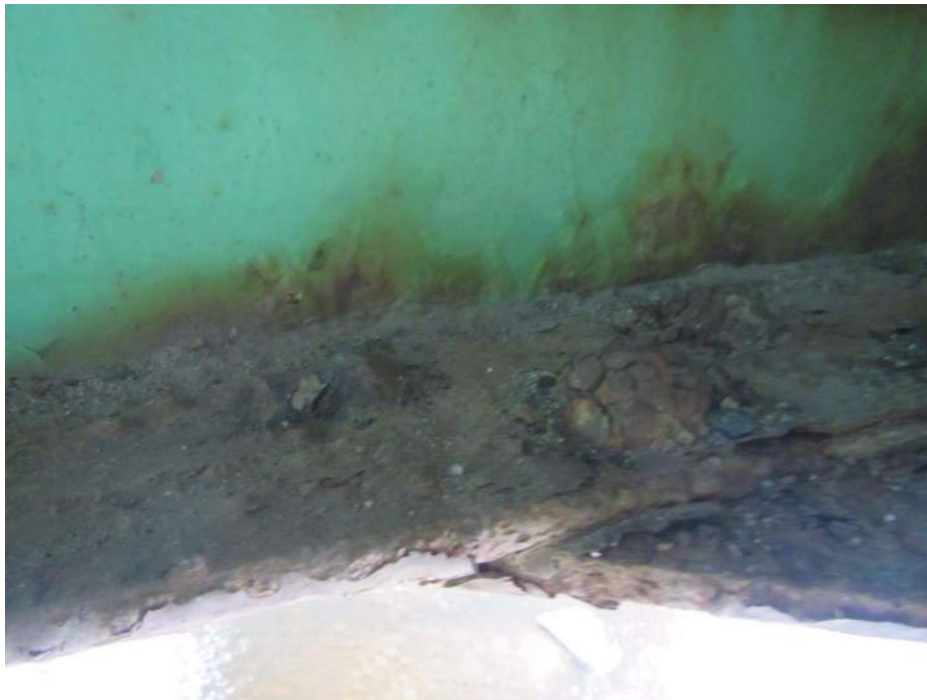
Description Scattered rivets with 100% section loss at floorbeam connections

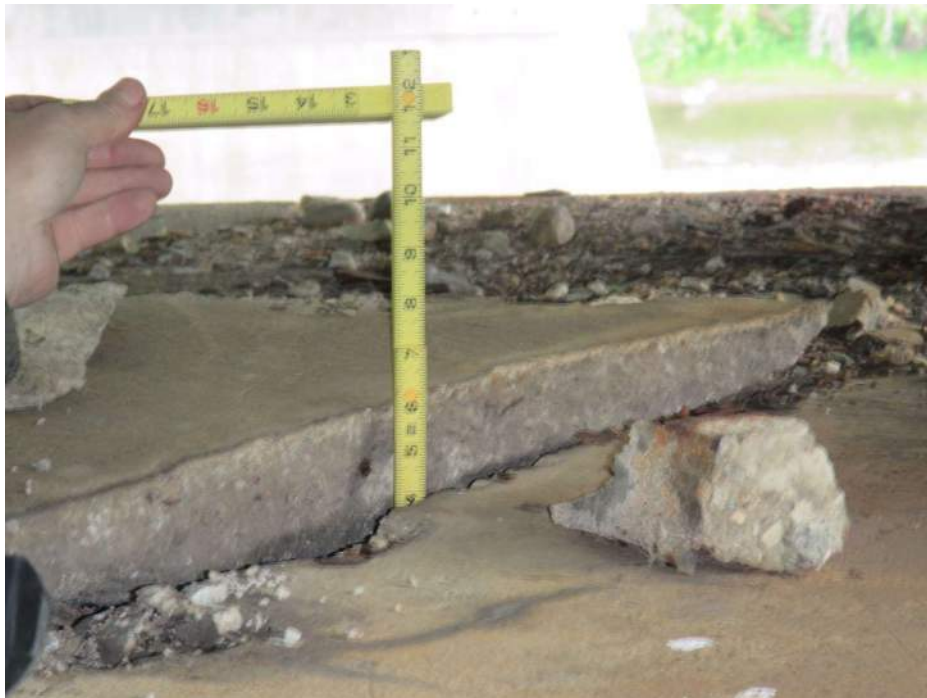
Description Scattered areas of deterioration at deck form joints below sidewalk

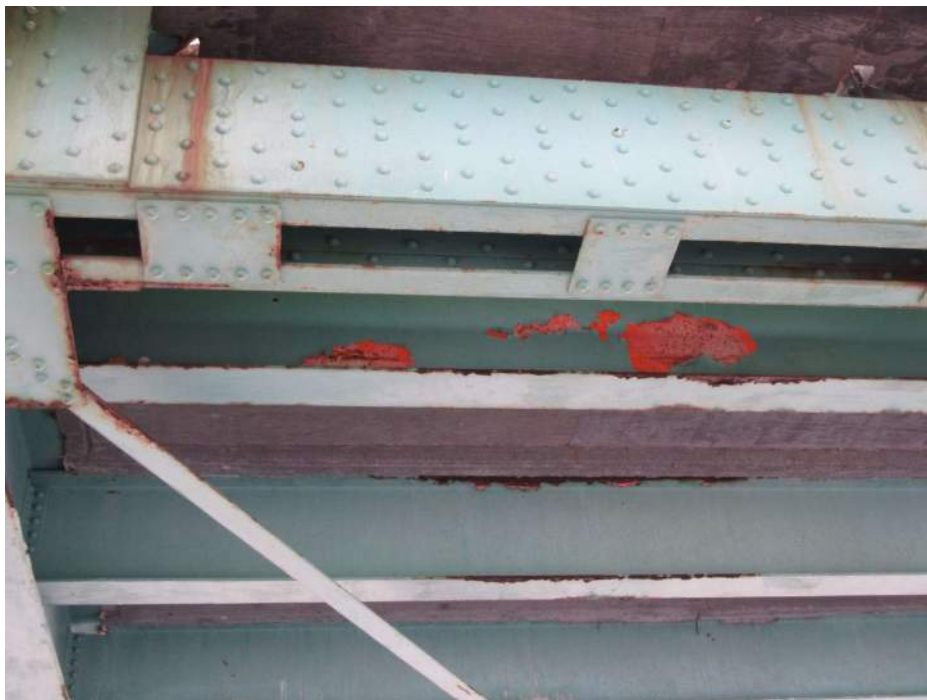
Description Cracking and soft concrete at east pier west bearing

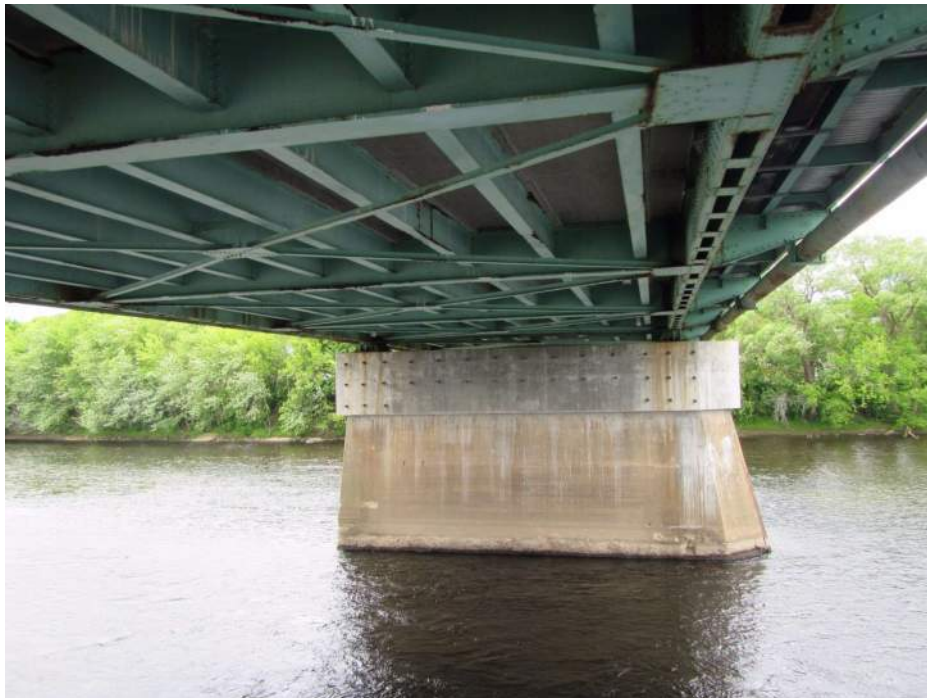
Description Heavy deterioration at sidewalk cantilevers

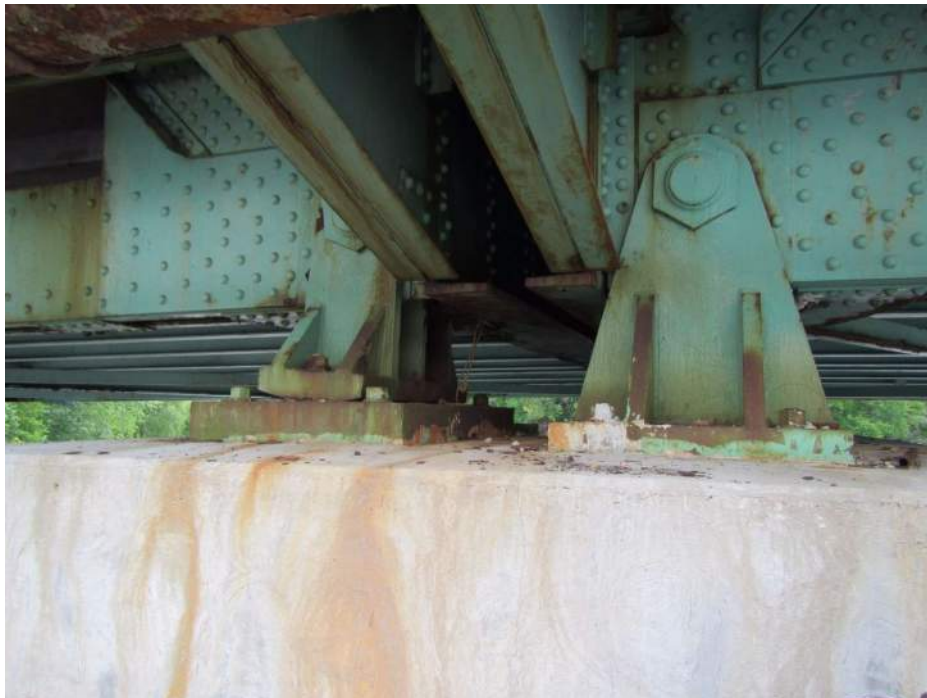
Description Section loss at bottom chord connection plate - Mid span, west span, DS side

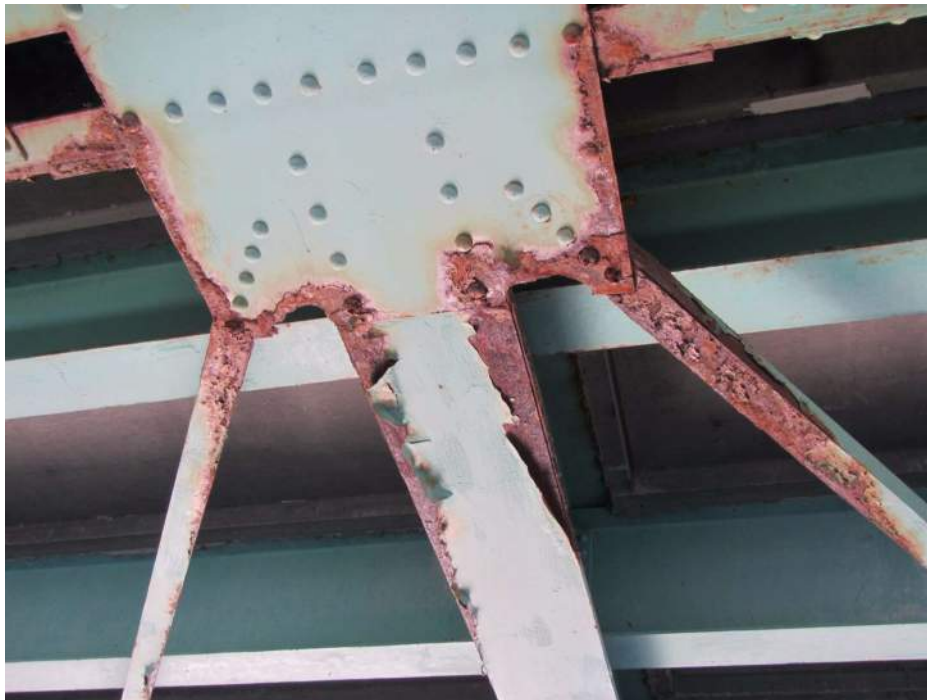
Description Wearing surface patches

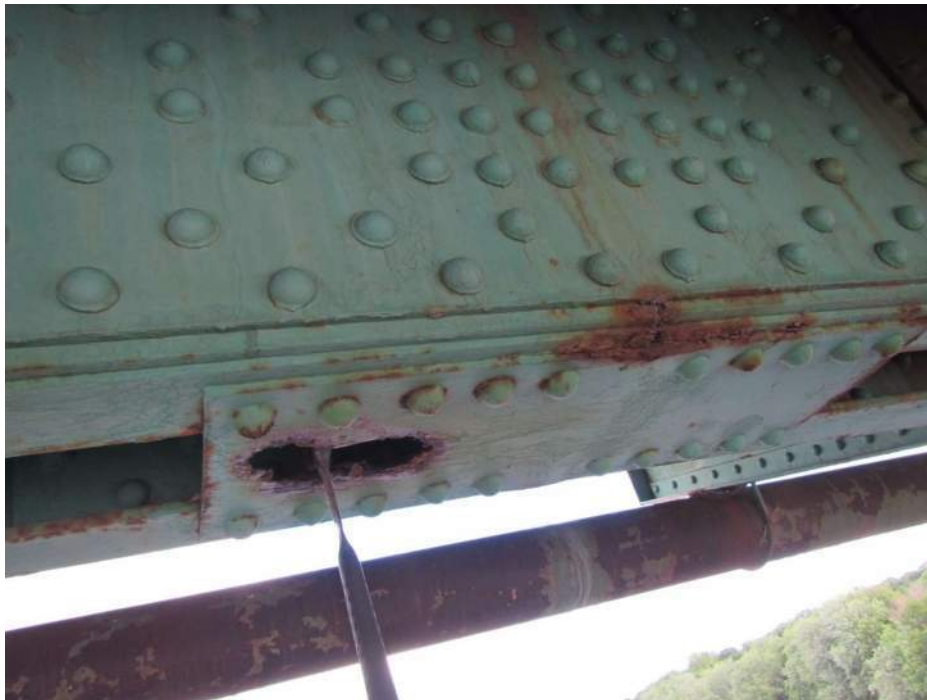
Description DS sidewalk deck forms deteriorating

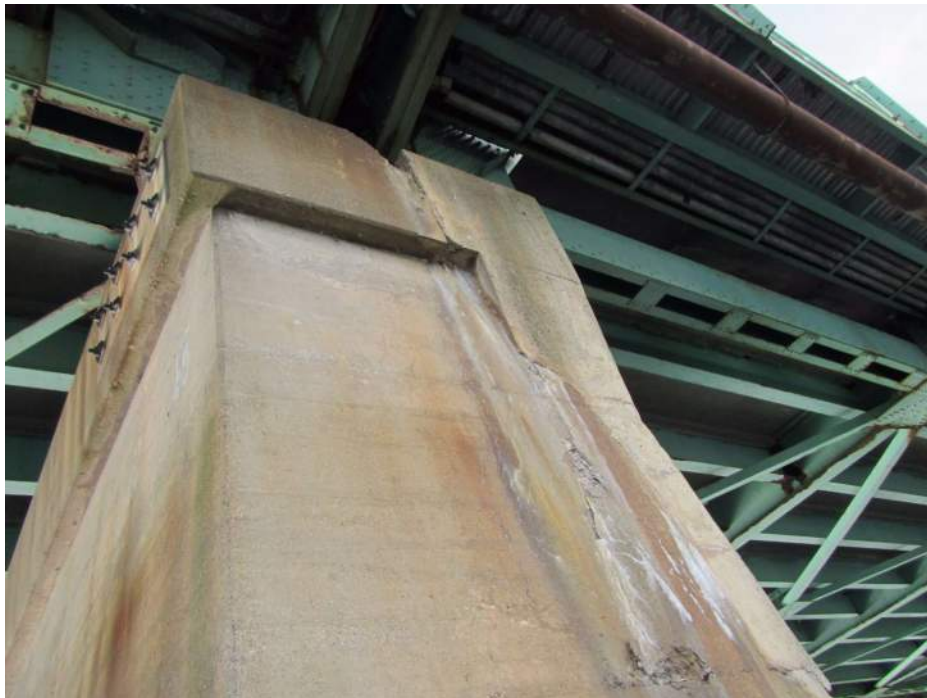
Description 4" deep crack with soft concrete on bridge seat adjacent to east pier DS bearing

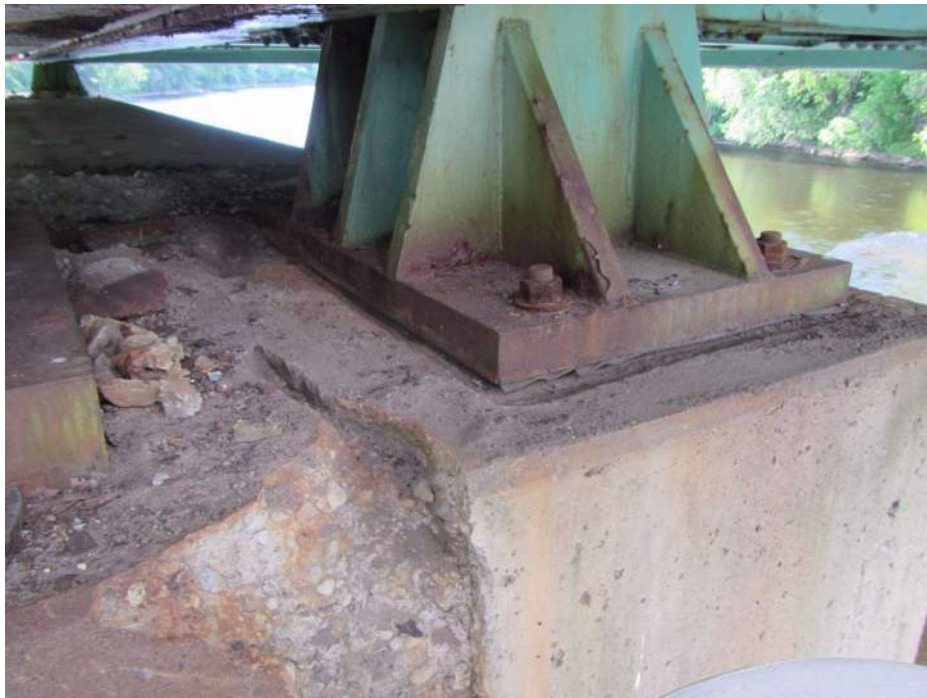
Description Concrete deterioration and cracking at DS end of east pier at bearing area

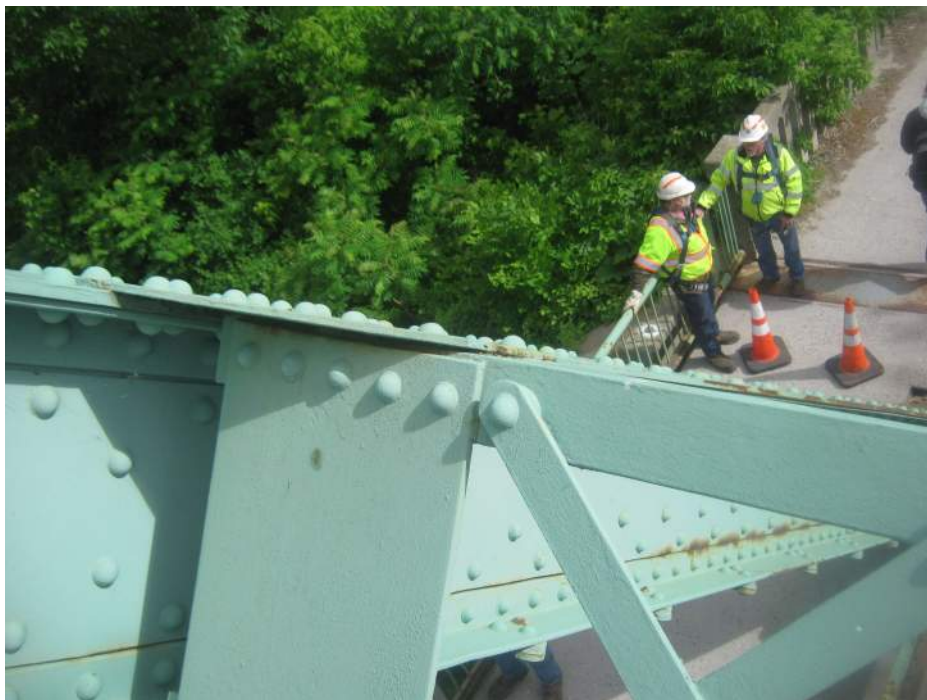
Description Spall with 2" deep rat hole to steel at the east abutment breastwall just below the DS bearing

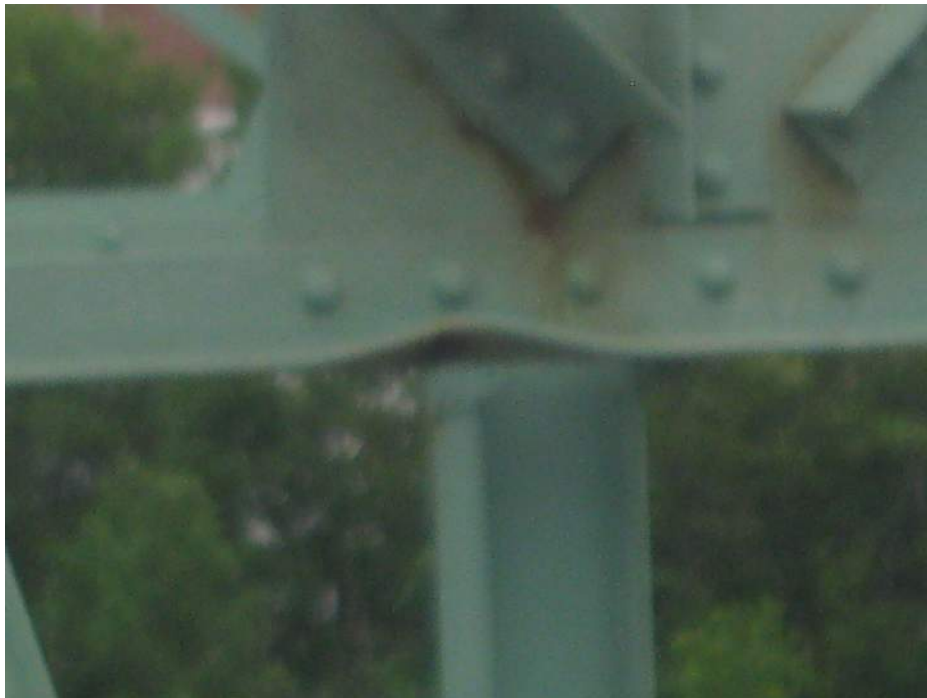
Description View showing typ. minor rusting along riveted beams
