From: Communications.MaineDOT@maine.gov
Sent: Saturday, March 24, 2018 3:41 PM
To: Gardner, David
Subject: Frank J. Wood Project Comment

Categories: FJW

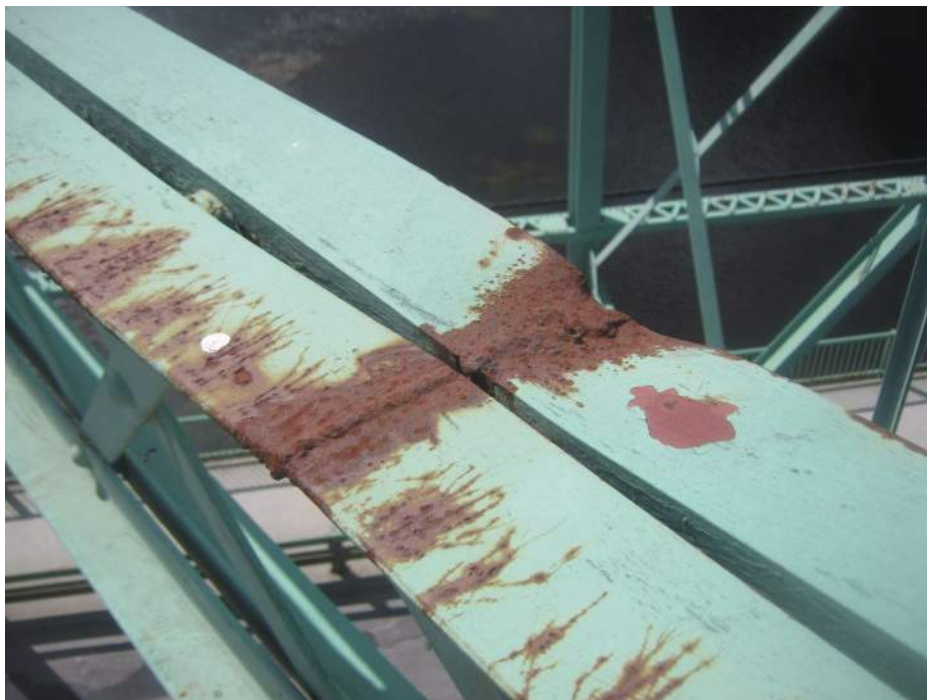
Description View showing damage to S portal

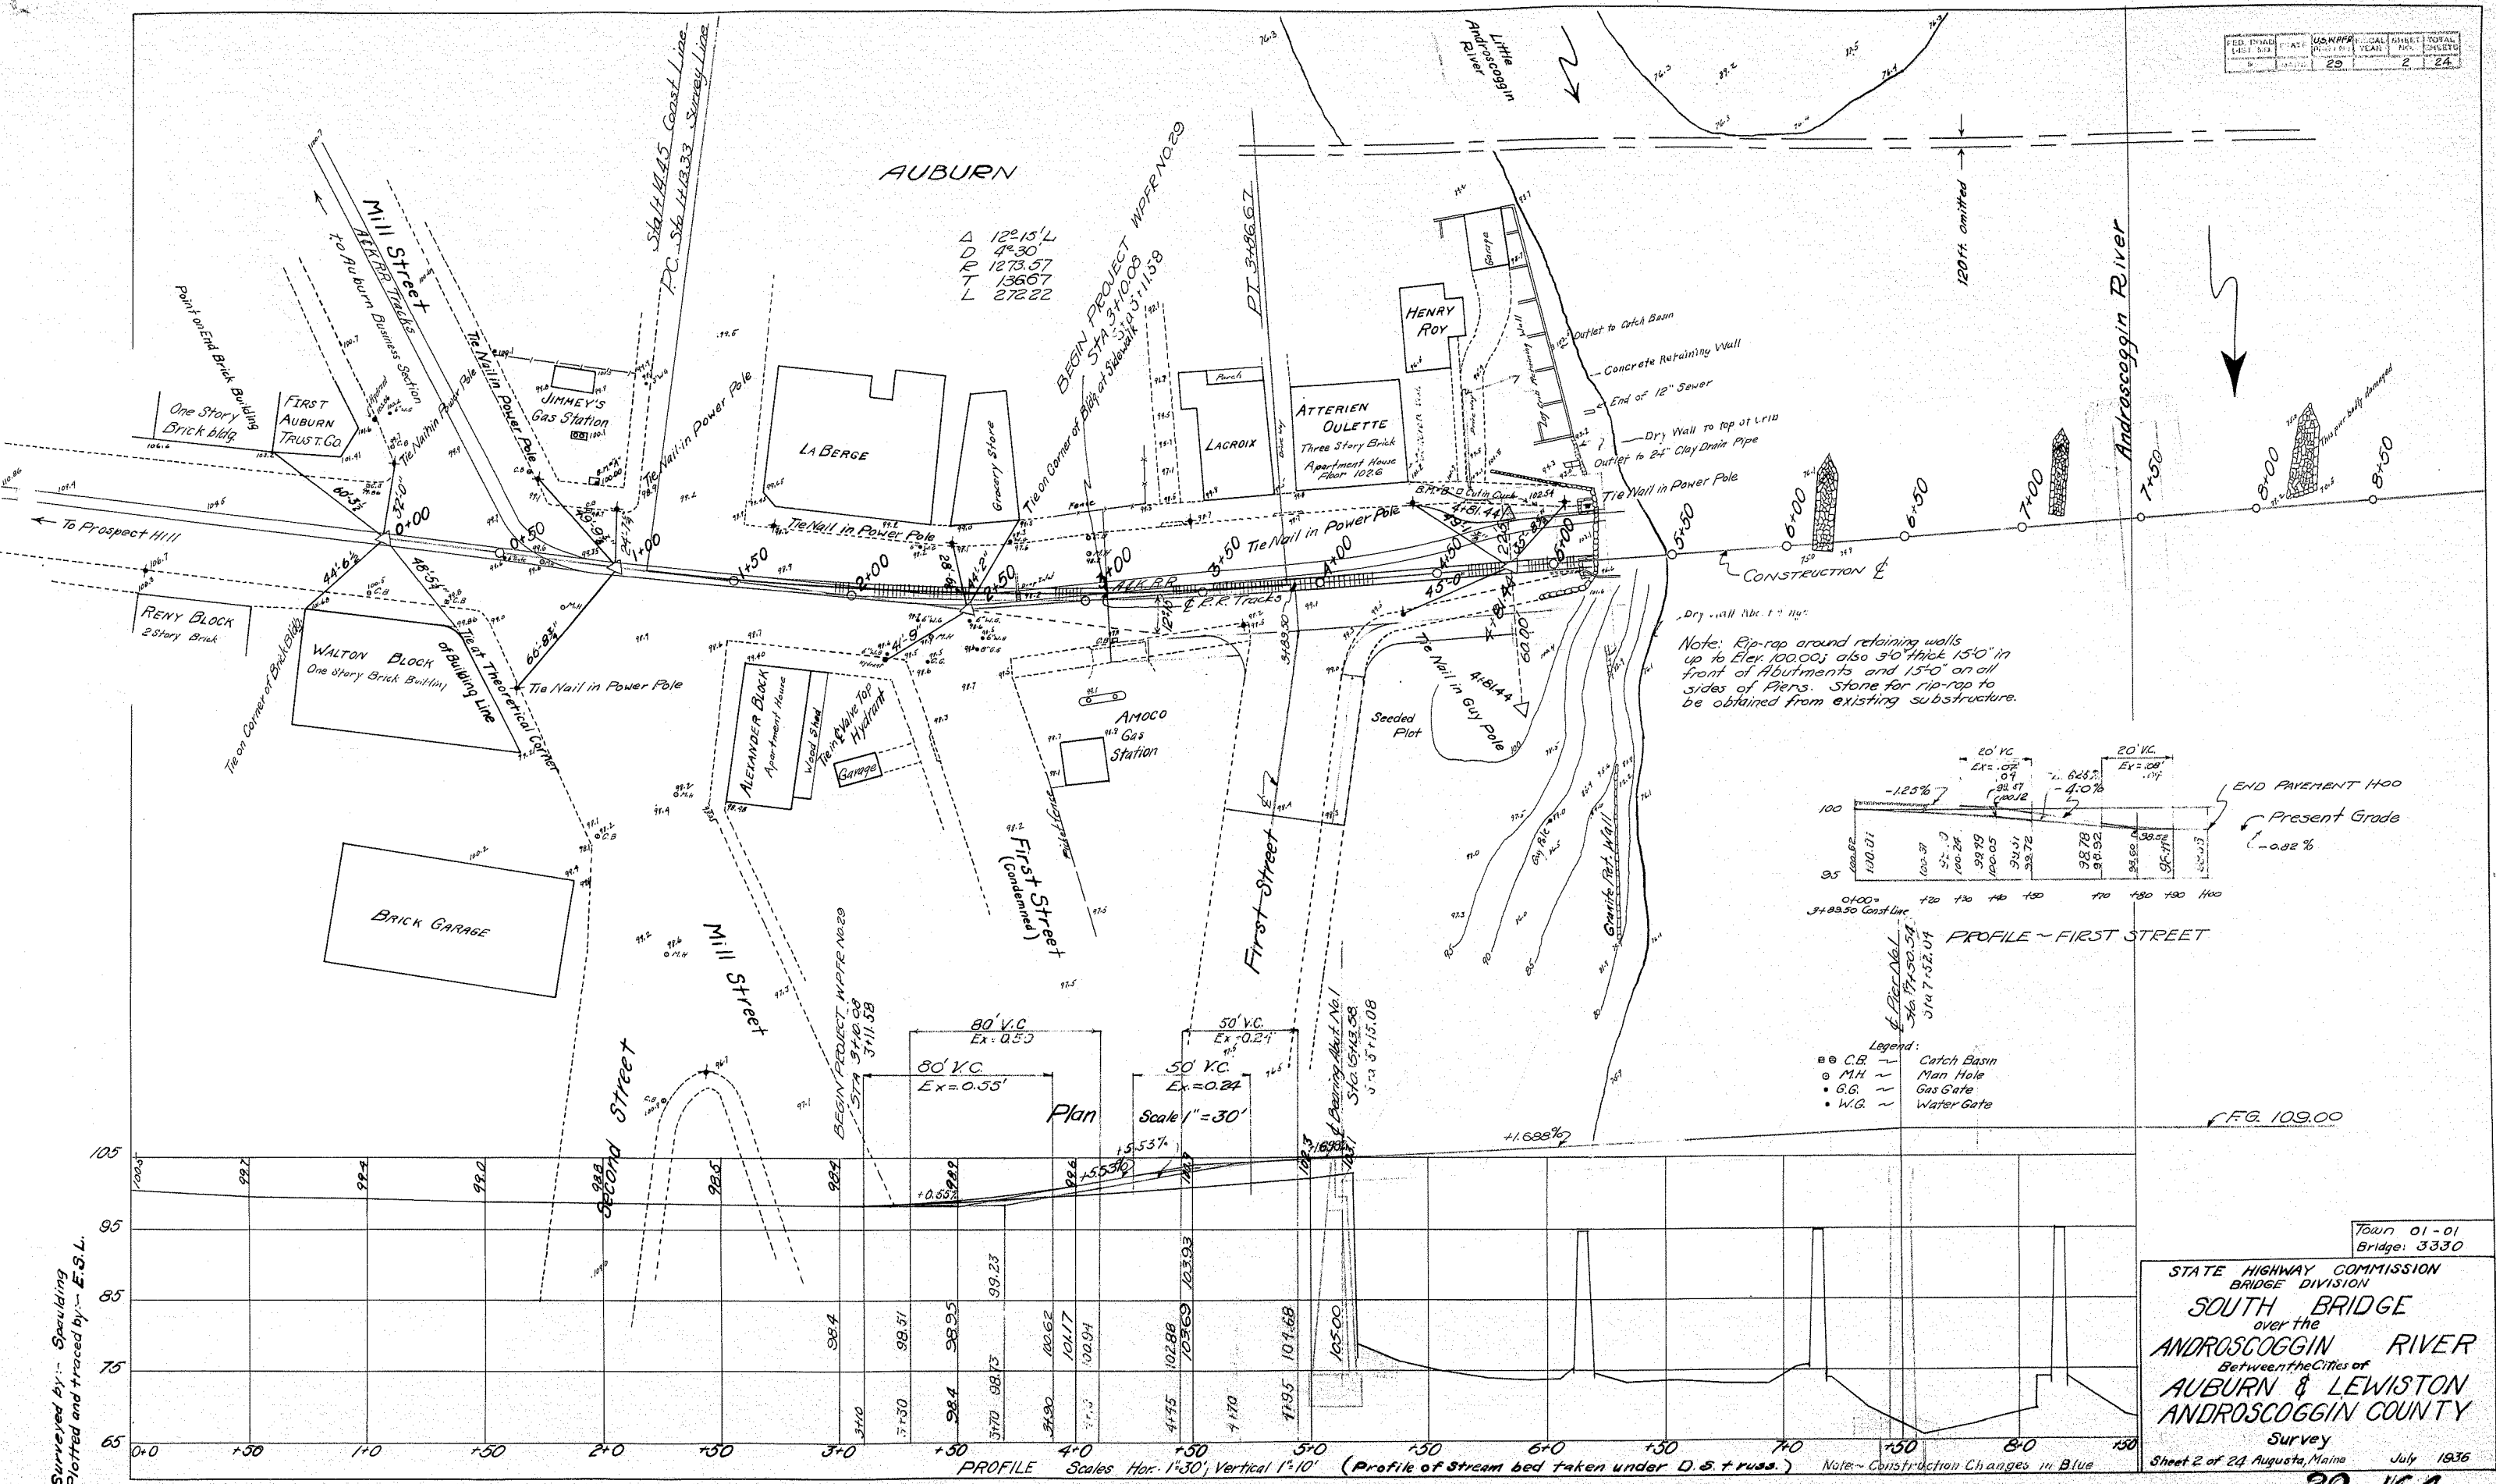
Surveyed by: Spaulding
Plotted and traced by: E.S.L.

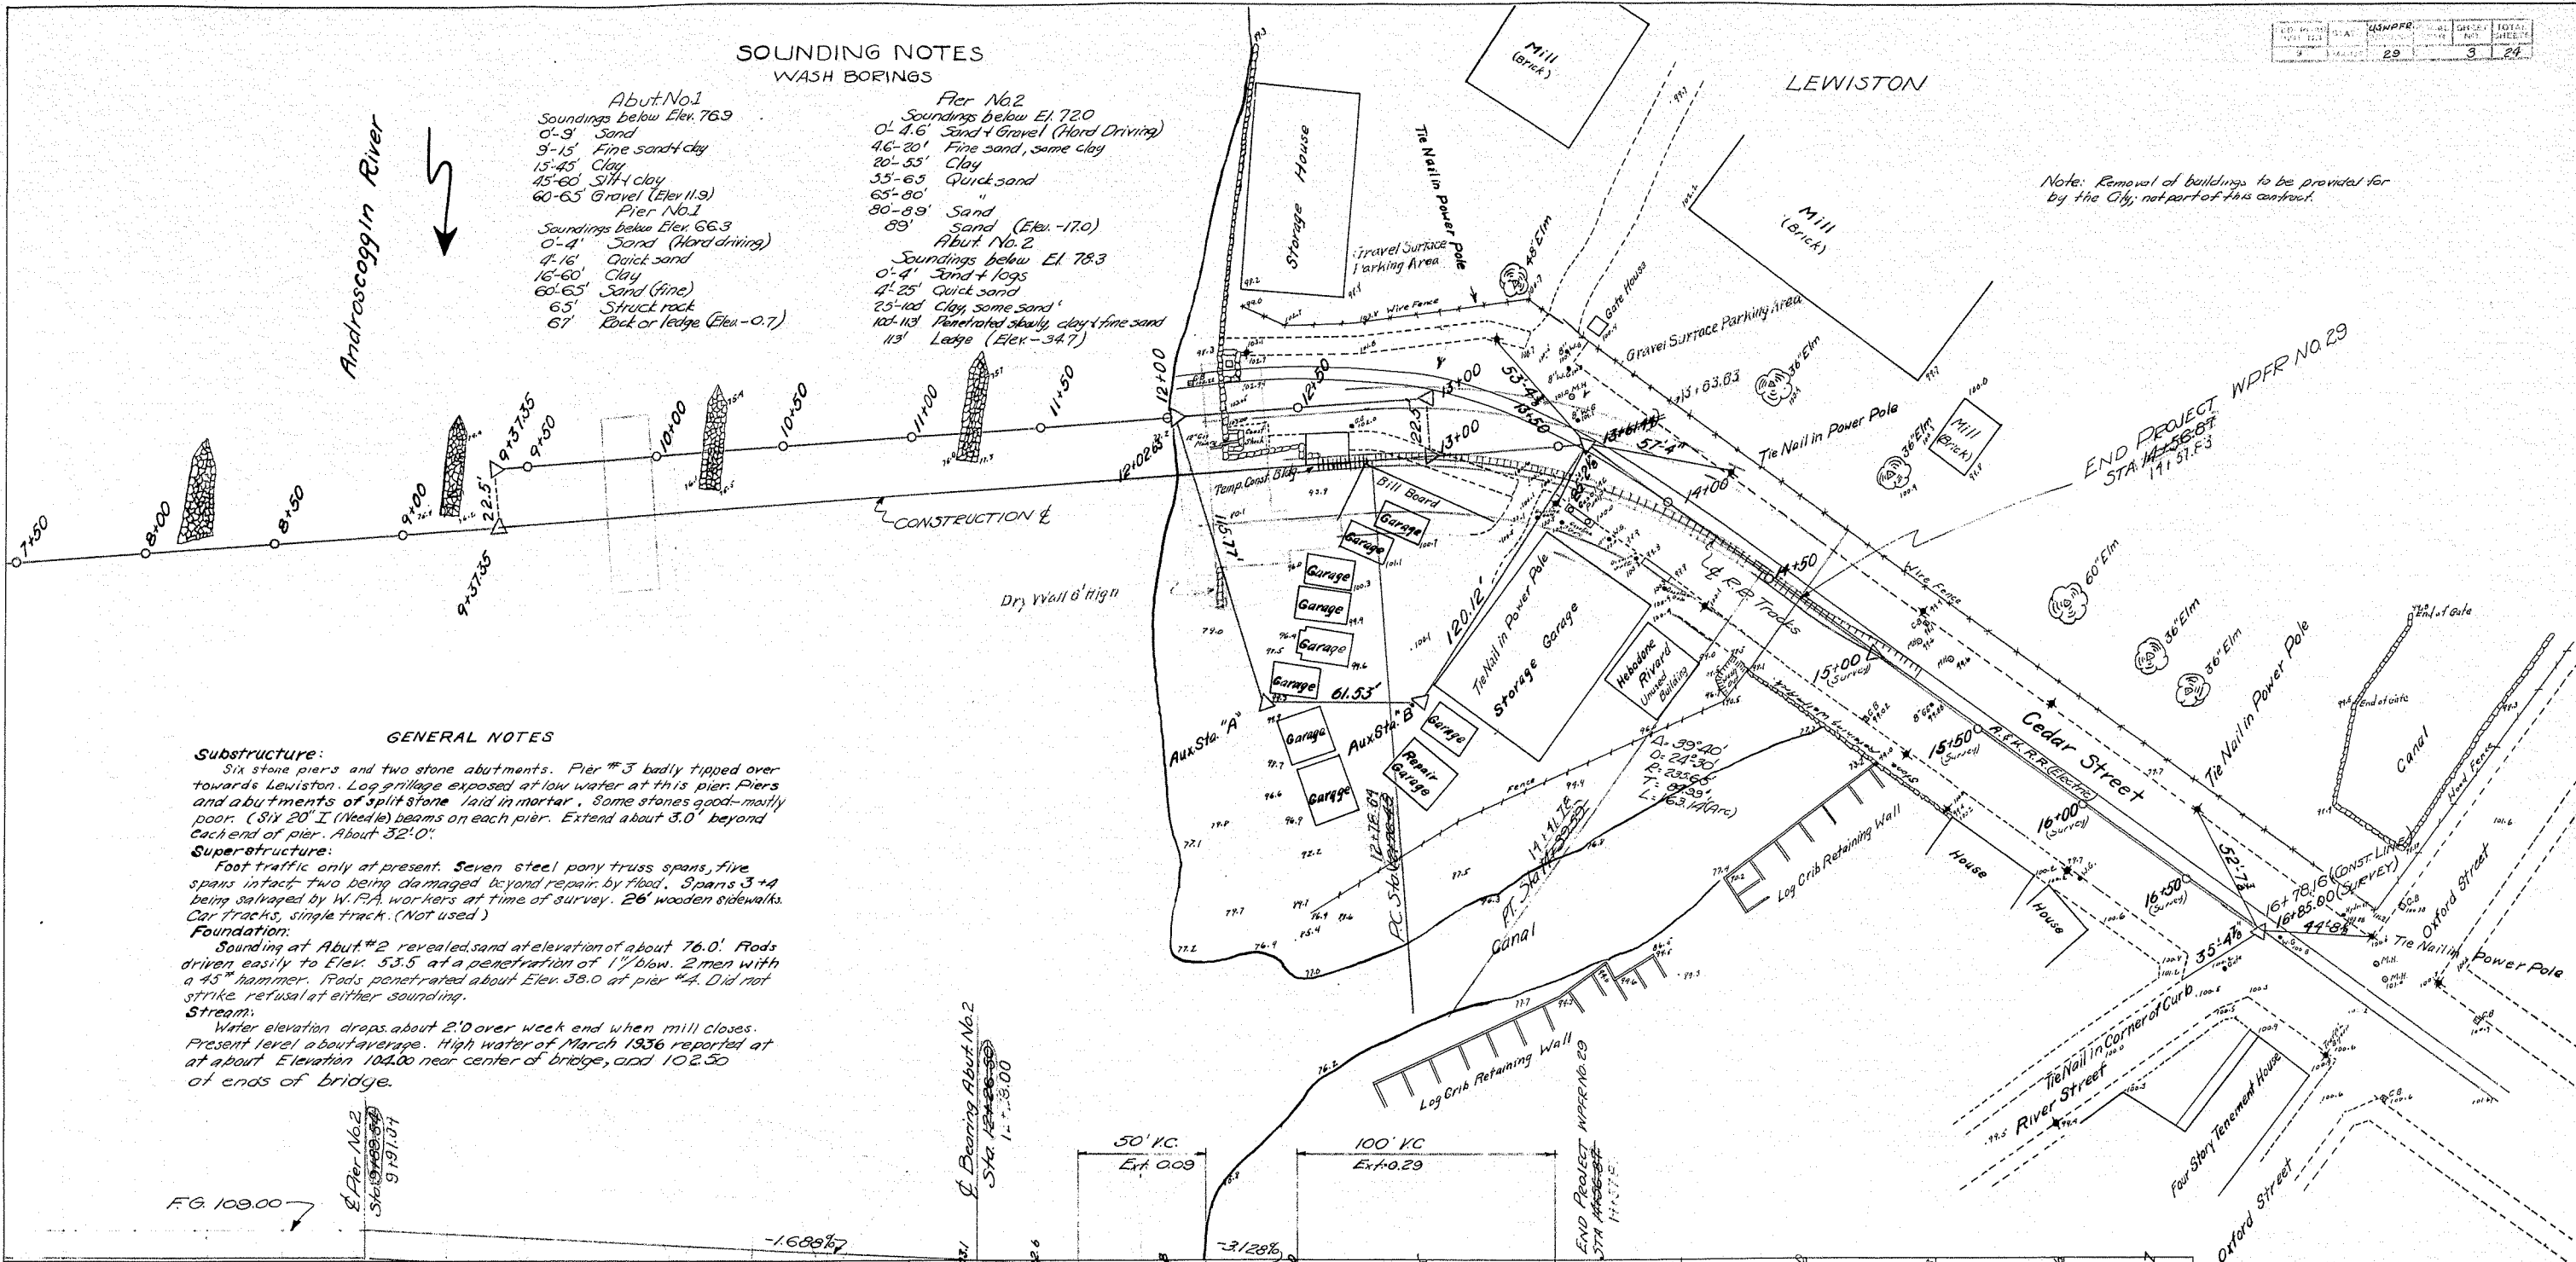
Note: Removal of buildings to be provided for by the City; not part of this contract.

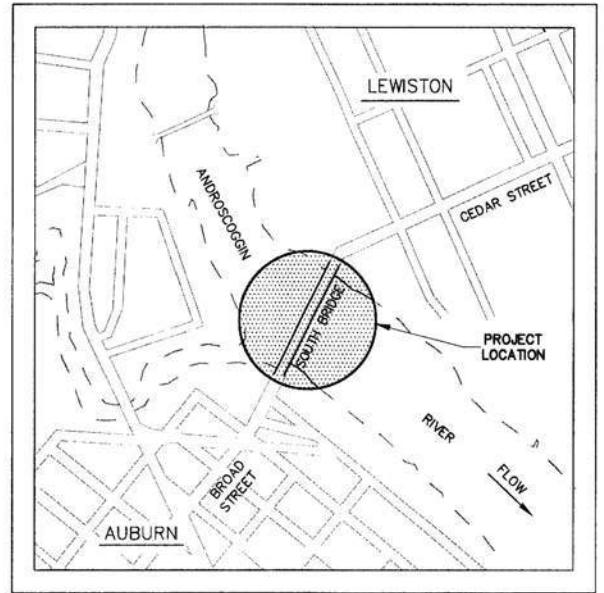
TRAFFIC DATA		SCOPE OF WORK
1994 AADT	18,090	REMOVE AND REPLACE EXISTING BITUMINOUS WEARING SURFACE WITH A NEW MEMBRANE AND BITUMINOUS WEARING SURFACE
2014 AADT	25,330	REMOVE AND REPLACE CONCRETE DECK
D.H.V.	2,533	REPLACE BRIDGE JOINTS
T%	4	SELECTIVE PAINTING OF NEEDLE AND FLOOR BMS
D%	3	PAVE APPROACHES TO MATCH BRIDGE PROFILE
DIRECTIONAL DIST.	60	REINFORCE CONCRETE PIER CAPS
18K EQUIV. P.2.0	257	
18K EQUIV. P.2.5	252

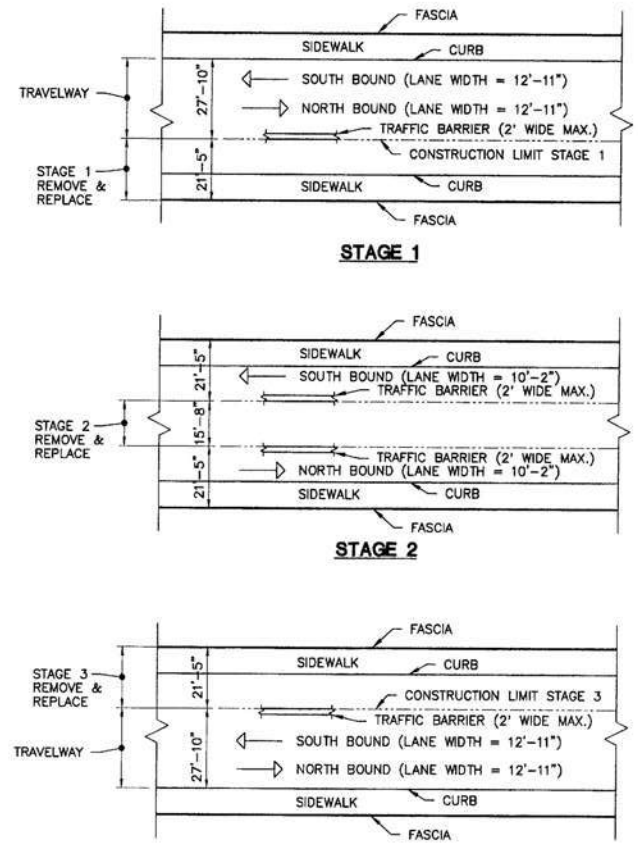
SCHEMATIC PLANS FOR STAGED CONSTRUCTION AND TRAFFIC MAINTENANCE.

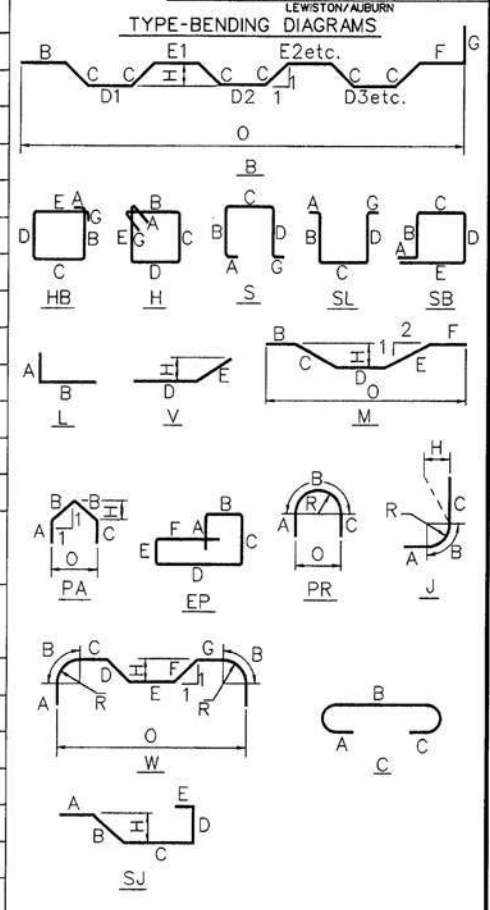
All dimensions are out to out of reinforcing bar
 Bending details and hooks shall conform to the recommendations of the current revision of ACI Standard 318
 Reinforcing Bar: ASTM A615 Grade 60

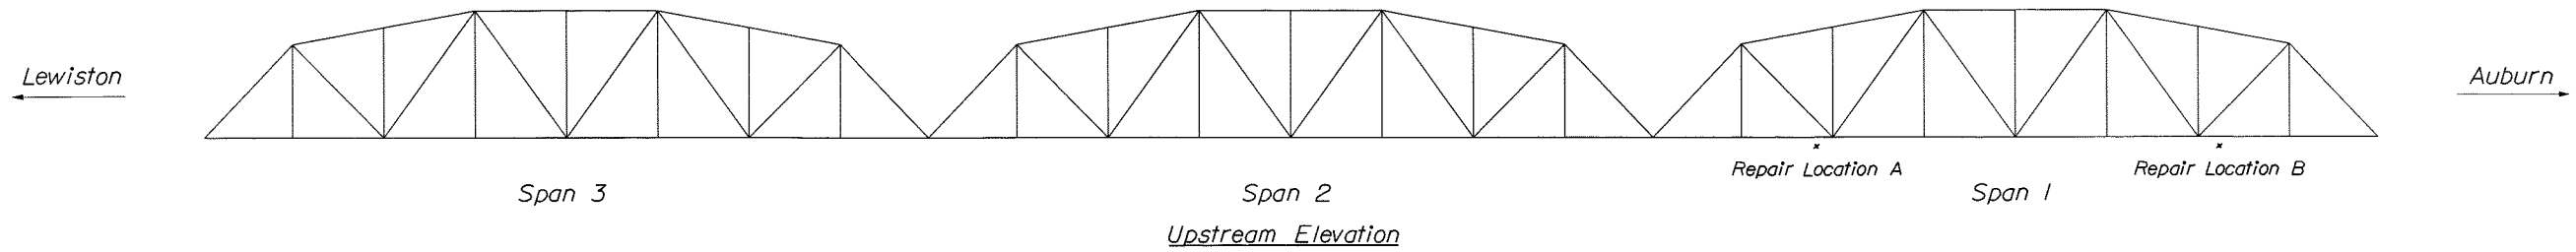
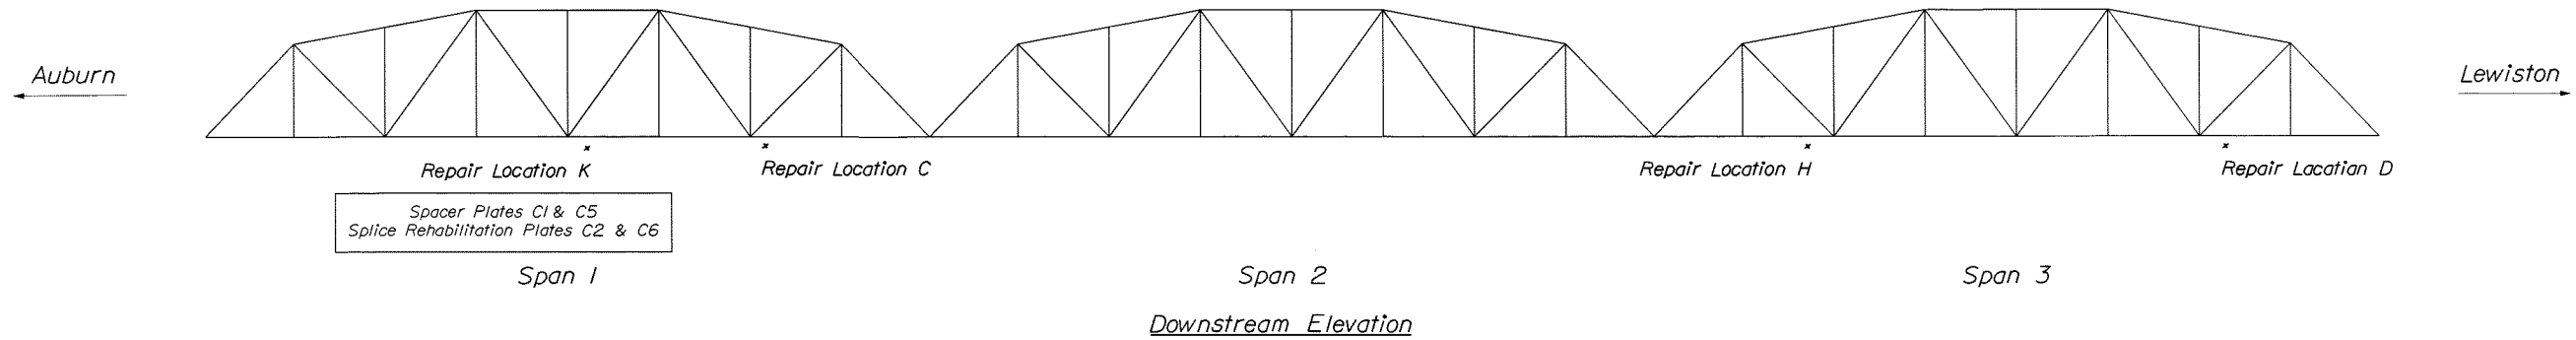
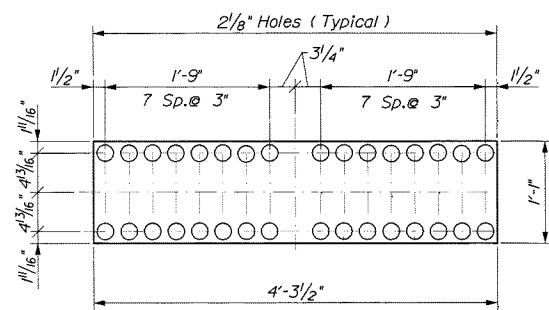
C1 Bottom Chord Spacer Plate
 1/4" Thick (1 Required) 196 lbs
 @ Repair Location K

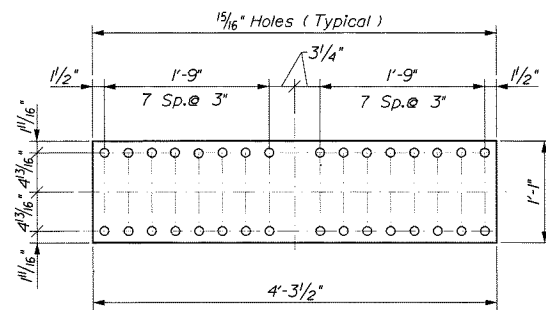
C2 Bottom Chord Splice Rehabilitation Plate
 3/4" Thick (1 Required) 137 lbs
 @ Repair Location K

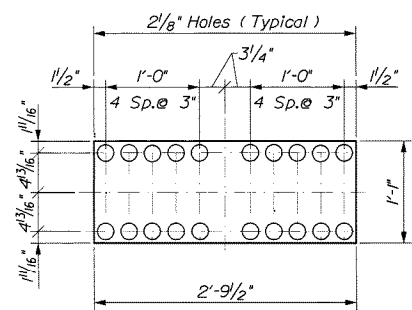
C3 Bottom Chord Spacer Plate
 1/4" Thick (5 Required) 128 lbs

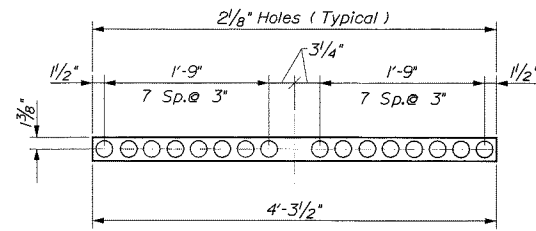
C5 Bottom Chord Spacer Plate
 1/4" Thick (2 Required) 30 lbs
 @ Repair Location K

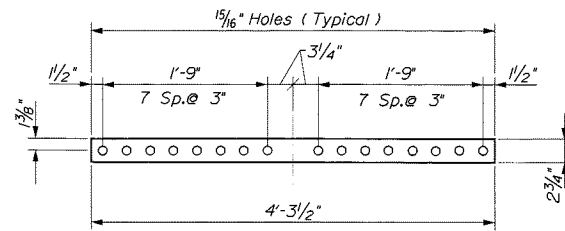
C6 Bottom Chord Splice Rehabilitation Plate
 3/4" Thick (2 Required) 28 lbs
 @ Repair Location K

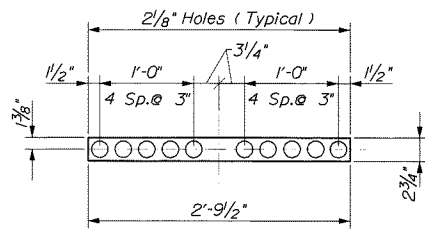
C7 Bottom Chord Spacer Plate
 1/4" Thick (10 Required) 20 lbs

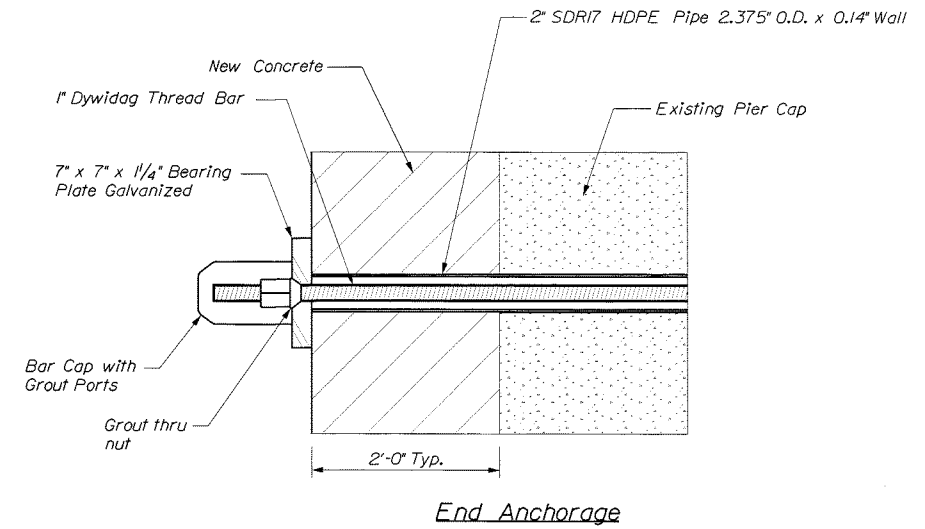
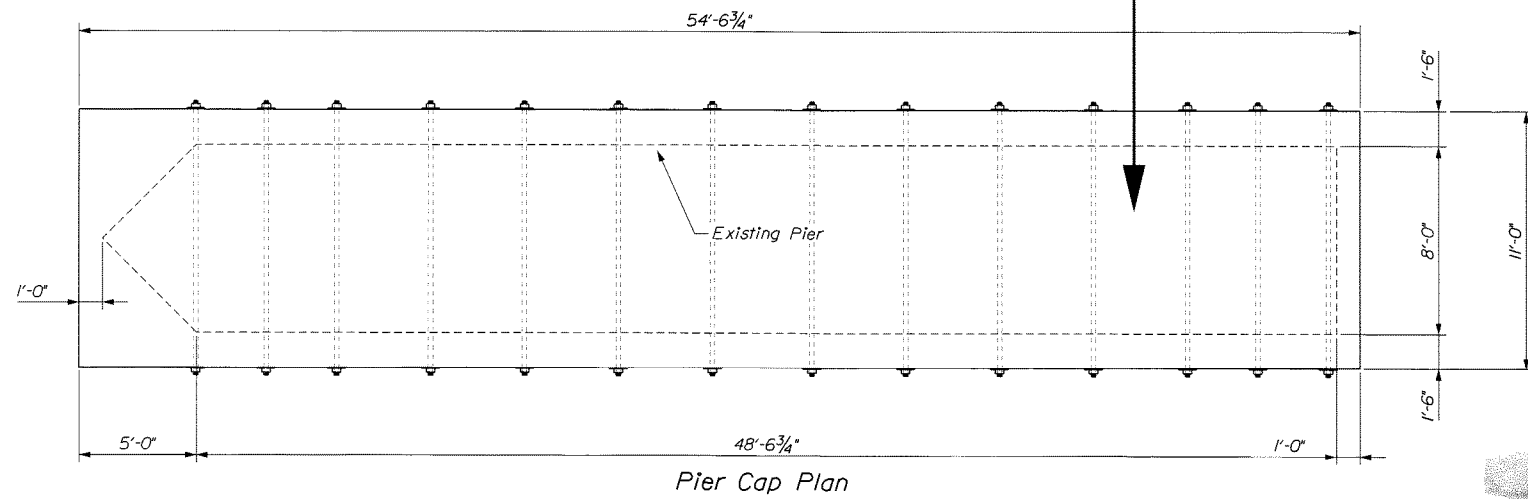
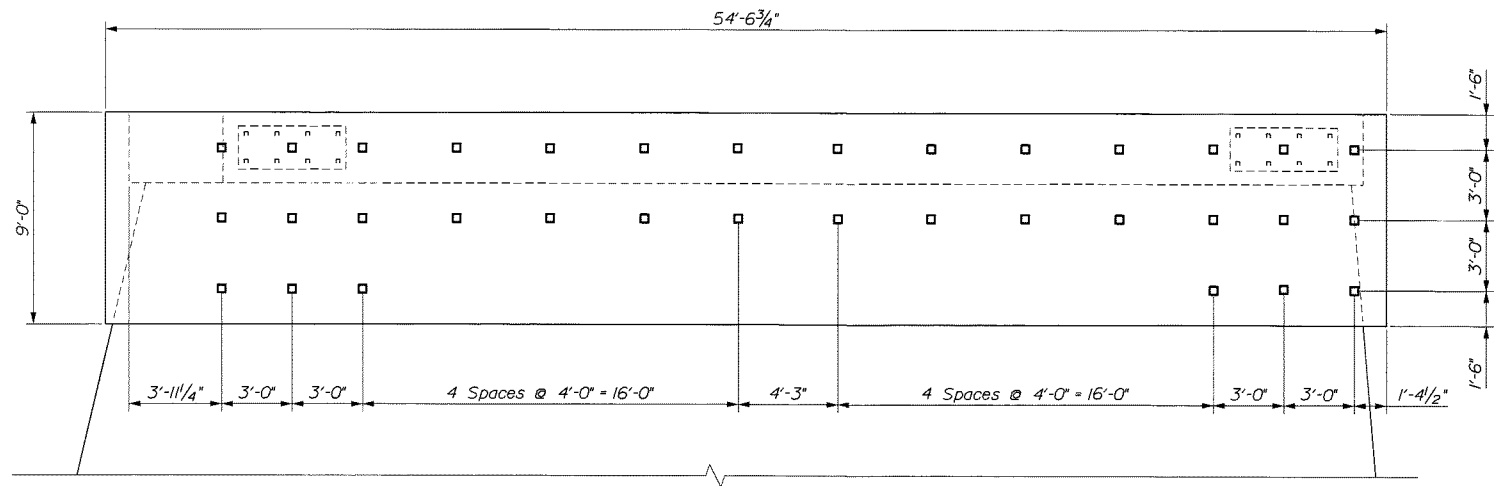
Dywidag Location At Pile Cap

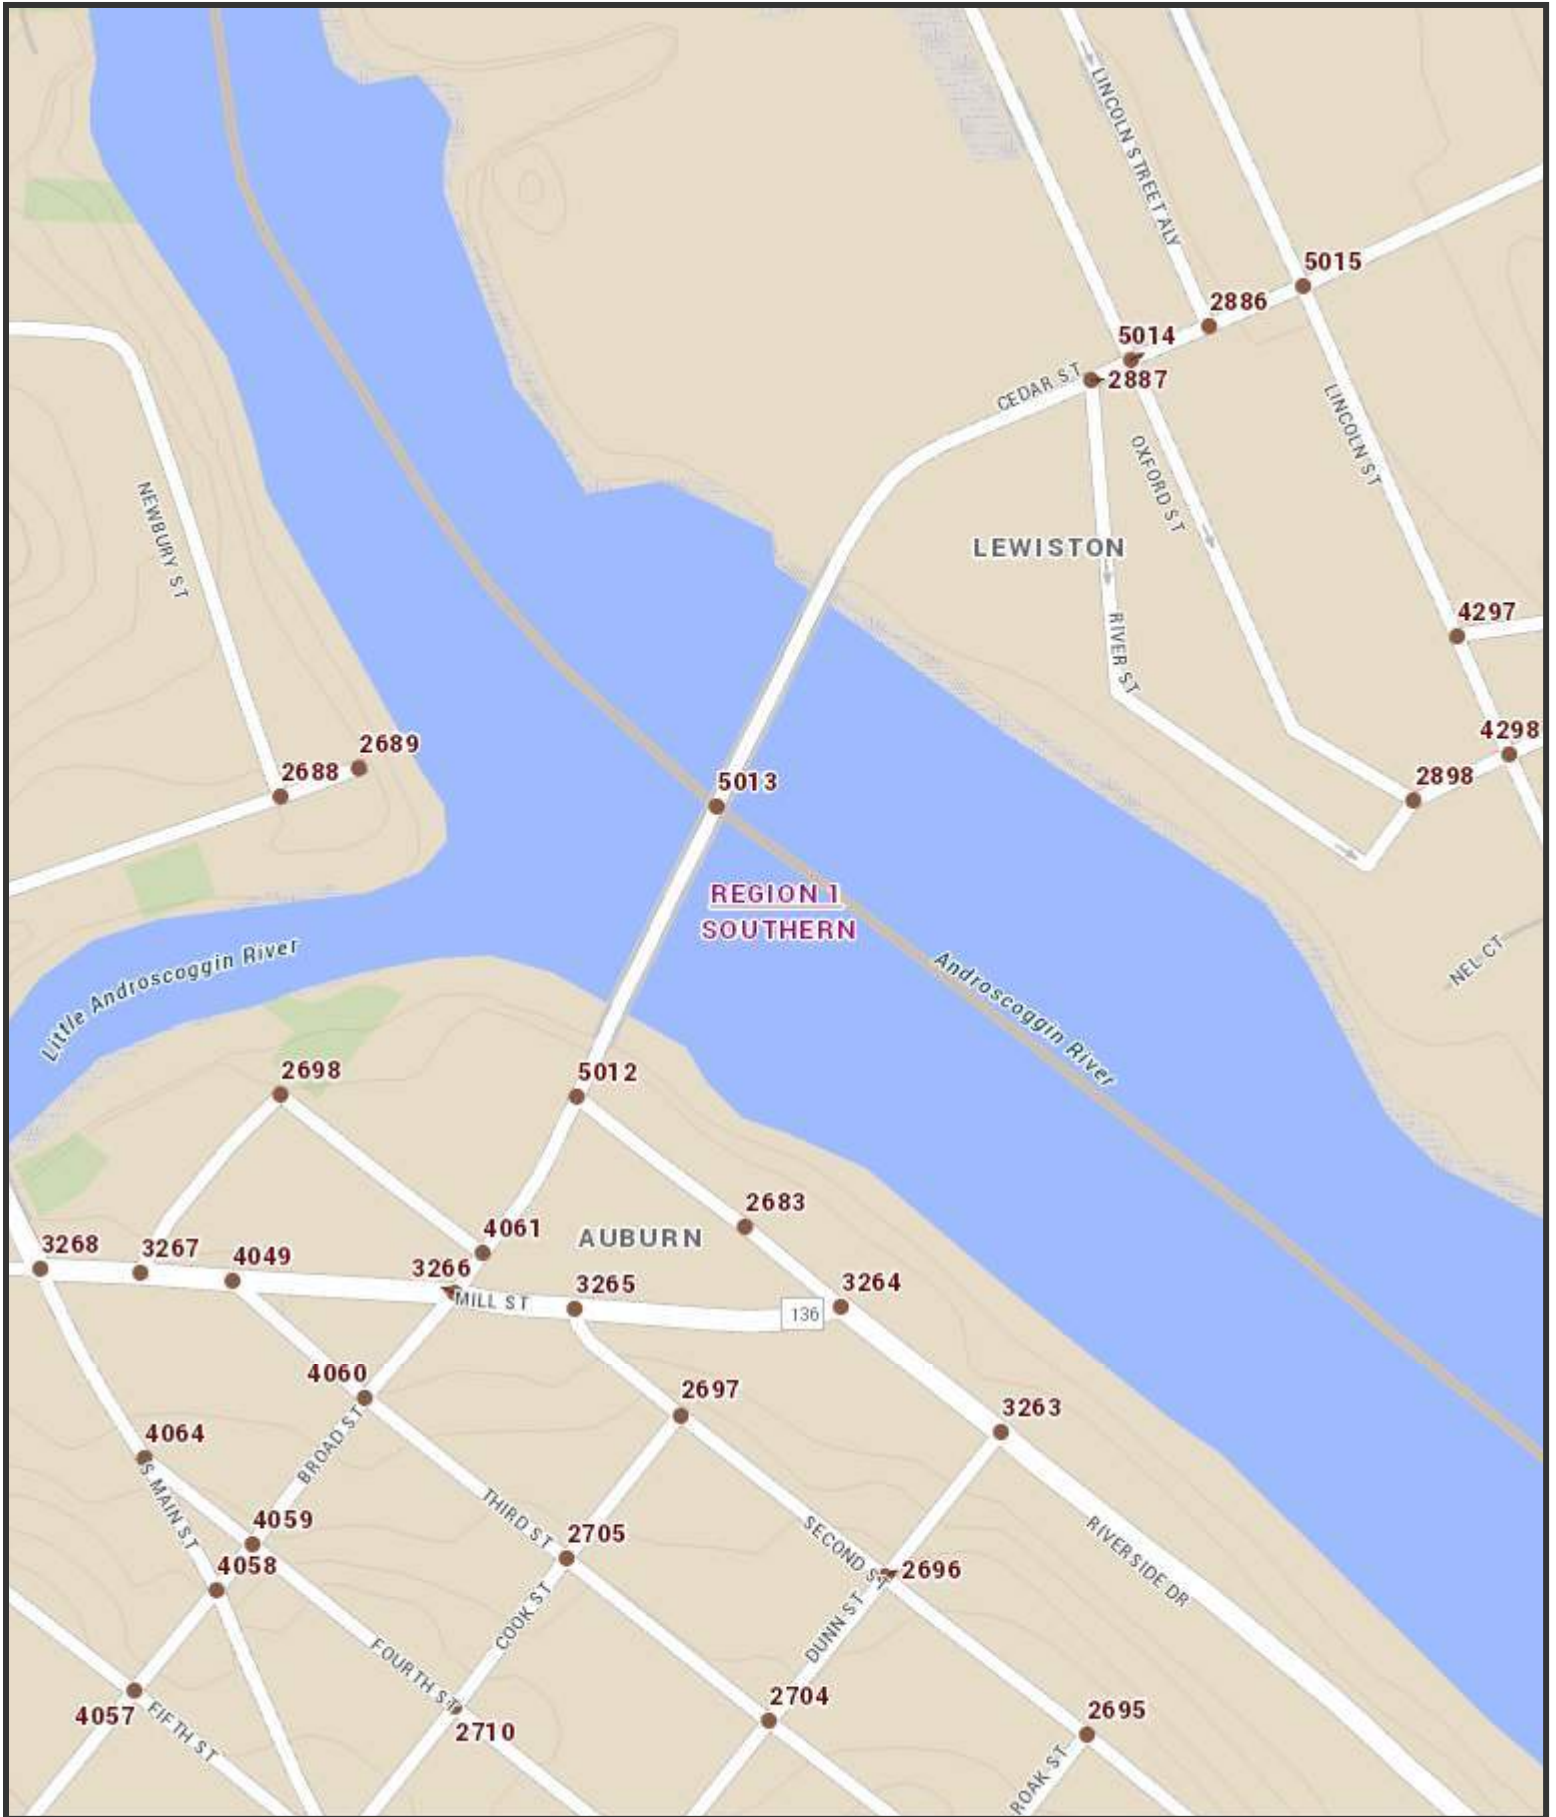
The Maine Department of Transportation provides this publication for information only. Reliance upon this information is at user risk. It is subject to revision and may be incomplete depending upon changing conditions. The Department assumes no liability if injuries or damages result from this information. This map is not intended to support emergency dispatch.

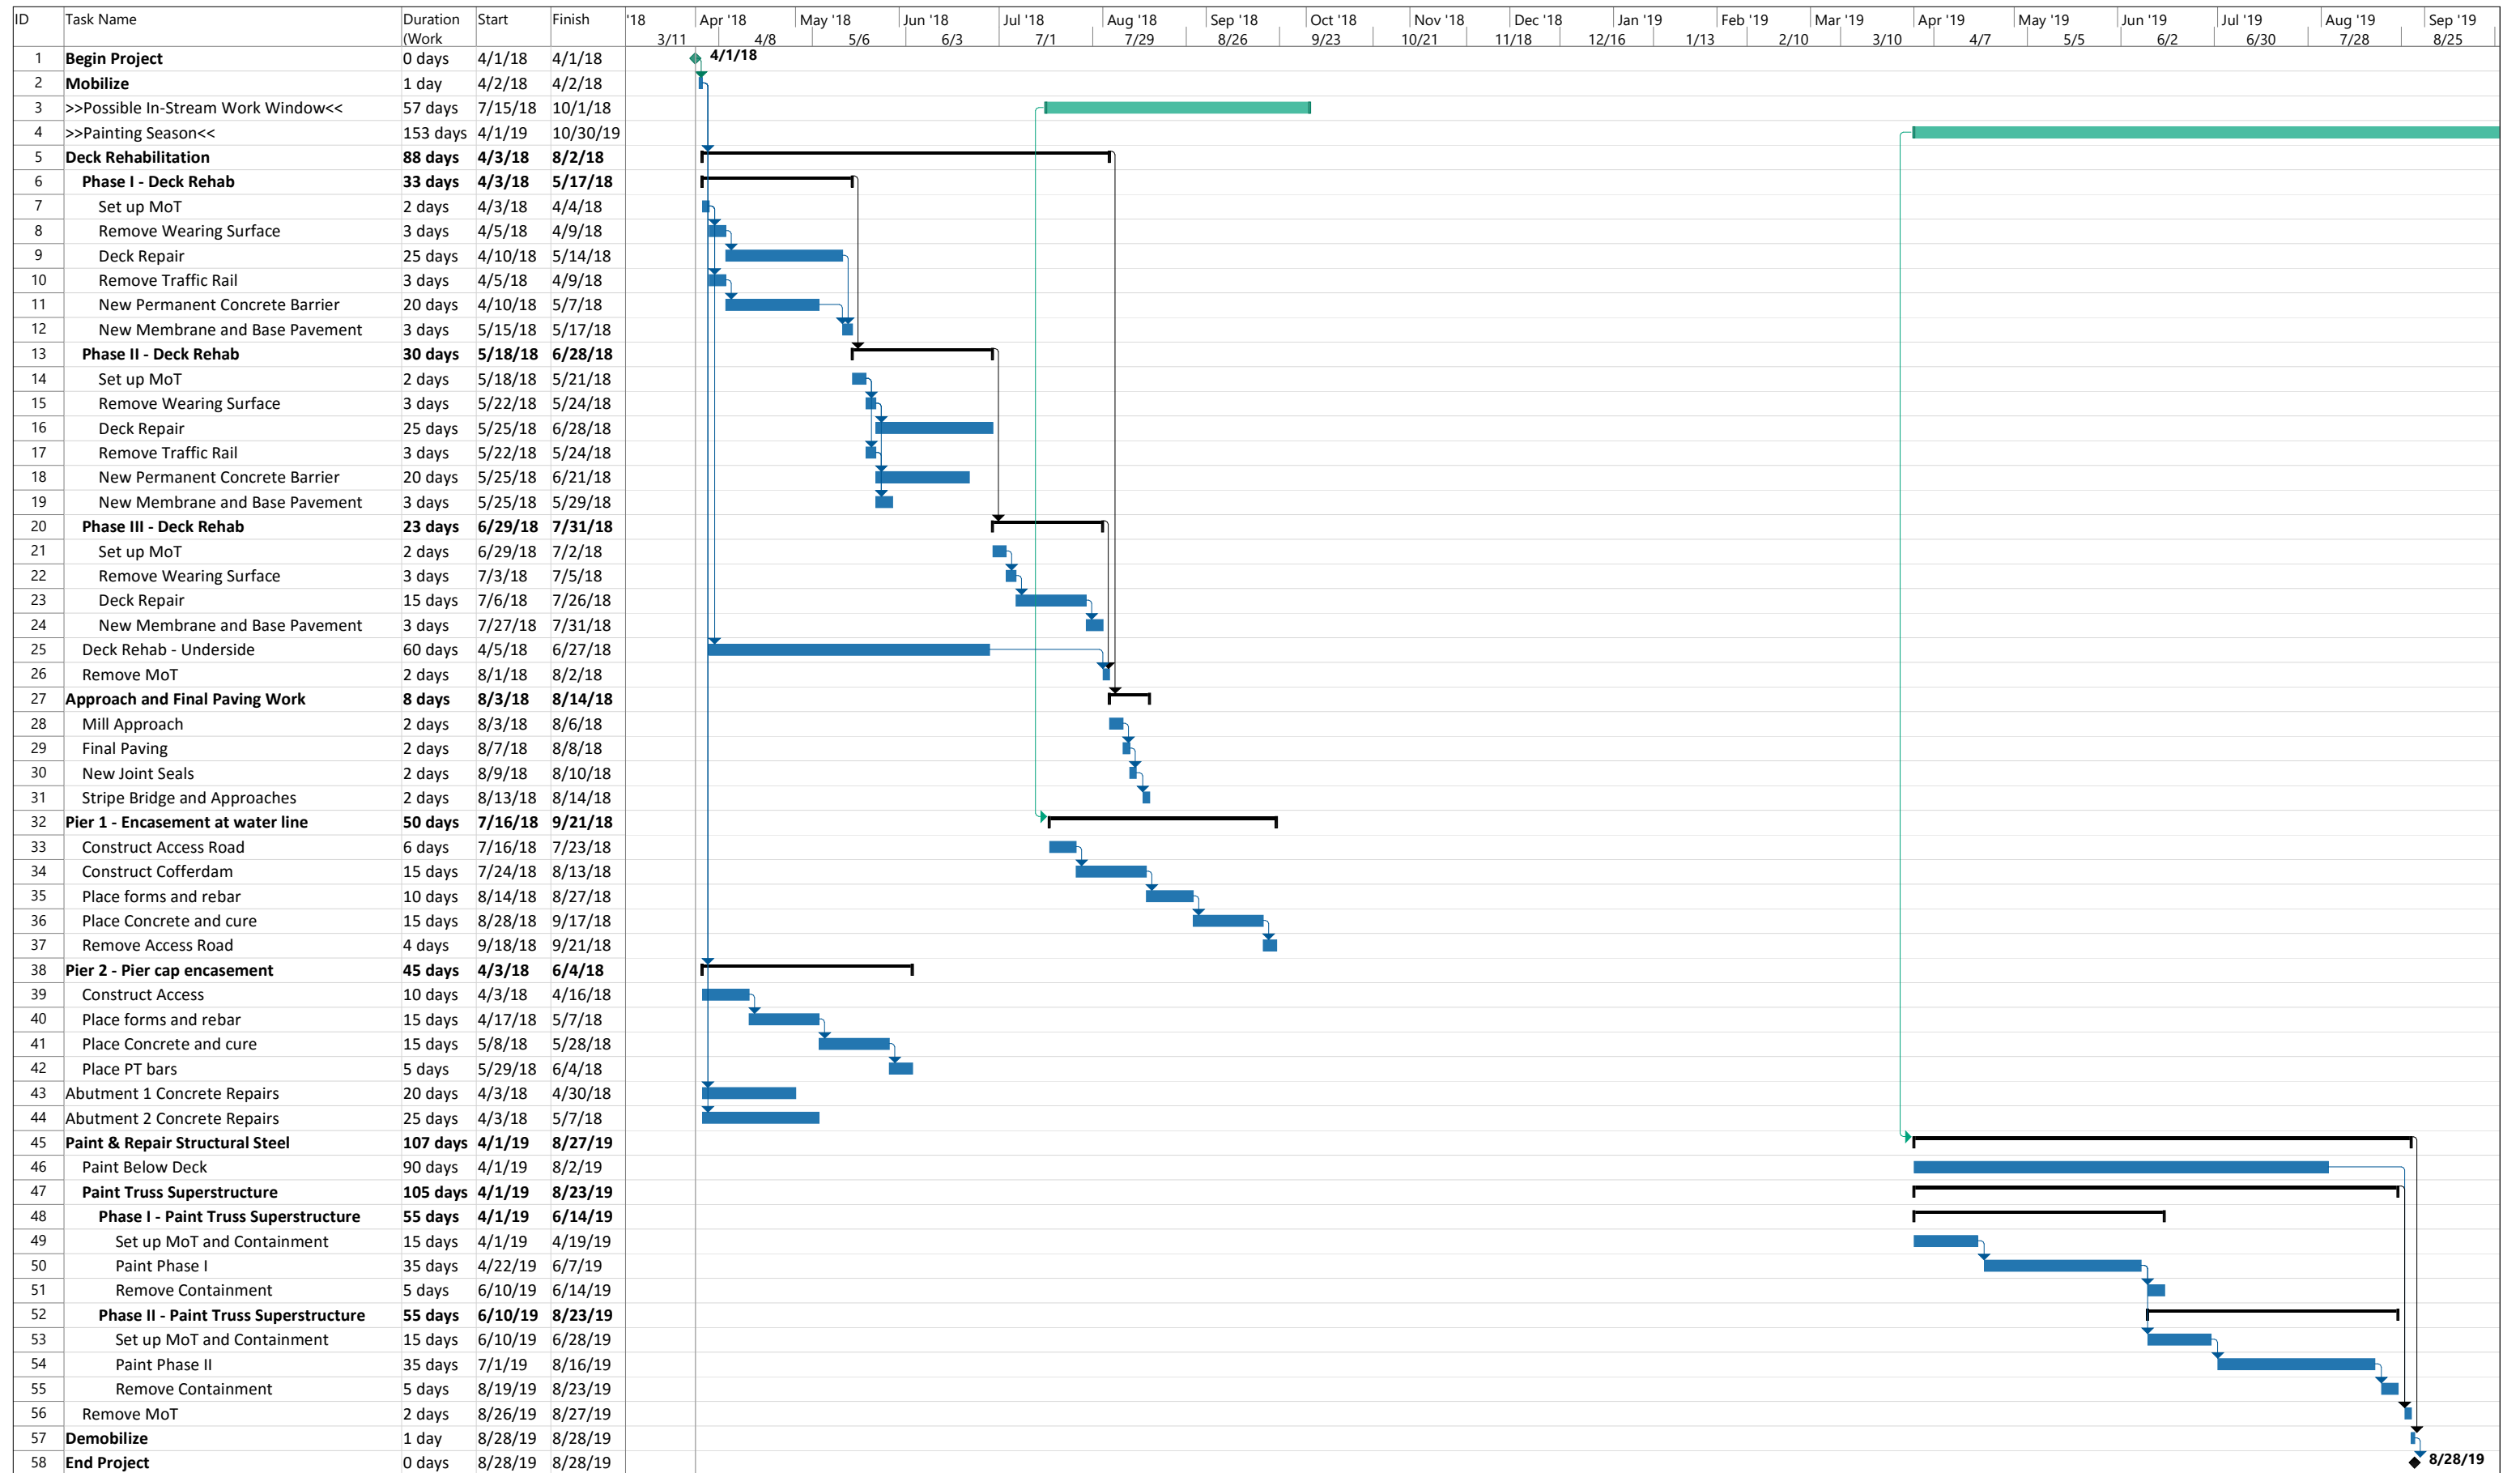
MaineDOT: Bernard Lown Peace Bridge (WIN 22599.00) PDR
 Estimated Construction Schedule for Bridge Rehabilitation Alternative
 Developed by Daniel Myers | Checked by David Sherlock | December 2016

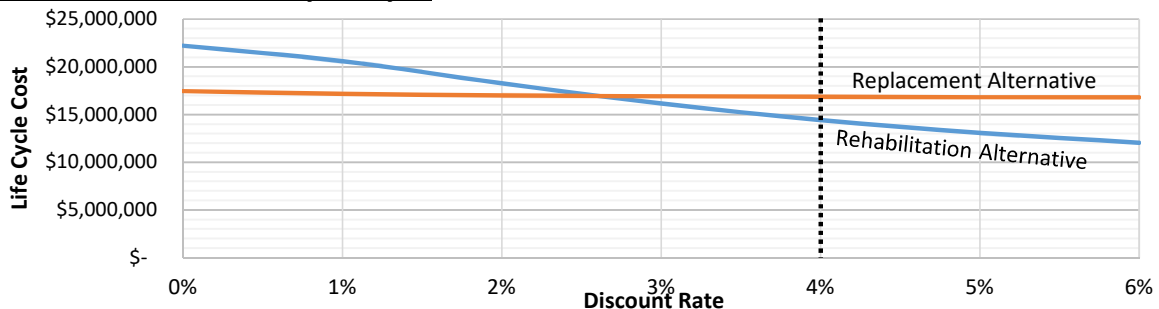
*PV/FV = Present Value of an Future Lump Sum, calculated as $1 / ((1 + D) ^ \text{Year})$

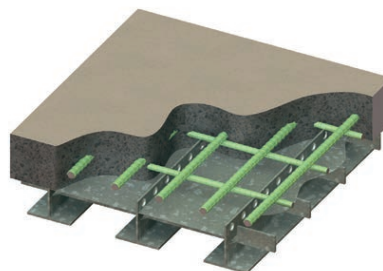
Case Study: Grand Island Bridge

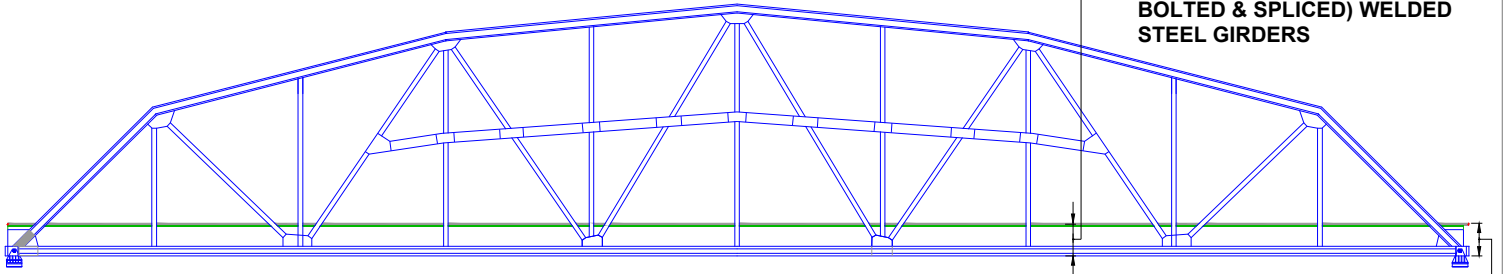
VERTICAL DEPTH OF PROPOSED NEW UNDERCARRIAGE ±7'-0"
