Geologic Site of the Month

April, 2013

Sandy River Bank Erosion, Avon, Maine – 2nd Update

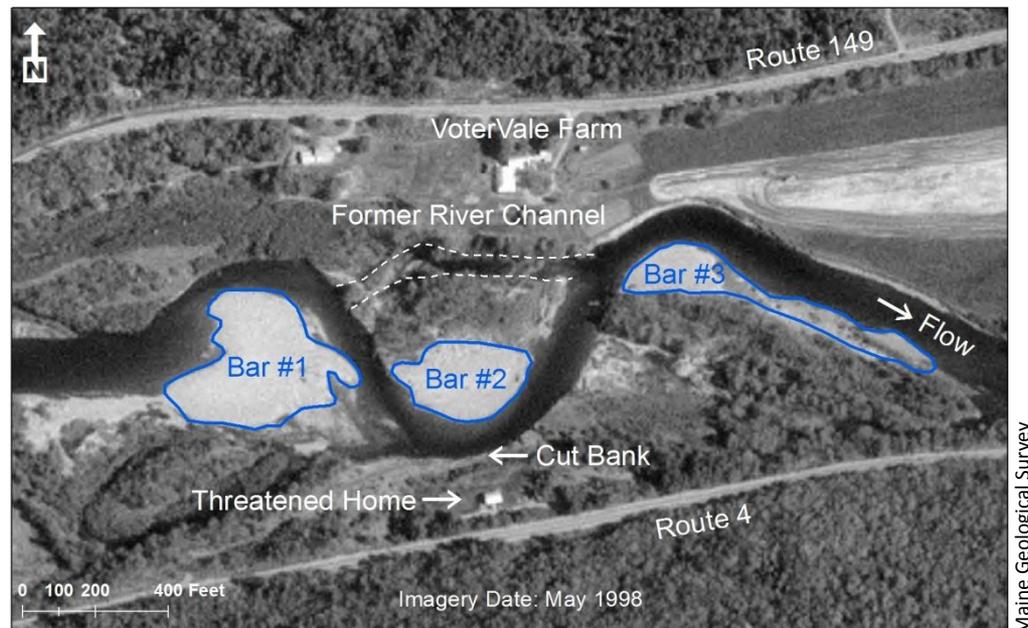
The Sandy River adjacent to the VoterVale Farm has seen significant changes over time. Back in 1998, the Maine Geological Survey was asked to comment on a proposal to remove sand and gravel from three point bars in an attempt to alleviate erosion on a cut bank which was threatening the property south of the VoterVale Farm (north of Route 4). Rather than remove material from these bars, a more direct and effective approach would have been to excavate a former channel which would cut off the meander and thus render this section of the river an eventual oxbow or at least a backwater channel in the short term. This appeared to be an environmentally prudent act since the river would eventually choose this course of action anyway.

Figure 2. Image of site depicting point bars, cut bank, and potentially threatened home in 1998. Also shown is a former river channel where dredging was proposed to cut off the meander.

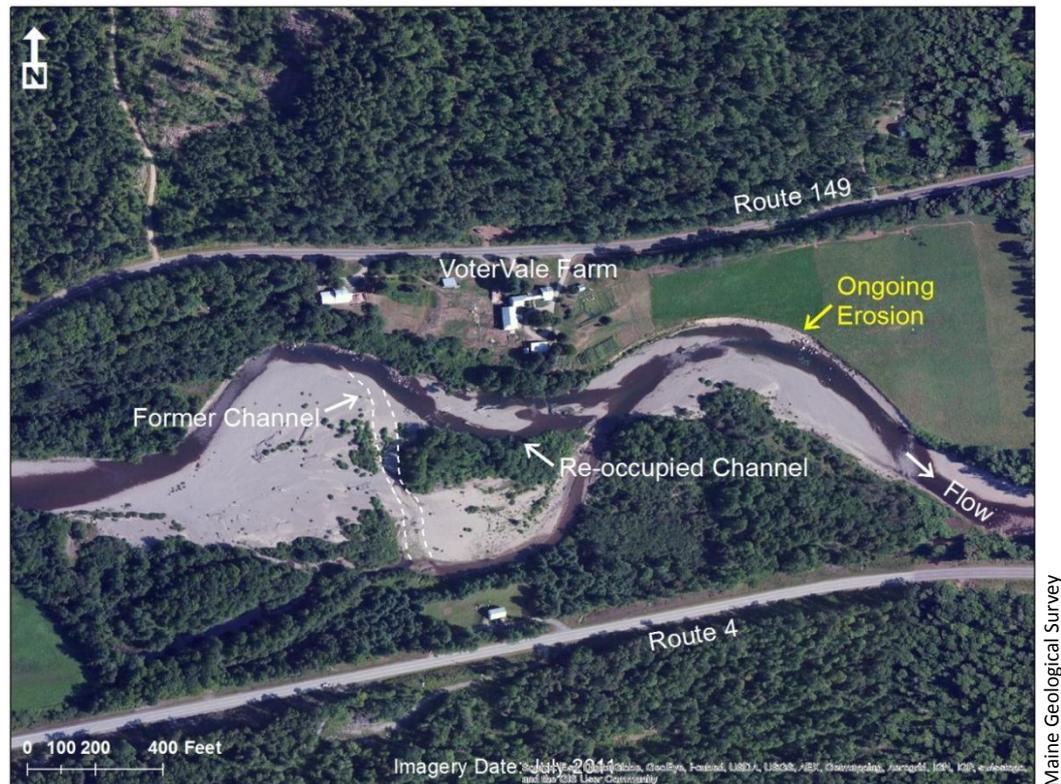
In the spring of 2005, the Sandy River changed course and re-occupied the former channel which cut across the meander. Clearly, this change of events significantly reduced the erosion on the cut-bank which was threatening the residence. However, erosion downstream of fields owned by the VoterVale Farm continues. An interesting outcome of abandoned channels is that they make excellent habitat for many types of wildlife.

Figure 3. Image depicting re-occupation of former channel and the abandonment of the meander to the south.

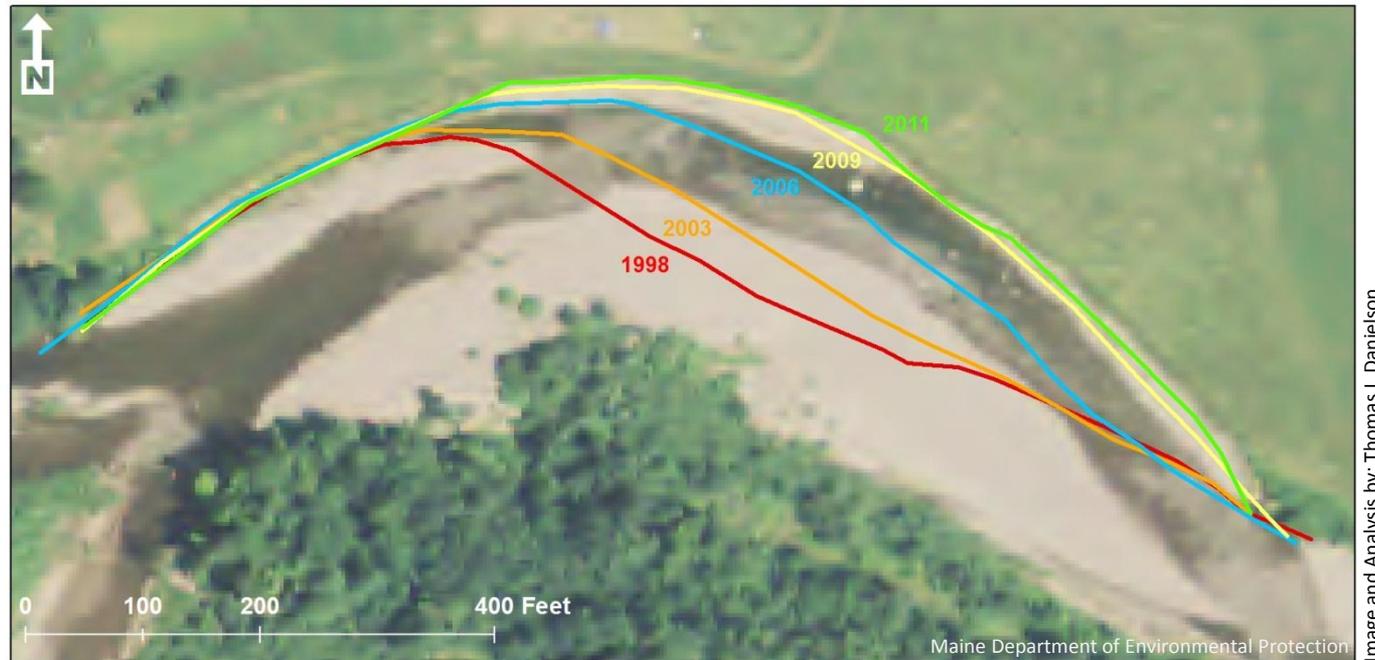
As a consequence of the natural change in river course across the meander, there continues to be significant erosion occurring over time that is well documented by studying aerial photographs from 1998 through 2011 (Refer to area noted in yellow on Figure 3 for location). In this analysis, a series of five aerial photographs were examined and the edge of the stream bank was delineated. The progression of these stream bank edge delineations from 1998 to 2011 can be clearly seen as a northeasterly encroachment of the Sandy River onto the VoterVale Farm field; a distance of approximately 175 feet. This resulted in a loss of approximately 1.9 acres of land.

Figure 4. This image depicts a detailed analysis of five delineated stream bank edges from aerial photographs dated 5/12/1998, 5/19/2003, 8/9/2006, 8/14/2009, and 7/16/2011.

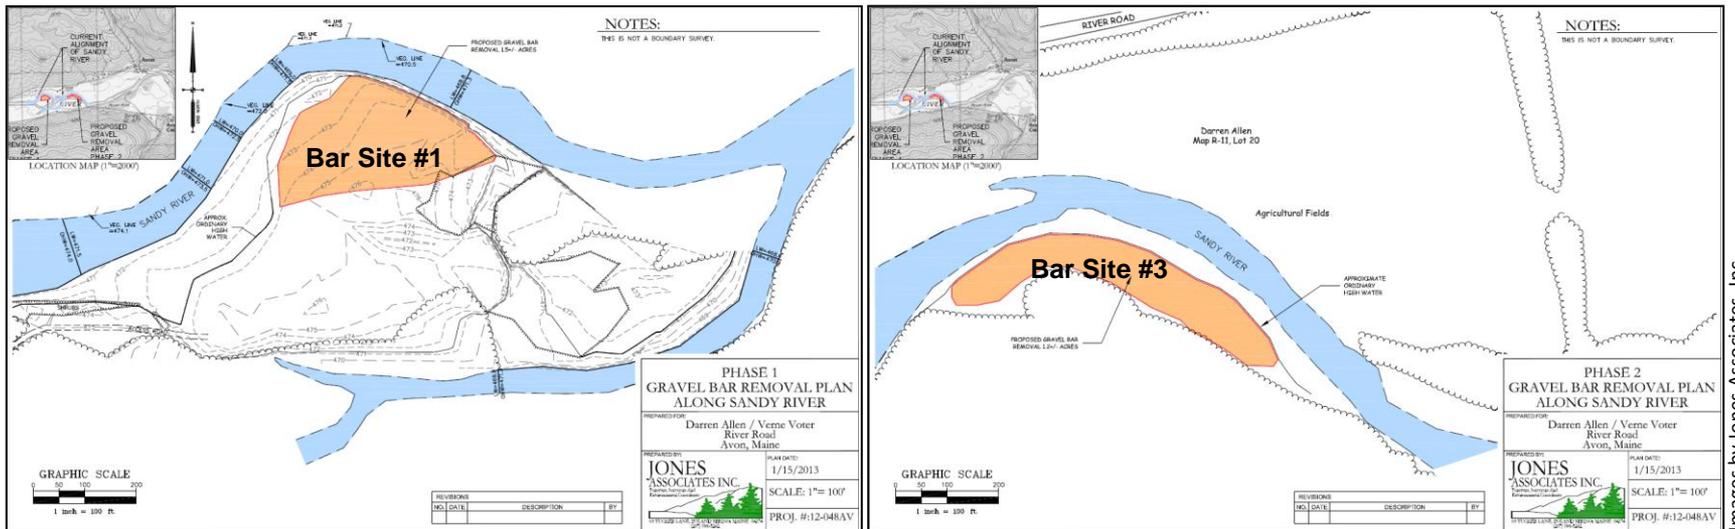
Figure 5. These engineering drawings, Phase 1 and 2, depict locations (in orange) where gravel is to be extracted down to approximately 6 inches above the seasonal low water level. Phase 2 also depicts the bar formed in Figure 4 as the river bend shifted northeasterly.

Recognizing that point bars typically form on the opposite side from eroding cut banks, it is appropriate in this case to “surgically skim” this material from defined locations to about 6 inches above the seasonal low water level. This would broaden the cross-section of the stream at high stages, and disperse the stream’s energy so that erosion of the cut banks would be reduced. Ultimately, it was decided that portions of point bars situated at bar sites #1 and #3 (Figure 2) should be surgically skimmed (Figure 5). A procedure for monitoring the effectiveness of this work has also been established.
