**QUALITATIVE HABITAT EVALUATION INDEX AND MACROINVERTEBRATE
SURVEY BASELINE REPORT
NORDIC AQUAFARMS INC. LAND-BASED AQUACULTURE FACILITY
285 NORTHPORT AVENUE
BELFAST, MAINE**

Project 171.05027.009
August 24, 2021

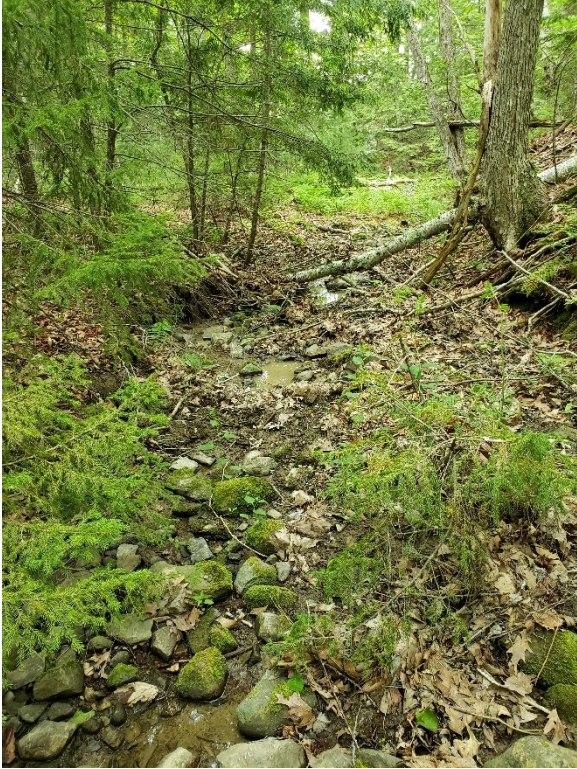
Photo 1: Stream 3, facing downstream near the Nordic property boundary.

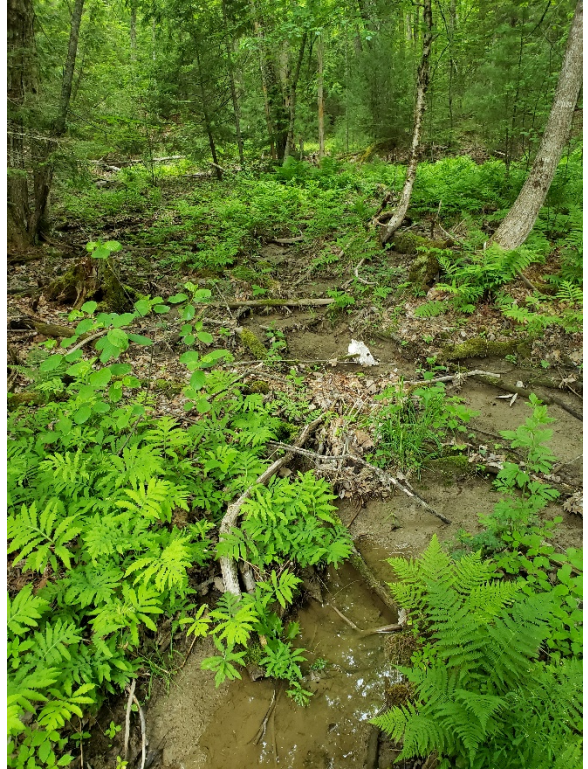
Photo 2: Stream 3, facing upstream from hiking trail.

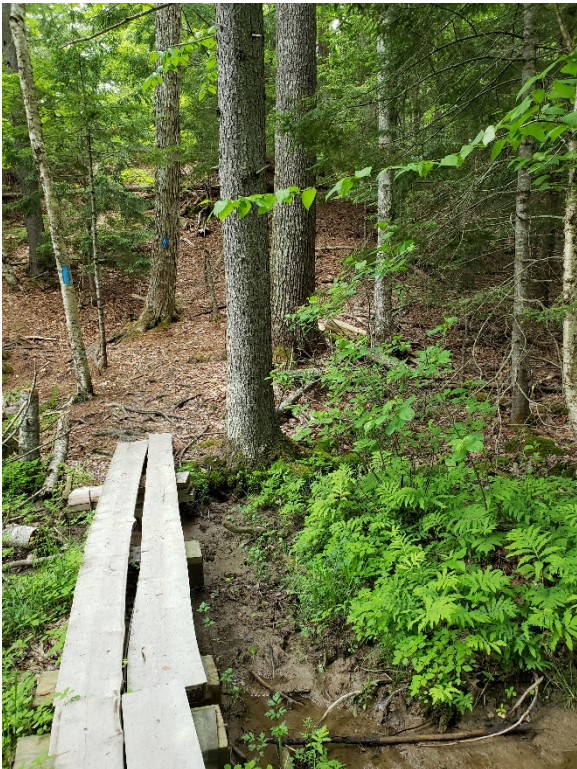
Photo 3: Hiking trail that passes over Stream 3 near its downstream end.

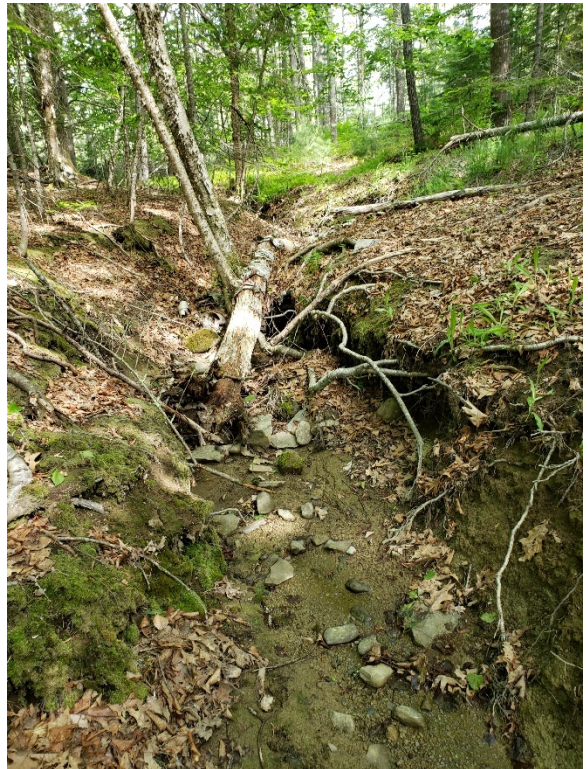
Photo 4: Stream 5, facing upstream near the Nordic property boundary (upstream end of assessment reach).

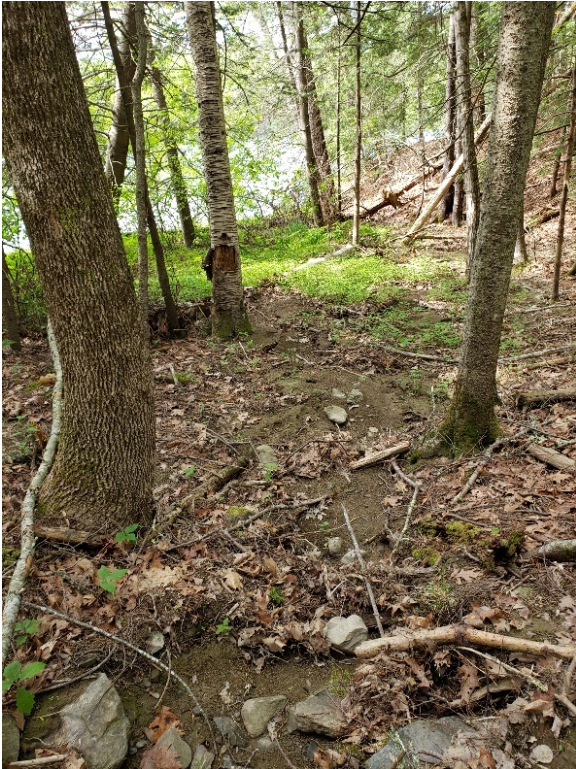
Photo 5: Stream 5, facing downstream from the hiking trail.

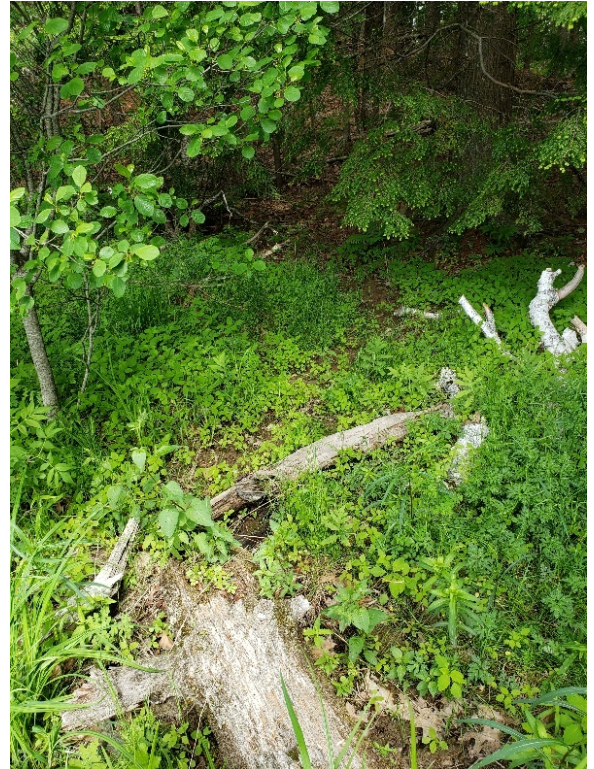
Photo 6: Stream 5 at the downstream end of the assessment reach (near outlet to Belfast Reservoir No. 1); photo taken from outlet and facing upstream.

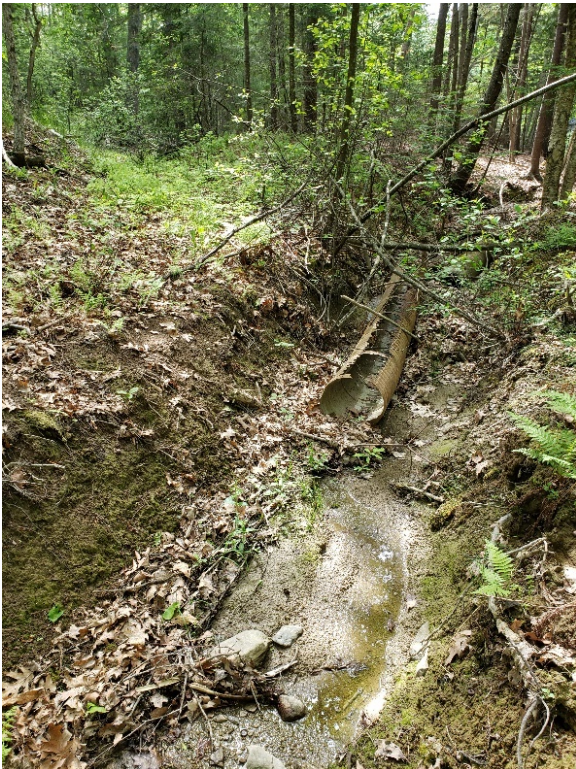
Area used for recreation (hiking trail) but stream itself is too small for recreational use. Concrete and metal culverts observed sitting in channel.

Photo 7: Broken culvert observed in sitting in the channel of Stream 5.

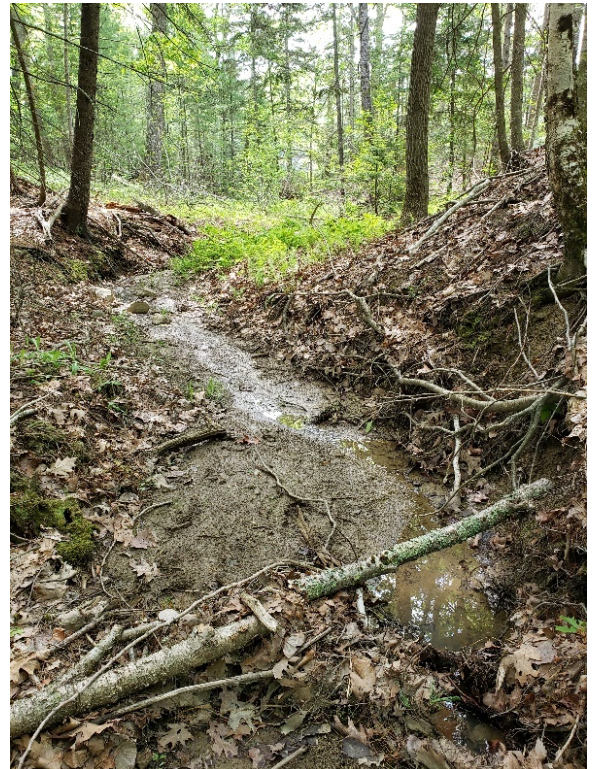
Photo 8: Stream 6, facing downstream near the Nordic property boundary (upstream end of assessment reach).

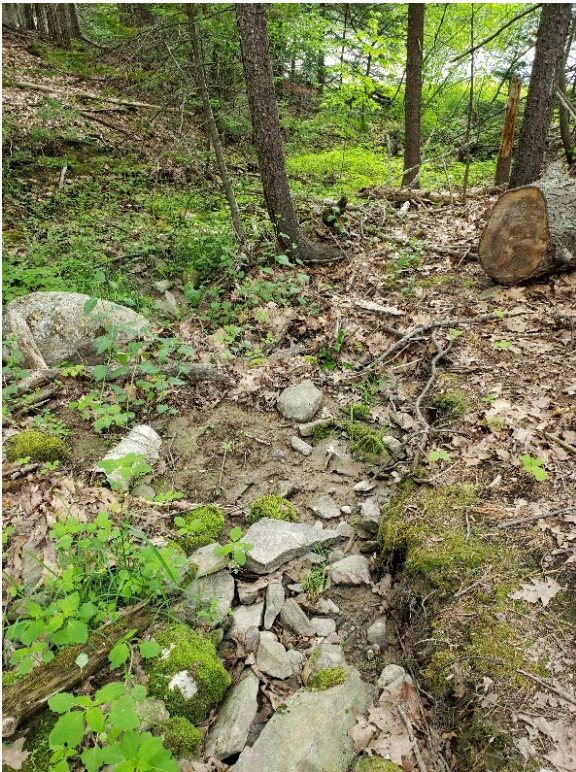
Photo 9: Stream 6, facing downstream from the hiking trail.

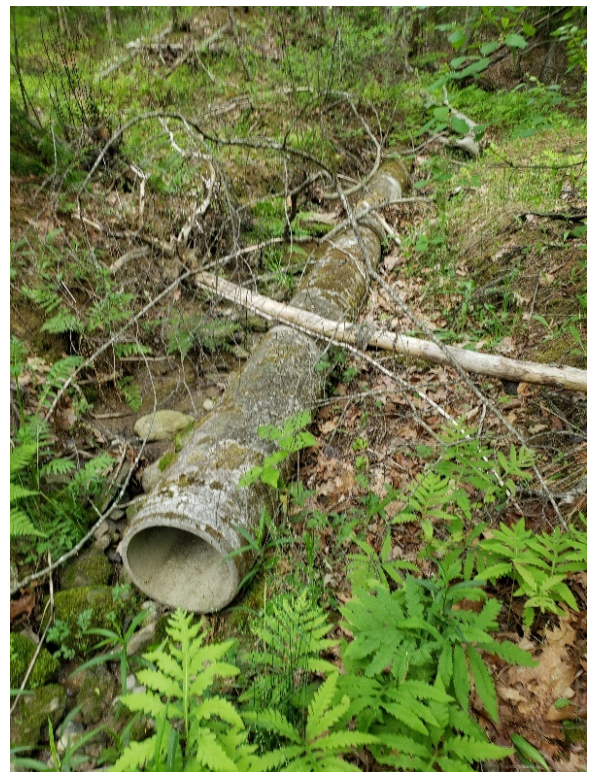
Area used for recreation (hiking trail) but stream itself is too small for recreational use. Concrete culvert observed sitting in channel.

Photo 10: Concrete culvert observed in sitting in the channel of Stream 6.

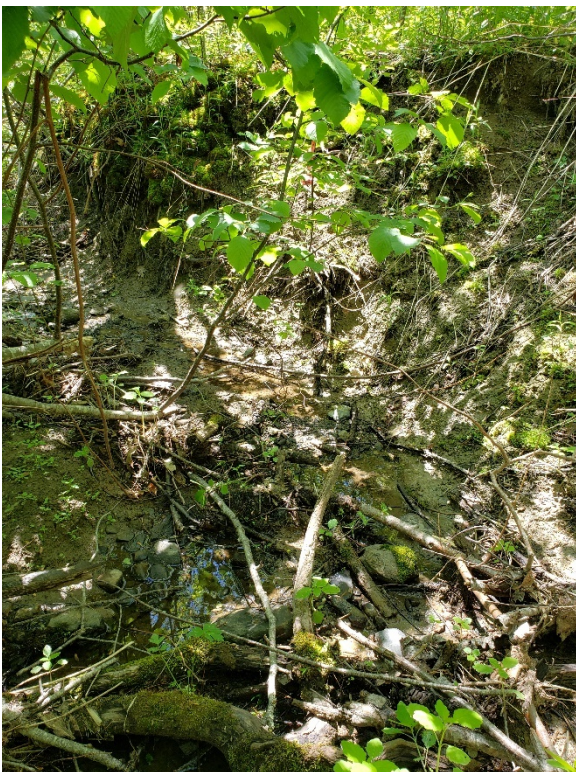
Photo 11: Stream reach 9A, facing downstream near the upstream extent of this reach.

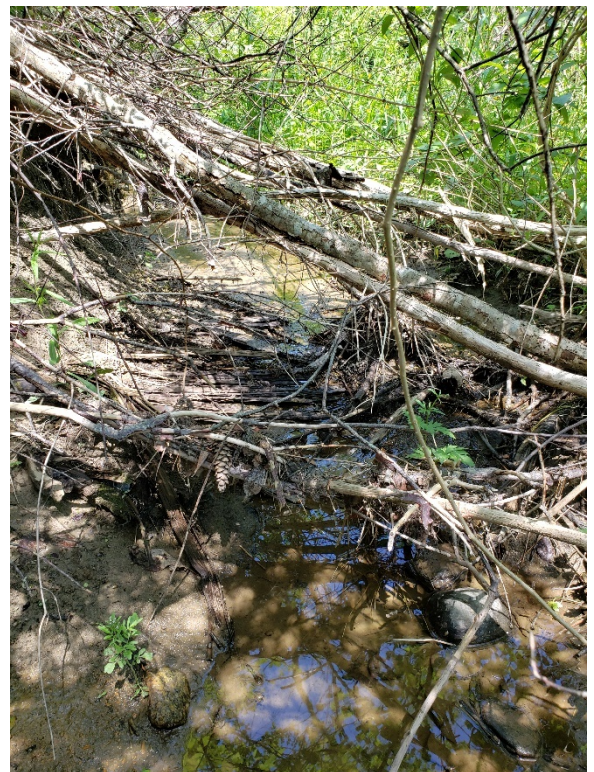
Photo 12: Stream reach 9A, facing upstream near the downstream extent of this reach.

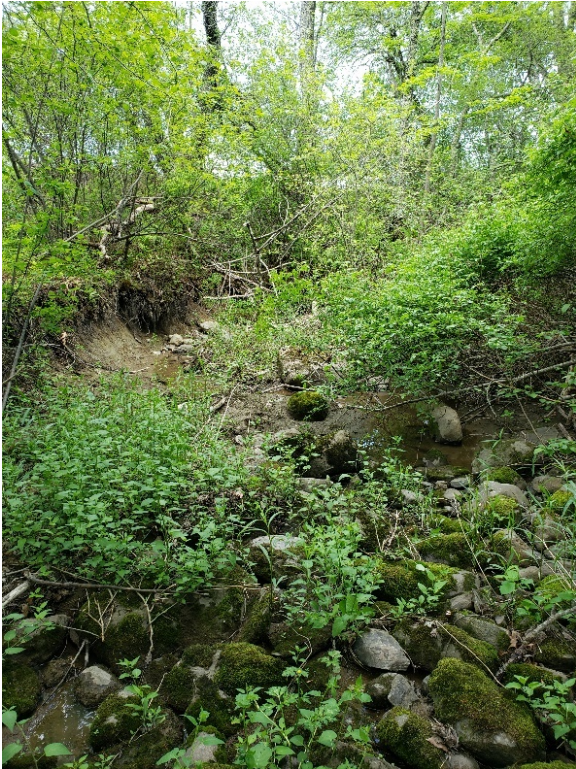
Photo 13: Stream reach 9B, facing downstream near the upstream extent of this reach.

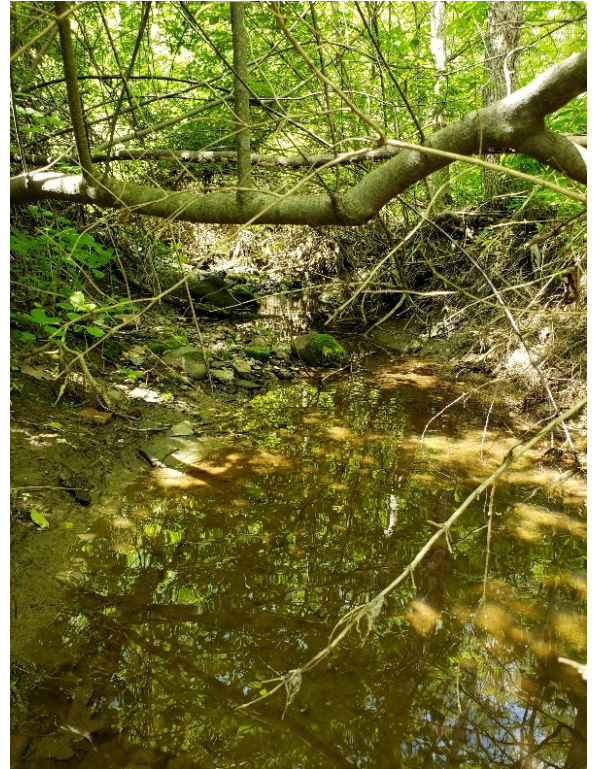
Photo 14: Stream reach 9B, facing upstream near the downstream extent of this reach.

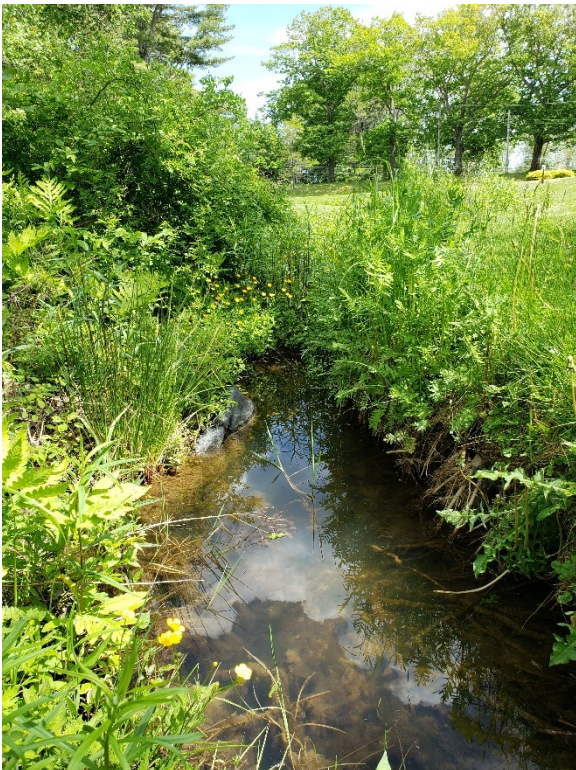
Photo 15: Stream reach 9C, facing downstream near the upstream extent of this reach.

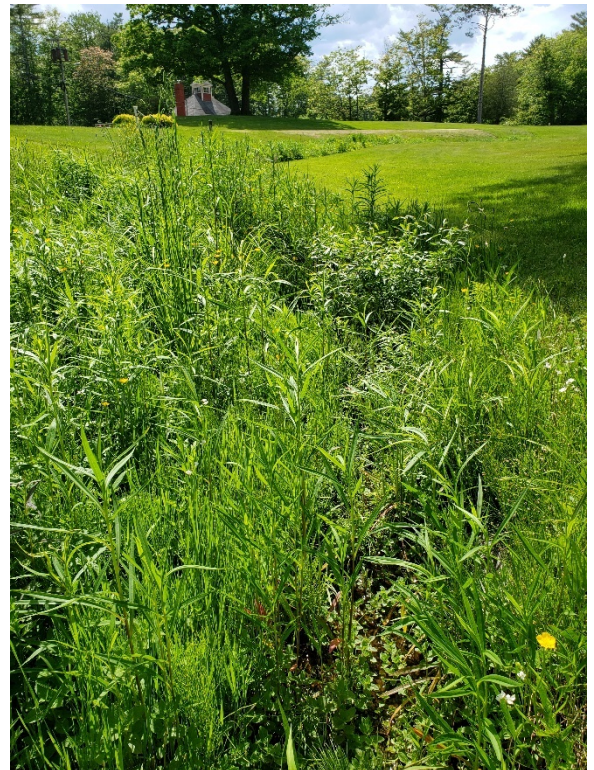
Photo 16: Stream reach 9C, facing upstream near the downstream extent of this reach.

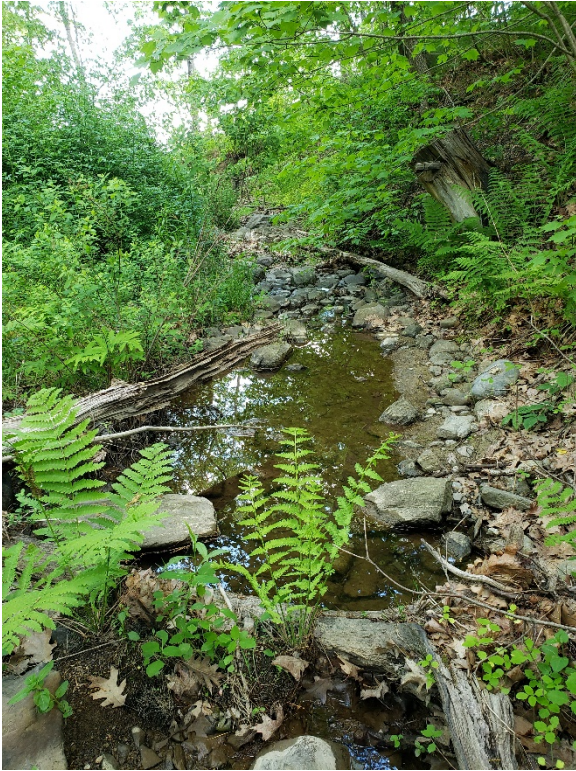
Photo 17: Stream reach 9D, facing downstream near the upstream extent of this reach.

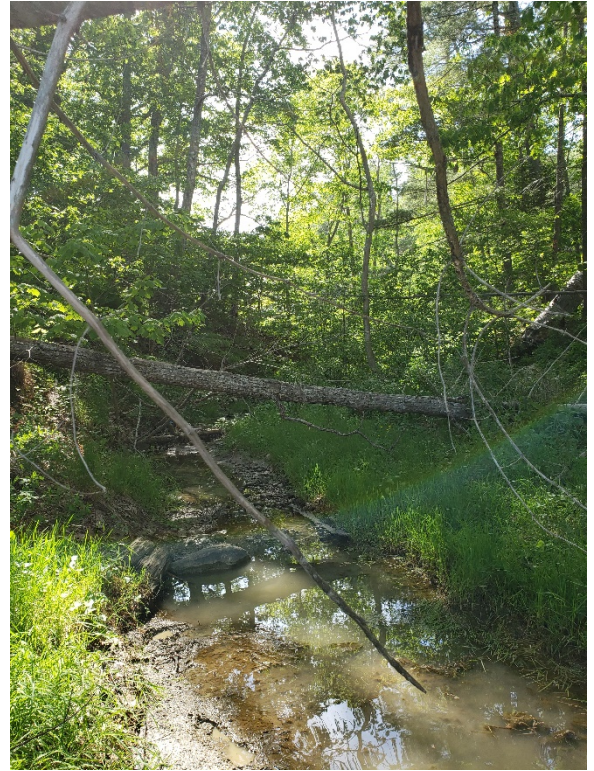
Photo 18: Stream reach 9D, facing upstream near the downstream extent of this reach.

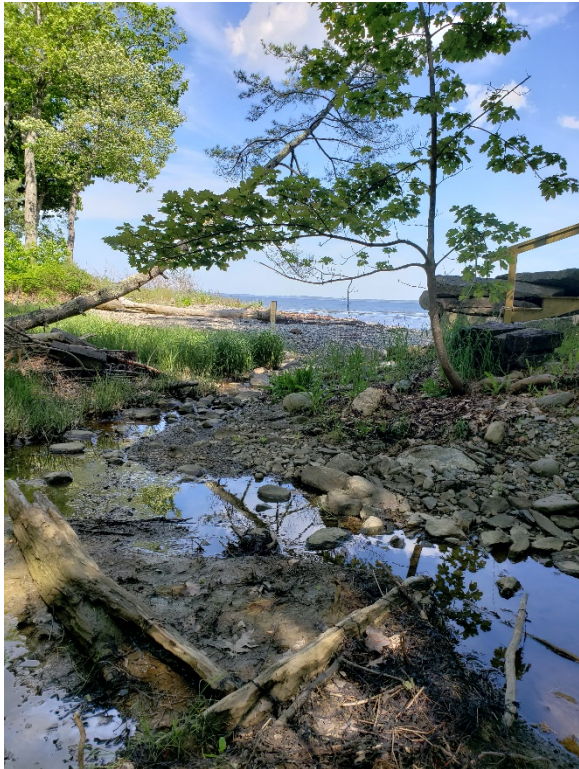
Photo 19: Stream reach 9D, facing downstream where the stream flows into the intertidal zone.
