LUCIA POND
T7R9 NWP, Piscataquis Co.
U.S.G.S. Sebec Lake, Me.

Surveyed - July, 1988
Maine Department of Inland Fisheries and Wildlife.
Funded in part by Federal Aid in Fish Restoration Act under
Federal Project F-28-P.
L0810E

LUCIA POND
T7R9 NWP, PISCATAQUIS CO., MAINE
AREA 46 ACRES

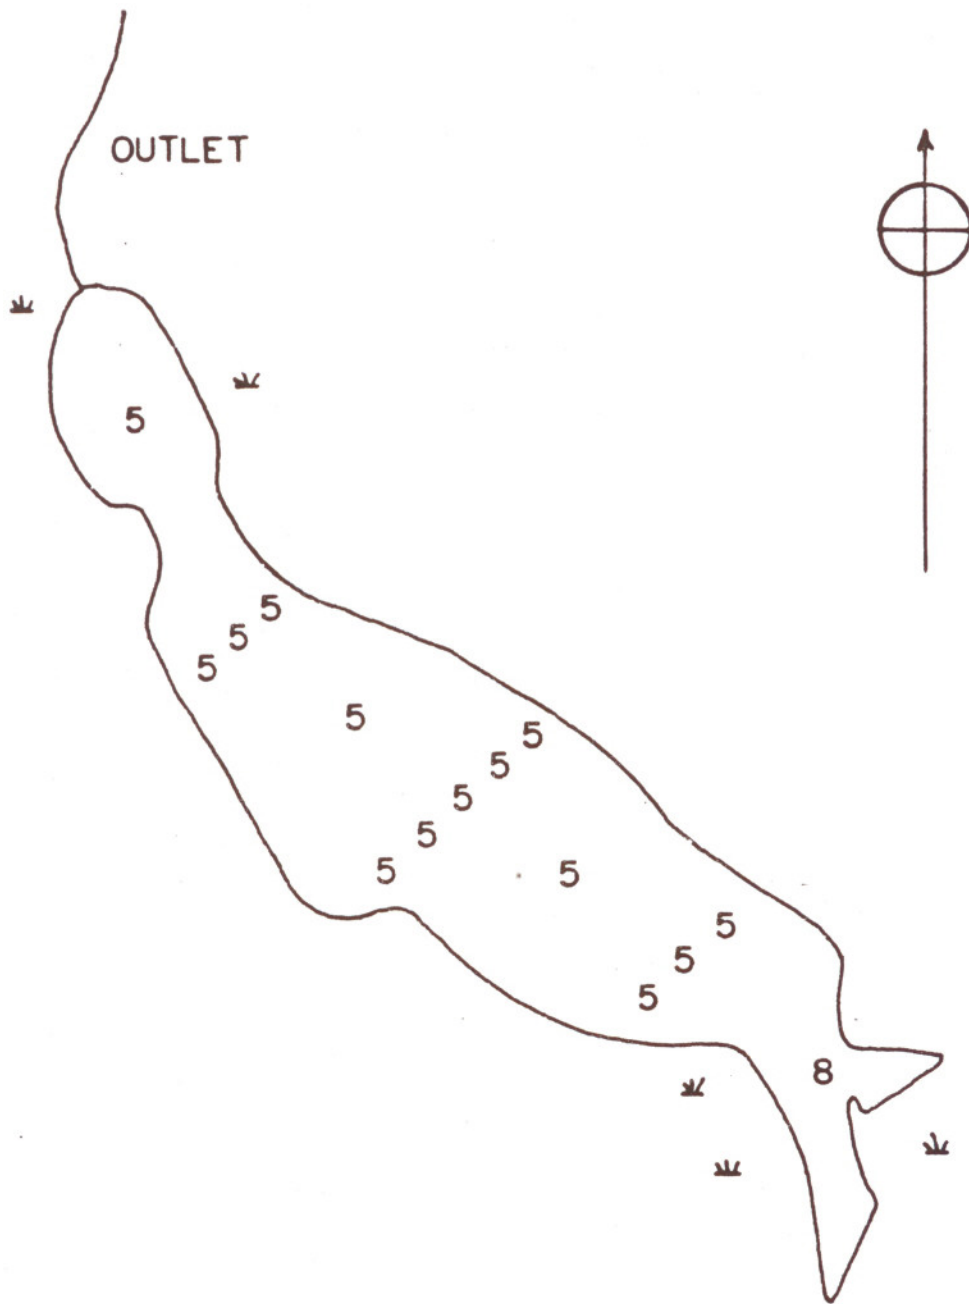
Area - 46 acres

Maximum depth - 8 feet
