Geologic Site of the Month
August, 2011

***Shoreline Erosion at Western and Ferry Beaches
Scarborough, Maine***

Text by
Peter A. Slovinsky

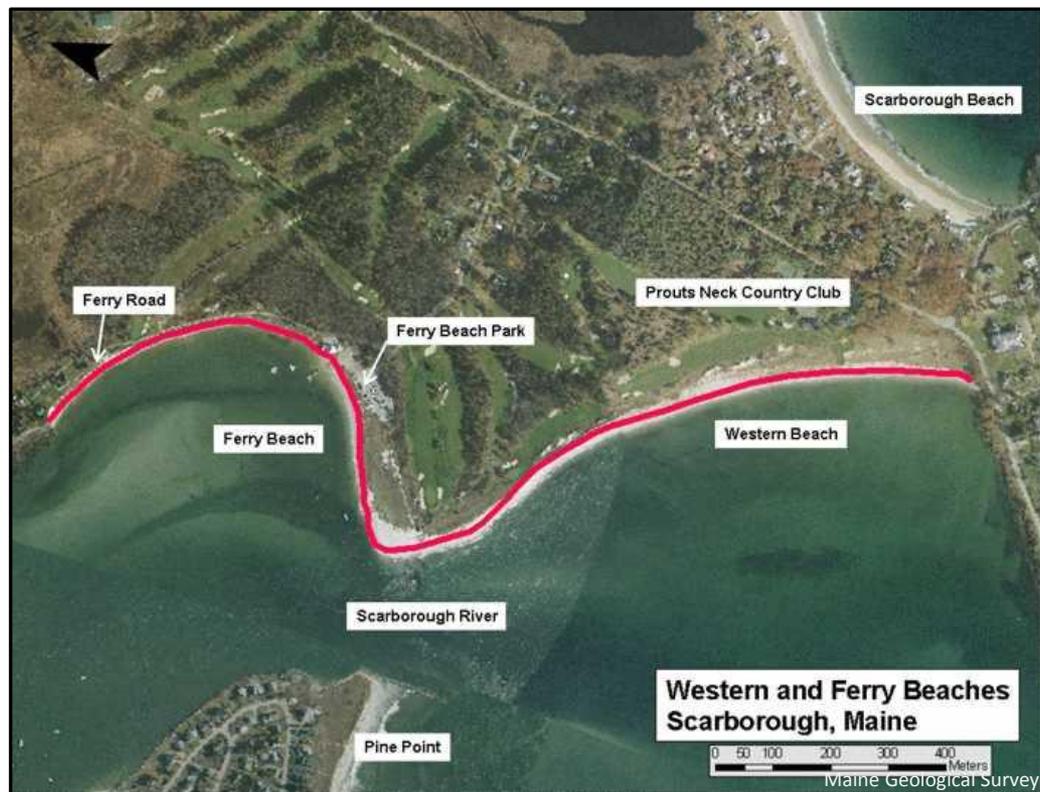
Since the summer of 2005, MGS has been using its Real Time Kinematic Global Positioning System (RTK-GPS) to measure notable alongshore shoreline features at Western Beach, where nourishment was undertaken, and at nearby Ferry Beach, and the neighboring beach that fronts Ferry Road (Figure 1).

Figure 1. Location of study areas that have been surveyed by MGS as part of the Maine Beach Mapping Program. Surveyed areas are shown in red and include Western Beach and Ferry Beach.

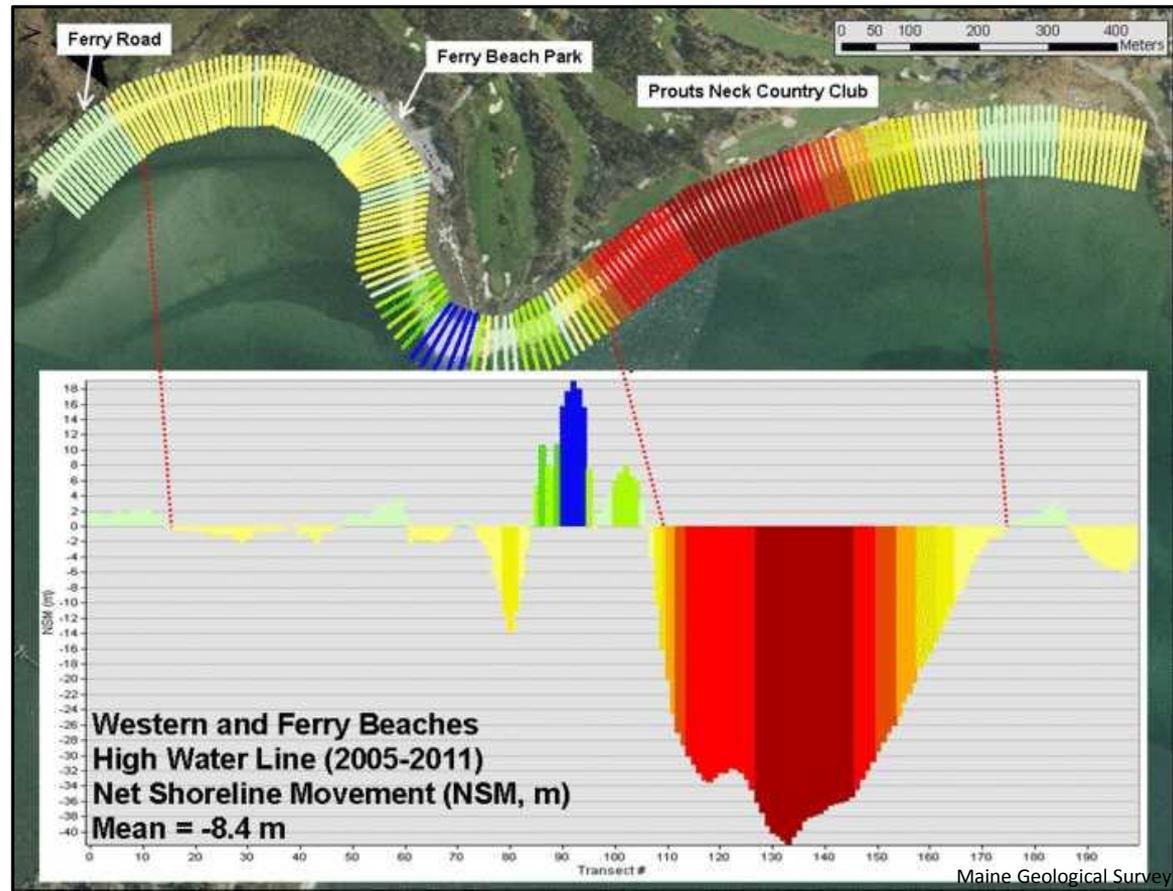
Figure 2. Color-coded transects showing net shoreline movement (in meters) from 2005-2011 of the high water line along both Western and Ferry Beaches, Scarborough.

The DSAS transects have been color-coded to represent different ranges of NSM, with light green and blue colored transects indicating accretion, and yellow to red colored transects indicating different levels of erosion. A corresponding graph that illustrates shoreline change data is included. Reference points, marked by dashed red lines, show the relationship between transects and the graphed shoreline change data. Note that transect and graph colors will vary for each figure shown, so pay attention to the Y-axis scale of the graphs.

For the overall study area, the mean NSM value for the high water line was -8.4 meters, indicating that as a whole, the study area has undergone substantial landward movement of the high water line from 2005-2011, indicative of beach erosion. Based on Figure 2, the high water line along Western Beach has eroded dramatically over this time period, up to 40 meters at its highest point, while accretion has occurred at the point between Ferry and Western Beach, up to about 20 meters.

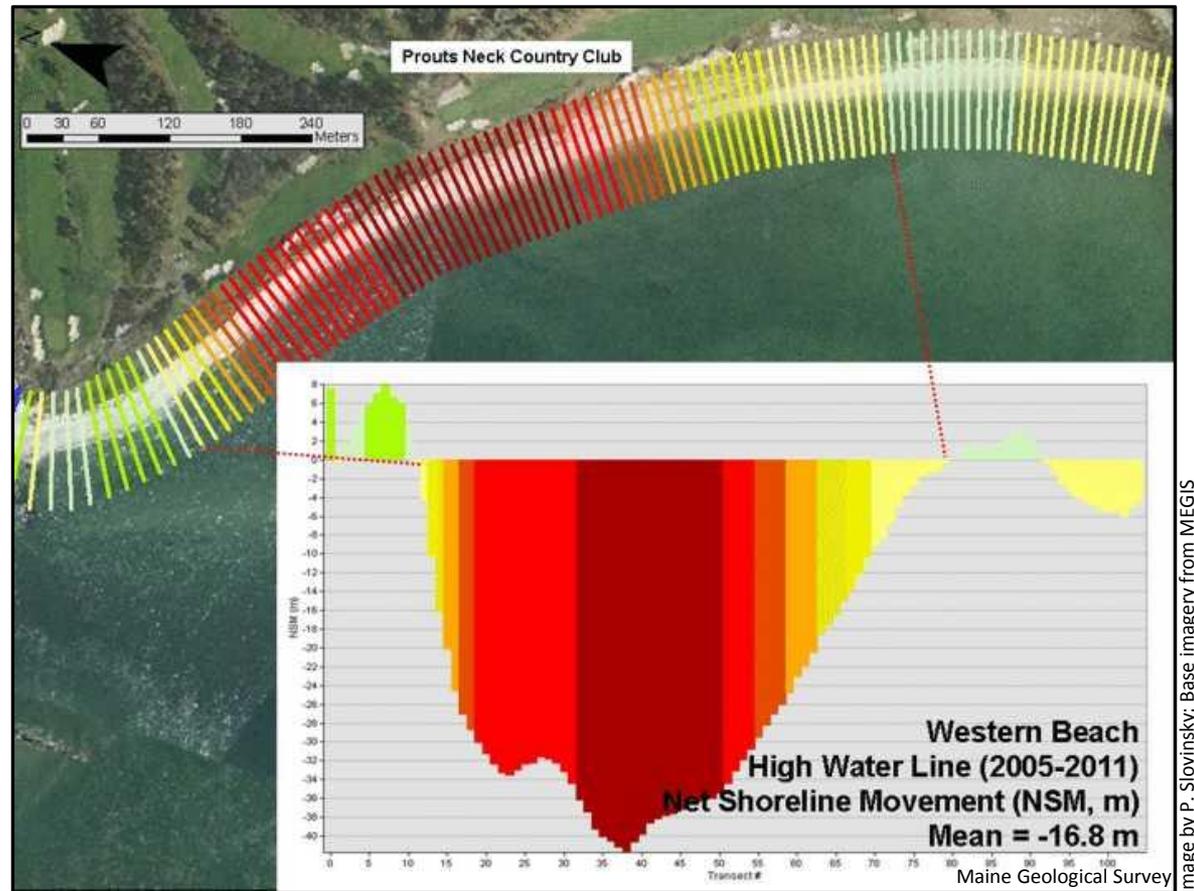
Figure 3. Color-coded transects showing net shoreline movement (in meters) from 2005-2011 of the high water line along Western Beach, Scarborough.

The central portion of the beach has undergone the most erosion, with the high water line receding up to 40 meters. Nodal points exist, where the trend switches from erosion to accretion; these points are marked with dashed red lines. The erosive trend switches to accretion nearest the point at the Scarborough River entrance, and at a small pocket along the eastern end of the beach. From 2005-2011, the mean NSM value for Western Beach is calculated to be -16.8 meters, indicating extensive erosion. Sand at Western Beach appears to be migrating from the central portion of the beach to the northwest (to the sand spit at the point), and slightly to the southeast, towards Prouts Neck.

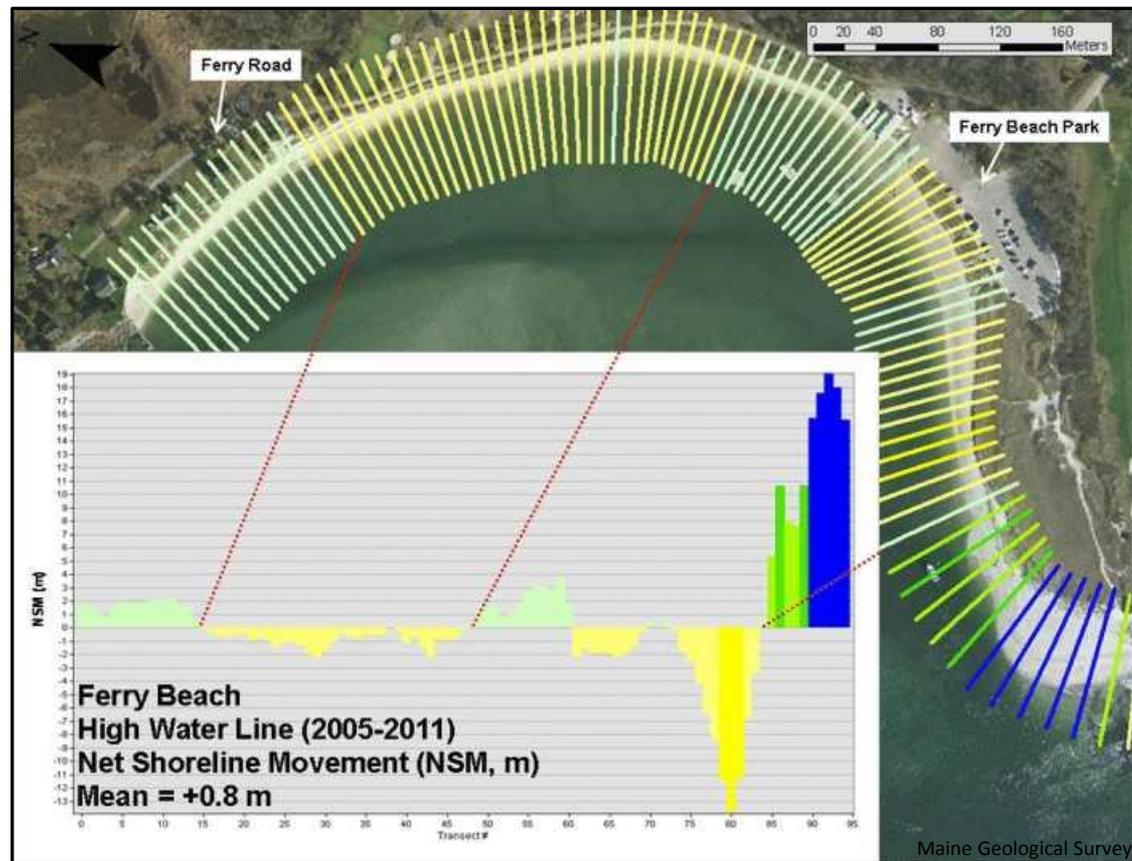
Figure 4. Color-coded transects showing net shoreline movement (in meters) from 2005-2011 of the high water line along Ferry Beach, Scarborough.

Nearest the point, a sand spit has clearly formed, with seaward movement of the high water line of up to 19 meters, indicating large amounts of accretion. Meanwhile, the high water line along Ferry Beach Park appears to be moving landward, indicating erosion of the beach and loss of dry beach space. Just past the boat houses, this trend reverses, showing slight accretion. Erosion of about 2 meters has occurred along Ferry Road, but accretion at the northwestern end of the beach, nearest the houses, is apparent. This stretch of beach has a mean NSM value of +0.8 m, indicating stability to slight accretion along the beach. The sand appears to be moving from Western Beach and is being trapped in a spit at the point.

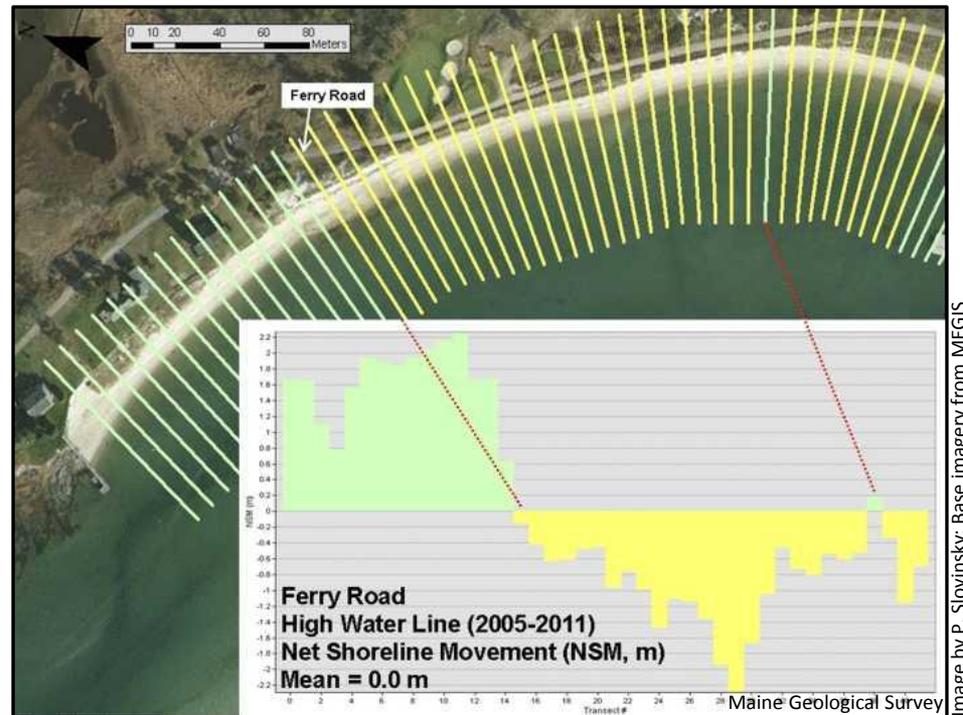
Figure 5 shows a close-up view of the net shoreline changes in the high water line along Ferry Road only. The southeastern portion of the beach along the road underwent clear erosion, up to about -2.2 meters; however, the northwestern portion of the beach, nearest the houses, has undergone accretion of about the same amount. The mean NSM value in this portion of the beach is 0.0 meters, indicating stability. The sand here clearly appears to be moving from southeast to northwest along the beach.

Figure 5. Color-coded transects showing net shoreline movement (in meters) from 2005-2011 of the high water line along a section of Ferry Road, Scarborough.

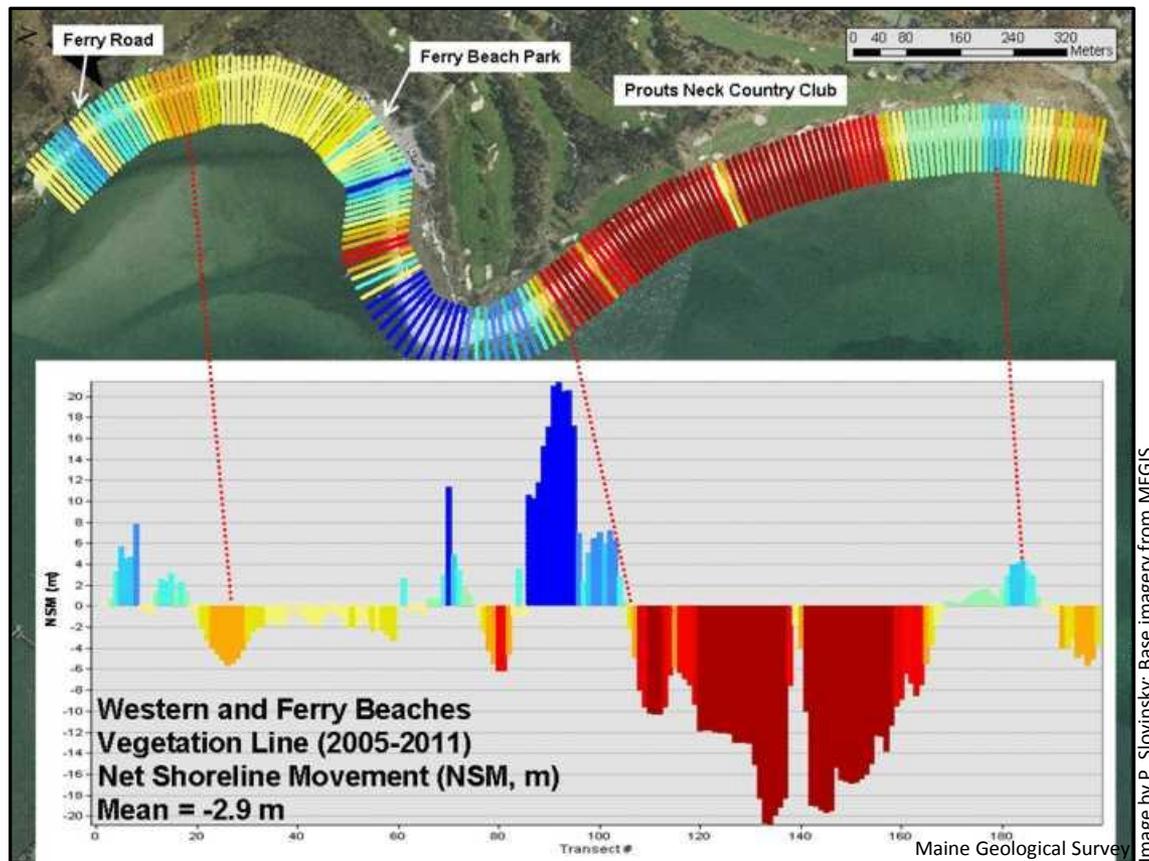
Figure 6. Color-coded transects showing net shoreline movement (in meters) from 2005-2011 of the vegetation line along both Western and Ferry Beaches, Scarborough.

Generally, the vegetation line is following the same overall trends as the high water line. That is, large amounts of dune erosion are concentrated along the central portion of Western Beach, while the dune has been prograding (building seaward) along the spit at the point between Western Beach and Ferry Beach. Along Ferry Beach, the dunes have undergone slight erosion from 2005-2011, with an isolated pocket of growth nearest the parking lot. The largest amount of dune erosion along Ferry Beach appears to be concentrated along a section of Ferry Road. The mean NSM value for the overall study area is -2.9 meters, indicating that overall, the dune is eroding.

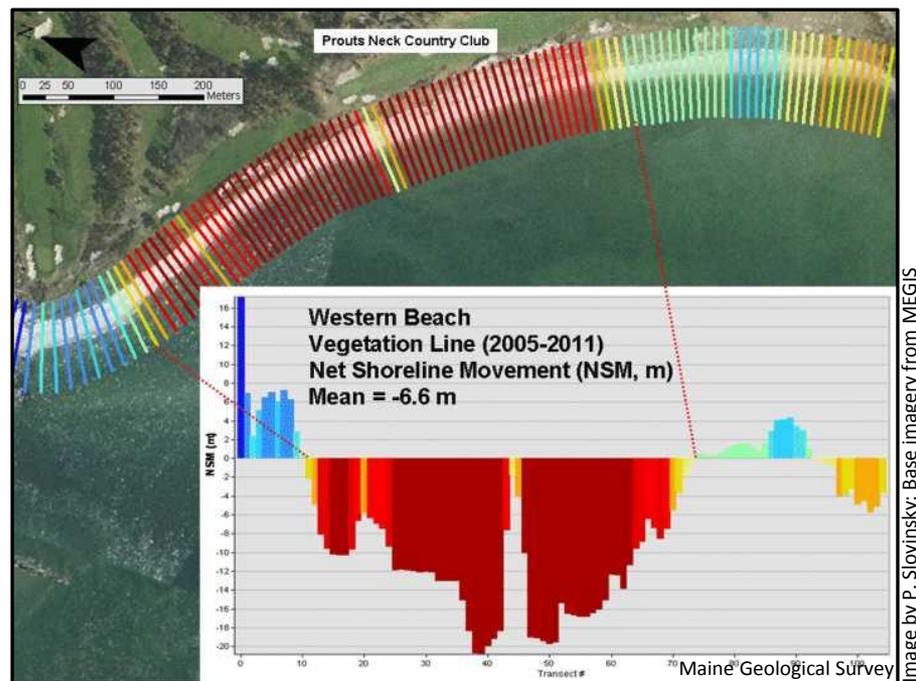
Figure 7 shows the net shoreline movement of the vegetation line along Western Beach specifically. The dune underwent the same trend as the high water line; that is, large amounts of erosion at the central portion of the beach (up to about 20 meters), with large amounts of dune growth near the point, and slightly smaller amounts to the southeast portion of the beach. The dunes in the southeastern-most portion of the beach, nearest Prouts Neck, have eroded up to about 6 meters from 2005-2011. The mean NSM value for the vegetation line along Western Beach is -6.6 meters.

Figure 7. Color-coded transects showing net shoreline movement (in meters) from 2005-2011 of the vegetation line along Western Beach, Scarborough.

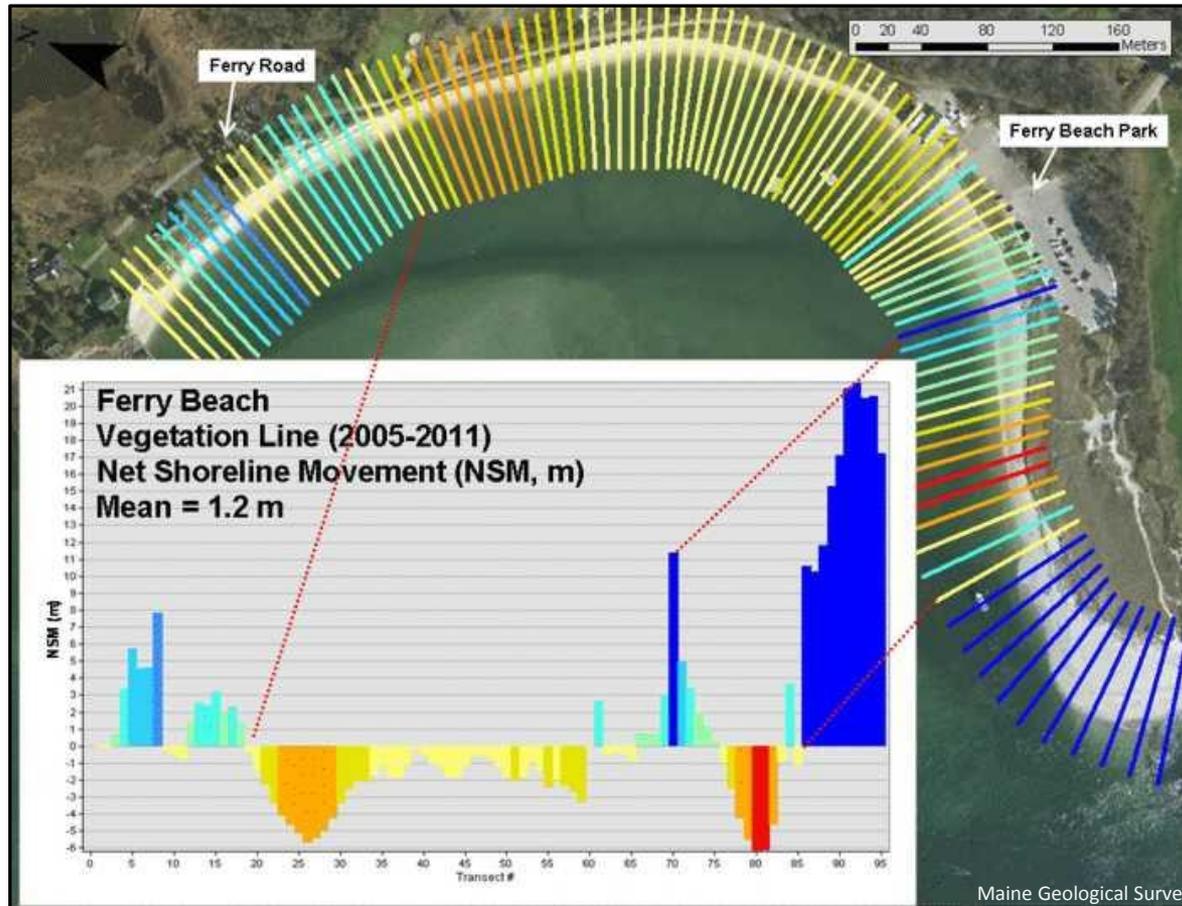
Figure 8. Color-coded transects showing net shoreline movement (in meters) from 2005-2011 of the vegetation line along Ferry Beach, Scarborough.

The dune has prograded dramatically nearest the point, with upwards of 20 meters of growth. This trend turned erosive, just around the corner, for a short stretch of the beach, but good dune growth was noted along most of Ferry Beach proper. The trend turned erosive again near the boat houses, with the dunes along this stretch and along the southeastern part of Ferry Road eroding around 2-3 meters. Along the rest of Ferry Road, erosion increased to around 4-6 meters, and a nodal point exists, where the dunes instead grew seaward up to about 8 meters, nearest the homes along Ferry Road. The mean NSM value for the vegetation line along Ferry Beach is +1.2 meters.

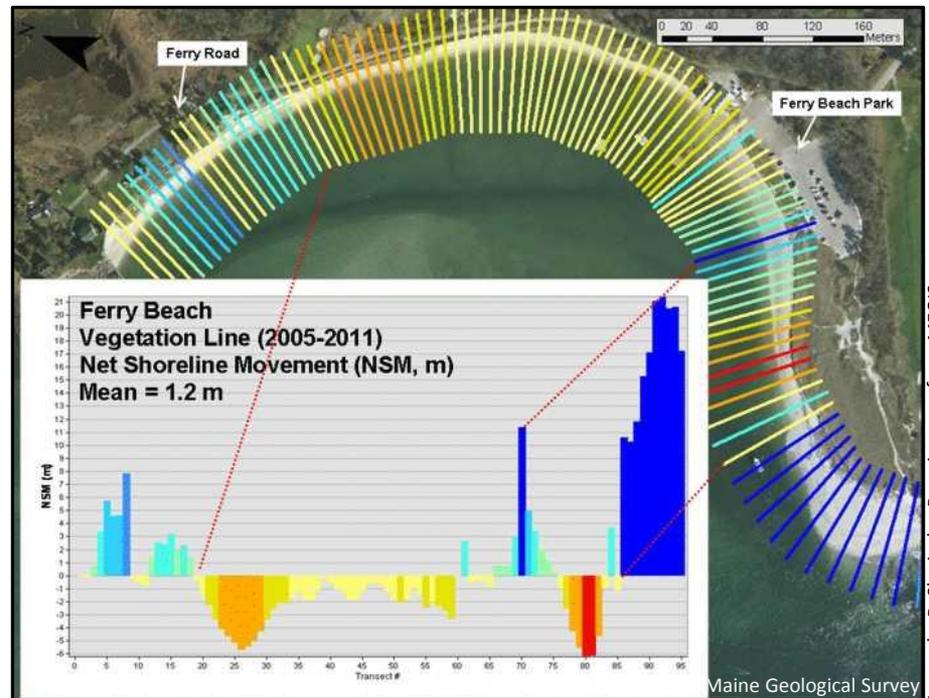
Figure 9 shows the net shoreline movement of the vegetation line along Ferry Road only. The dunes along Ferry Road show similar changes as the high water line, with erosion along the eastern portion of the road up to around -5 meters. A distinct nodal point is apparent (near transect 20) where this trend changes to dune growth, nearer the houses, similar to the high water line trend. The dunes here underwent growth of up to 8 meters. The mean NSM value for the vegetation line along Ferry Road is -0.5 meters.

Figure 9. Color-coded transects showing net shoreline movement (in meters) from 2005-2011 of the vegetation line along a section of Ferry Road, Scarborough.

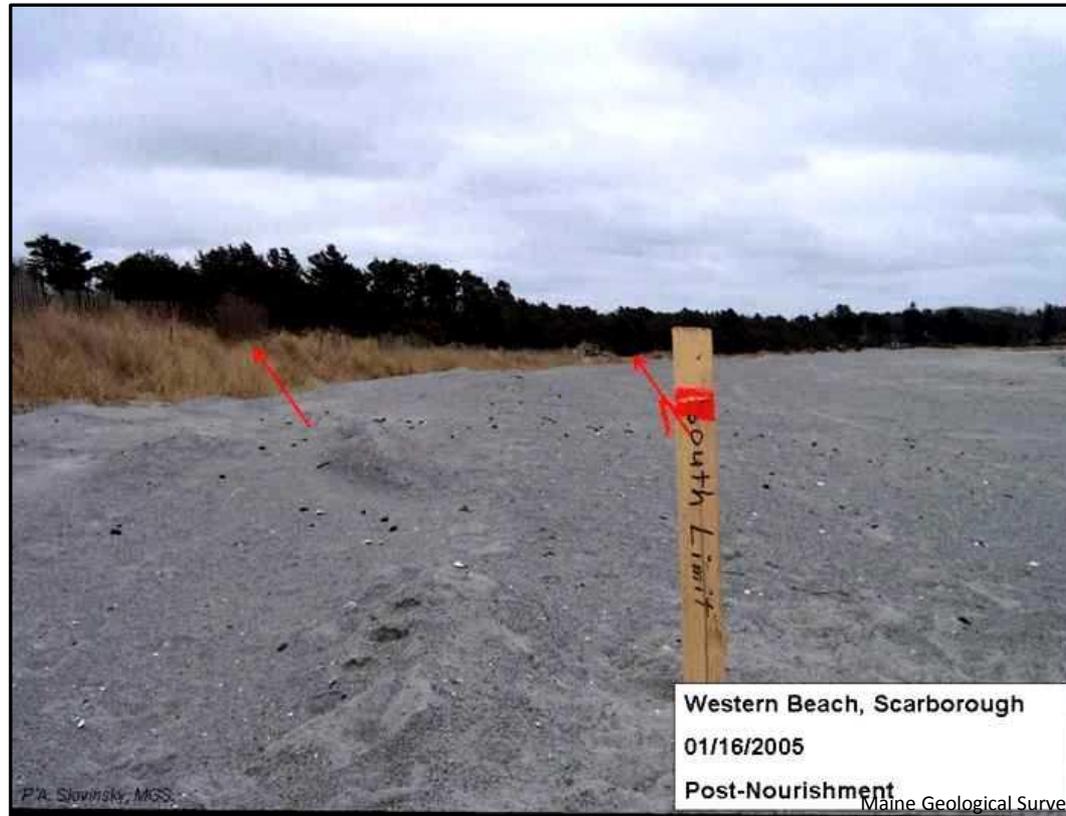
The changes along this central portion of Western Beach are reflected very well by comparing photographs taken by MGS of the beach and dune from 2005 and 2011. Figure 10 shows the beach and dune in June 2005, with a stake marking the southern limit of the beach nourishment project.

Figure 10. Photograph, looking east, along the post-nourishment beach in June 2005. Red arrows indicate landmarks for comparison with Figure 11.

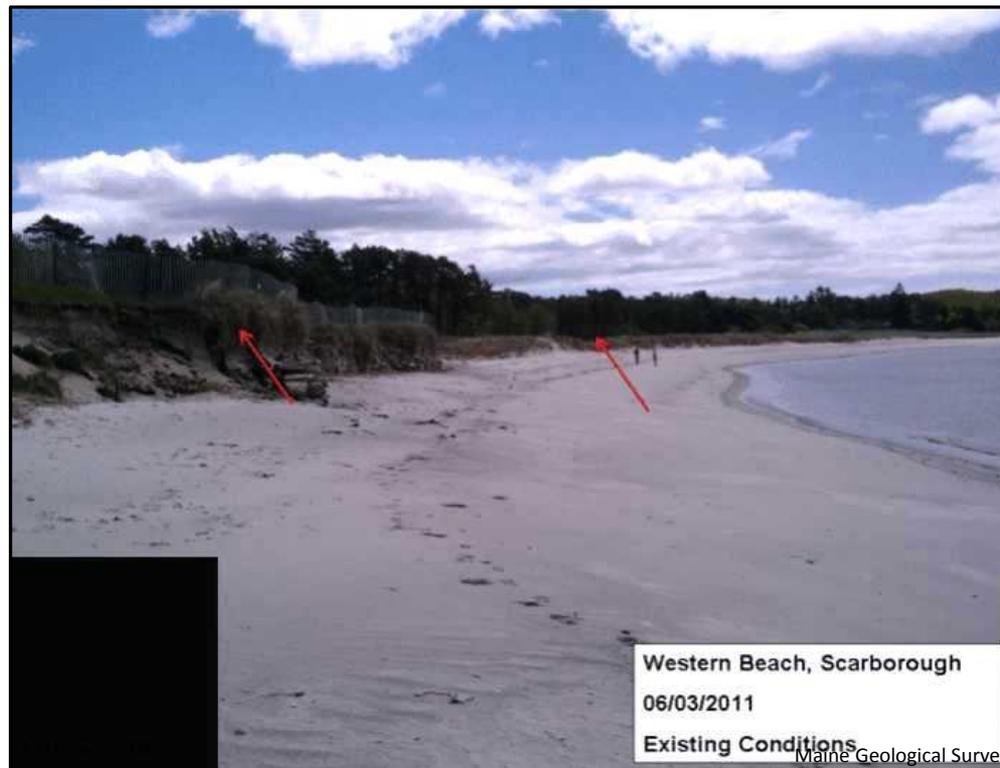
Figure 11 shows the beach and dune condition in June 2011 from the same approximate location. The arrows in the photographs are meant to show landmarks (a patch of grass and a low area of the dune crest) which are apparent in both pictures. Note the dramatic loss and lowering of the beach, and the scarping (vertical cutting) of the dune.

Figure 11. Photograph, looking east, along the approximate same stretch of beach shown in Figure 10 in June 2011. Note loss of beach elevation, and scarping of dune.

This type of shoreline change analysis can help determine erosion and accretion patterns along the beach, which in turn, helps determine expected future nourishment lifetimes at Western Beach. It also can be used to help pinpoint where future nourishment may be placed along Western Beach in order to maximize the beach and dune shape, fill lifetime, and hence beach and bird habitat, should a future dredging project occur by the U.S. Army Corps of Engineers.

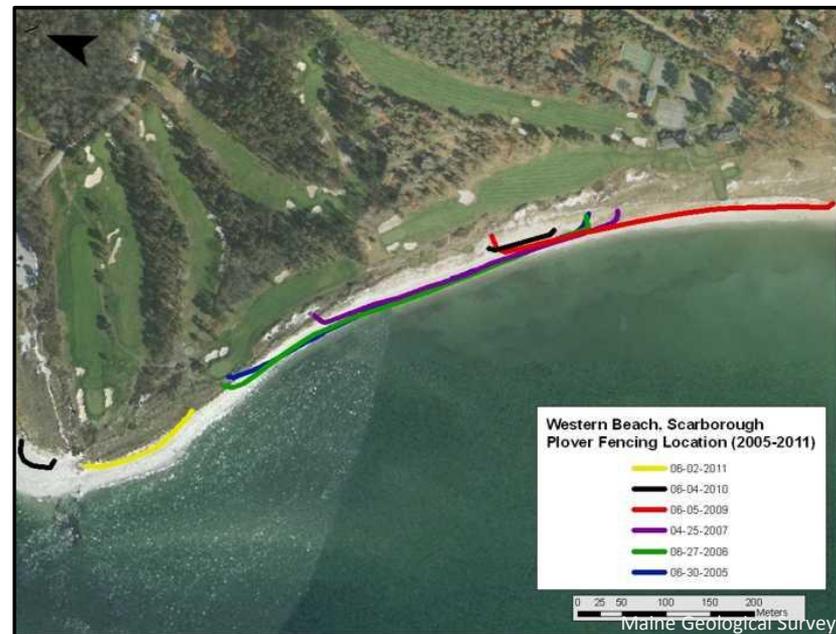
Figure 12 shows the changes in bird fencing placed by the Maine Audubon Society from 2005 through 2011. In June of 2005 (blue line) and 2006 (green line), the entire central portion of the beach was fenced for habitat. In 2007 (purple line), the fencing area decreased on its northern side. No data was collected in 2008, but by 2009 (red line), the fencing was concentrated at the southeastern end of the beach. By 2010, the fenced habitat was decreased to a small section in the central portion of the beach, and around the point along the Ferry Beach side. In 2011, only a small section near the northern end of the beach was fenced for bird habitat. It is clear that the amount of available bird habitat has decreased substantially as the beach has eroded.

Figure 12. Locations of bird habitat fencing placed by Maine Audubon Society from 2005-2011.
