Geologic Site of the Month  
December, 2004

***Coastal Landslide with Outrunner Blocks  
Bunganuc Bluff***

Text by  
Thomas K. Weddle and Henry N. Berry IV

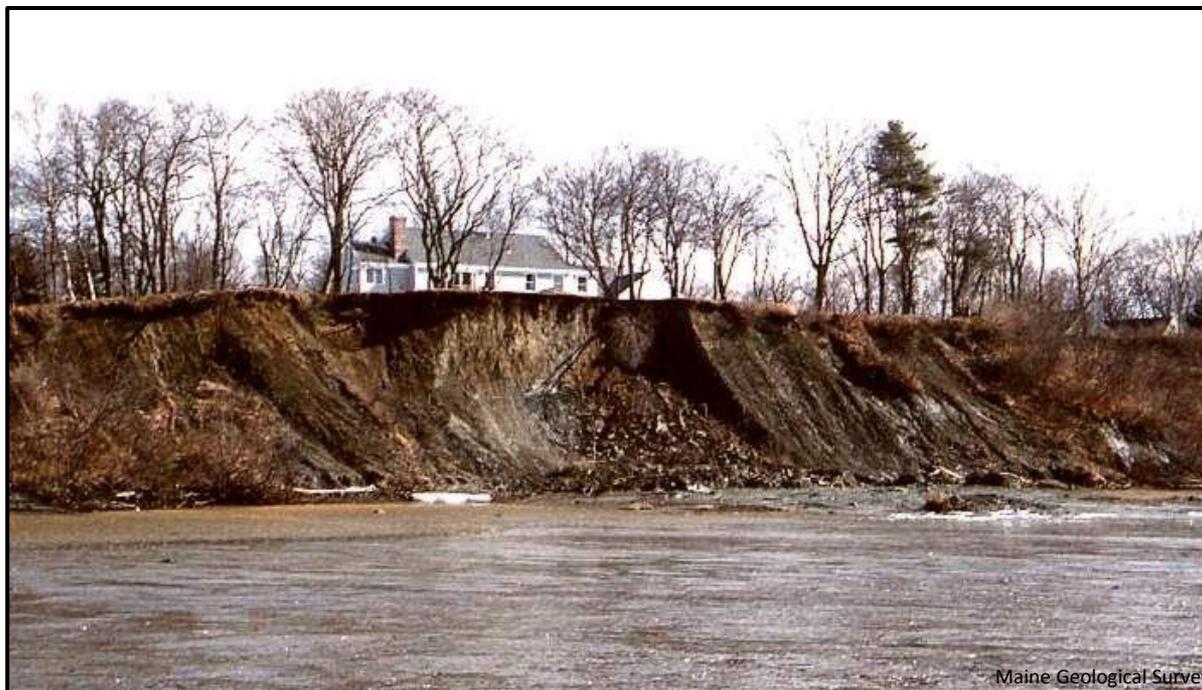
**Figure 1.** Photo of Bunganuc Bluff, 1997; landslide scarp is near the center of the bluff below house in background. The top of the bluff is approximately 40 feet above the mudflat.

In late March of 1997, staff at the Maine Geological Survey received a telephone call from a concerned homeowner in the coastal area in Brunswick, Maine, known as Bunganuc. The homeowner reported that a few days earlier, a landslide (Figure 1) occurred on his property at the edge of the coastal bluffs of glacial marine deposits exposed there.

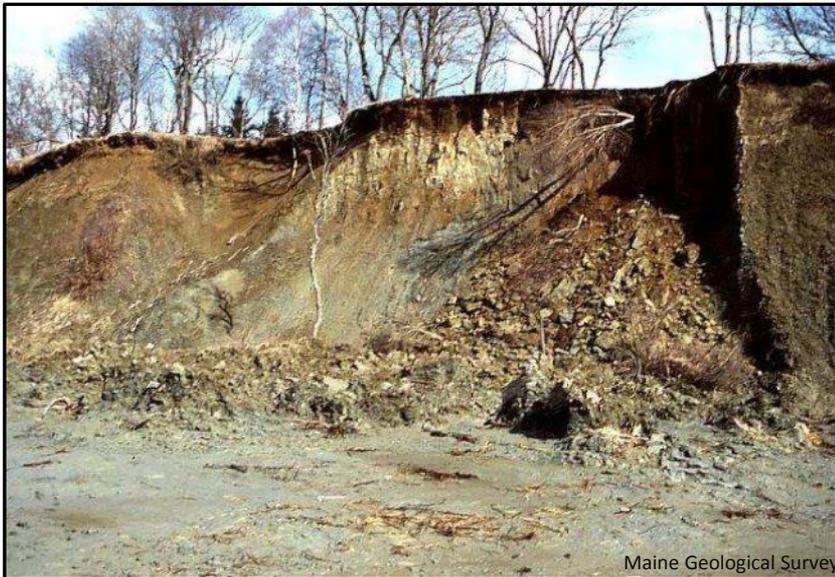
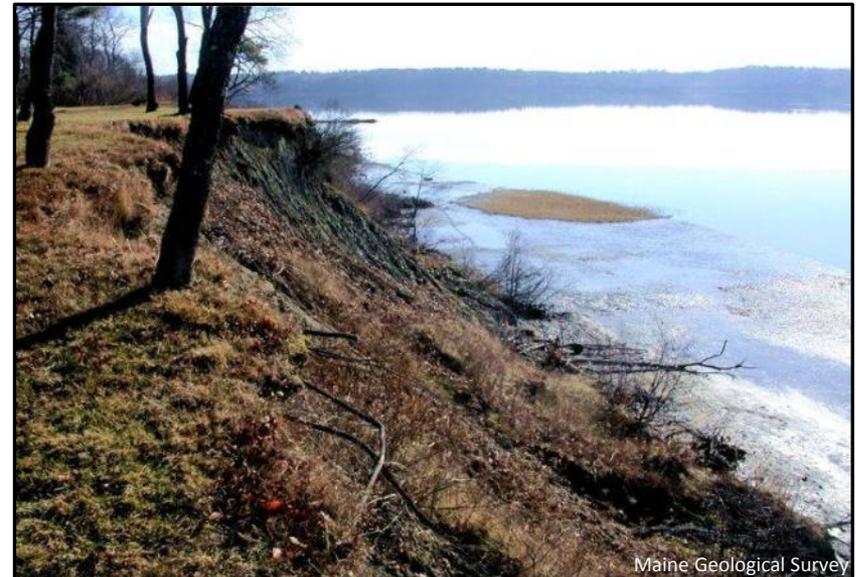
**Figure 2.** (Left) Close-up of slump in 1997. (Right) November 2004 photo. Old 1997 landslide scarp is just to the left of the most prominent part of the bluff in the center of the photo (dead trees at base). Note light gray mud at base of scarp lying on the mudflat; this is a remnant of a small slump that occurred fairly recently, and is now being reworked by tidal and wave activity.

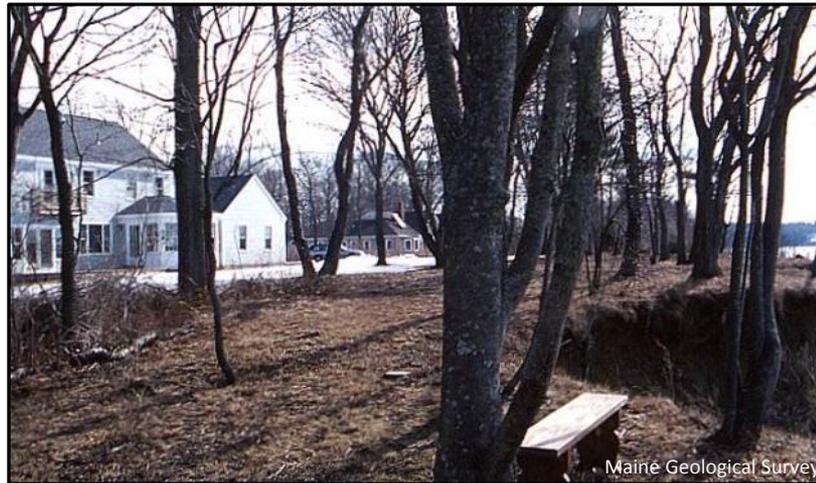
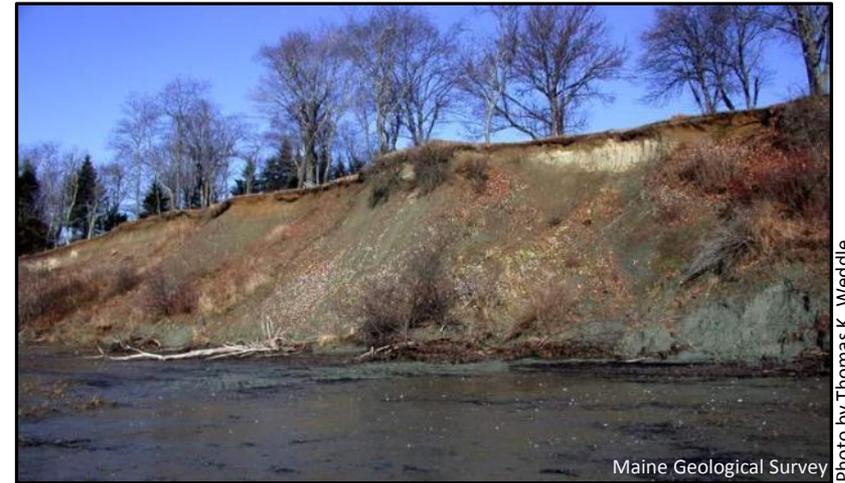
**Figure 3.** (Left) Photo from 1997 of house above landslide scarp (head of scarp is visible in right of photo). (Right) Photo from 2004. The fresh exposures of clay along the base of the bluff indicate that the bluff is still being gradually eroded at high tide. Erosion at the foot of the bluff steepens the bluff slope and will eventually lead to another landslide.

However, he felt that with enough shore frontage, he was willing to take the risk of building in a landslide-prone area. Following the slide in March, the owner's home measured approximately 100 feet from the edge of the landslide head scarp (Figures 3 - 4), and he thought it was important to contact the Survey.

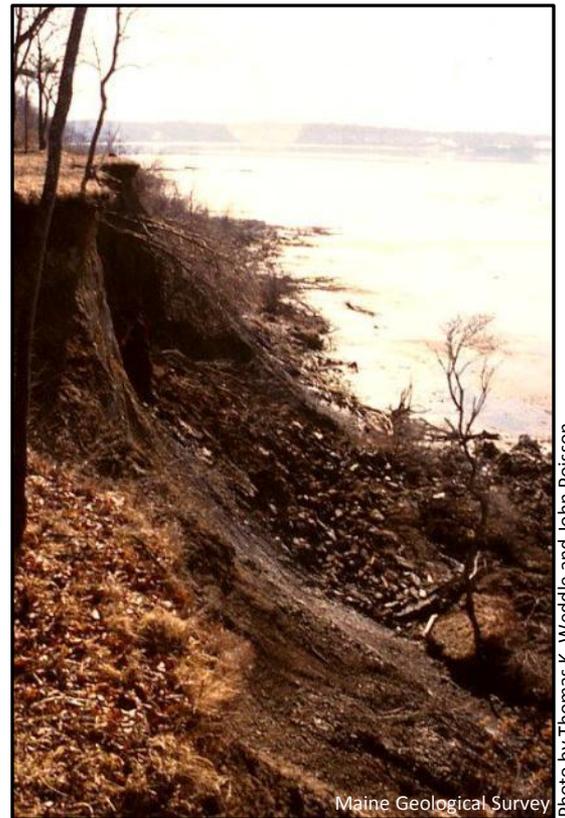
**Figure 4.** Photo of head of scarp, 1997.

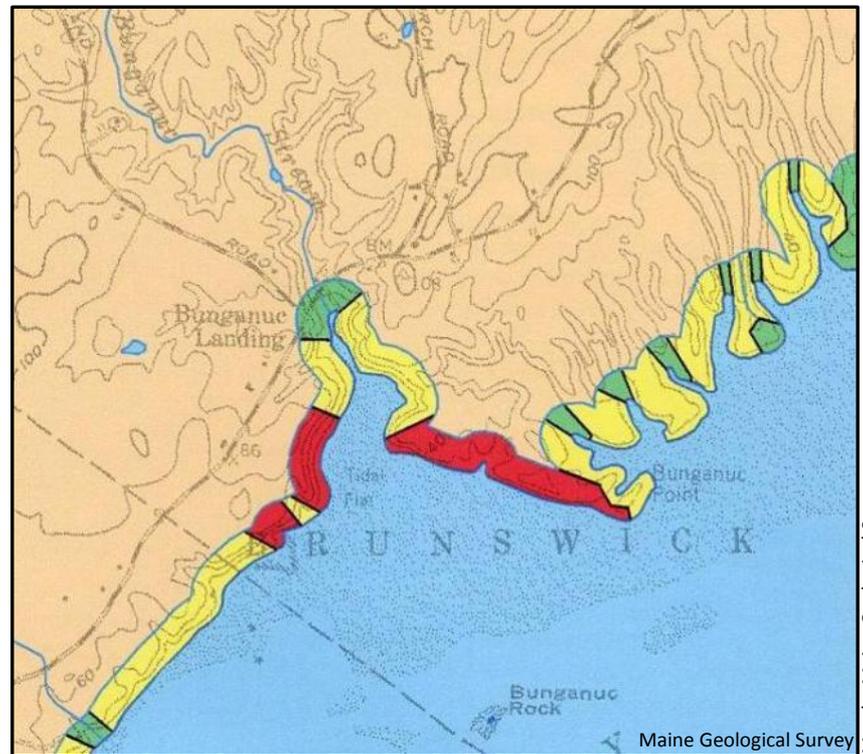
**Figure 5.** Bunganuc area as shown on part of the [Coastal Landslide Hazard Map](#) of the Freeport quadrangle. Red indicates areas of known or interpreted landslides. Areas colored yellow are potential landslide areas; green colored areas are low coastal bluffs generally not at risk of landslides (Refer to [map explanation pdf](#) for more details).

The Maine Geological Survey has published a series of [Coastal Landslide Hazards Maps](#) that covers most of Maine's coastal bluffs. The Bunganuc area is shown on the Coastal Landslide Hazard Map of the Freeport quadrangle to be a location of known or interpreted landslides (Figure 5).

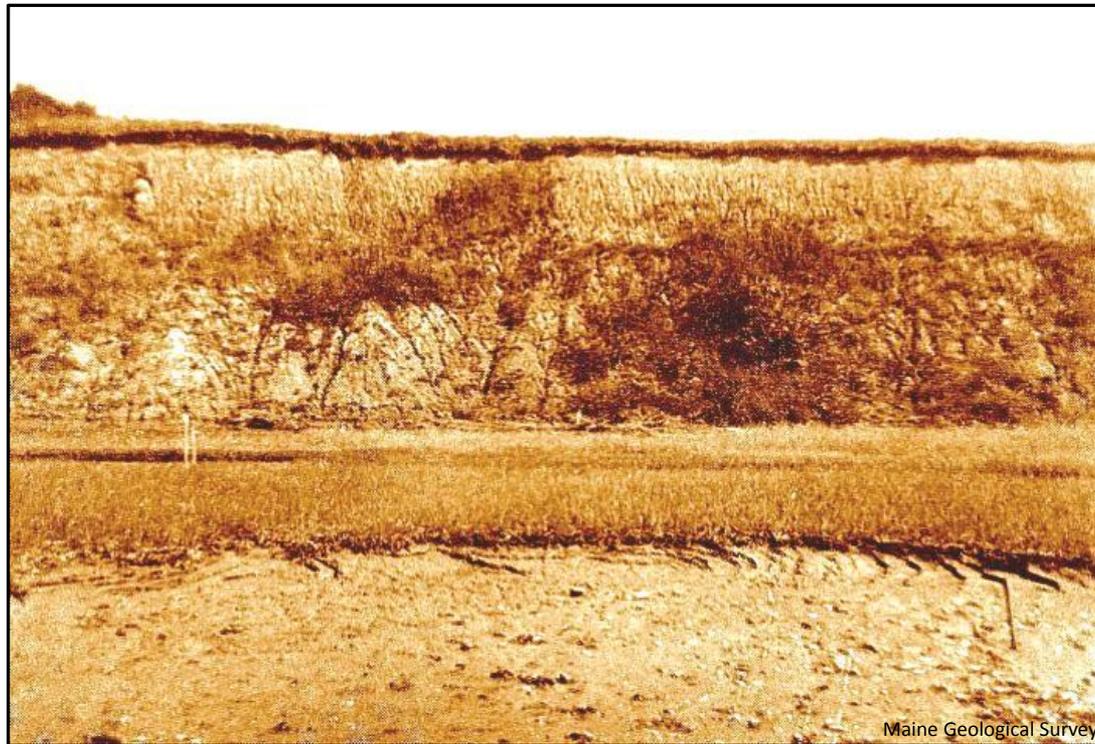
**Figure 6.** View of the bare brown marine clay bank at Bunganuc Shore.

Moreover, landslides in the area were documented in reports as early as March 1952 (Figure 6) in the Report of the State Geologist 1951-1952. Slides at the bluffs have been known by local people well before the early 1950's. The mudflat, exposed during low tide, is a prime clam and worm-digging locale. The source of the mudflat is the glacial marine clay found in the bluff; it is eroded by the landslide process and is distributed to the mudflat by tidal cycles and wave processes.

All three of these 1953 archival photos (Figures 6-7) show the bluff where the March 1997 slide occurred. Notice the lack of trees at the top of the bluff, and no visible homes. Residential development in this location has been relatively recent, starting after 1980.

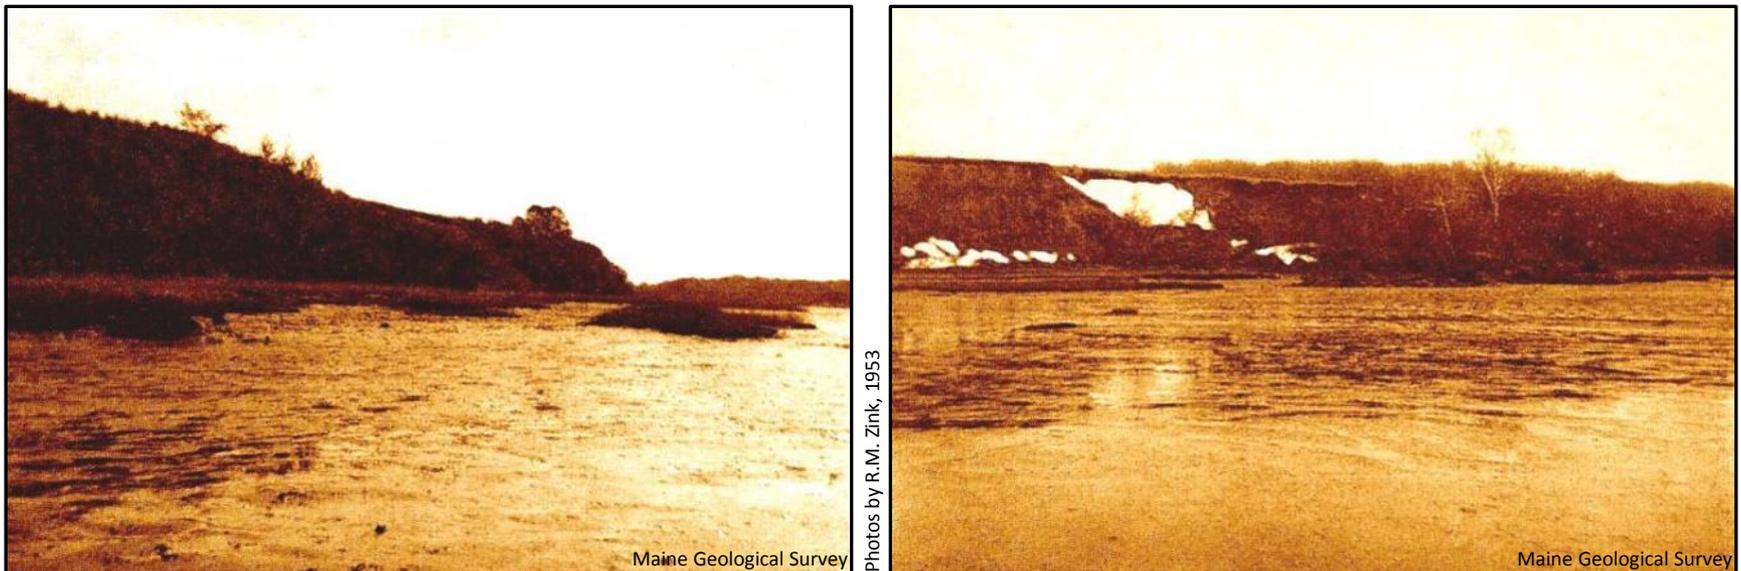
**Figure 7.** (Left) View of Bunganuc Shore showing how the shoreline looked before the landslide occurred. (Right) View of the landslide that took place on March 21, 1952. Notice the pocket of snow in the cuplike depression left by the landslide. The overall shape is similar to that of the 1997 landslide.

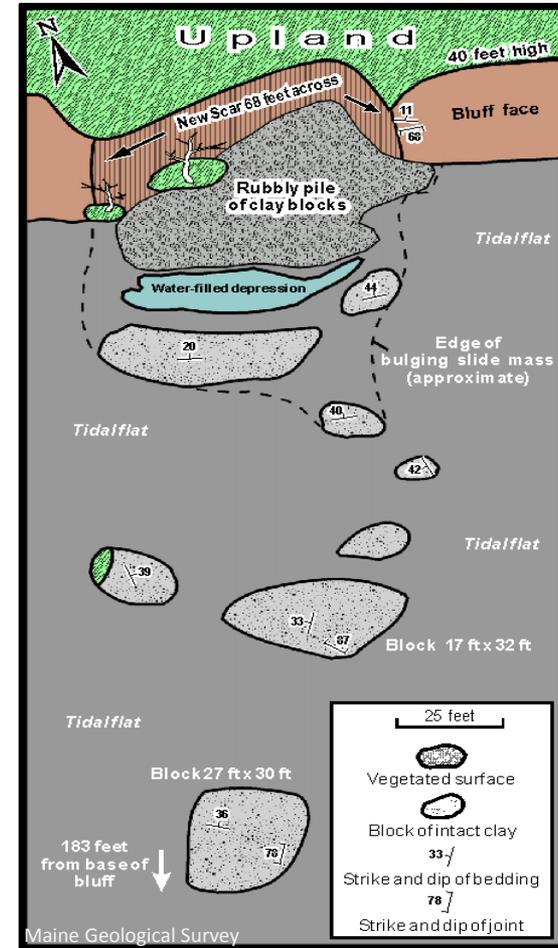
**Figure 8.** Map (drawn to scale) of the landslide at Bunganuc Bluff. See Figure 9 for a cross-section.

The slide of March 1997 is interesting because of how far from the bluff face some of the blocks slid. Figure 8 is a map of the various landslide features including the "outrunner" blocks, the farthest of which traveled 183 feet from the base of the bluff. Grass and trees indicate that some blocks were at the top of the bluff before the slide. Bedding in the displaced blocks is tilted generally back toward the bluff, as illustrated by the map symbols. This backward tilt is typical of a rotational slump in which the slope failure occurs on curved planes behind the bluff face. The higher blocks move down on nearly vertical surfaces, and the weak clay at the base of the bluff is forced outward laterally onto the tidal flat.

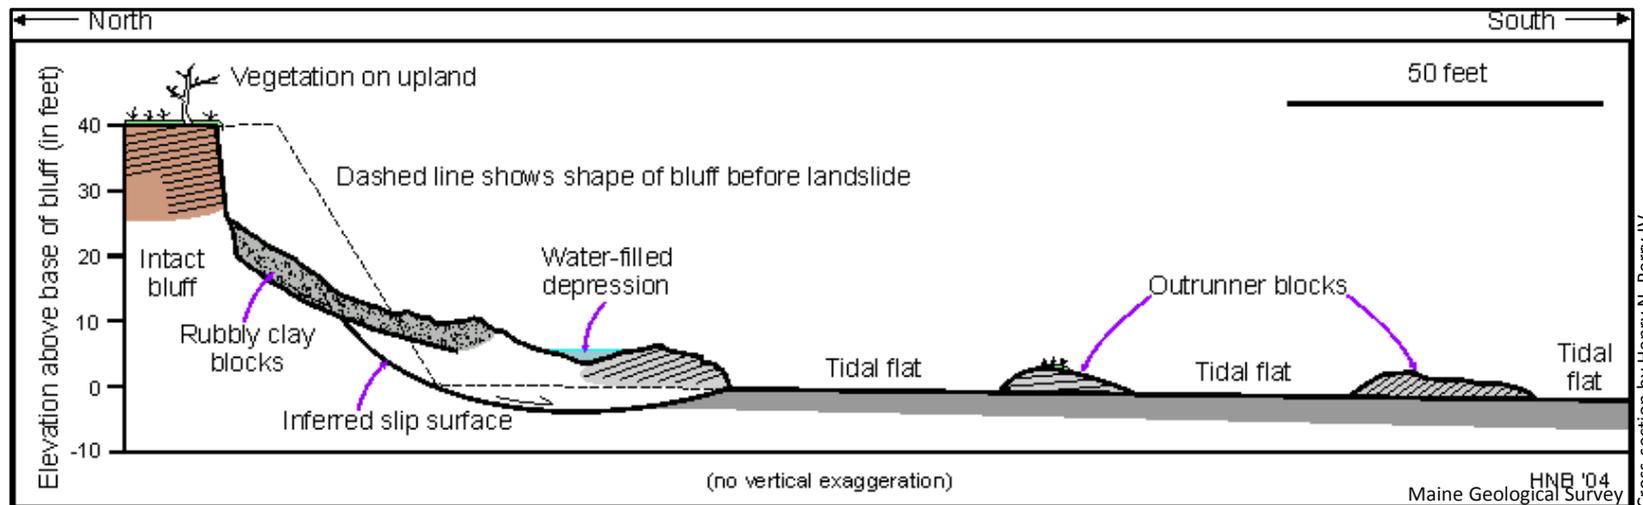
**Figure 9.** Cross-section of the March 1997 landslide, drawn through middle of the map in Figure 5. The upland is to the left, and the outrunner blocks traveled toward the right. The ruled lines in the intact bluff represent clay layers (beds) that are tilted slightly to the north. Similar ruling in transported blocks shows that they have rotated by various amounts during the landslide movement as measured at the site.

Figure 9 is a cross-section perspective showing the same features viewed from the side. The initial blocks that slumped from the bluff were propelled seaward along the slick mudflat surface by a combination of their initial momentum and sliding on a gentle slope with very low friction. An important aspect of rotational slumps, common in high clay bluffs such as this, is that failure occurs on a curved slip surface at depth because the clay is not strong enough to support the overlying weight. Comparison of the bluff before (dashed line) and after the slump shows that the base of the bluff has moved forward and the top of the bluff has moved back, effectively reducing the slope angle to a more stable configuration.

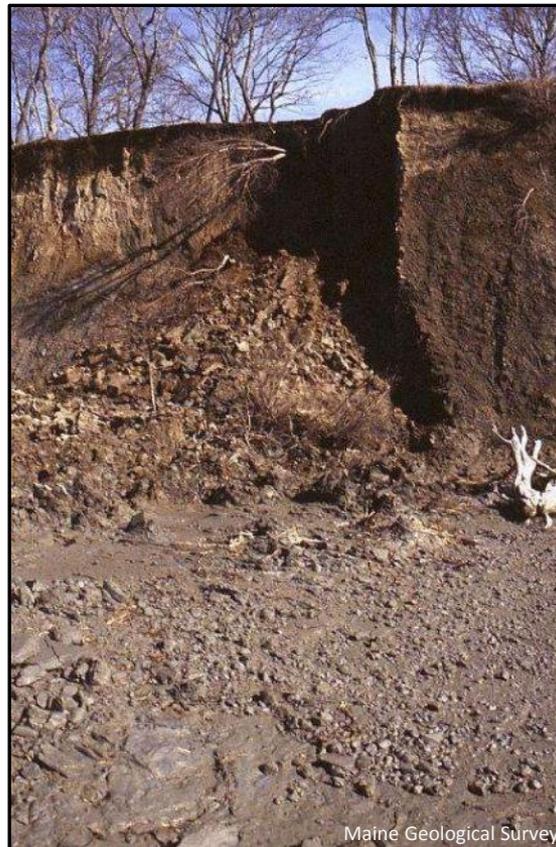
**Figure 10.** View facing the bluff with exposure of the vertical landslide scarp; note blocky and rubby debris at the base of the bluff and the sharp sidewall.

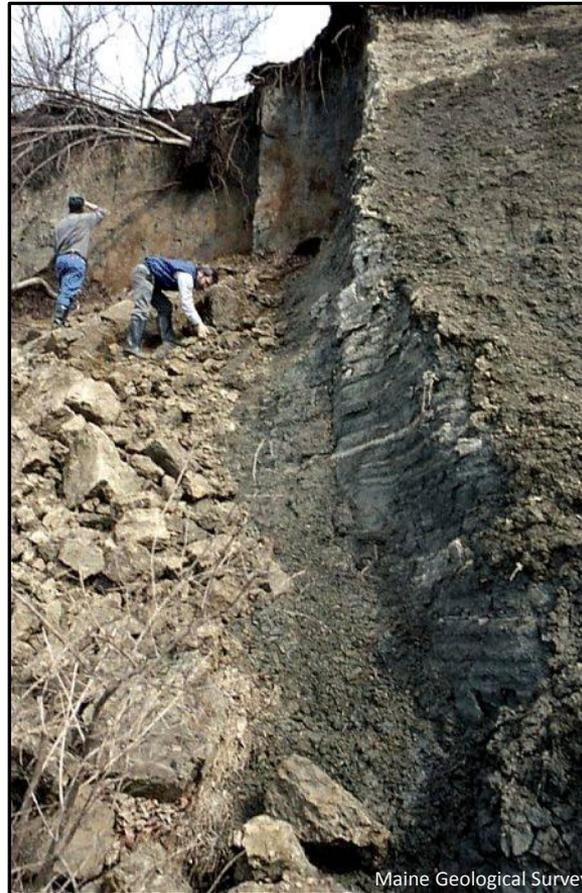
**Figure 11.** Maine Geological Survey staff examining landslide scarp. Thin layering (bedding) in the fine-grained glacial marine deposit is exposed in the undisturbed bluff face to the right of the geologists. About half way up the section from the base, a white layer of fine sand is visible.

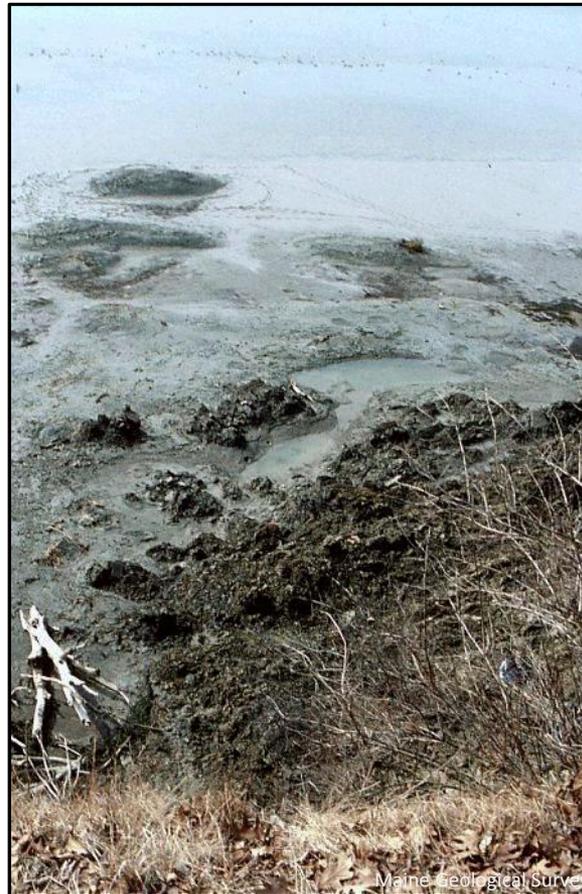
**Figure 12.** View from top of the bluff looking seaward. Note rubbly debris near base of bluff and detached outrunner blocks farther seaward. Of the three farthest-traveled blocks, the one on the right has vegetation on its surface indicating that it started at the top of the bluff and slid to its position on the mudflat.

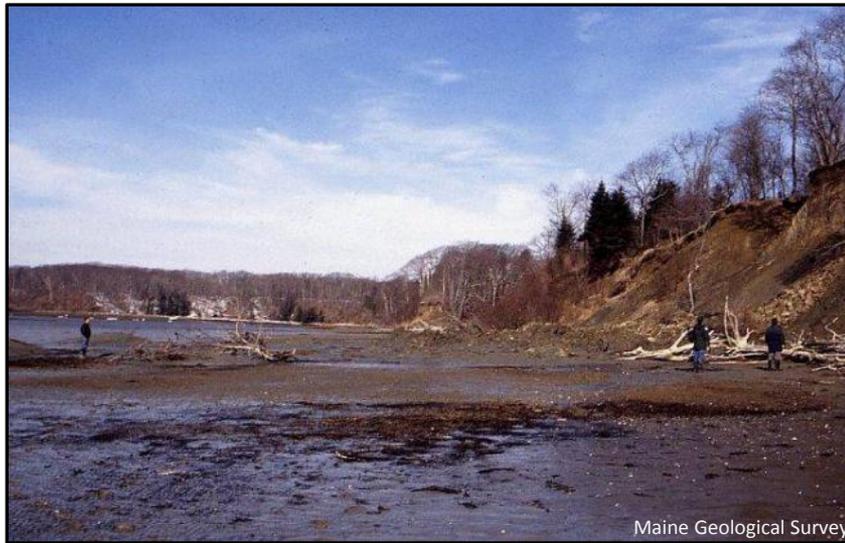
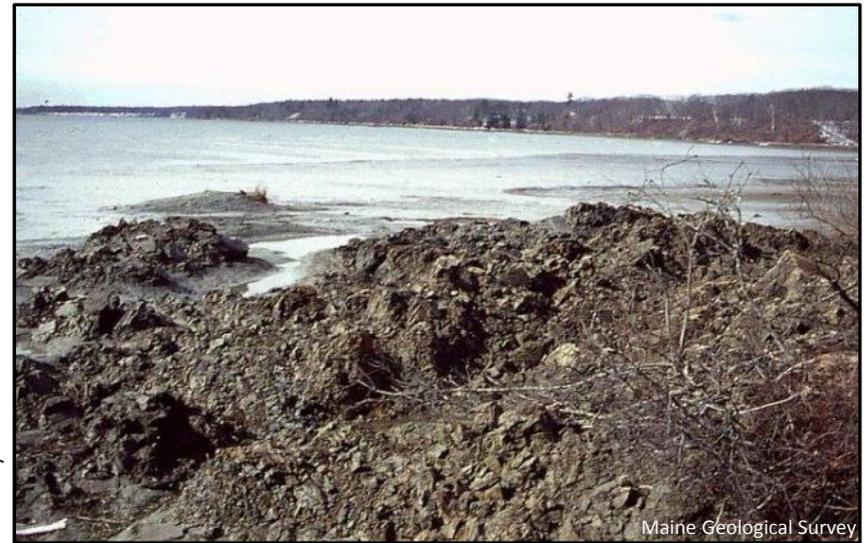
**Figure 13.** (Left) Mudflat view looking west, perpendicular to the sliding direction of the landslide. (Right) Seaward view from base of rubble and blocky debris.

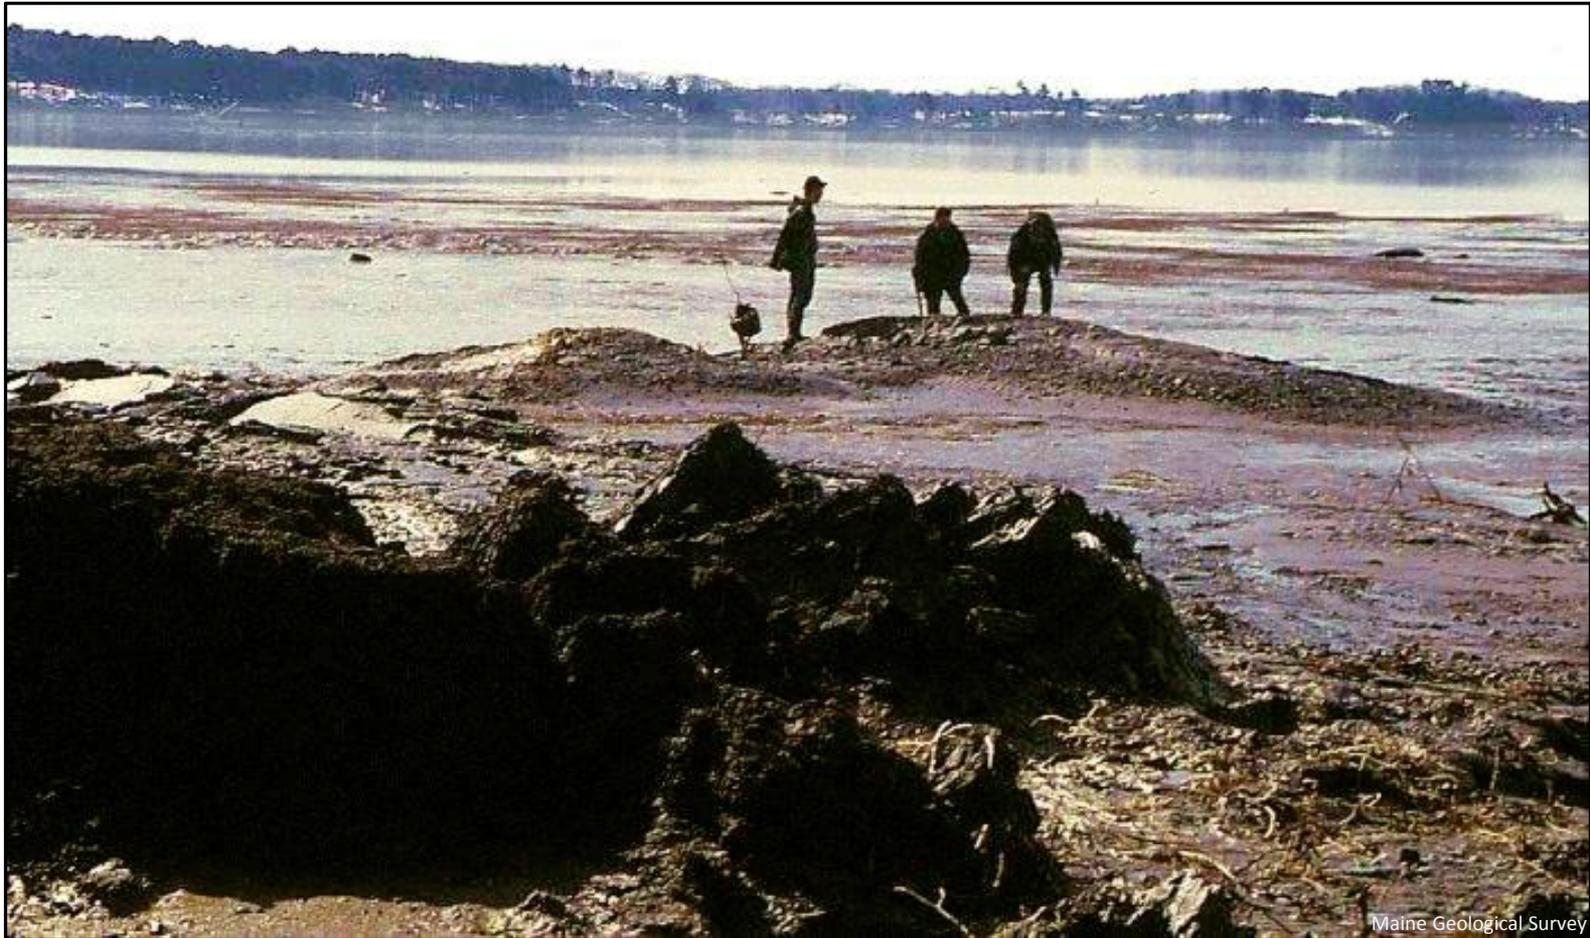
**Figure 14.** Maine Geological Survey staff examine detached distal landslide block.

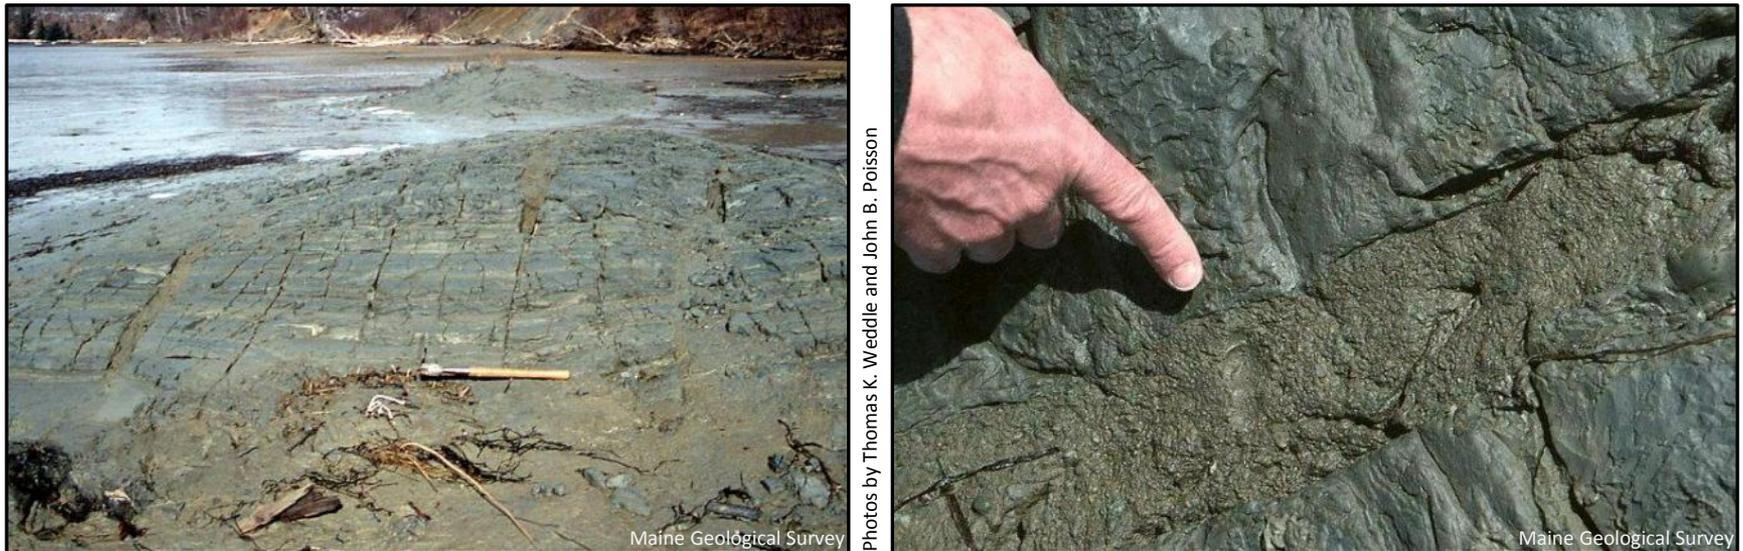
**Figure 15.** Close-ups of detached block. The original bedding in the deposit is represented by the light- and dark-colored layers parallel to the shovel handle. The dark features on the block surface are fractures in the block, nearly perpendicular to the bedding. Some of the fractures are filled with muddy debris, including mud and small, broken clay fragments (right-hand photo). Notice that the bedding in the smaller block in the background has a different orientation from that in the larger foreground block, demonstrating that the two blocks moved independently.
