# **Maine Forestry Best Management Practices Use and Effectiveness 2006 - 2007**

Department of Conservation  
Maine Forest Service  
22 State House Station  
Augusta, Maine 04333  
Forest Policy and Management Division

**October 2008**

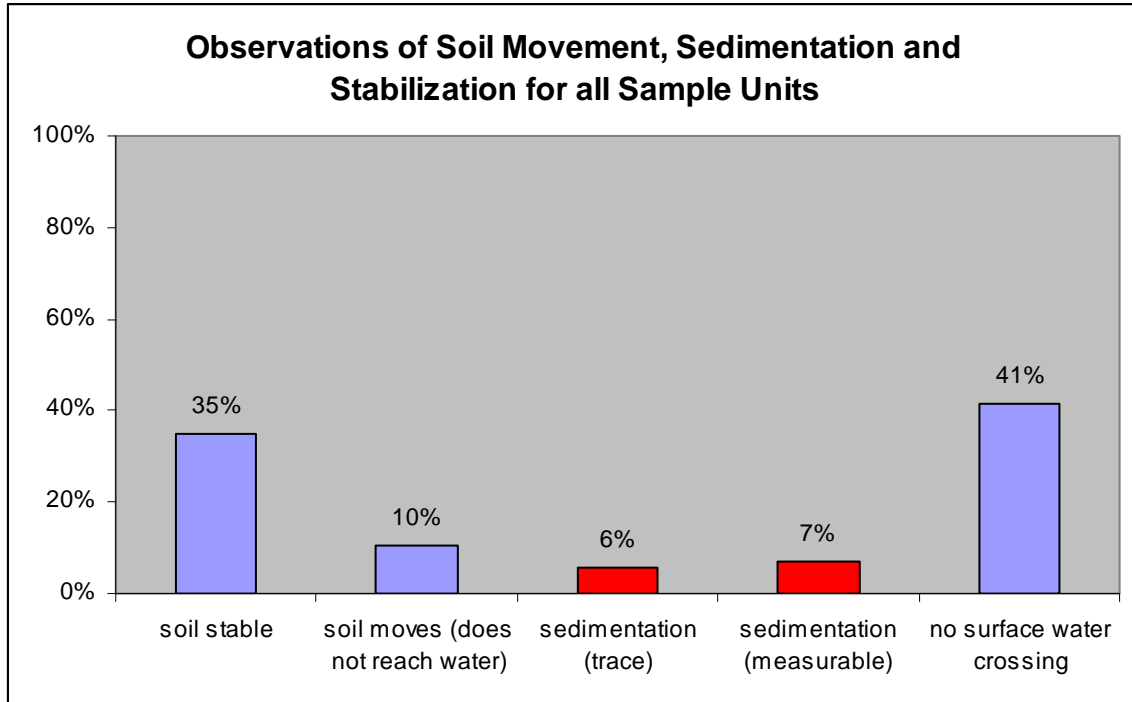
**Figure 5** Observations of soil movement, sedimentation and stabilization as a proportion of total opportunities to observe soil conditions in the protocol (n=1260)

Of the 1260 opportunities to observe soil conditions *87% showed no sediment entering the waterbody, a 4% improvement from the 2005 reporting period.* Of the remaining 13% of opportunities to evaluate soil movement 6% showed trace and 7% showed measurable amounts of sediment reached the waterbody (Figure 5).

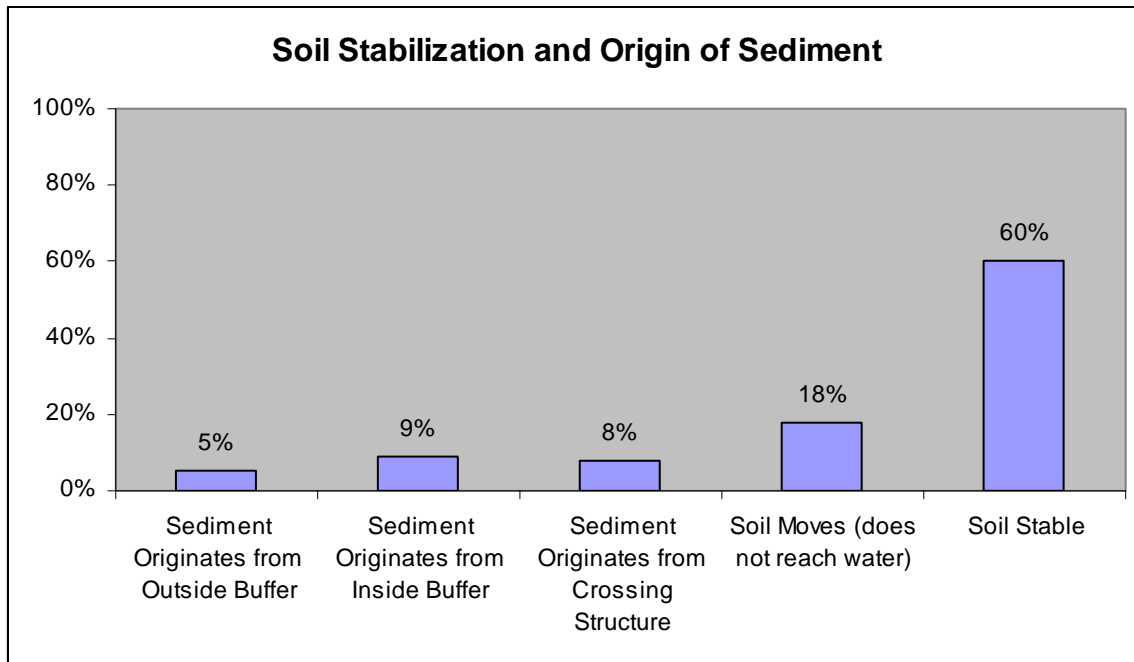
**Figure 6** Soil stabilization and origin of sediment from sample units with water crossings (n=732).

In sample units with crossings 78% of observations showed that no soil reached the waterbody or was deposited within bankfull width of the channel. (See **Appendix A** for a further explanation on bankfull elevation and width.) For the 22% of the observations where sediment did reach the waterbody, the sediment was just as likely to originate from the buffer (approaches) as from the crossing structure. Sediment originating from the approaches *outside* the buffer accounted for about one-quarter of the cases of sedimentation. The fact that sedimentation was just as likely to originate from the approaches as the crossing structure indicates the importance of extending erosion control measures to the point where overland flow originates.

Because of the small sample size we are not able to say anything definitive about how the origin of the sediment (crossing structure vs. approaches) relates to the amount of sediment delivered (trace vs. measurable) to the waterbody. Percentages of sediment originating from each area were similar to 2005 data with a possible slight reduction in measurable sediment delivered from the approaches. As BMP use increases, one would expect to see a decrease in measurable sedimentation relative to trace sedimentation.

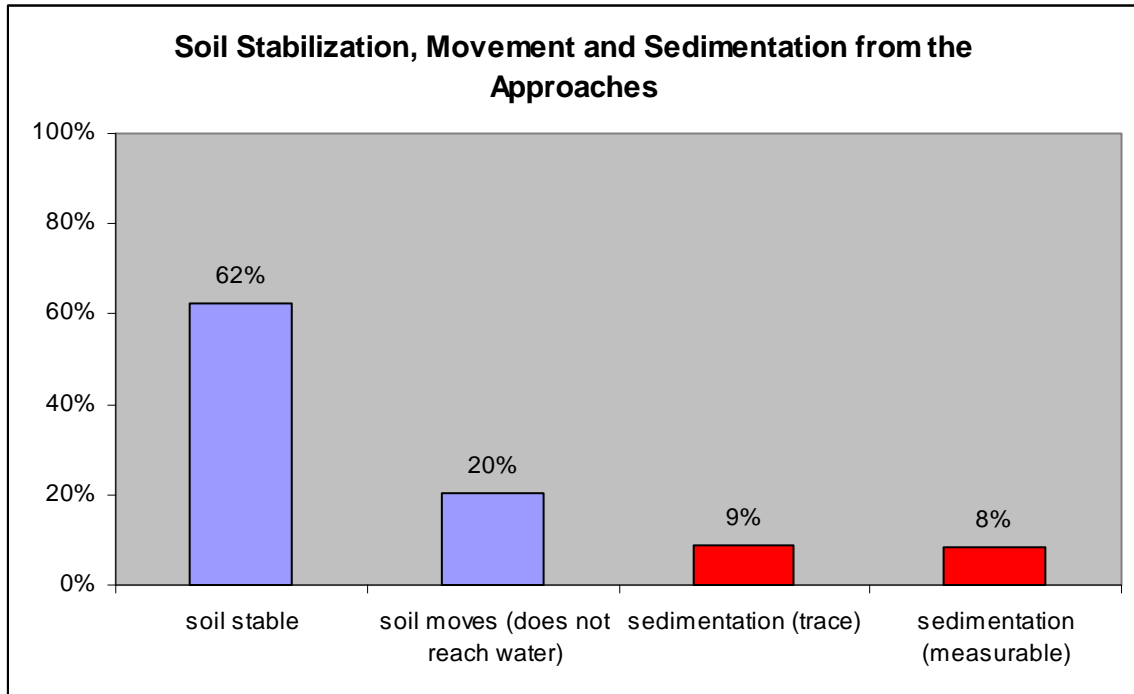
**Figure 7** Soil stabilization, Movement and Sedimentation from the Approaches (n=585).

*In 82% of the cases no soil reached the water body from the approaches* (Figure 7). This indicates that planning and implementation of BMPs are keeping sediment from entering the water in most cases. Analysis of the 18% of cases where sedimentation did occur from the approaches indicates the majority of sedimentation was due to inadequate maintenance or inadequate installation of additional BMPs (Figure 8). Assessment of BMP application when sedimentation occurred indicates that in most cases BMP implementation was either inadequate or BMPs were not applied (Figure 9). Improved or increased education for loggers, machine operators and foresters on the importance of controlling water flow on roads and skid trails *throughout the operation* is likely to improve the installation and maintenance of BMPs. These educational efforts should also stress the importance of proper closeout of operations since returning to a site to fix a problem after a harvest is completed represents an additional cost.

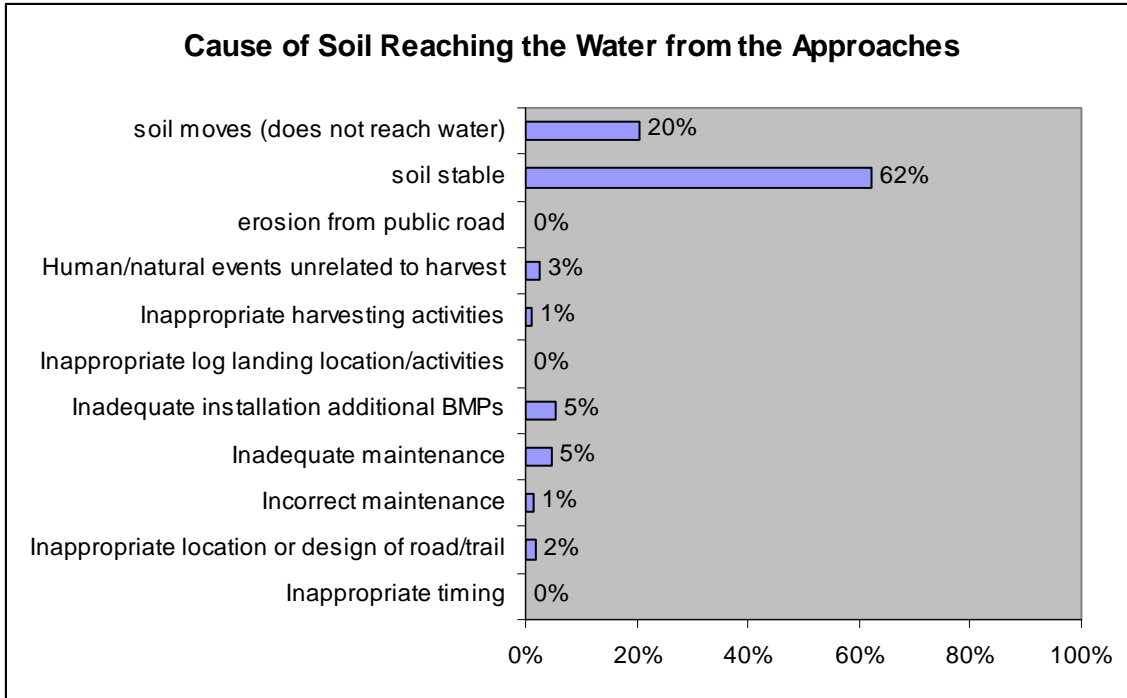
**Figure 8** Causes of sedimentation from the approaches on sample units with crossings (n=585).

About 15% of cases (3% of total observations) of sedimentation were due to events unrelated to the harvest (Figure 8). This may indicate an opportunity to educate others (likely recreational user groups) of the importance of staying off of roads during inappropriate times of year.

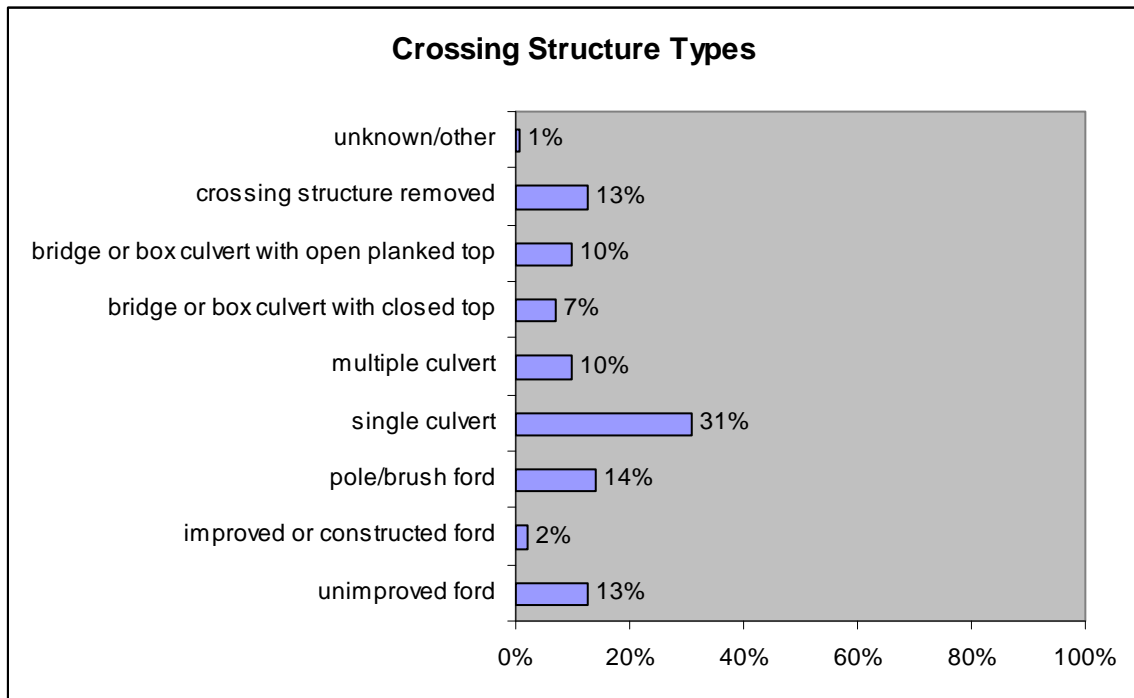
Figure 10 Crossing structure types (n=141).

Across all sample units single culverts were the most common type of crossing structure encountered (Figure 10). Single and multiple culverts were the most common type of structure encountered on haul roads while fords (both unimproved and pole and brush fords) and removed structures were the most common encountered on skid trails (data not shown).

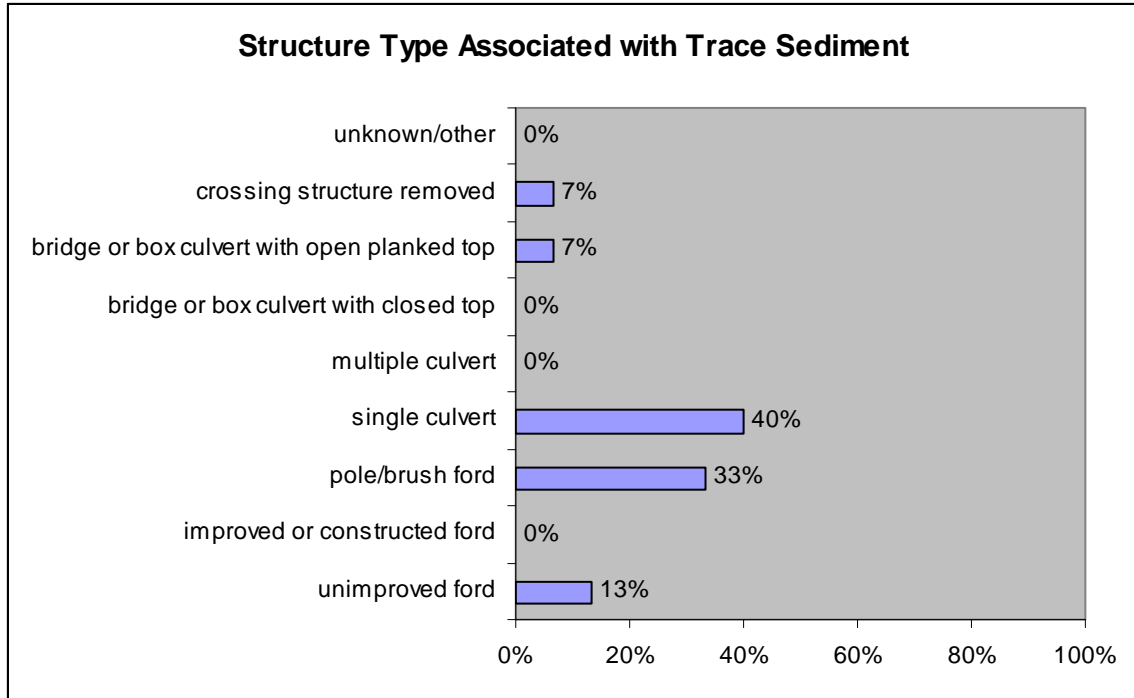
**Figure 12** Structure type associated with trace sedimentation (n=15).

Single culverts were the type of structure most often associated with the addition of both trace (Figure 12) and measurable (Figure 13) amounts of sediment to the waterbody. This was due at least in part to the fact that single culverts were the most common type of structure encountered. When the data are normalized to account for the frequency of each structure, multiple culverts were the structure type that had the highest risk of being associated with sedimentation (Figure 14).

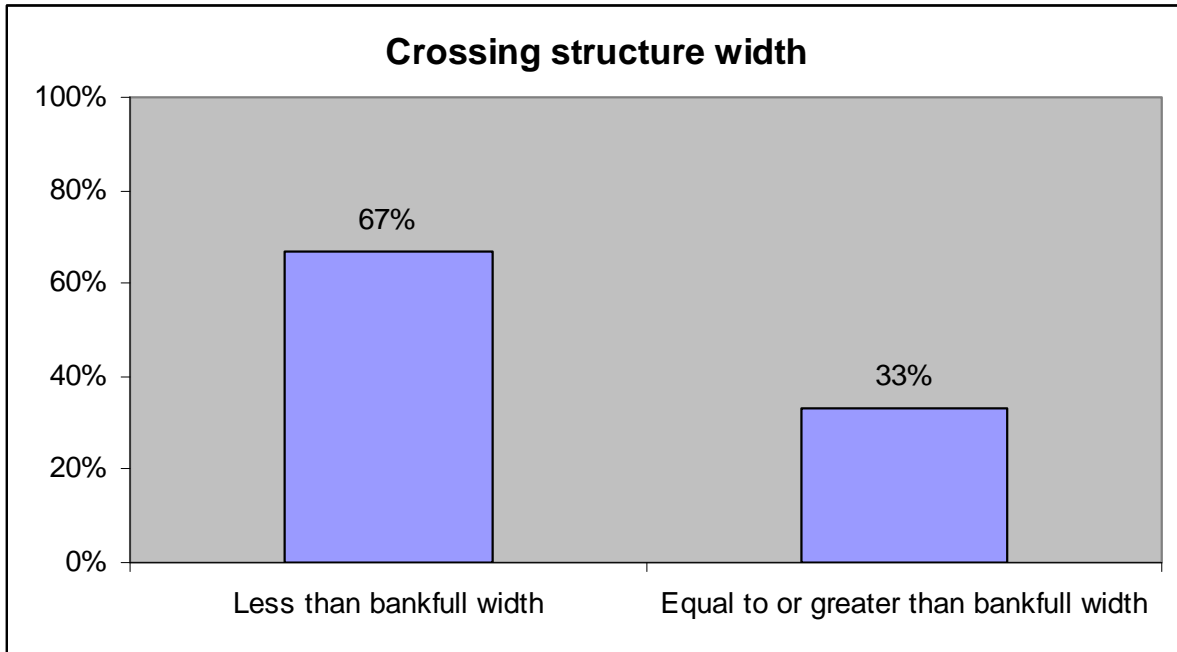
**Figure 15** Width of crossing structure in relation to waterbody width at pre structure bankfull elevation. (n=141)

In Maine legal requirements for structure opening size vary depending on the jurisdiction. Maine Forest Service BMPs recommend that temporary crossings and permanent structures that will be regularly maintained be sized to accommodate a 10 year flood event (2.5 times the cross sectional area of the stream channel at bankfull). BMPs recommend permanent crossings that will not be regularly maintained be sized to accommodate a 25 year flood event (3.5 times cross sectional area). Properly sized structures typically should also be *at least* equal to the bankfull width of the channel. Undersized crossings can lead to

conditions that limit fish passage including increased flow velocities, perched outlets and accumulated debris barriers. Undersized structures are also at increased risk of being unable to handle high water flows and therefore are more likely to experience catastrophic failures leading to large sediment inputs. *67% of the crossings evaluated did not span the bankfull width of the channel* (Figure 15).

**2 - Undersized crossing structures.** Upgrading crossing structures so they do not restrict the stream channel can be costly. Therefore, prioritizing which structures should be considered for replacement is important. MFS currently is partnering with the US Fish and Wildlife Service on a stream crossing survey in the Penobscot River Watershed. This survey ranks crossing structures based on their potential to impede passage of fish, position in the stream, and the amount of habitat that would be opened above the structure were it to be upgraded. Efforts to secure funding to assist willing landowners to upgrade critical crossings should also be considered.

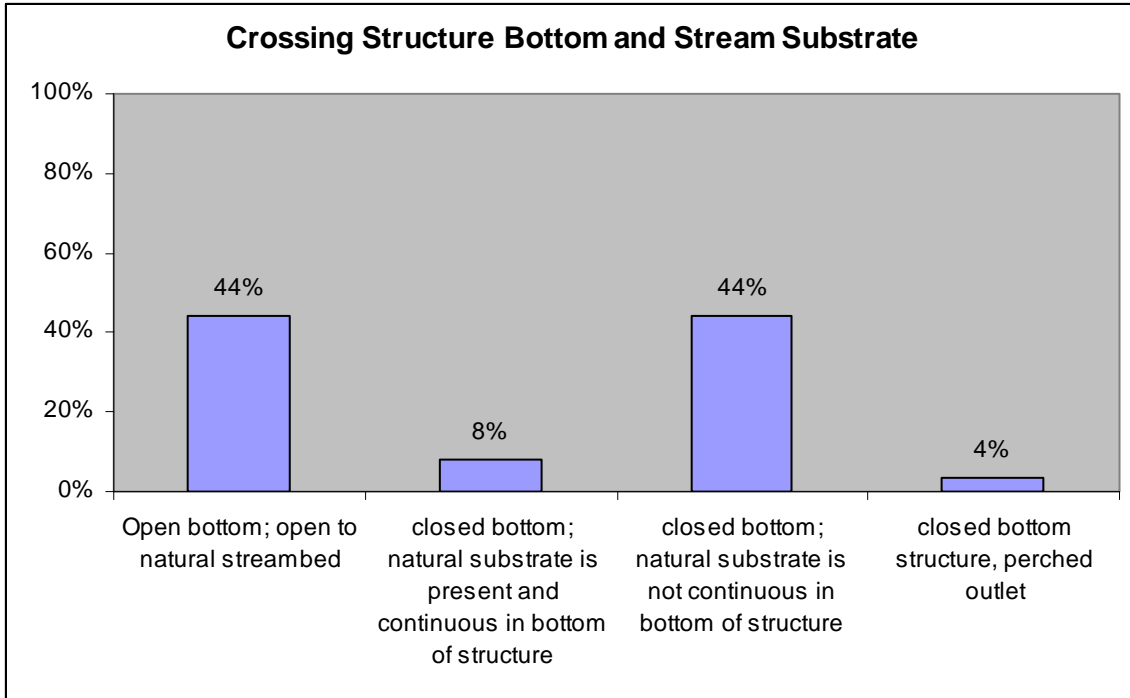
**Figure 16** Presence of substrate in crossing structures. (n=109)

Crossing structures properly designed and installed to allow fish passage incorporate either natural or simulated natural stream bed substrate in the bottom of the structure. Open bottom structures such as bridges and arch culverts allow natural stream bed substrate to be maintained. Closed bottom structures such as round culverts, box culverts and pipe arches can also incorporate substrate by being embedded in the stream bottom or being sized large enough to allow bed load substrate to accumulate in their bottoms over time. **52%** of the crossing structures were either open to the natural stream bed or had continuous substrate in the bottom of the structure. The majority of structures with substrate were open bottom structures rather than closed bottom ones with substrate in the bottom (Figure 16).

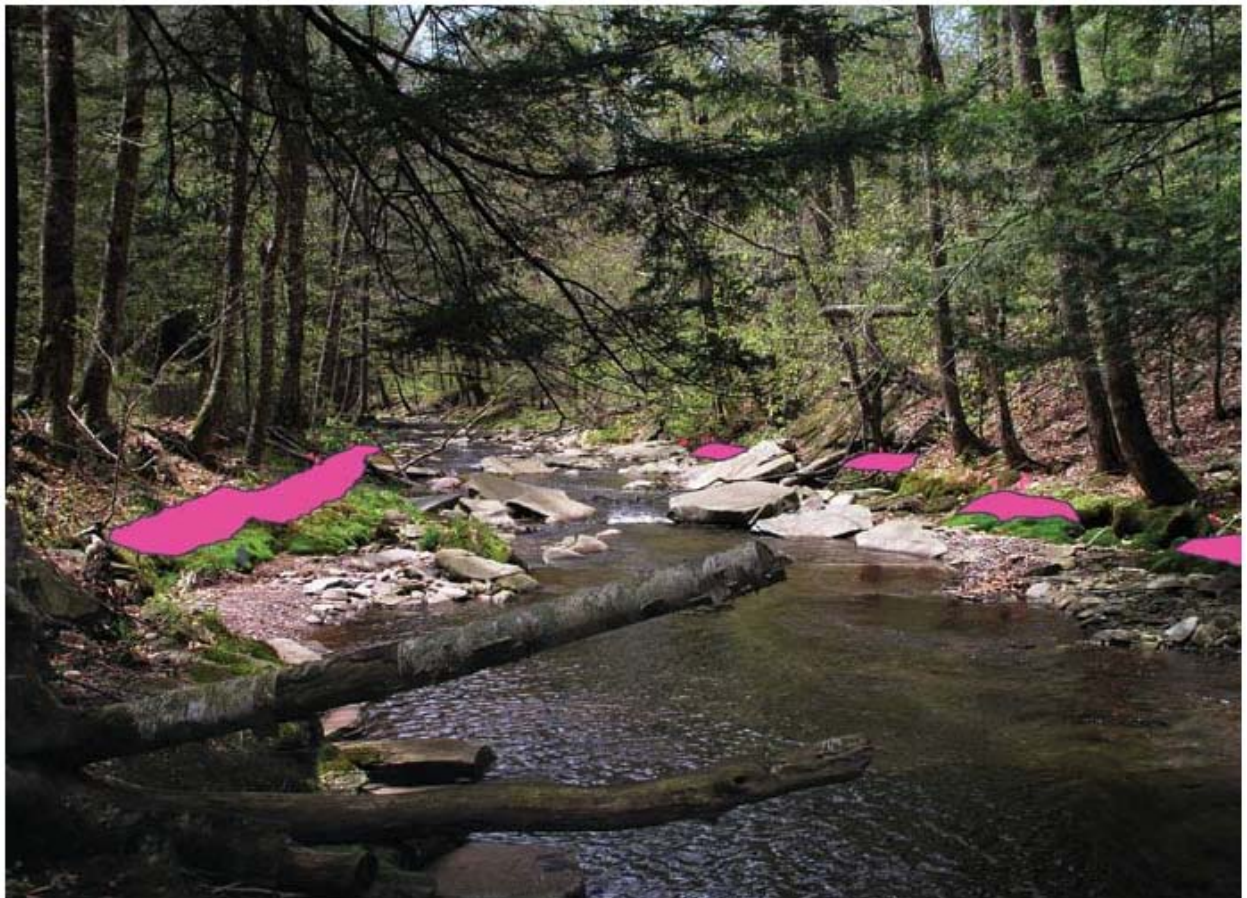
Bankfull elevation may be defined as the point of demarcation between the stream channel and the floodplain. The bankfull elevation is at the elevation of the lowest depositional flat immediately above the channel and is often identified by the deposition of fine sediments indicated by the first depositional flat above the channel.

**Figure 19** Bankfull indicators visible at low flow. The bankfull elevation is indicated by the first depositional flat above the channel. On very confined channels, the bankfull elevation may only be evident as the discontinuous flat depositional areas shaded on the photo.
