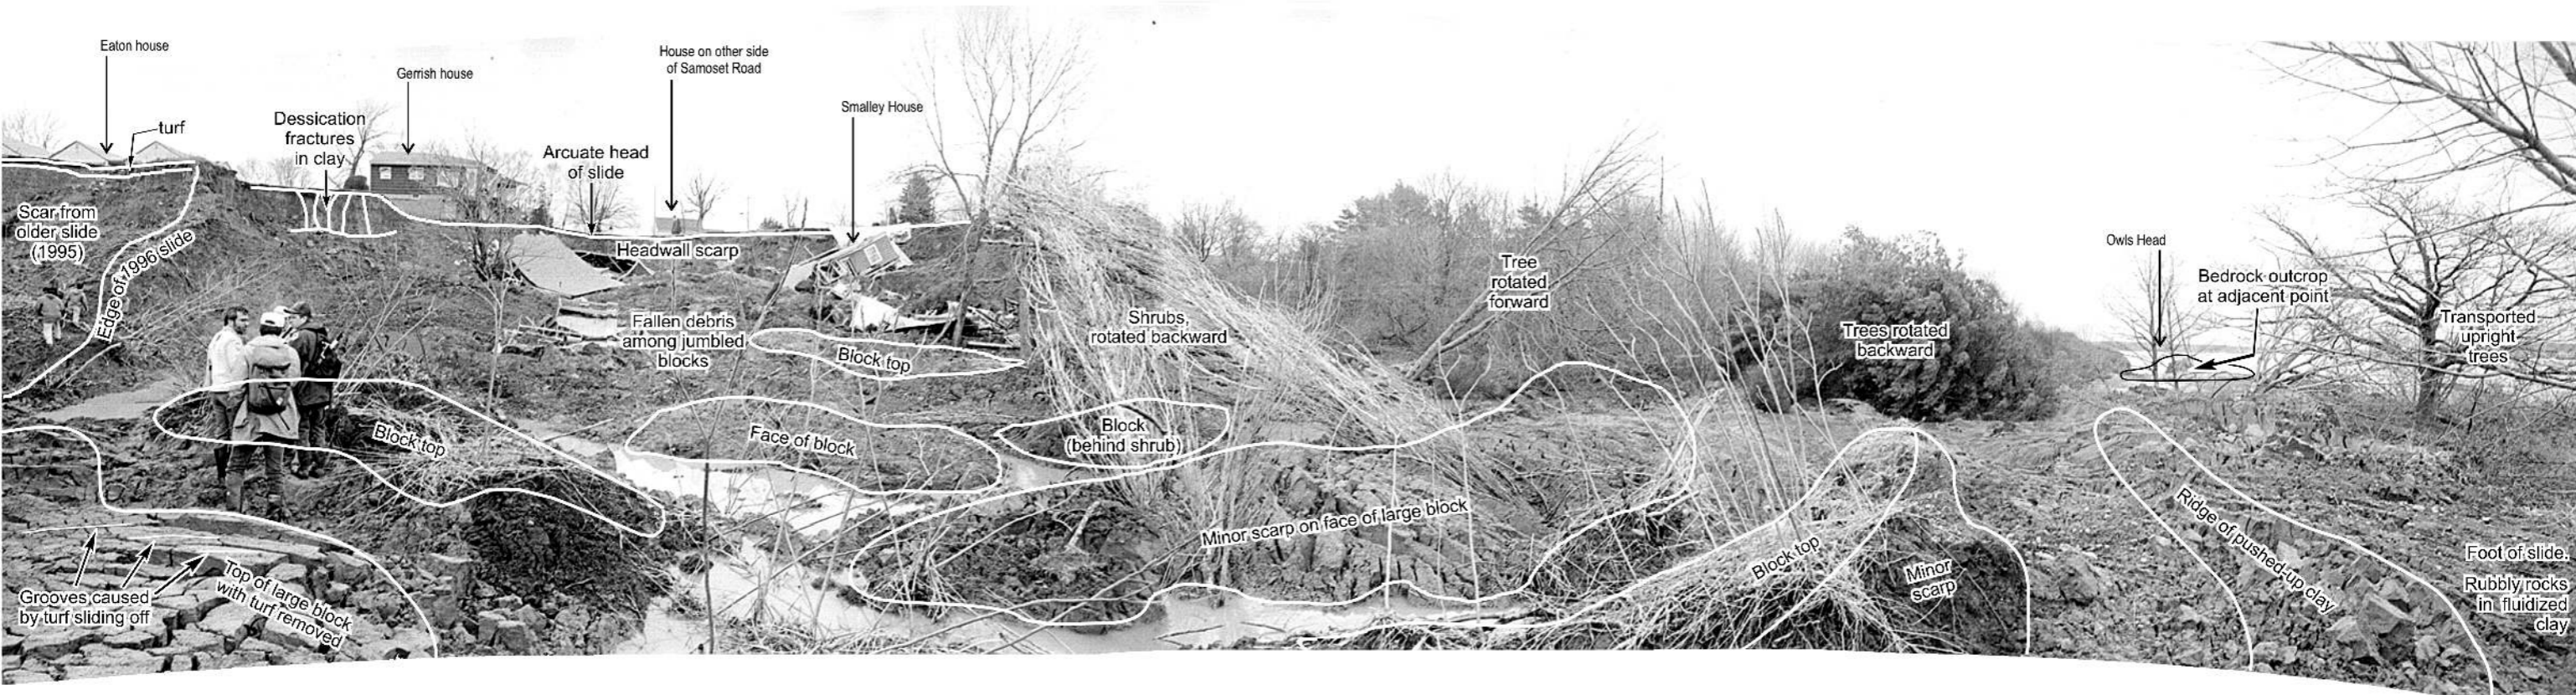
Dessication fractures in clay

Arcuate head of slide

Headwall scarp

Fallen debris among jumbled blocks

Shrubs, rotated backward

Tree rotated forward

Trees rotated backward

Transported upright trees

Scar from older slide (1995)

Edge of 1996 slide

Minor scarp on face of large block

Minor scarp

Ridge of pushed-up clay

Foot of slide. Rubby rocks in fluidized clay

Grooves, caused by turf sliding off

Top of large block with turf removed
