Stinson Neck Quadrangle, Maine

Coastal landslide hazard mapping by

Open-File No. 01-544
2001

Coastal Landslide Hazards

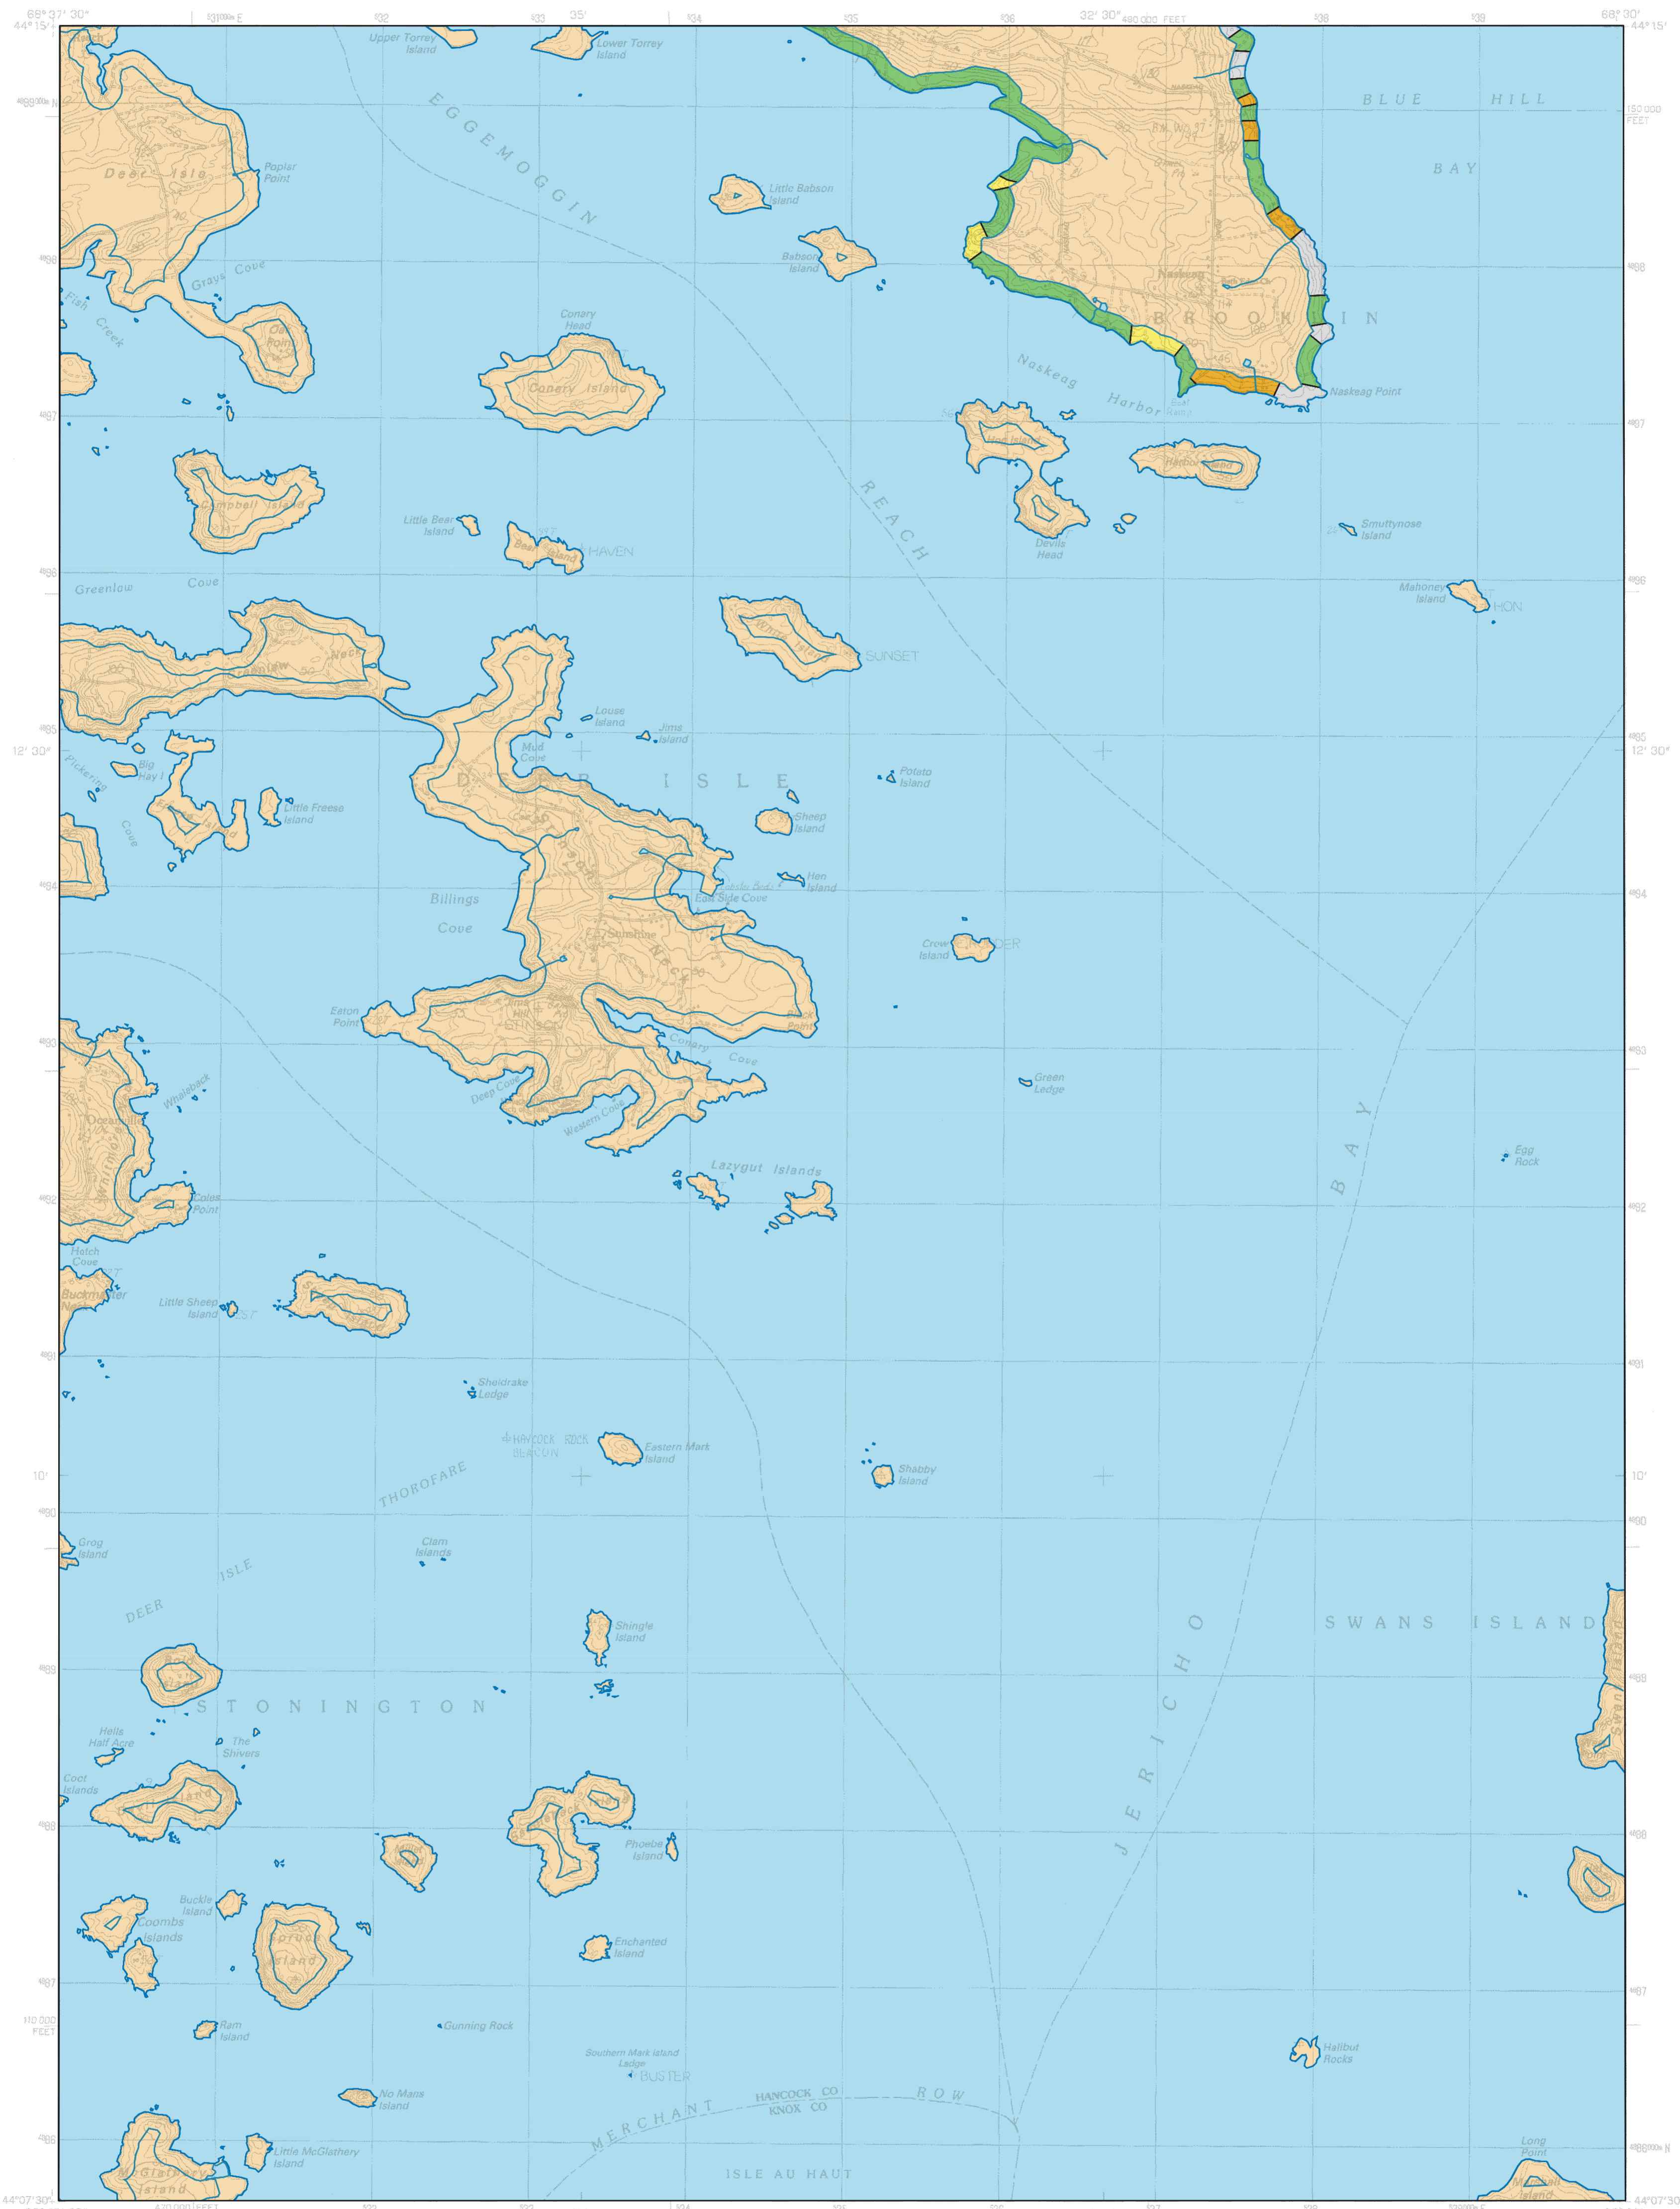
Note: The landslide hazard classification is indicated by a colored, patterned band extending landward from the shoreline (dark blue line). The width of the band does NOT indicate the distance inland that a landslide may occur. This distance is difficult to predict and will vary from site to site. The colored buffer is for illustration purposes only. Due to variations in coastal geology, not all units in the explanation below will appear on this map.

Landslide Site - Location of known or interpreted coastal landslide. Includes historically recorded landslides and slides interpreted from air photos.

Landslide Risk Area - Land features indicate conditions that may be suitable for a landslide to occur. Features often include a steep or arcuate scarp, bluff blocks, sediment lobes, or uneven land surfaces. Bluff sediments are usually muddy and twenty feet or more in thickness.

Potential Landslide Area - Shoreline with sedimentary coastal bluff twenty or more feet high. These bluff areas have not had field investigations that are necessary to evaluate the risk of a landslide. However, some similar high coastal bluffs have experienced landslides.

Low Coastal Bluff - Shoreline with a sedimentary coastal bluff that has less than twenty feet of relief immediately adjacent to the shoreline. Some bluffs over twenty feet in height are included in this map unit if the bluff face is not steep. In general, low coastal bluffs are not at risk of failing in the form of a landslide.

Non-Bluff Shoreline - Coastal areas without extensive sedimentary bluffs. Corresponds to the no-bluff unit on MGS Coastal Bluff Maps.

Unmapped Shoreline - These sites generally are in the inland reaches of estuaries or beyond the scope of the field effort in this region.

Landslide Site - Includes the following: (1) Locations based on historical records and eyewitness accounts. In general, these earth movements have occurred in the last three centuries. (2) Locations based on interpretation of aerial photography. The age of these features is usually unknown. Some may have formed in the last few years, others in the last century, and some possibly sometime in the last few thousand years.
Landslide Risk Area - Includes the following: (1) Observations from a land corroborated with geomorphology observed on air photos, sediment types shown on surficial geologic maps, and both elevation above sea level and steepness of bluff slopes shown on topographic maps. Bluff sediments are usually muddy and twenty feet or more in thickness. The slope on the bluff face appears steep and similar to areas where there have been landslides in the past. (2) Observations from a small boat. Primarily steep-sloping sediment bluffs that were visually estimated to be twenty feet or more in elevation. Other instability characteristics included unvegetated slopes on the bluff face; leaning, fallen, or crooked tree trunks; and visible slump deposits at the base of the bluff near the high-tide line. The site may be adjacent to previous landslides. In this second category, aerial photographs were not used nor were the surficial geologic materials investigated.

Potential Landslide Area - This determination was based on the presence of a bluff as indicated on MGS Coastal Bluff Maps and the proximity of a twenty-foot topographic contour to the shoreline (similar to areas adjacent to previous landslides) and geomorphology visible in air photos. These bluff areas have not had field investigations to fully evaluate landslide risk.
Low Coastal Bluff - This determination was based on the presence of a bluff as indicated on MGS Coastal Bluff Maps and the proximity of a twenty-foot topographic contour to the shoreline. By comparison with bluffs adjacent to previous landslides, these areas are less steep than those that have shown a tendency to fail due to weakness in the earth landward of the top of the bluff.
Non-Bluff Shoreline - This shoreline type was determined by visual observation from a small boat and corresponds to the no-bluff unit on MGS Coastal Bluff Maps. These shorelines can be composed of bedrock, salt marshes, beaches and dunes, or low-lying sediments without the presence of a bluff more than three feet high and 150 feet long. Within this category there may be short shoreline segments that contain bluffs. These small coastal bluffs are not illustrated on this map.

Unmapped Shoreline - In some locations, access to a shoreline was limited so no areas remain unmapped. These sites generally are in the inland reaches of estuaries or beyond the scope of the field effort in this region.
