Preliminary Design Report

Beals Island Bridge #5500
Bridge Street
over
Moosabec Reach

Jonesport-Beals, Maine

WIN 22626.00

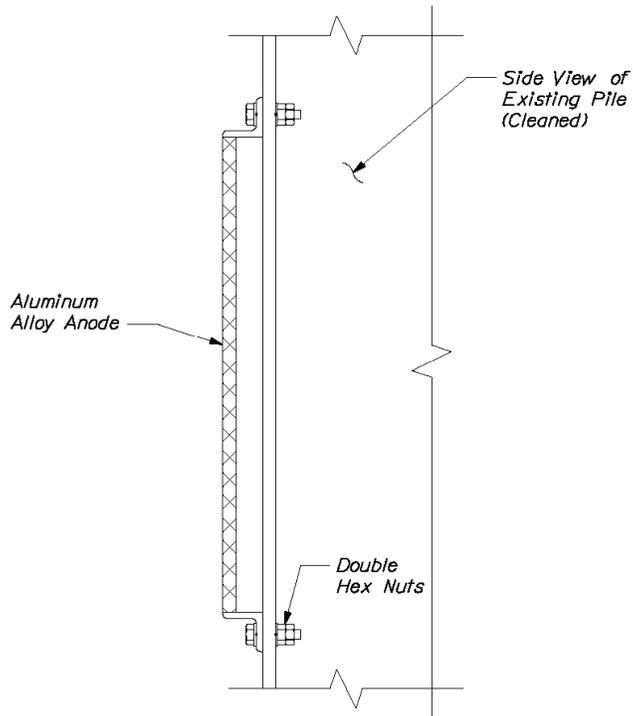
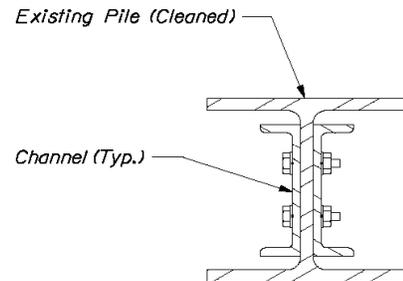
STRENGTHENING SECTION

CATHODIC PROTECTION

- Complete cleaning of all exposed steel pier piles
- Structural steel repairs to all piles
- Installation of cathodic protection (sacrificial anodes) on all piles

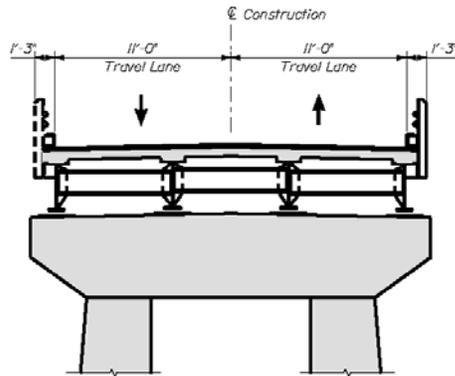
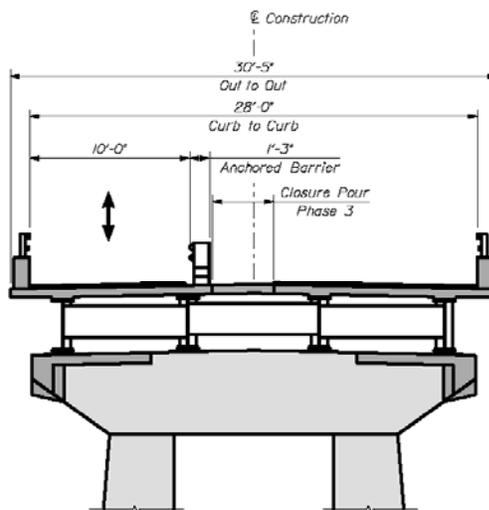
SUPERSTRUCTURE REPLACEMENT PHASING

EXISTING

PHASE 1

PHASE 2-3

Rehabilitation options with a superstructure replacement require phased construction using a temporary traffic signal system to provide one lane of alternating two-way traffic. For these options, a narrow TL-3 railing is recommended to maximize temporary lane widths during phased construction while minimizing the overall width of the bridge. See superstructure replacement phasing figure.

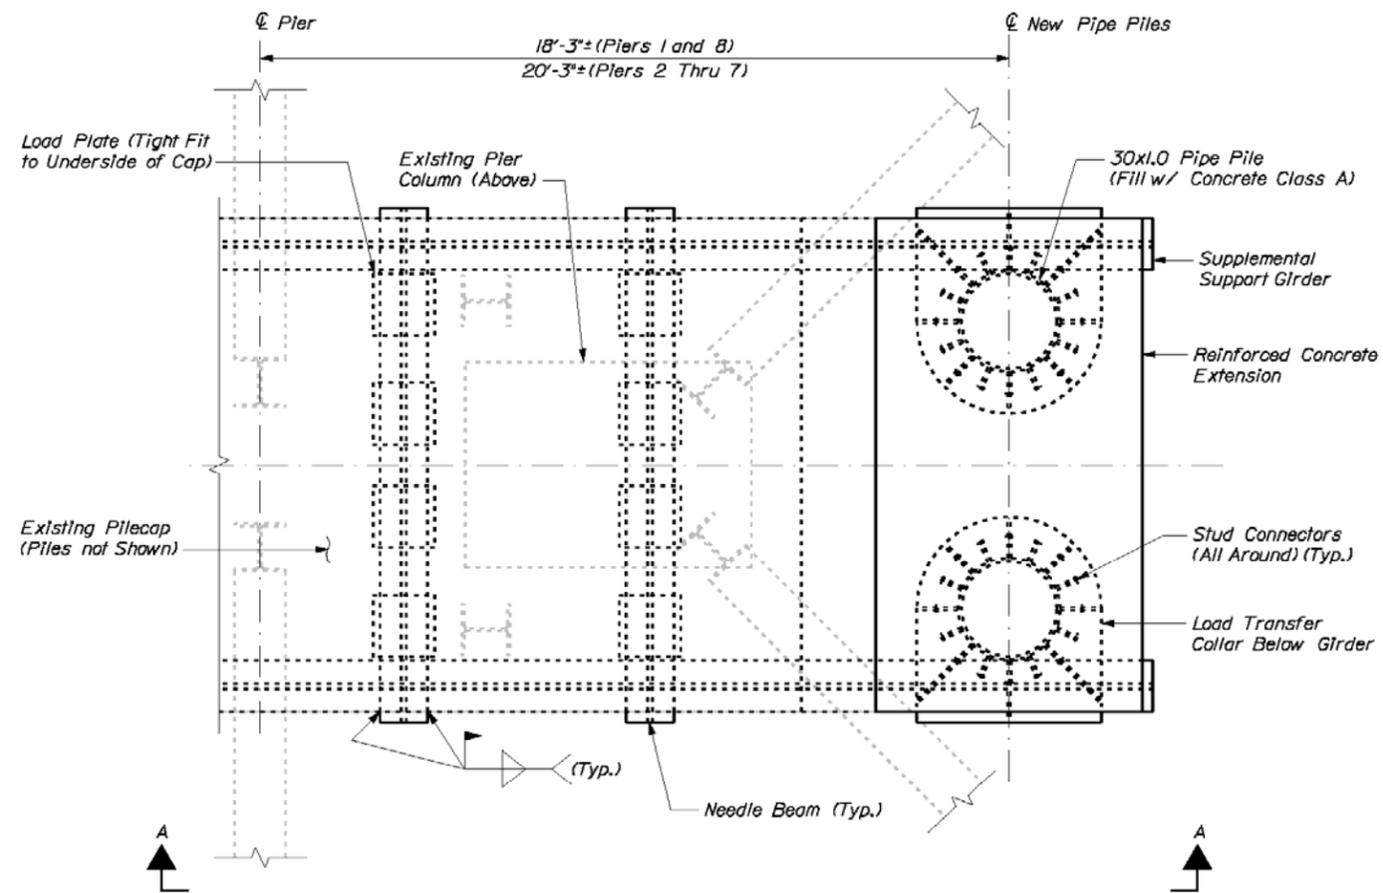
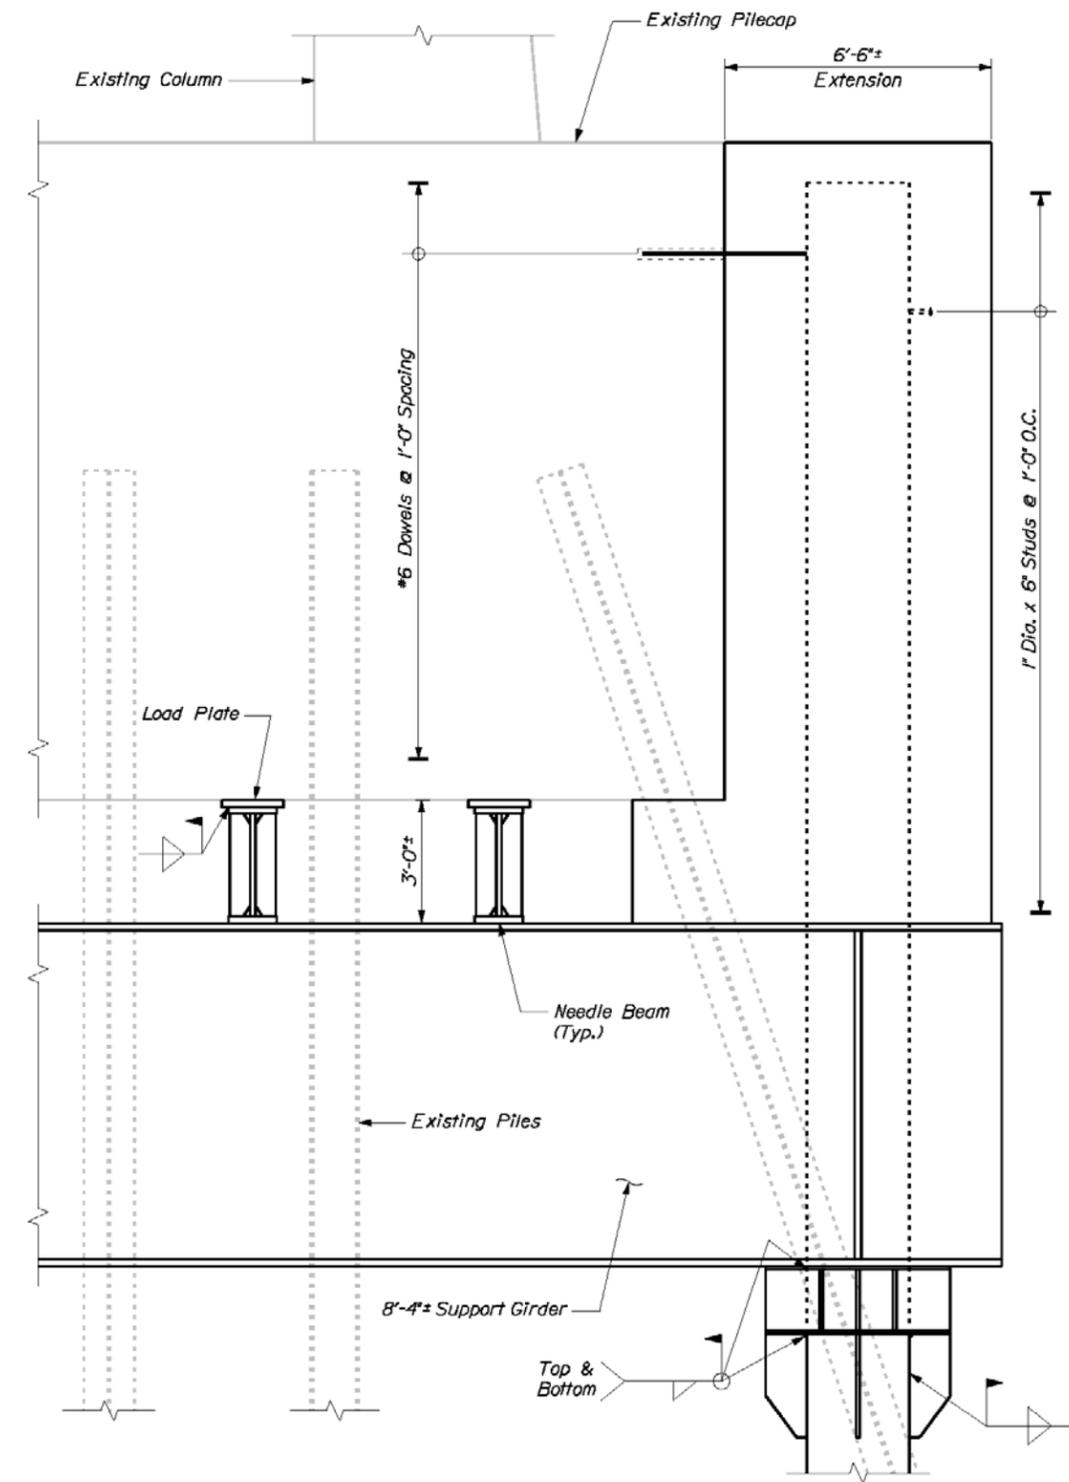
**SUPPLEMENTAL FOUNDATION
PIERS 1 THRU 8**

PLAN
(Pier 1 Shown, Other Piers Similar)

VIEW A-A

Substructure repairs can be completed independently or in conjunction with superstructure repairs and phasing. For supplemental foundation concepts, see figures showing supplemental foundation at piers 1 thru 8 and pier 9.

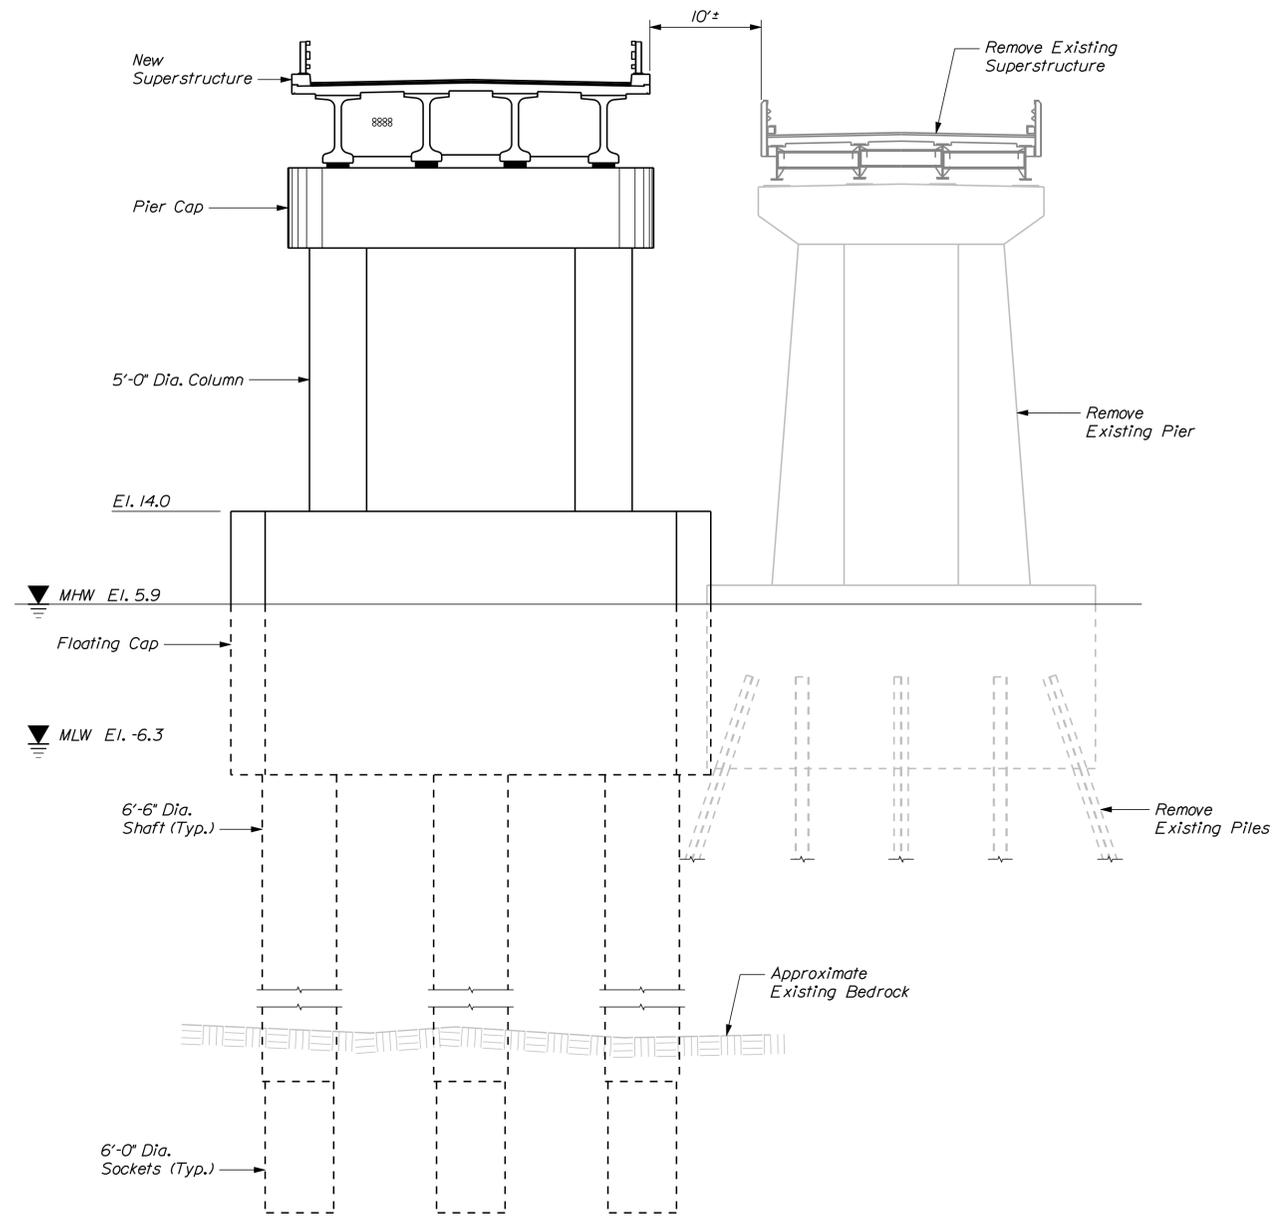
PIER NO. 4 SECTION
(Piers 3, 4 and 5 are Similar)

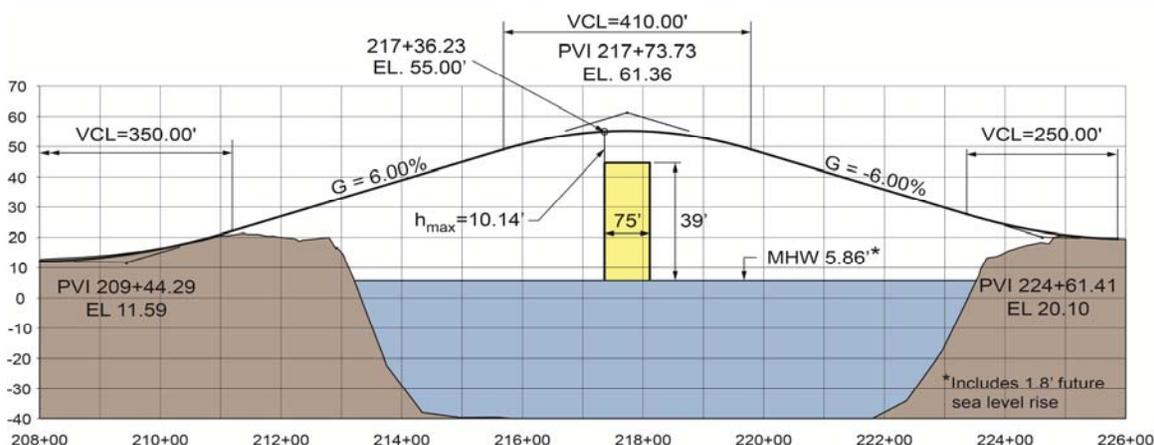
Figure 1 – Proposed Profile of the Beals Island Bridge Replacement

Six percent grades are used to elevate Bridge Street over the navigational channel which passes between existing Pier 4 and Pier 5. The depth of the proposed bridge is governed by this profile as it crosses the down-station limit of the 75' wide navigational channel. The maximum depth of bridge including overlay is 10.14'.

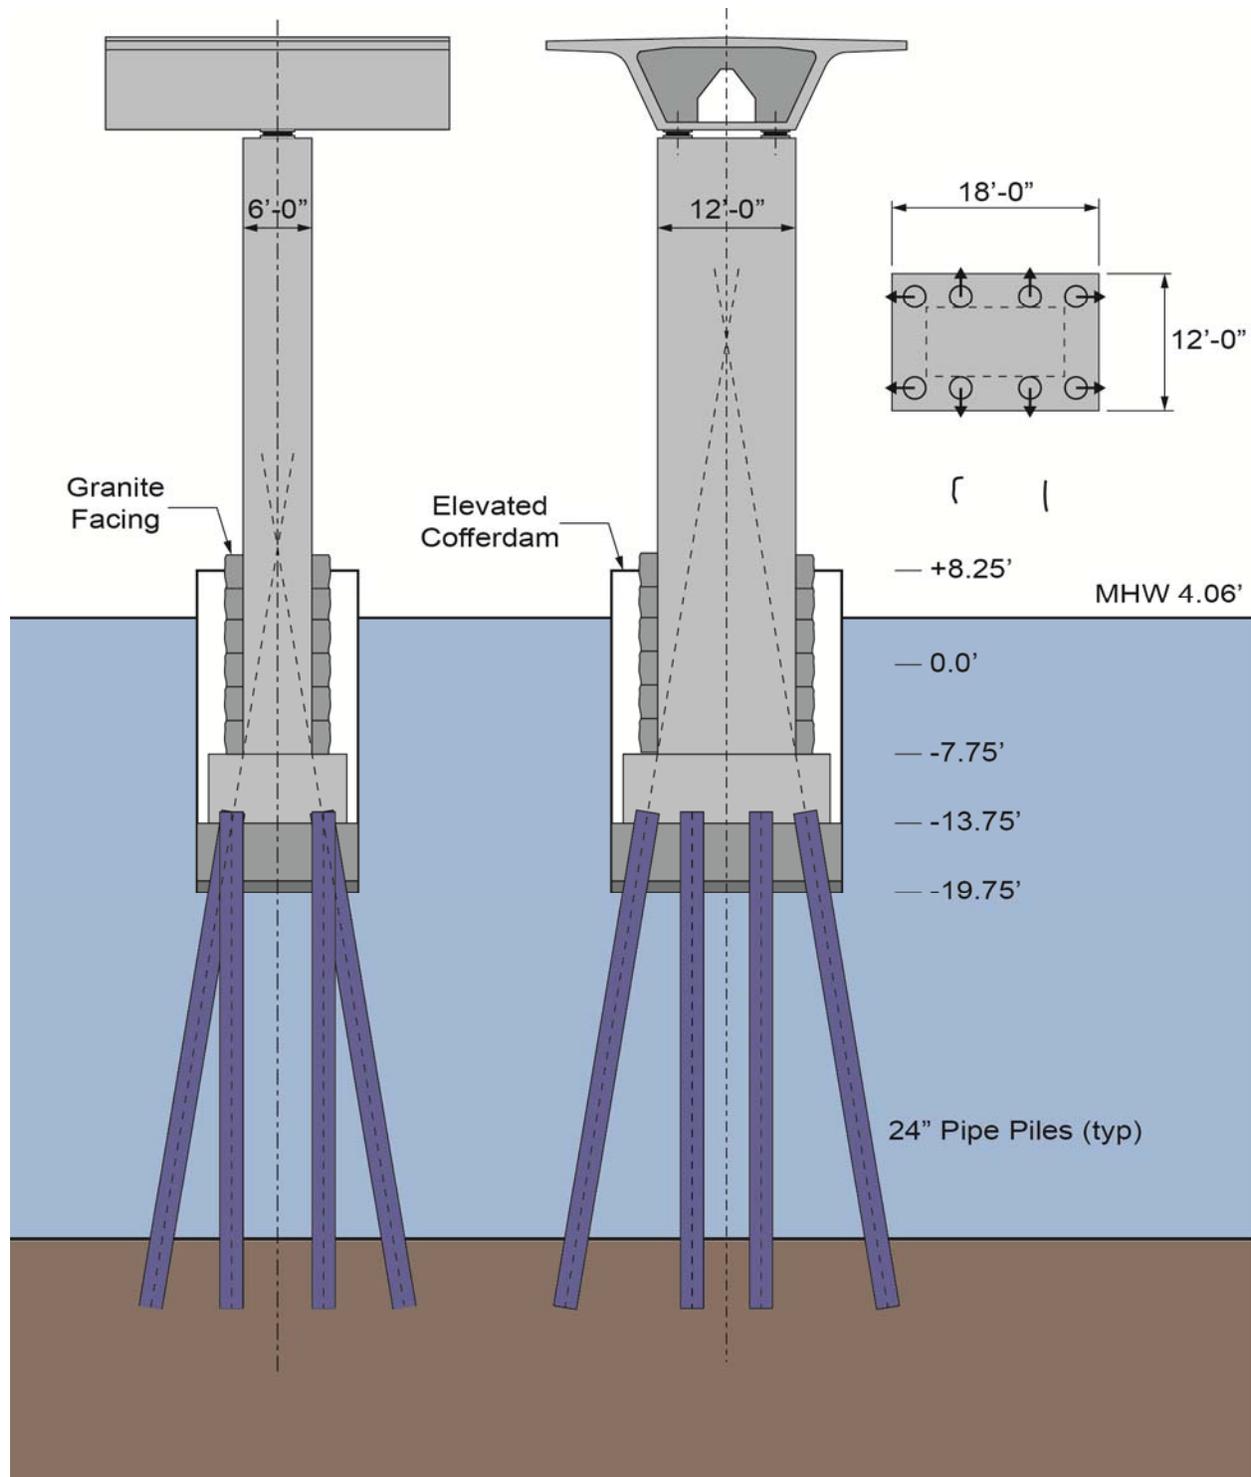
Figure 7 – Substructure for the Span-by-Span Segmental Alternate

The footing and a portion of the pier is constructed in the dewatered cofferdam. When pier construction reaches approximately +15', the cofferdam is disassembled and relocated to the next pier to be constructed.

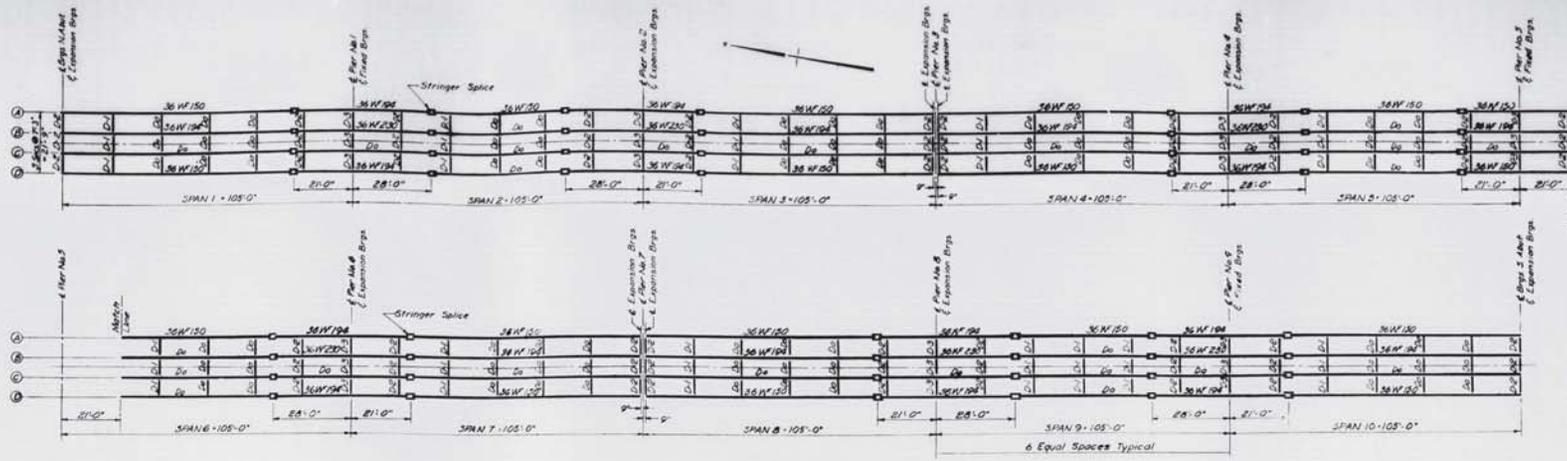
ELEVATIONS OF BEARINGS (BOTTOM OF MASONRY PLATES)

Bearings	ADD	B&C
North Abut	26.17	26.27
Pier 1	31.46	31.66
Pier 2	36.28	36.79
Span 3	41.08	41.14
Pier 3	41.08	41.14
Pier 4	43.72	43.33
Pier 5	43.36	43.45
Pier 6	40.91	41.72
Pier 7	36.69	36.70
Span 7	36.69	36.70
Pier 8	31.29	31.89
Pier 9	26.21	26.41
South Abut	20.98	21.08

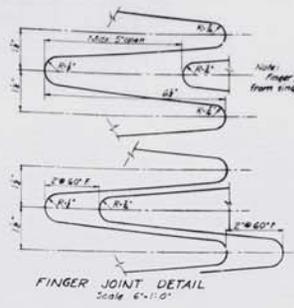
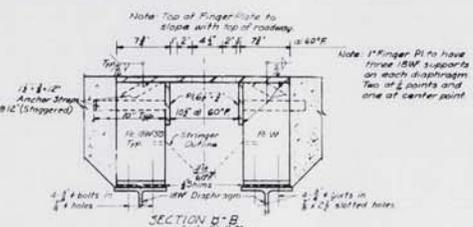
DETAILS OF EXPANSION JOINT AT PIER
Scales as noted

Note Diaphragm D-3 shown, Diaphragm D-2 slopes parallel to roadway cross slope. See Sheet No. 10.

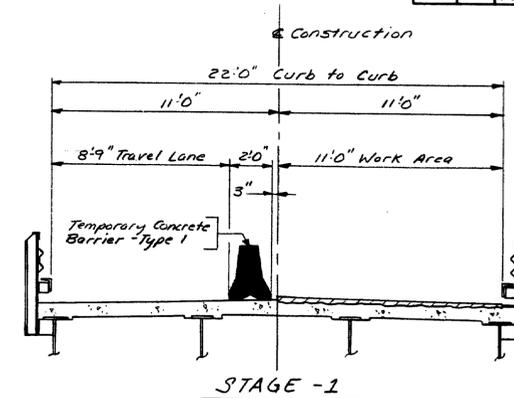
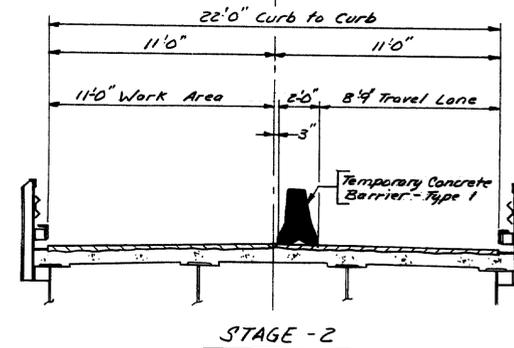
SEQUENCE OF CONSTRUCTION

- STAGE-1**
 Install traffic control devices,
 Maintain 8'-9" travel lane,
 Modify expansion devices, Scarify deck,
 Place wearing surface.
- STAGE-2**
 Relocate traffic control devices,
 Maintain 8'-9" travel lane,
 Modify expansion devices, Scarify deck,
 Place wearing surface.

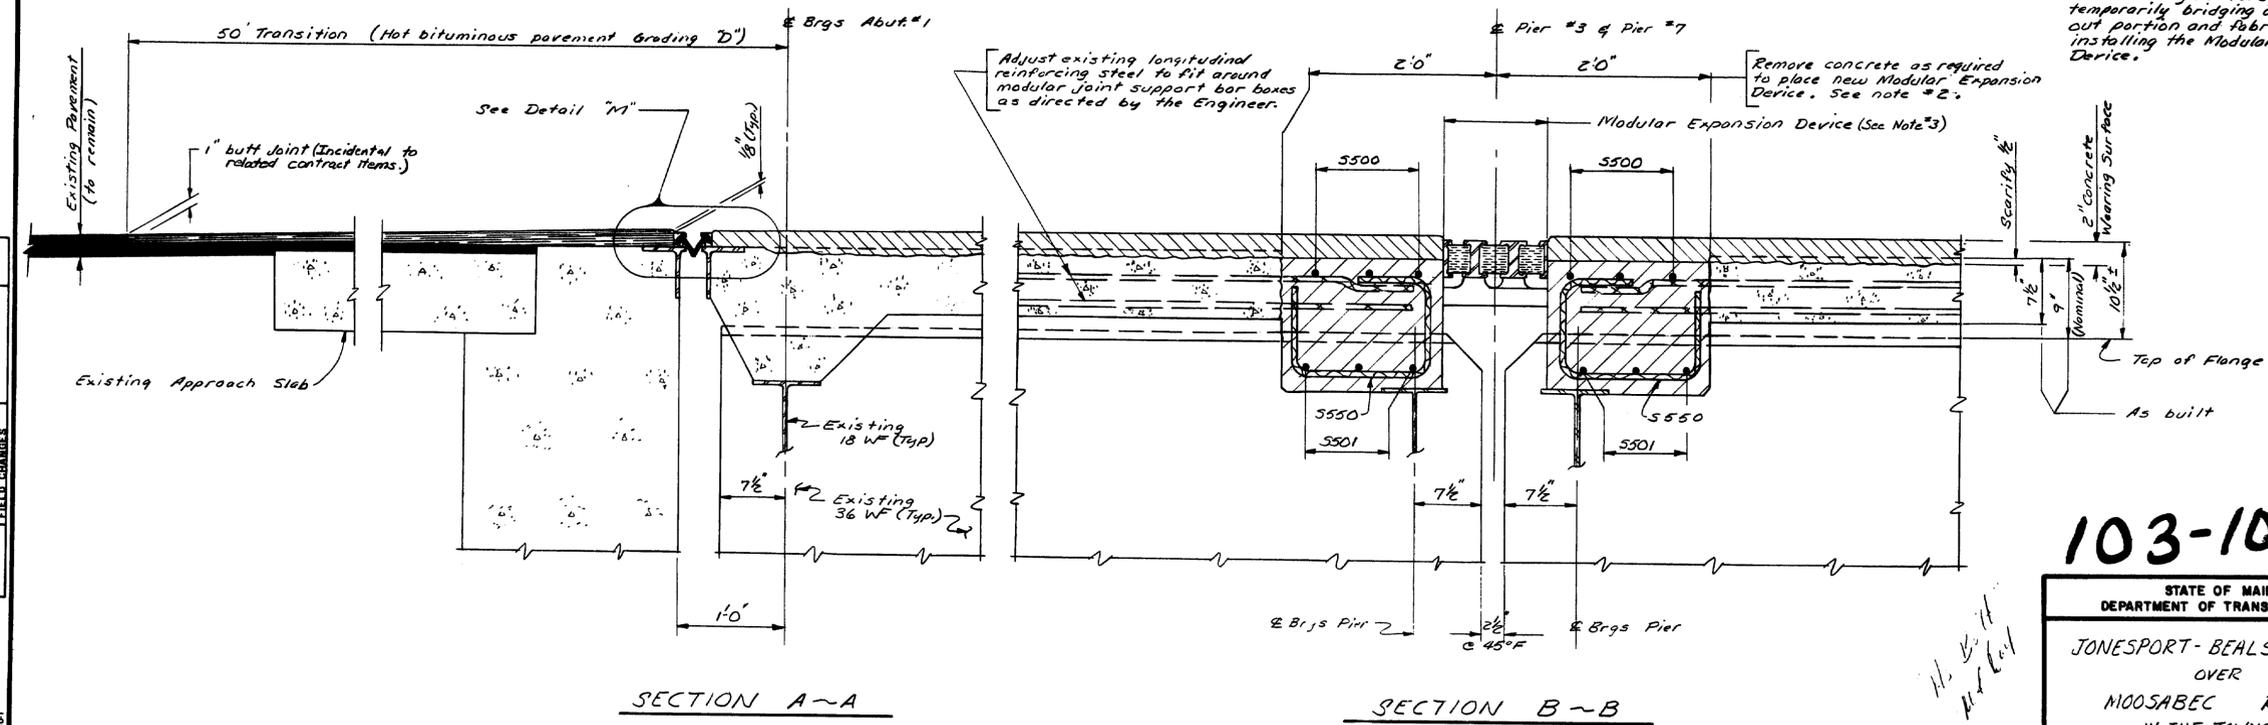
- The Modular Expansion Device shall be installed complete as one unit. The Contractor shall maintain traffic over the blocked out portions of the deck with an approved temporary bridging system. Payment will be made under Item 532.06, Modular Expansion Device and will be considered full compensation for all materials, labor, equipment, and incidentals necessary to complete to work, including removing and replacing structural concrete, adjusting and cleaning reinforcing steel, temporarily bridging over the blocked out portion and fabricating and installing the Modular Expansion Device.

SECTION A-A

SECTION B-B

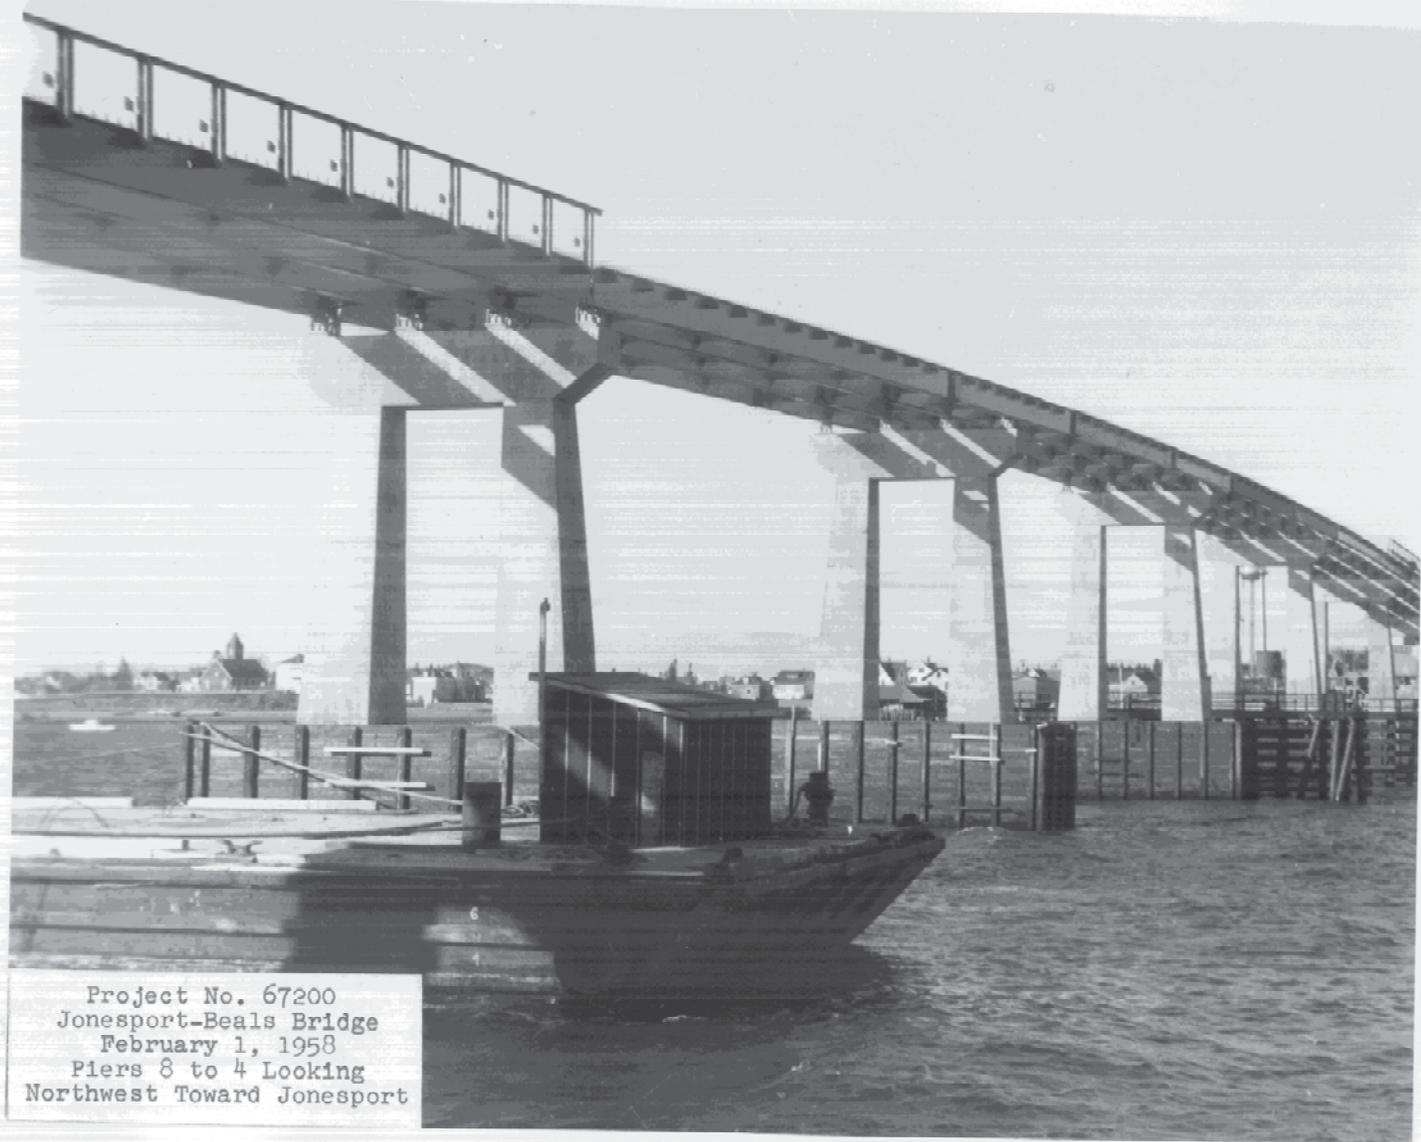
Project No. 67200
Jonesport-Beals Bridge
February 1, 1958
Looking Toward Beals Island
From North Abutment
