October 11, 2012 MaineDOT's Bridge Maintenance Forces and representatives of EMSEAL installed a demonstration bridge joint seal on the Old Bath Road Bridge (#6033) over US Route 1 in Brunswick. The EMSEAL (BEJS) is a 'pre-compressed' 100% acrylic cellular foam compression-type seal with a silicone external facing. The pre-compressed seal is confined between wood slats and shrink-wrap.

MaineDOT's Transportation Research Division inspected the joint on October 16, 2013 with Don McKenna, Region 1 Bridge Maintenance TOM.

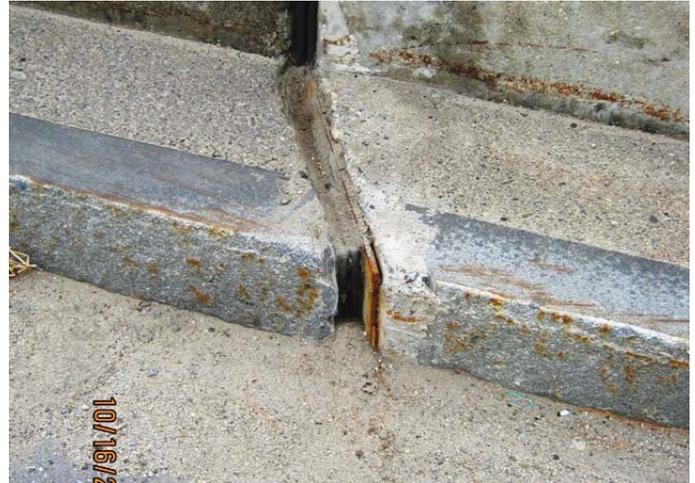
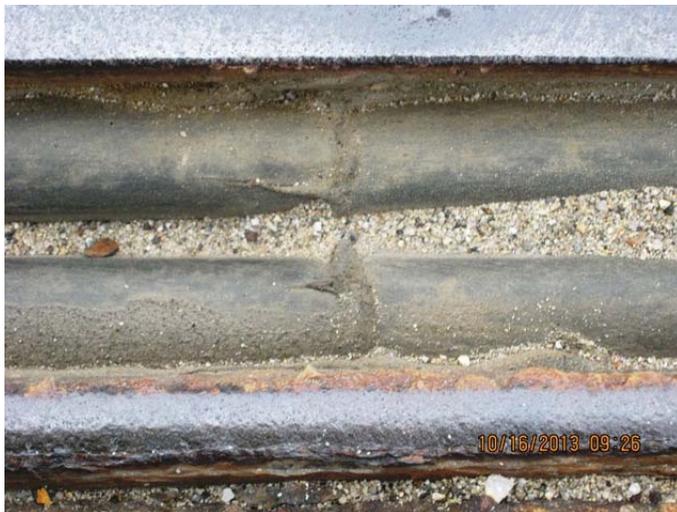
We found a considerable amount of debris accumulated within the joint after one year. According to NCHRP 319, debris accumulation can be detrimental to the performance of these types of compression seals (NCHRP 219, p.12).

No doubt, a contributing factor to the debris accumulation is that the seal was carried up the face of curb creating a dam, rather than running the seal straight through which would allow water and non-compressible materials to exit the road surface.

The joint seal splices (left photo) seem to be holding up well. The seal is supplied in 6.56 LF (2 m) lengths and is bonded end to end in the field with a silicone adhesive prior to insertion into the joint. The silicone sealant bead that runs the length of the seal and bonds to the steel is still holding up well for the most part.

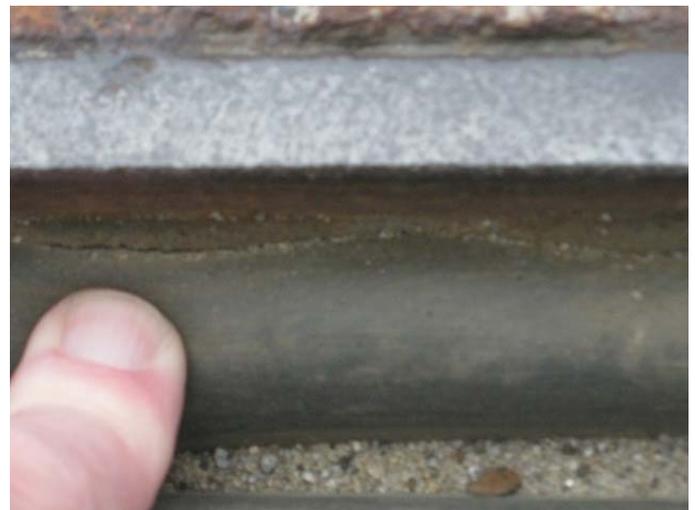
It was noted that in some areas the bond has begun to weaken on the seal side of the bead and has caused some separation. It is unclear to what depth the debondment extends to. See photo below.
