GREEN LAKE PROJECT (P7189)

APPENDIX C – STUDIES

***RE: Green Lake Hydroelectric Project (FERC No. 7189)
Initial Study Report***

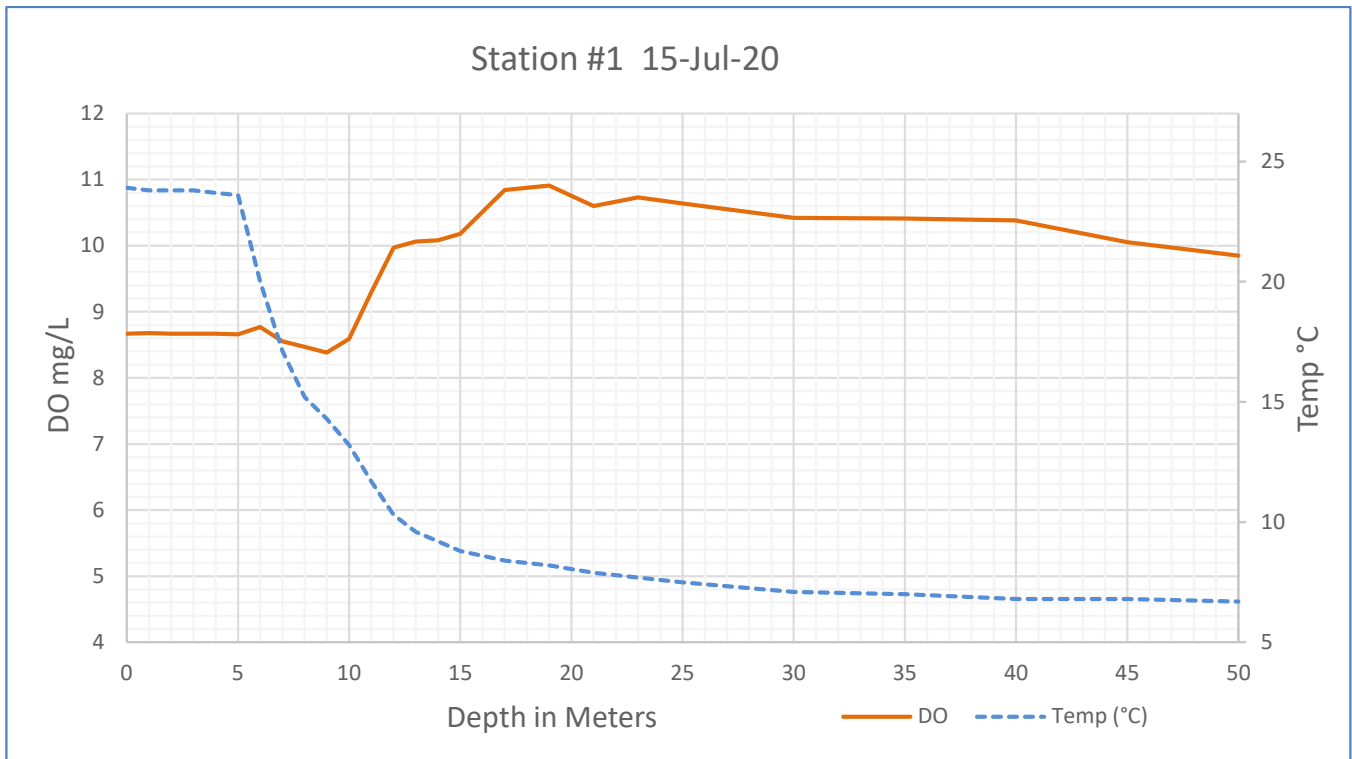
Figure 2-3 – Station #1 15-Jul-20 DO & Temp

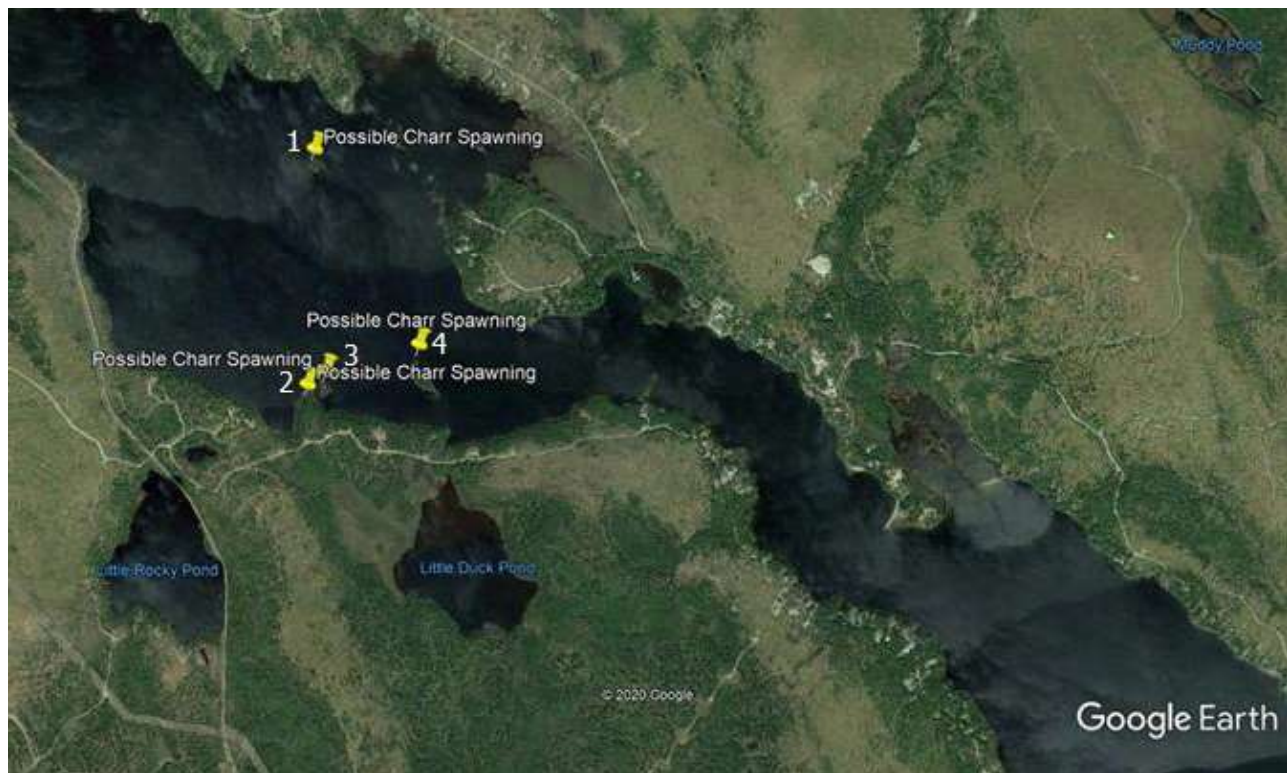
Given the possible spawning sites for arctic char, loggers were deployed from August 31, 2020 to December 1, 2020 with the goal of determining when the temperature of the lake goes below 50 °F

Figure 2-26 – Possible Arctic Char Spawning Sites – Map provided by MDIFW

Two data loggers were deployed in two separate locations on August 31, 2020. The Loggers were located at location 2 and 4 on the map above. The other sites proved unsafe to access with our boat.

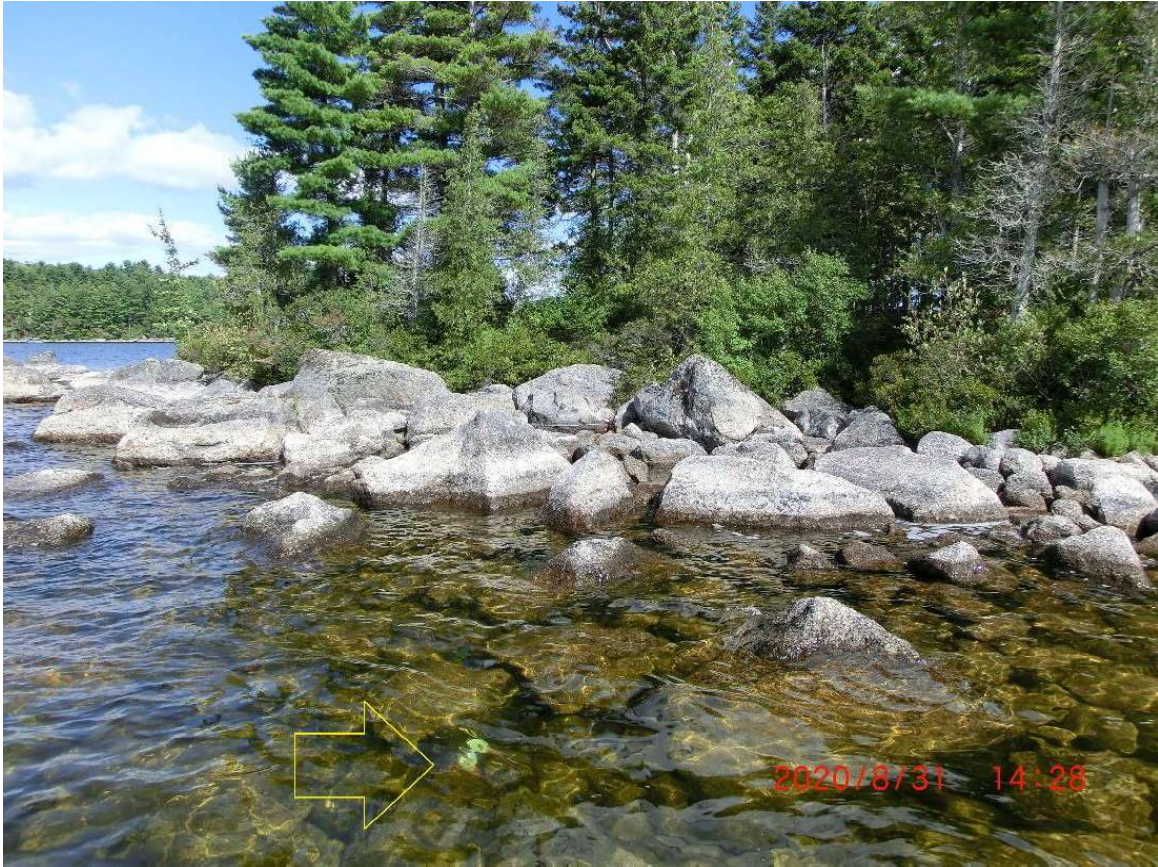
The devices were placed such that they would stay within the 18” to 6’ deep range required throughout the allowed lake level range.

Photo 2-12 – Logger 1 at location 4

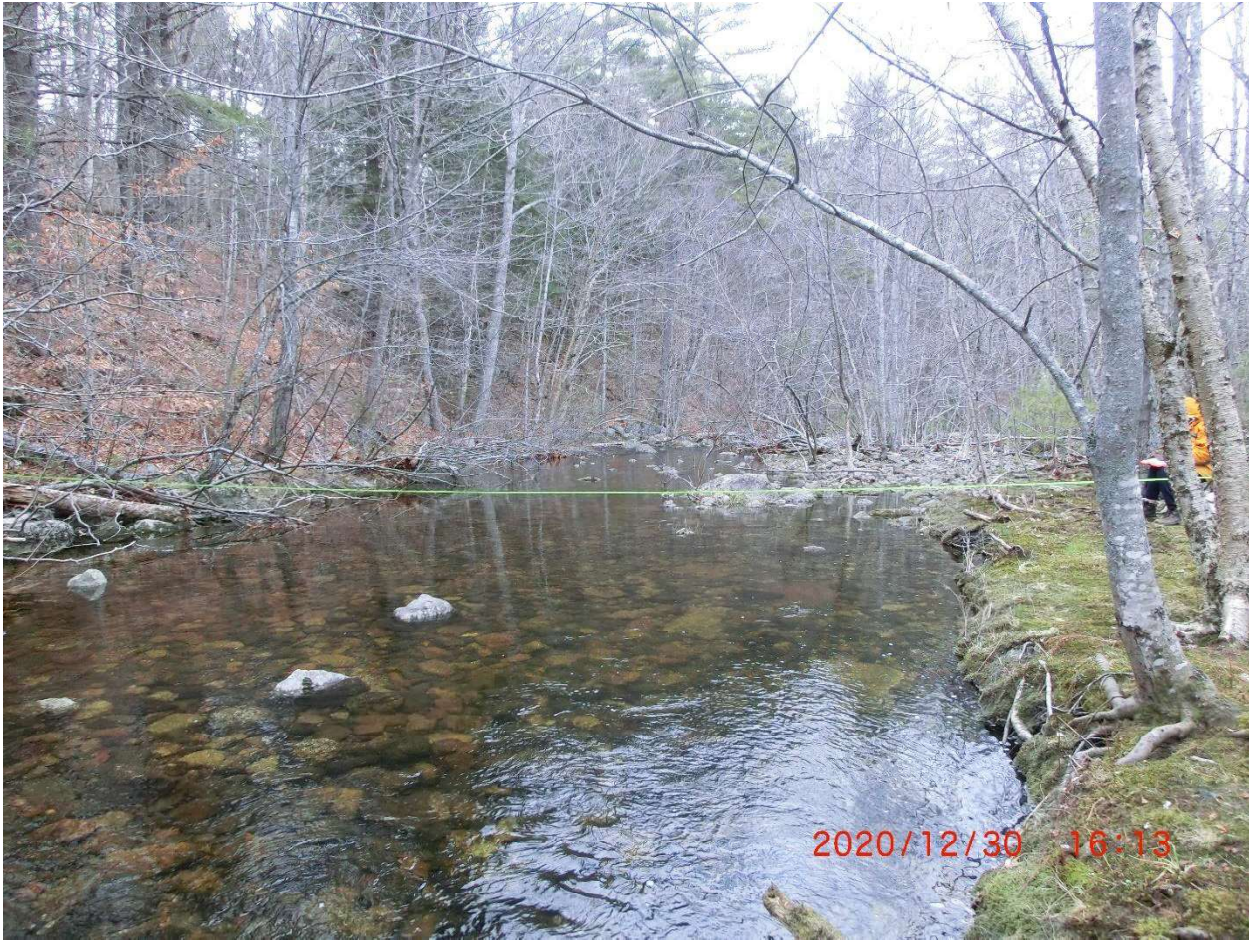
Transect 1 is 307 ft from the start of the Brook. It is a large, wide pool with an in-water substrate of small and medium cobble with interspersed gravel of varying sizes.

Photo 2-15 – Transect 1

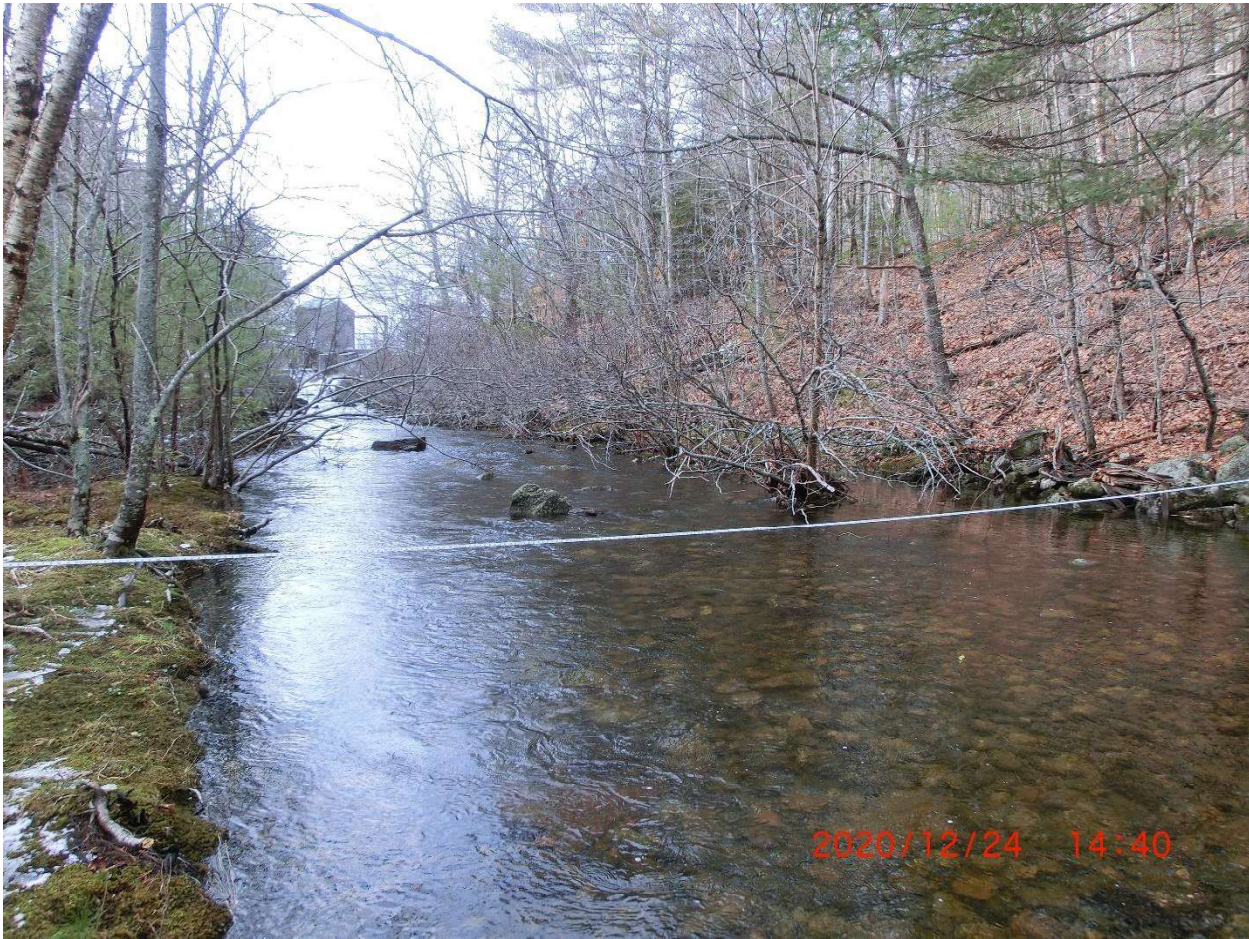
Bank full at Transect 1 appears to be about Flow 4, as shown in the following picture:

Photo 2-16 – Bank full at Transect 1

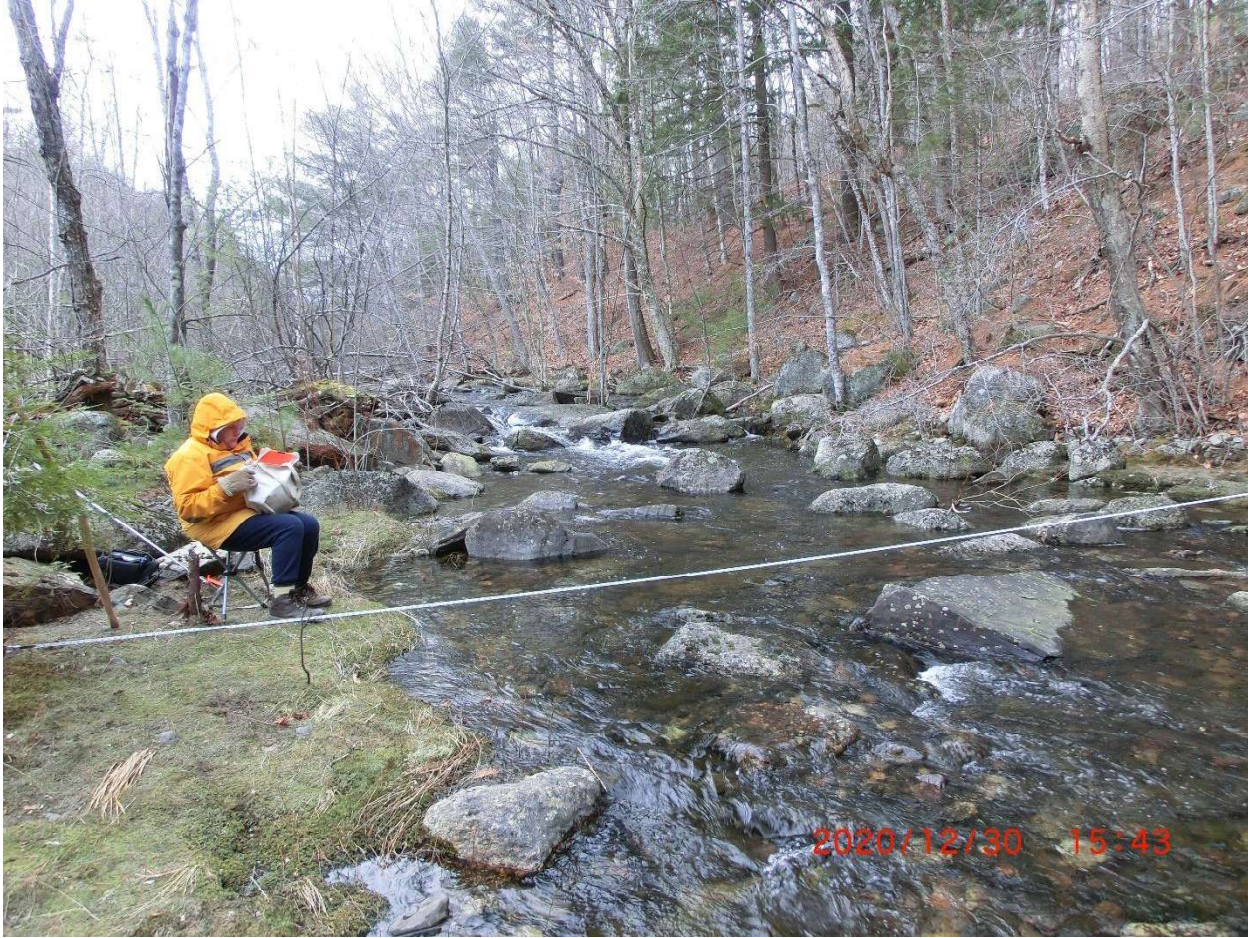
Transect 2 is 471 ft from the start of the Brook and 164 feet from Transect 1. It is in a part of the Brook that is largely riffle, with some pools.

Photo 2-21 – Transect 2

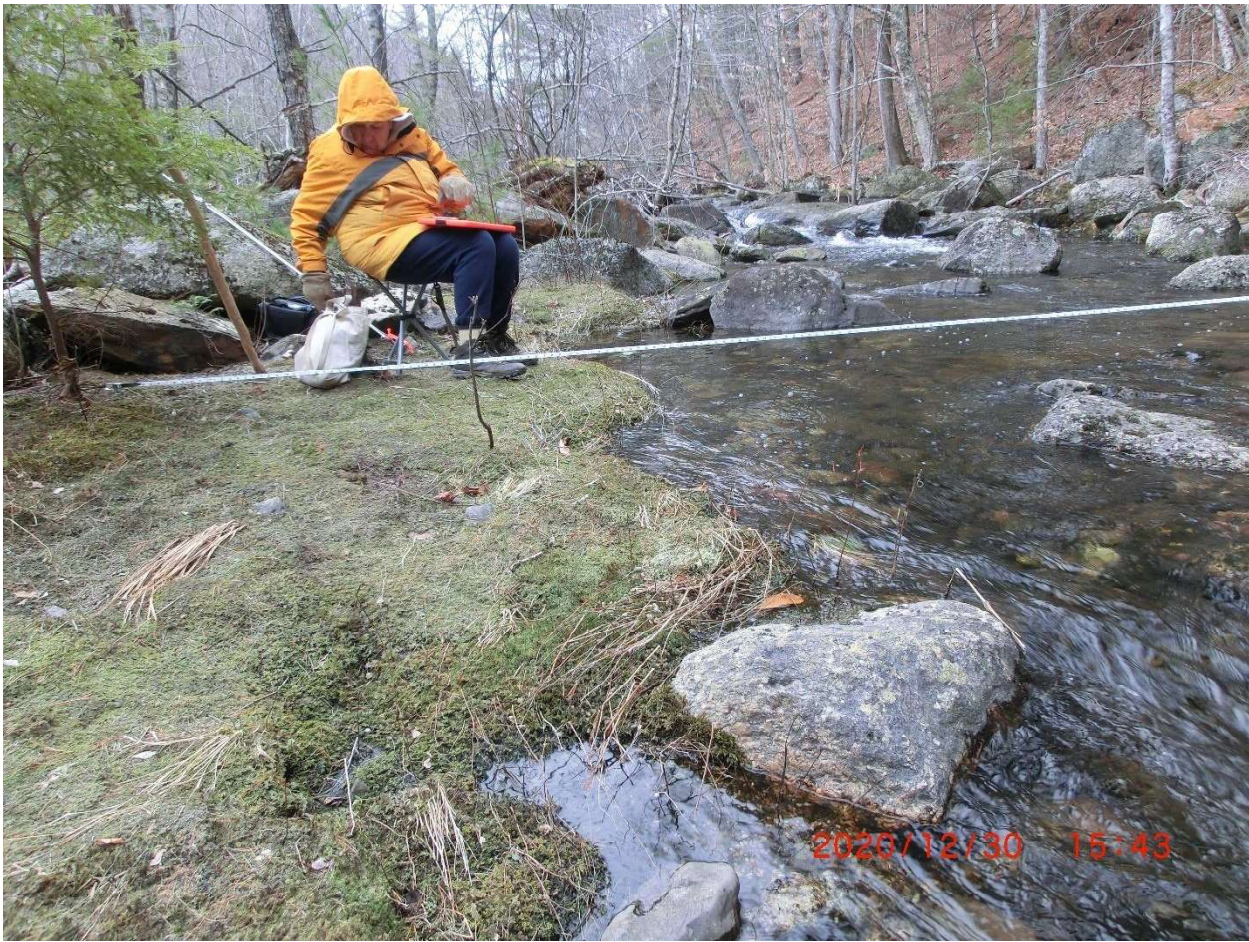
Bank full for Transect 2 is about Flow 2 as shown in the following picture:

Photo 2-22 – Bank full for Transect 2

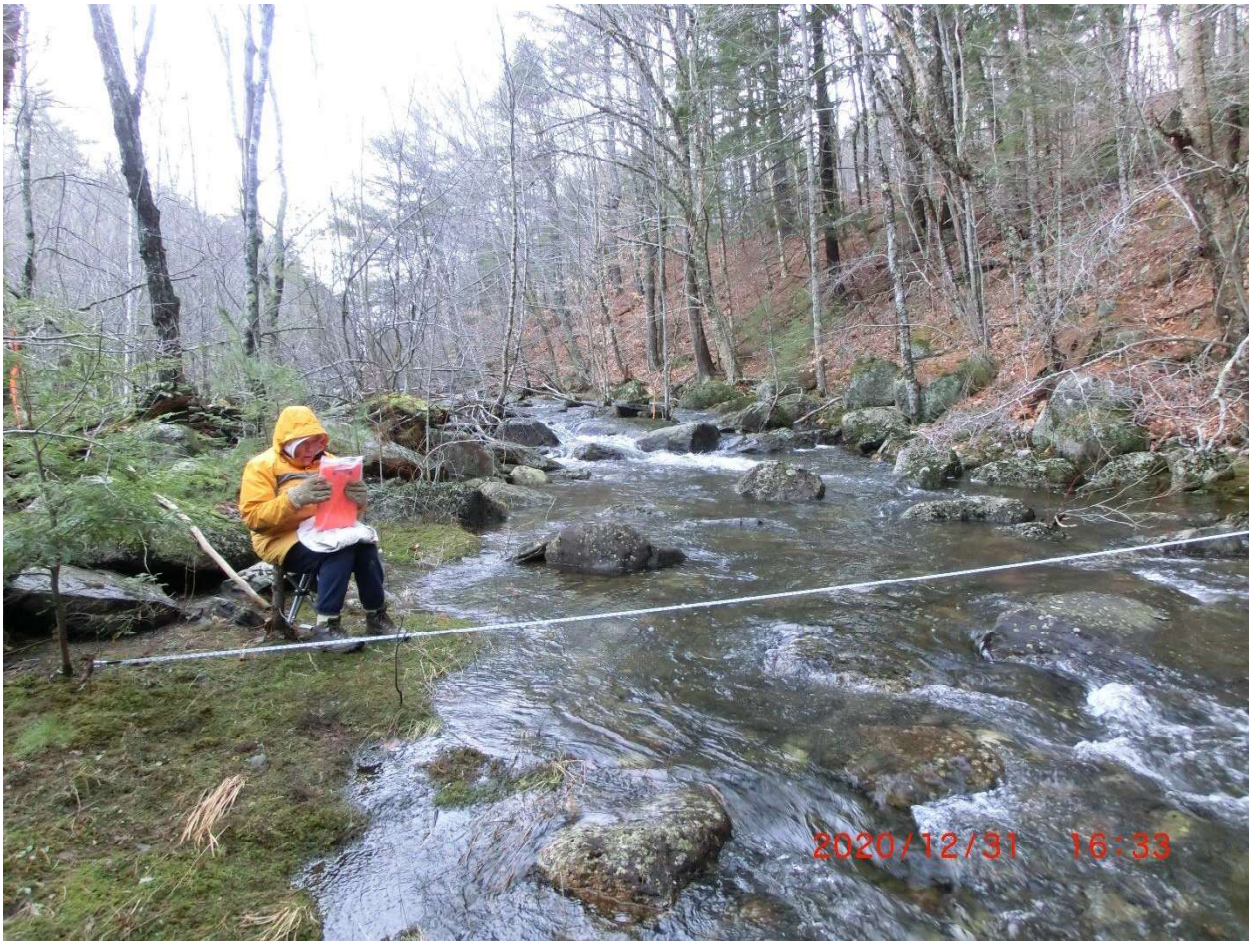
The following picture shows Flow 3 overtopping the bank:

Photo 2-23 – Transect 2

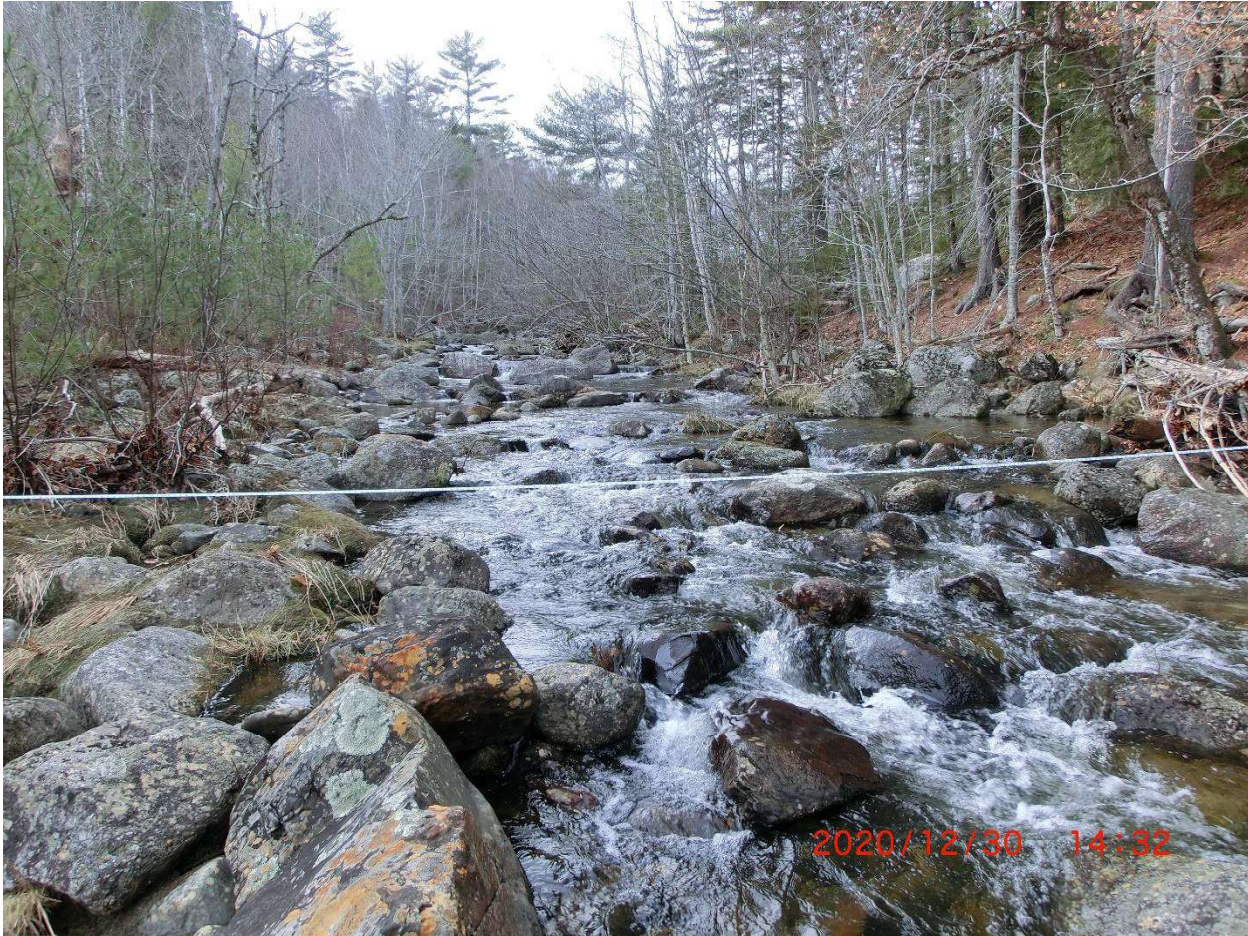
Transect 3 is 1061 ft from the start of the Brook and 590 feet from Transect 2. It is in the steepest part of the Brook that is largely riffle, with some small pools.

Photo 2-28 – Transect 3

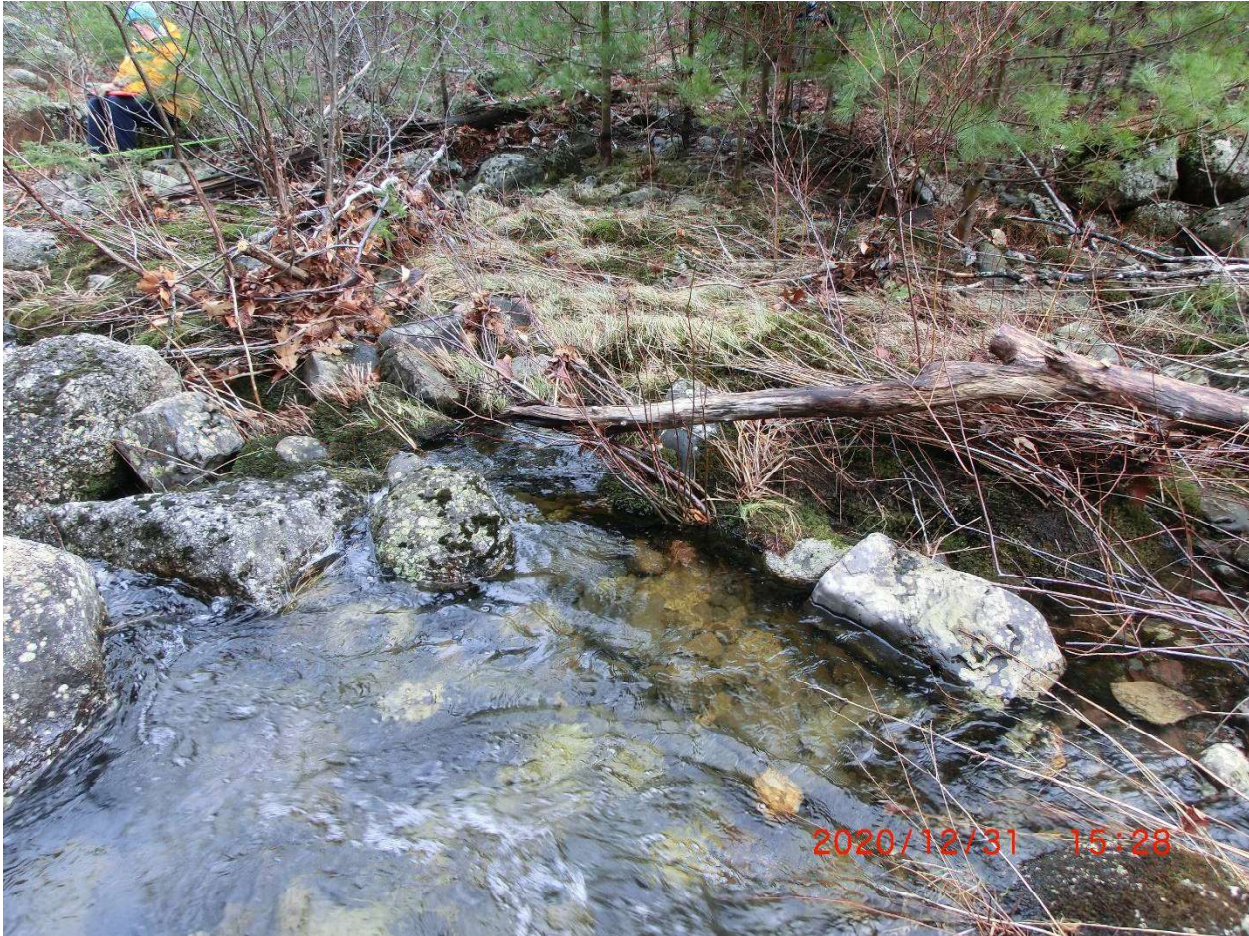
Bank full is a bit more difficult to determine at Transect 3 because the banks are composed of large cobble and boulders. It appears to be about Flow 3, as shown in the following picture:

Photo 2-29 – Transect 3 Bank Full

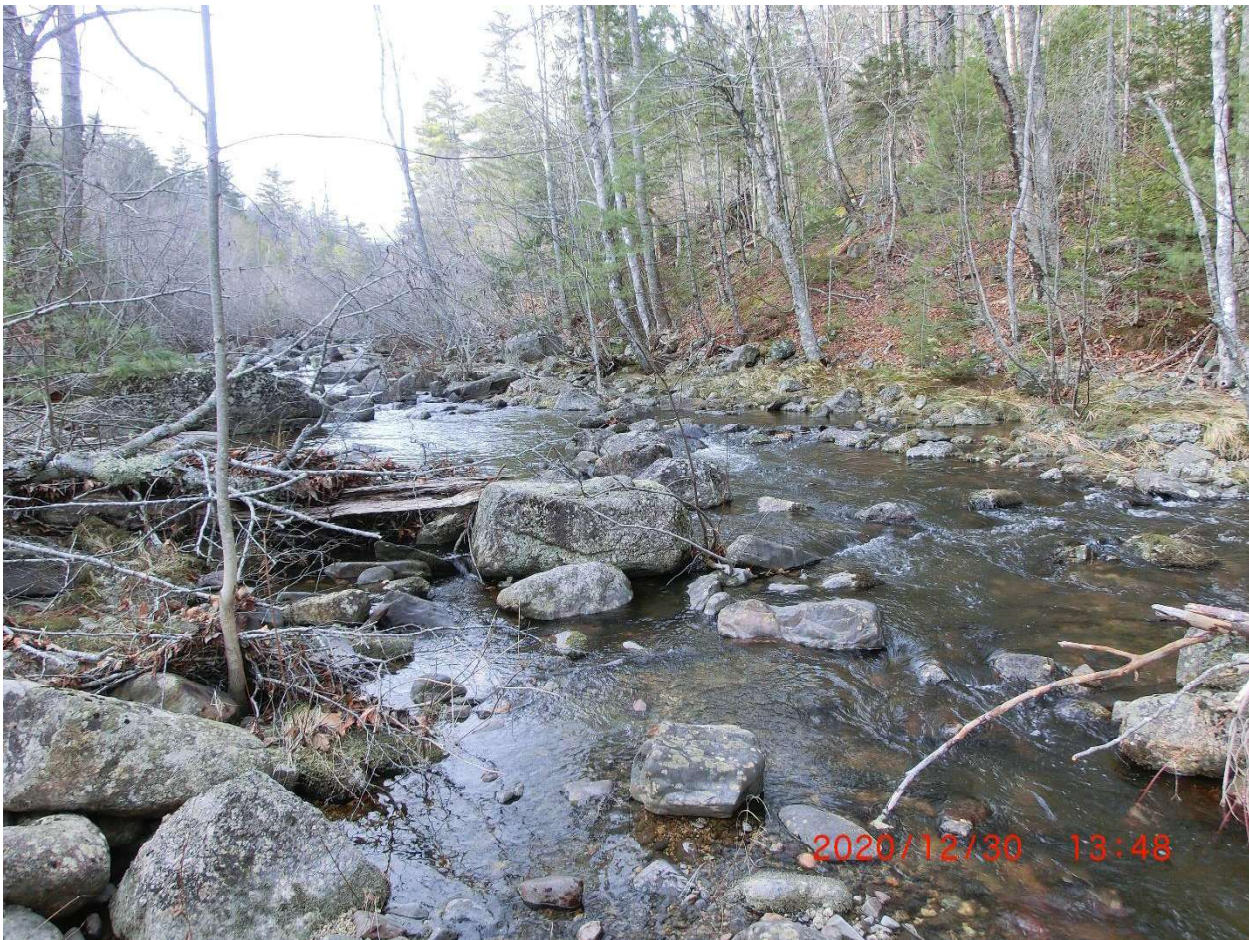
Transect 4 is 1453 ft from the start of the Brook, 392 feet from Transect 3, and 531 feet from Graham Lake. It is at the end of the steepest part of the Brook. The Brook from Transect 4 to Graham Lake is a mixture of riffle and pools.

Photo 2-34 – Transect 4

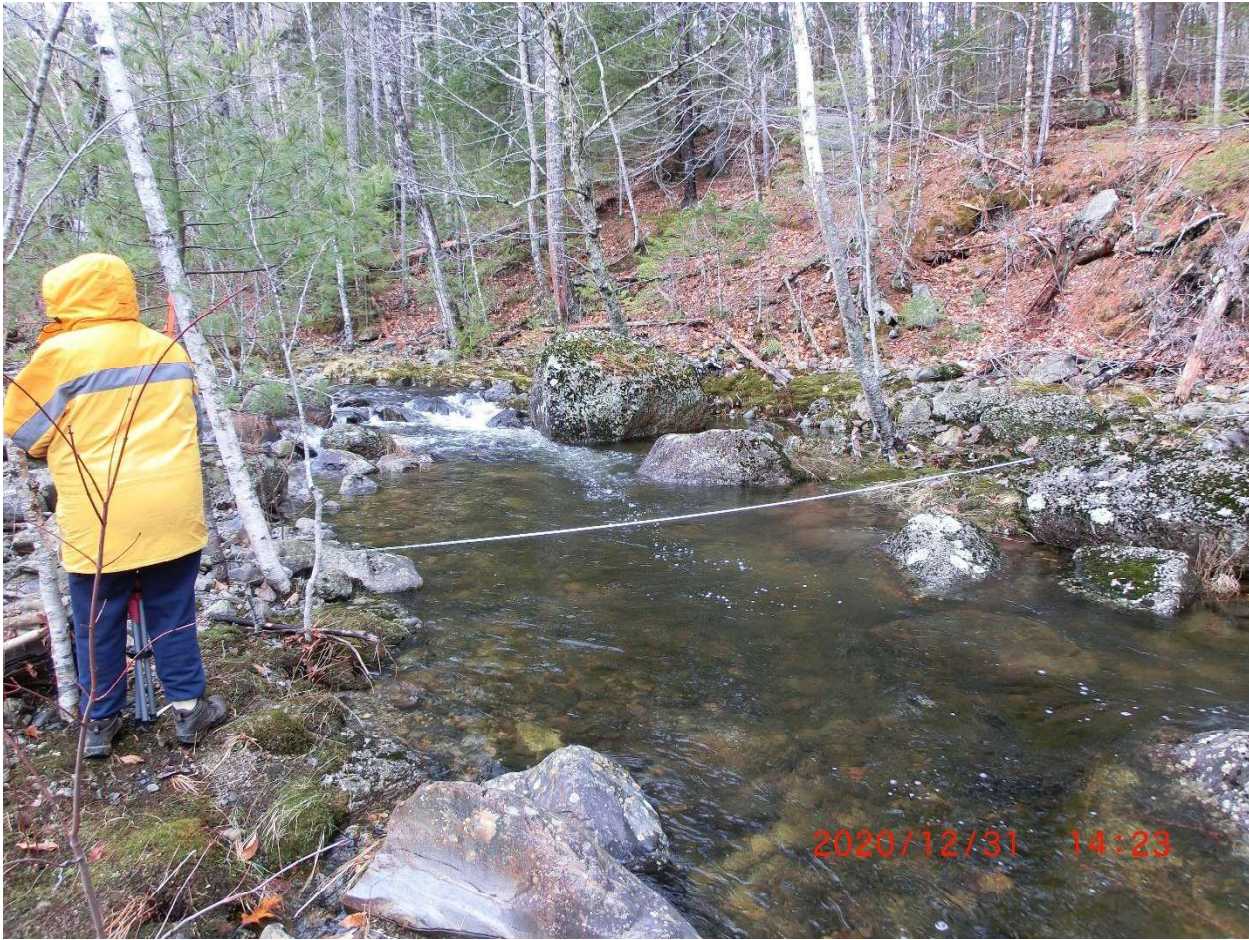
Transect 4 appears to be bank full around Flow 3, as shown in the following picture:

Photo 2-36 – Transect 4 Bank Full

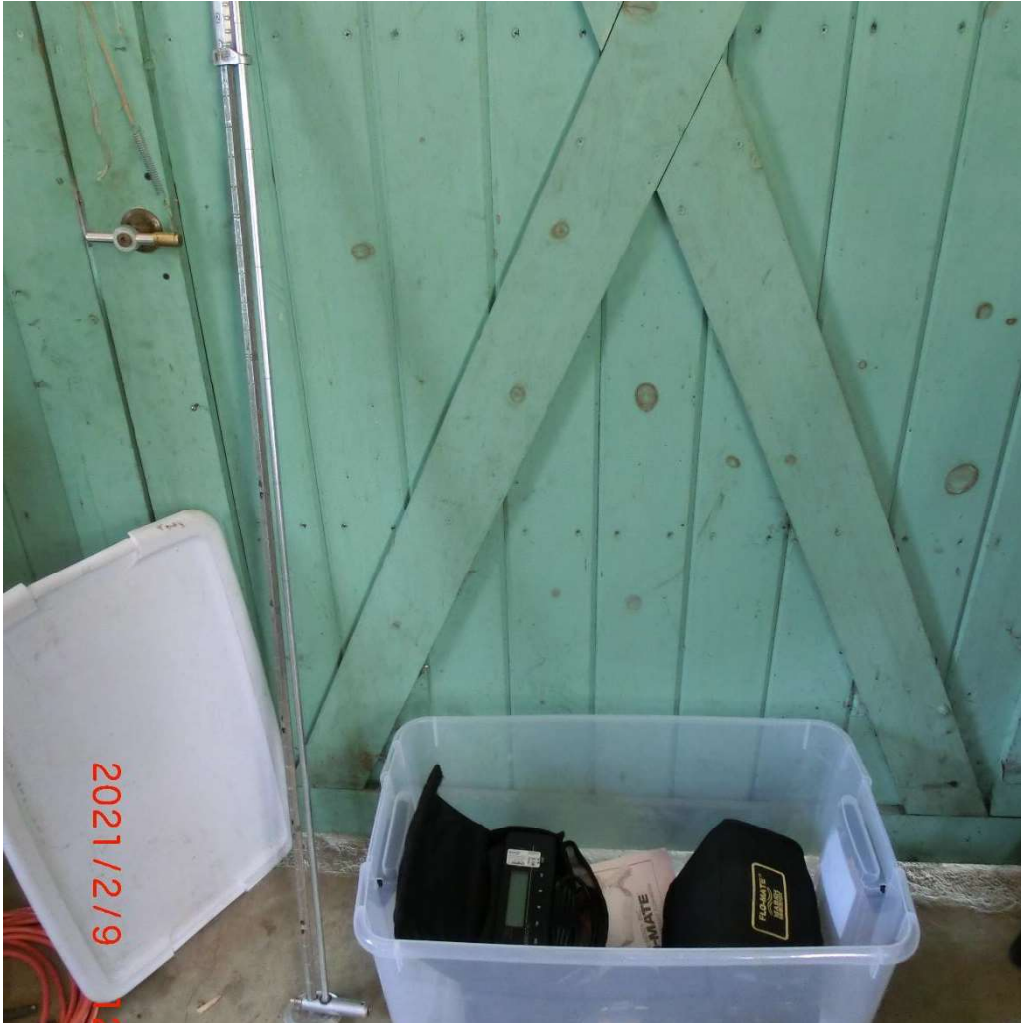
The power station “known elevation” spot was measured at the start and completion of the mapping work. The heights calculated from the two sets of readings differed by less than ½ foot. From the testing of the units it appears the GPS accuracy (with clear view of the sky and several minutes of readings) is within about 2 feet. With a couple minutes of readings the altimeter appears to be accurate to less than 1 foot. Its resolution is less than 3 inches.

Photo 2-41 – Flow Meters
