**2020**  
**Macroinvertebrate Sampling Study**  
**Downstream**  
**of**  
**Green Lake Dam**  
**Ellsworth Maine**  
**FERC No. 7189**

**Paul C. Leeper**  
**Moody Mountain Environmental**  
**137 Diamond Str**  
**Searsmont Maine 04973**

**Green Lake Water Power Company**  
**Ellsworth, Maine**  
**Date: 3-15-21**

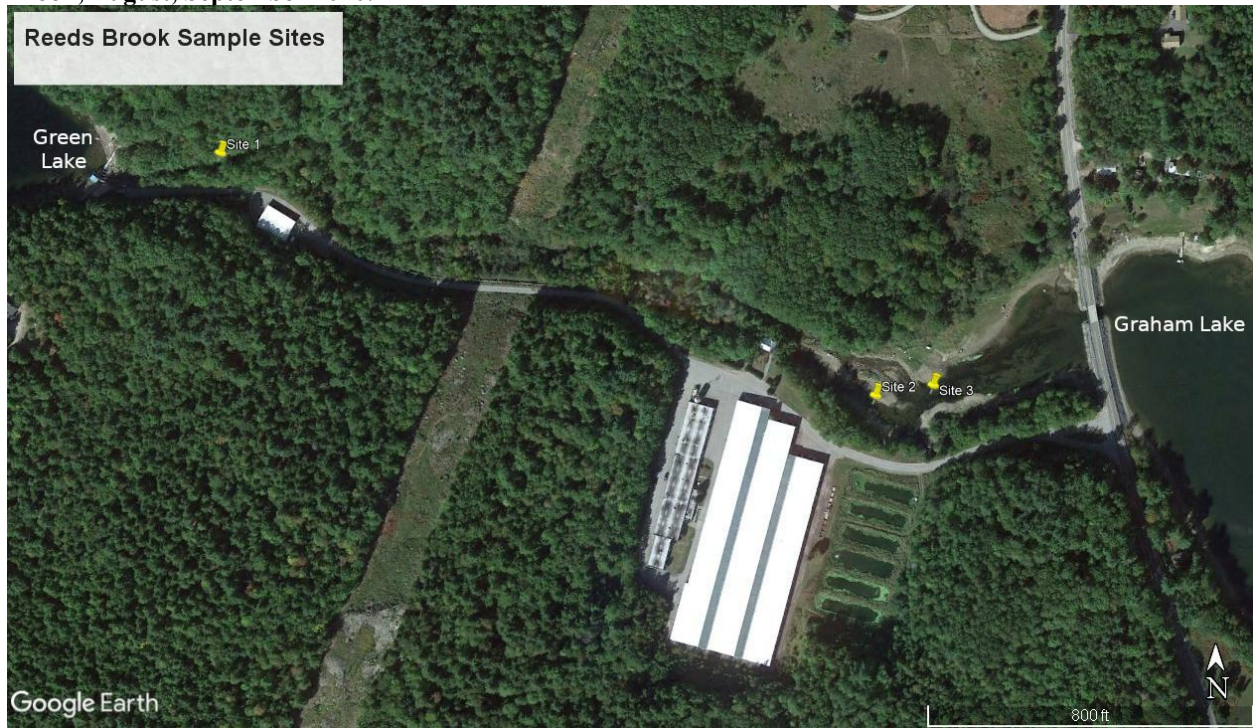
**Figure 1. Location of aquatic macroinvertebrate sampling site downstream of the Green Lake Dam. Reeds Brook, August, September 2020.**

In 2020 we placed samples at three (3) sites in Reeds Brook to study aquatic macroinvertebrates (Figure 1) after conferring with the Maine Department of Environmental Protection (MDEP). **Site 1** was located approximately 290ft downstream of the existing dam. This site was located upstream of the Green Lake Hatchery discharge. **Site 2** was located approximately 240 ft downstream of the powerhouse and approximately 2240 ft downstream of the dam. Site 3 was located approximately 400 downstream of the confluence of Reeds Brook and the powerhouse tailrace, approximately 2350 ft downstream of the dam.

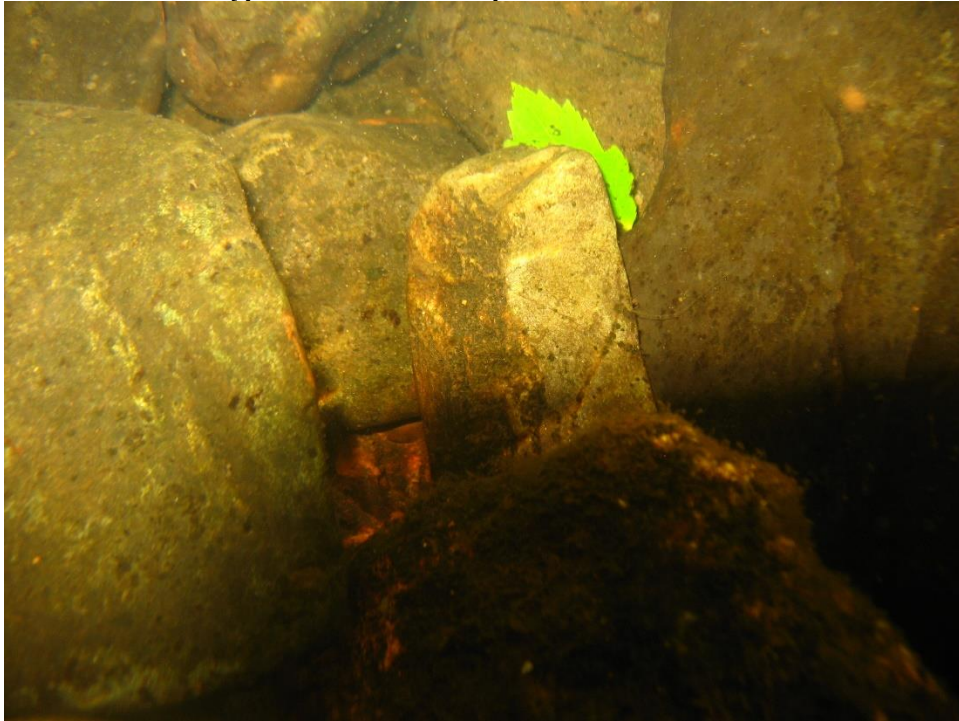
**Photo 3. Typical substrate at sample site. Reeds Brk. 9/24/20 PCL**

<b>4. Physical Characteristics of Bottom</b> estimate % over 12 m stretch					
	Bedrock	[40	Cobble (2.5" – 10")		Sand (<1/8")
	Boulders (>10")	[10	Gravel (1/8" – 2.5")		Clay
					Muck

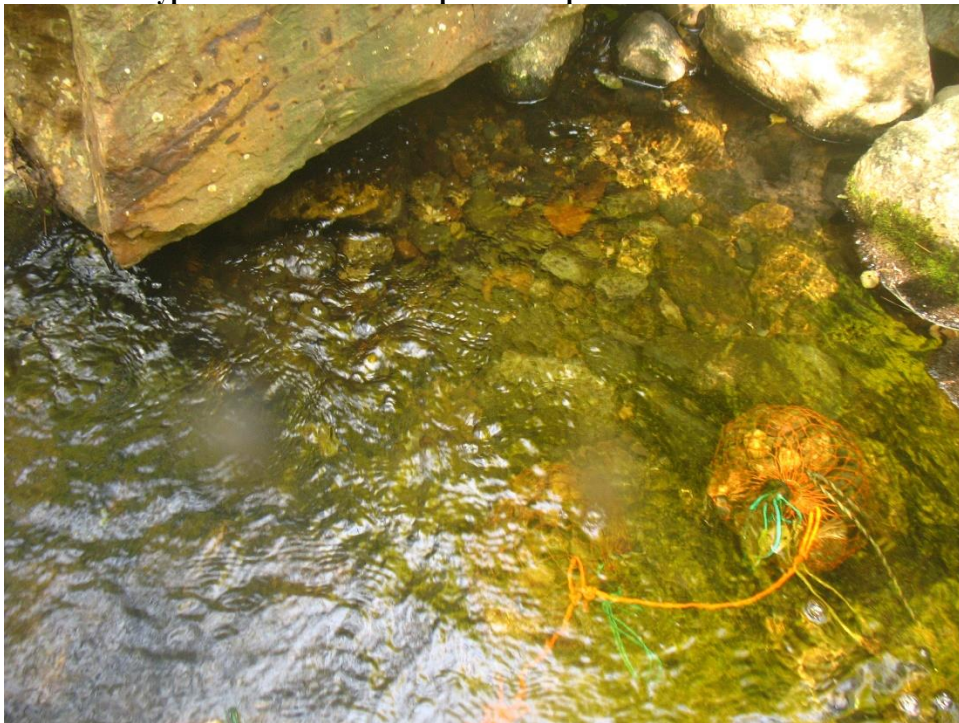
**Photo 4. Typical substrate and sampler at sample site. Reeds Brk. 9/24/20 PCL**

The DEP standard rock bag samplers were used for this study. These samplers hold approximately 16 lbs. of clean, washed, bank-run cobble, graded to uniform diameter range of 1.5 to 3 inches. Three (3) samplers were placed at the sample sites; samplers were left in the river for approximately 28 days ( $\pm$  4 days) to allow for invertebrate colonization. Retrieval of the samplers was done using an aquatic D-net. The net was placed directly downstream of a sampler; the sampler was then picked up and placed in the net. The contents of each sampler and the net were washed through a sieve bucket and preserved in labeled jars. Habitat measurements including substrate type, depth, and temperature were collected at sampler collection retrieval.
