Portland Bangor Waste Oil Robbins Property, Ellsworth

Summary of the Remedial Investigation & Remedial Action

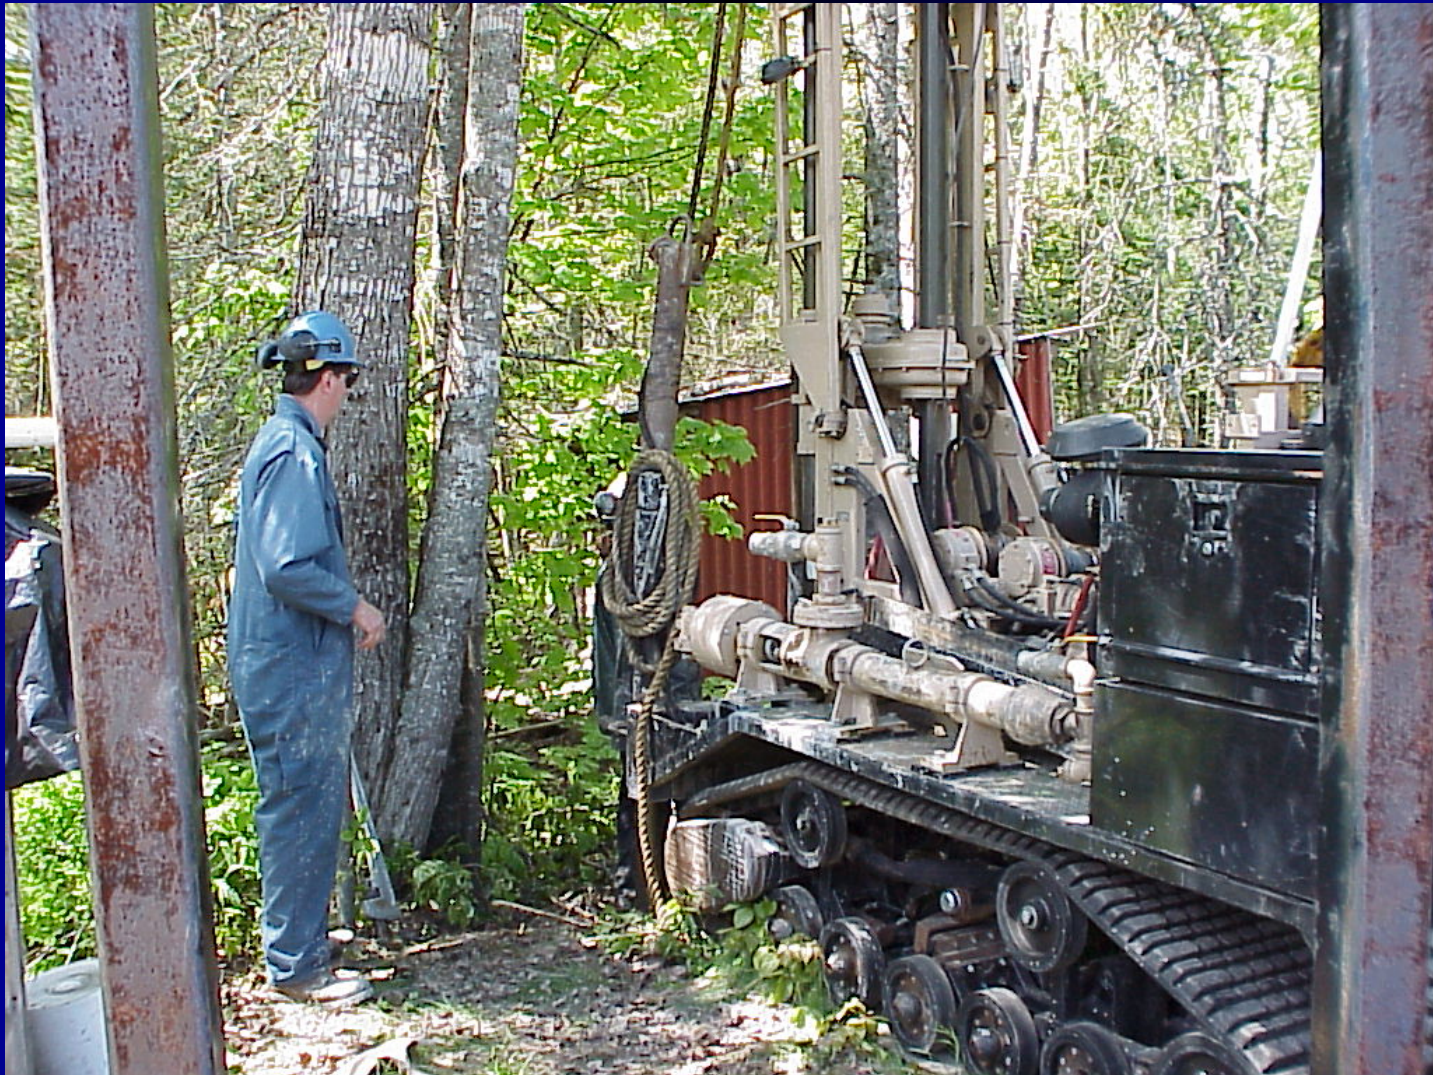
Soil & Ground Water Sampling (via Geoprobe)

- Samples collected from 58 locations
 - Solvent concentrations (tetrachloroethylene or PCE) in soil detected as high as 1,400 mg/kg
 - Maine Remedial Action Guidelines (MRAGs): as low as 3 mg/kg
 - PCE concentration in site groundwater detected as high as 400,000 $\mu\text{g/L}$
 - ME Exposure Guidelines (MEG): 5 $\mu\text{g/L}$ (residential)

Estimated TPH contamination area

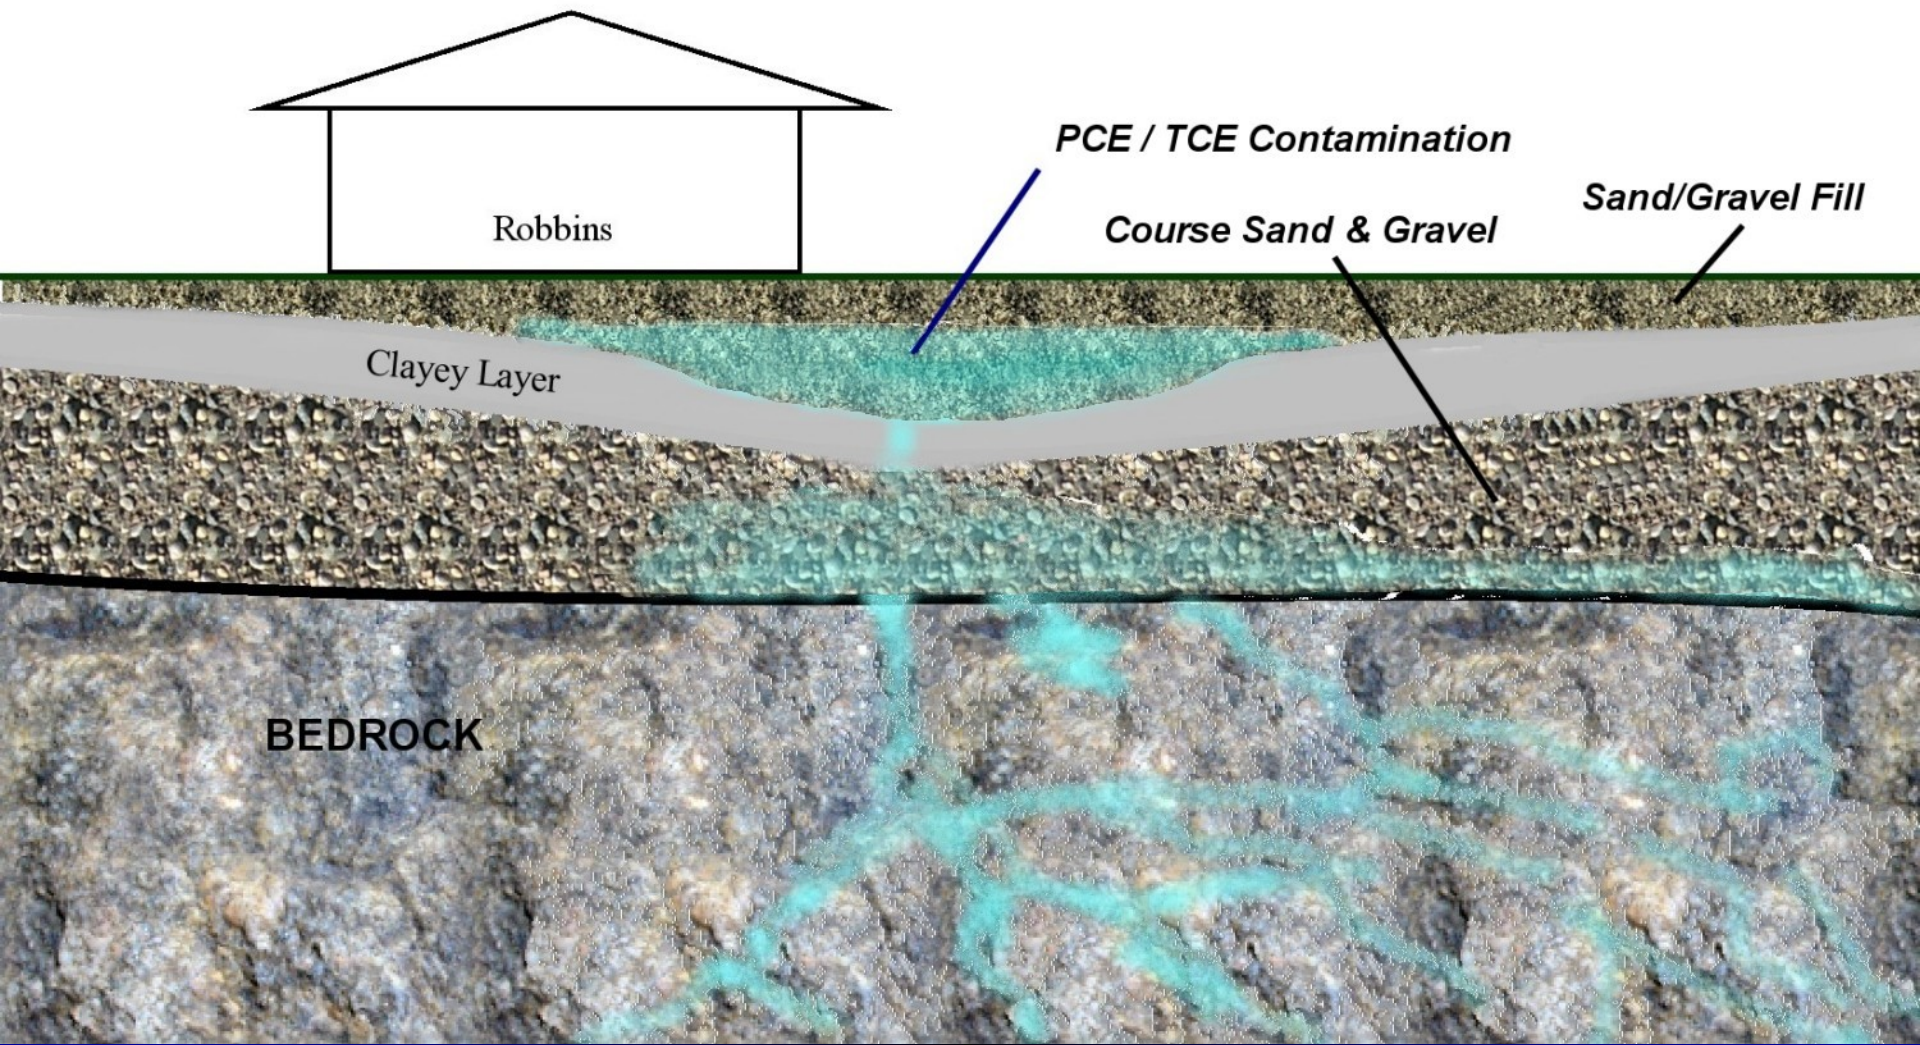
Composite Model Cross-Section

Robbins Property
Uncontrolled Hazardous Substance Site
Ellsworth, Maine

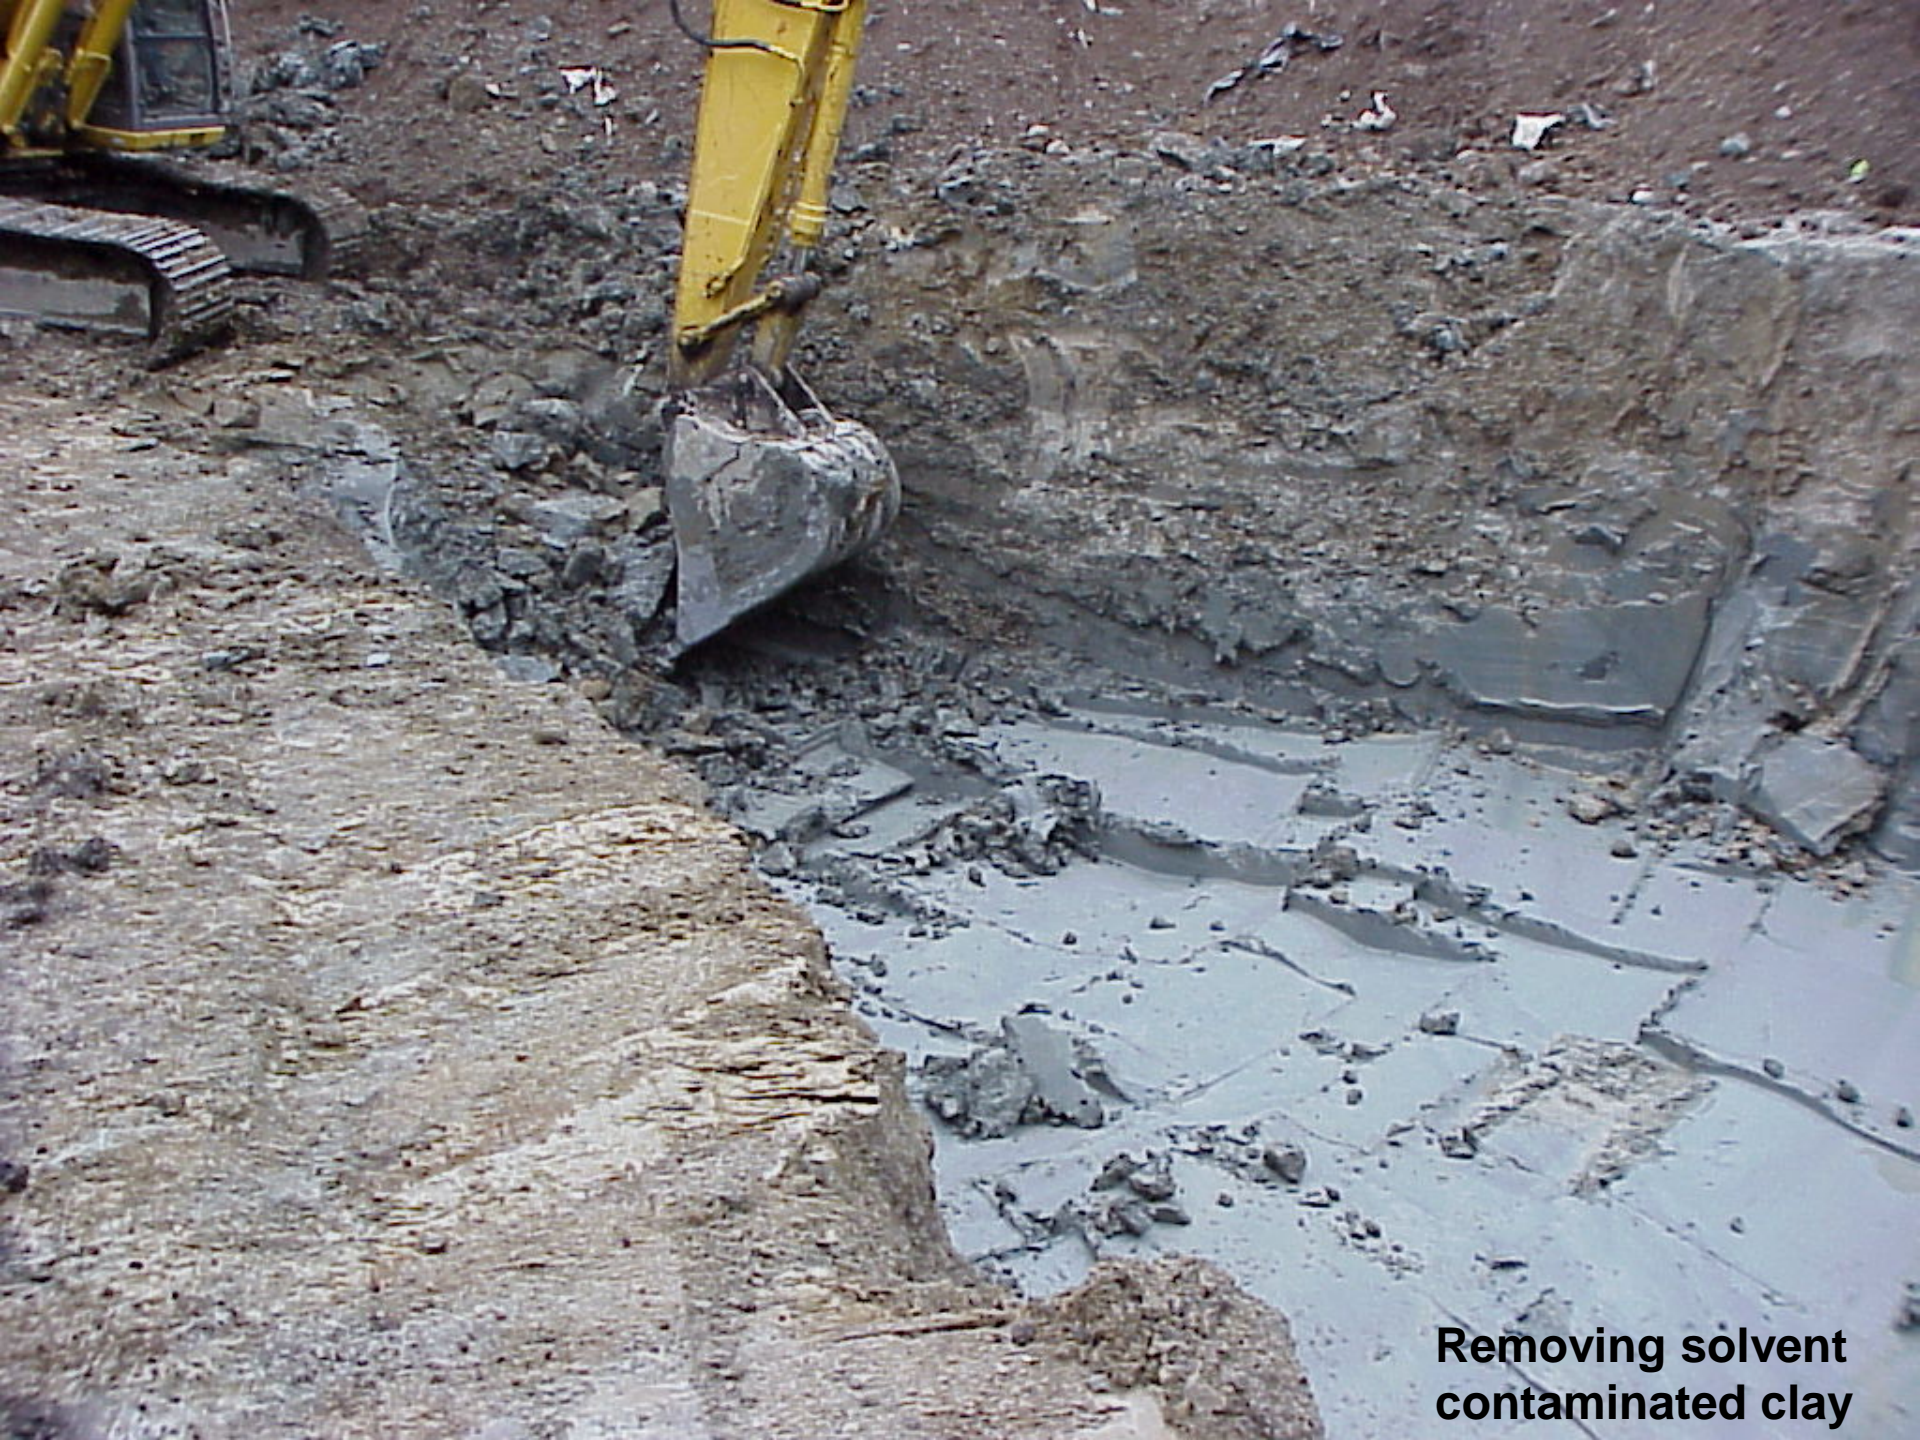
**Removing solvent
contaminated clay**

- 1,989 tons contaminated soil removed
 - 824 tons disposed at GSI, Canada (hazardous by characteristic)
 - 1,165 tons disposed at Pine Tree Landfill, Hampden, Maine (non-hazardous, special waste)
- 12,000 gallons of contaminated groundwater recovered during excavation dewatering
 - 10,250 gallons treated on-site
 - 1,555 gallons transported off-site and disposed at United Oil Recovery in Newington, NH

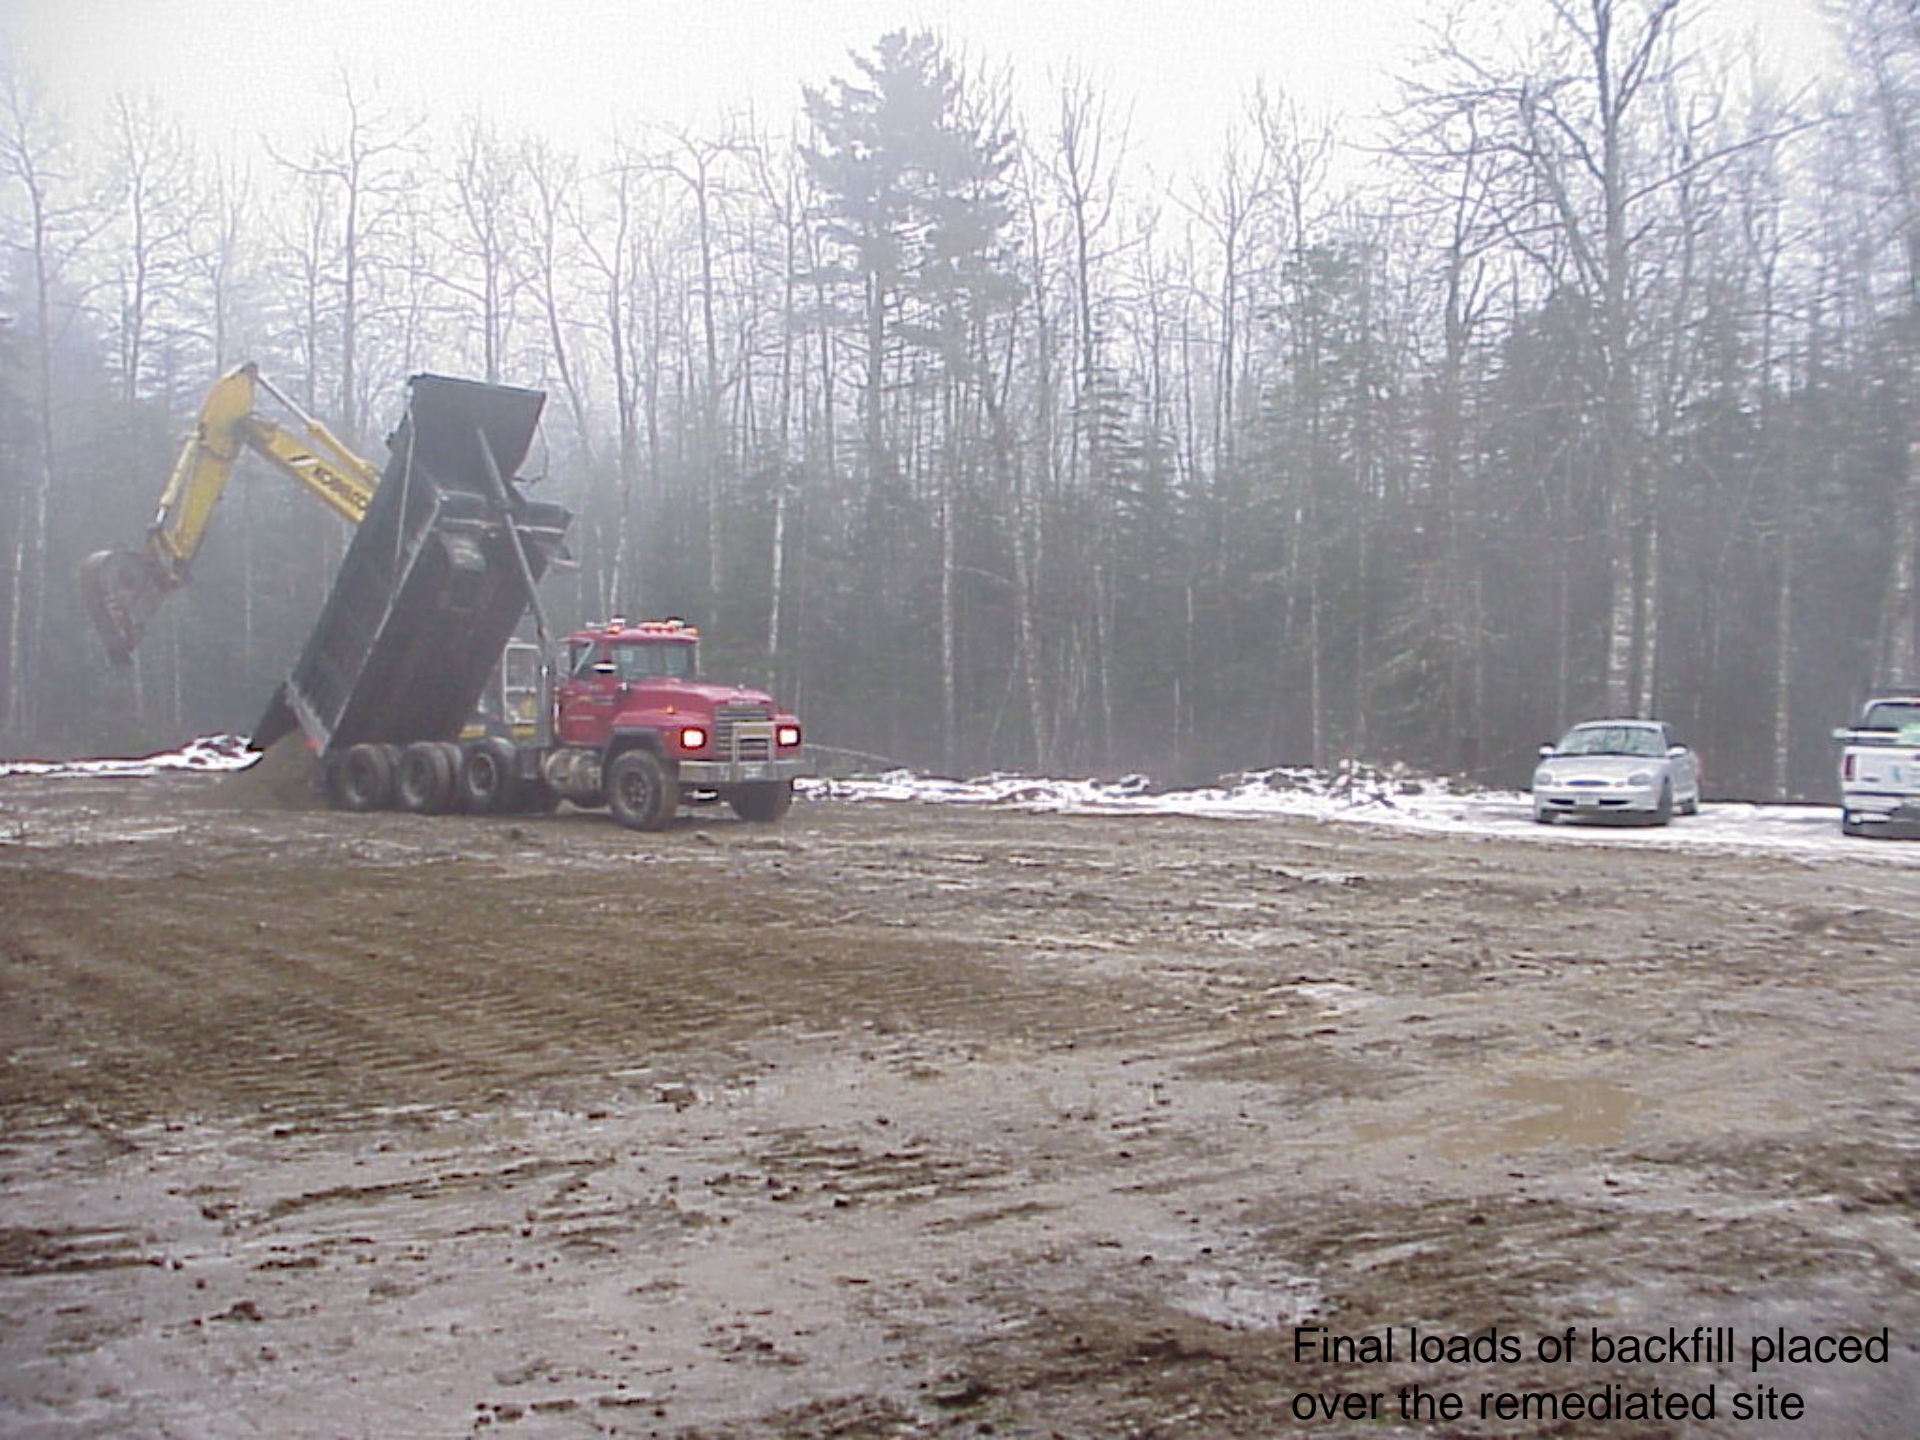
Final loads of backfill placed over the remediated site

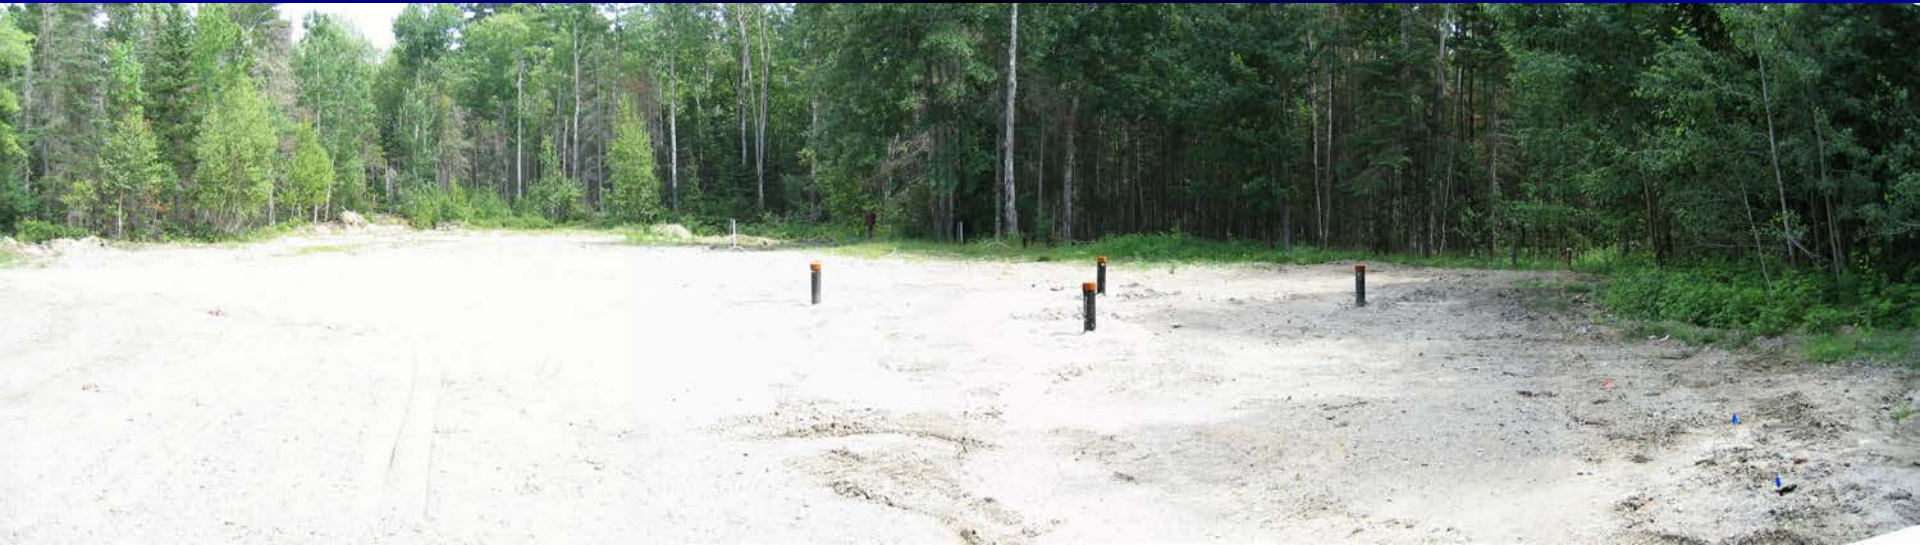
Remaining monitoring wells left on site to permit routine monitoring and sampling
