STATE OF MAINE  
BOARD OF ENVIRONMENTAL PROTECTION

NORDIC AQUAFARMS, INC

PRE-FILED DIRECT TESTIMONY OF ADELE FIORILLO

**Stream Assessment Report  
Nordic Aquafarms Aquaculture Facility  
285 Northport Avenue  
Belfast, Maine**

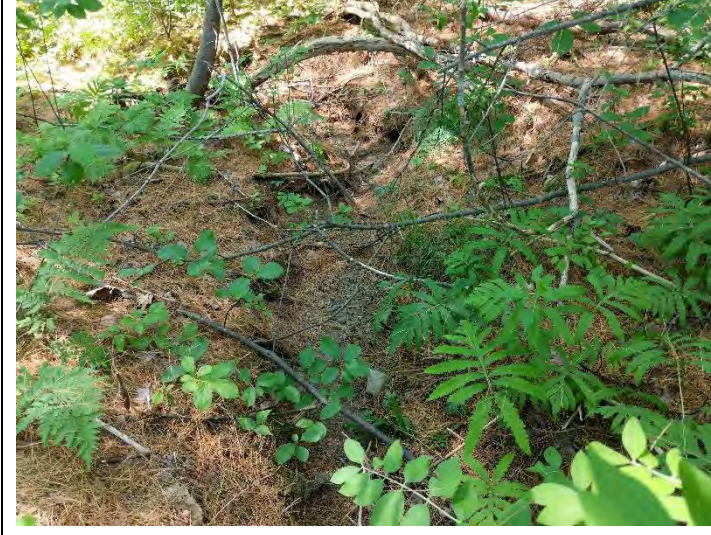
**Photo #: 1**  
S3 – dry portion covered with pine needles.

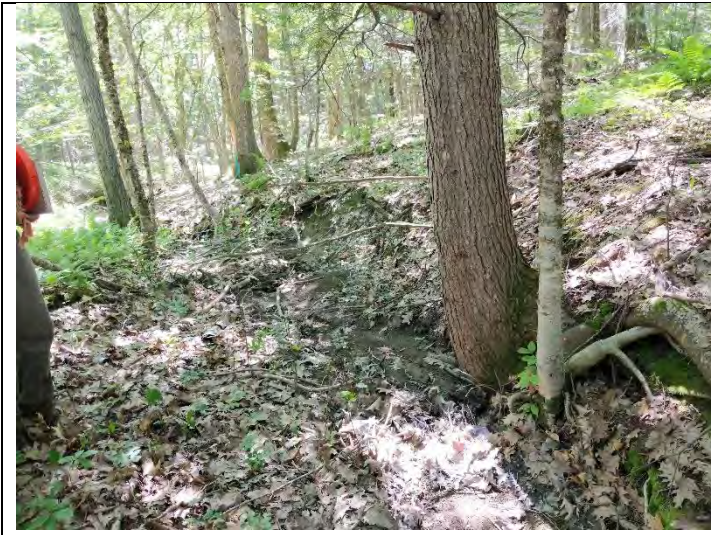
**Photo #: 2**  
S3 – looking downstream near edge of the project area.

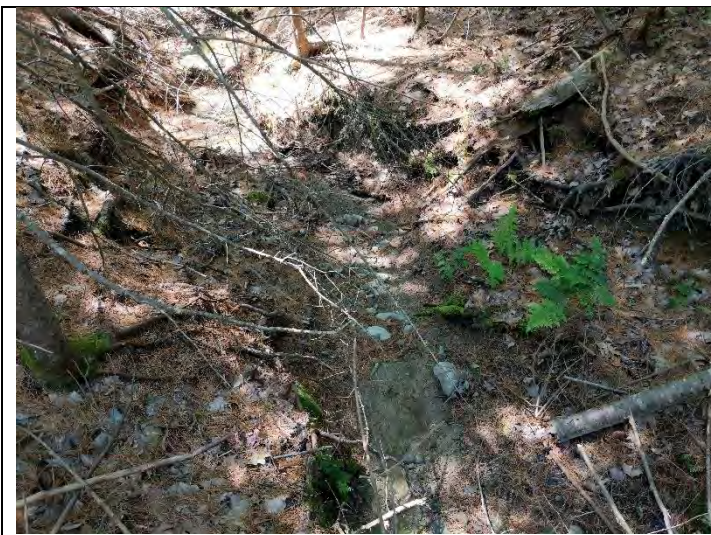
**Photo #: 3**  
S3 – near upstream start of channelized flows.

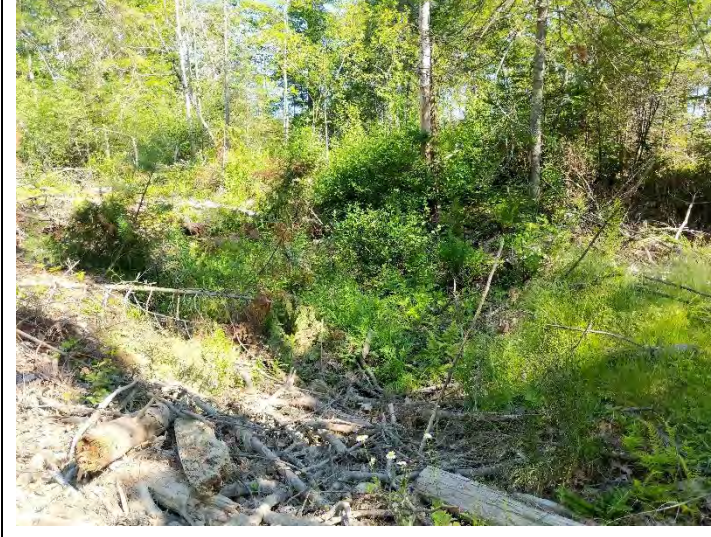
**Photo #: 4**  
S5 – looking downstream from middle section.

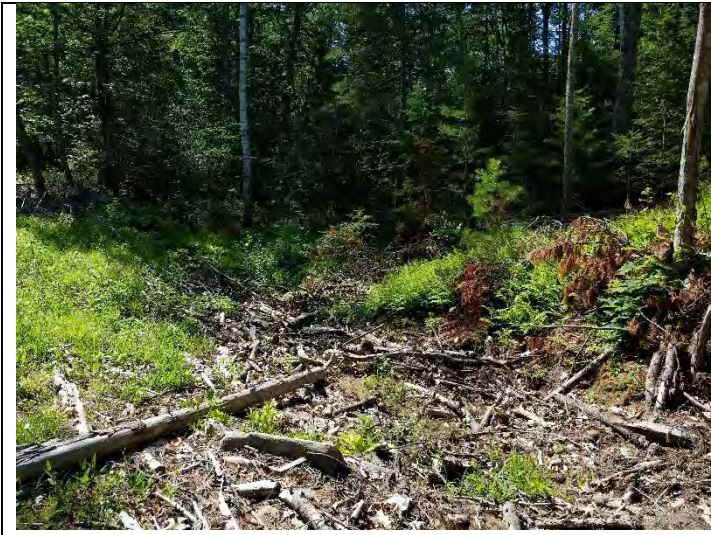
**Photo #: 5**  
S5 – Looking upstream from middle section.

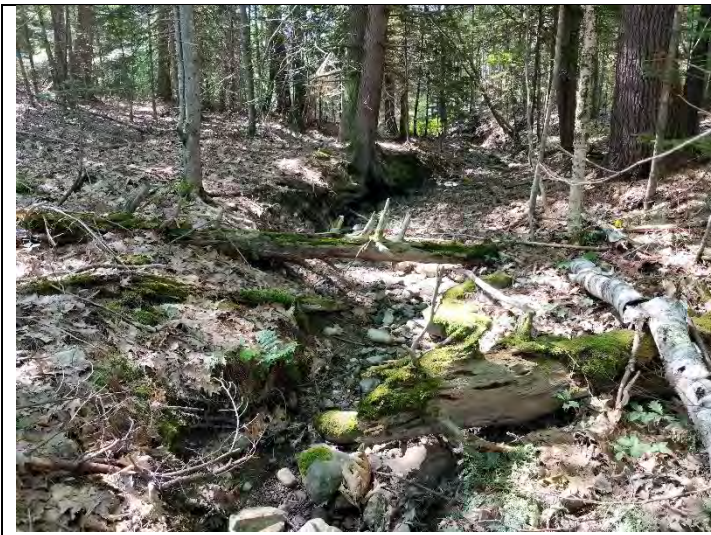
**Photo #: 6**  
S5 – Looking upstream in upper portion.

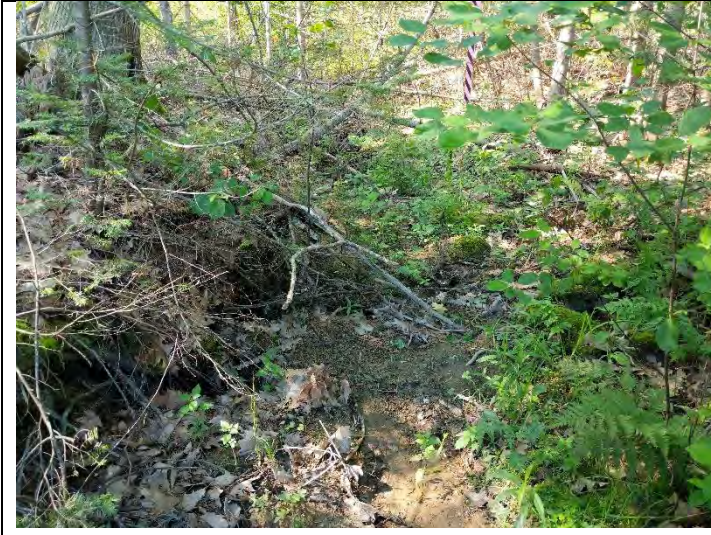
**Photo #: 7**

S6 – Looking downstream from upstream portion.

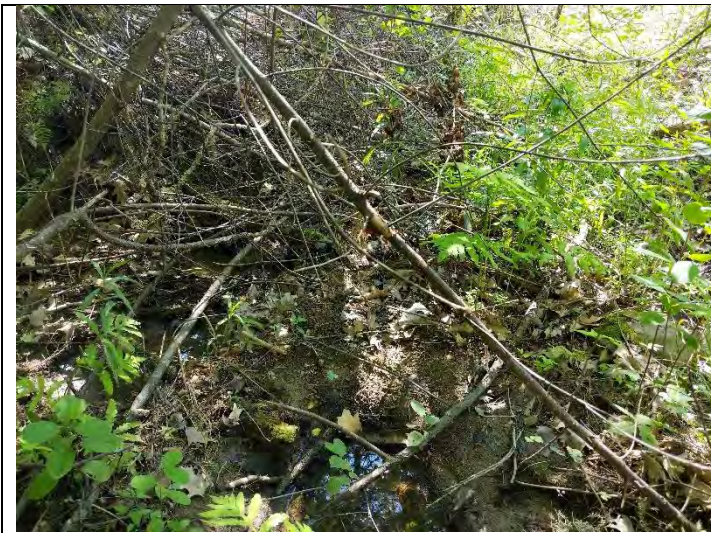
**Photo #: 8**

S6 – Isolated small pool.

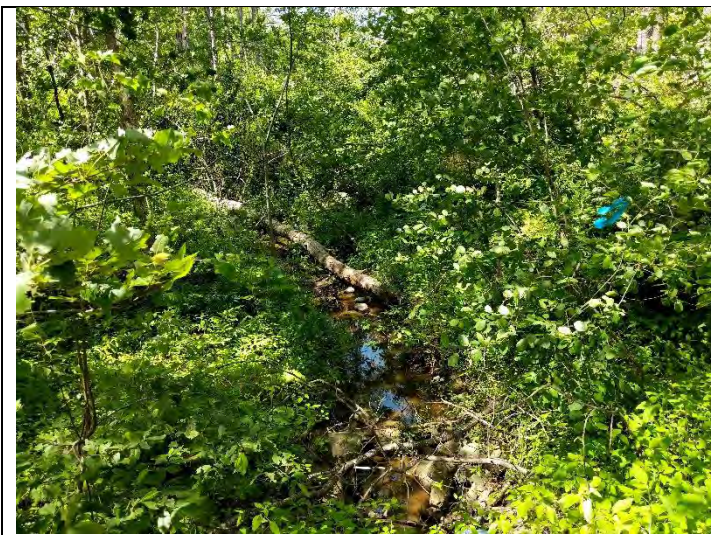
**Photo #: 9**

S8 – Looking downstream from Eckrote driveway.

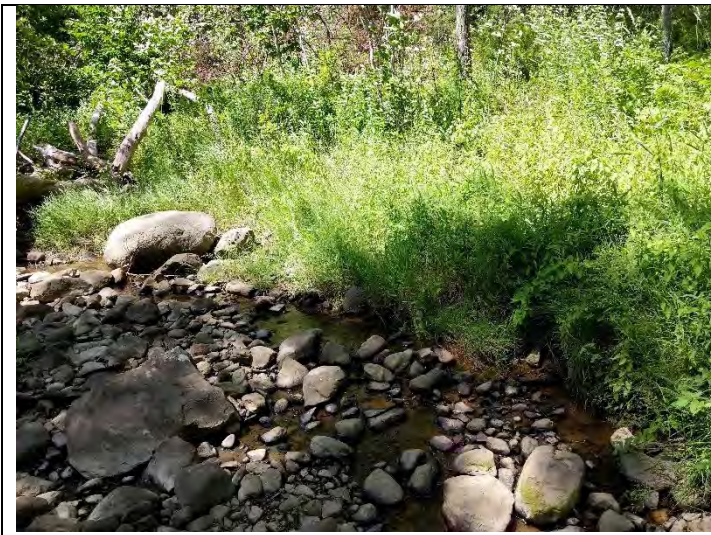
**Photo #: 11**

S8 – Looking upstream from the downstream portion.

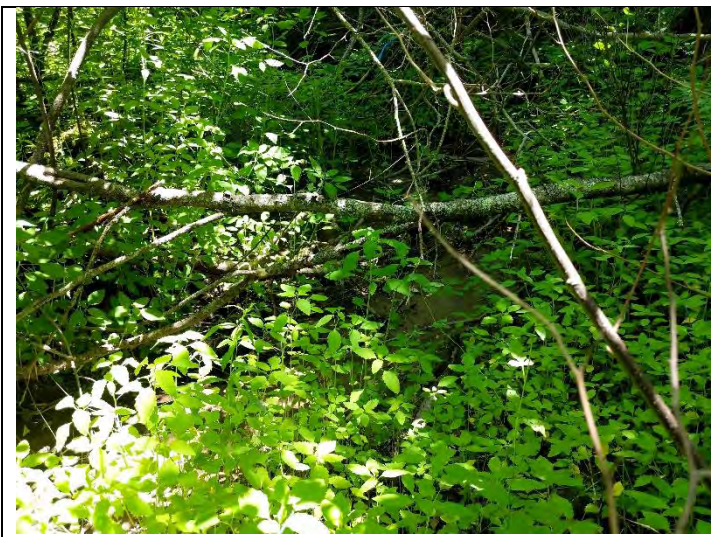
**Photo #: 12**

S9a – Densely vegetated portion, facing downstream.

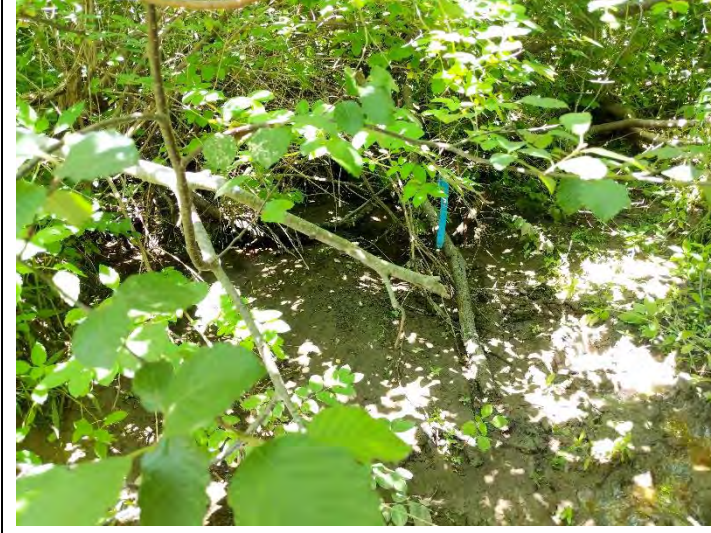
**Photo #: 13**

S9a – Densely vegetated portion looking upstream.

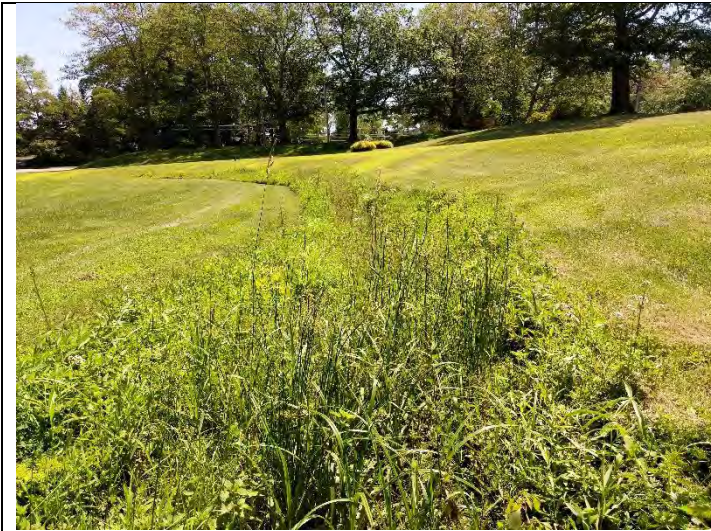
**Photo #: 14**

S9b – Cleared reach, facing downstream.

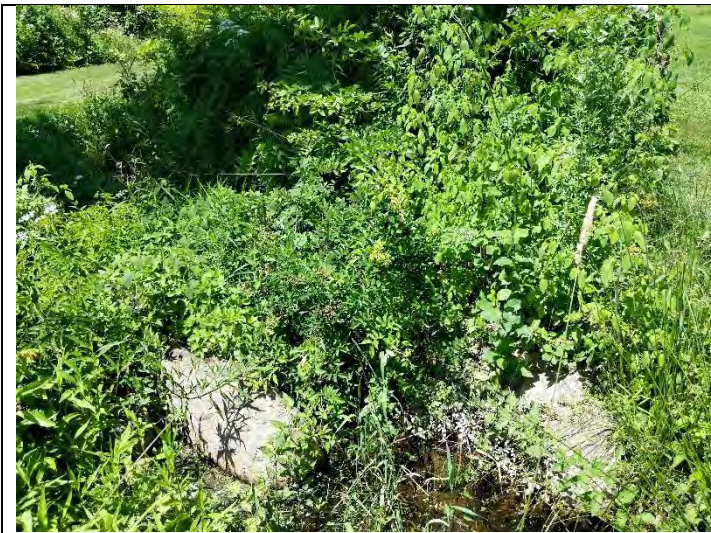
**Photo #: 15**

S9b – Cleared reach, facing upstream.

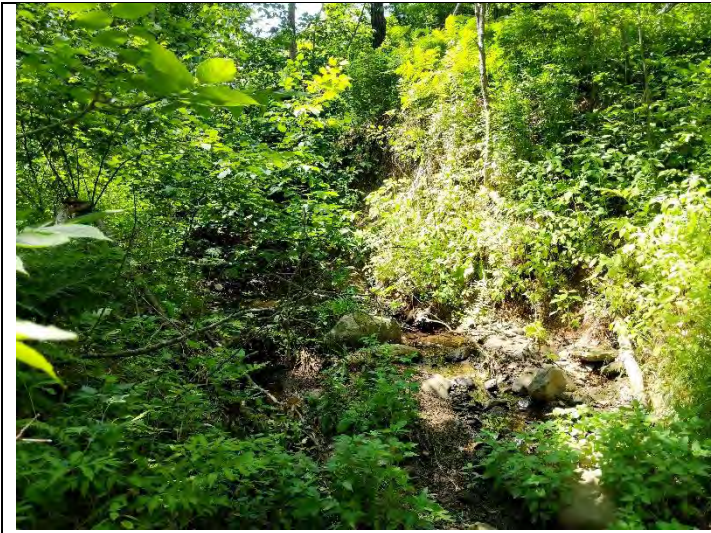
**Photo #: 17**  
S9c – Lower reach, facing upstream.

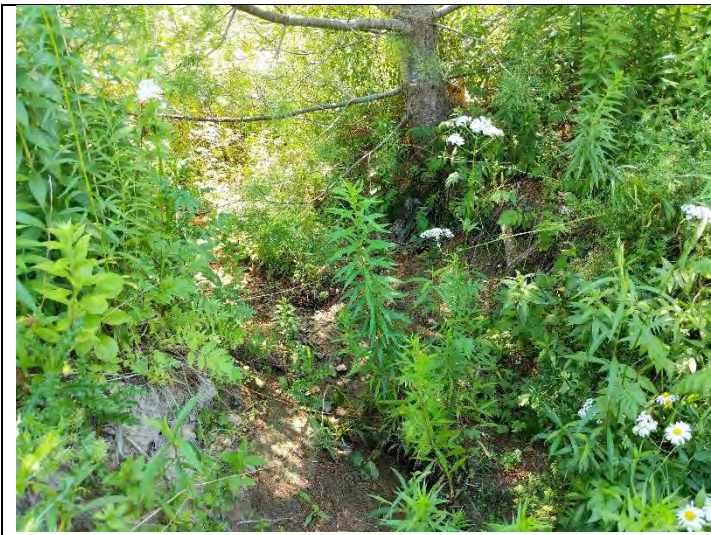
**Photo #: 18**  
S10 – Looking downstream from field.

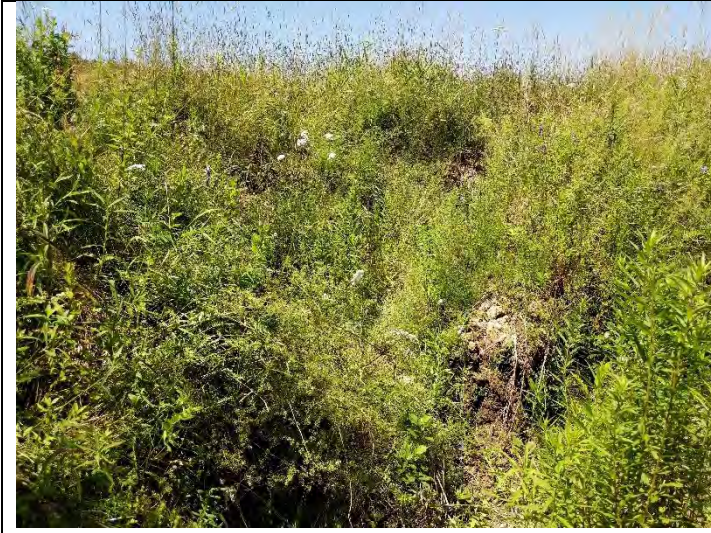
**Photo #: 19**

S10 – Facing upstream from the edge of the field.

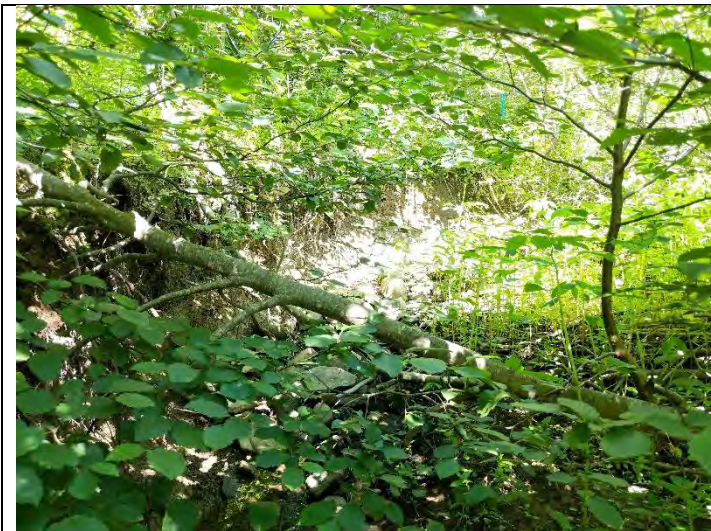
**Photo #: 20**

S10 – Facing upstream from shrub portion.
