Purpose: Experimental lease for the bottom culture of American/Eastern Oyster (*Crassostrea virginica*).

Maine Department of Marine Resources Site Report

Jeffrey Schroeder
Turkey Cove, St. George River
St. George

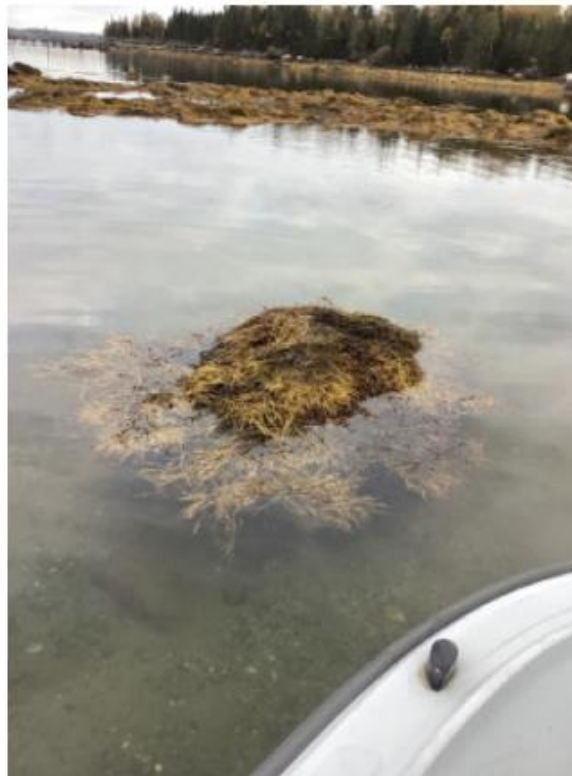
MDMR staff began collecting depths at the proposed site shortly after low tide at approximately 7:40AM. Measured depths at corners of the proposed lease site ranged from 1.8 to 5.7 feet. Correcting for tidal variation derives water depths at the corners of the proposal at mean low water (MLW, 0.0 feet) to be from 0.9 to 4.8 feet (Table 1). During the site visit, an intertidal rock approximately three feet across was observed in the northeast corner of the proposal (Image 1). The water surrounding the observed rock was entirely subtidal.

Image 1. Intertidal rock observed during MDMR site visit.

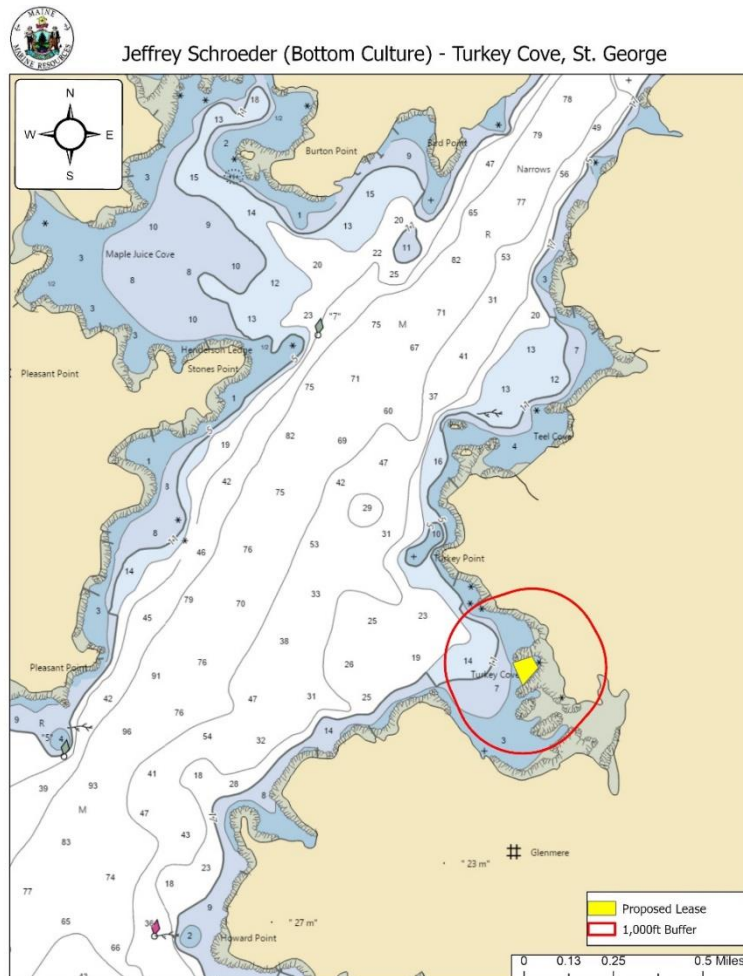
The proposal is located within Turkey Cove approximately 2,760 feet to the east of the navigational channel (Figure 3). While Turkey Cove is not part of the main navigational channel, there are riparian landowners within the cove who may navigate to and from their property. If the proposal is granted, there would be approximately 1,086.15 feet of navigable water to the west of the site at MLW. During MDMR's site visit, no vessel traffic was observed.

Figure 3. Navigational channels in the vicinity of the proposed lease area.

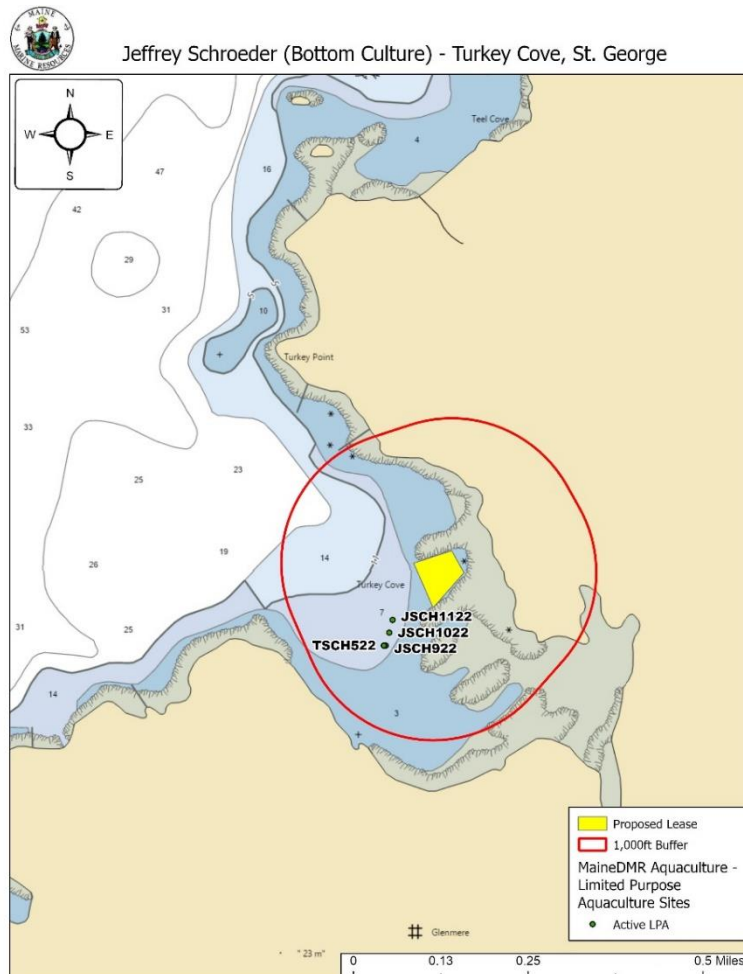
There are no active aquaculture leases within 1,000 feet of the proposal. There are four Limited Purpose Aquaculture (LPA) licenses within 1,000 feet of the proposal (JSCH922, JSCH1022, JSCH1122, and TSCH522). The nearest LPA is located approximately 318.9 feet to the southeast of the proposed lease. The applicant holds three of the LPAs (JSCH922, JSCH1022, and JSCH1122). The fourth LPA, TSCH522, is licensed to the applicant’s wife (Figure 4).

Figure 4. Aquaculture leases and LPA licenses in the vicinity of the proposed lease area.

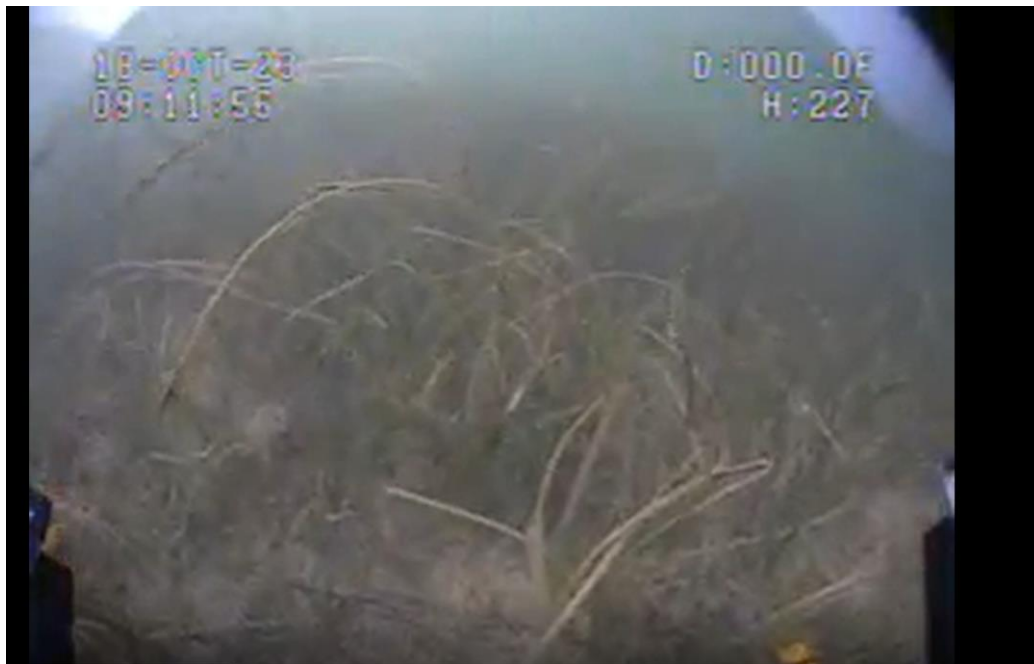
MDMR scientists confirmed the presence of rooted eelgrass within the proposal boundaries during the site visit on October 18, 2023. Rooted eelgrass was observed near the southwest corner and center of the proposal (Figure 5). Eelgrass observed in the SW corner of the proposal was dense, rooted to the seafloor, and measured approximately 10 x 10 feet in area (Image 2). Eelgrass observed near the center of the proposal was sparse to moderate in density and rooted to the seafloor (Image 3). Water depth in this area is approximately 0.9 to 4.8 feet at MLW. MDMR scientists noted that the observed eelgrass had begun its seasonal senescence.

Image 2. Observed eelgrass in the SW corner of the proposal.

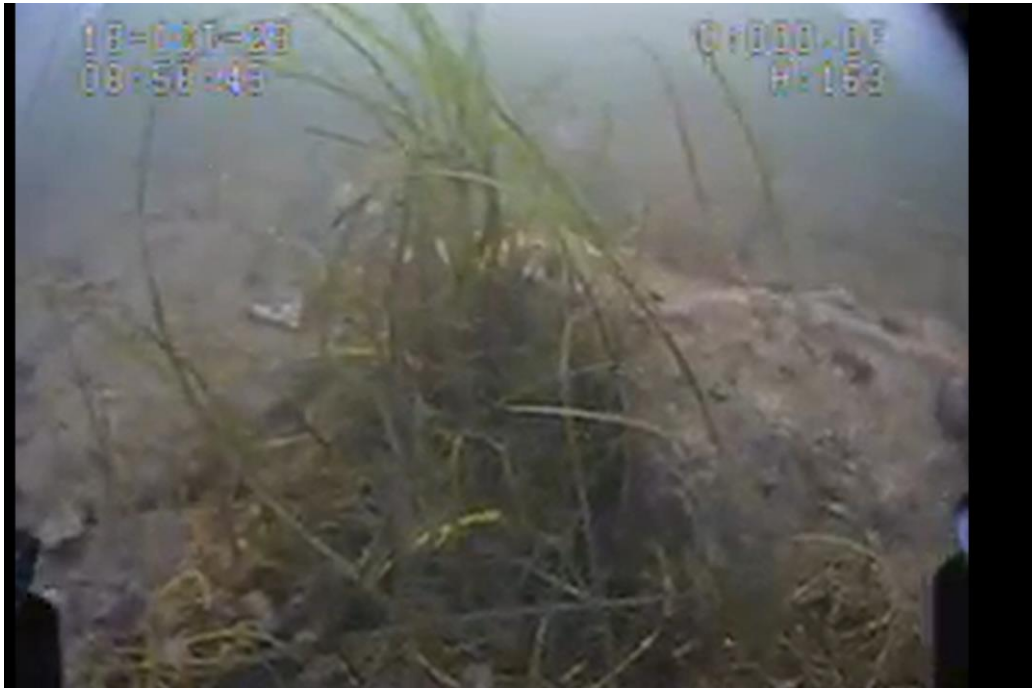
Image 3. Observed eelgrass near the center of the proposal.

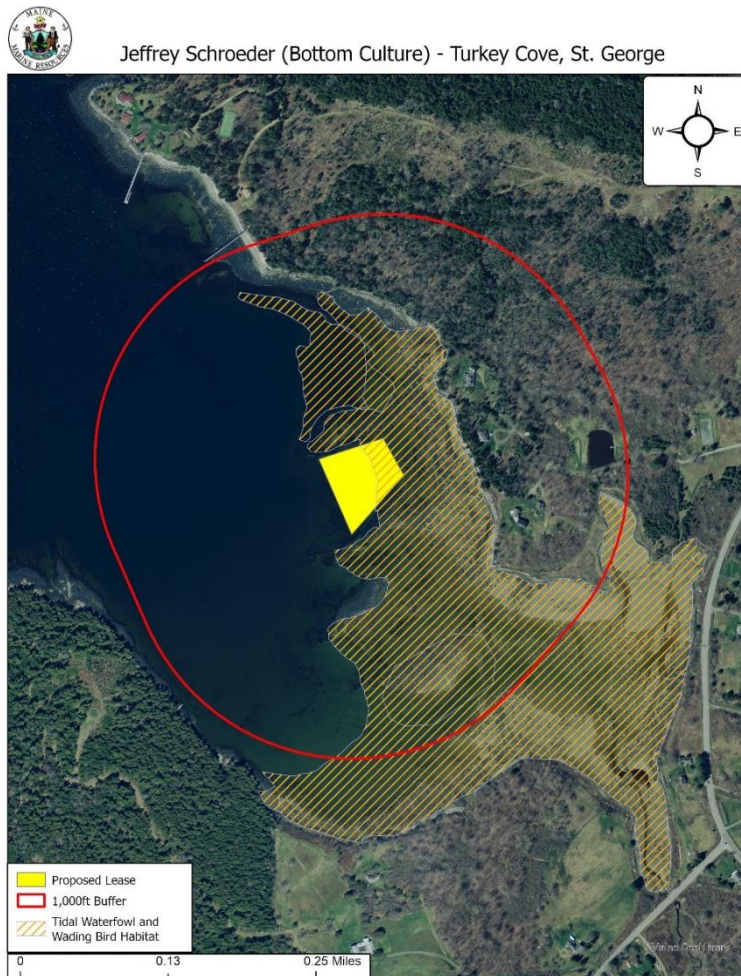
According to Geographic Information System (GIS) data maintained by the Maine Department of Inland Fisheries and Wildlife (MDIFW) and available through the Maine Office of GIS (MEGIS), the proposed lease is located approximately 148.5 feet within mapped Tidal Waterfowl and Wading Bird Habitat (Figure 6). Data collected by the United States Fish and Wildlife Service in 2023 by aerial nest survey shows the closest mapped bald eagle nesting site to be approximately 2.1 miles northwest of the proposal.

Figure 6. Tidal Waterfowl and Wading Bird Habitat. ⁶

On July 17, 2023, a Wildlife Biologist with MDIFW responded by email to a “Request for Agency Review and Comment” stating that the proposed lease is within Tidal Waterfowl and Wading Bird Habitat as well as a Shorebird Area; both of which are considered Significant Wildlife Habitat. It is MDIFW’s recommendation that this lease not be located within these resources.⁵
