# Preliminary Geotechnical Data Report REV01

*Interstate 95 Bridges 1427 and 5800 over Stillwater Avenue, Bangor, Maine  
(WIN 027176.00)*

**Maine Department of Transportation**

**WSP USA, Inc.**

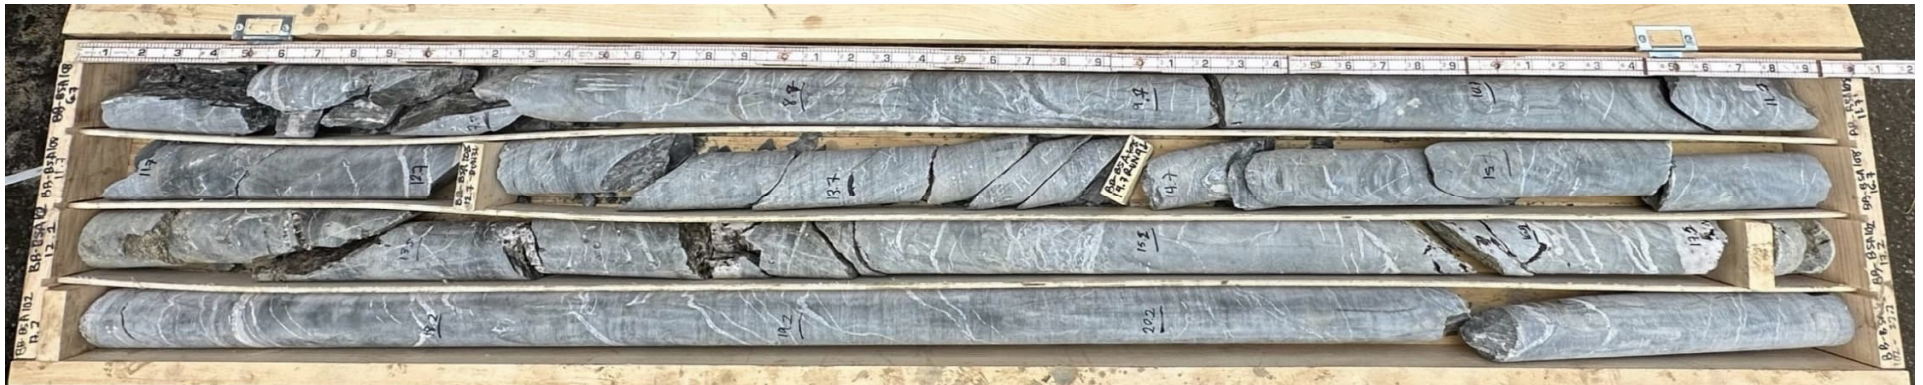
Boring	Run	Depth Below Surface		Recovery		RQD		Rock Type	Box Row	Date Cored	
		Feet		Feet	%	Feet	%				
BB-BSA-102	R1	12.2	- 17.2	4.50	/ 5.0	90	3.7 / 5.0	73	Metawacke	3	5/8/2024
	R2	17.2	- 22.2	4.9	/ 5.0	98	4.9 / 5.0	98	Metawacke	4	5/8/2024
BB-BSA-108	R1	6.7	- 11.7	4.9	/ 5.0	98	3.0 / 5.0	59	Metawacke	1	5/7/2024
	R2	11.7	- 12.7	0.9	/ 1.0	92	0.4 / 1.0	40	Metawacke	2	5/7/2024
	R3	12.7	- 14.7	1.76	/ 2.0	88	0.38 / 2.0	19	Metawacke	2	5/7/2024
	R4	14.7	- 16.7	1.92	/ 2.0	96	0.74 / 2.0	37	Metawacke	2	5/7/2024

1. "Box row" indicates the section of the box where the core is contained: 1 = top, 4 = bottom.
2. Top of each core run is on the left and increases with depth to the right.

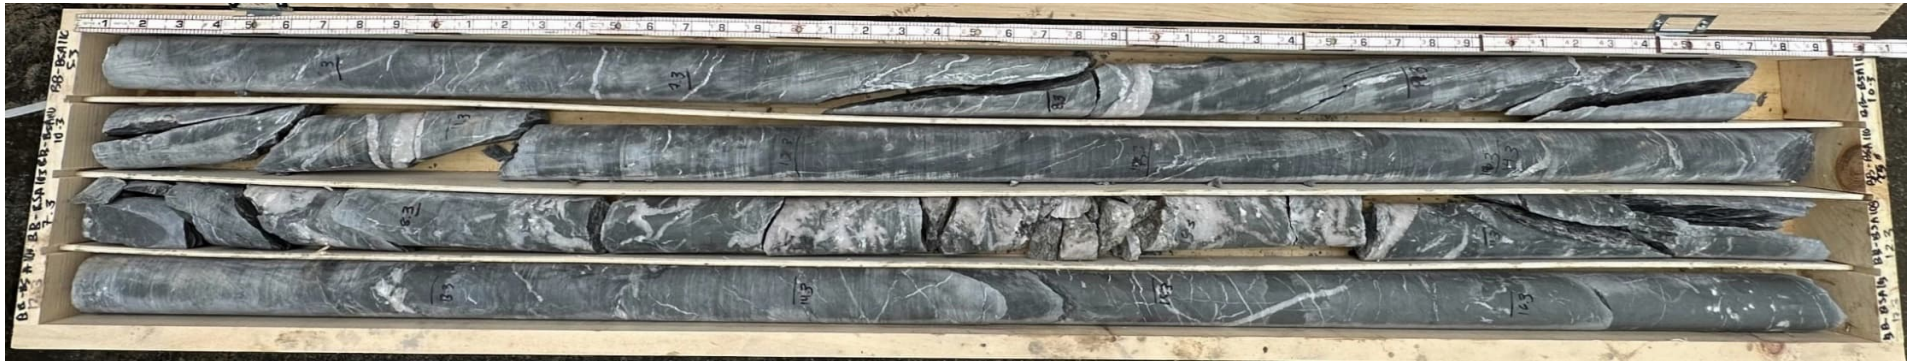
Boring	Run	Depth Below Surface		Recovery			RQD		Rock Type	Box Row	Date Cored
		Feet		Feet		%	Feet	%			
BB-BSA-103	R1	7.2	- 12.2	5.0	/ 5.0	100	1.6 / 5.0	31	Metawacke	3	5/8/2024
	R2	12.2	- 17.2	5.0	/ 5.0	100	3.6 / 5.0	71	Metawacke	4	5/8/2024
BB-BSA-110	R1	5.3	- 10.3	4.8	/ 5.0	95	2.6 / 5.0	52	Metawacke	1	5/8/2024
	R2	10.3	- 15.3	5.0	/ 5.0	100	3.6 / 5.0	72	Metawacke	2	5/8/2024

1. "Box row" indicates the section of the box where the core is contained: 1 = top, 4 = bottom.
2. Top of each core run is on the left and increases with depth to the right.

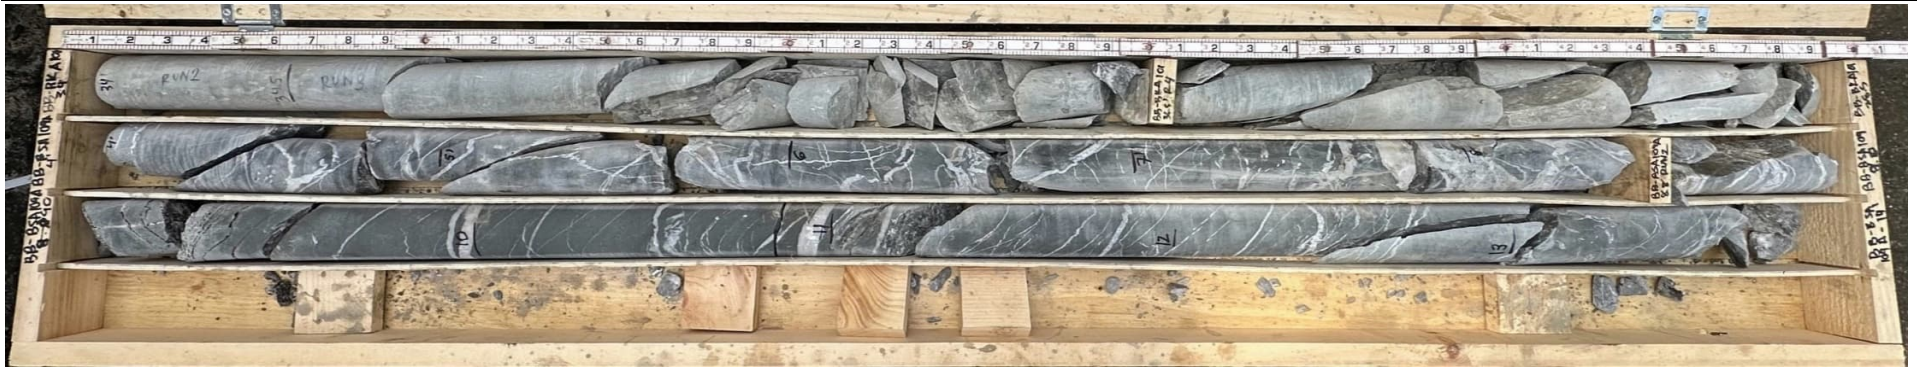
Boring	Run	Depth Below Surface		Recovery			RQD		Rock Type	Box Row	Date Cored	
		Feet		Feet		%	Feet					%
BB-BSA109A	R1	4.0	- 8.8	4.3	/ 4.8	90	1.6	/ 4.8	33	Metawacke	2	5/7/2024
	R2	8.8	- 13.9	4.8	/ 5.1	93	2.5	/ 5.1	49	Metawacke	2,3	5/7/2024

- Notes:
- 1. "Box row" indicates the section of the box where the core is contained: 1 = top, 4 = bottom.
  - 2. Top of each core run is on the left and increases with depth to the right.

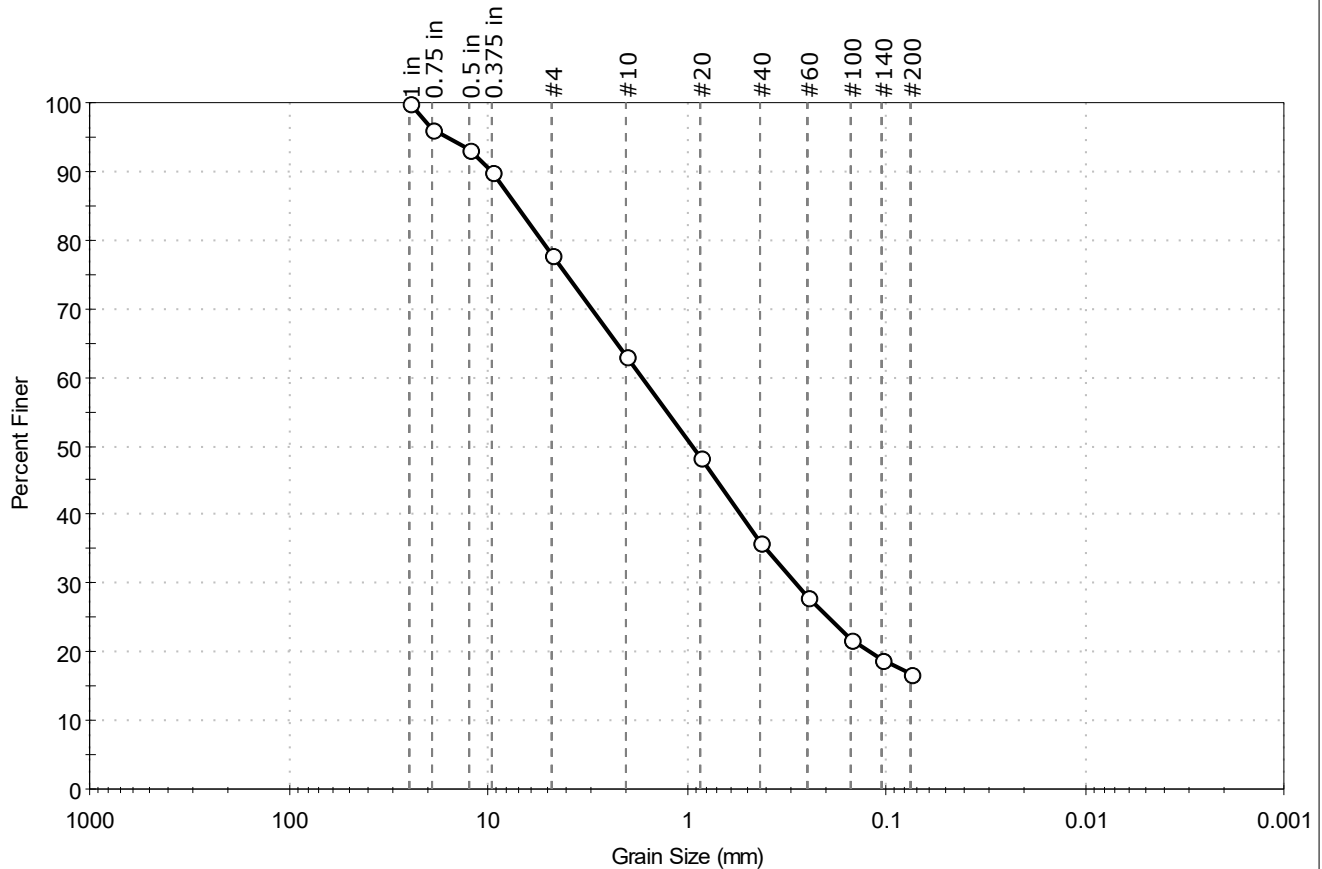
## Particle Size Analysis - ASTM D6913

% Cobble	% Gravel	% Sand	% Silt & Clay Size
—	22.0	61.2	16.8

Sieve Name	Sieve Size, mm	Percent Finer	Spec. Percent	Complies
1 in	25.00	100		
0.75 in	19.00	96		
0.5 in	12.50	93		
0.375 in	9.50	90		
#4	4.75	78		
#10	2.00	63		
#20	0.85	48		
#40	0.42	36		
#60	0.25	28		
#100	0.15	22		
#140	0.11	19		
#200	0.075	17

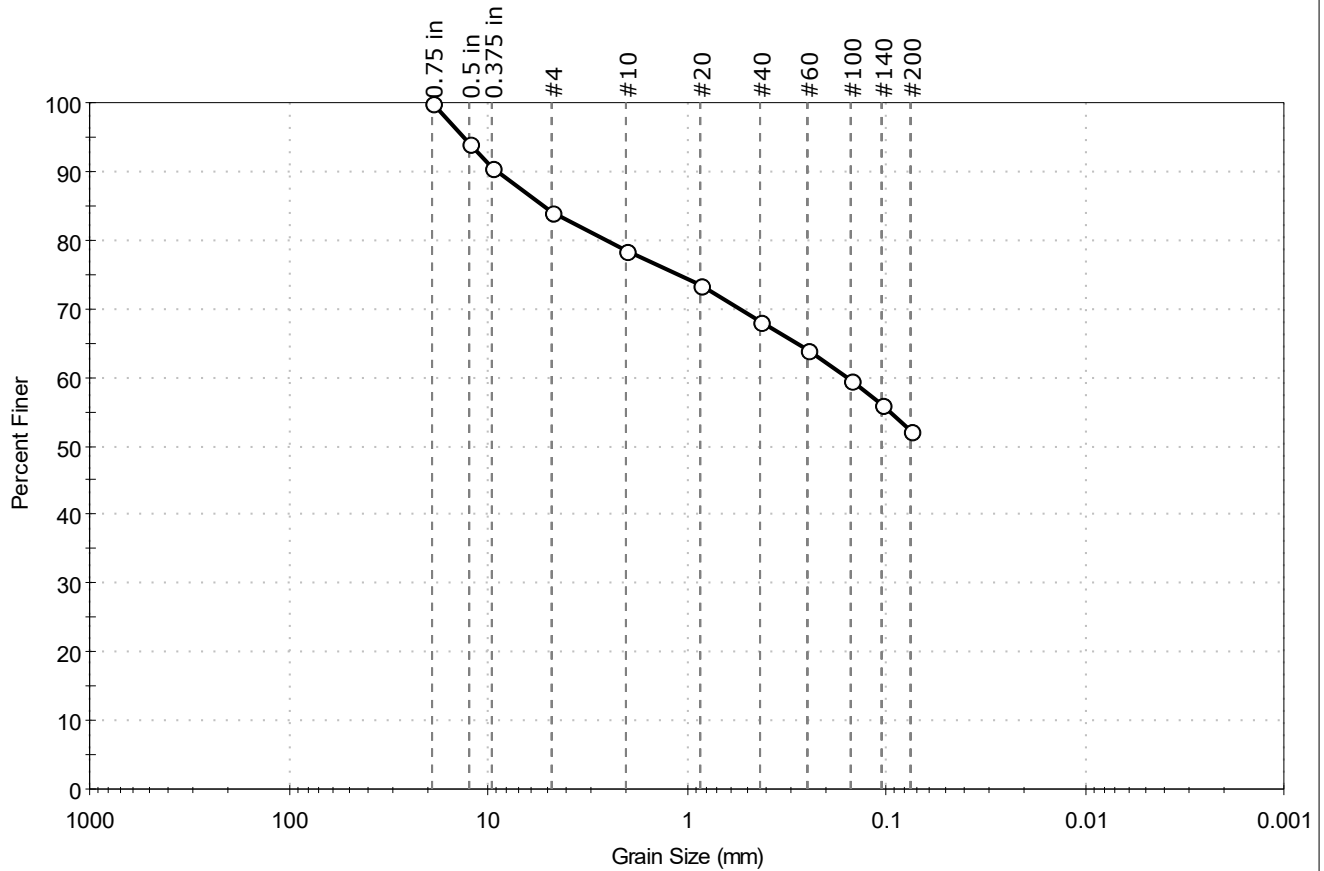
## Particle Size Analysis - ASTM D6913

% Cobble	% Gravel	% Sand	% Silt & Clay Size
—	15.8	32.0	52.2

Sieve Name	Sieve Size, mm	Percent Finer	Spec. Percent	Complies
0.75 in	19.00	100		
0.5 in	12.50	94		
0.375 in	9.50	91		
#4	4.75	84		
#10	2.00	79		
#20	0.85	73		
#40	0.42	68		
#60	0.25	64		
#100	0.15	59		
#140	0.11	56		
#200	0.075	52

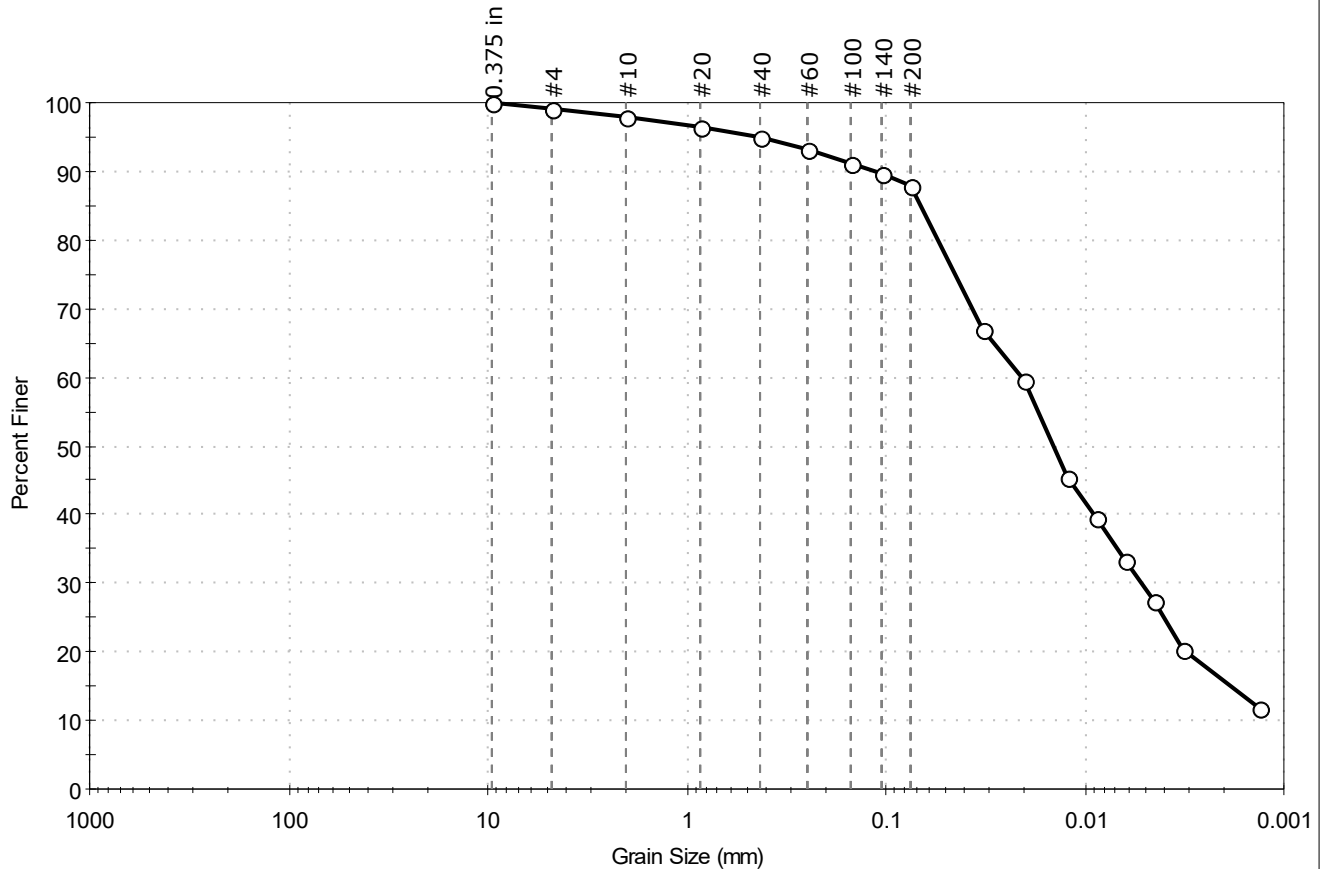
## Particle Size Analysis - ASTM D6913/D7928

% Cobble	% Gravel	% Sand	% Silt & Clay Size
—	1.0	11.2	87.8

Sieve Name	Sieve Size, mm	Percent Finer	Spec. Percent	Complies
0.375 in	9.50	100		
#4	4.75	99		
#10	2.00	98		
#20	0.85	96		
#40	0.42	95		
#60	0.25	93		
#100	0.15	91		
#140	0.11	90		
#200	0.075	88		
Hydrometer	Particle Size (mm)	Percent Finer	Spec. Percent	Complies
---	0.0324	67		
---	0.0201	60		
---	0.0122	45		
---	0.0088	39		
---	0.0063	33		
---	0.0045	27		
---	0.0032	20		
---	0.0013	12

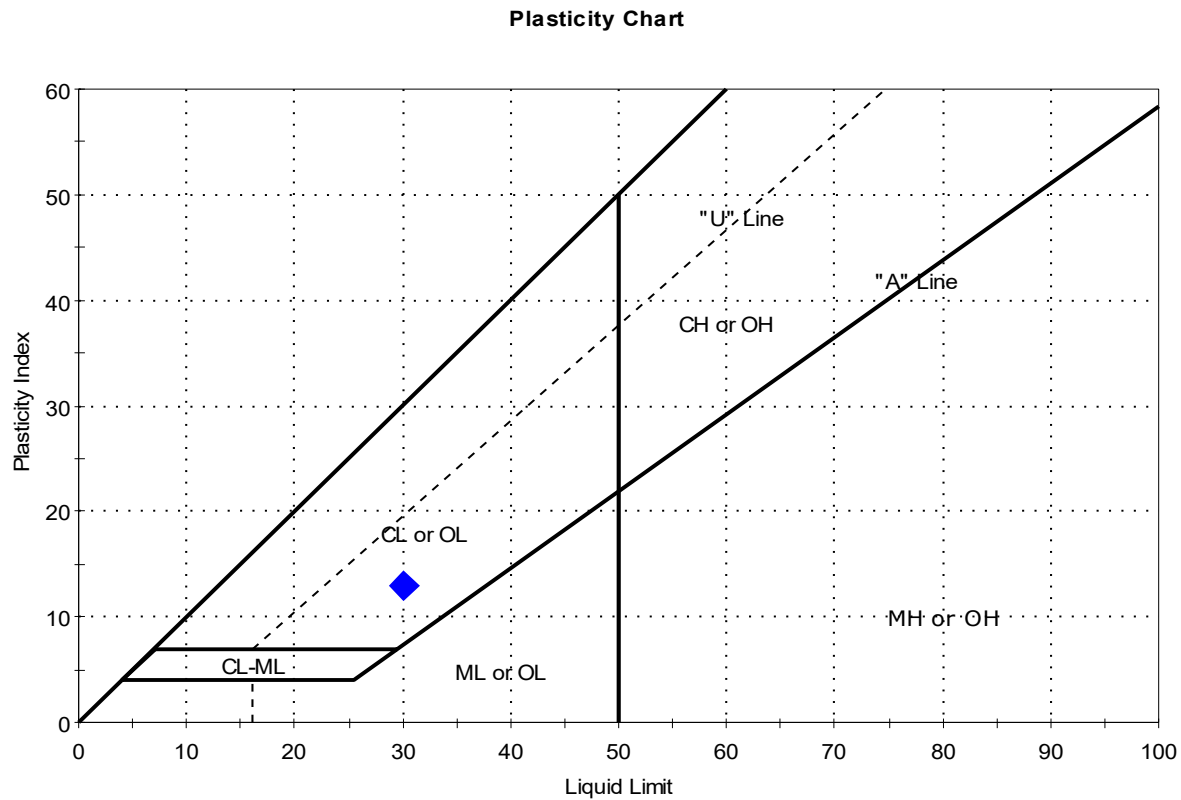
## Atterberg Limits - ASTM D4318

Symbol	Sample ID	Boring	Depth	Natural Moisture Content, %	Liquid Limit	Plastic Limit	Plasticity Index	Liquidity Index	Soil Classification
◆	6D	B-BSA-10	15-17 ft	25	30	17	13	0.6	Lean CLAY (CL)

Sample Prepared using the WET method  
 5% Retained on #40 Sieve  
 Dry Strength: VERY HIGH  
 Dilatancy: SLOW  
 Toughness: LOW

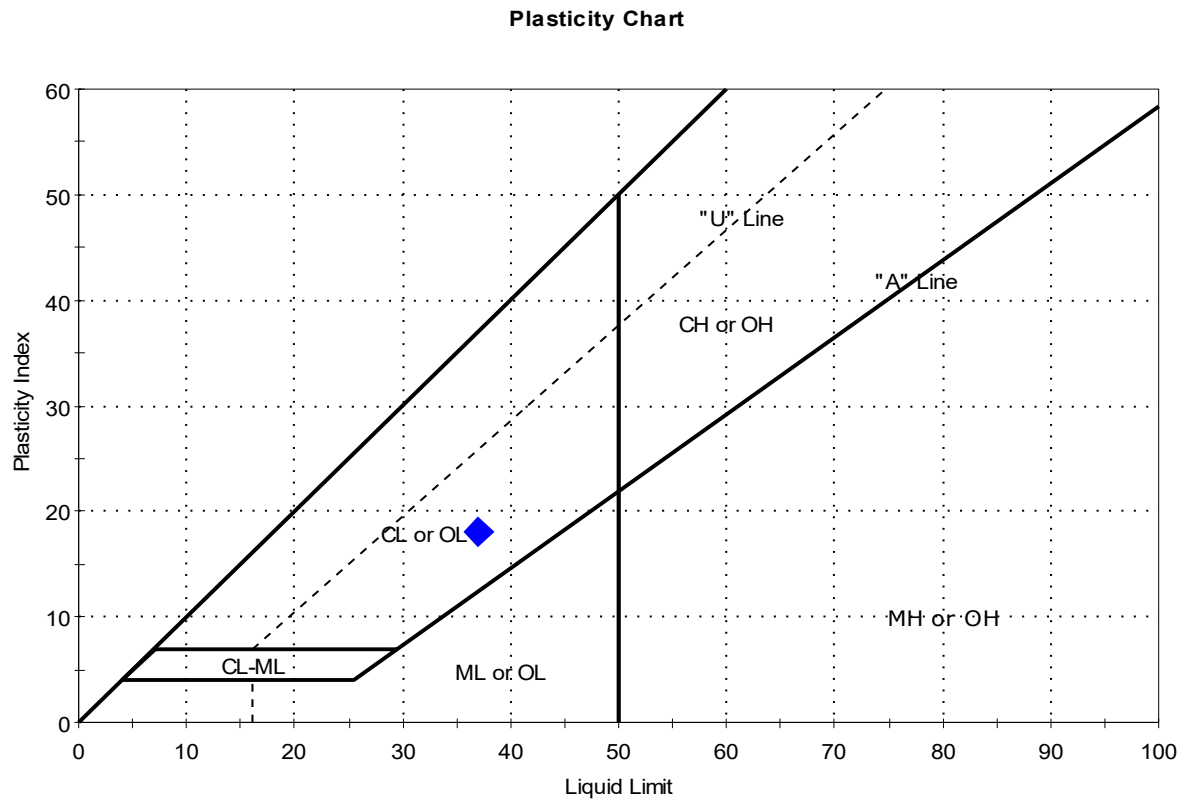
## Atterberg Limits - ASTM D4318

Symbol	Sample ID	Boring	Depth	Natural Moisture Content, %	Liquid Limit	Plastic Limit	Plasticity Index	Liquidity Index	Soil Classification
◆	7D	B-BSA-10	20-22 ft	26	37	19	18	0.4	Lean CLAY (CL)

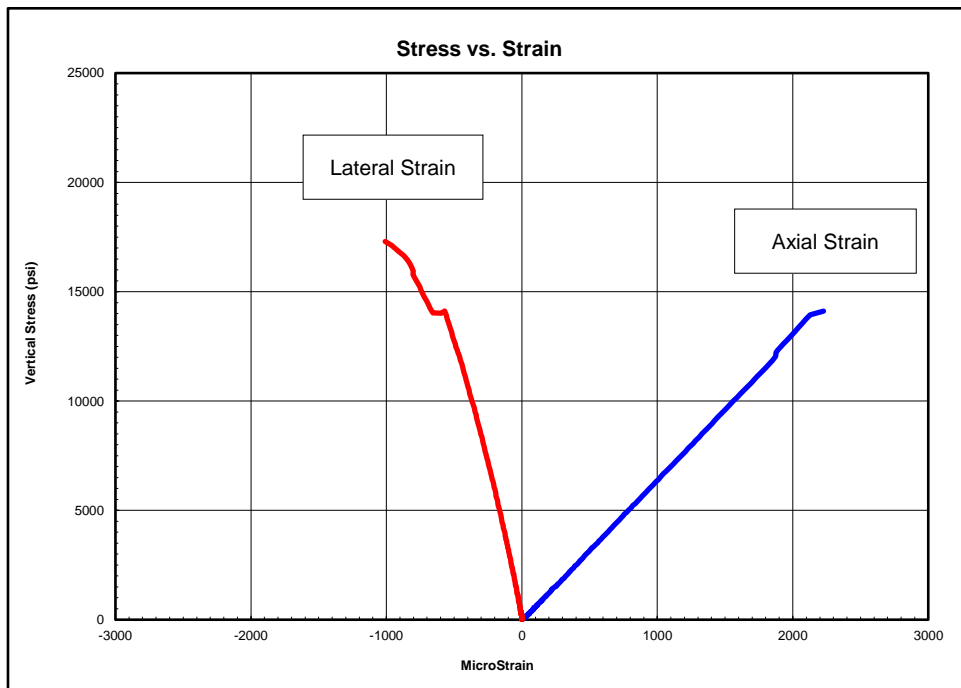
## Compressive Strength and Elastic Moduli of Rock by ASTM D7012 - Method D

Peak Compressive Stress: 17,296 psi

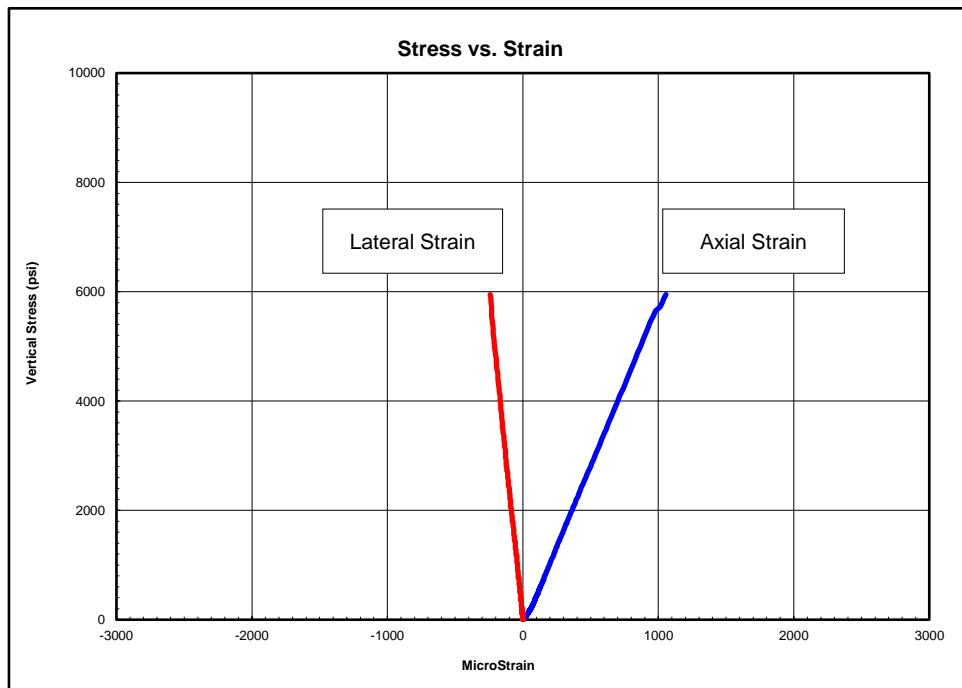
## Compressive Strength and Elastic Moduli of Rock by ASTM D7012 - Method D

Peak Compressive Stress: 5,948 psi

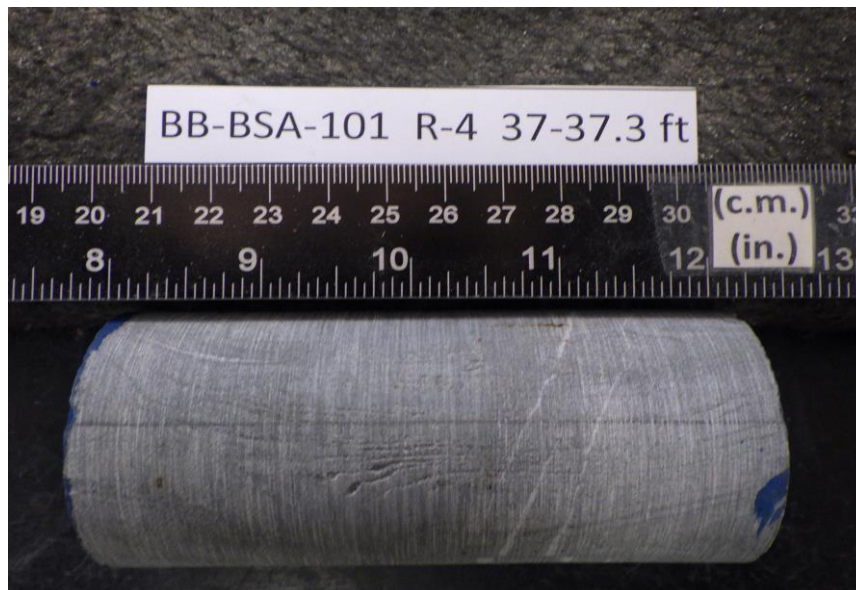
Client:	WSP USA, Inc.
Project Name:	MaineDOT I-95 Bridge over Stillwater
Project Location:	Merrimack, NH
GTX #:	319180
Test Date:	8/29/2024
Tested By:	gp
Checked By:	smd
Boring ID:	BB-BSA-101
Sample ID:	R-4
Depth, ft:	37-37.3

After cutting and grinding

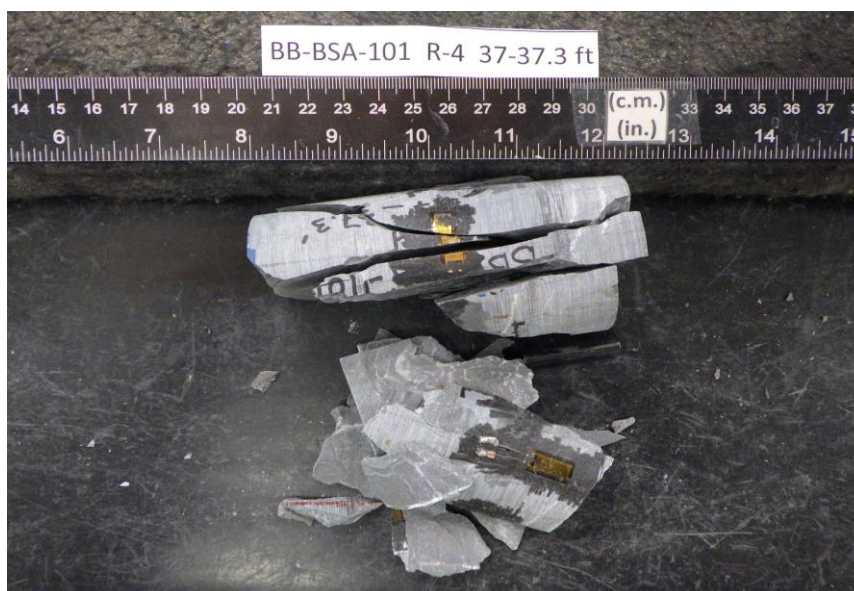
After break

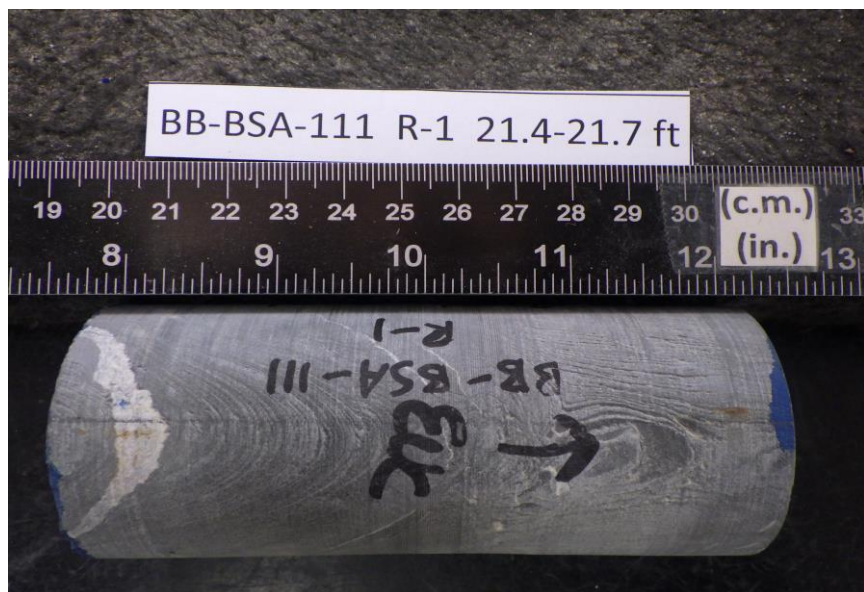
Client:	WSP USA, Inc.
Project Name:	MaineDOT I-95 Bridge over Stillwater
Project Location:	Merrimack, NH
GTX #:	319180
Test Date:	8/29/2024
Tested By:	gp
Checked By:	smd
Boring ID:	BB-BSA-111
Sample ID:	R-1
Depth, ft:	21.4-21.7

After cutting and grinding

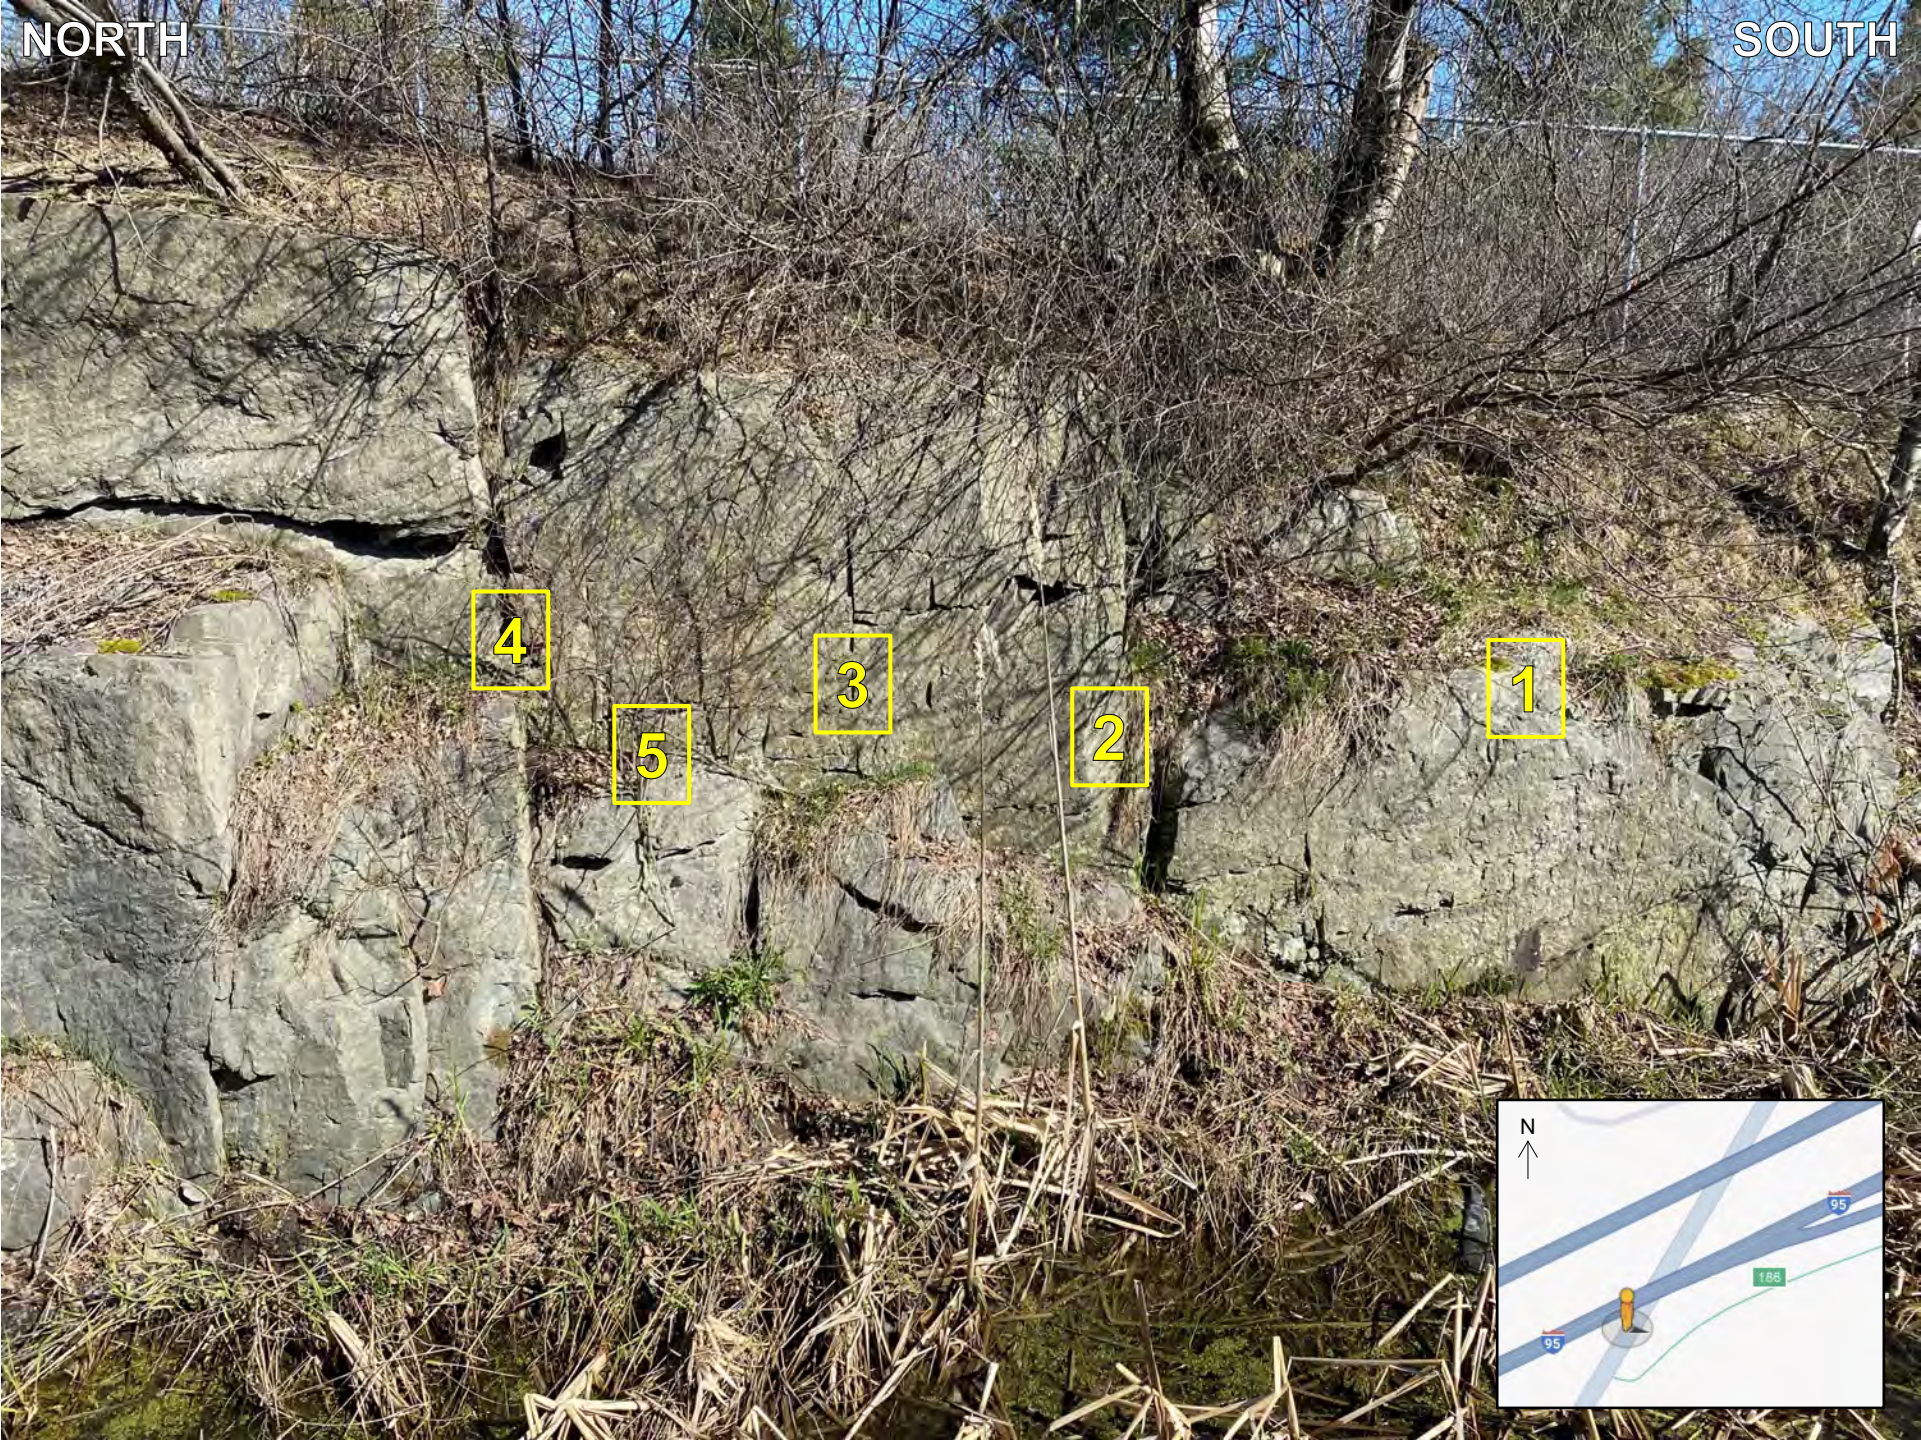
ROCK CUT DISCONTINUITY ID LOCATIONS  
STILLWATER AVENUE NORTHBOUND

On April 23, 2024, WSP visited the Stillwater Avenue site to collect geological data from the exposed rock cuts along Stillwater Avenue beneath the I-95 existing bridge foundations. The general locations of the exposed rock cuts are shown in plan view in Appendix D. During the site visit, WSP measured 37 geologic discontinuities and photographed existing rock cut conditions. Photographs of the existing rock cut conditions and discontinuities evaluated are presented in Appendix E. Our discontinuity measurements and observations are summarized in Table 2 (attached) and include discontinuity type, orientation, persistence, aperture, infilling materials, estimated strength, surface roughness, shape, spacing, and groundwater conditions. Our measured discontinuity orientations are plotted in Appendix D.1.

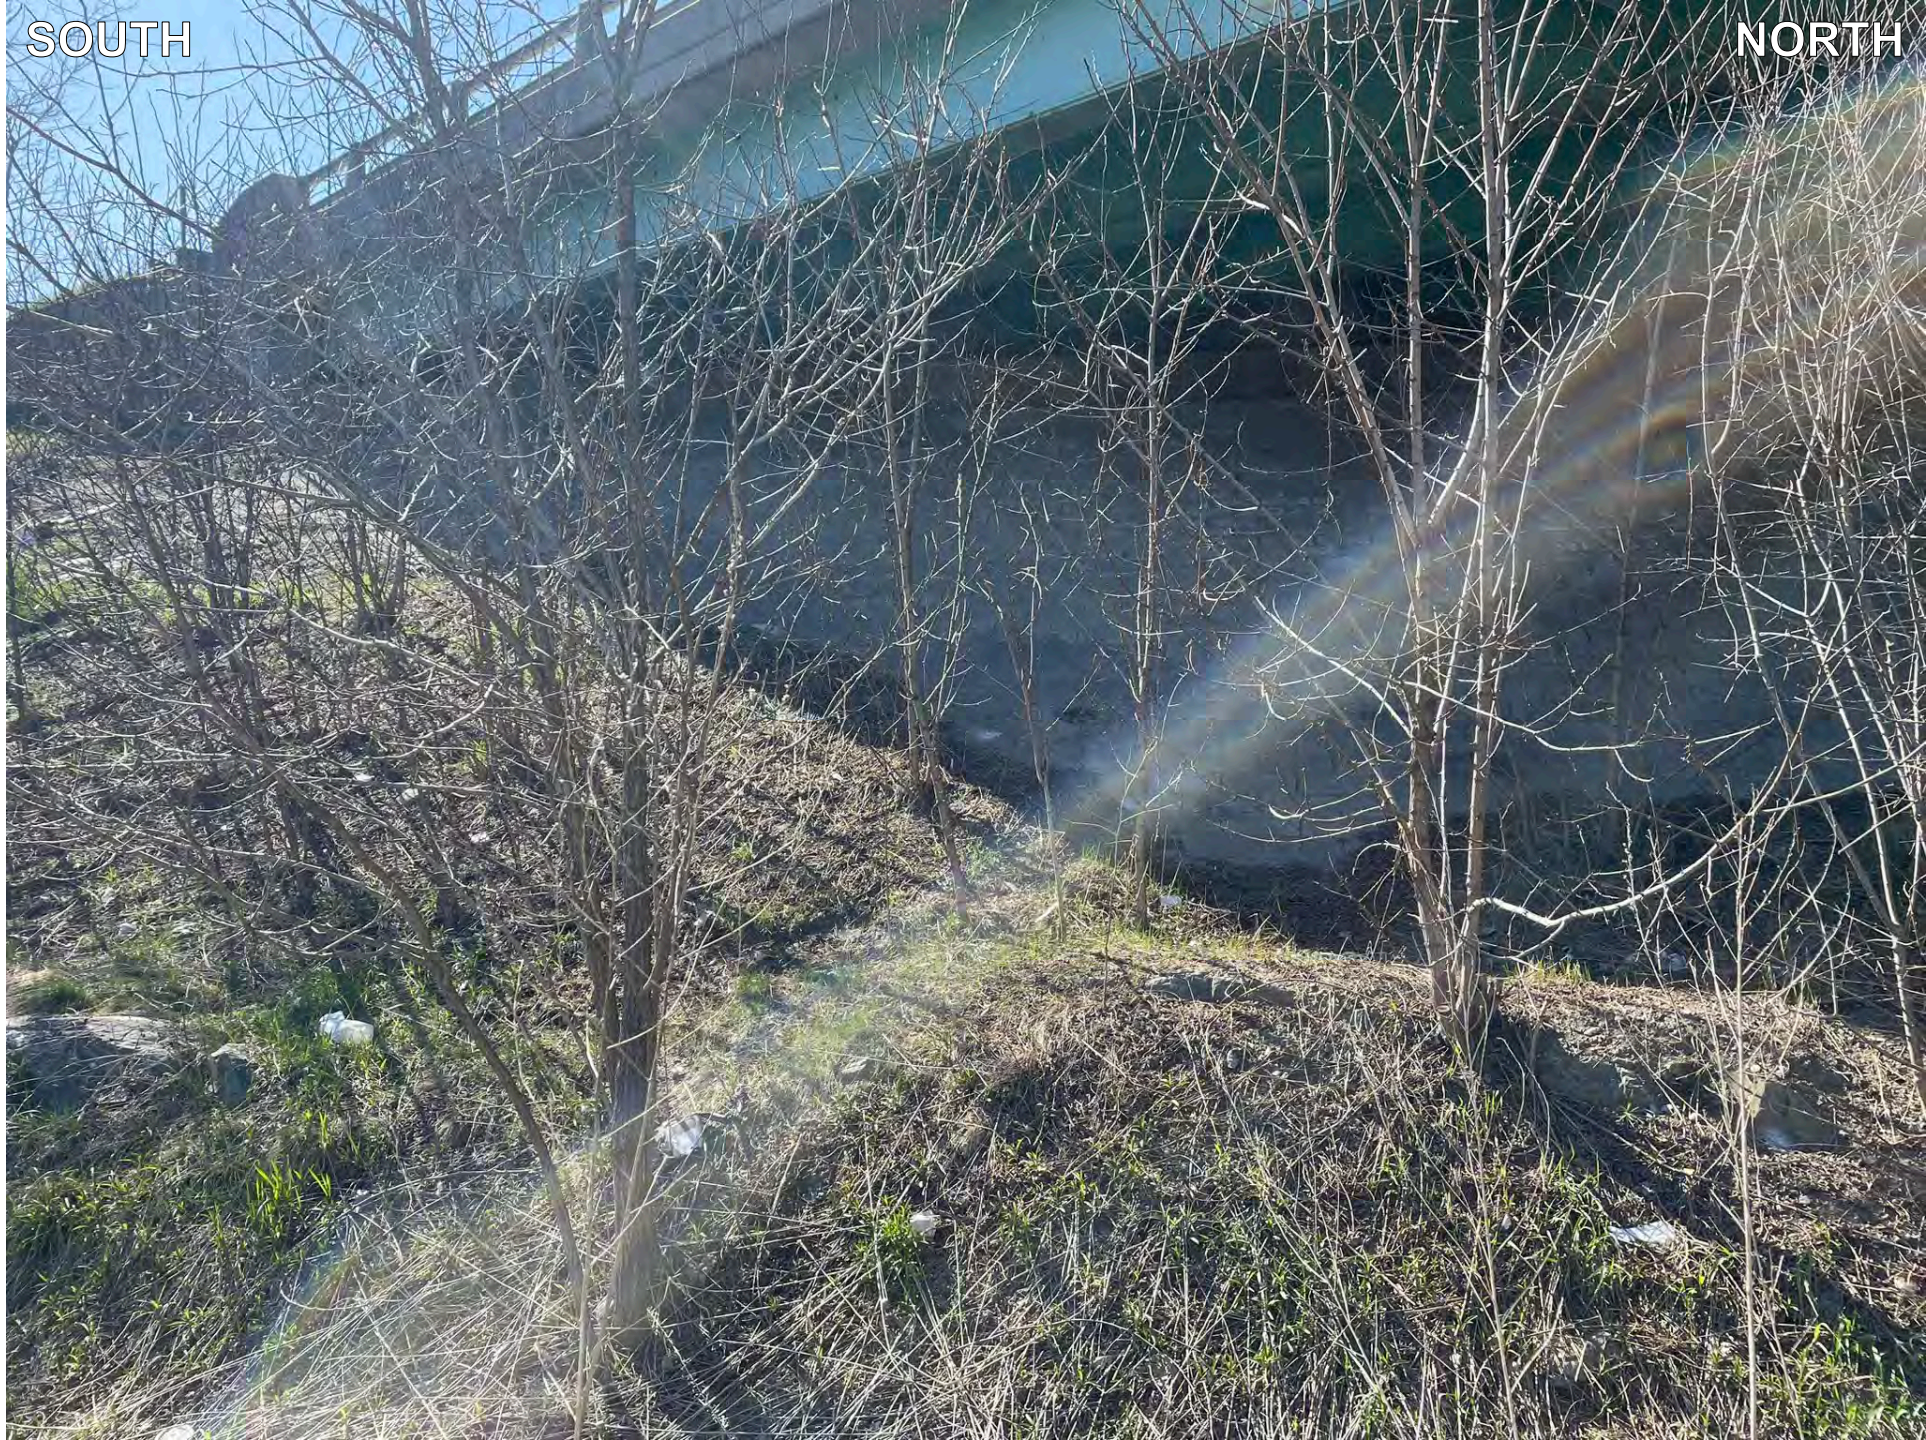
ROCK CUT DISCONTINUITY ID LOCATIONS  
STILLWATER AVENUE SOUTHBOUND
