**Coastal Wetland Habitat  
Functions & Values Assessment  
Report**

Maine Department of Transportation  
Offshore Wind Port and Wind Turbine  
Launch Site, Sears Island

April 2024

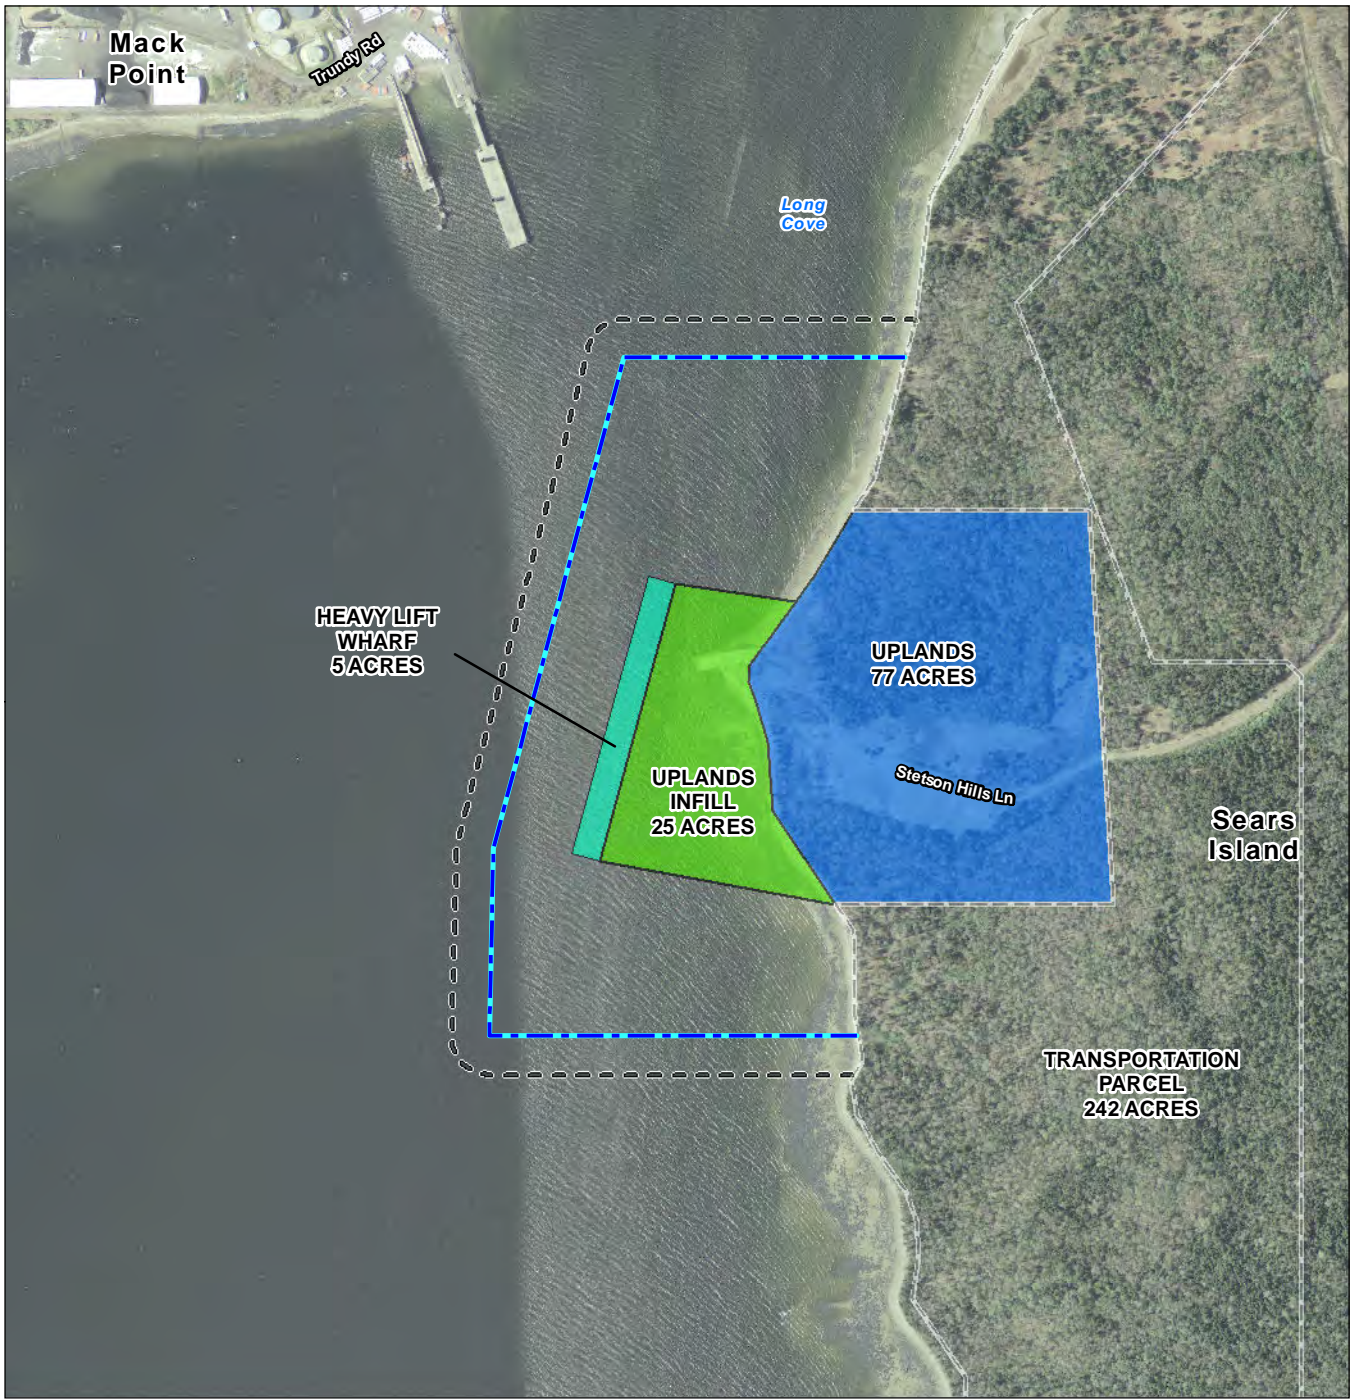
- Legend**
- 200 ft Buffer
  - Potential Intertidal and Subtidal Project Footprint
  - Uplands (77 acres)
  - Uplands Infill (25 acres)
  - Heavy Lift Wharf (5 acres)
  - Transportation Parcel (242 acres)

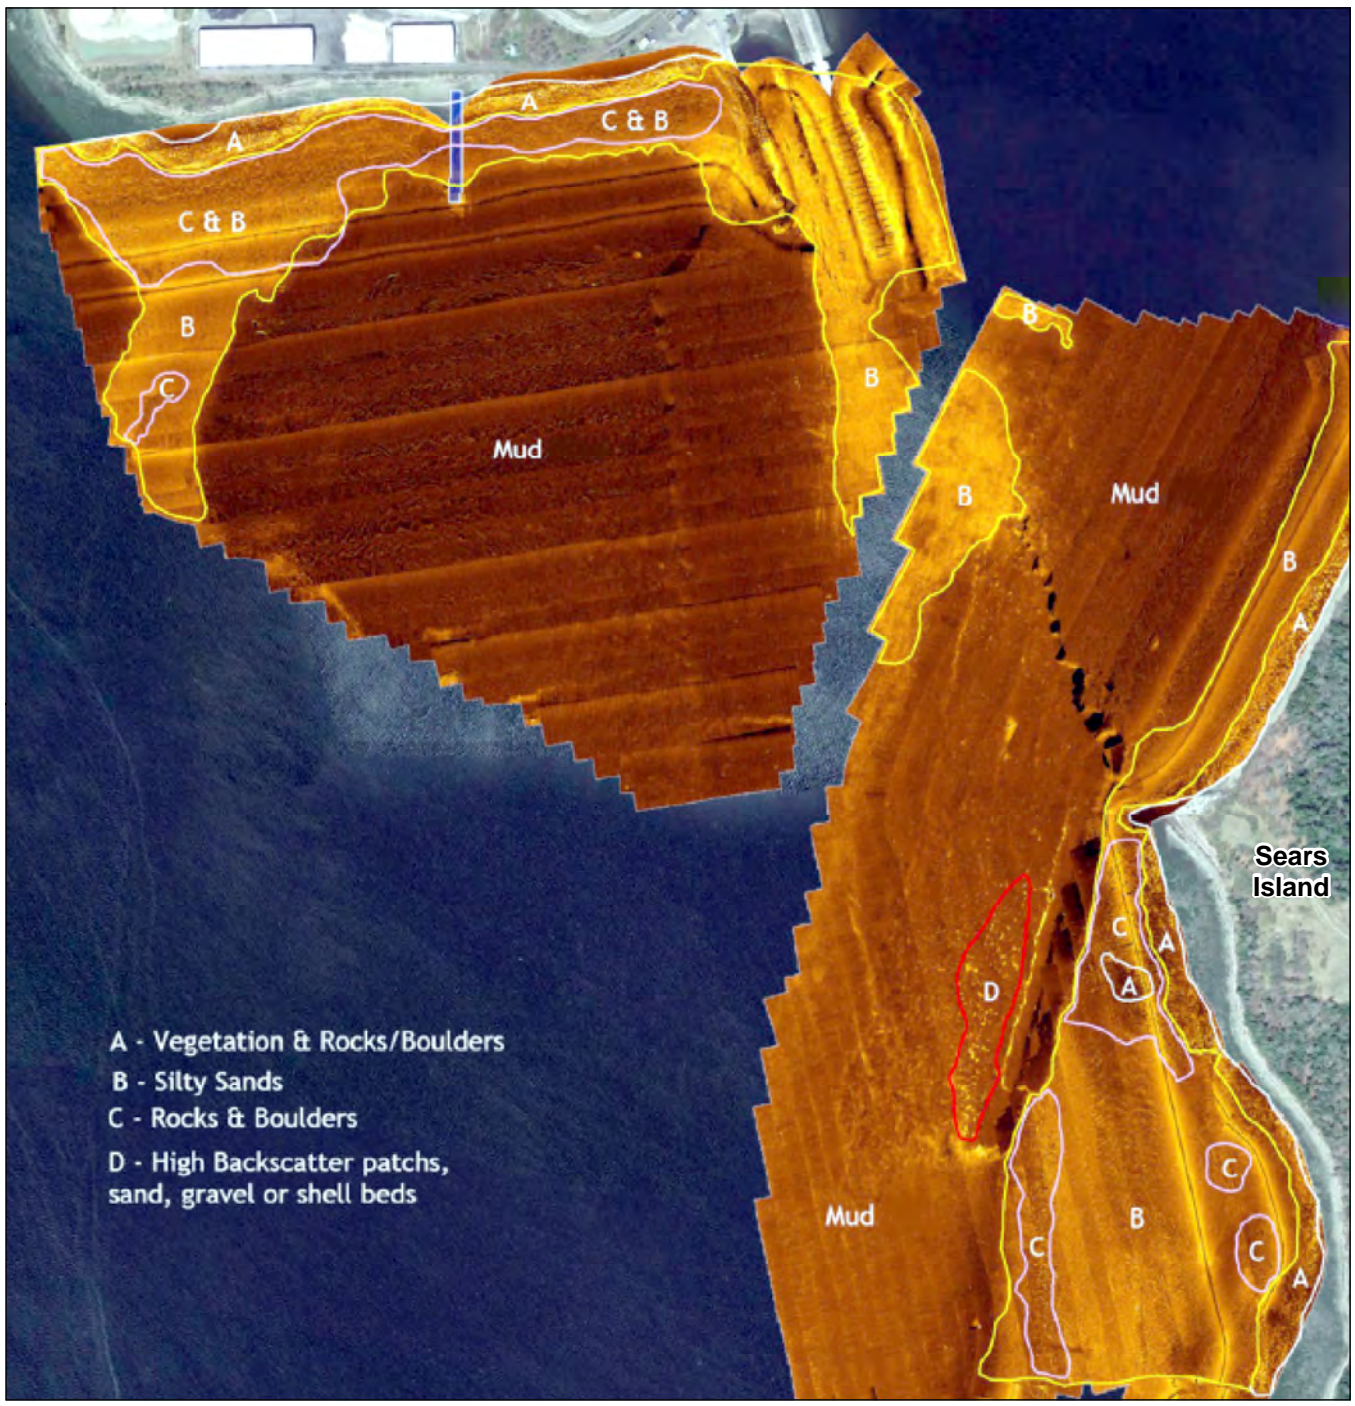
- A - Vegetation & Rocks/Boulders
- B - Silty Sands
- C - Rocks & Boulders
- D - High Backscatter patches, sand, gravel or shell beds

- On October 25 and 26, 2023, Steele Associates Marine Consultants, LLC. (SAMC) completed a side-scan sonar survey of the subtidal Sears Island Survey Area. Side-scan sonar transects were performed at 75-foot intervals oriented parallel to the shoreline (SAMC 2023).

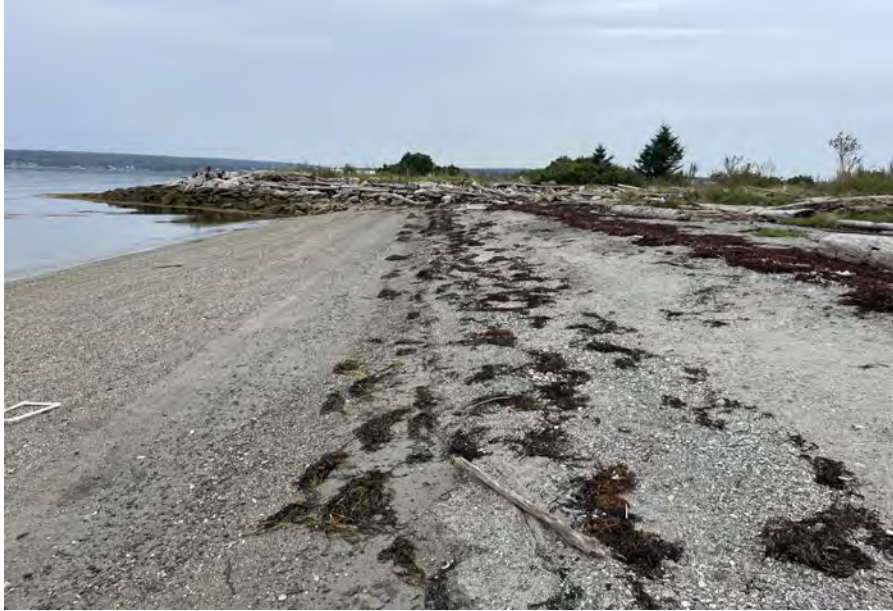
Photo 1. Depositional area to the south of the riprap jetty at Sears Island. September 2023.

The Project Area includes a small coastal sand dune system on the south side of an existing jetty (Stantec 2023c). The site includes a sloping sand and gravel beach beginning at the approximate mean low water elevation and extending landward to the approximate high tide limit, which was identified by field characteristics including a prominent wrack line. Landward of the high tide limit, a narrow dune berm (approximately 20 to 25 feet wide) consisting predominantly of medium- to fine-grained slopes gently upward to a low frontal dune ridge. The dune berm is subject to occasional tidal inundation during extreme high tide and storm events as evidence by a scattering of wrack material (primarily seaweed) along the berm. The frontal dune consists of a very narrow (approximately 15 feet wide) and sparsely vegetated coarse sand and gravel ridge. The top of the ridge has large accumulations of coarse woody debris and wrack that has accumulated during extreme high tide and storm events. Based on the field observations, the sand dune system observed at the Sears Island site meets the NRPA definition of a coastal sand dune. This sand dune system has been created by placement of the jetty at the site and accumulation of sand south of the jetty.

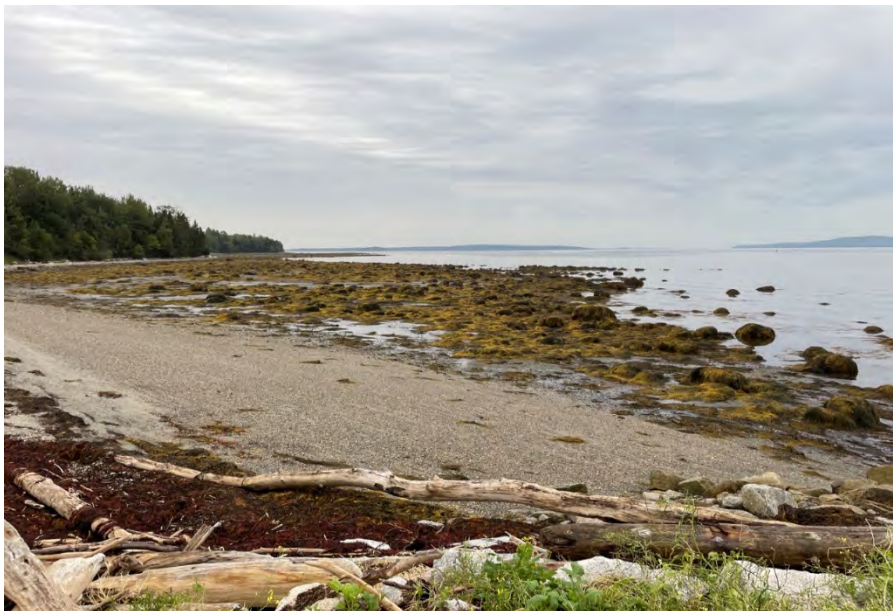
Photo 2. Depositional area to the south of the riprap jetty at Sears Island with boulder and cobble substrate in background. September 2023.

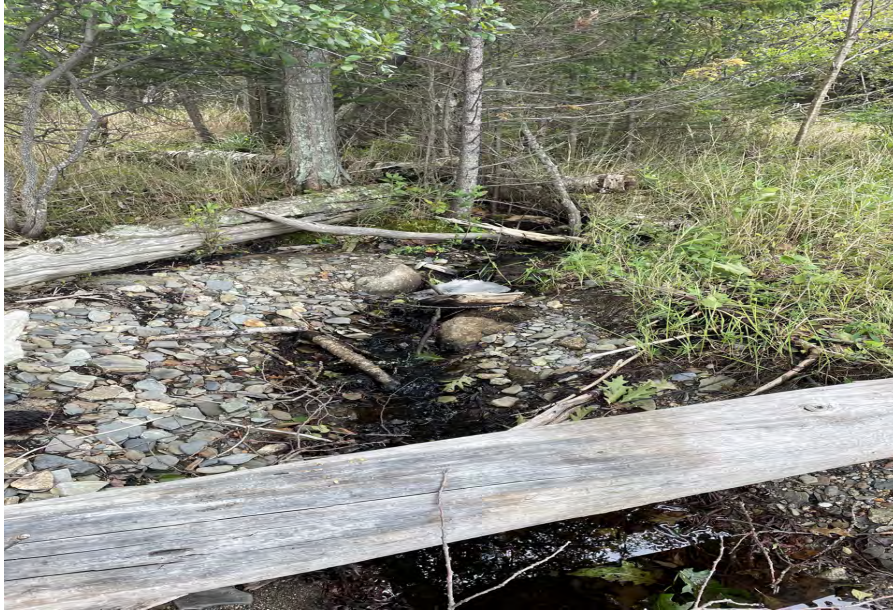
Photo 3. Freshwater seep from the forested wetland habitat at Sears Island draining into high intertidal. September 2023.

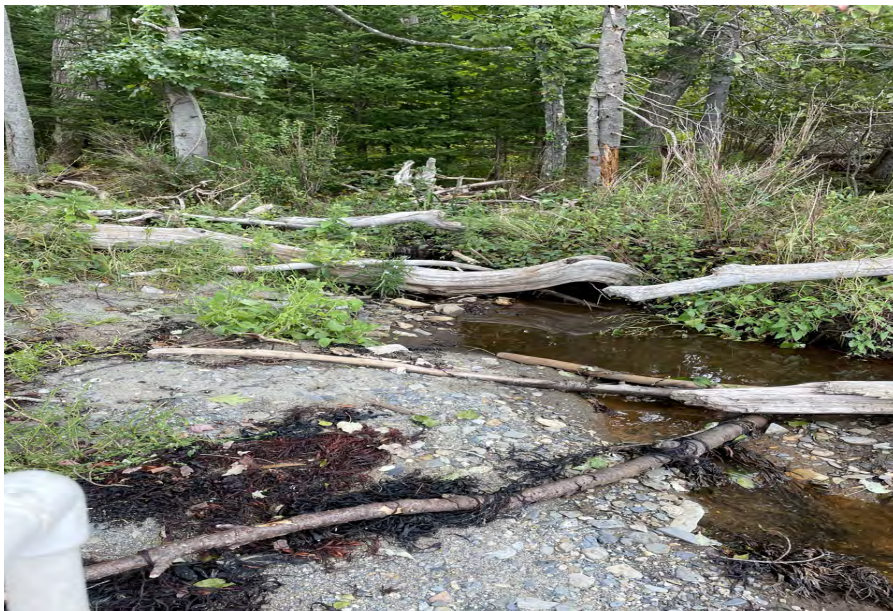
Photo 4. Freshwater seep from the forested wetland habitat at Sears Island draining into high intertidal. September 2023.

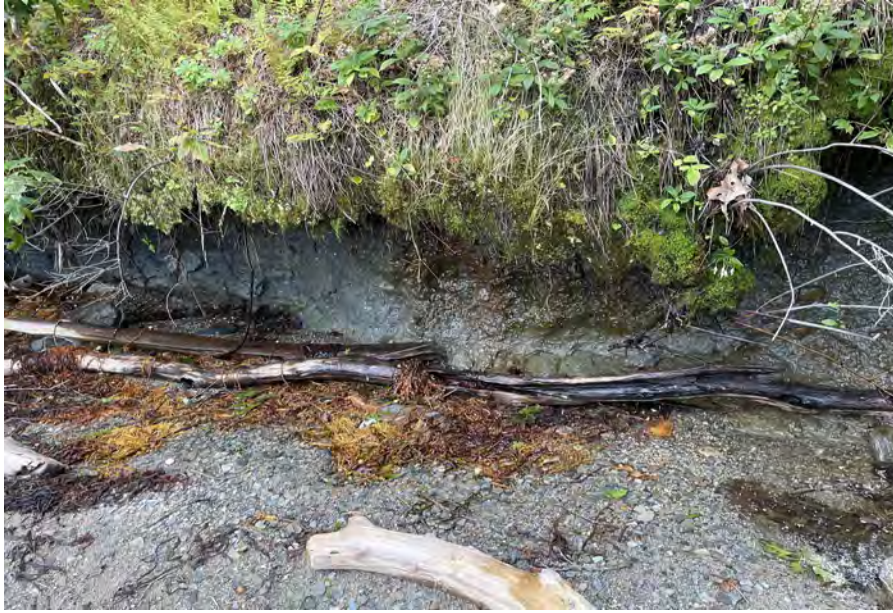
Photo 5. Steep eroding upland bank at Sears Island. September 2023.

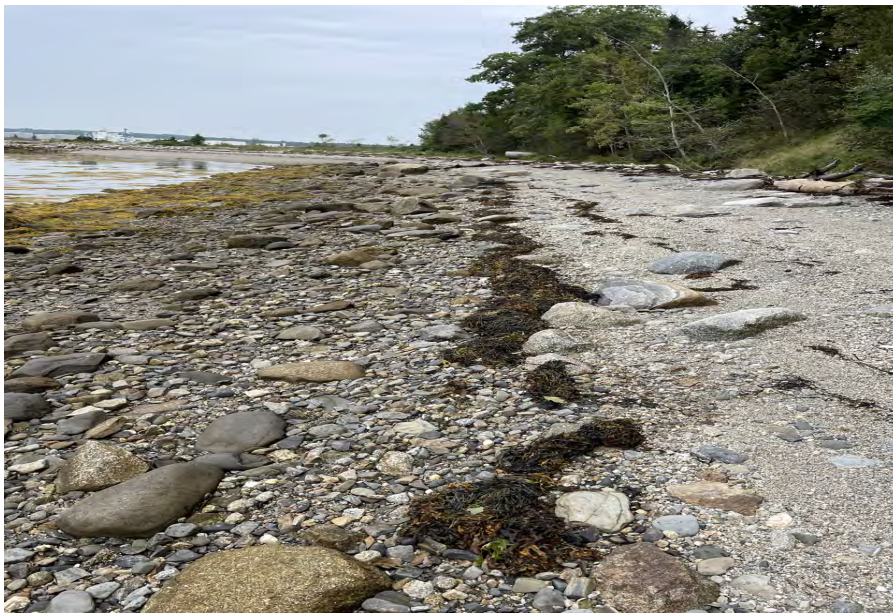
Photo 6. High intertidal characterized by cobble and gravel with sand/silt and scattered boulders at Sears Island south of jetty. September 2023.

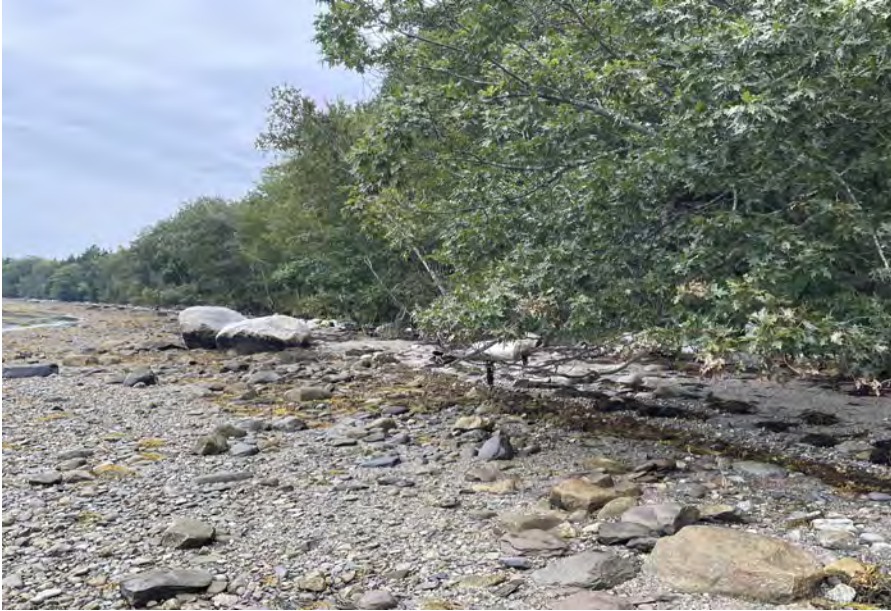
Photo 7. Coarse sand and gravel with scattered cobble in the high intertidal at Sears Island north of jetty. September 2023.

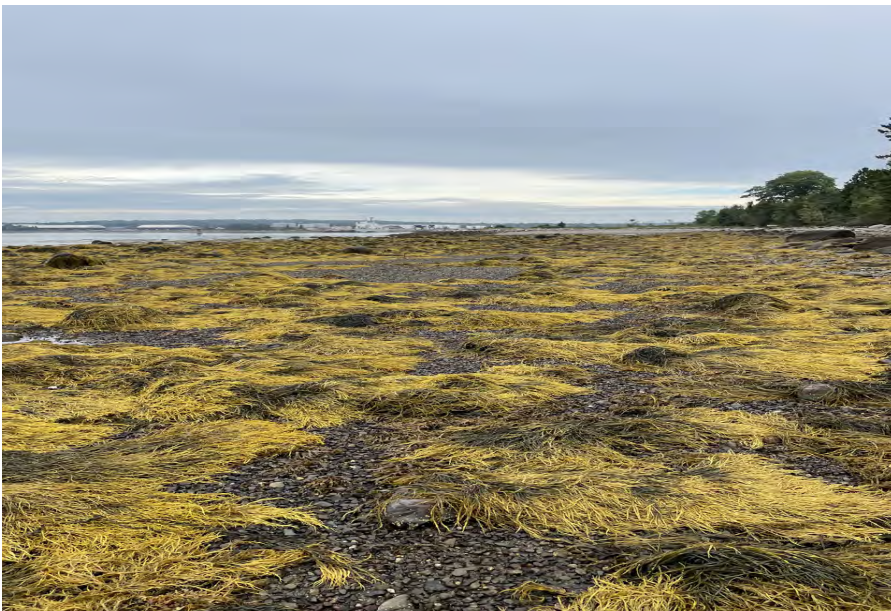
Photo 8. Mid intertidal substrate dominated by cobble, gravel and coarse sand with scattered boulders at Sears Island south of jetty. September 2023.

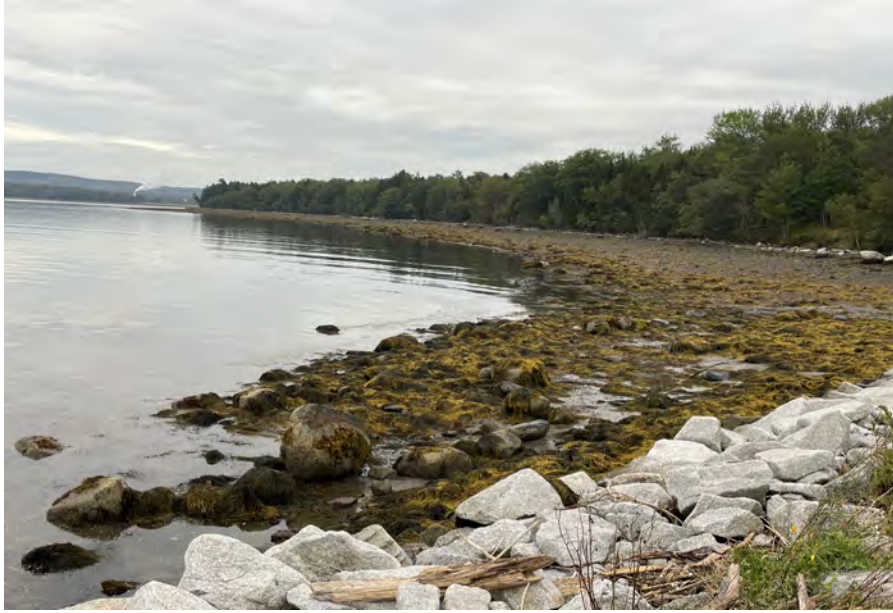
Photo 9. Boulder and cobble with scattered gravel, sand, and silt in the mid intertidal at Sears Island north of jetty. September 2023.

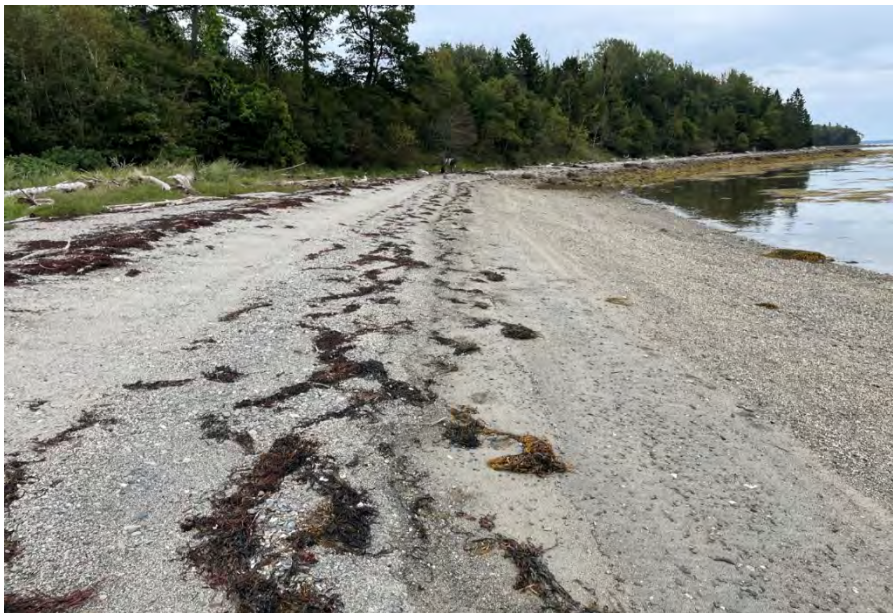
Photo 10. Coarse sand and gravel south of the jetty in the mid intertidal at Sears Island. September 2023.

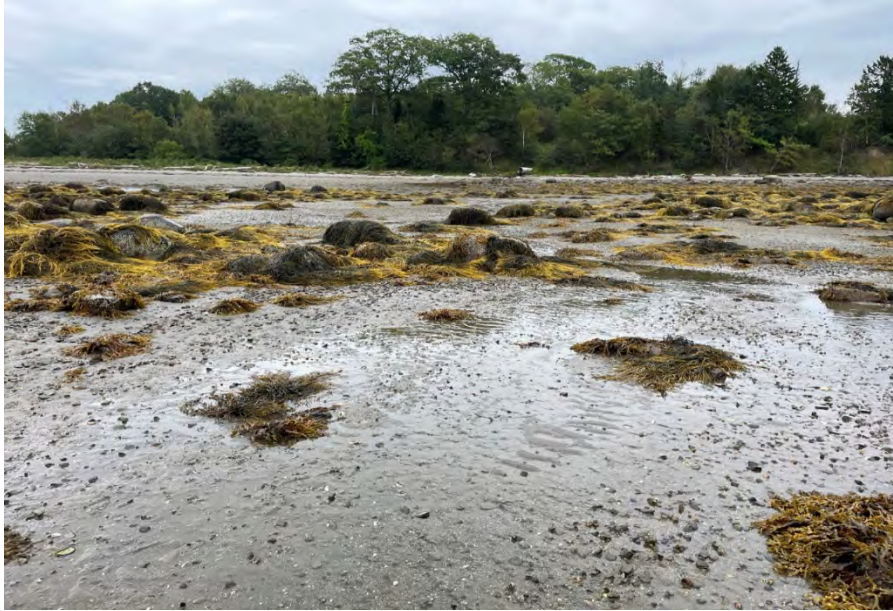
Photo 11. Scattered macroalgae on boulders in the finer grained substrate present in the mid intertidal at Sears Island south of jetty. September 2023.

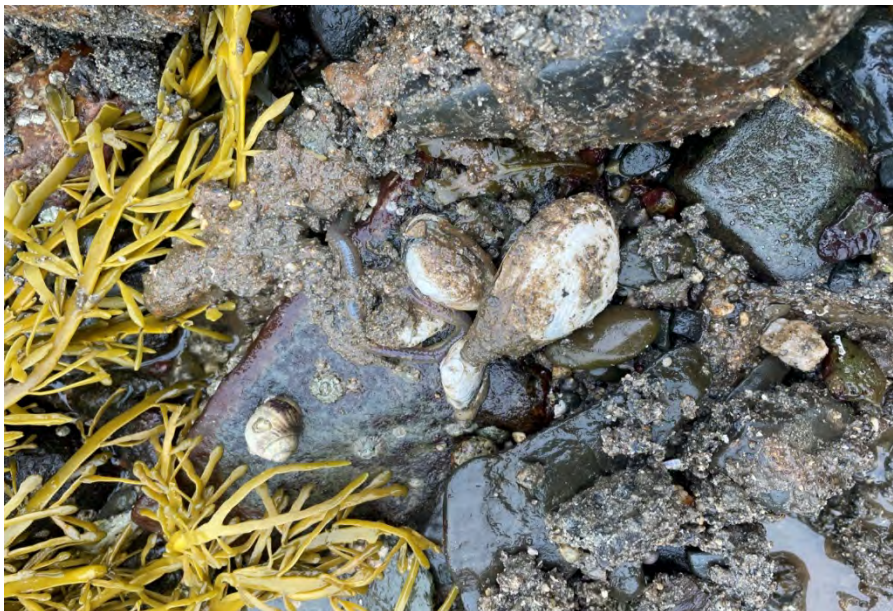
Photo 12. Soft-shell clams were common within this finer grained substrate in the mid intertidal at Sears Island. September 2023.

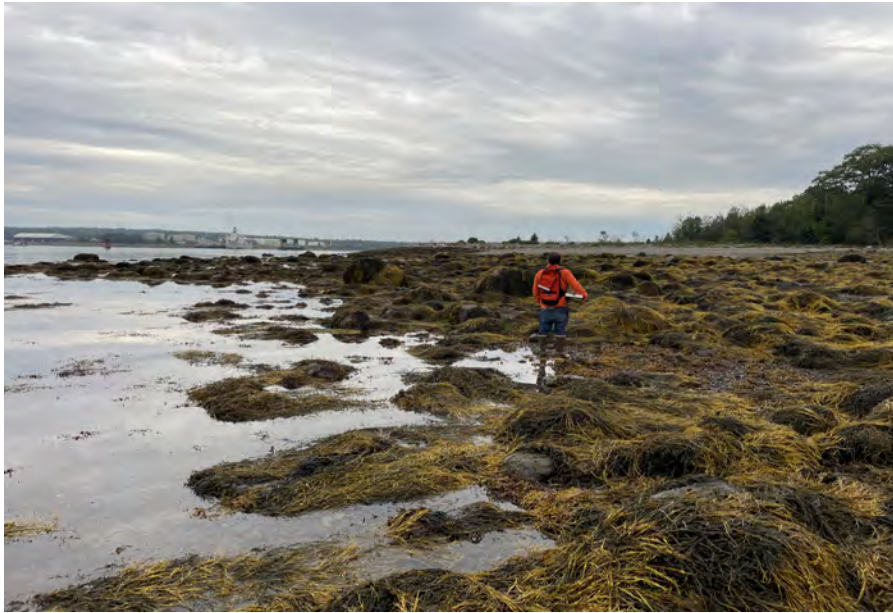
Photo 13. Boulders and cobble in the mid intertidal embedded in the gravel, sand, and silt at Sears Island south of jetty. September 2023.

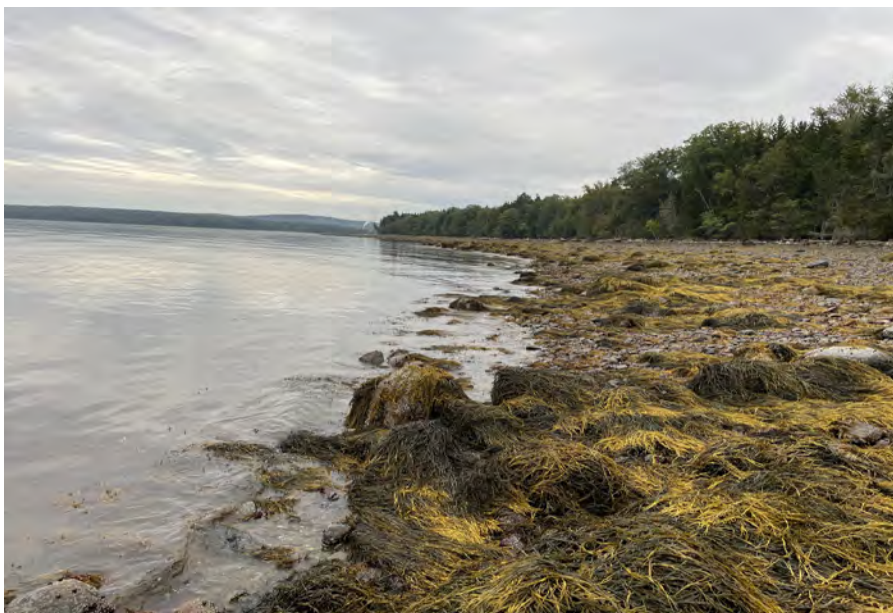
Photo 14. Low intertidal dominated by boulder and cobble and abundant macroalgae (knotted wrack and rockweed) at Sears Island north of jetty. September 2023.

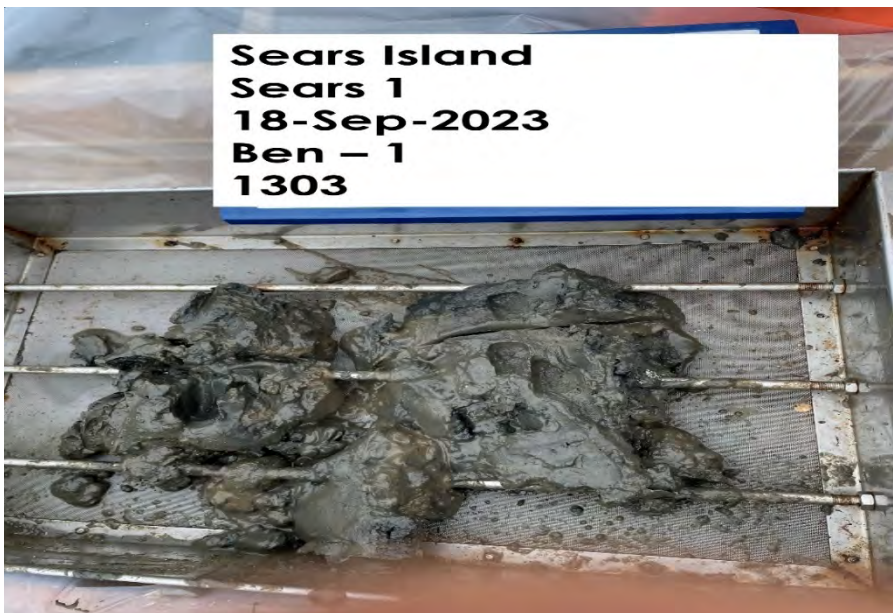
Photo 20. Sears Island Benthic Sample 1. September 2023.

On September 18, 2023, Stantec collected five grab samples from subtidal areas with unconsolidated sediments (Figure 2). The sediments in the five grab samples consisted of olive silt and fine sand (Appendix D: Photos 20–24). Macroinvertebrate samples from the sediment grabs were sent for sorting, enumeration, and speciation to Haley Ward, which is a qualified Maine taxonomic laboratory. Identified species, total number of individuals, individuals per meter squared, species richness (number of species), species evenness (a description of the relative abundance across species in a sample), Shannon-Weiner Index, and functional groups present for each sample per the methods in Ward (1999a) are presented in Appendix E.
