# South Bog Stream Brook Trout Habitat Restoration

FISHERY INTERIM SUMMARY REPORT SERIES NO. 08-02  
SOUTH BOG STREAM BROOK TROUT HABITAT RESTORATION

SOUTH BOG STREAM BROOK TROUT HABITAT RESTORATION  
INTERIM SUMMARY REPORT NO. 3 (2003-2007)

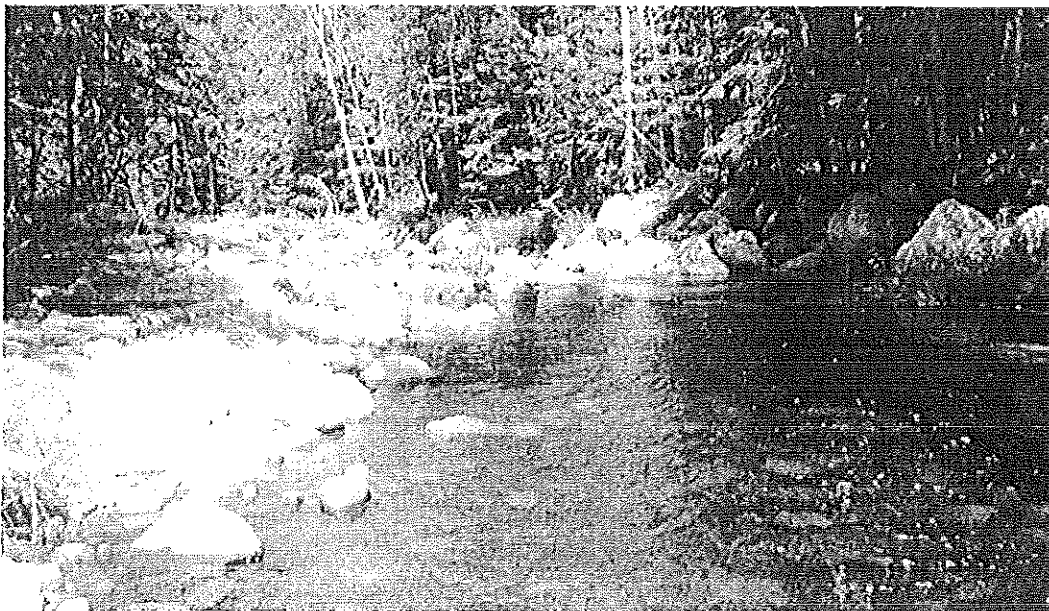
Transect 5 (control) looking downstream, 2007. Two logs are on left bank; upper rock vein visible in distance.

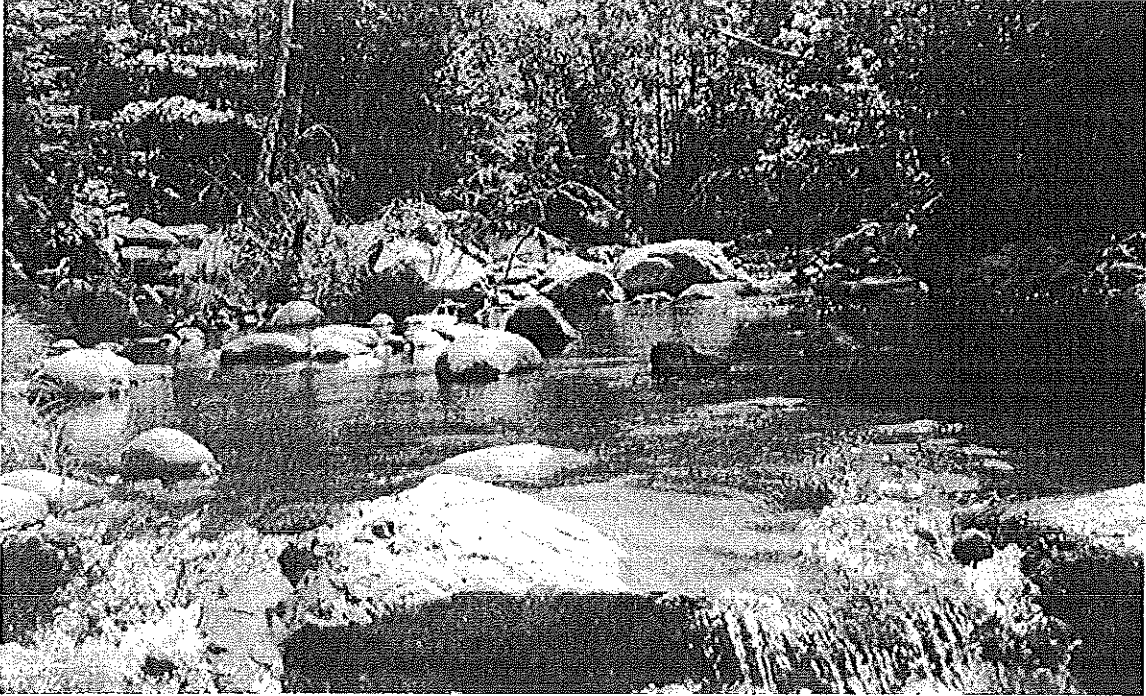
Transect 6a looking upstream. Apex of rock weir No. 2 in immediate foreground.

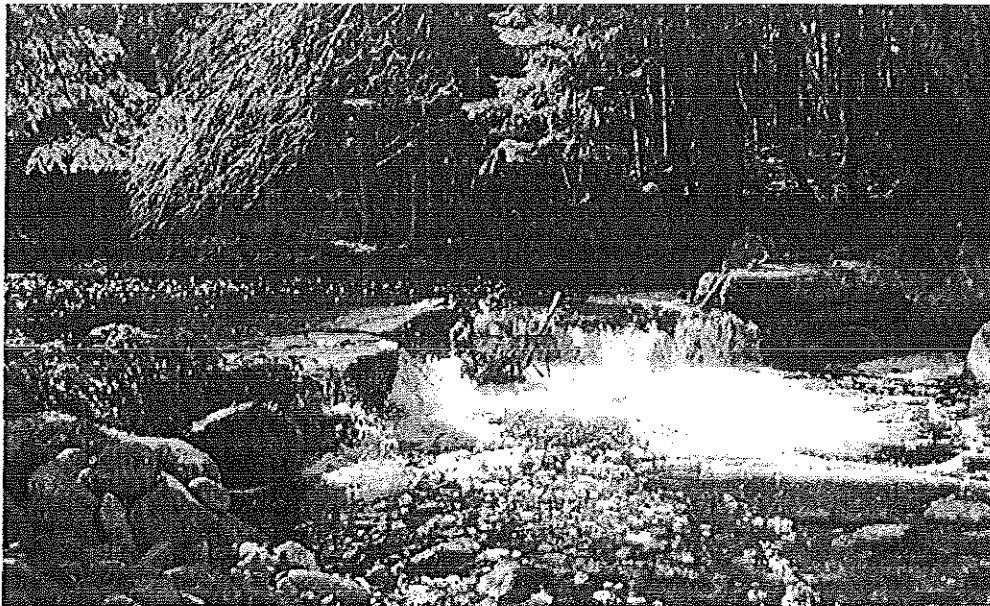
Rock weir No. 2, Lower Project, October 2007, two months after construction. The river-left log deflector of the lower-most pair (which suffered ice damage) was removed to construct this weir.
