Maine Department of Transportation

Pavement Condition Report

OXFORD COUNTY REGIONAL AIRPORT (81B)

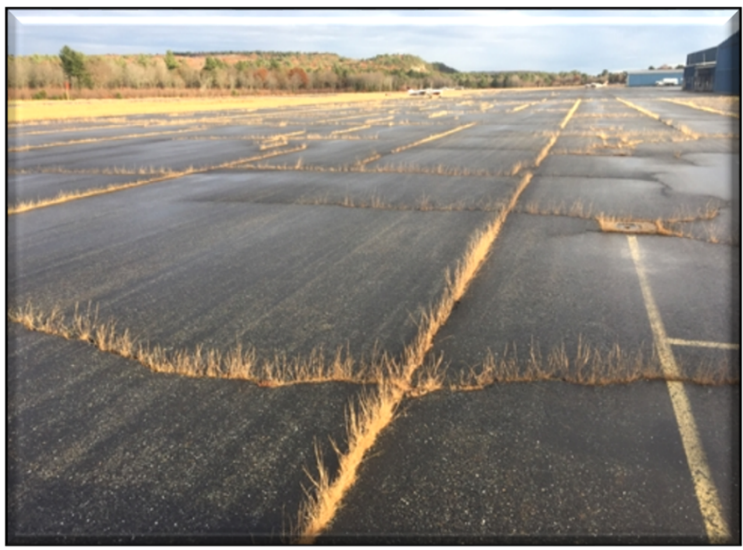
M&R	Action	Year / Quantity	Cost (\$)	Ending PCI
Major	Major M&R	2020	4,545,042	100
Minor	All Minor	2020	40,230	70
1	Crack Sealing - AC	17877 Ft	24,670	-
2	Patching - AC Deep	837 SqFt	15,560	-
3	-	-	-	-
4	-	-	-	-
5	-	-	-	-
6	-	-	-	-
7	-	-	-	-

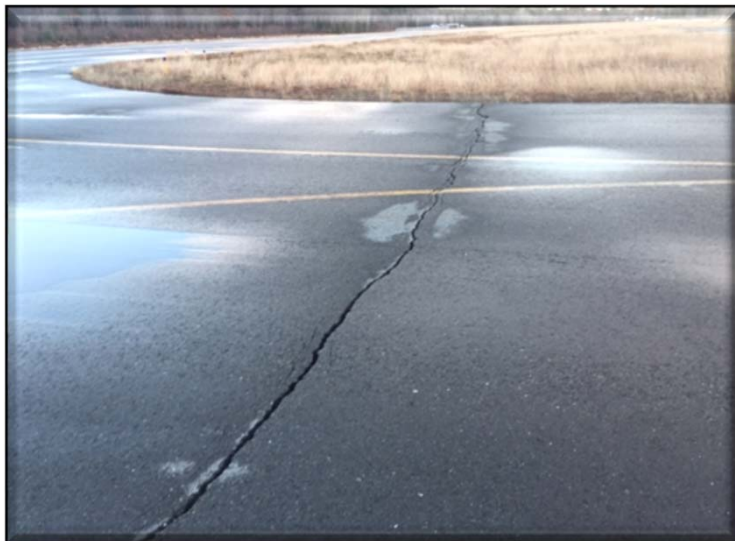
M&R	Action	Year / Quantity	Cost (\$)	Ending PCI
Major	Major M&R	2026	26,399	100
Minor	All Minor	2020	64	89
1	Crack Sealing - AC	46 Ft	64	-
2	-	-	-	-
3	-	-	-	-
4	-	-	-	-
5	-	-	-	-
6	-	-	-	-
7	-	-	-	-

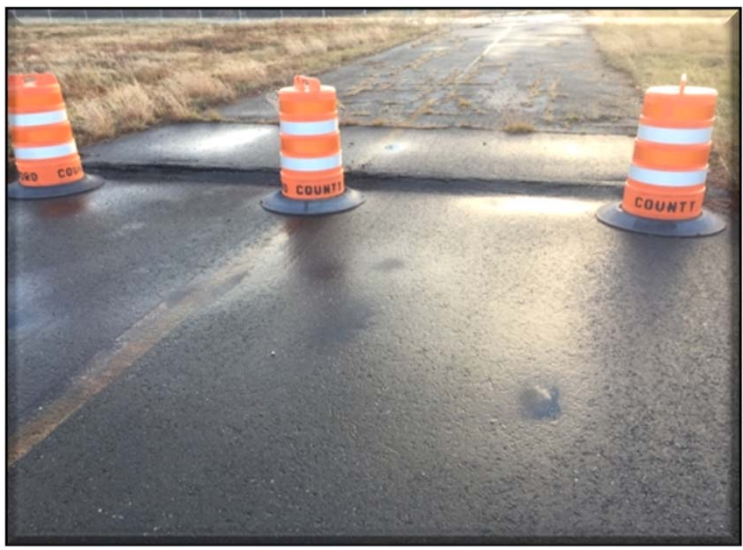
M&R	Action	Year / Quantity	Cost (\$)	Ending PCI
Major	-	-	-	-
Minor	All Minor	2020	1,386	91
1	Patching - AC Shallow	83 SqFt	1,386	-
2	-	-	-	-
3	-	-	-	-
4	-	-	-	-
5	-	-	-	-
6	-	-	-	-
7	-	-	-	-
