# *Maine Department of Transportation*

Pavement Condition Report

## **SUGARLOAF REGIONAL AIRPORT (KB21)**

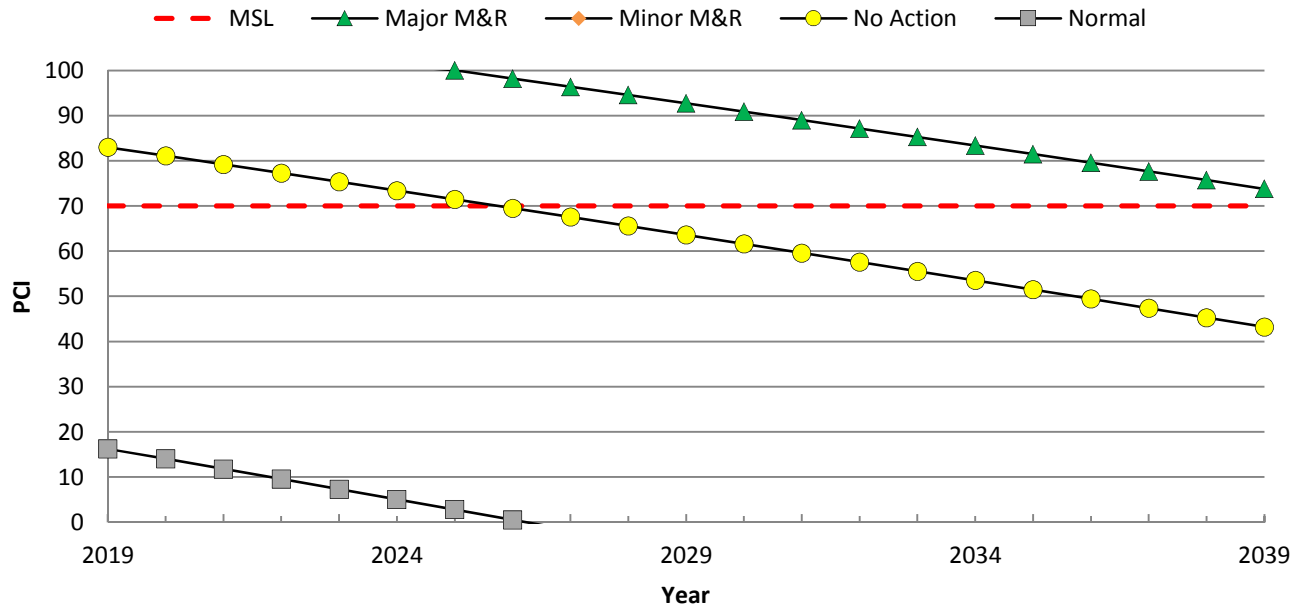
Apron A

M&R	Action	Year / Quantity	Cost (\$)	Ending PCI
Major	Major M&R	2025	120,034	100
Minor	-	-	-	-
1	-	-	-	-
2	-	-	-	-
3	-	-	-	-
4	-	-	-	-
5	-	-	-	-
6	-	-	-	-
7	-	-	-	-

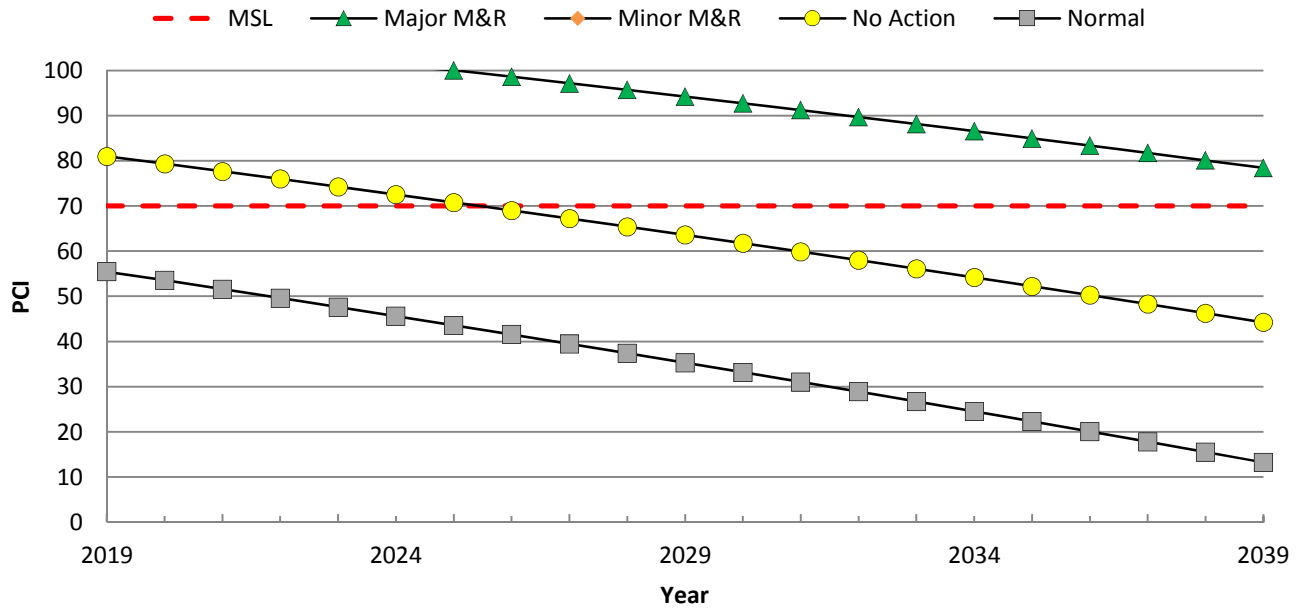
Connecting Taxiway A

M&R	Action	Year / Quantity	Cost (\$)	Ending PCI
Major	Major M&R	2025	15,262	100
Minor	-	-	-	-
1	-	-	-	-
2	-	-	-	-
3	-	-	-	-
4	-	-	-	-
5	-	-	-	-
6	-	-	-	-
7	-	-	-	-

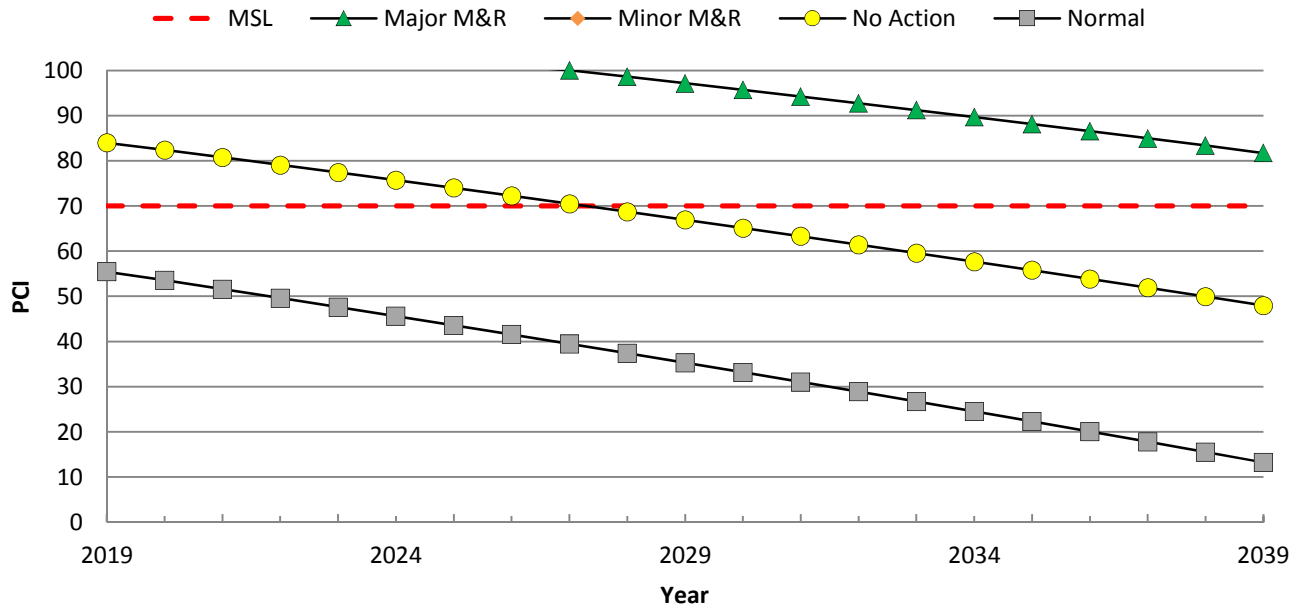
Connecting Taxiway B

M&R	Action	Year / Quantity	Cost (\$)	Ending PCI
Major	Major M&R	2027	13,750	100
Minor	-	-	-	-
1	-	-	-	-
2	-	-	-	-
3	-	-	-	-
4	-	-	-	-
5	-	-	-	-
6	-	-	-	-
7	-	-	-	-

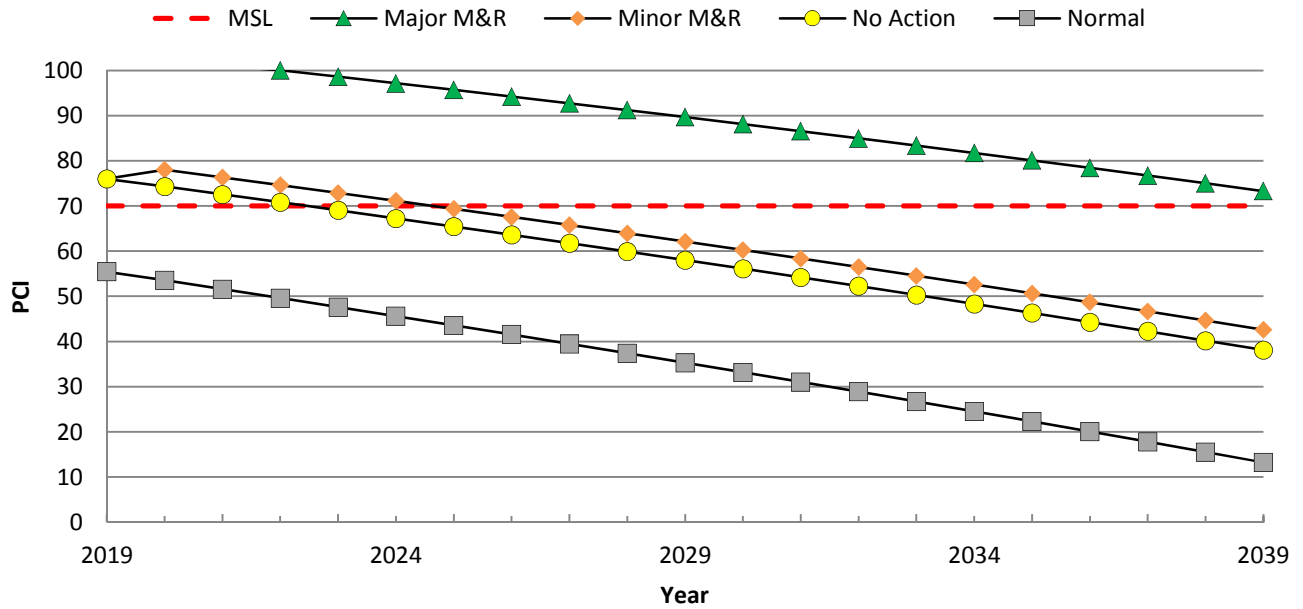
<b>Section:</b>	<b>B21::RY1735::001</b>
<b>Description:</b>	Runway 17-35
<b>PaveType:</b>	AC
<b>Area:</b>	209,950
<b>Built:</b>	1/15/1992
<b>Age:</b>	27yr

M&R	Action	Year / Quantity	Cost (\$)	Ending PCI
Major	Major M&R	2022	577,348	100
Minor	All Minor	2020	1,667	78
1	Crack Sealing - AC	1208 Ft	1,667	-
2	-	-	-	-
3	-	-	-	-
4	-	-	-	-
5	-	-	-	-
6	-	-	-	-
7	-	-	-	-
