Maine Department of Transportation

Pavement Condition Report

EASTPORT MUNICIPAL AIRPORT (KEPM)

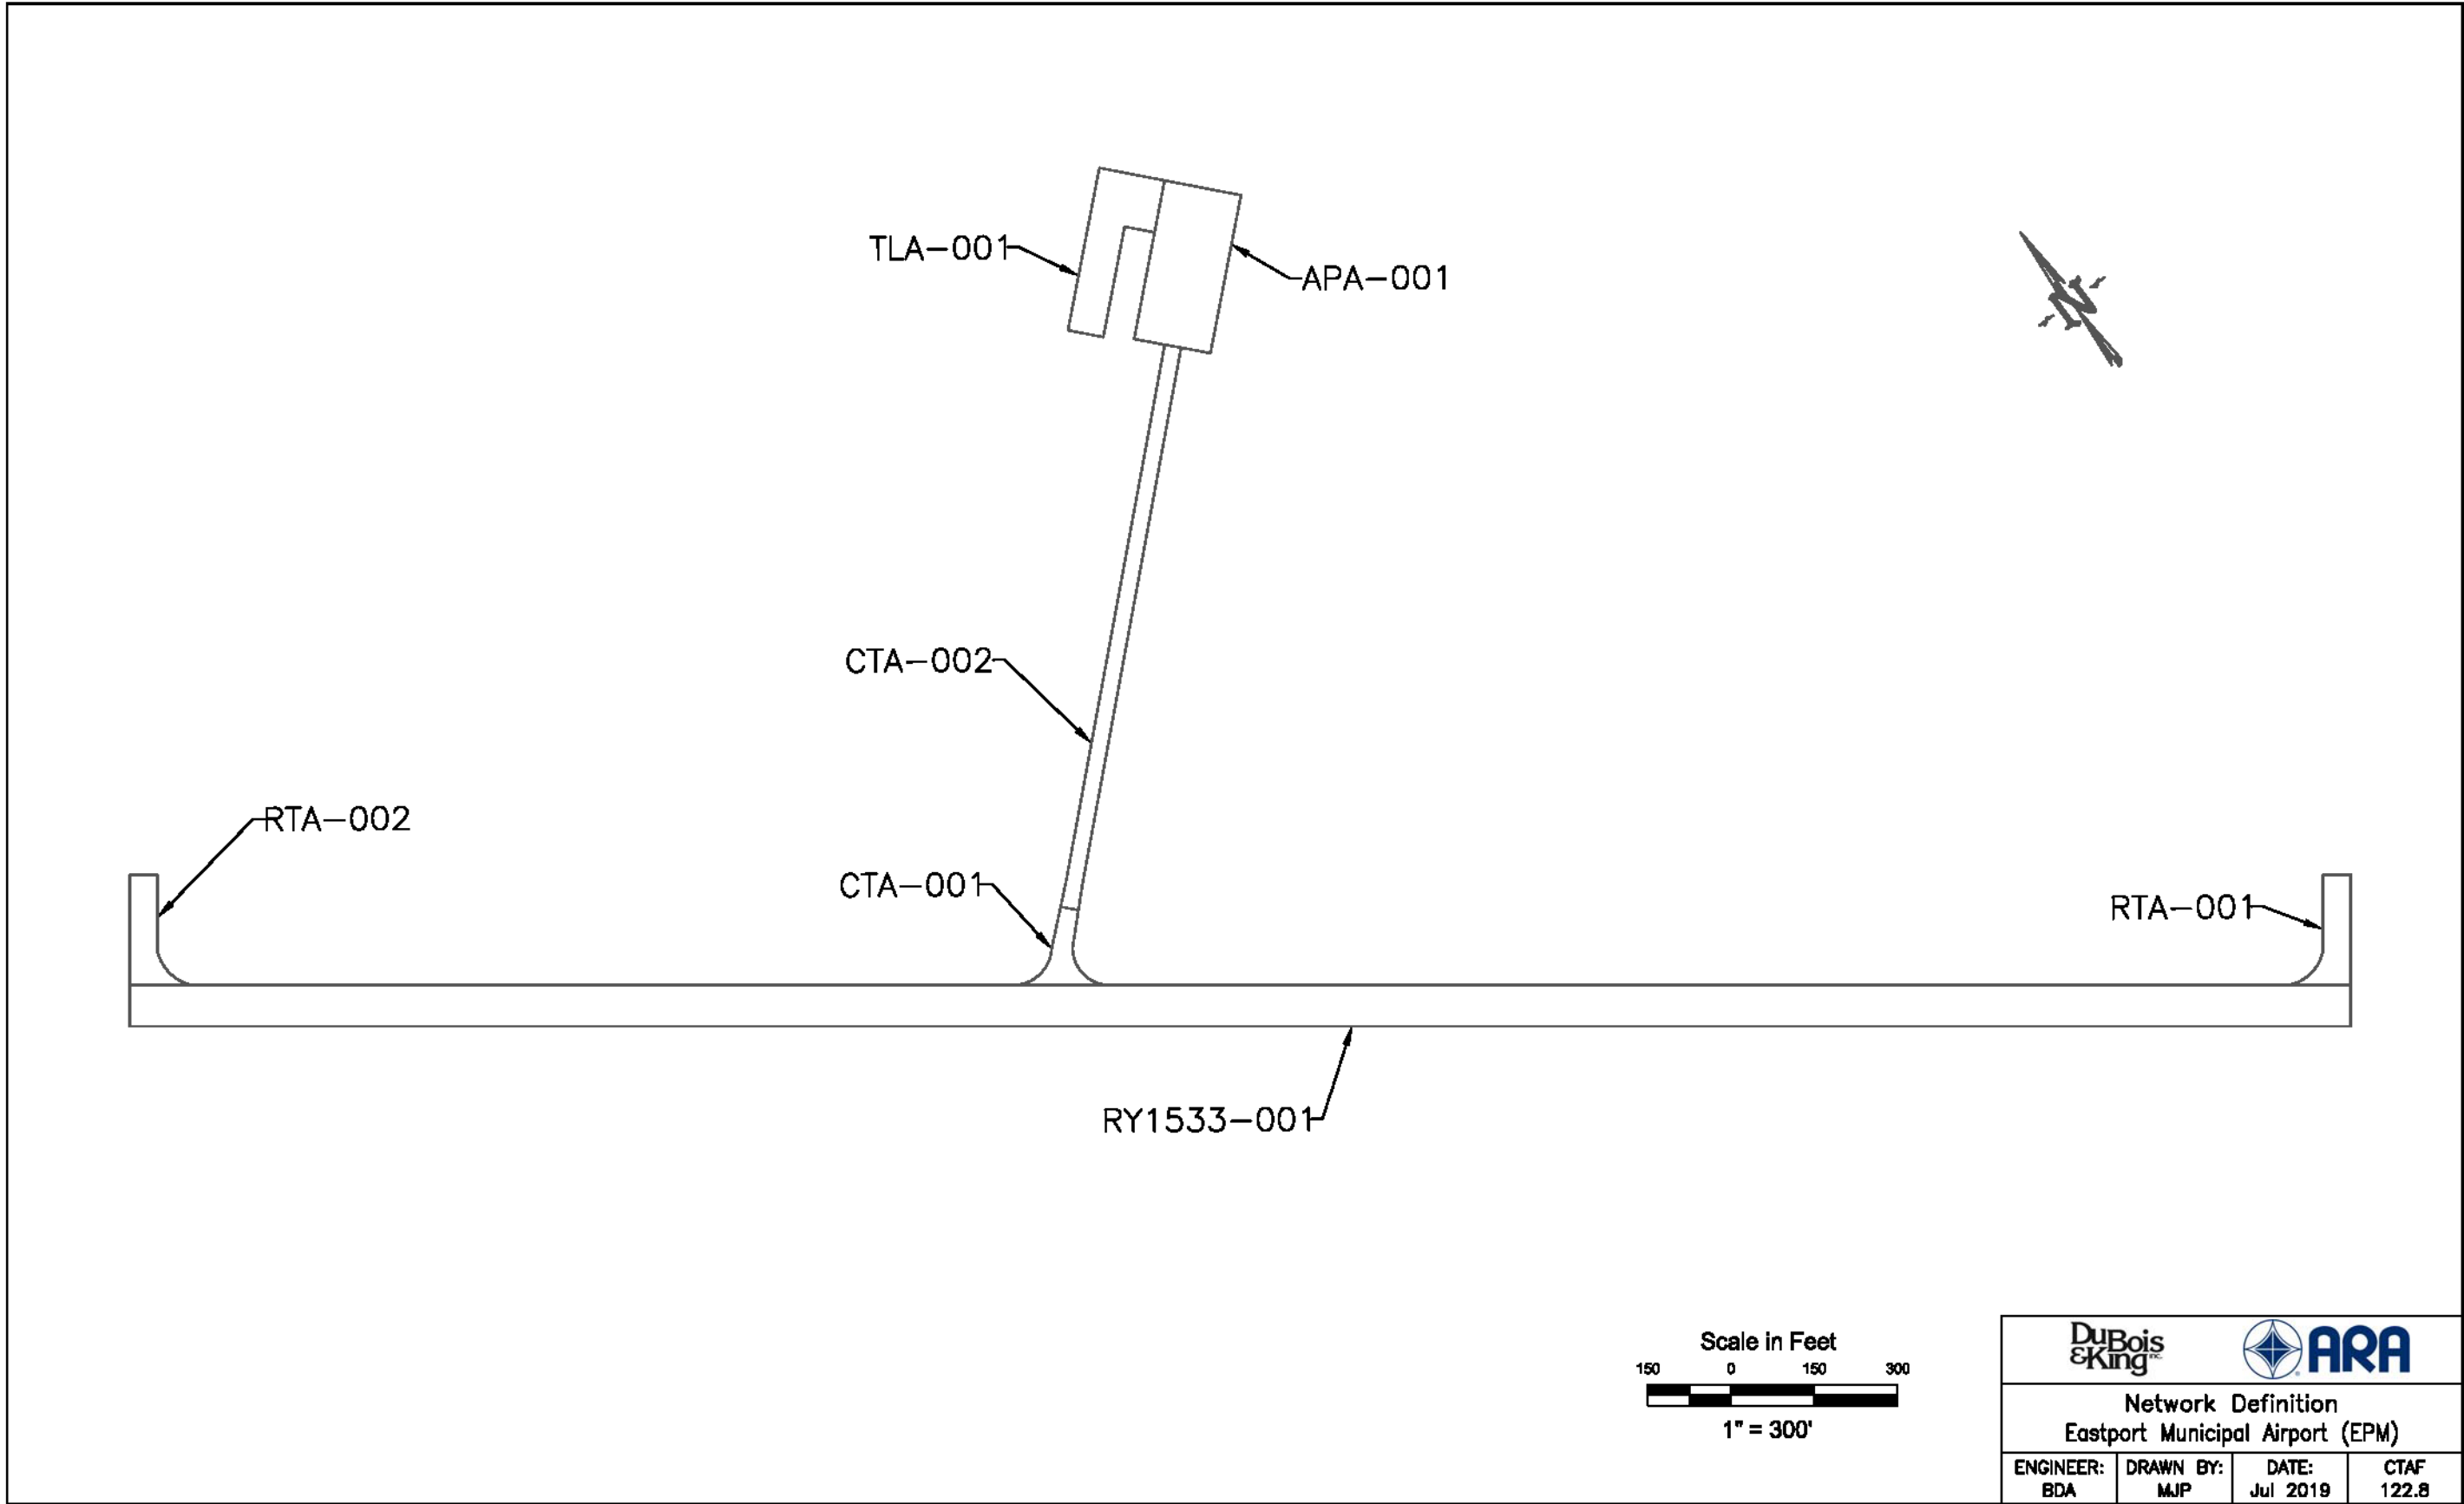
Figure 2. Network Definition at Eastport Municipal Airport (EPM)

Figure 2 presents the network definition for EPM and represents the pavements included in the APMS. Some privately built/maintained pavements and “driveways” leading into hangars may not be included within this report nor represented on Figure 2 because they are considered outside the scope of work.

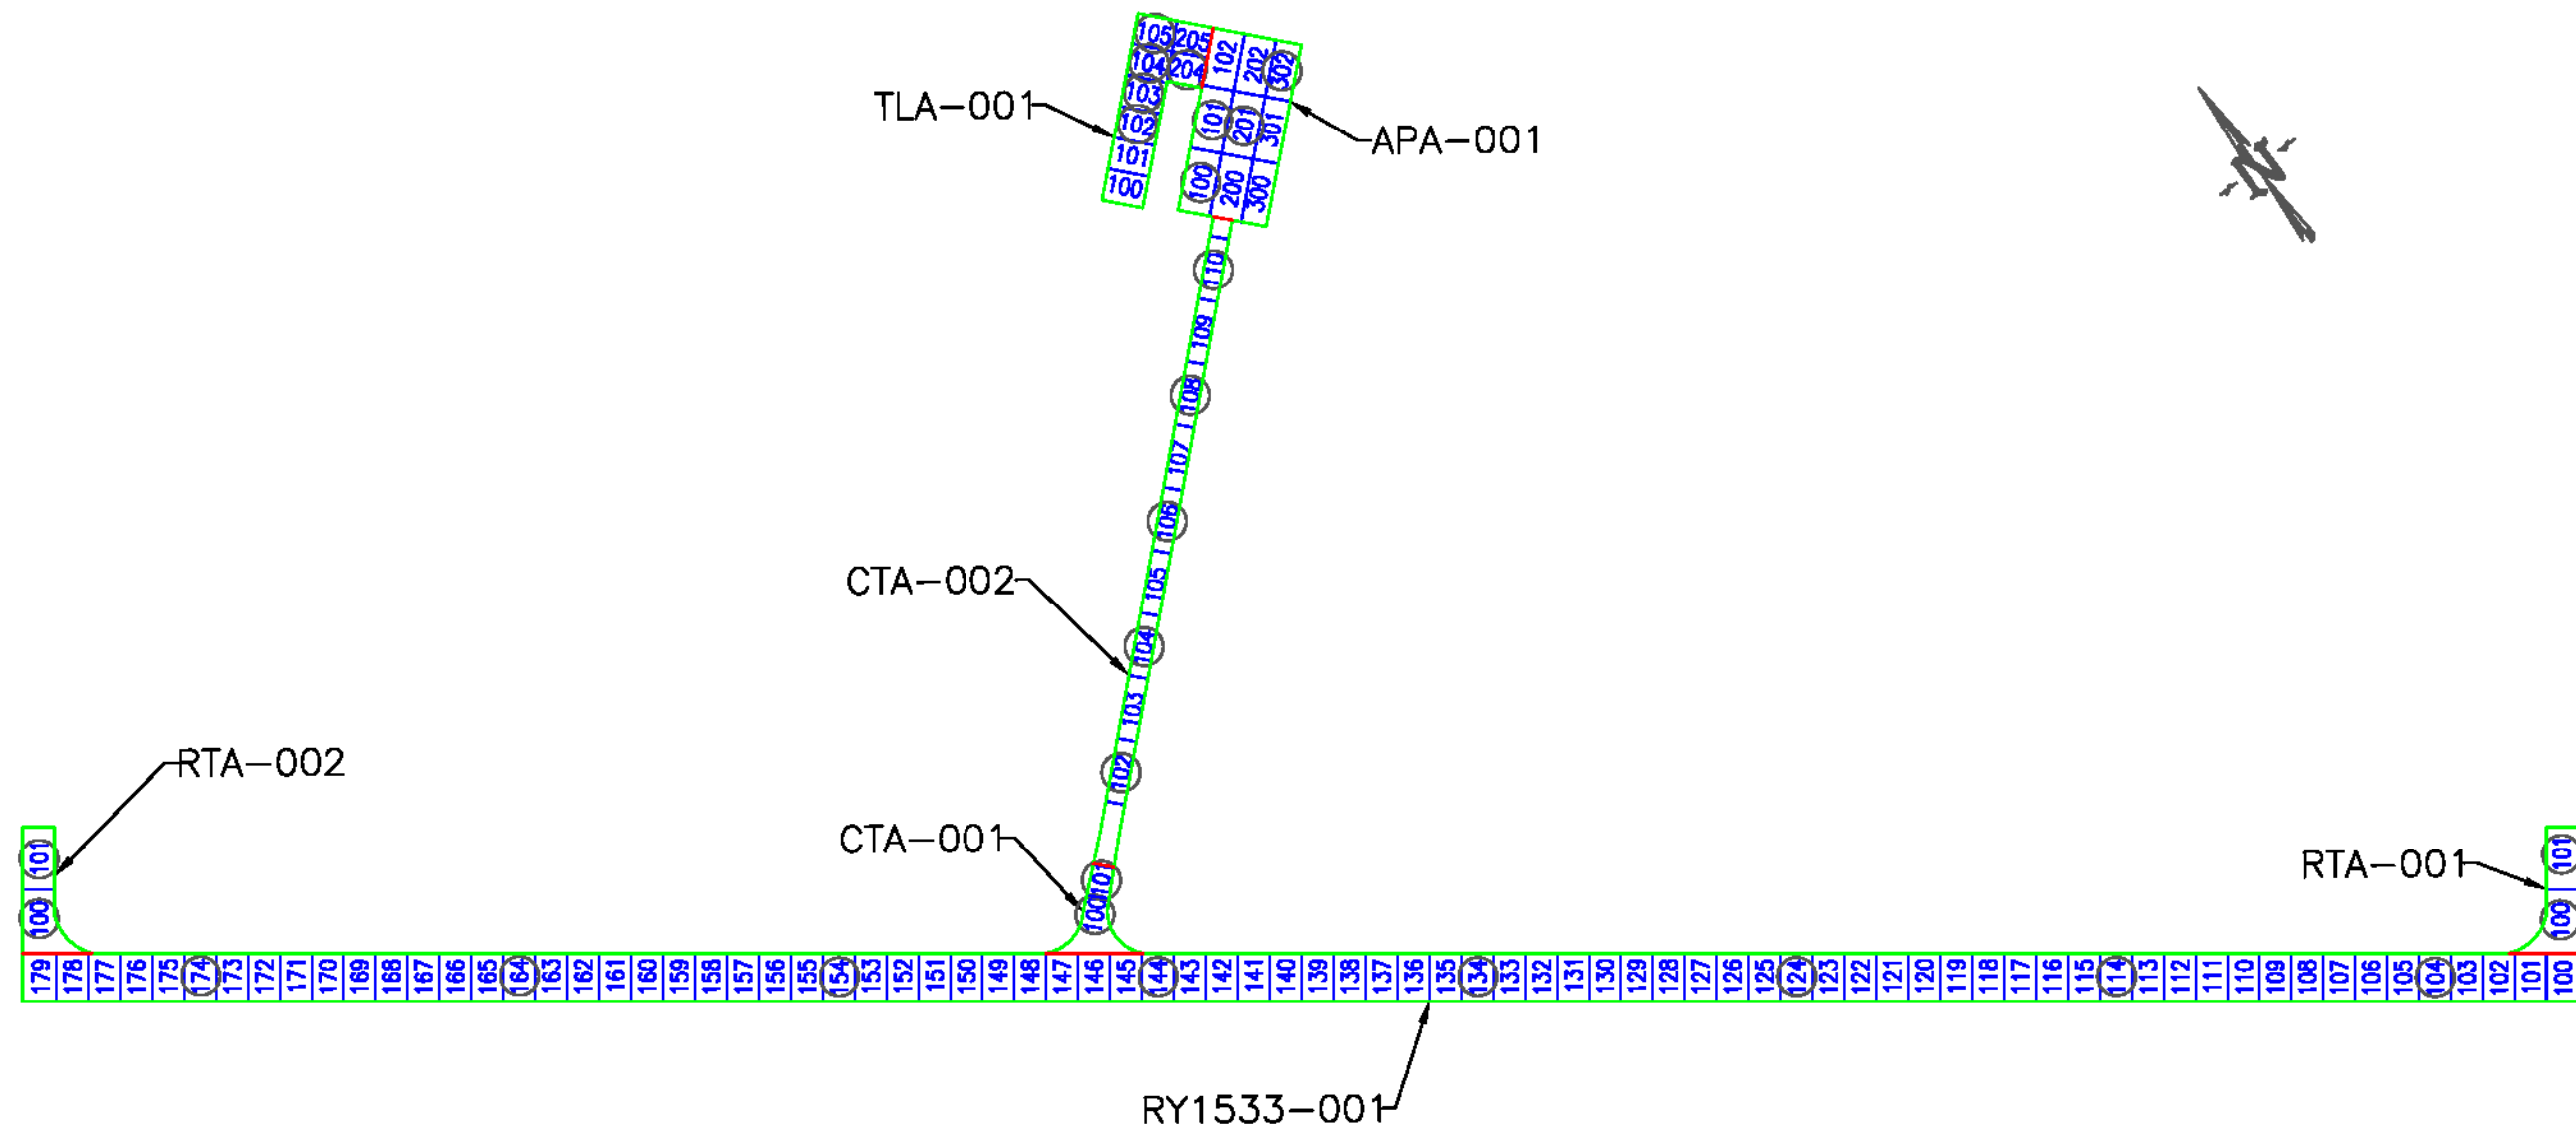
Figure A1. Sample Unit Layout at Eastport Municipal Airport (EPM)

- Denotes sample unit surveyed
- ◇ Denotes additional sample unit surveyed

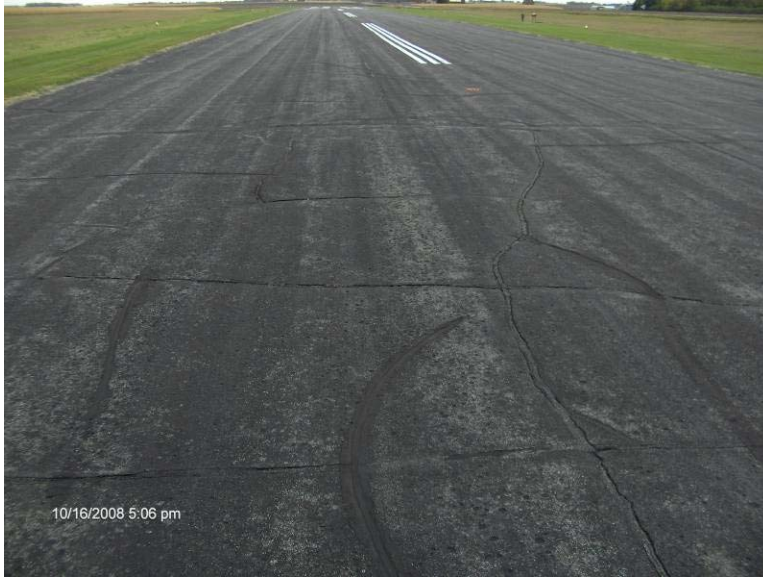
Example of Block Cracking

Block cracking is longitudinal and transverse cracking that has established a pattern of blocks ranging in size from 1ft x 1ft to 10ft x 10ft. This distress typically happens in older asphalt pavements and is an indication that the bituminous binder has lost most of its flexibility. The severity determination is basically determined by the crack width criteria defined for longitudinal and transverse cracking. Crack sealing typically is used to repair block cracking; however, the amount of required sealant can be extensive due to the high density of cracks.

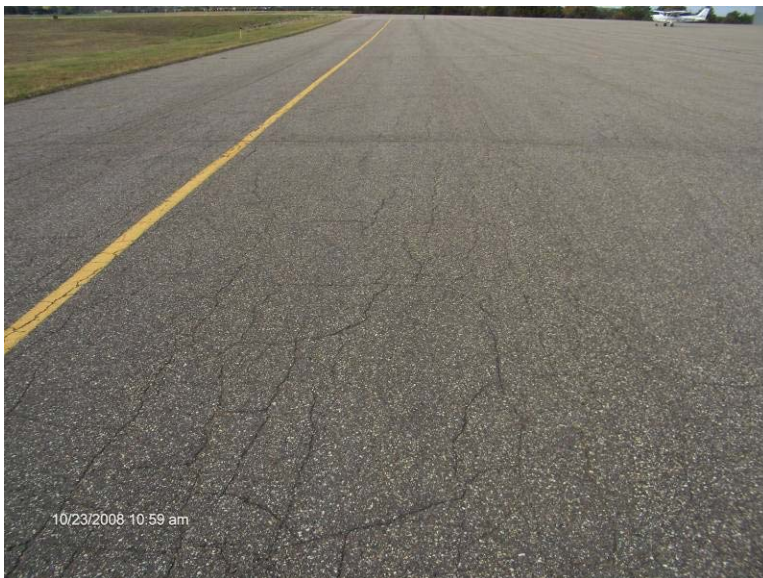
Example of Alligator Cracking

Alligator (or fatigue) cracks are a series of interconnected load-related cracks caused by fatigue of the asphalt surface. Alligator cracking is a significant structural distress and develops only in places subject to traffic loads. These cracks typically initiate at the bottom of the asphalt layer (where tensile strains

are highest) and propagate upward - so once a fatigue crack is visible, significant damage has already occurred.
