Maine Department of Transportation

Pavement Condition Report

EASTERN SLOPE REGIONAL AIRPORT (KIZG)

To assist individual airports to effectively maintain their pavement infrastructure and help improve airport pavement conditions statewide, the Maine Department of Transportation (MaineDOT) contracted with DuBois & King, Inc. (D&K) to provide pavement evaluation surveys at local airports. Assisting D&K on this effort was Applied Research Associates, Inc. (ARA). This report documents the pavement condition at Eastern Slopes Regional Airport (IZG) in November 2018.

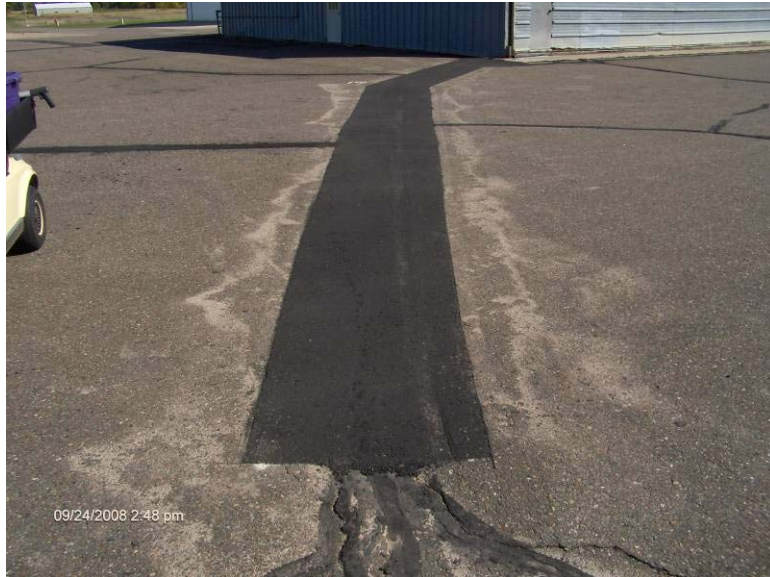
Example of Patching

Patched areas are defined when a portion of the original pavement is replaced with a material intended as a semi-permanent repair. A patch is documented as a defect because it is considered a break in the integrity of the pavement structure. Patches are constructed for a variety of reasons including utility repairs, correcting grade issues, and addressing a defect in the original pavement. The severity level of patches is determined by the amount of distress (i.e. cracking, depression, weathering/raveling, etc.) occurring within the limits of the patched area.

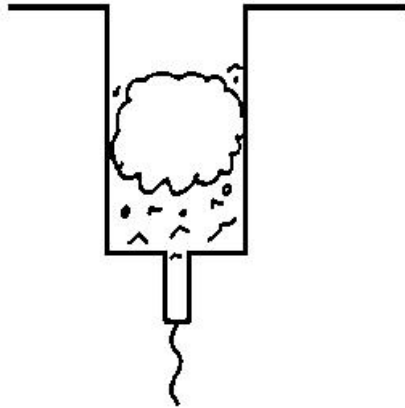
Typical joint with deficient sealant and a collection of debris & incompressibles.
