Pavement Condition Report

MILLINOCKET MUNICIPAL AIRPORT (KMLT)

**DuBois
& King** inc.

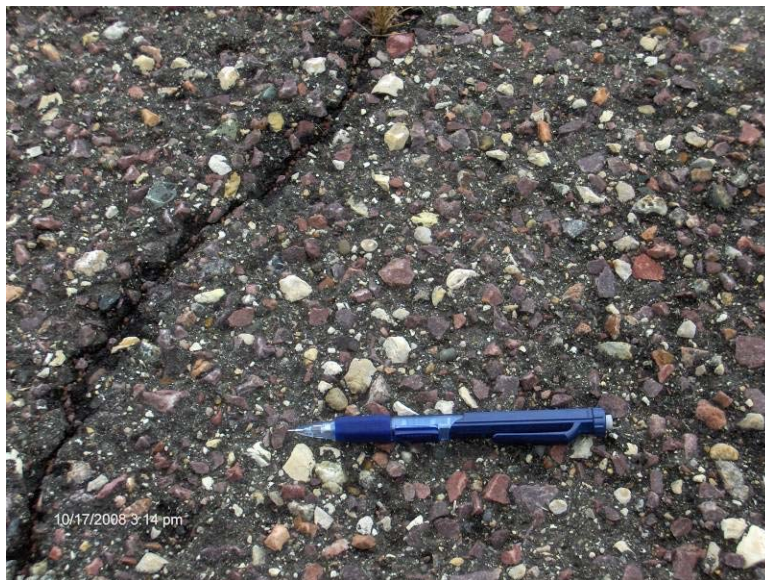
Example of Raveling/Weathering

Raveling and weathering are the wearing away of the pavement surface. Raveling is the condition where the mid- to large size aggregates are becoming dislodged; weathering is when the fine aggregate wears away exposing the edges of the larger aggregate. These distresses are usually evident over large areas and may occur together (pictured above) or separately. Raveling and weathering may indicate that the asphalt binder has hardened significantly.

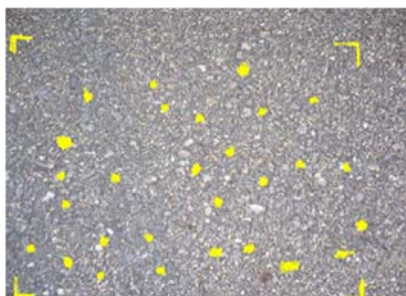
Raveling – At low severity, the number of missing coarse aggregates (> 3/8 inch) is between 5-20 missing/yd², medium severity (pictured below where the missing coarse aggregates have been dotted with yellow paint) is 21-40 missing/yd², and high severity is > 40 missing/yd².

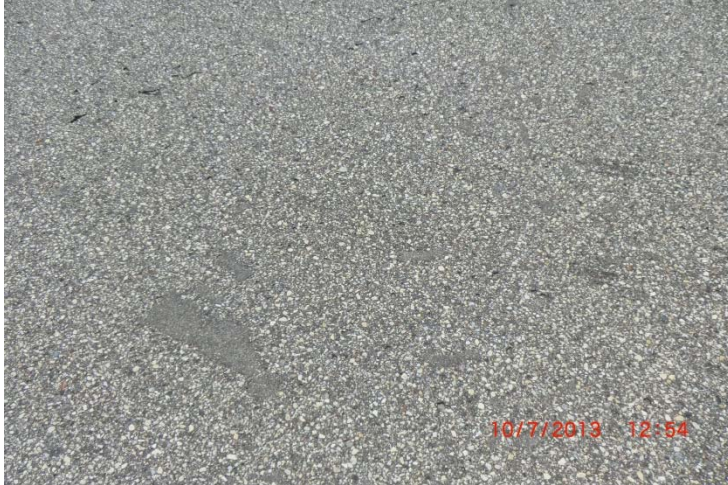
Low severity

Weathering – At low severity, the coarse aggregate is slightly exposed due to the wearing away of the fine aggregate. At medium severity, the coarse aggregate is exposed up to $\frac{1}{4}$ the width of the longest side. At high severity, the coarse is exposed greater than $\frac{1}{4}$ the width of the longest side.

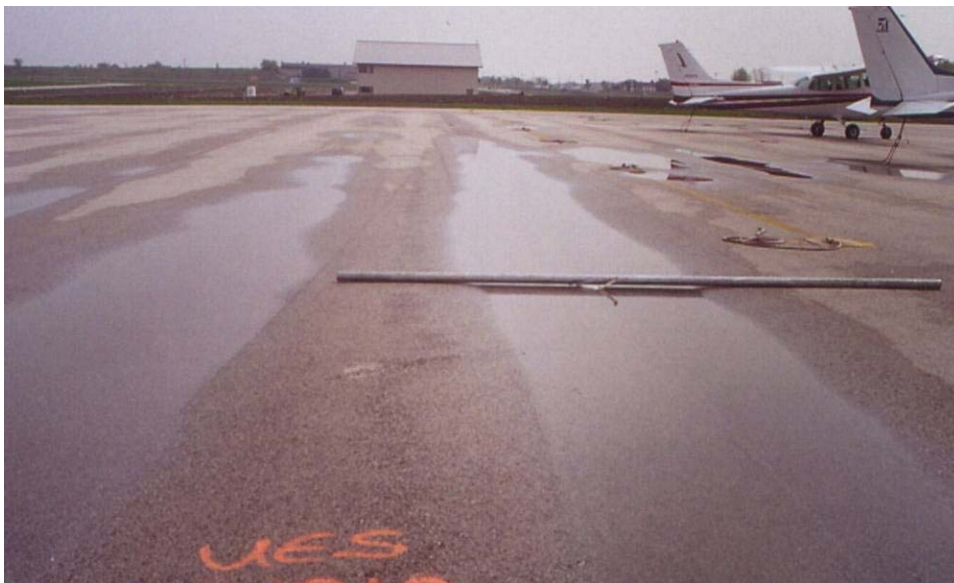
Example of Rutting

Ruts are localized, load related, areas of pavement having elevations lower than the surrounding sections. Rutting is due to base and subgrade consolidation, caused by excessive wheel loads or poor compaction. Ruts indicate structural failure, and can cause hydroplaning. At low severity, ruts have an

average depth of ¼ to ½ inches. At medium severity, ruts have an average depth of ½ to 1 inch. High severity, ruts have an average depth greater than 1 inch. Full-depth patching is the appropriate repair for ruts.

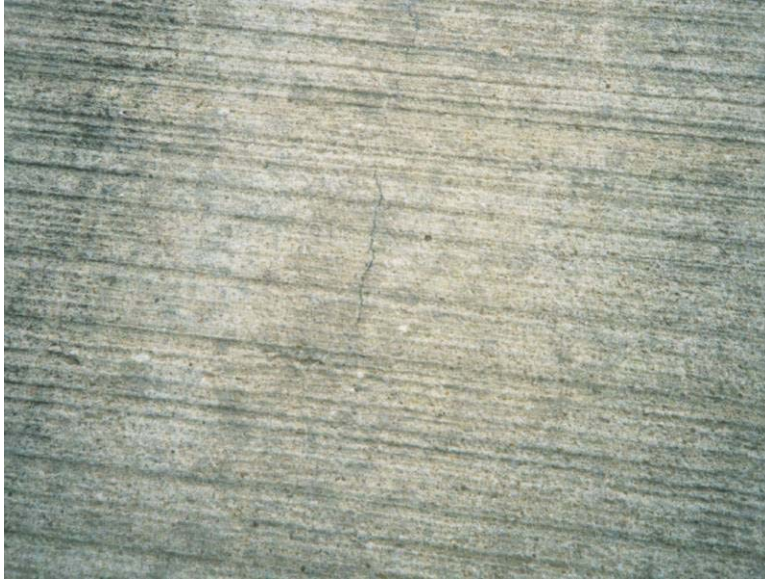
Example of Shrinkage Cracking

Shrinkage cracks are small, nonworking (no spalling along edge) cracks that are visible at the surface but do not penetrate through the full depth of concrete. Shrinkage cracks most commonly occur shortly after construction due to concrete shrinkage during the curing process. Shrinkage cracks are usually so small that they are not visible until staining or material loss at crack edges begins to take place. Shrinkage cracks do not represent a structural weakness, and no corrective action is prescribed.

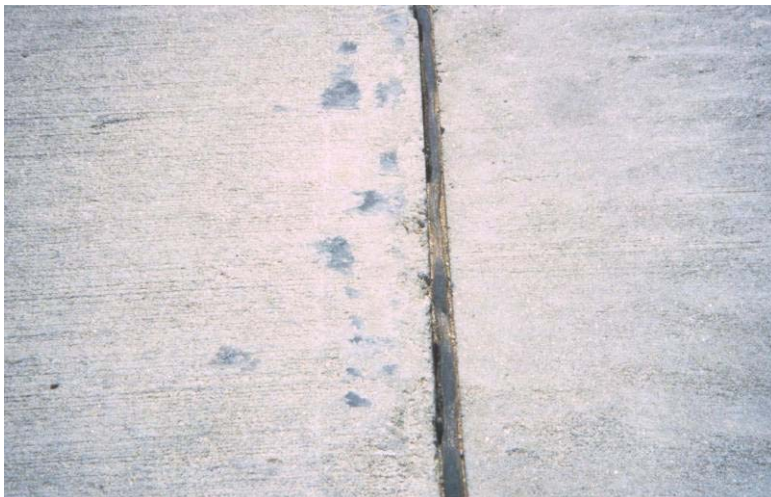
Example of Joint Seal Damage

Joint seal damage is recorded at three severities: low, medium, and high. When joint sealant is in perfect condition (no damage), it is not a distress. At low severity, at least 10 percent of the sealant is debonded but still in contact with the joint edges (i.e., joint sealant is in serviceable condition but should

be monitored for evidence of more serious failure). Medium-severity joint seal damage is recorded when at least 10 percent of the sealant has visible gaps smaller than 1/8th inch and is an indicator that replacement should be programmed as soon as is practicable. In the meantime, aggressive inspection and sustaining maintenance is recommended to minimize subsurface damage from moisture penetration. At high severity, visible gaps exceed 1/8th inch and the amount and degree of joint seal damage is such that repair is no longer feasible. The only appropriate corrective action is sealant replacement.
