Maine Department of Transportation

Pavement Condition Report

CENTRAL MAINE AIRPORT OF NORRIDGEWOCK (KOWK)

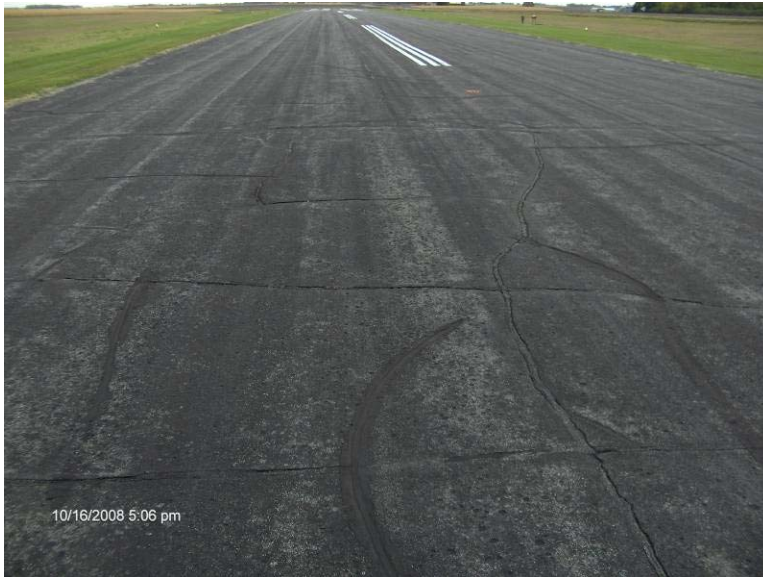
Example of Block Cracking

Block cracking is longitudinal and transverse cracking that has established a pattern of blocks ranging in size from 1ft x 1ft to 10ft x 10ft. This distress typically happens in older asphalt pavements and is an indication that the bituminous binder has lost most of its flexibility. The severity determination is basically determined by the crack width criteria defined for longitudinal and transverse cracking. Crack sealing typically is used to repair block cracking; however, the amount of required sealant can be extensive due to the high density of cracks.
